Ref: 13113

19 December 2010

**Report: Arboricultural Hazard Assessment & Resistograph Testing
Wollongong Hospital, Wollongong NSW (*the site*).**

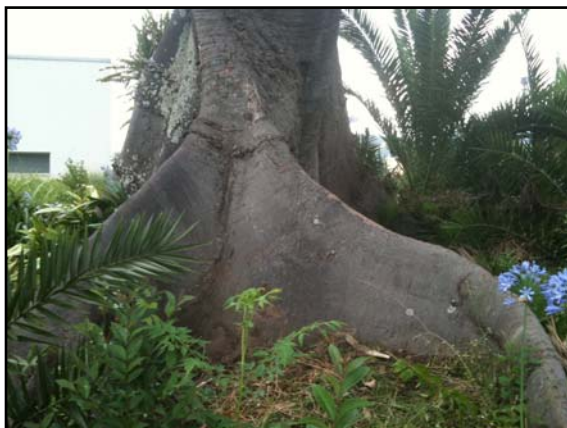
Photo 5

Below – View of trunk facing west

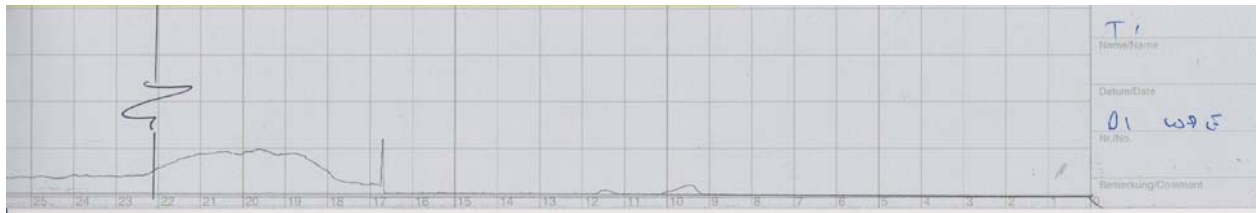
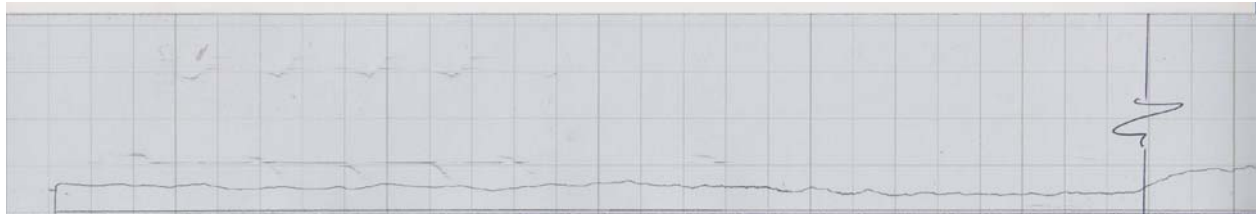
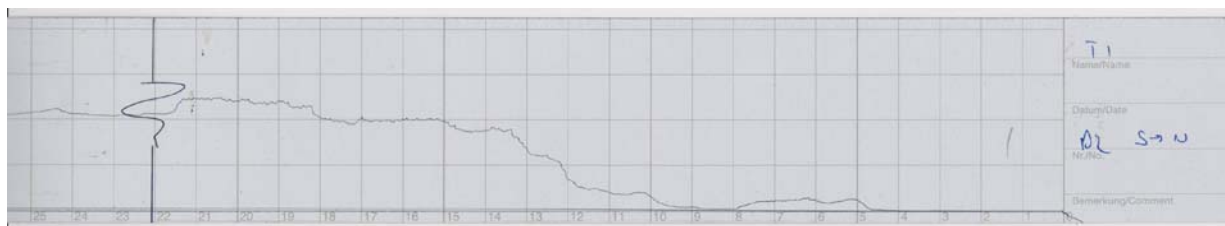
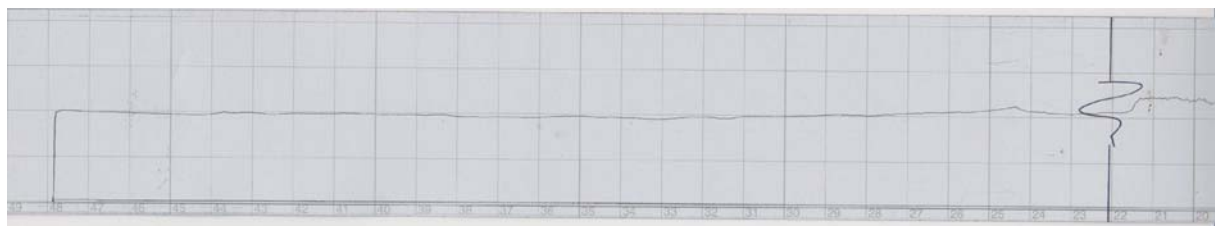
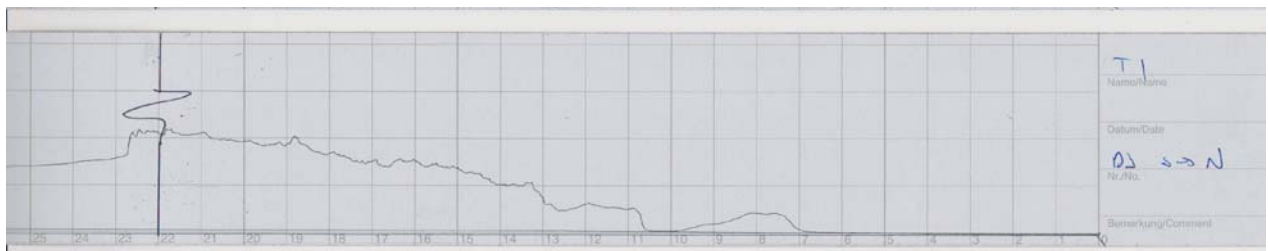
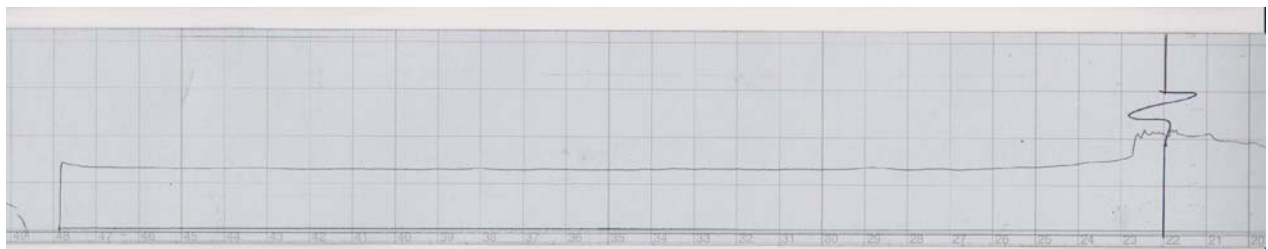
Adequate sound wood is currently expected with ample sound wood situated above the decay within the buttress to the north/west.

The failure potential at the lower trunk is currently considered low to medium.

Tree 1 supported decay which was situated basally and predominately confined to the trunk tissue. Adequate sound wood remains with a low to medium failure potential.

Tree 1 should again be assessed with Resistograph testing undertaken in 3 -5 years to determine the speed of deterioration and pattern of internal decay.

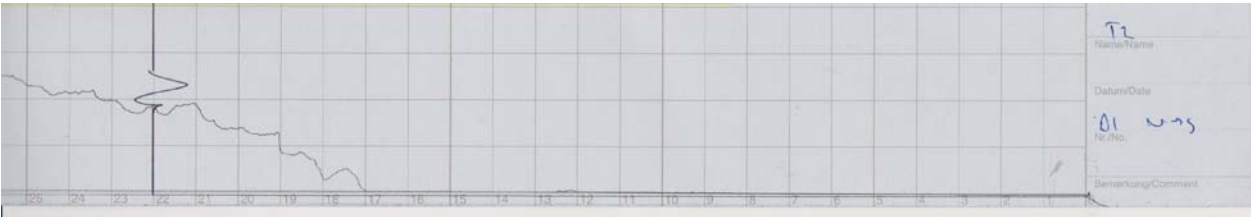
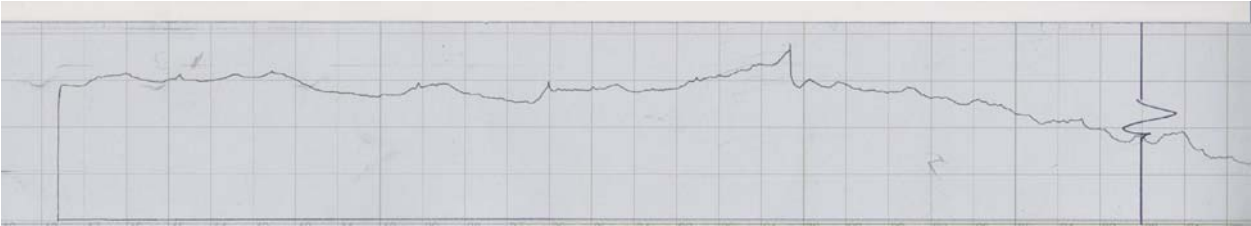
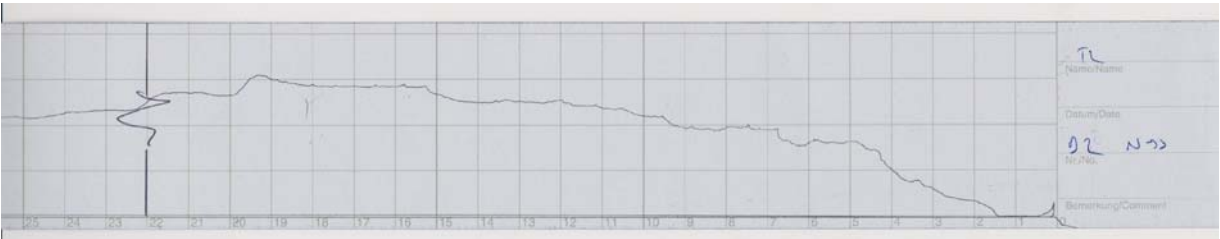
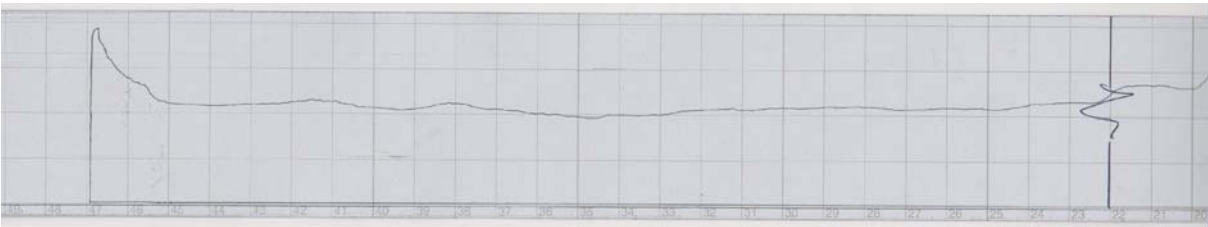
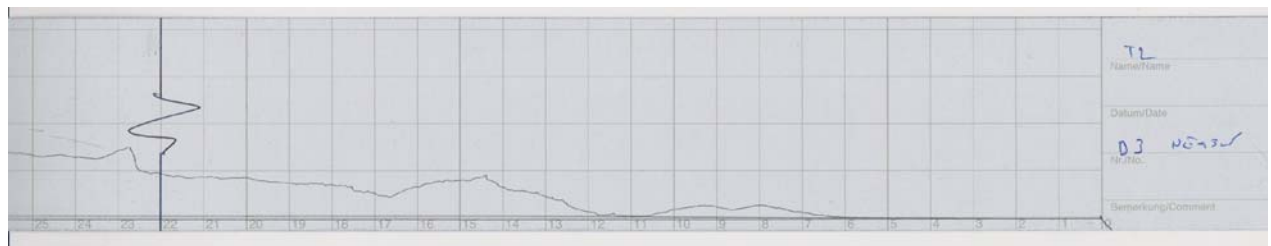
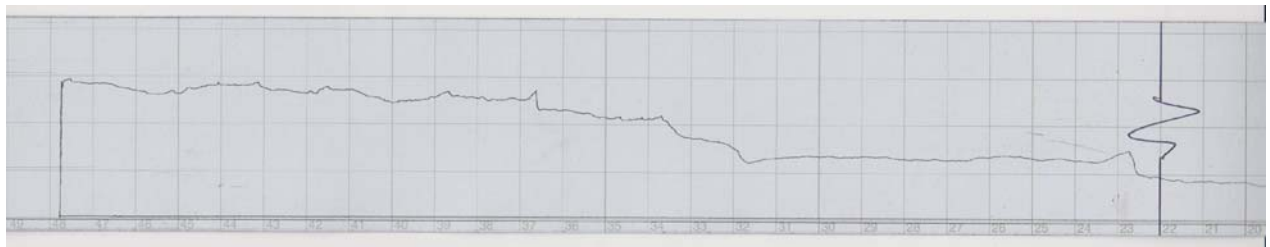
Sufficient supporting wood remained at the lower trunk in cross section. Minimal decay only was detected, with no adverse affect on the mechanical strength expected.

The tree was observed to be currently structurally sound and stable, with no indication of potential failure by bending fracture or cross sectional flattening. The failure potential for Tree 2 at the cross section examined is currently considered low.

Tree 2 supported minimal decay with the failure potential considered low.
