**HERITAGE IMPACT ASSESSMENT
PROPOSED BLASTING CLOSE TO
HERITAGE LISTED DRY STONE WALL
(G2B H54) ON TOOLIJOOA RIDGE
FOXGROUND AND BERRY BYPASS**

Prepared for Fulton Hogan Construction

Mayne-Wilson & Associates

October 2014

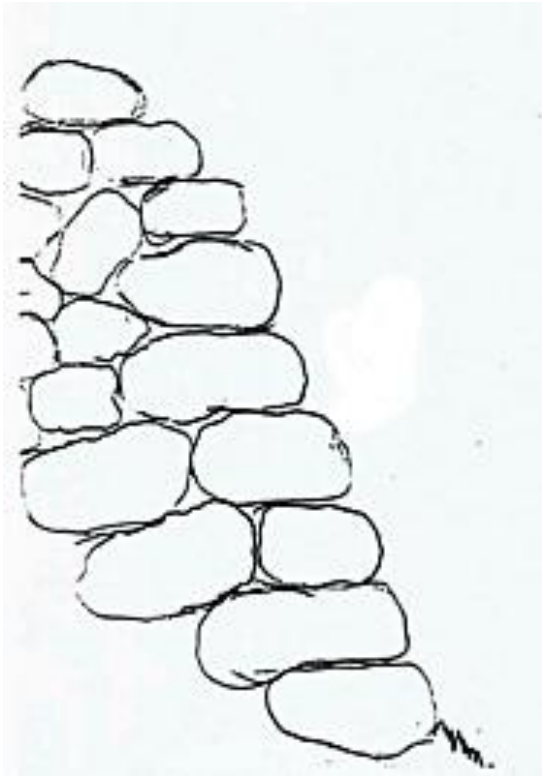
This is the recommended technique for walls along a steep slope, with stepped and overlapped large foundation and coping stones, all leaning a little back into the slope.

As can be seen from these images, the wall is already in a partially dilapidated condition with only a few small sections retaining its original A-frame construction. This is due to a number of factors:

- Loss of some or a lot of the coping stones which were placed on top of the original wall to provide the pressure that was intended to hold the two 'skins' (double dyke) together
- Intrusive vegetation, particularly lantana, the branches of which have grown between both the side stones and the internal rubble stones and through swelling, loosening their binding
- Storms and heavy rainfall causing the underlying ground to become temporarily soggy and allow some shifting of the heavy blocks at the base, and consequently up through the skins of the wall.
- Neglect of the landholder/s to maintain the wall, especially the coping stones, and the invasive vegetation
- Only moderate skill sets by the waller himself; and
- The awkward shape of some the basaltic rocks which made tight fitting together (cohesion) quite difficult.

- Undertake trial blasts to determine future vibration levels near the wall
- Undertake detailed photographic recording of the current condition of the wall in the area likely to be affected by increased blasting criteria, and
- Undertake an inspection of the affected section of the wall before and after each blast to monitor the effects of blasting on the wall.
