# ARBORIST'S REPORT

PROPERTY:	3 Murray Rose Avenue, Sydney Olympic Park
NUMBER OF SUBJECT TREES:	50
DATE OF REPORT:	11/7/2012
REQUESTED BY:	Lend Lease Project Management and Construction
CONTACT:	Grant Eckett

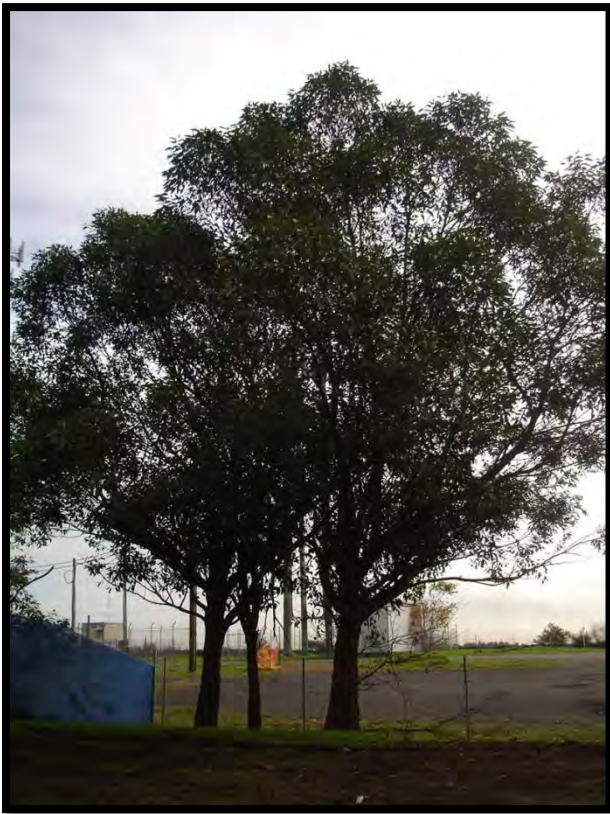
Trees 12, 13 & 14 (left to right).

<u>CBH</u>	560mm			
	<u>DBH</u>	178mm			
<b>Common Name</b> Swamp Mahogany	<u>Height:</u>	9 metres			
	<u>Canopy Spread:</u>	5m X 4m			
<b>Tree 14</b> <b>Botanical Name</b> <i>Eucalyptus robusta</i>	<u>Age:</u>	Mature	The tree is in fair health, having a leaf density of 60% coverage. Slight deadwood to 70mm diameter is present.	The tree has a poor structure having the main leader broken off at 4 metres high, with a deadwood stub 500mm long x 80mm diameter remaining. A moderate amount of epicormic growth to 7 metres long x 100mm diameter is present.	The tree has been given a ULE of 3B due to the poor structure.
	<u>CBH</u>	1380mm			
	<u>DBH</u>	439mm			
<b>Common Name</b> Swamp Mahogany	<u>Height:</u>	11 metres			
	<u>Canopy Spread:</u>	10m X 9m

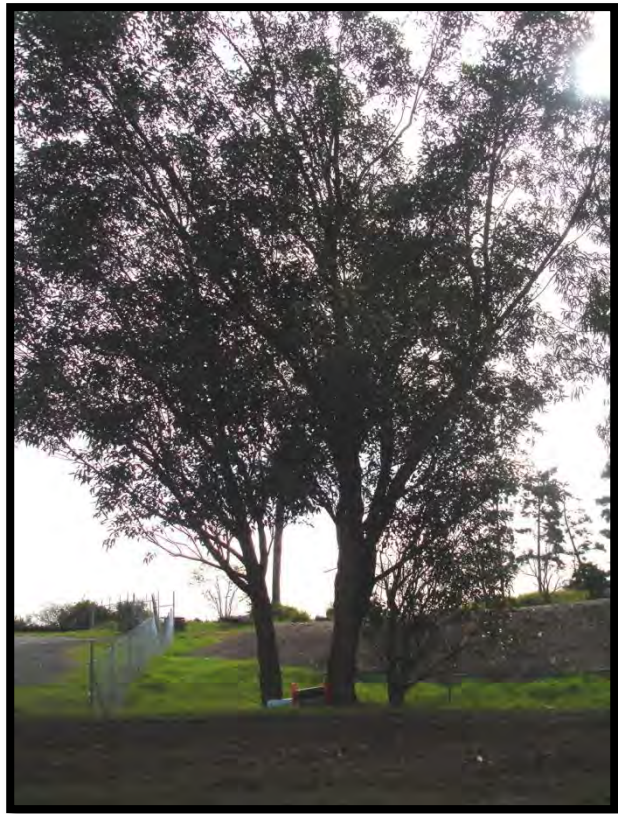
Trees 15, 16 (left to right).

Tree Identification	Description		Health	Structure	U.L.E. (Useful Life Expectancy)
<b>Tree 15</b> <b>Botanical Name</b> <i>Eucalyptus robusta</i>	<u>Age:</u>	Early Mature	The tree is in fair health, having a leaf density of 60% coverage. Slight deadwood to 50mm diameter is present.	The tree has a fair structure having some small epicormic growth to 2 metres long x 50mm diameter, and a natural lean of 5° to the west [away from Tree 16.	The tree has been given a ULE of 3B due to the fair condition.
	<u>CBH</u>	940mm			
	<u>DBH</u>	299mm			
<b>Common Name</b> Swamp Mahogany	<u>Height:</u>	9 metres			
	<u>Canopy Spread:</u>	9m X 6m			
<b>Tree 16</b> <b>Botanical Name</b> <i>Eucalyptus robusta</i>	<u>Age:</u>	Mature	The tree is in fair health, having a leaf density of 60% coverage. Slight deadwood to 60mm diameter is present. A deadwood stub measuring 300mm long x 80mm diameter is present at 3 metres high.	The tree has a fair structure having scaffold branches from 1100mm high. A moderate amount of epicormic growth measuring 5 metres long x 70mm diameter is present.	The tree has been given a ULE of 3B due to the fair condition.

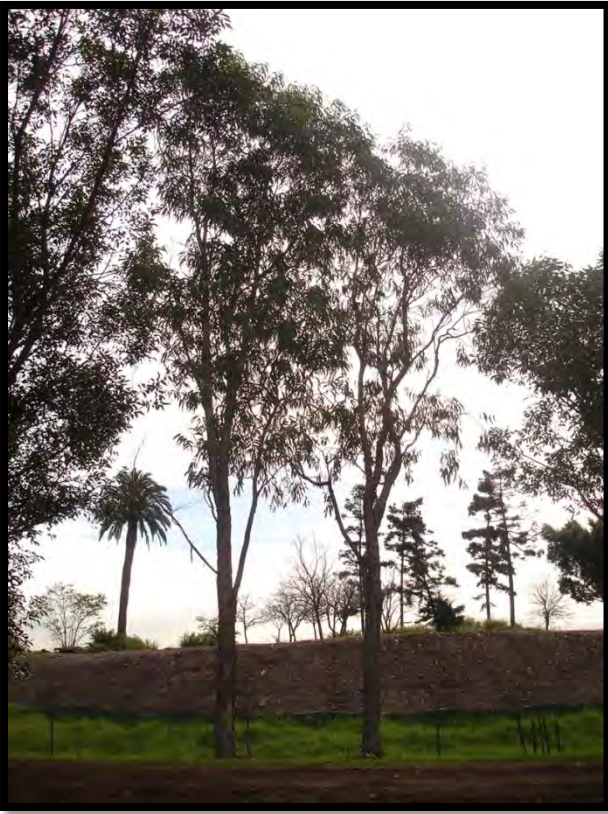
Trees 17 & 18 (centre).

<u>CBH</u>	1370mm (at 900mm high)			
	<u>DBH</u>	436mm (at 900mm high)			
<b>Common Name</b> Swamp Mahogany	<u>Height:</u>	12 metres			
	<u>Canopy Spread:</u>	13m X 10m			
<b>Tree 17</b> <b>Botanical Name</b> <i>Corymbia eximia</i>	<u>Age:</u>	Early Mature	The tree is in fair health, having a leaf density of 60% coverage. Slight deadwood to 50mm diameter is present.	The tree has a fair structure having co - dominant stems from 4 metres high.	The tree has been given a ULE of 3B due to the fair condition.
	<u>CBH</u>	800mm			
	<u>DBH</u>	254mm			
<b>Common Name</b> Yellow Bloodwood	<u>Height:</u>	11 metres			
	<u>Canopy Spread:</u>	7m X 4m

Tree Identification	Description		Health	Structure	U.L.E. (Useful Life Expectancy)
<b>Tree 18</b> <b>Botanical Name</b> <i>Corymbia eximia</i>	<u>Age:</u>	Semi Mature	The tree is in fair health, having a leaf density of 50% coverage. Slight deadwood to 50mm diameter is present. Slight tip dieback is present on the north side of the canopy.	The tree has a fair structure having 3 dominant stems from 4 metres high.	The tree has been given a ULE of 3B due to the fair condition.
	<u>CBH</u>	680mm			
	<u>DBH</u>	216mm			
<b>Common Name</b> Yellow Bloodwood	<u>Height:</u>	10 metres			
	<u>Canopy Spread:</u>	5m X 4m			
<b>Tree 19</b> <b>Botanical Name</b> <i>Eucalyptus robusta</i>	<u>Age:</u>	Early Mature	The tree is in fair health, having a leaf density of 60% coverage. Moderate deadwood to 80mm diameter is present.	The tree has a fair structure having scaffold branches from 1.2 metres high. Some epicormic growth to 2 metres long x 60mm diameter is present.	The tree has been given a ULE of 3B due to the fair condition.

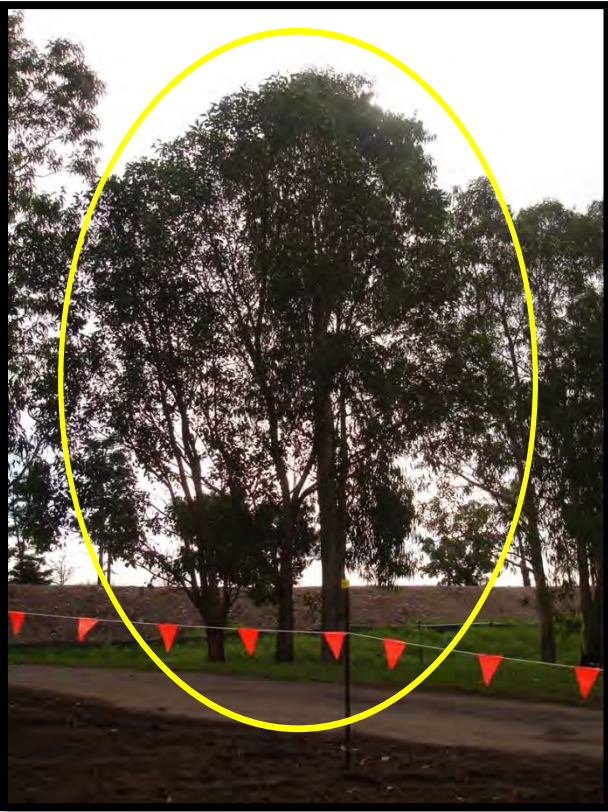
Trees 21, 22, & 23 (outlined).

Tree Identification	Description		Health	Structure	U.L.E. (Useful Life Expectancy)
<b>Tree 21</b> <b>Botanical Name</b> <i>Eucalyptus robusta</i>	<u>Age:</u>	Early Mature	The tree is in fair health, having a leaf density of 60% coverage. Slight deadwood to 50mm diameter is present.	The tree has a poor structure. The main leader has broken off, and the canopy has 3 dominant stems from 1 metre high, which is all epicormic growth to 8 metres long x 150mm diameter.	The tree has been given a ULE of 4C due to the poor structure.
	<u>CBH</u>	900mm (at 500mm high)			
	<u>DBH</u>	286mm (at 500mm high)			
<b>Common Name</b> Swamp Mahogany	<u>Height:</u>	9 metres			
	<u>Canopy Spread:</u>	8m X 5m			
<b>Tree 22</b> <b>Botanical Name</b> <i>Eucalyptus robusta</i>	<u>Age:</u>	Early Mature	The tree is in fair health, having a leaf density of 60% coverage. Slight deadwood to 50mm diameter is present.	The tree has a poor structure having co - dominant stems from 1.2 metres high. A moderate amount of epicormic growth measuring 6 metres long x 80mm diameter is present.	The tree has been given a ULE of 3B due to the poor structure.

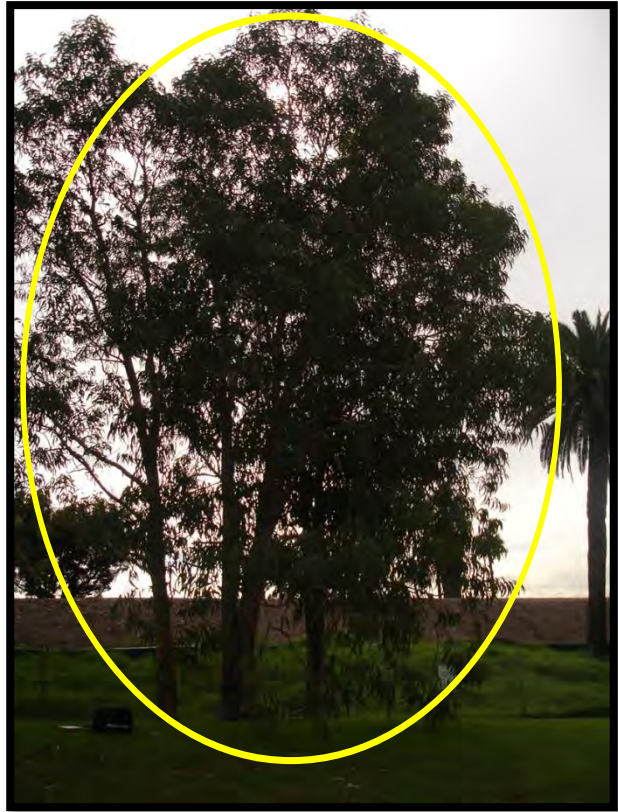
Trees 24, 25, & 26 (outlined).

Tree Identification	Description		Health	Structure	U.L.E. (Useful Life Expectancy)
<b>Tree 24</b> <b>Botanical Name</b> <i>Corymbia eximia</i>	<u>Age:</u>	Semi Mature	The tree is in fair health, having a leaf density of 50% coverage. Slight deadwood to 50mm diameter is present.	The tree has a fair structure having co - dominant stems from 4.5 metres high.	The tree has been given a ULE of 3B due to the fair condition.
	<u>CBH</u>	790mm			
	<u>DBH</u>	251mm			
<b>Common Name</b> Yellow Bloodwood	<u>Height:</u>	10 metres			
	<u>Canopy Spread:</u>	8. m X 5m			
<b>Tree 25</b> <b>Botanical Name</b> <i>Corymbia eximia</i>	<u>Age:</u>	Semi Mature	The tree is in fair health, having a leaf density of 50% coverage. Slight deadwood to 50mm diameter is present.	The tree has a poor structure having 3 dominant stems from 200mm high with included bark to 1.3 metres high. The south stem is a large epicormic shoot 8 metres long x 200mm diameter. Some branch rubbing is present.	The tree has been given a ULE of 4C due to the poor structure.

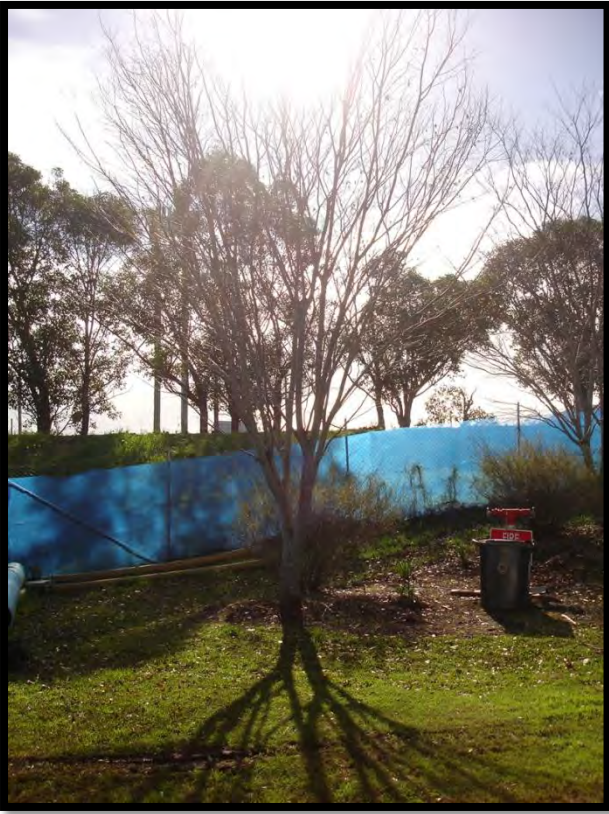
Tree 29.

<b>Common Name</b> Chinese Elm	<u>Height:</u>	6 metres			
	<u>Canopy Spread:</u>	5m X 6m			
<b>Tree 29</b> <b>Botanical Name</b> <i>Ulmus parvifolia</i>	<u>Age:</u>	Early Mature	The tree is in fair health. Slight stem borer activity is present around some branch unions. No live borer specimens were observed.	The tree has a fair structure having co - dominant stems from 800mm high.	The tree has been given a ULE of 3B due to the co - dominant stems.
	<u>CBH</u>	730mm (at 500mm high)			
	<u>DBH</u>	232mm (at 500mm high)			
<b>Common Name</b> Chinese Elm	<u>Height:</u>	6 metres			
	<u>Canopy Spread:</u>	5m X 5m
