DEMOLITION/REFURBISHMENT HAZARDOUS MATERIAL RISK ASSESSMENT

DATE: FEBRUARY 2020

OUR REFERENCE:
C107662 : J162866

JDH ARCHITECTS
BANKSTOWN NORTH PUBLIC SCHOOL
322 HUME HIGHWAY, BANKSTOWN NSW 2200

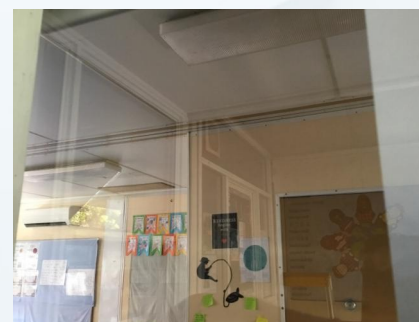
ITEM NO.: 117
 PHOTO NO.: J162866-1124-PHOTO090
 RESULT: ASBESTOS - PRESUMED POSITIVE
 BUILDING/LEVEL: D15243 - GROUND LEVEL
 ROOM/LOCATION: ALL ROOMS - THROUGHOUT
 FEATURE/MATERIAL: CEILING LINING - FIBRE CEMENT SHEETING
 SAMPLE NO.: SIMILAR TO: J162866-1124-012

117	All rooms - Throughout Ceiling Lining - Fibre Cement Sheeting	Asbestos	Similar To: J162866-1124-012	Presumed Positive	J162866-124-Photo 091 J162866-124-Photo 090	50 m ²	Good	Non Friable	Low	Low	Not Labelled	19/02/2025	P4	Remove under controlled conditions by an appropriately licensed asbestos contractor prior to refurbishment or demolition likely to disturb the material. Maintain in-situ if not to be affected by proposed works.

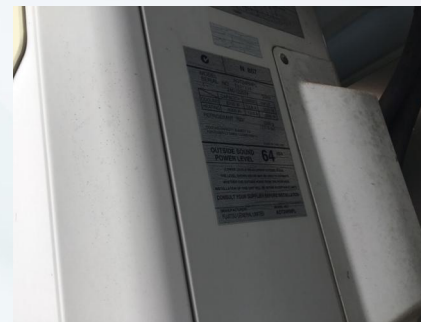
ITEM NO.: 118
 PHOTO NO.: J162866-1124-PHOTO059
 RESULT: ODS - POSITIVE
 BUILDING/LEVEL: D15583 - GROUND LEVEL
 ROOM/LOCATION:
 FEATURE/MATERIAL: A/C UNIT - R22 - CHLORODIFLUOROMETHANE
 SAMPLE NO.: -

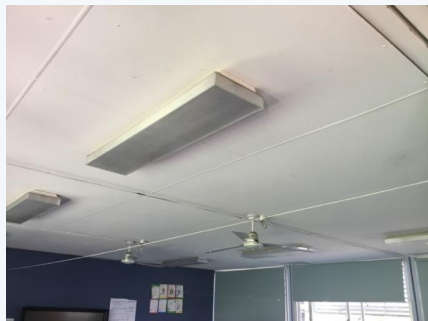
ITEM NO.: 123
 PHOTO NO.: J162866-1124-PHOTO078
 RESULT: ASBESTOS - POSITIVE
 BUILDING/LEVEL: D15583 - GROUND LEVEL
 ROOM/LOCATION: ALL AREAS - THROUGHOUT
 FEATURE/MATERIAL: CEILING LINING - FIBRE CEMENT SHEETING
 SAMPLE NO.: J162866-1124-024

D15583 - Interior - Ground Level															
123	All areas - Throughout Ceiling Lining - Fibre Cement Sheeting	Asbestos	J162866-1124-024	Positive	J162866-1 124-Photo 078	50 m ²	Good	Non Friable	Low	Low	Not Labelled	19/02/2025	P4	Remove under controlled conditions by an appropriately licensed asbestos contractor prior to refurbishment or demolition likely to disturb the material. Maintain in-situ if not to be affected by proposed works.	
124	All rooms Fluorescent Light Fitting - Capacitor	PCB		Presumed Positive	J162866-1 124-Photo 079	8 Unit/s	Good							Remove by an appropriately experienced contractor under controlled conditions and using correct PPE if this item will be impacted by refurbishment/ demolition works.	
125	Classroom - Northeast Electrical Distribution Board - Electrical Components - No keys, DB 1682	Asbestos	Not Sampled Restricted Access	Presumed Positive	J162866-1 124-Photo 081	1 Unit/s	Good	Non Friable	Low	Low	Not Labelled	19/02/2025	P4	Remove under controlled conditions by an appropriately licensed asbestos contractor prior to refurbishment or demolition likely to disturb the material. Maintain in-situ if not to be affected by proposed works.

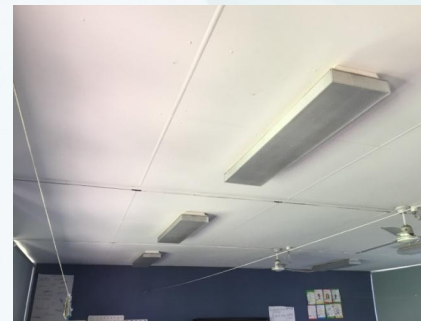
ITEM NO.: 124
 PHOTO NO.: J162866-1124-PHOTO079
 RESULT: PCB - PRESUMED POSITIVE
 BUILDING/LEVEL: D15583 - GROUND LEVEL
 ROOM/LOCATION: ALL ROOMS
 FEATURE/MATERIAL: FLUORESCENT LIGHT FITTING - CAPACITOR
 SAMPLE NO.: -

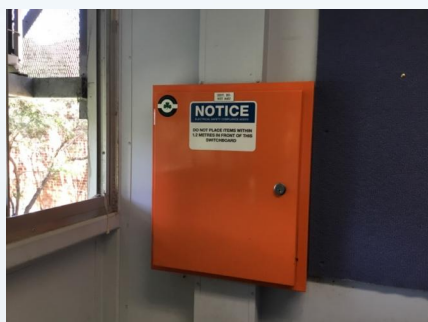
ITEM NO.: 125
 PHOTO NO.: J162866-1124-PHOTO081
 RESULT: ASBESTOS - PRESUMED POSITIVE
 BUILDING/LEVEL: D15583 - GROUND LEVEL
 ROOM/LOCATION: CLASSROOM - NORTHEAST
 FEATURE/MATERIAL: ELECTRICAL DISTRIBUTION BOARD - ELECTRICAL COMPONENTS
 SAMPLE NO.: NOT SAMPLED RESTRICTED ACCESS

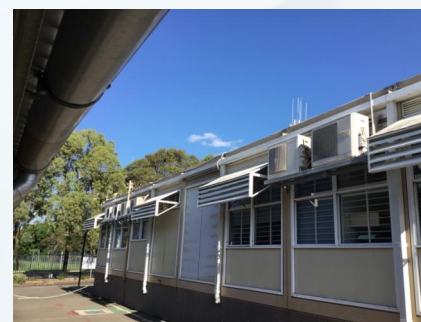
ITEM NO.: 128
 PHOTO NO.: J162866-1124-PHOTO130
 RESULT: ODS - PRESUMED POSITIVE
 BUILDING/LEVEL: D15886 - GROUND LEVEL
 ROOM/LOCATION: EXTERIOR - NORTH
 FEATURE/MATERIAL: A/C UNIT - UNABLE TO DETERMINE
 SAMPLE NO.: -

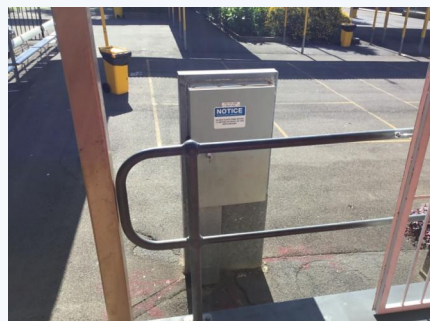
ITEM NO.: 130
 PHOTO NO.: J162866-1124-PHOTO129
 RESULT: **ASBESTOS - PRESUMED POSITIVE**
 BUILDING/LEVEL: **D15886 - GROUND LEVEL**
 ROOM/LOCATION: **EXTERIOR - SOUTHWEST**
 FEATURE/MATERIAL: **ELECTRICAL DISTRIBUTION BOARD - ELECTRICAL COMPONENTS**
 SAMPLE NO.: **NOT SAMPLED RESTRICTED ACCESS**

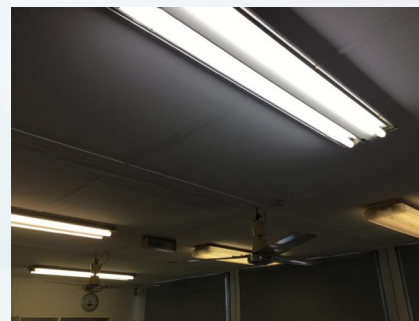
ITEM NO.: 137
 PHOTO NO.: J162866-1124-PHOTO114
 RESULT: **PCB - PRESUMED POSITIVE**
 BUILDING/LEVEL: **D15886 - GROUND LEVEL**
 ROOM/LOCATION: **ALL ROOMS**
 FEATURE/MATERIAL: **FLUORESCENT LIGHT FITTING - CAPACITOR**
 SAMPLE NO.: -

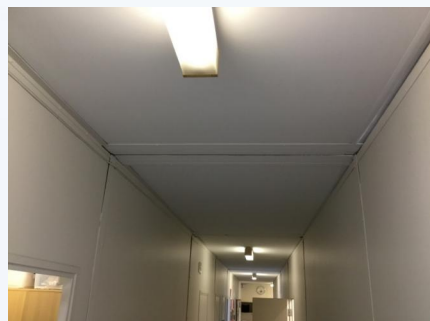
ITEM NO.: 137
 PHOTO NO.: J162866-1124-PHOTO115
 RESULT: **PCB - PRESUMED POSITIVE**
 BUILDING/LEVEL: **D15886 - GROUND LEVEL**
 ROOM/LOCATION: **ALL ROOMS**
 FEATURE/MATERIAL: **FLUORESCENT LIGHT FITTING - CAPACITOR**
 SAMPLE NO.: -

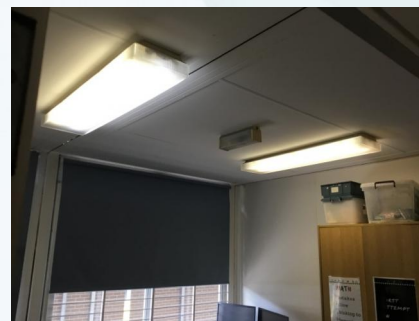
ITEM NO.: 137
 PHOTO NO.: J162866-1124-PHOTO117
 RESULT: **PCB - PRESUMED POSITIVE**
 BUILDING/LEVEL: **D15886 - GROUND LEVEL**
 ROOM/LOCATION: **ALL ROOMS**
 FEATURE/MATERIAL: **FLUORESCENT LIGHT FITTING - CAPACITOR**
 SAMPLE NO.: -

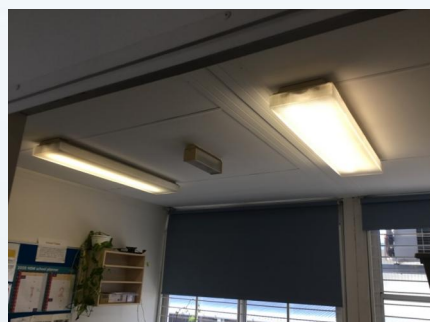
ITEM NO.: 137
 PHOTO NO.: J162866-1124-PHOTO116
 RESULT: **PCB - PRESUMED POSITIVE**
 BUILDING/LEVEL: **D15886 - GROUND LEVEL**
 ROOM/LOCATION: **ALL ROOMS**
 FEATURE/MATERIAL: **FLUORESCENT LIGHT FITTING - CAPACITOR**
 SAMPLE NO.: -

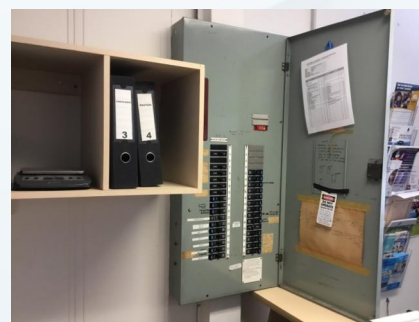
ITEM NO.: 141
 PHOTO NO.: J162866-1124-PHOTO127
 RESULT: **ASBESTOS - PRESUMED POSITIVE**
 BUILDING/LEVEL: **D15886 - GROUND LEVEL**
 ROOM/LOCATION: **RECEPTION DESK - EAST**
 FEATURE/MATERIAL: **ELECTRICAL DISTRIBUTION BOARD - ELECTRICAL COMPONENTS**
 SAMPLE NO.: **NOT SAMPLED LIVE ELECTRICAL HAZARD**

141	Reception Desk - East Electrical Distribution Board - Electrical Components - DB Admin	Asbestos	Not Sampled Live Electrical Hazard	Presumed Positive	J162866-1 124-Photo 127	36 Unit/s	Good	Non Friable	Low	Low	Not Labelled	19/02/2025	P4	Remove under controlled conditions by an appropriately licensed asbestos contractor prior to refurbishment or demolition likely to disturb the material. Maintain in-situ if not to be affected by proposed works.	
142	Sick Bay - East Floor Covering - Sheet Vinyl - Pale blue mottled dark blue	Asbestos	Not Sampled New Appearance	Presumed Negative											
143	Staff Room - East Floor Covering - Sheet Vinyl - Pale blue mottled dark blue	Asbestos	Not Sampled New Appearance	Presumed Negative											
144	Staff Room - East - Above Sink Hot Water Heater - Insulation Material	SMF		Presumed Positive	J162866-1 124-Photo 121	1 Unit/s	Good	Bonded (SMF)						Remove by an appropriately experienced contractor under controlled conditions and using correct PPE if this material will be impacted by refurbishment/ demolition works.

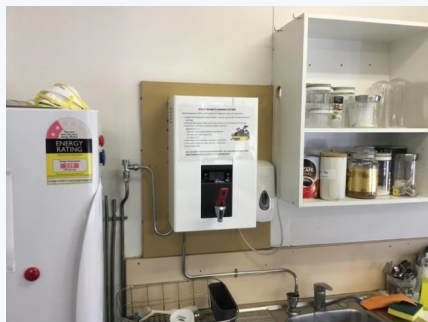
ITEM NO.: 144
PHOTO NO.: J162866-1124-PHOTO121
RESULT: SMF - PRESUMED POSITIVE
BUILDING/LEVEL: D15886 - GROUND LEVEL
ROOM/LOCATION: STAFF ROOM - EAST - ABOVE SINK
FEATURE/MATERIAL: HOT WATER HEATER - INSULATION MATERIAL
SAMPLE NO.: -

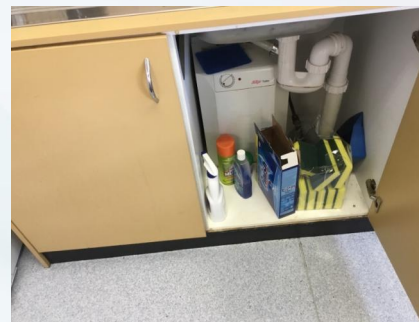
ITEM NO.: 145
PHOTO NO.: J162866-1124-PHOTO122
RESULT: SMF - PRESUMED POSITIVE
BUILDING/LEVEL: D15886 - GROUND LEVEL
ROOM/LOCATION: STAFF ROOM - EAST - BELOW SINK
FEATURE/MATERIAL: HOT WATER HEATER - INSULATION MATERIAL
SAMPLE NO.: -

145	Staff Room - East - Below Sink Hot Water Heater - Insulation Material	SMF		Presumed Positive	J162866-1 124-Photo 122	1 Unit/s	Good	Bonded (SMF)						Remove by an appropriately experienced contractor under controlled conditions and using correct PPE if this material will be impacted by refurbishment/ demolition works.
