Preliminary Arboricultural Report

Tweed Valley Hospital Project

17 October 2018

Preliminary Arboricultural Report relating to four (4) individual trees and 150+ hedgerow trees located at 771 Cudgen Road Kingscliff NSW

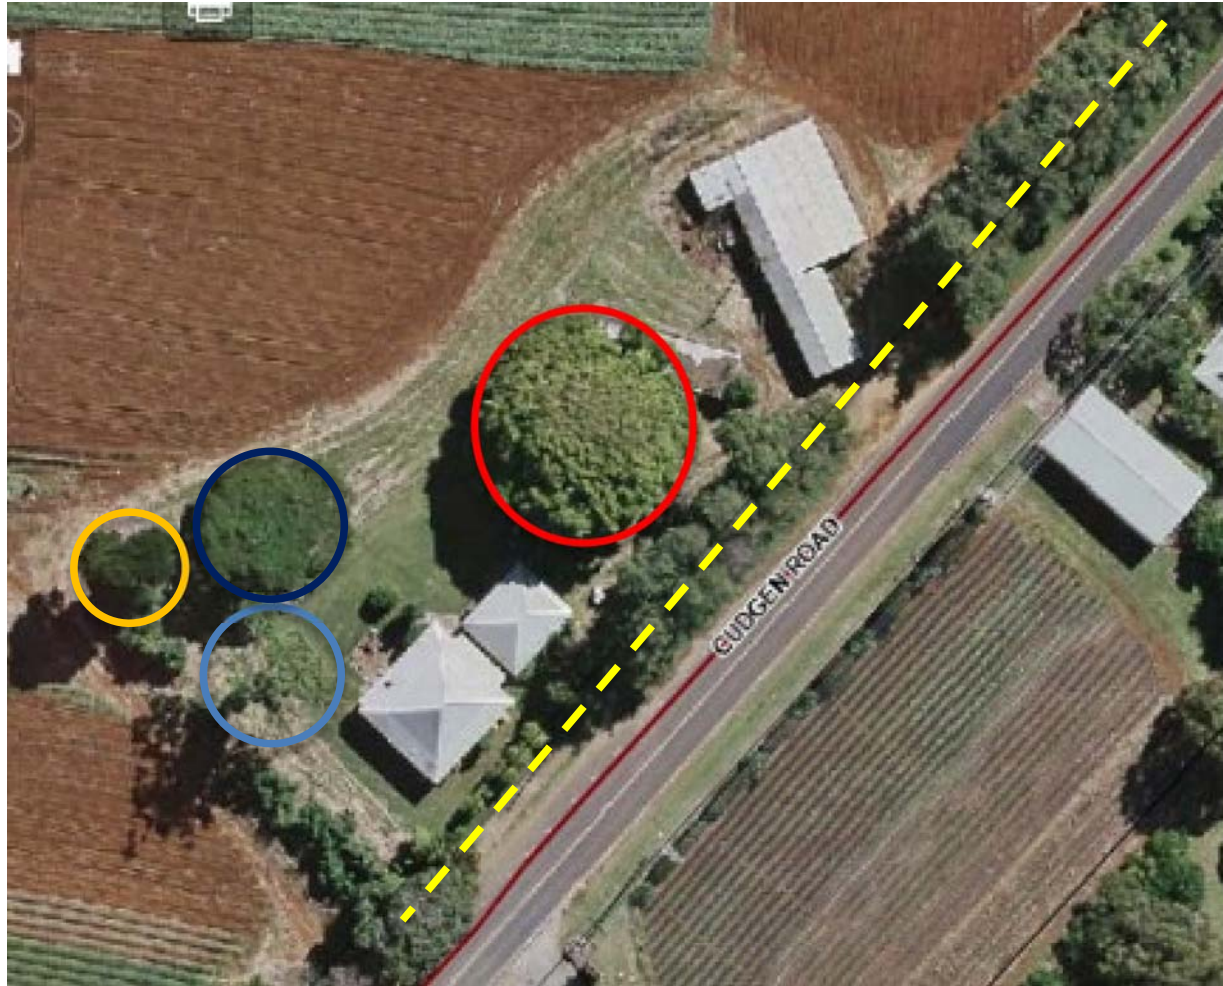
- 4.2.4 An existing house, and associated farm sheds, were located adjacent to Cudgen Road along the site's southern boundary. The four (4) individual site trees subject to this report are located adjacent to the existing property as represented in Figure 4.

Figure 4. The location of the four (4) individual site trees around the existing house site and the line of windbreak trees. Tree 1 – light blue circle, Tree 2 – orange circle, Tree 3 – purple circle, Tree 4 – red circle, Windbreak and regenerating trees – yellow dash line. Source: Image obtained from Tweed Shire Council LEP mapping tool, August 2018. Coloured circles and lines placed by the author.

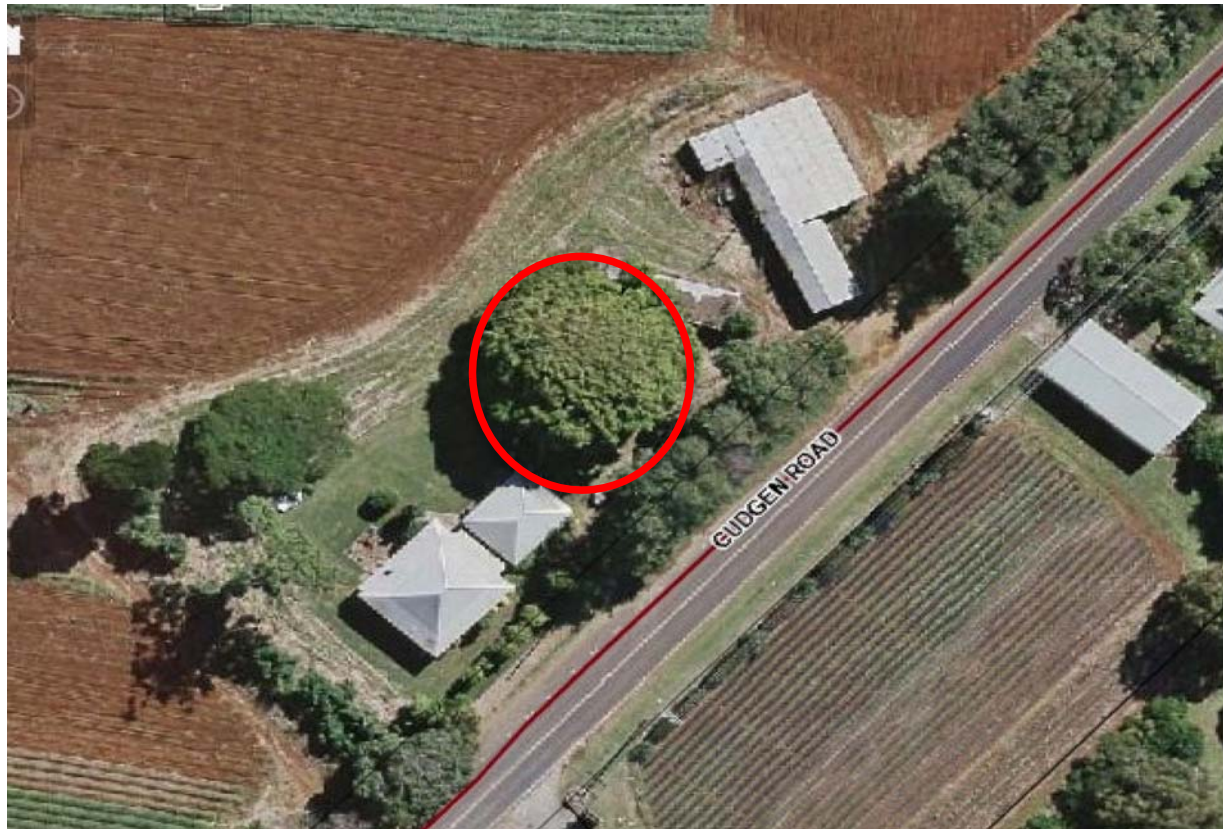
5.2.2 The one (1) Category A Tree was tree number 4.

Figure 5. Aerial image showing the location of High Retention Value Trees. Tree attributes are to be obtained from the Appendix C – Preliminary Tree Assessment Data. Source: image obtained from Tweed Shire Council LEP mapping tool, August 2018. Coloured circle placed by the author

- 5.2.3 Tree 4 was a *Ficus benjamina* (Weeping Fig). The tree was located adjacent to Cudgen road, immediately east of the existing house structure. The tree was large and well established for its species and formed a significant feature within the landscape (see Figure 6).
- 5.2.4 Tree 4 was of good health and fair structure and had an estimated life expectancy of greater than 25 years (25–50 years). The lower trunk structure was a mass of competing stems typical of the species (see Figure 7).
- 5.2.5 The TPZ for Tree 4 is 15m, and the SRZ is 3.9m, measured at a radial distance from the centre of the trunk.

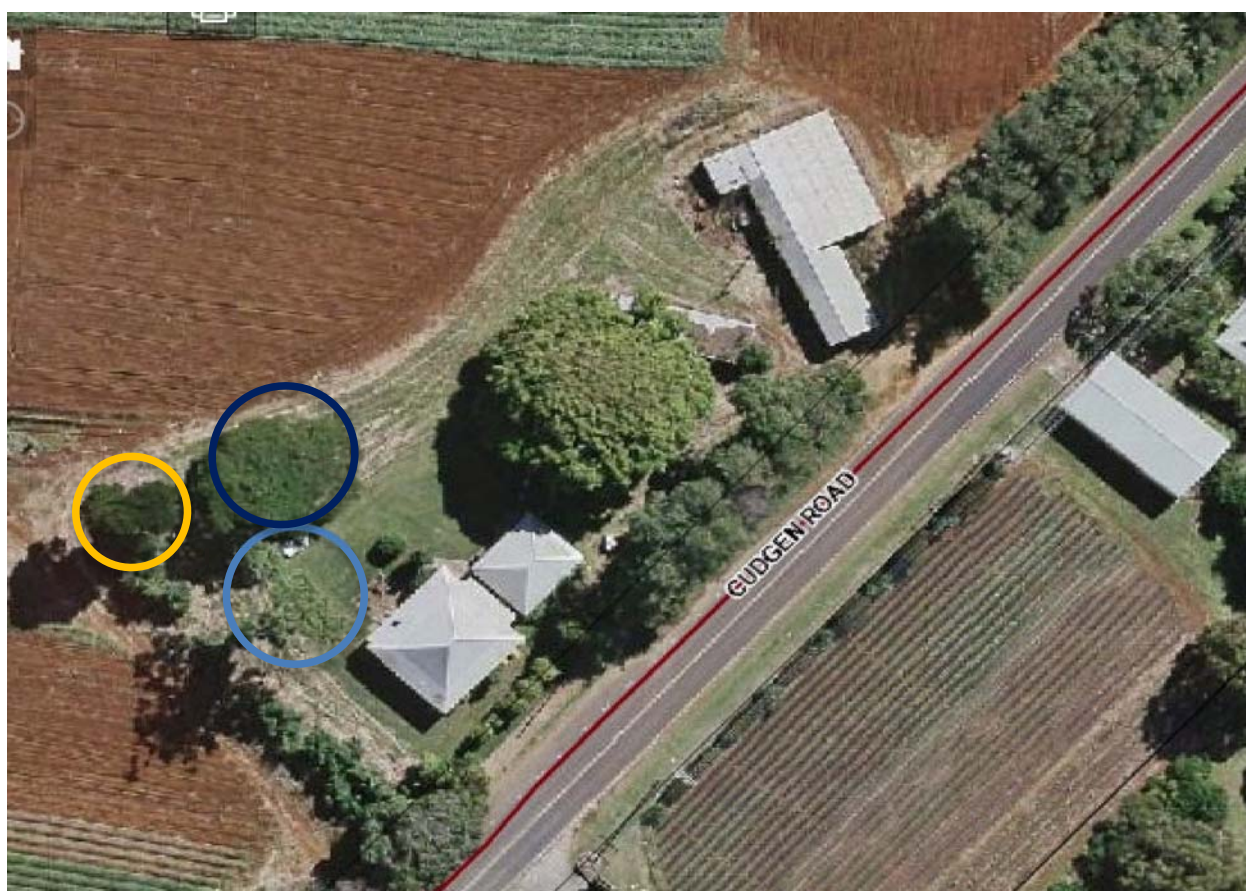
5.3.2 Category B Trees were numbered; 1, 2 & 3 (see Figure 8).

Figure 8. Aerial image showing location of three (3) Moderate Retention Value Trees. Tree 1 – light blue circle, Tree 2 – orange circle, Tree 3 – purple circle. Tree attributes are to be obtained from the Appendix C – Preliminary Tree Assessment Data. Source: image obtained from Tweed Shire Council LEP mapping tool, August 2018. Coloured circles placed by the author

- 5.3.3 Tree 1 was a *Ficus obliqua* (Small Leafed Fig). The tree was considered to be in good health with a fair structure. The tree canopy had a significantly crown bias to the east, attributed to suppression from an adjacent, previously removed tree, which detracted from its overall visual / aesthetic appearance (see Figure 9).
- 5.3.4 The tree had established over and around a decaying stump, from the previously removed tree, causing cavities and uneven growth with the basal area and structural roots. Overall structural stability was not considered to be compromised, at the time of inspection, and root growth of this kind was considered typical of the species. A large European bees' nest was observed within the basal hollows of the tree.
- 5.3.5 The TPZ for Tree 1 is 12m, and the SRZ is 4.4m, measured at a radial distance from the centre of the trunk.

- 5.3.6 Tree 2 was a *Cupaniopsis anacardioides* (Tuckeroo). The tree was of a large size for the species and considered in good health with a fair structure. The tree canopy had a significantly crown bias to the north east, attributed to suppression from an adjacent previously removed tree, which detracted from its overall visual / aesthetic appearance (see Figures 10 and 11). Several wounds from previous lateral branch failures were observed within the crown.
- 5.3.7 The TPZ for Tree 2 is 7.2m, and the SRZ is 2.8m, measured at a radial distance from the centre of the trunk.

- 5.3.8 Tree 3 was a *Delonix regia* (Poinciana). The tree was of a moderate height for the species and was in good health with a fair structure. Several included unions between co-dominant stems were observed. Although these unions were considered stable at the time of assessment they could detract from the tree's long-term structural stability.
- 5.3.9 The TPZ for Tree 3 is 9.4m, and the SRZ is 3.4m, measured at a radial distance from the centre of the trunk.

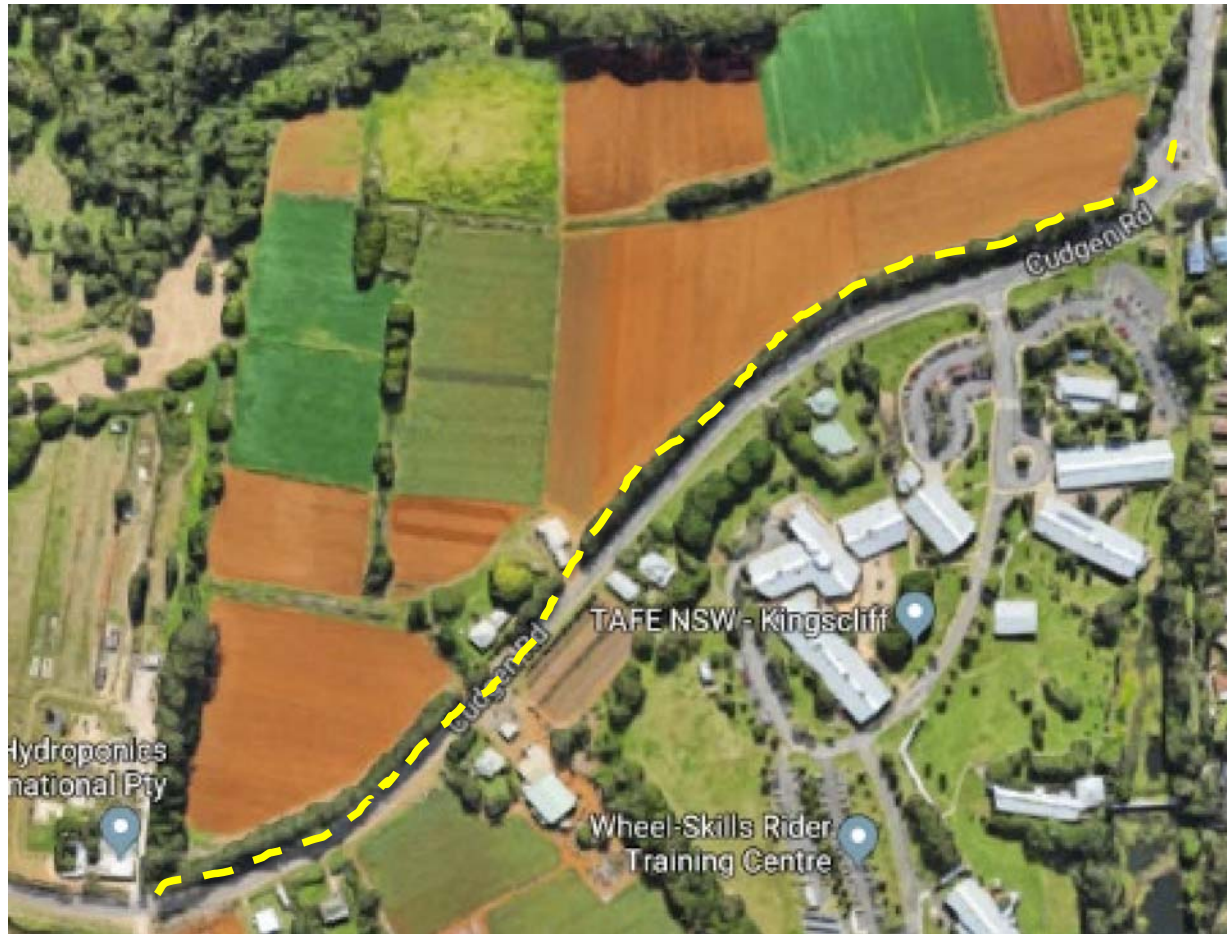
- 5.4.1 The wind break / hedge trees described in Section 4.4.5 of this report, including the various associated regenerating / understory trees, were considered Category C Trees. Trees in this category are typically of low quality with an estimated remaining life expectancy of 5–15 years, or young trees that are easily replaceable, may have poor health and/or structure, are easily replaceable, or are of undesirable species and do not warrant design consideration.
- 5.4.2 Category C trees are identified as wind break and regenerating trees within Appendix C of this report.

Figure 13. Aerial image showing location of Low Retention Value wind break and regenerating trees. The tree locations are identified by the yellow dash line.
Source: image obtained from Tweed Shire Council LEP mapping tool, August 2018. Line placed by the author

- 5.4.3 The line of wind break trees on the boundary of Cudgen Road were identified as *Pinus elliottii* (Slash Pine), of which there were over 150 individual trees (estimated), planted at 3-4m spacings. The DBH of the larger trees was observed to be approximately 40cm (at 1.4m above ground level) with estimated heights of between 15–20m.
- 5.4.4 *Pinus elliottii* (Slash Pine) is regarded as an environmental weed in Queensland and New South Wales (BCC website – 2018) with a variety of control recommendations.
- 5.4.5 The trees provide some screen value between the site and neighbouring properties, however ease of growth (possible weedy tendencies), limited ULE and species type resulted in a classification of Low Retention Value.
- 5.4.6 The average TPZ for the *Pinus elliottii* (Slash Pine) was 4.8m, measured at a radial distance from the centre trunk.

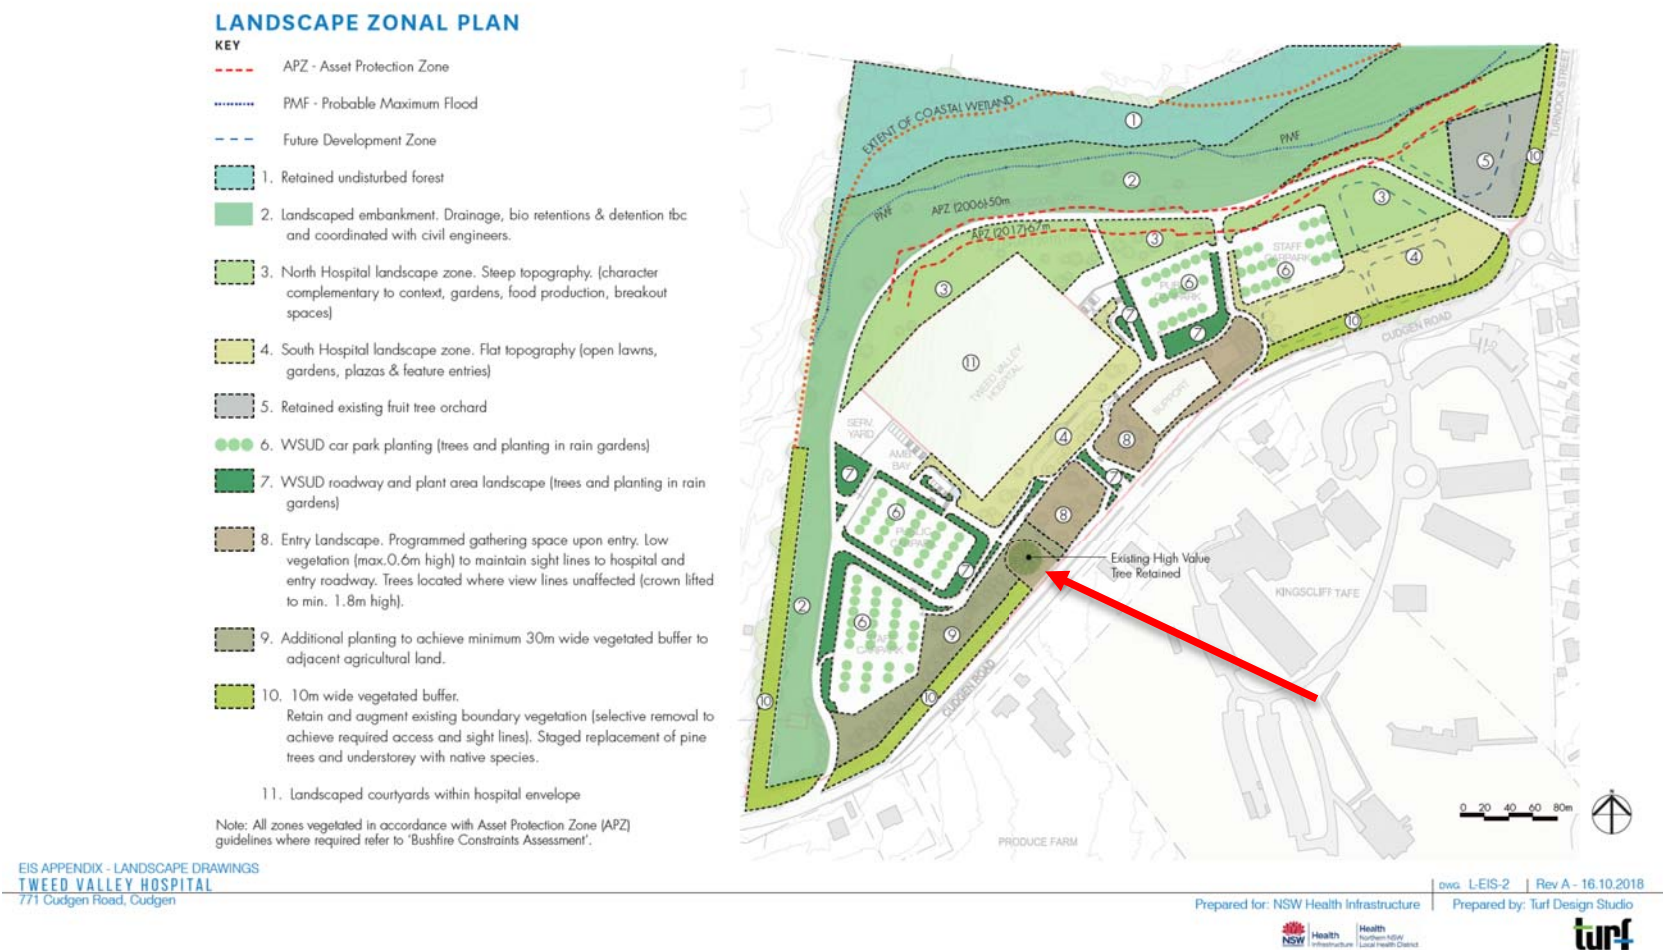
6.2.6 Based on the recently released draft 'Concept Landscape Zonal Plan' (Figure 16) the removal of a number of individual subject trees, along with sections of the existing roadside windbreak trees, was considered likely due to major encroachments potentially occurring during the proposed road construction works. This presumption was supported by a review the draft 'Tree Removal and Preservation Plan' (Figure 17).

Figure 16. Concept Zonal Landscape Plan. The location of Tree 4 is identified with a red arrow.
Source: Provided by TSA Management, 16 October 2018

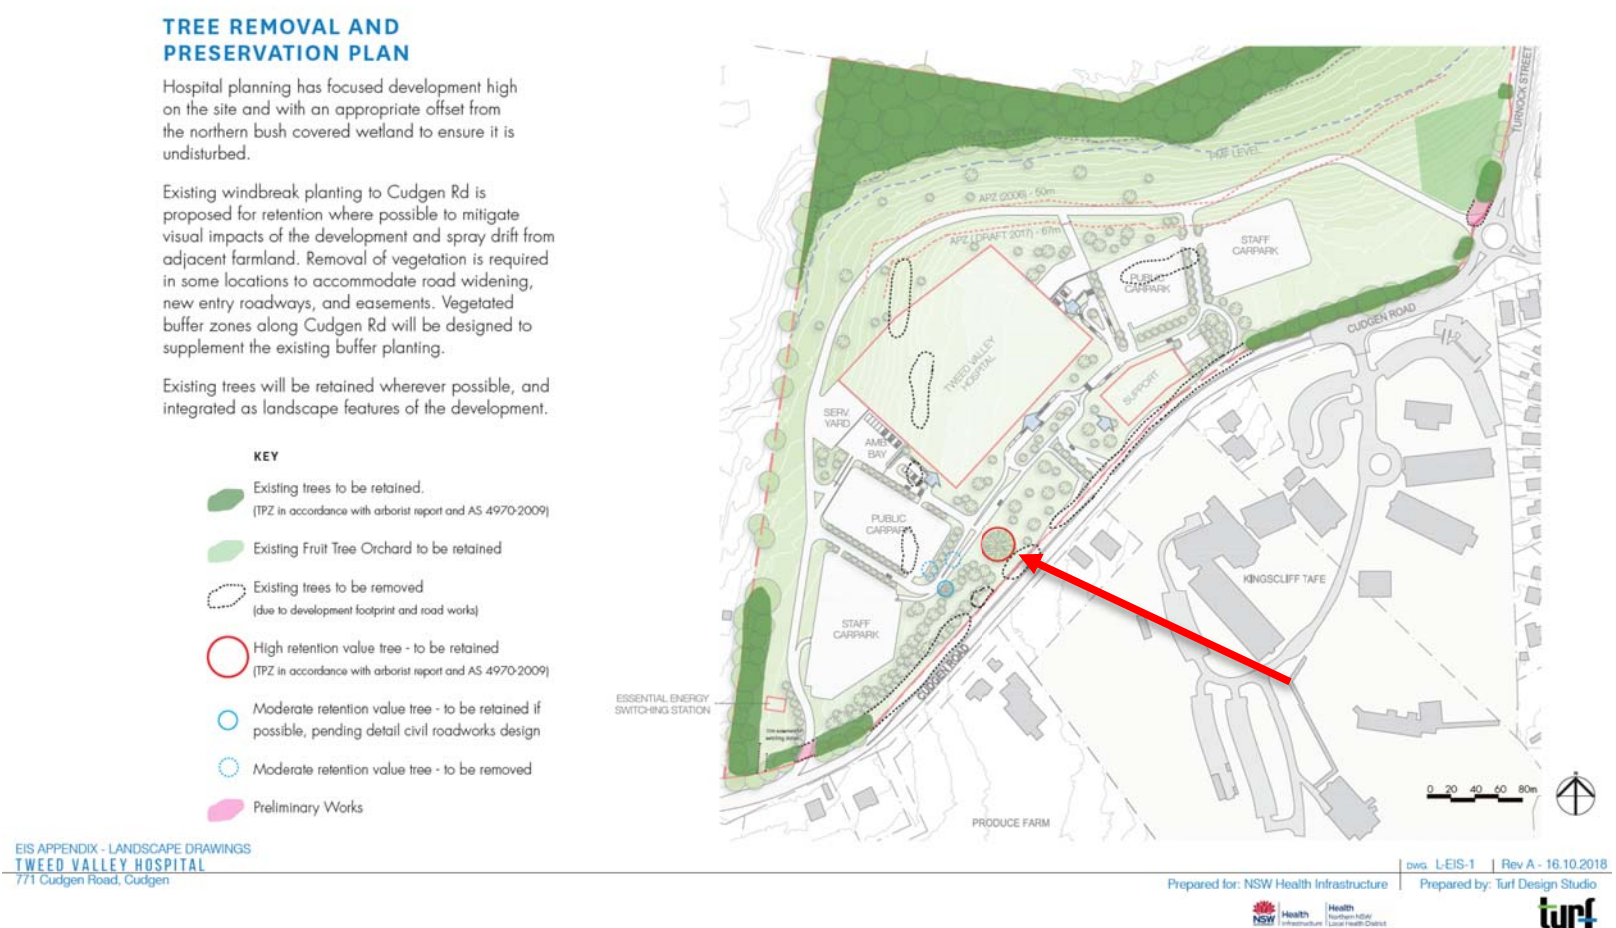
Figure 17. Concept 'Tree Removal and Preservation Plan'. The location of Tree 4 is identified with a red arrow.
Source: Provided by TSA Management, 16 October 2018
