# **HAZARDOUS MATERIALS REINSPECTION REPORT, CATHERINE MCAULEY HIGH SCHOOL WESTMEAD.**

**20<sup>th</sup> March 2016**

Prepared for:  
**Catholic Education Diocese of Parramatta,  
Locked Bag 4,  
North Parramatta. NSW. 1750.**

Prepared by:  
**Banksia EOHS Pty Limited.**

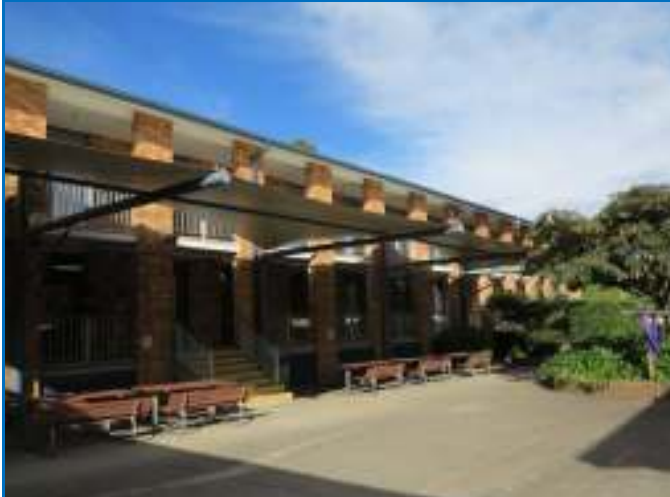
**Photo 1: Block A Eaves, Upper Level Ceiling Linings & Awnings Lined With Fibre Cement. Deemed Asbestos Present.**

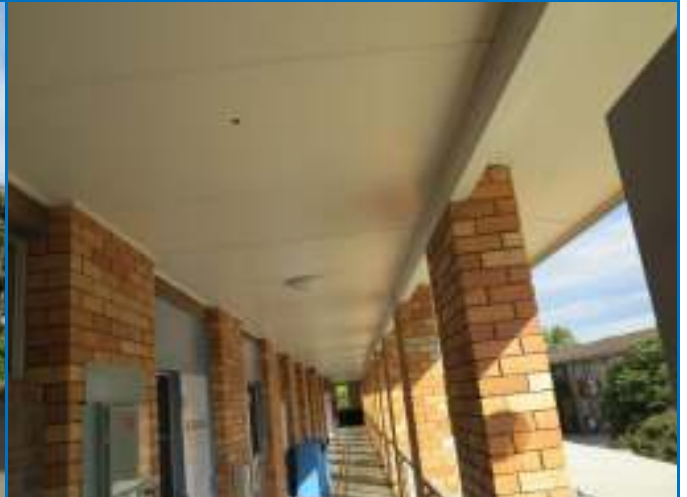
**Photo 2: Block A Awnings & Classroom Ceilings Lined With Fibre Cement. Deemed Asbestos Present.**

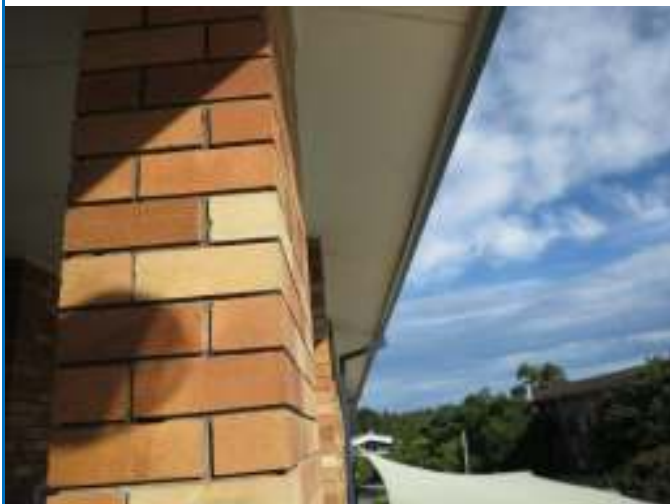
**Photo 3: Block A Eaves Lined With Fibre Cement. Deemed Asbestos Present.**

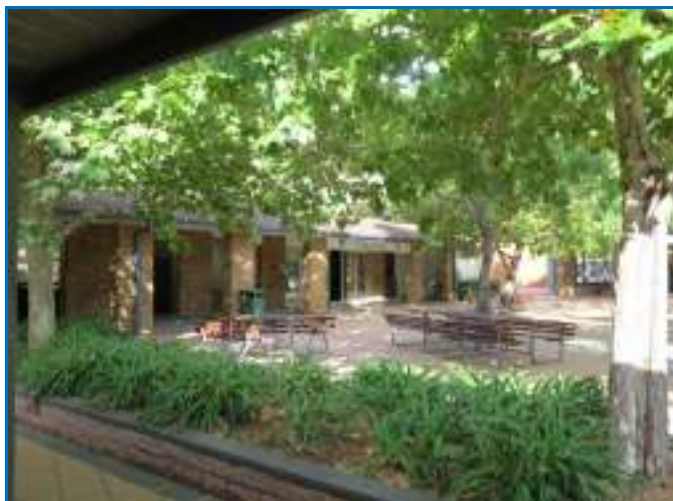
Block C (Photographs 7 and 8) has been modified as a result of the construction of a new, multi-level classroom block. This building have eaves which are lined with fibre cement which was deemed to contain asbestos.

***Photo 7: Block C. Eaves Lined With Fibre Cement.  
Deemed Asbestos Present.***

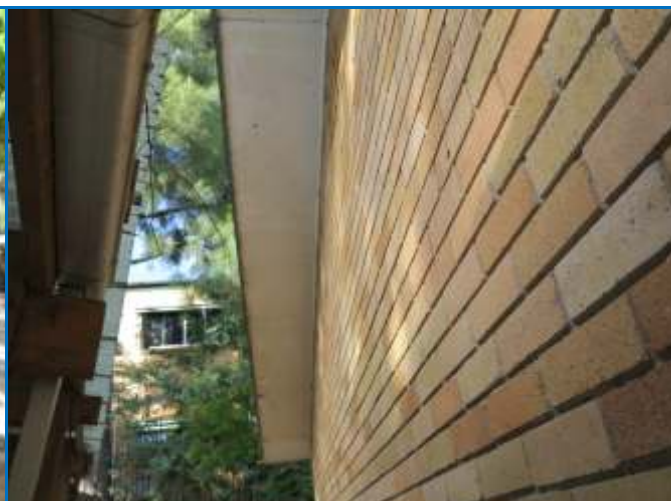
***Photo 8: Block C. Eaves Lined With Fibre Cement.  
Deemed Asbestos Present.***

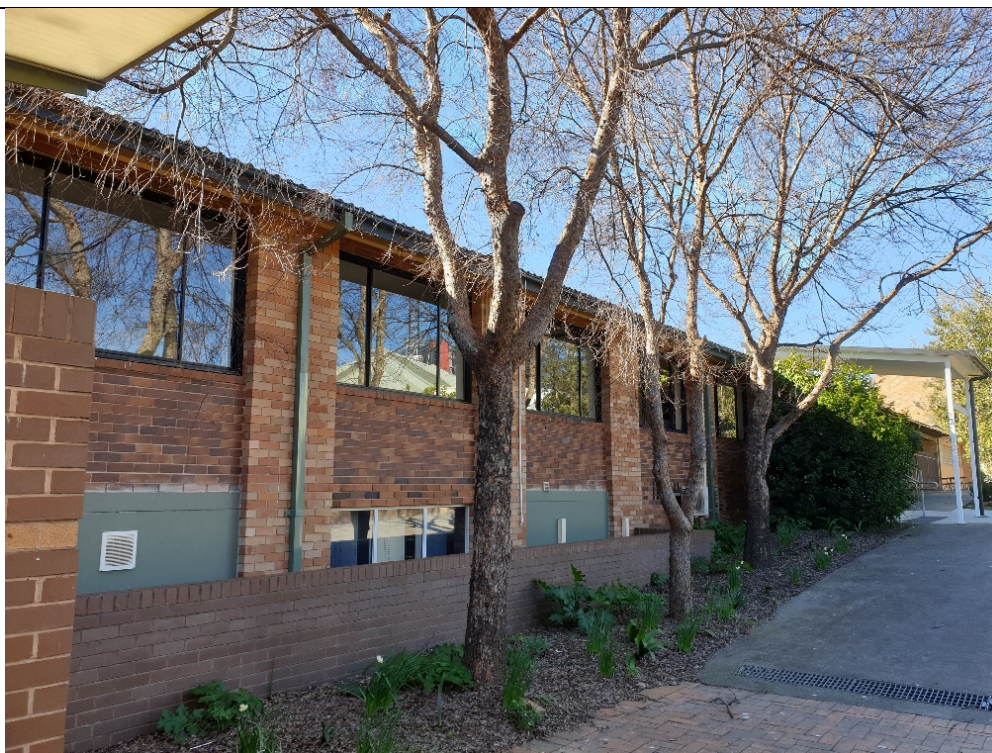
***Photo 8 – Block G***

The fibre cement eave linings to the perimeter of this building were also deemed to be asbestos-based (Photographs 8 & 9).

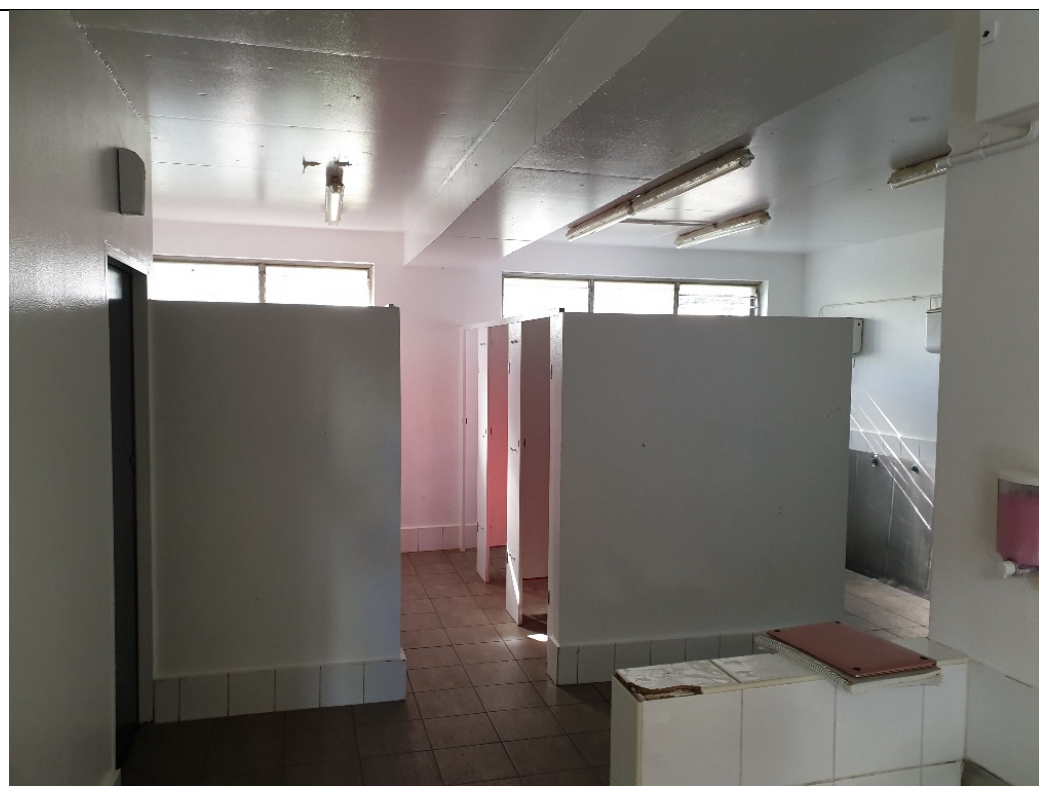
***Photo 12 – Block J, Student Toilet Facilities***

The thick compressed fibre cement toilet partitioning used in the student toilet facilities on the lower level of this block were deemed to be asbestos-based (Photographs 12 & 13).

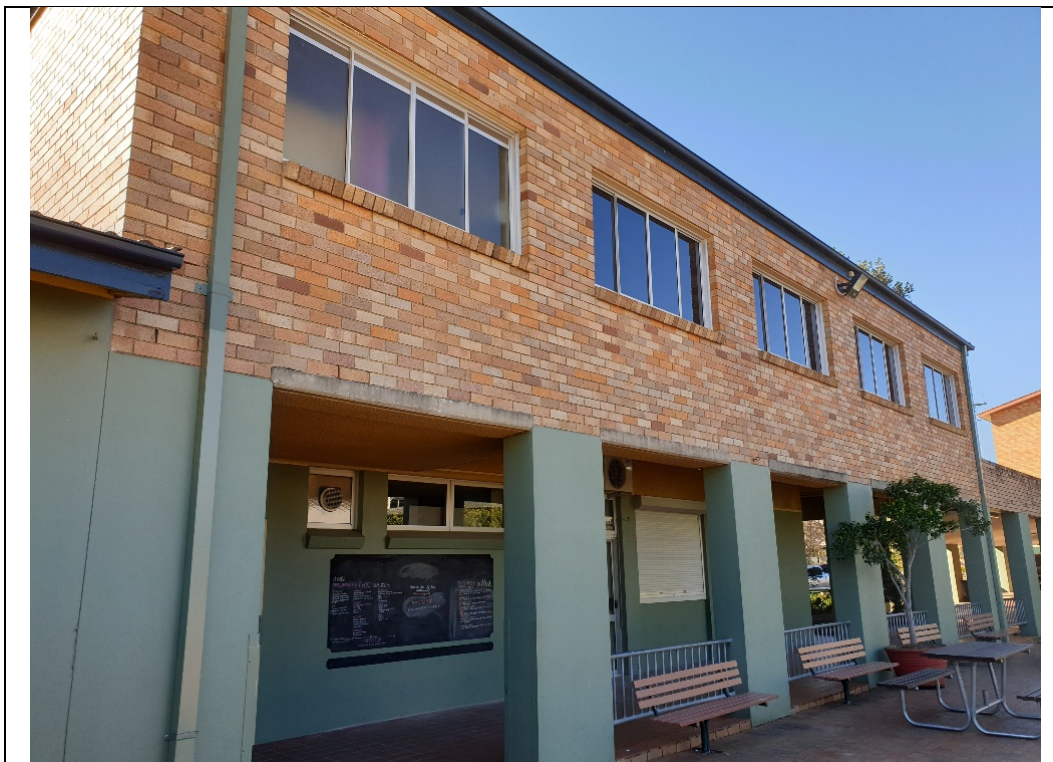
***Photo 15 – Block I***

Vermiculite plaster has been used to coat the lower level walkway ceiling of this block (Photographs 15, 16 & 17). Although unlikely to contain asbestos, this material was deemed to contain asbestos as a precaution.

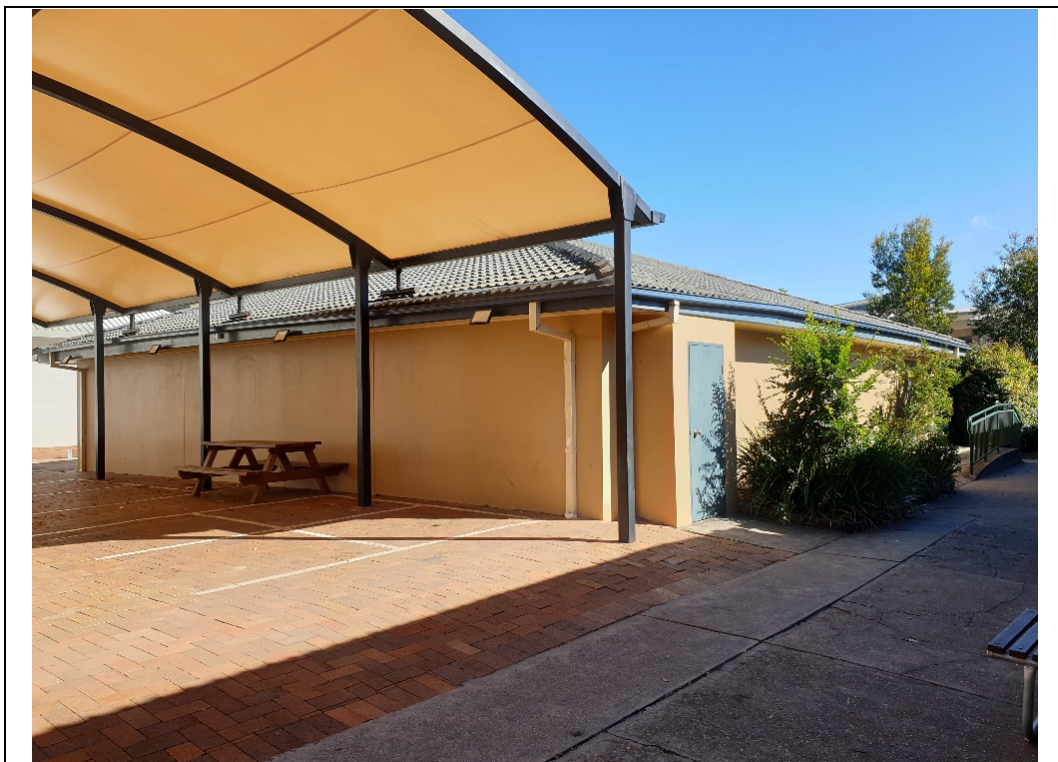
***Photo 19 – Block F***

The fibre cement eave linings to the perimeter of this building were also deemed to be asbestos-based (Photographs 19 & 20).

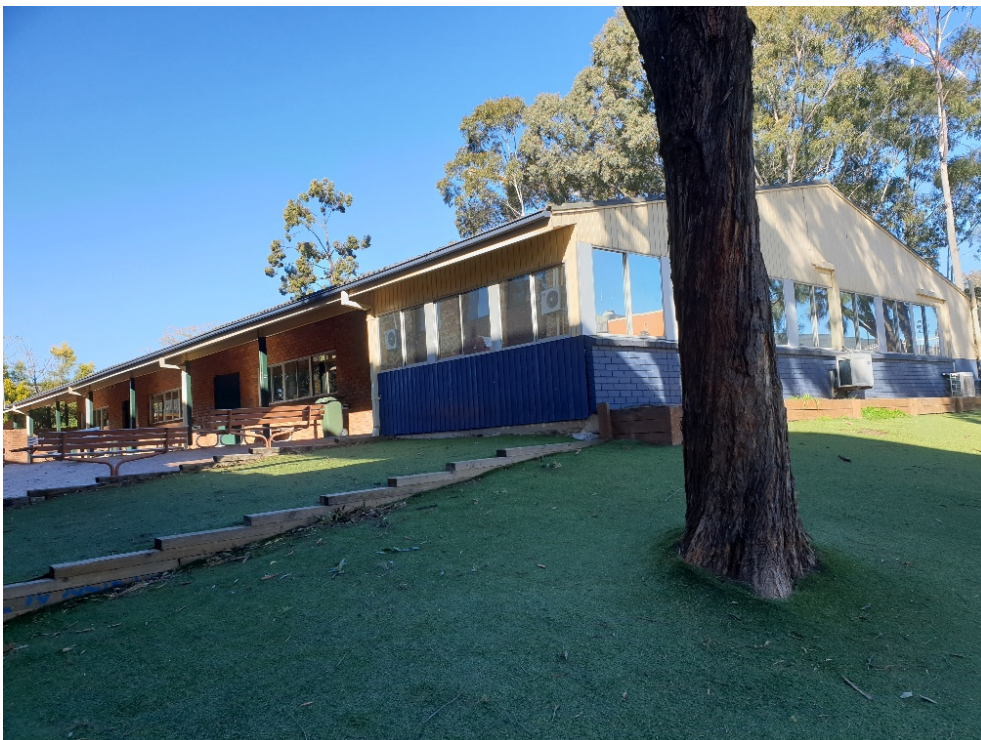
***Photo 21 – Block E***

The fibre cement walkway awning and eave linings of this building were deemed to be asbestos-based (Photographs 21, 22, 23 & 24).

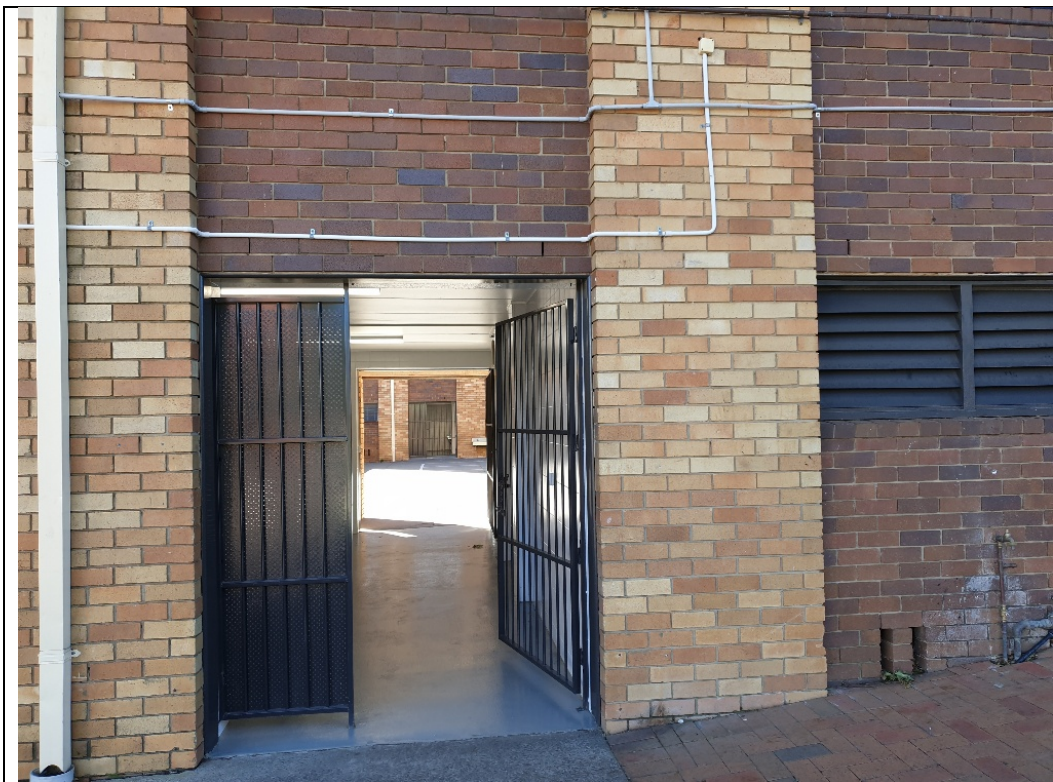
***Photo 27 – Block D, Student Toilet Facilities***

Fibre cement has also been used to line the ceiling of the accessway to the student toilets on the lower level of this block (Photographs 27 & 28). This material was also deemed to contain asbestos.

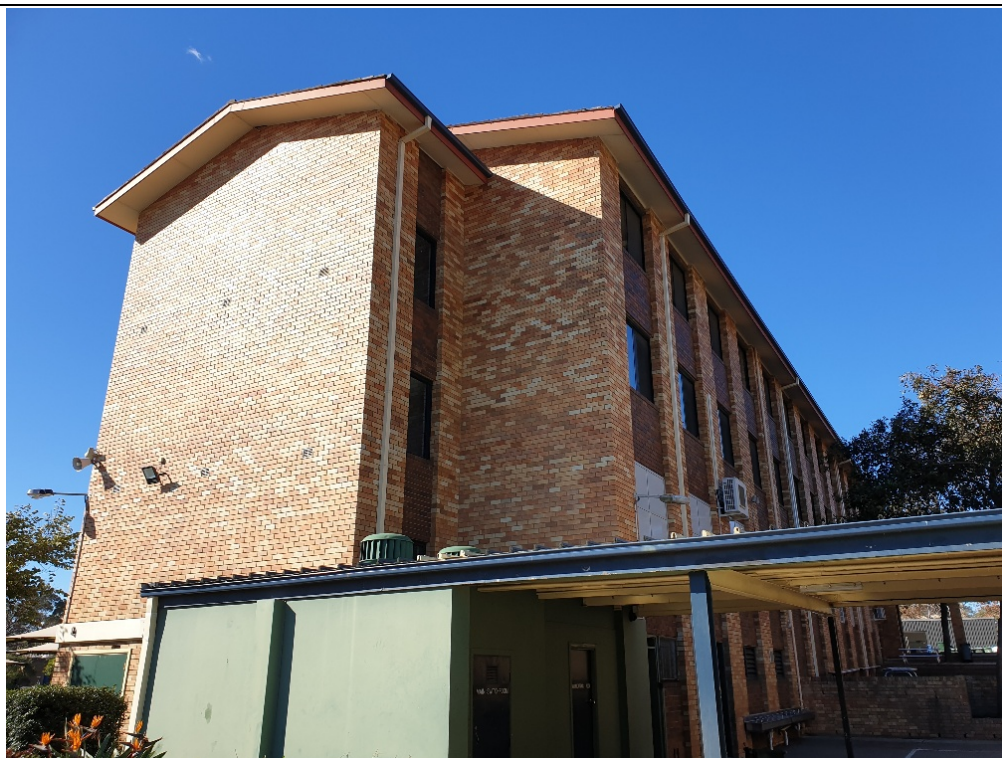
***Photo 29 – Block C***

The fibre cement walkway awning to the upper level and eave linings of this 3-story building were deemed to be asbestos-based (Photographs 29, 30 & 31).
