# Hazardous Materials Survey Report and Register

Liverpool Hospital,  
Liverpool NSW

South Western Sydney  
LHD

Contract Number: C19 8144  
Report Number: EMS19 6723

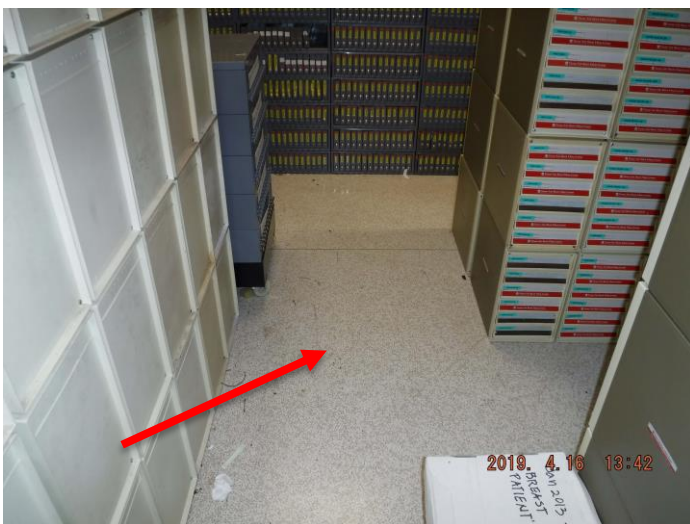
Photograph 3:

Alex Grimson, Identical throughout  
Basement level

Asbestos backed brown vinyl sheeting

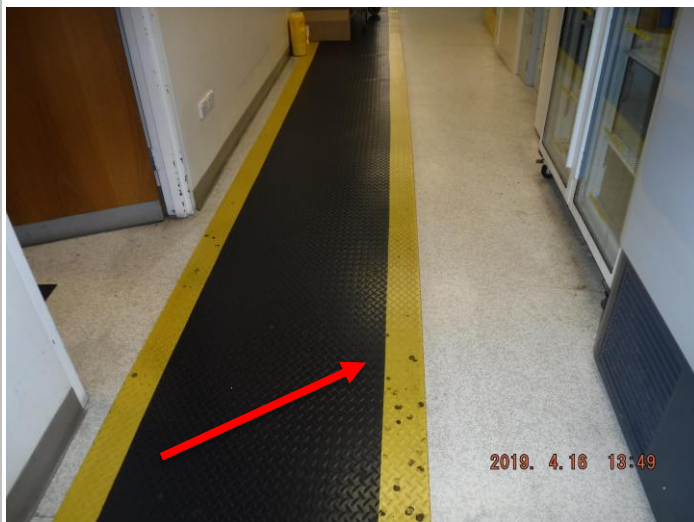
Photograph 4:

Alex Grimson, Pathology Slide Room,  
Identical throughout Basement level  
Asbestos backed brown vinyl sheeting

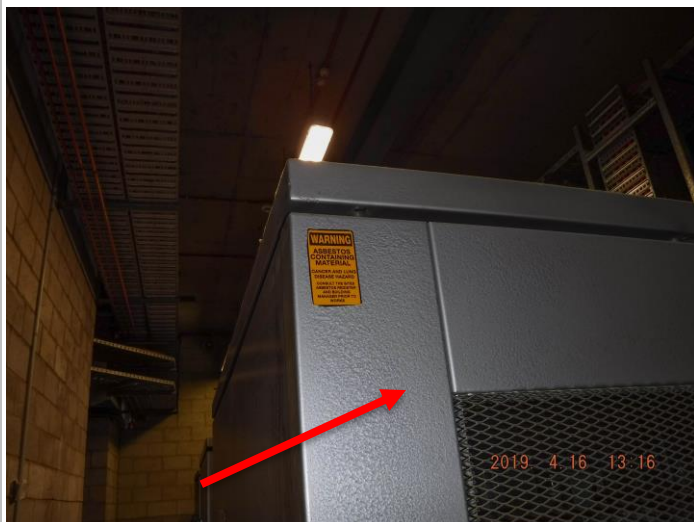
Photograph 16:

Alex Grimson, Plant Room – High Voltage Room

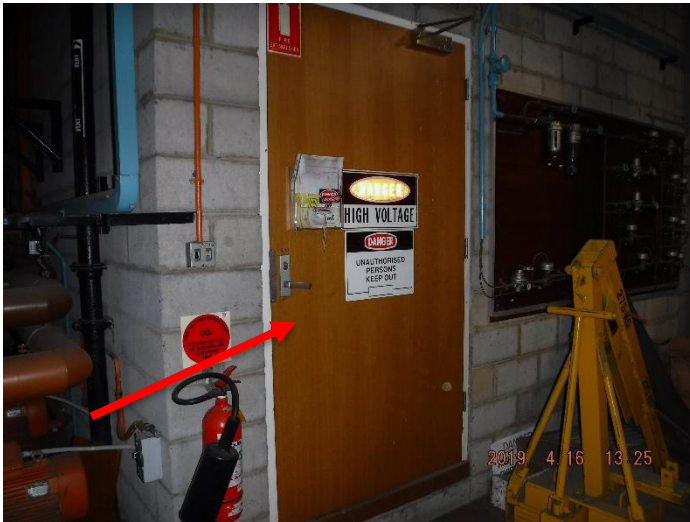
Photograph 19:

Alex Grimson Plant Room – Original Wood Veneered Fire Doors throughout  
Asbestos core within

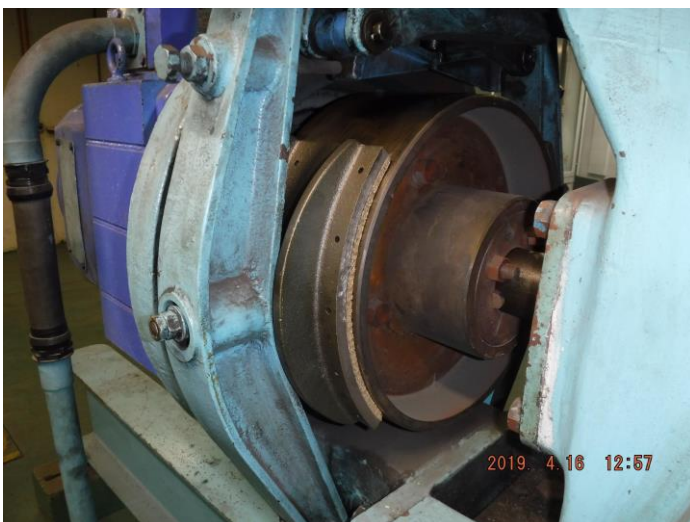
Photograph 21:

Alex Grimson, Lift Motor Room  
Assumed asbestos brake shoes to lift motor

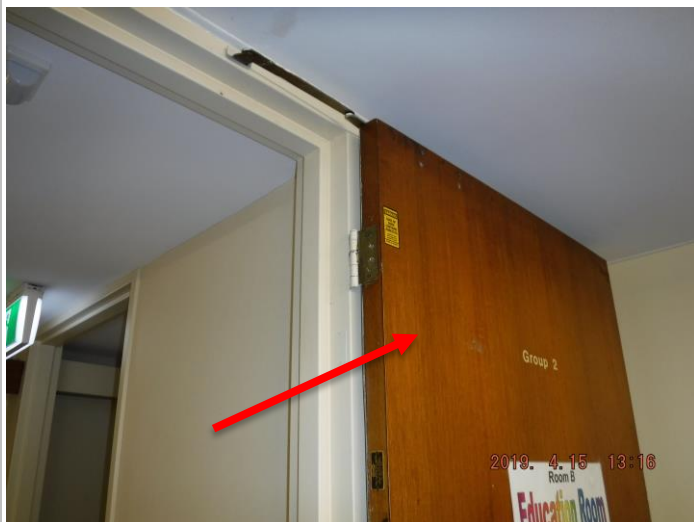
Photograph 31:

Don Everett First Floor – Fire Doors  
Wood Veneered Fire Doors throughout  
Asbestos core within

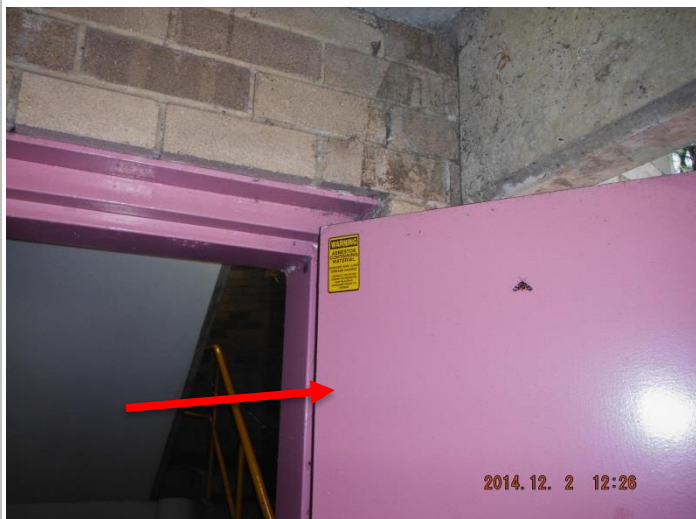
Photograph 40:

Ron Dunbier Building ground, first and second floor, external access stair fire doors  
Asbestos core to door

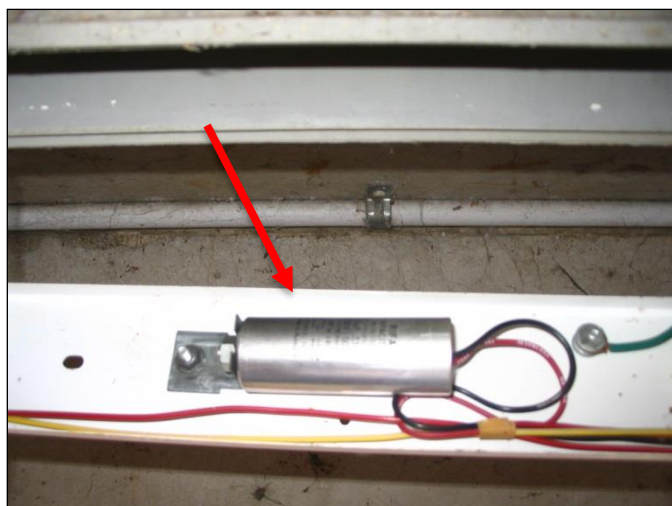
Photograph 47:

Metal capacitors within the older style fluorescent light fittings were found within the Don Everett, Alex Grimson, Ron Dunbier and Central Energy buildings and are presumed to contain PCB's.

Ron Dunbier – Fluorescent light fittings  
PCB containing capacitors to older light fittings

**RECOMMENDATIONS:** Any older type fluorescent light fitting not detailed in this report suspected of containing a PCB capacitor should be checked by a competent person prior to disposal.

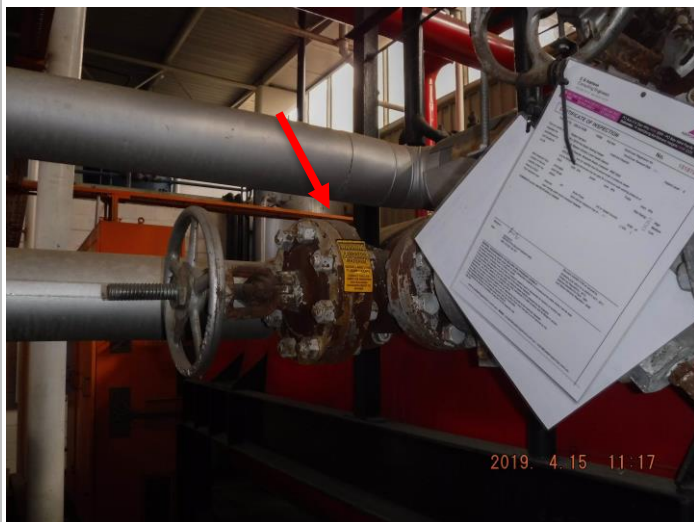
Photograph 55:

Central Energy, ground floor, above north eastern MTW heating vessel no. 2.  
Asbestos debris to pipe flange

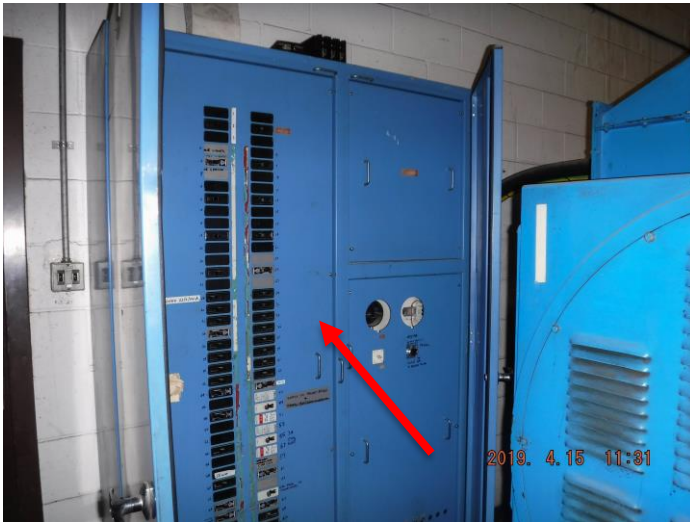
Photograph 58:

Central Energy, ground floor, southern side, backup generator room  
EBBs presumed to be present internally within equipment

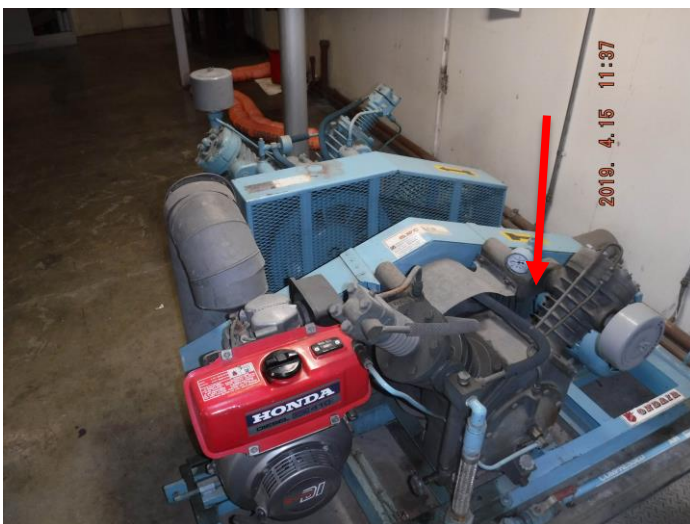
Photograph 60:

Central Energy, ground floor, southern side, backup generator room  
Gaskets to flanges of small compressors may contain asbestos

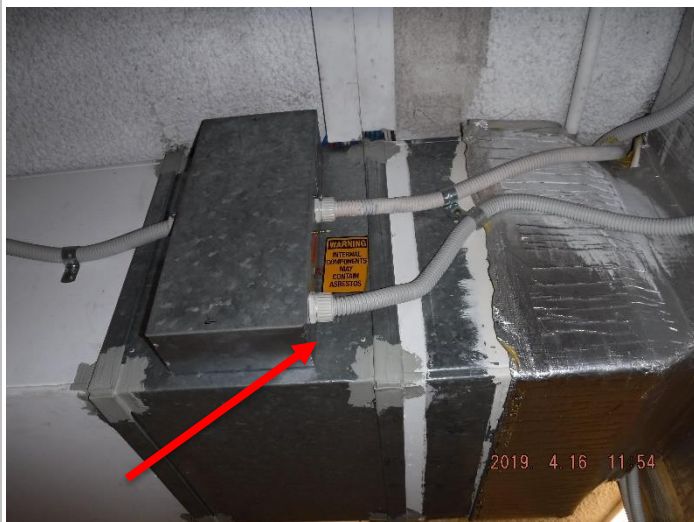
Photograph 70:

Bigge Park Centre - Kitchen heater duct  
Assumed asbestos containing insulation materials within

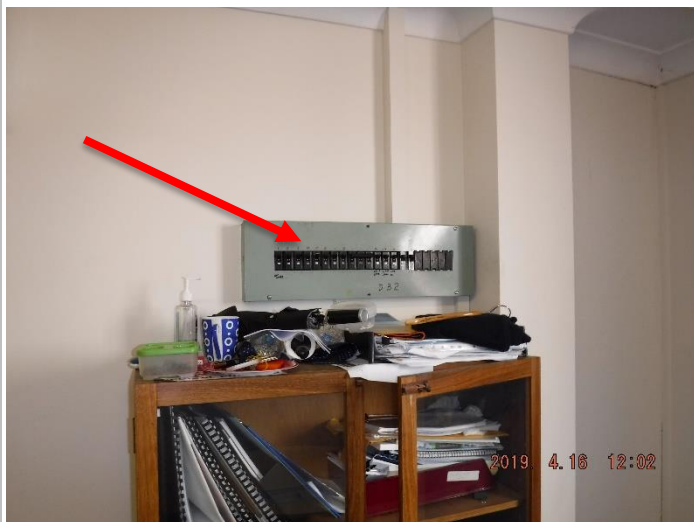
Photograph 73:

Bigge Park Centre – Offices  
Electrical distribution board on wall may contain an asbestos electrical backing board within
