STORMWATER CHANNEL

HASLAM'S CREEK

Internal Concrete Floor & Walls

Photo ID **HC-SWC-1.1**
To
Photo ID **HC-SWC-1.73**
(INCLUSIVE)

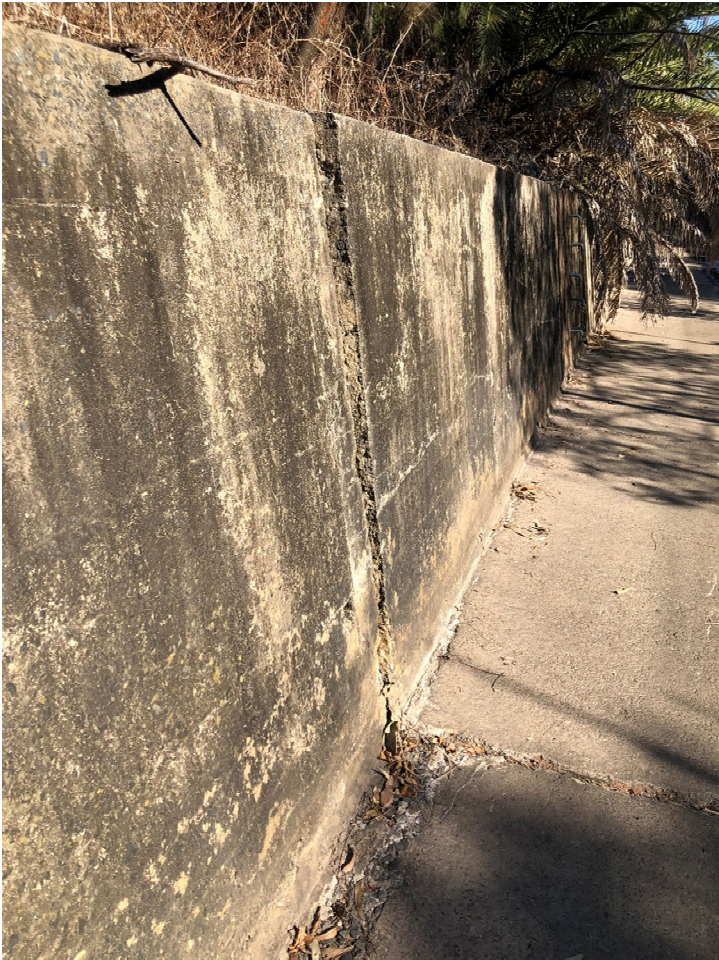
LOCATION: HASLAM'S CREEK STORMWATER CHANNEL – Internal Concrete Floor & Walls		
PHOTO ID	PHOTO	DESCRIPTION/CONDITION
HC-SWC-1.67

<p>Floors & Walls within Haslam's Creek Stormwater Channel (including Stormwater Discharge Outlets) outside South-Eastern Boundary of Site.</p> <ul style="list-style-type: none">• Visible sediment to bottom of Drainage Outlet.• Overgrown Vegetation in Drainage Channel and on each side of Canal Walls. Trees leaning over canal.• Surface Cracking & pitting to concrete base/floor• Surface Cracking to concrete Walls. Visible evident of movement/misalignment• Graffiti/Vandalism• Grass/vegetation & trees poorly maintained. Waste/Litter <p><u>Condition:</u> POOR/DAMAGED</p>

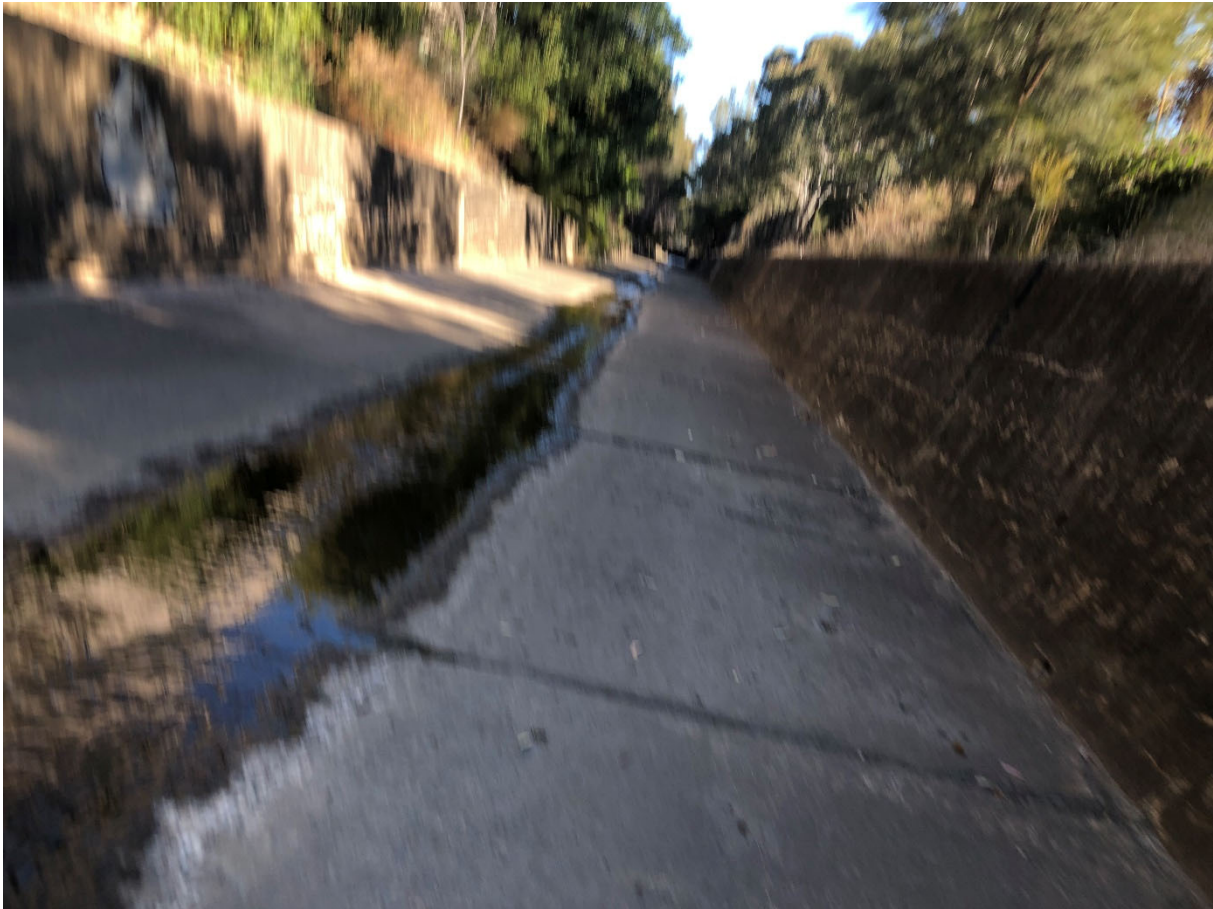
LOCATION: HASLAM'S CREEK STORMWATER CHANNEL – Internal Concrete Floor & Walls		
PHOTO ID	PHOTO	DESCRIPTION/CONDITION
HC-SWC-1.70

<p>Floors & Walls within Haslam's Creek Stormwater Channel (including Stormwater Discharge Outlets) outside South-Eastern Boundary of Site.</p> <ul style="list-style-type: none">• Visible sediment to bottom of Drainage Outlet.• Overgrown Vegetation in Drainage Channel and on each side of Canal Walls. Trees leaning over canal.• Surface Cracking & pitting to concrete base/floor• Surface Cracking to concrete Walls. Visible evident of movement/misalignment• Graffiti/Vandalism• Grass/vegetation & trees poorly maintained. Waste/Litter <p><u>Condition:</u> POOR/DAMAGED</p>

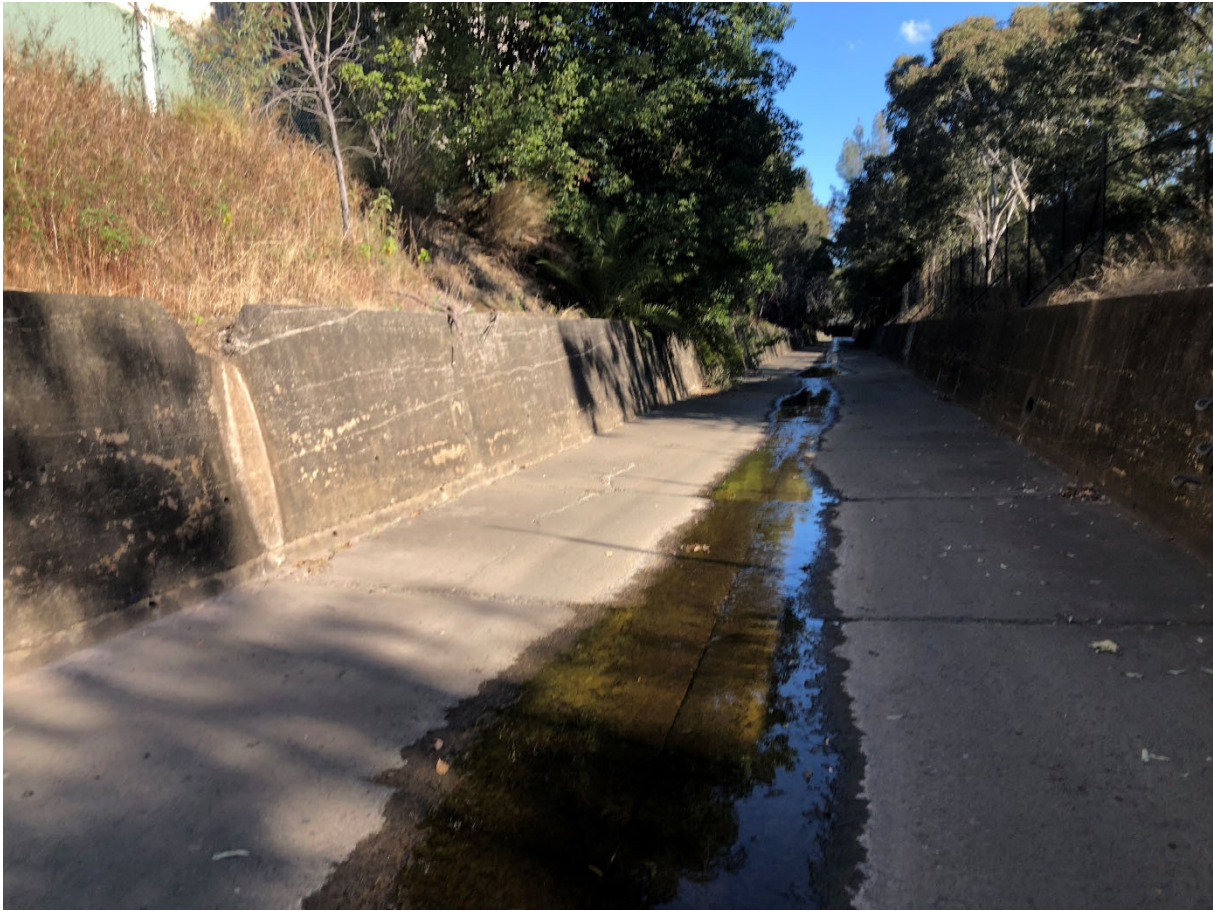
LOCATION: HASLAM'S CREEK STORMWATER CHANNEL – Internal Concrete Floor & Walls		
PHOTO ID	PHOTO	DESCRIPTION/CONDITION
HC-SWC-1.71

<p>Floors & Walls within Haslam's Creek Stormwater Channel (including Stormwater Discharge Outlets) outside South-Eastern Boundary of Site.</p> <ul style="list-style-type: none">• Visible sediment to bottom of Drainage Outlet.• Overgrown Vegetation in Drainage Channel and on each side of Canal Walls. Trees leaning over canal.• Surface Cracking & pitting to concrete base/floor• Surface Cracking to concrete Walls. Visible evident of movement/misalignment• Graffiti/Vandalism• Grass/vegetation & trees poorly maintained. Waste/Litter <p><u>Condition:</u> POOR/DAMAGED</p>
