18 August 2021
Ref: E33177Plet-ADDrev1

ADDENDUM TO PRELIMINARY AND DETAILED SITE INVESTIGATION REPORTS
PROPOSED NEW PRIMARY SCHOOL IN MULGOA RISE
1-23 FORESTWOOD DRIVE, GLENMORE PARK, NSW

1 INTRODUCTION

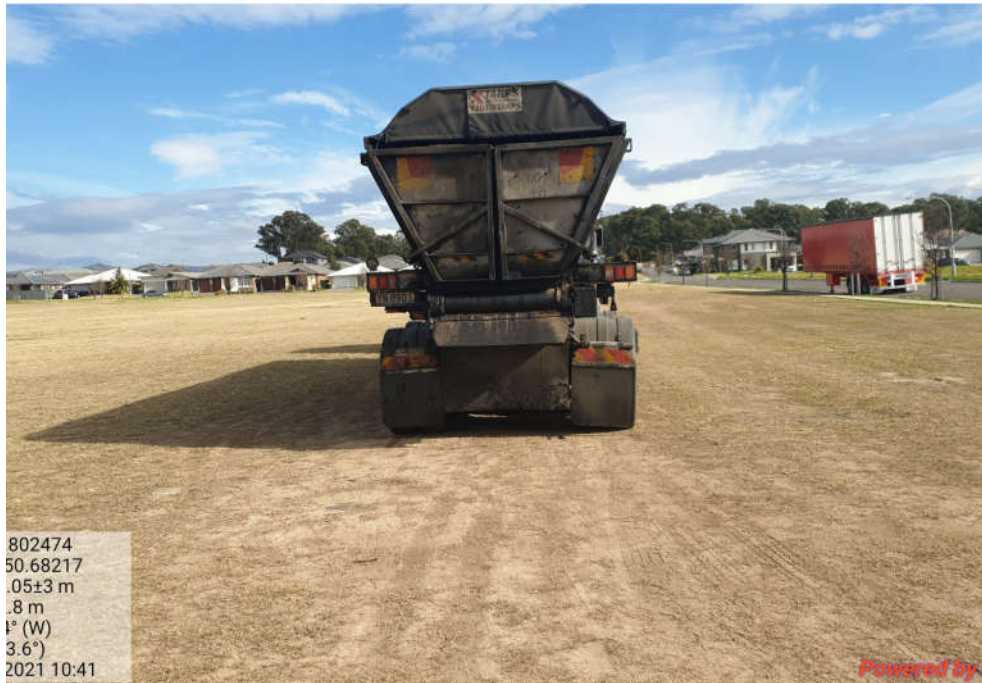
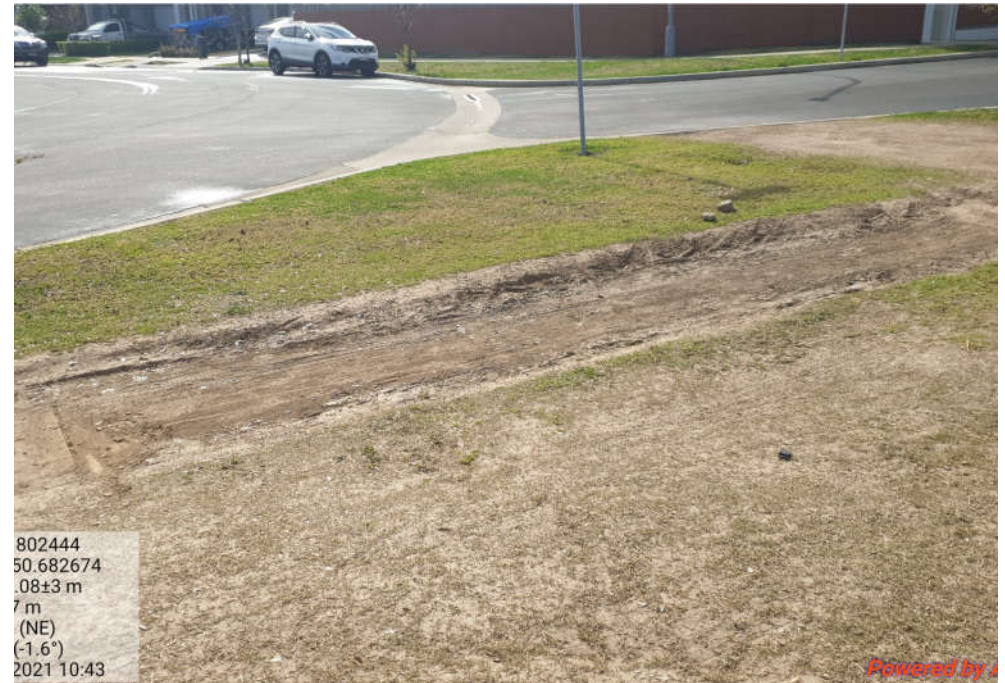
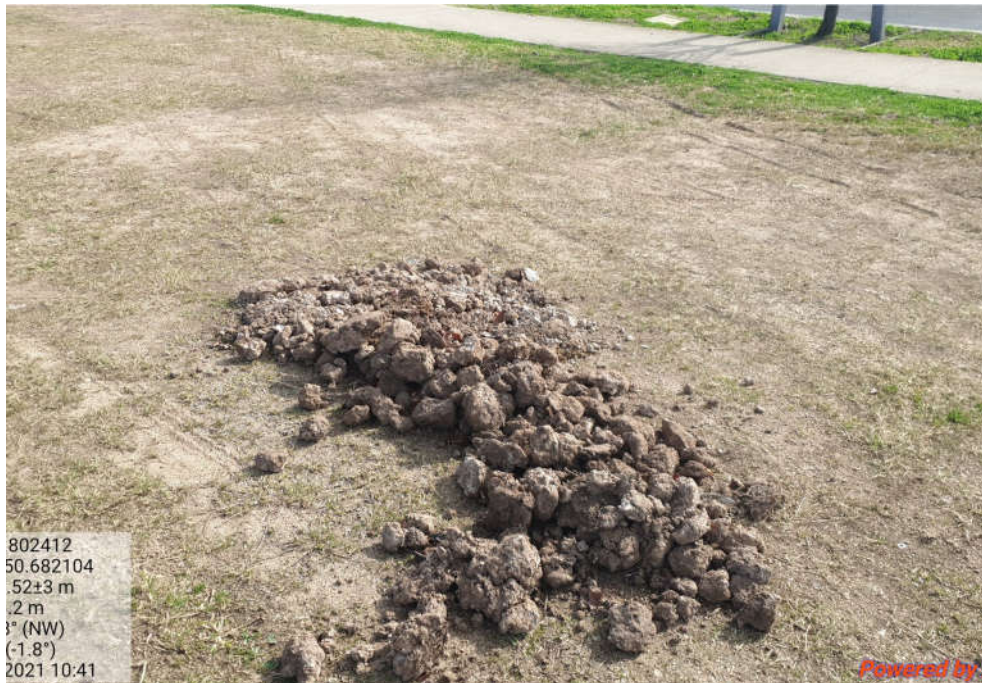
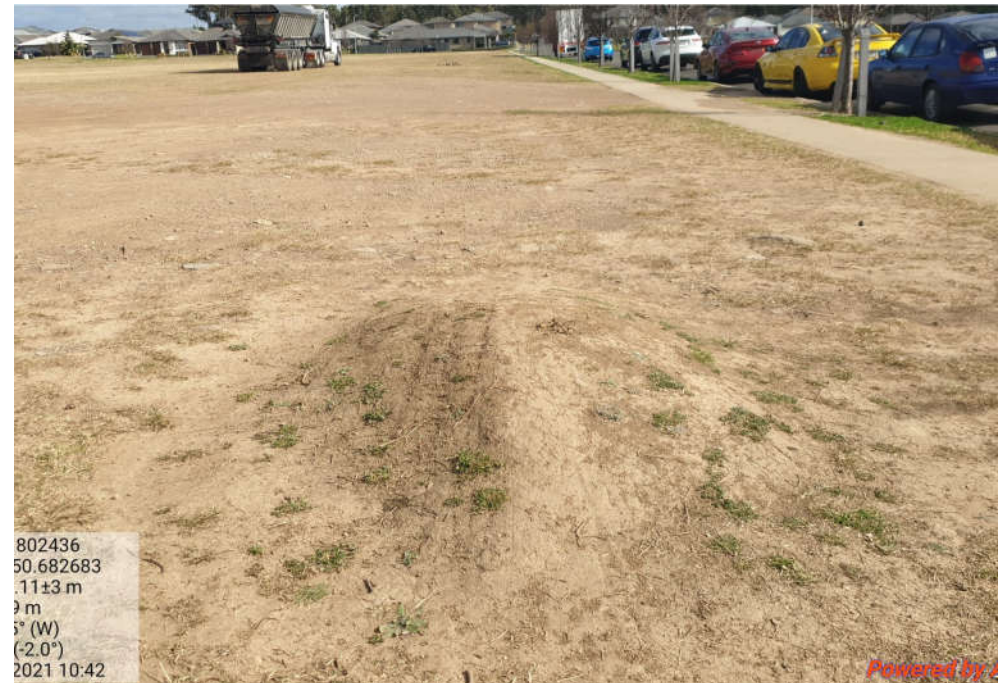
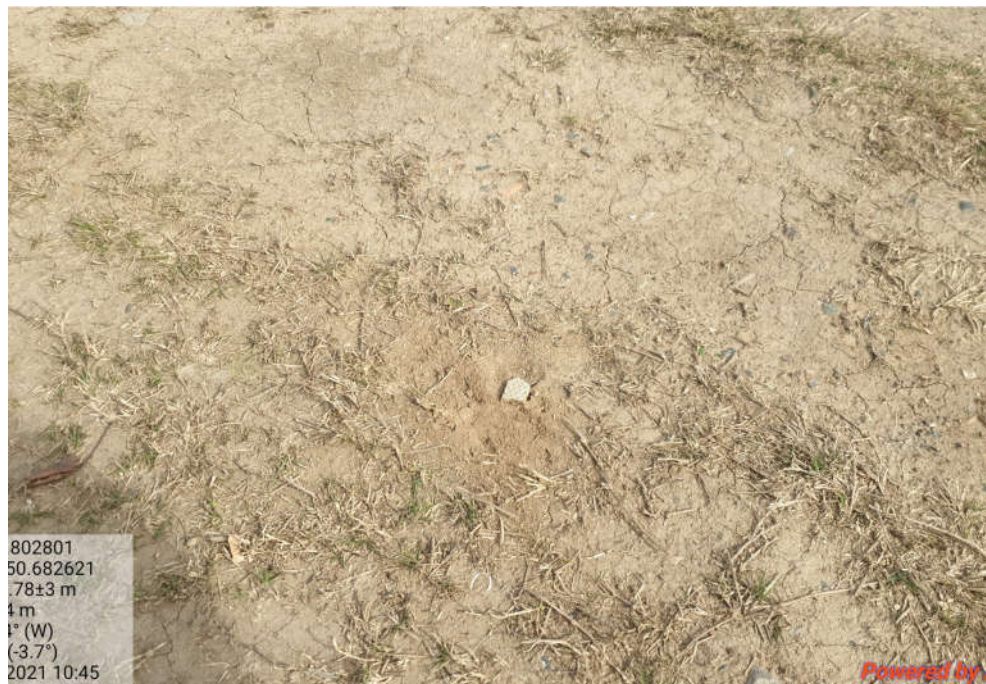
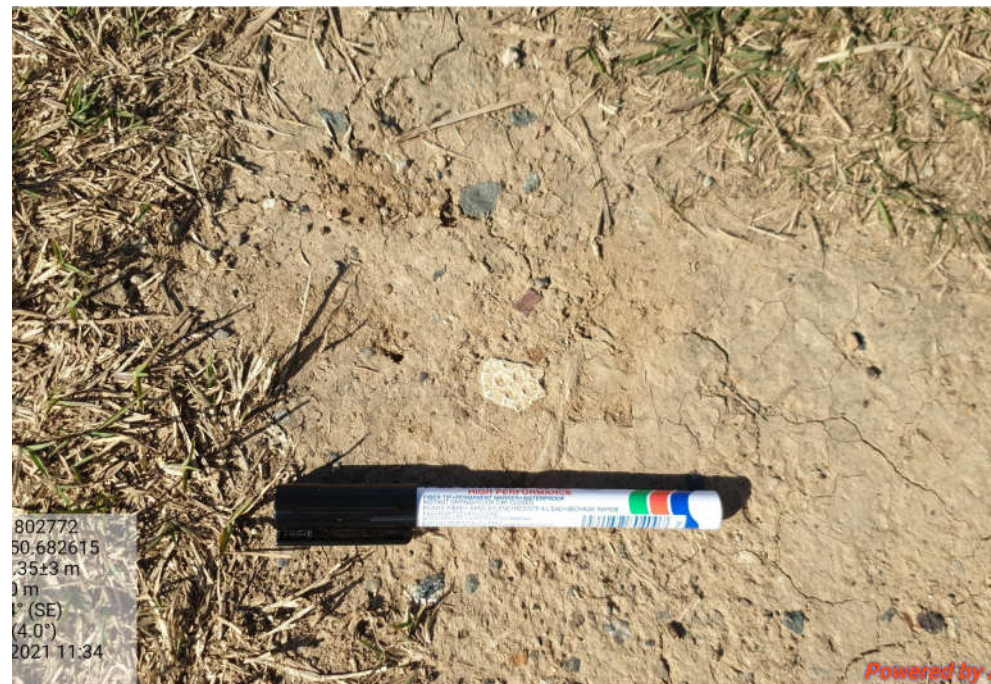
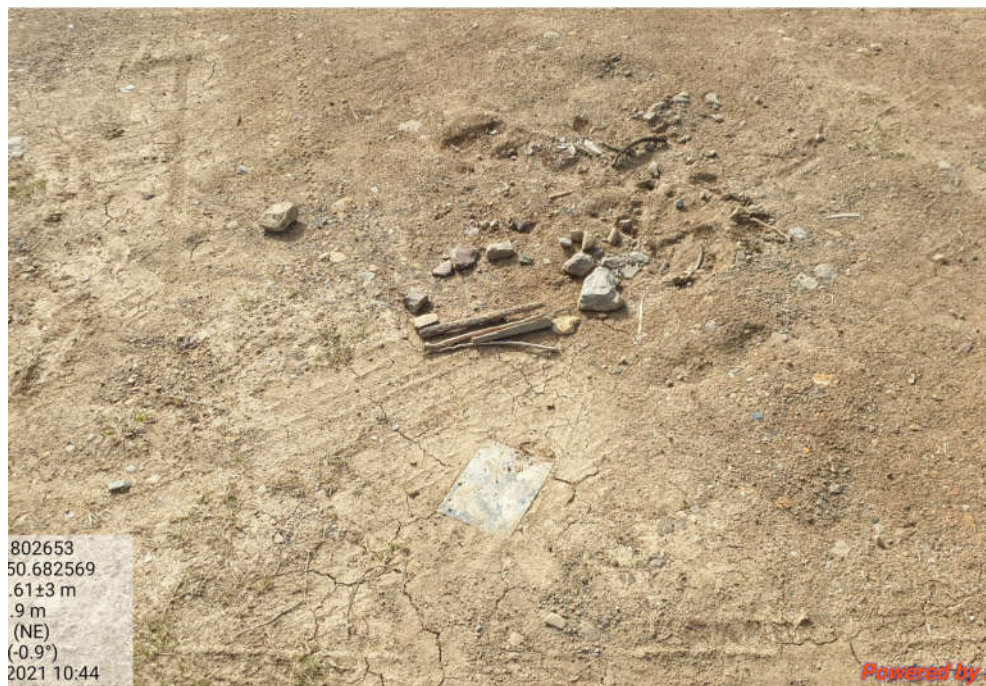
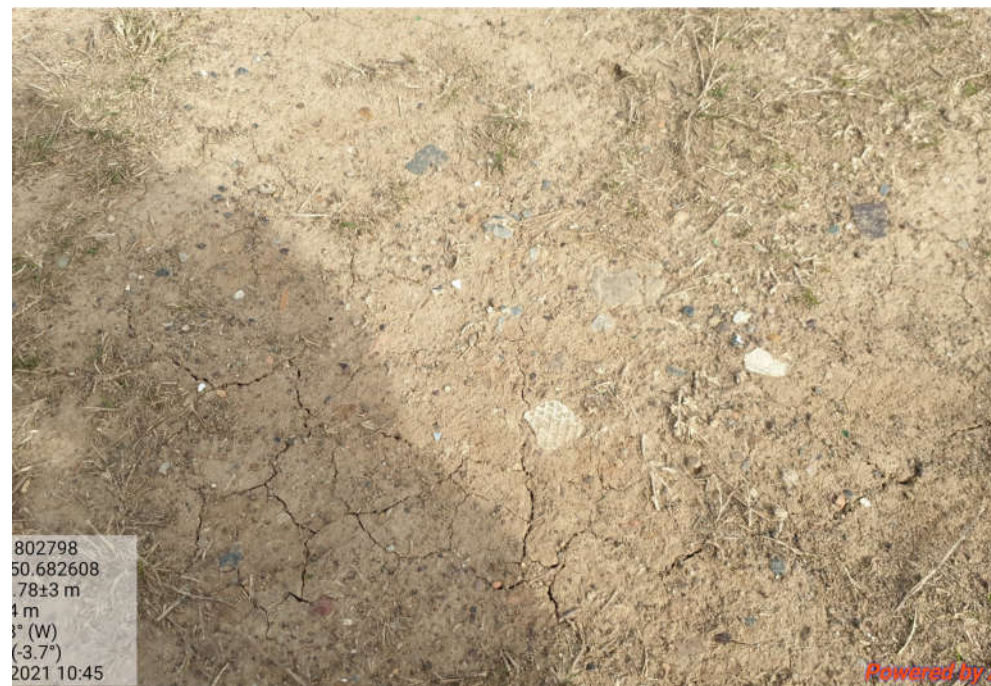
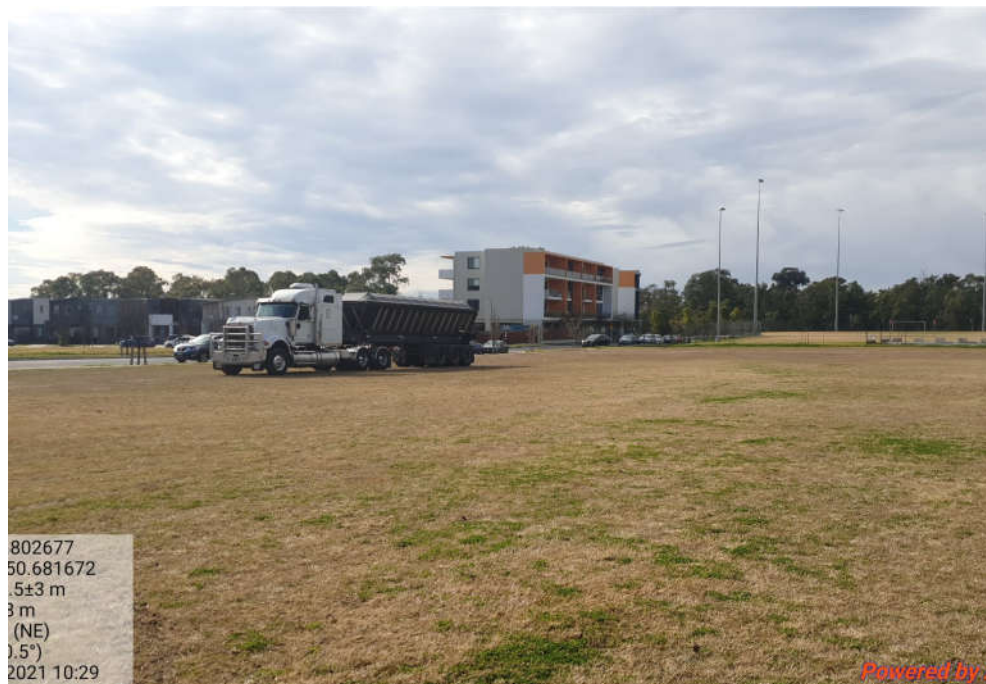
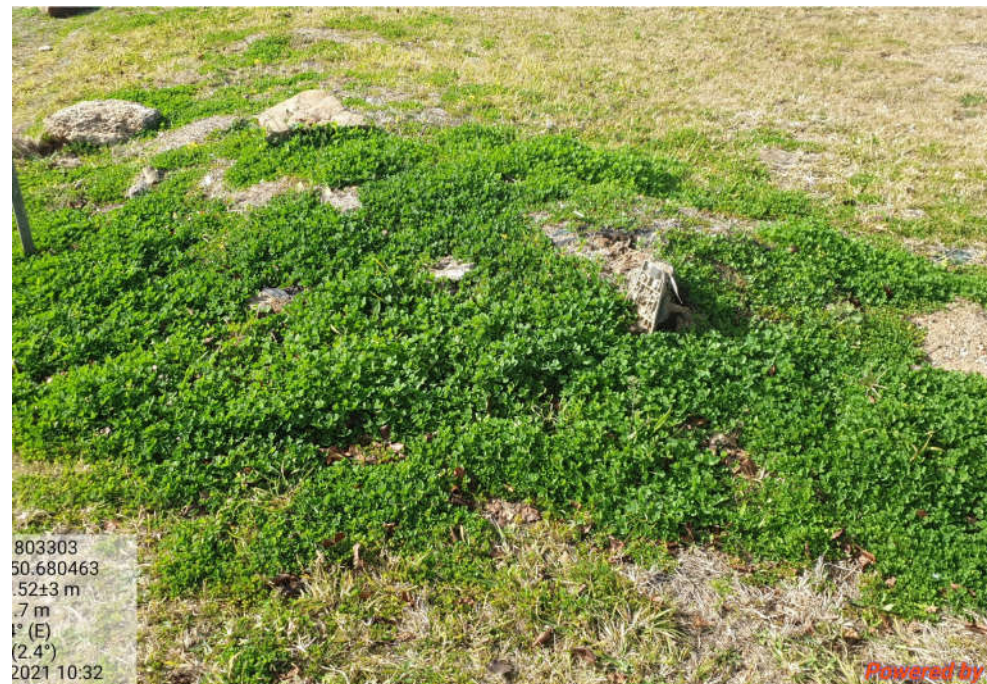
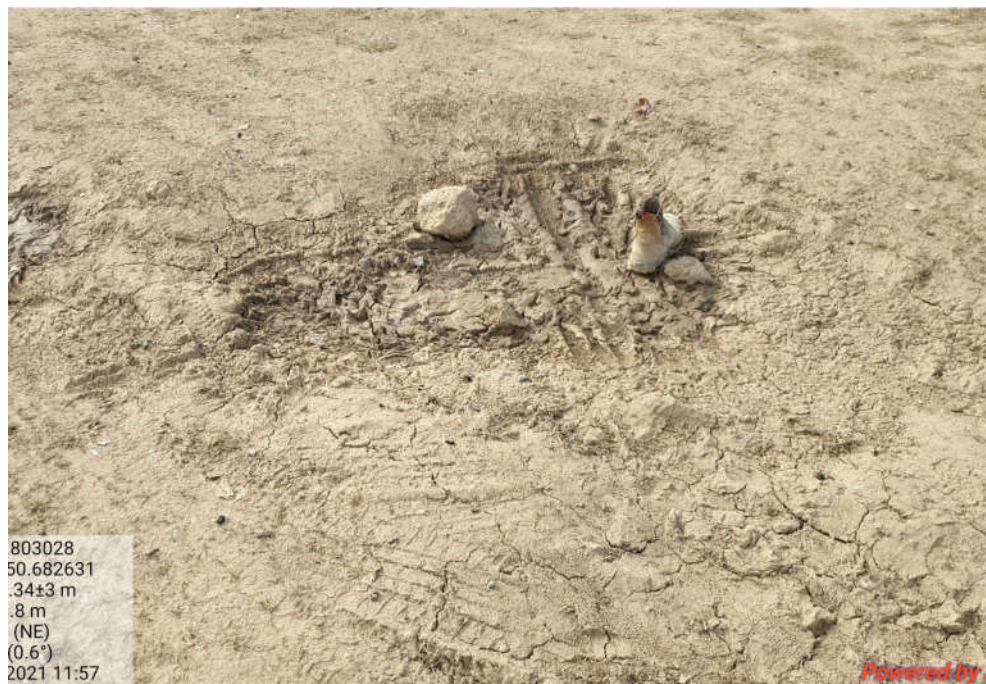
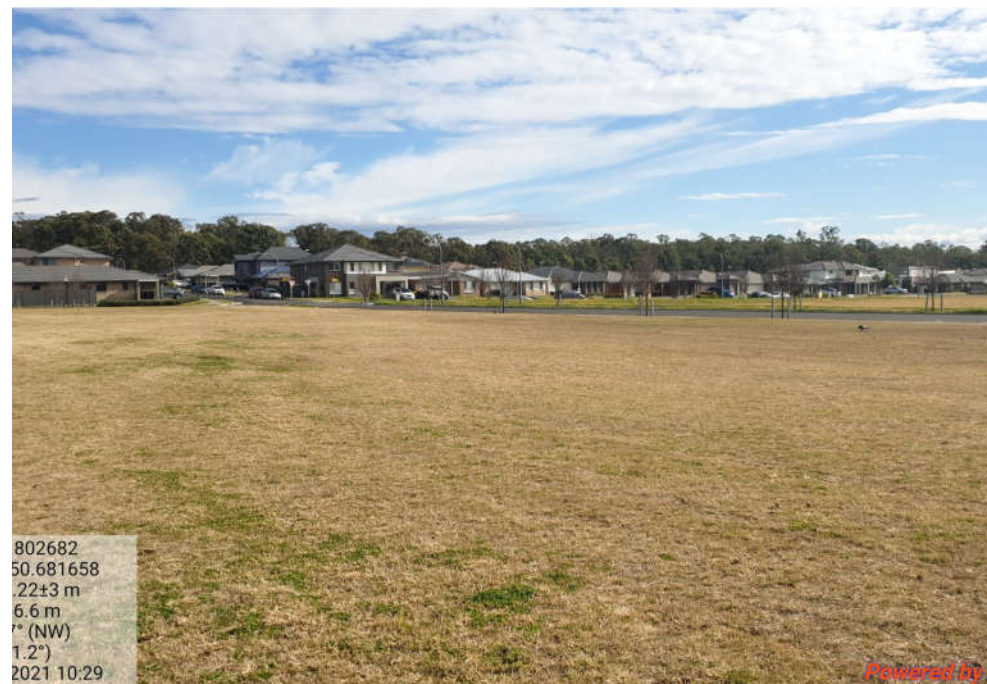
Appendix C: Inspection Photographs (23 July 2021)

We consider that the ACM identified at the ground surface during the 2021 inspection is potentially a result of fly-tipping and/or from debris associated with trucks that have utilised the site for parking, subsequent to completion of the DSI. Given that the site is uncontrolled and unfenced, this is plausible. It is noted that a site inspection was completed on 29 April by Zoic and Richard Crookes Constructions representatives, and IA01 also documented the occurrence of fly-tipping.

JKE recommend the following to mitigate risks from ACM and to verify the CSM relating to the potential extent of the asbestos impact:

- Subsequently, asbestos quantification sampling is to occur to verify the removal of the ACM and to confirm that impacts do not extend beneath the surface. This is to involve bulk sampling/screening utilising the same field methods as documented in the DSI. We recommend that sampling occurs on a 12m grid spacing and that samples be collected from the surface (0-0.05m depth interval) and from the subsurface at depths of approximately 0.5m and 1m, whilst ensuring that all district fill profiles down to the termination depth of the investigation are sampled/screened. These details should be outlined in a Sampling, Analysis and Quality Plan (SAQP) prior to the commencement of the investigation and the SAQP should be approved by the site auditor; and

- A Supplementary Asbestos Investigation Report is to be prepared presenting the results of the investigation, along with a discussion/assessment of risk and any recommendations.
