# Asbestos and Hazardous Materials Limited Pre-Demolition Assessment

Prepared for  
CBRE on Behalf of Health Infrastructure

19 June 2020

754-SYDEN273910

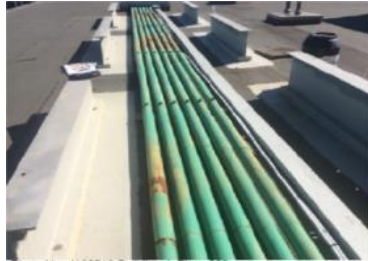
No access was gained within and behind walls, floors, subfloors, tiles, urinals, cavities, ceiling voids, plant/machinery, live electrics or to heights above 3m. Limited access below floor coverings, behind wall coverings and where large amounts of stored units were present. These areas may require further investigation.													
<b>Synthetic Mineral Fibre (SMF)</b>													
Exterior: level 5, roof area, various throughout	Insulation material	Pipework	2	Visual Observation	Suspected SMF	~150m	S	G	F	L	Low

Maintain in current condition if to remain in-situ. Remove under controlled SMF conditions as per the Code of Practice for the Safe Use of Synthetic Mineral Fibres [NOHSC: 2006 (1990)].

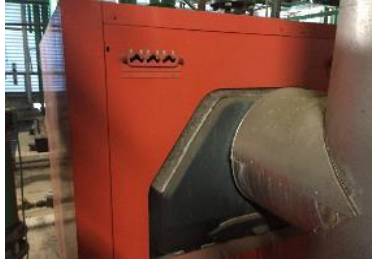
Primary Location	Description	Secondary Location	Photograph No.	Sample Number	Sample Results	Approx. Quantity	Surface Treatment	Extent of Damage	Friability	Likelihood of Disturbance	Action Rating	Photograph	Recommendations
Interior: level 5, plant room, boiler room	Insulation material - internal	Boiler	7	Visual Observation	Suspected SMF	1 unit	S	G	F	L	Low

Maintain in current condition if to remain in-situ. Remove under controlled SMF conditions as per the Code of Practice for the Safe Use of Synthetic Mineral Fibres [NOHSC: 2006 (1990)].
Interior: level 5, plant room	Insulation material	Insulation mats to Weishaupt plant	8	Visual Observation	Suspected SMF	<1m <sup>2</sup>	S	G	F	L	Low

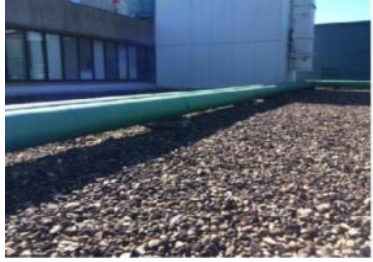
Maintain in current condition if to remain in-situ. Remove under controlled SMF conditions as per the Code of Practice for the Safe Use of Synthetic Mineral Fibres [NOHSC: 2006 (1990)].
Exterior: level 4, roof area, throughout	Insulation material	Pipework	9	Visual Observation	Suspected SMF	~100m <sup>2</sup>	S	G	F	L	Low

Maintain in current condition if to remain in-situ. Remove under controlled SMF conditions as per the Code of Practice for the Safe Use of Synthetic Mineral Fibres [NOHSC: 2006 (1990)].

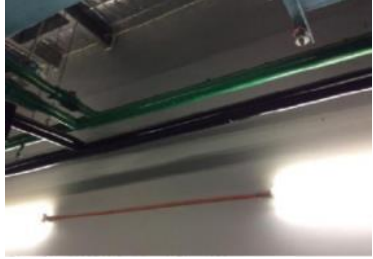
Exterior: level 4, roof area, plant room TSHAF09	Insulation material	Pipework	10	Visual Observation	Suspected SMF	~50m	S	G	F	L	Low

Maintain in current condition if to remain in-situ. Remove under controlled SMF conditions as per the Code of Practice for the Safe Use of Synthetic Mineral Fibres [NOHSC: 2006 (1990)].

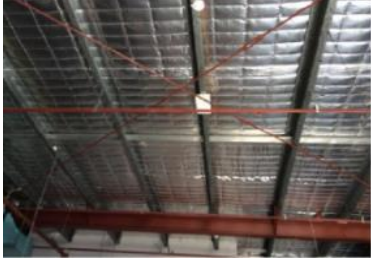
Primary Location	Description	Secondary Location	Photograph No.	Sample Number	Sample Results	Approx. Quantity	Surface Treatment	Extent of Damage	Friability	Likelihood of Disturbance	Action Rating	Photograph	Recommendations
Exterior: level 4, roof area, plant room TSHAF09	Sarking insulation	Underside of roof	11	Visual Observation	Suspected SMF	~50m <sup>2</sup>	S	G	F	L	Low

Maintain in current condition if to remain in-situ. Remove under controlled SMF conditions as per the Code of Practice for the Safe Use of Synthetic Mineral Fibres [NOHSC: 2006 (1990)].
Interior: level 4, ceiling space, throughout	Sarking insulation	Underside of roof	12	Visual Observation	Suspected SMF	~1000m <sup>2</sup>	S	G	F	L	Low

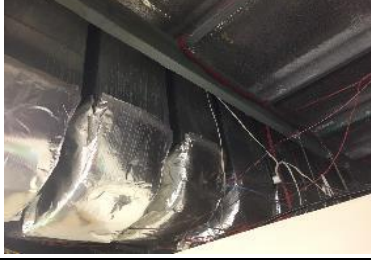
Interior: level 4, ceiling space, throughout	Insulation material	AC ductwork	13	Visual Observation	Suspected SMF	~300m	S	G	F	L	Low

Maintain in current condition if to remain in-situ. Remove under controlled SMF conditions as per the Code of Practice for the Safe Use of Synthetic Mineral Fibres [NOHSC: 2006 (1990)].
Interior: level 4, ceiling space, throughout	Insulation material	Flexible ductwork	14	Visual Observation	Suspected SMF	~200m	S	G	F	L	Low

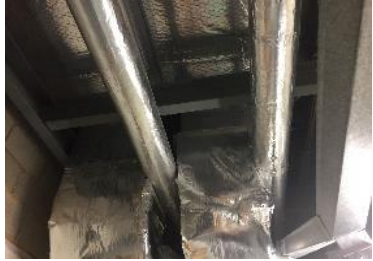
Primary Location	Description	Secondary Location	Photograph No.	Sample Number	Sample Results	Approx. Quantity	Surface Treatment	Extent of Damage	Friability	Likelihood of Disturbance	Action Rating	Photograph	Recommendations
Interior: level 4, ceiling space, throughout	Insulation material	Pipework	15	Visual Observation	Suspected SMF	~300m	S	G	F	L	Low

Maintain in current condition if to remain in-situ. Remove under controlled SMF conditions as per the Code of Practice for the Safe Use of Synthetic Mineral Fibres [NOHSC: 2006 (1990)].
Interior: level 4, ceiling, throughout	Compressed ceiling tiles	Ceiling	16	Visual Observation	Suspected SMF	~1000m <sup>2</sup>	S	G	F	L	Low

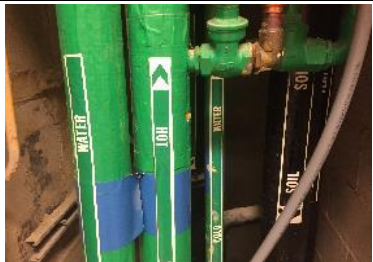
Maintain in current condition if to remain in-situ. Remove under controlled SMF conditions as per the Code of Practice for the Safe Use of Synthetic Mineral Fibres [NOHSC: 2006 (1990)].
Interior: level 4, risers, throughout	Insulation material	Pipework	17	Visual Observation	Suspected SMF	~200m	S	G	F	L	Low

Maintain in current condition if to remain in-situ. Remove under controlled SMF conditions as per the Code of Practice for the Safe Use of Synthetic Mineral Fibres [NOHSC: 2006 (1990)].

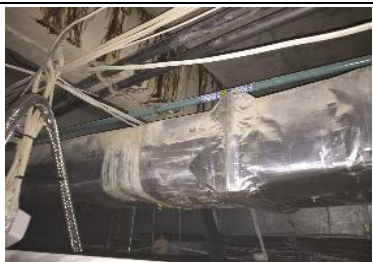
Interior: level 3, ceiling space, throughout	Insulation material	AC ductwork	18	Visual Observation	Suspected SMF	~300m	S	G	F	L	Low

Maintain in current condition if to remain in-situ. Remove under controlled SMF conditions as per the Code of Practice for the Safe Use of Synthetic Mineral Fibres [NOHSC: 2006 (1990)].

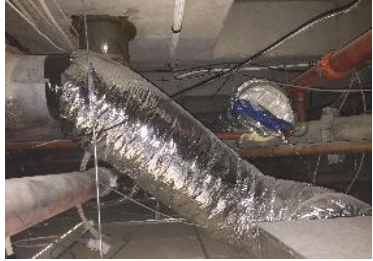
Primary Location	Description	Secondary Location	Photograph No.	Sample Number	Sample Results	Approx. Quantity	Surface Treatment	Extent of Damage	Friability	Likelihood of Disturbance	Action Rating	Photograph	Recommendations
Interior: level 3, ceiling space, throughout	Insulation material	Flexible ductwork	19	Visual Observation	Suspected SMF	~200m	S	G	F	L	Low

Maintain in current condition if to remain in-situ. Remove under controlled SMF conditions as per the Code of Practice for the Safe Use of Synthetic Mineral Fibres [NOHSC: 2006 (1990)].
Interior: level 3, ceiling, throughout various offices	Compressed ceiling tiles	Ceiling	20	Visual Observation	Suspected SMF	~1000m <sup>2</sup>	S	G	F	L	Low

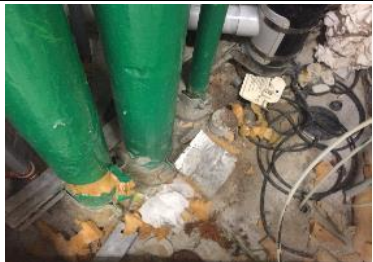
Maintain in current condition if to remain in-situ. Remove under controlled SMF conditions as per the Code of Practice for the Safe Use of Synthetic Mineral Fibres [NOHSC: 2006 (1990)].
Interior: level 3, risers, throughout	Insulation material	Pipework	21	Visual Observation	Suspected SMF	~200m	S	P	F	L	Low

Maintain in current condition if to remain in-situ. Remove under controlled SMF conditions as per the Code of Practice for the Safe Use of Synthetic Mineral Fibres [NOHSC: 2006 (1990)].

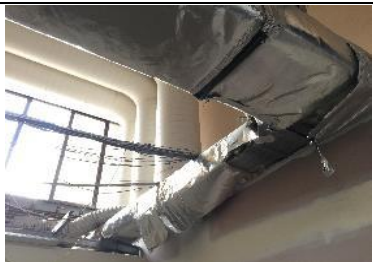
Interior: level 2, ceiling space, throughout	Insulation material	AC ductwork	22	Visual Observation	Suspected SMF	~300m	S	G	F	L	Low

Maintain in current condition if to remain in-situ. Remove under controlled SMF conditions as per the Code of Practice for the Safe Use of Synthetic Mineral Fibres [NOHSC: 2006 (1990)].
