# WOLLONGONG COAL LTD

## Russell Vale Colliery

### Bellambi Creek Diversion Pipeline Assessment

**December 2017**

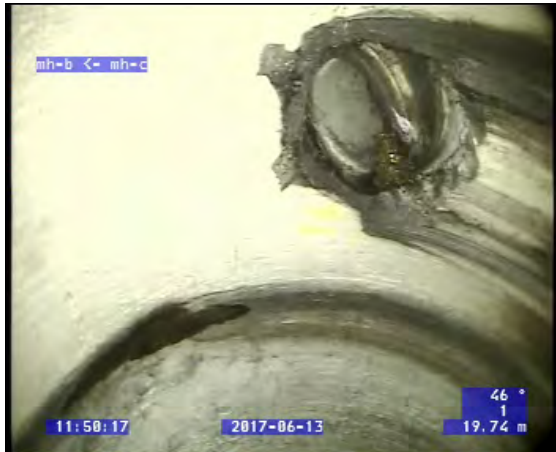
Photo: SW001 (Section 3)\_MH B\_MH  
C\_20062017\_110637\_A.jpg  
19.74m, Connection, poor workmanship, connection appears to be open , diameter approx 225mm , General Comments suspect a possible displacement

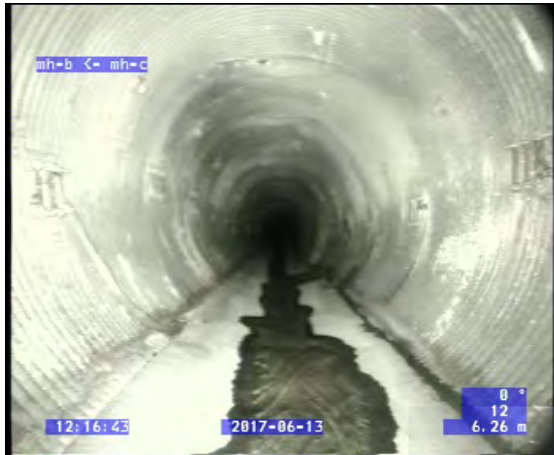
Photo: SW001 (Section 3A)\_MH B\_MH  
C\_20062017\_112729\_A.jpg  
6.26m, New material, Corrugated Iron

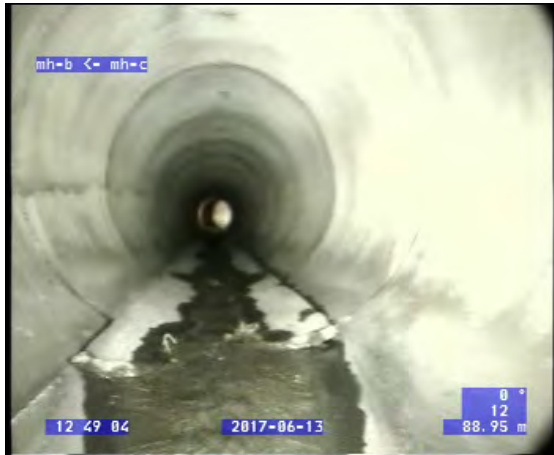
Photo: SW001 (Section 3C)\_MH B\_MH  
C\_20062017\_122557\_A.jpg  
88.95m, Dropped invert , depth of drop 10mm, General  
Comments dip in pipe invert

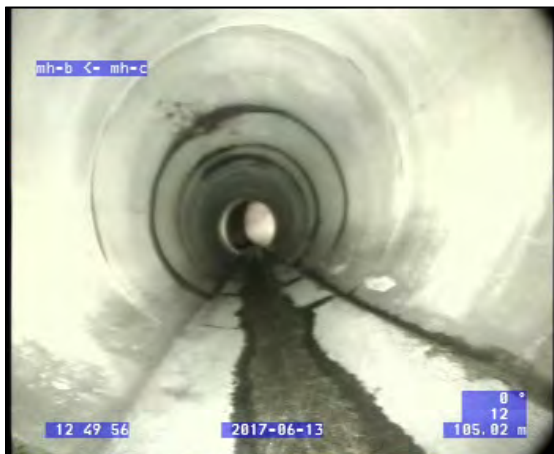
Photo: SW001 (Section 3C)\_MH B\_MH  
C\_20062017\_122831\_A.jpg  
105.02m, Vertical deformation , change in diameter 5-10%,  
length of deformation 500mm , at 12 o'clock

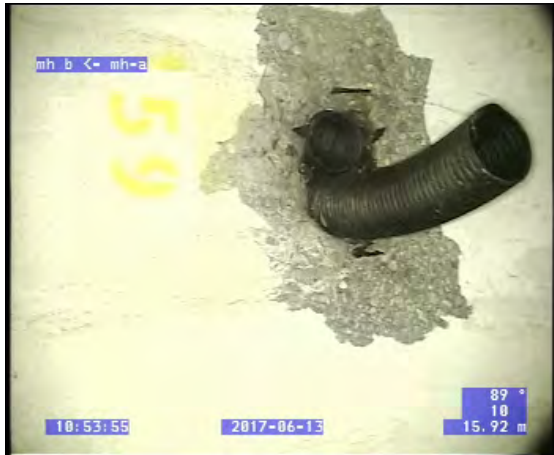
Photo: SW001 (US Part 1)\_MH A\_MH B\_20062017\_124808\_A.jpg  
15.92m, Intruding connection, magnitude of intrusion: 5-20%,  
General Comments Protruding into line, at 10 o'clock

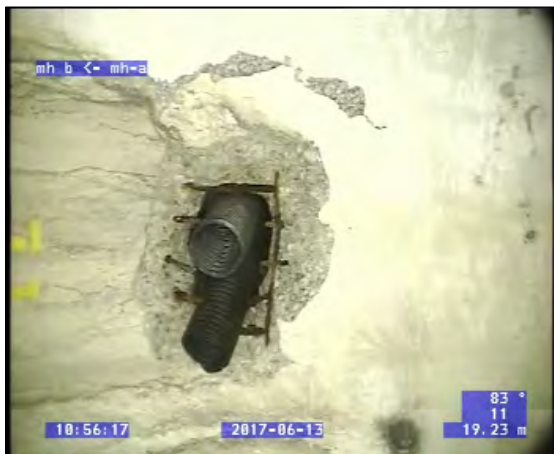
Photo: SW001 (US Part 1)\_MH A\_MH B\_20062017\_124943\_A.jpg  
19.23m, Intruding connection, magnitude of intrusion: 5-20%,  
General Comments Protruding into line with reinforcement exposed, at 11 o'clock

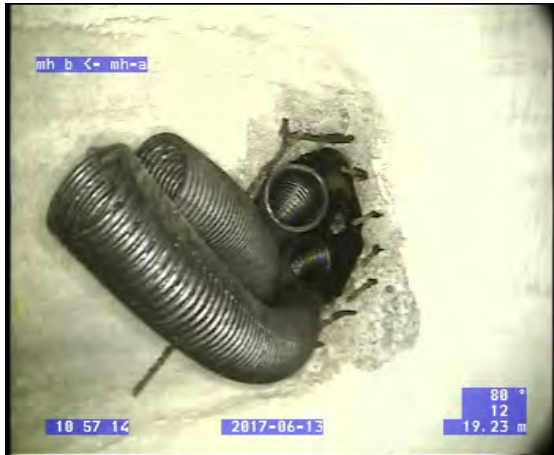
Photo: SW001 (US Part 1)\_MH A\_MH B\_20062017\_125036\_A.jpg  
19.23m, Intruding connection, magnitude of intrusion: 5-20%, General Comments Protruding into line with reinforcement exposed, at 12 o'clock

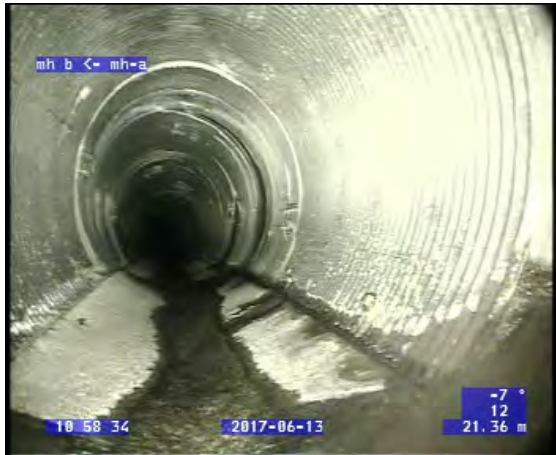
Photo: SW001 (US Part 1)\_MH A\_MH  
B\_20062017\_125234\_A.jpg  
21.36m, New material, Corrugated Iron

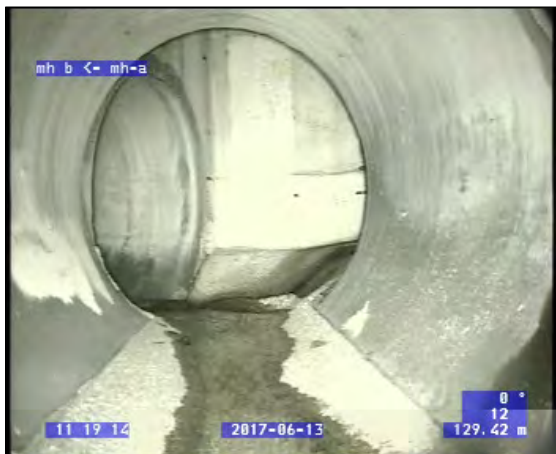
Photo: SW001 ( US Part 2)\_MH A\_MH  
B\_20062017\_133200\_A.jpg  
129.42m, New material, Concrete Pipe , General Comments  
returns to original pipe material
