Tasman Extension Project Environmental Impact Statement

PRIVATE DRIVEWAY/ GEORGE BOOTH DRIVE REVIEW

Tasman Extension Project

Safety Review of George Booth Drive Shoulder Widening

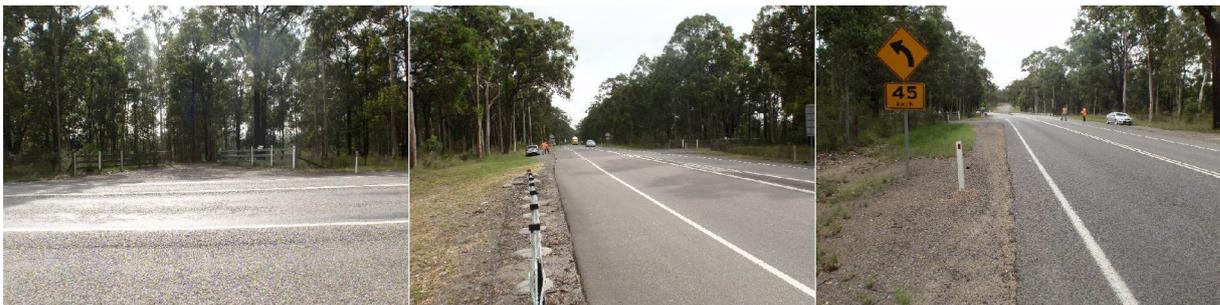
3.1 Current Provisions

- There are well worn vehicle tracks evident on the southbound side of the road prior to the driveway, which suggests that the motorists entering the driveway are leaving the travel lane early in order to turn left into their property;
- A damaged Telstra pit was observed at the entrance to the property and it is likely that it is caused by vehicles leaving the road early to undertake a left turn into the property;

- ▶ Some minor erosion has occurred at the edge of the seal on both sides of the road, creating a small drop to the unsealed shoulder – Refer Appendix A, Photo 1 and Photo 2;
- ▶ Both sides of the road have wide unsealed areas that are clear of non-frangible hazards; and
- ▶ Sight distance to a vehicle propped to turn right into the driveway is reduced due to the sharp right hand curve to the south of the driveway. Vehicles travelling north on George Booth Drive will not see a propped vehicle until they have negotiated the curve. However, the speed of the through vehicle is reduced due to the tightness of this curve.

- ▶ Provide a short length of sealed shoulder widening for the left turn into the property, which would require repairs to the existing Telstra pit.

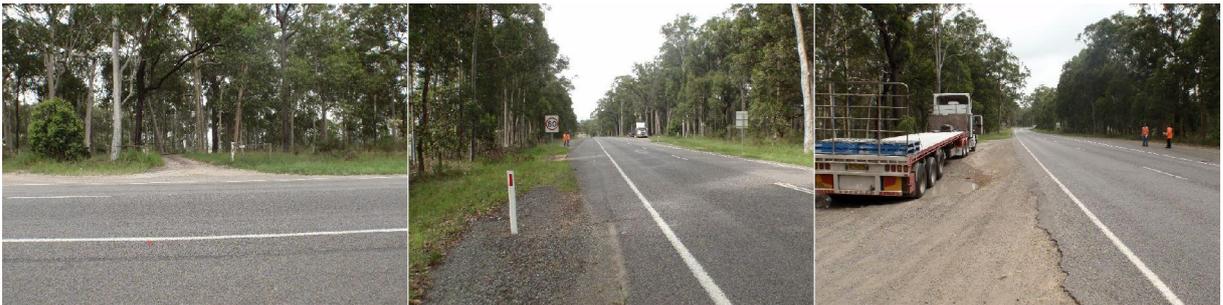
4.1 Current Provisions

- Both sides of the road have wide unsealed areas that are clear of non-frangible hazards. A semi-trailer was observed to be parking in one of the widened unsealed verges;
- A large hole is present in the road verge on left turn approach to the driveway – Refer Appendix A, Photo 3;
- Some minor erosion has occurred at the edge of seal on both sides of the road, creating a small drop to the unsealed shoulder – Refer Appendix A, Photo 4;

Provide sealed shoulder widening for the left turn into the driveway.

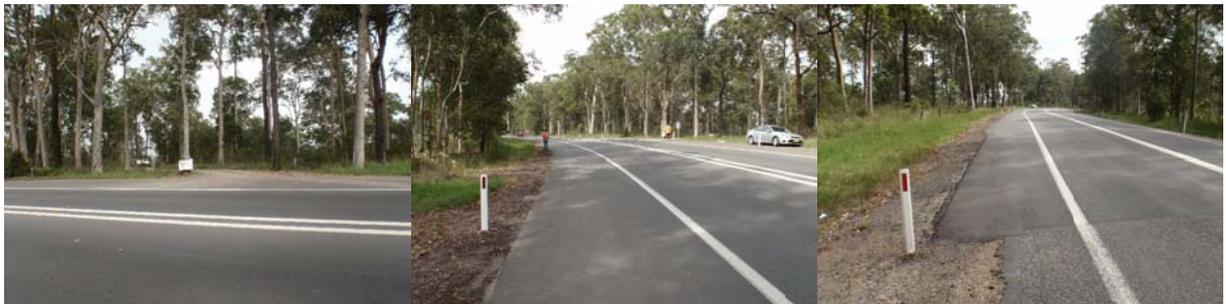
5.1 Current Provisions

- ▶ This section of George Booth Drive has been constructed using asphalt rather than a bitumen seal as per the rest of the road;
- ▶ Vehicles turning right into the property were observed to take a diagonal movement across the northbound lane on George Booth Drive rather than a 90 degree turn into the property;

No improvements or modifications are proposed at this driveway.

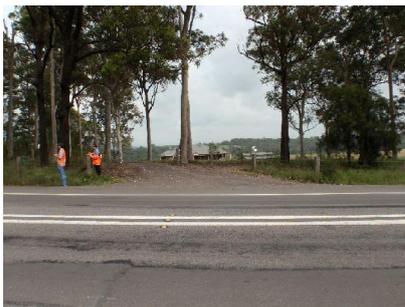
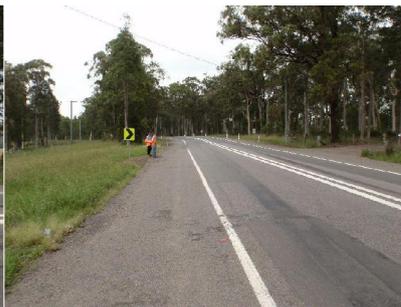
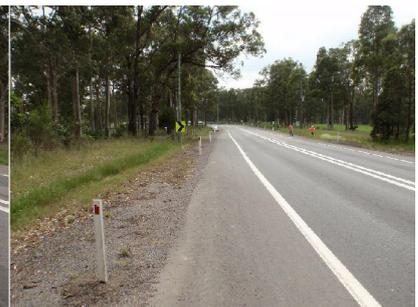
Table 4 Existing Provisions at No. 1395 George Booth Drive

- While the sealed right turn shoulder widening does extend out to 2.5m (approximately), the actual available shoulder width is limited by the position of the guideposts at this location which are offset approximately 200mm from the edge of seal. It is noted that the guide posts have not been provided in the immediate vicinity of the driveway – Refer Appendix A, Photo 5; and

- ▶ Concrete culvert at the driveway entrance is missing a headwall and the end of the pipe had signs of damage with some of the reinforcement being observed.

- ▶ Provide additional width for the right turn shoulder widening; and
- ▶ Guide posts to be relocated to outside the sealed pavement area.

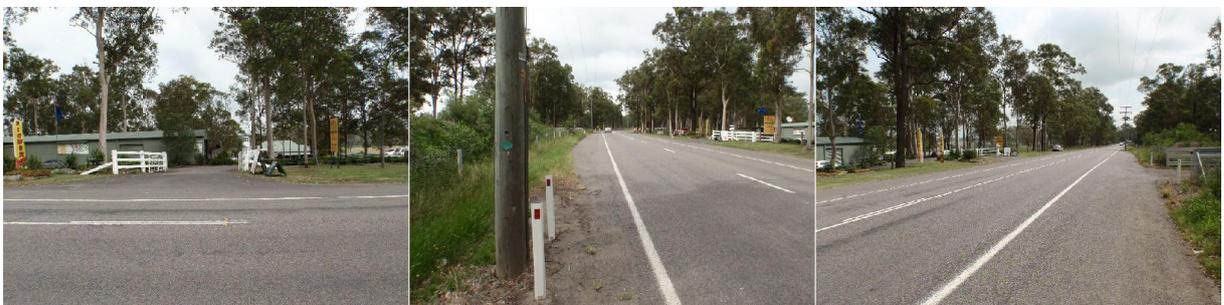
7.1 Current Provisions

- At end of widened shoulder (2.75m from edge line on road).These poles will create a non-frangible hazard for an errant vehicle on George Booth Drive – Refer Appendix A, Photo 6 and Photo 7;

- ▶ Consider the relocation of the power poles to outside of the clear zone for the road. These poles restrict the extents of the widened shoulders. It is also noted that should a vehicle overshoot the widened shoulder at this location it would travel straight into one of the poles; and
- ▶ Trim or remove vegetation on the southbound side of the road, north of the driveway into property No. 1408 to improve sightlines out of the driveway to approaching vehicles.

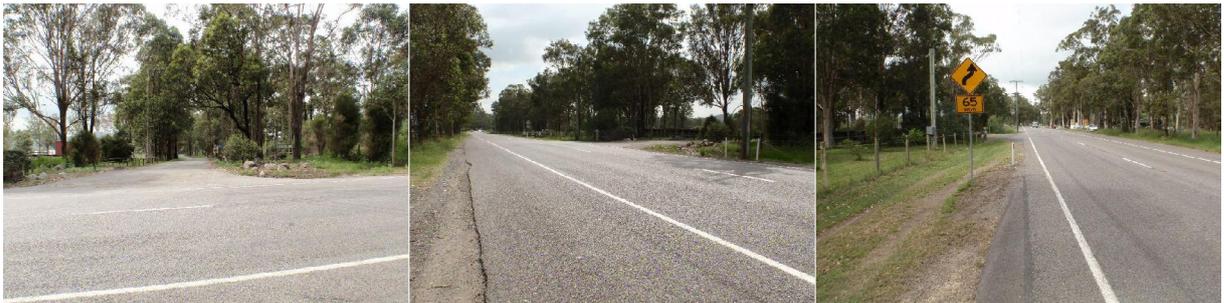
8.1 Current Provisions

- ▶ The driveway pavement was observed to be damaged with signs of crocodile cracking and potholes. This is thought to be attributed to the number of heavy vehicles that enter and leave the property – Refer Appendix A, Photo 10;

- ▶ At the throat of the driveway deep tyre tracks were observed into the unsealed pavement to the south – Refer Appendix A, Photo 11;
- ▶ Tyre marks on the road indicate that there are large numbers of heavy vehicles that turn into and out of the property, and that these vehicles regularly use the road shoulders to be able to make the manoeuvre. During the time of the safety review a B-Double vehicle was observed to turn right out of the property, this vehicle used the entire northbound road shoulder for the movement and encroached into the unsealed shoulder for a section while exiting the property – Refer Appendix A, Photo 12 and Photo 13. It can be seen in Photo 13, how a light vehicle has pulled over in the unsealed verge to turn left.

It is considered that the issues associated with this driveway are due to the commercial nature of the property. However, some shoulder widening could be provided for the left turn into the driveway. Any existing damage to the existing driveway should be the responsibility of the property owner given that the driveway is used by heavy vehicles associated with these commercial premises.

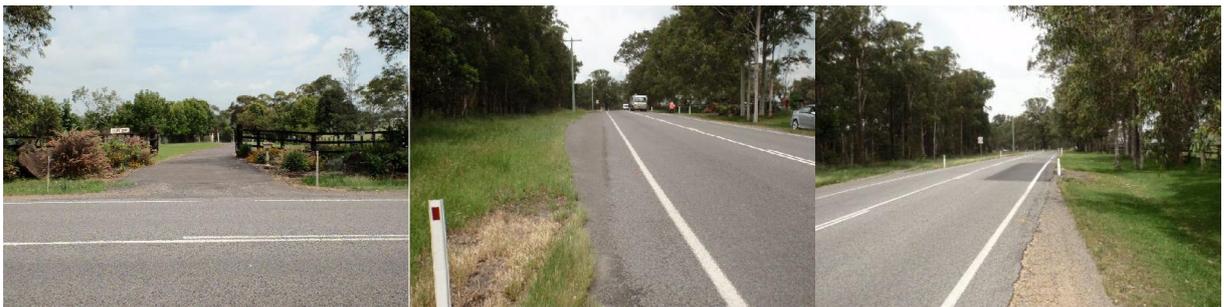
10.1 Current Provisions

- ▶ There is a power pole that is within the clear zone for the road, directly opposite the driveway. The pole is located 4.5 metres from the lane edge line and adjacent to the shoulder widening and poses as a hazard should a vehicle be clipped or clip another when passing around a stationary vehicle – Refer Appendix A, Photo 18;

- ▶ Providing throat widening or shoulder widening for the left turn into the driveway may require the existing culvert under the driveway to be modified or even replaced; and

- ▶ Provide a sealed widened shoulder for the left turn into the property; and
- ▶ Consider the relocation of the power pole to outside of the clear zone.

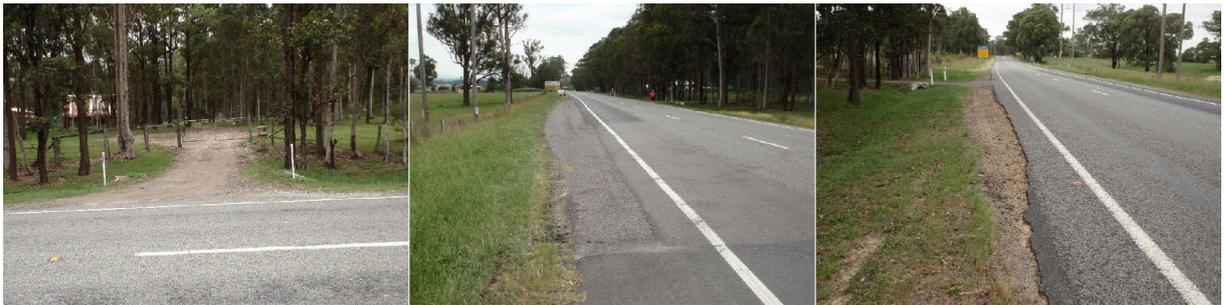
11.1 Current Provisions

- The road widening for right turning vehicles is inconsistent in width and appears to be inadequate for vehicles to pass turning vehicles. At the critical area where overtaking/passing will occur the shoulder widening is 2.5m wide. There is no additional unsealed shoulder width for vehicles to use in order to pass a vehicle propped to turn right into the property. Wheel tracks were observed in the unsealed shoulder suggesting that it is used for the left turn into the property – Refer Appendix A, Photo 20;

- ▶ A Hunter Expressway construction sign, located opposite the property access, has 3 x 90 mm diameter posts spaced at 0.8 metres, with the first post located 3.1m from the edge line. These poles create a non-frangible hazard within the clear zone for the road – Refer Appendix A, Photo 22;

- ▶ Provide a sealed widened shoulder for the left turn into the property;
- ▶ Consider relocation of the Hunter Expressway sign to outside of the clear zone for the road. This should be requested / referred to the Hunter Expressway Alliance office; and
- ▶ Provide additional widening for the northbound shoulder and smooth off the drop in pavement due to the rehabilitation works.

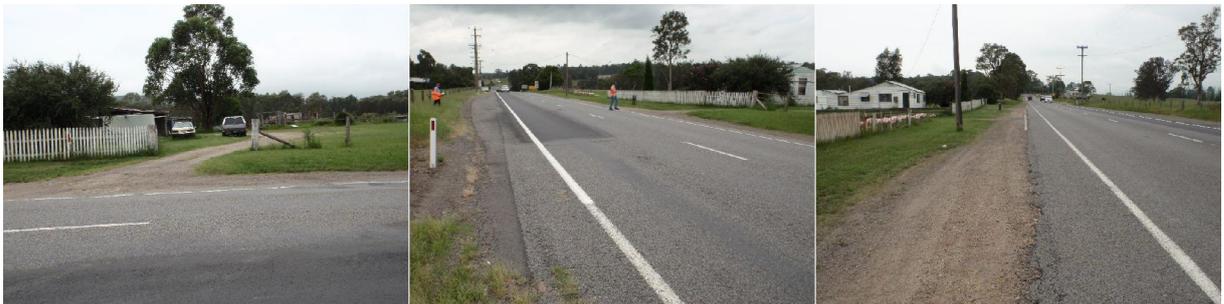
14.1 Current Provisions

- ▶ Some minor erosion has occurred at the edge of the southbound sealed pavement – Refer Appendix A, Photo 28;
- ▶ There is a large unsealed shoulder for the left turns into the properties, with wheel tracks suggesting that they are used regularly – Refer Appendix A, Photo 28; and
- ▶ A power pole is located approximately 3.5 meters from the edge of the travel lane, at the end of the widened shoulder taper. This is within the designated clear zone for the road environment and poses as a hazard to errant vehicles – Refer Appendix A, Photo 29.

- ▶ Extend the northbound shoulder widening to the south of property No. 1530 so that it will allow the safe overtaking of a vehicle propped to turn right into the property. Consider the relocation of the power pole adjacent to the widening; and
- ▶ Provide sealed shoulder widening for the left turns into the driveways.
