# Safe Useful Life Expectancy tree report

Proposed new clinical building

Blacktown Hospital Blacktown Road, Blacktown

Date: 15 August 2012 Prepared for: Health Infrastructure Prepared by: Abel Ecology

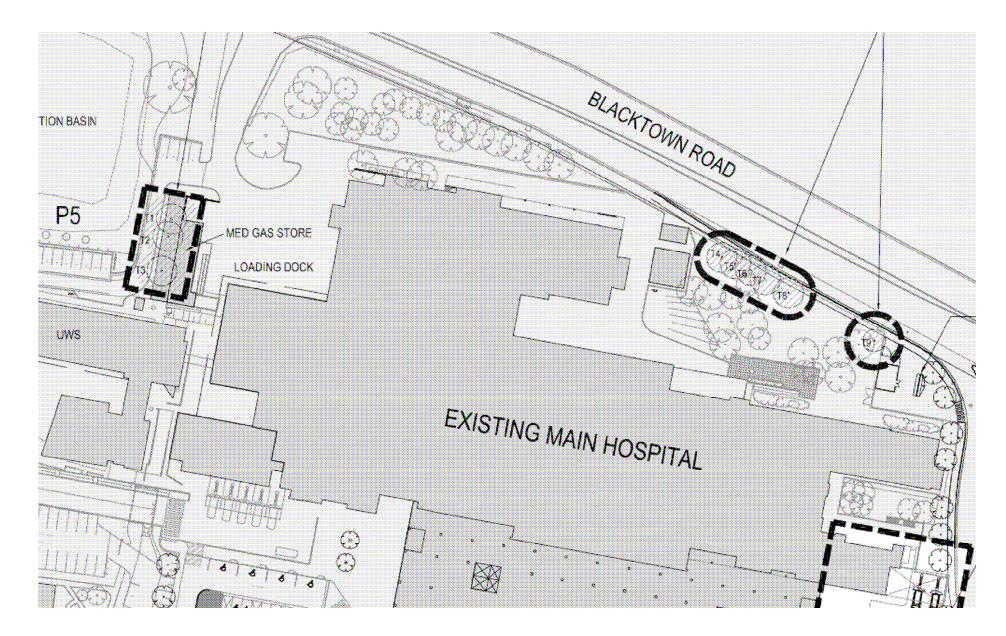
Figure 3. Close up of Extract from Site Works P11 & Tree Removal Proposal Drawing No BIN-AR-DG-0476

A tree assessment was carried out under instruction from the Senior Project Manager, Tony Kiernan, on a section of the site only (see Figure 3). Tony Kieman has requested that only the numbered trees require a report. The proposal is to remove the numbered trees.
