Flora and Fauna Assessment including Arborist Report

Flora and fauna assessment report

Kempsey District Hospital

Document No: 1123-REP-23-ISS-6

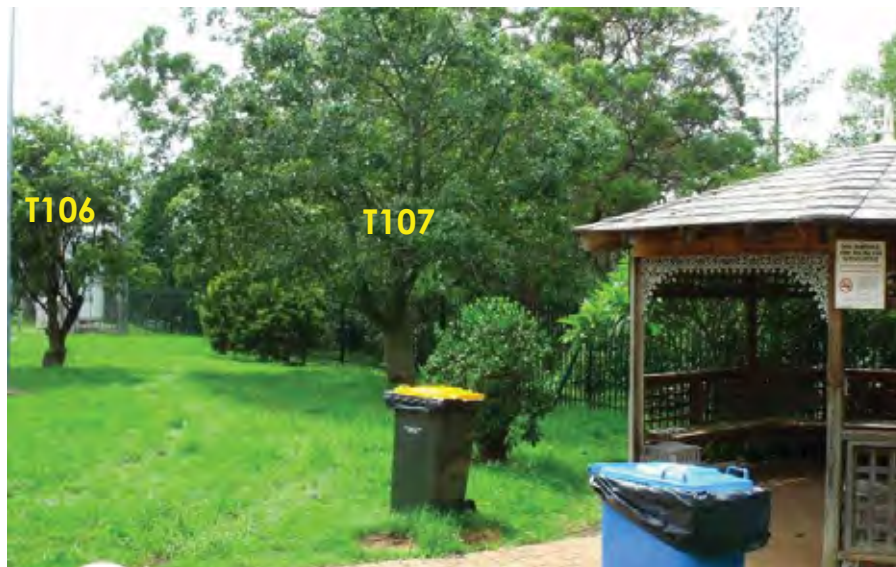
2 **Figure 7. Unnumbered shrubs in the area of Trees T106 and T107 affected by car park works**

12 High voltage electricity supply, sewer and stormwater services all require trenching.
 14 Clearances are shown in the table in section 5.2 Tree Schedule above. A variety of small
 16 shrubs which are not numbered appear on some plans. Those shrubs may be removed
 18 where they are affected by proposed works. Other small and unnumbered shrubs are
 20 illustrated below.

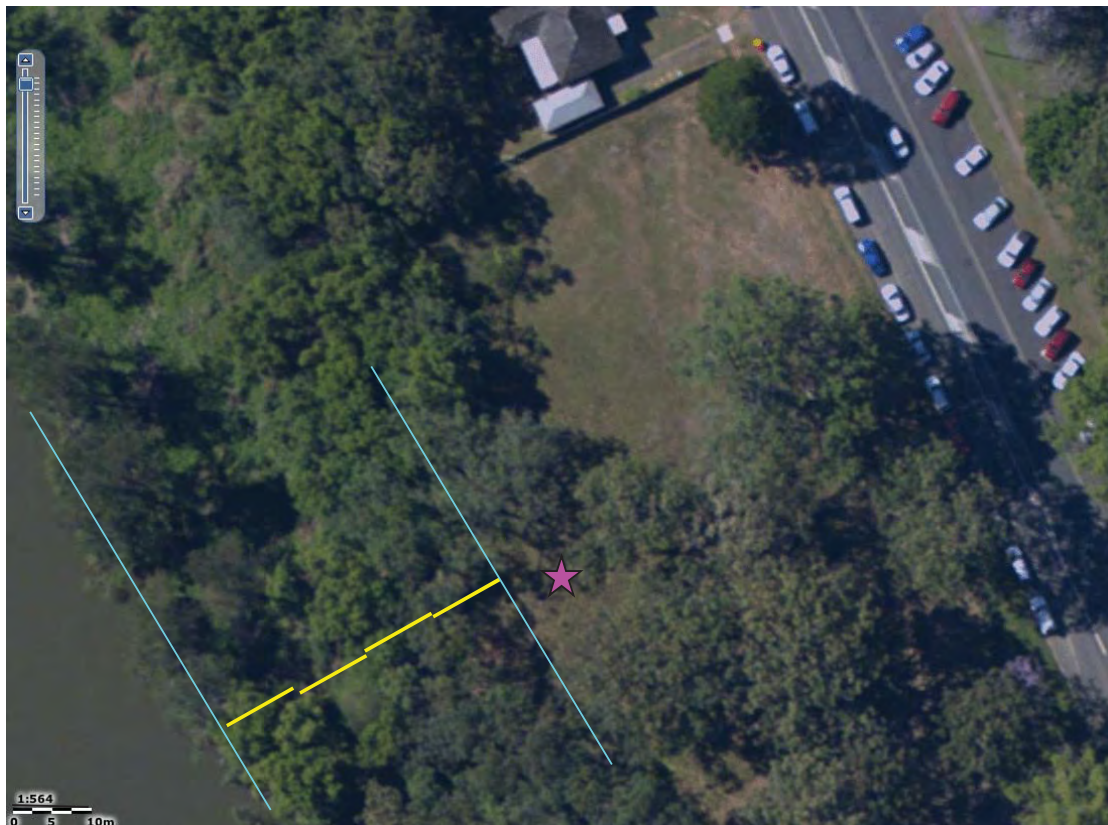
Figure 13. Macleay River and proposed car park area

Approximate edge of 40m riparian zone shown in blue, yellow scale bar is 10m.

Approximate location of new headwall is shown by a pink star.

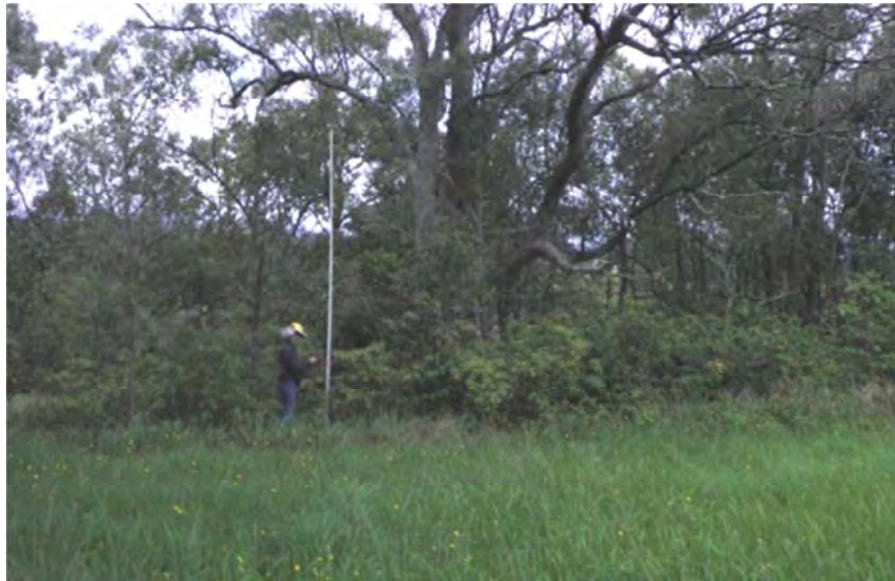
Figure 14. Approximate location of proposed new stormwater outlet

The existing stormwater outlet headwall is adjacent to the cliff edge with water dispersing directly over the cliff. The proposed new headwall is adjacent to the edge of the cliff (Figure 14). There are no mature trees downslope of the headwall in the likely flow path of stormwater so no impact on trees is anticipated.

Note that water flows downslope from right to left.
