Blast Impact Assessment Main Creek

**REVIEW OF THE IMPACT OF BLASTING ON ROCK
STRATA FRACTURING ON MAIN CREEK**

Report No: UM-1705-240518

**Thomas Lewandowski
24th May 2018**

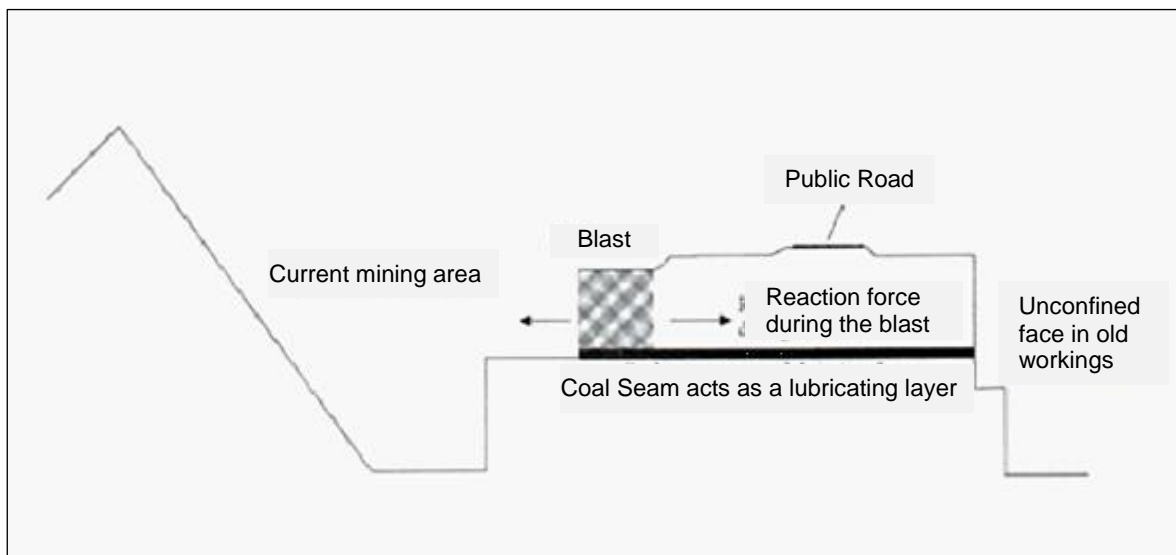
As a result of these blast design control measures the blast produced a low vibration impact, well below the specified limit of 150 mm/s. The back damage (behind the blast) was very limited and there was no evidence of bulk ground displacement. No damage to the road was detected.

Figure 4 – A Simplified Cross-section Showing the Risk of Bulk Displacement of the Road Bearing Pillar as a Result of Reaction Forces from the Blast on the West Side (left) of the Road (after Rorke and Thabethe, 2004)

To minimise any potential bulk displacement the number of rows was reduced to eight and deck charges employed with an appropriate initiation sequence. This was to minimise the amount of shock wave (minimise reaction forces to the block) delivered to the strata.

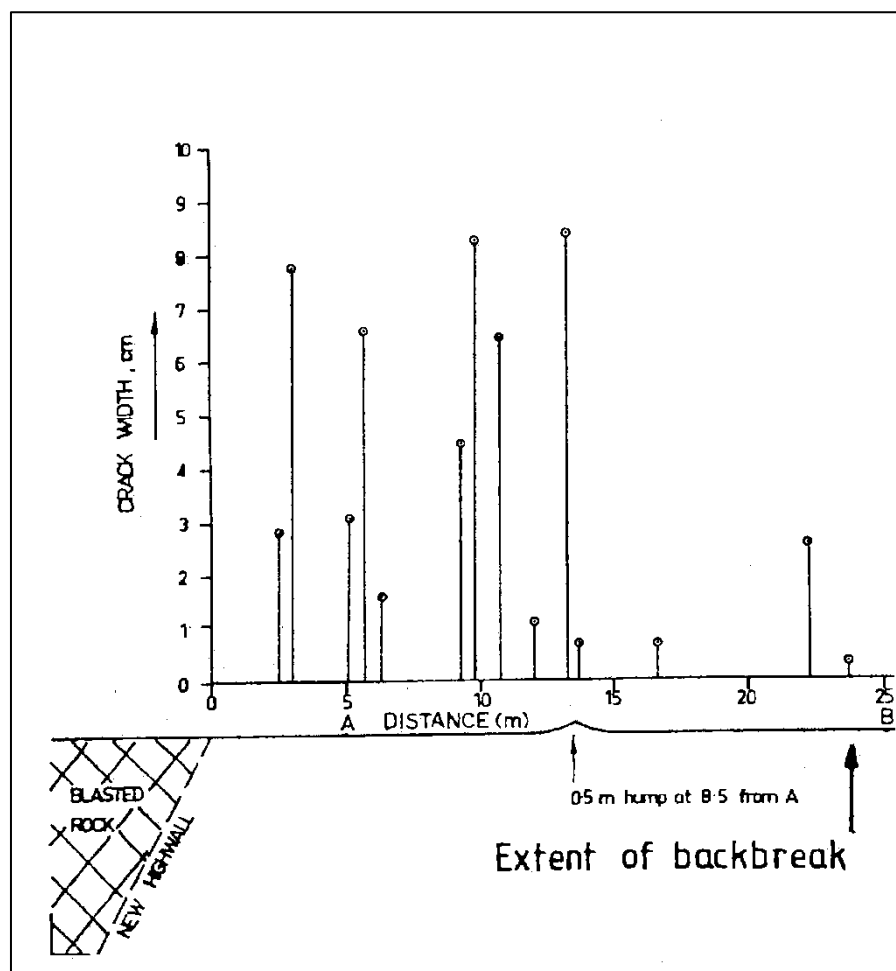
Figure 5C – Estimation of Back-break Cracking (after CSIRO 1983 report)

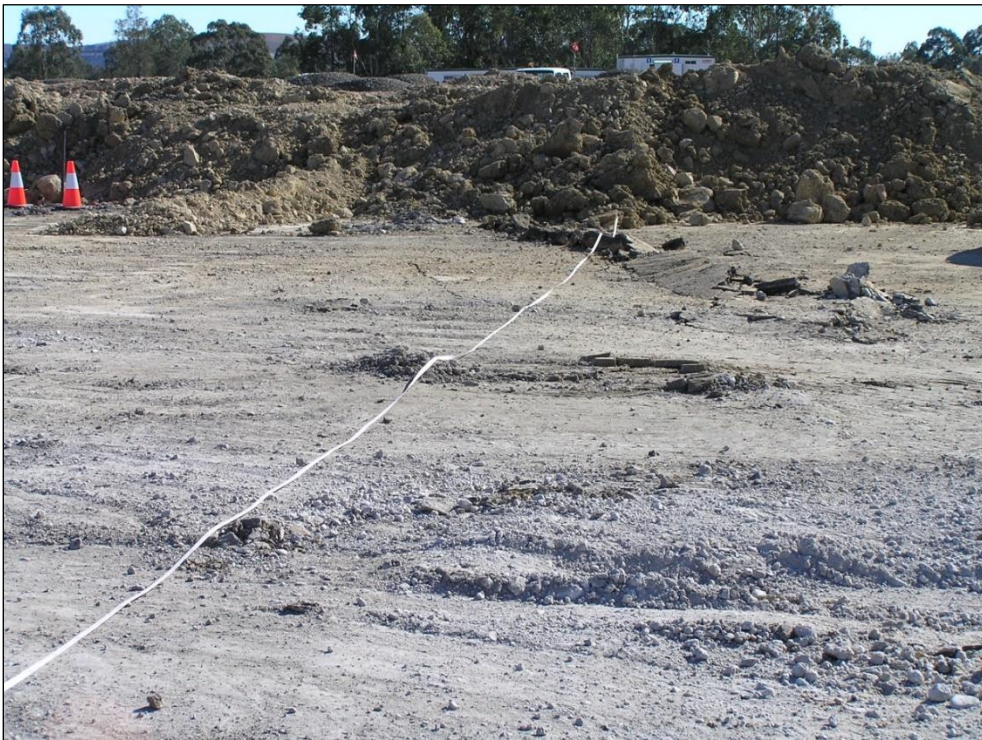
The blasts of interest included pre-split blasts with an MIC of 530 kg. For these particular geological conditions the extent of damage was relatively limited and was in line with other open cut mine experiences in the Hunter Valley, i.e. up to approximately 20 m behind the blast. The detected damage (manifested as a number of surface cracks and some surface layer displacement) was estimated to be in the order of up to 17 m from the edge of the blast, see **Figures 6B** and **6C**.

Figure 6C – Scanline behind the Pre-split Line and Surface Cracking (after Lewandowski and Cope 2009)

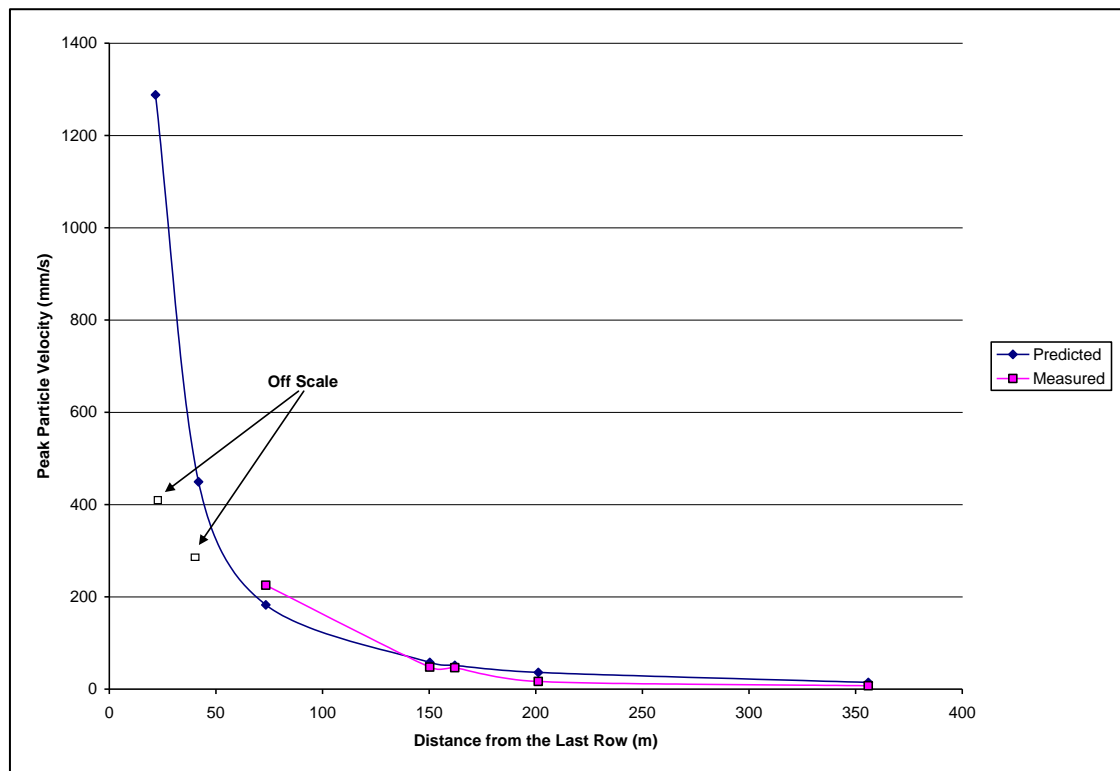
- The extent of rock strata damage for the adjacent bench to the blasting area, including back break, was limited to approximately 11.5 m from the edge of the blasted bench.
- The damage zone, including back break, was exposed to vibration levels well in excess of 400 mm/s (i.e. beyond instrument capability, see **Figure 7**), confirming that extremely high vibration levels are required to induce rock strata damage.

Figure 7 – Measured versus Predicted Vibration Behaviour

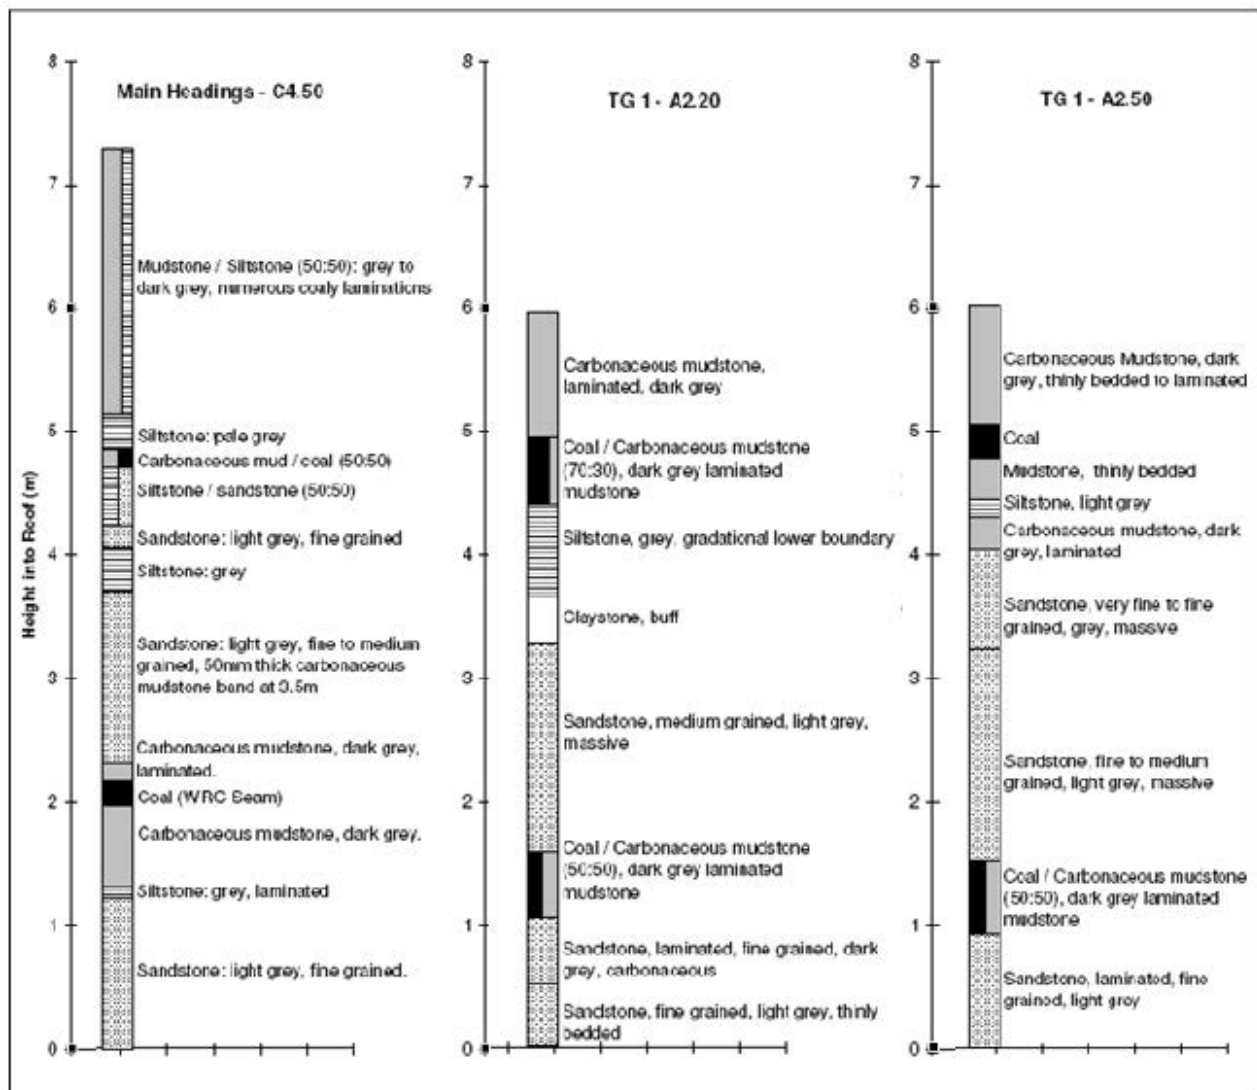
Figure 8C – Stratification of the Immediate Roof of the Underground Roadways in the Vicinity of the Underground Mine Entry (ESC Study 2008)

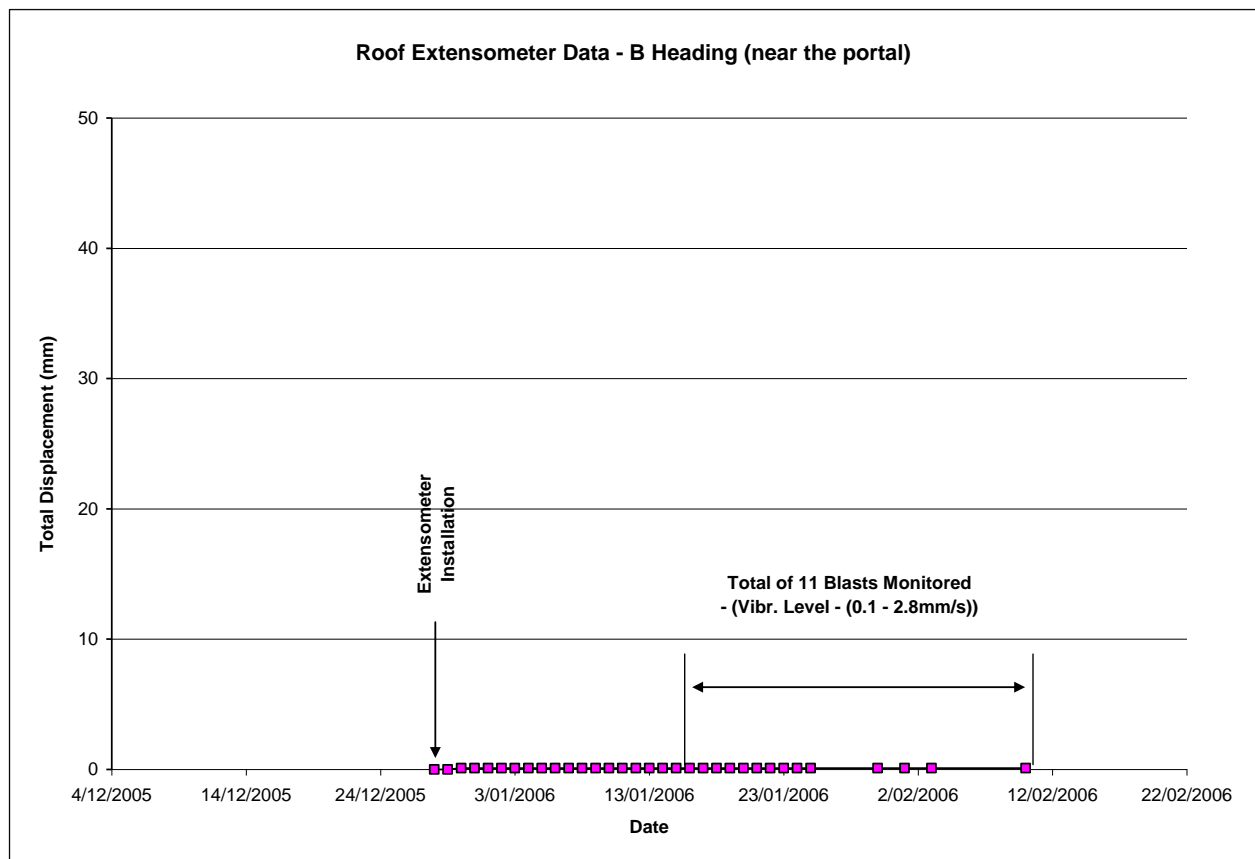
The study included an assessment of ground fracturing and rock wall damage within the underground tunnel, see **Figure 8B**. The assessment included a detailed inspection of the rock strata conditions for the underground tunnel, with the main aim to assess the level and extent of damage to the rock strata. A sample of the strata immediately above the roof of the underground roadways is shown in **Figure 8C**. The study was also supported by analysis of roof dilation data using roof extensometer measurements. This would provide evidence of horizontal crack formation caused by the adjacent strata blasting, see **Figure 8D**.

Figure 8D – Roof Extensometer Data near the Portal Entry

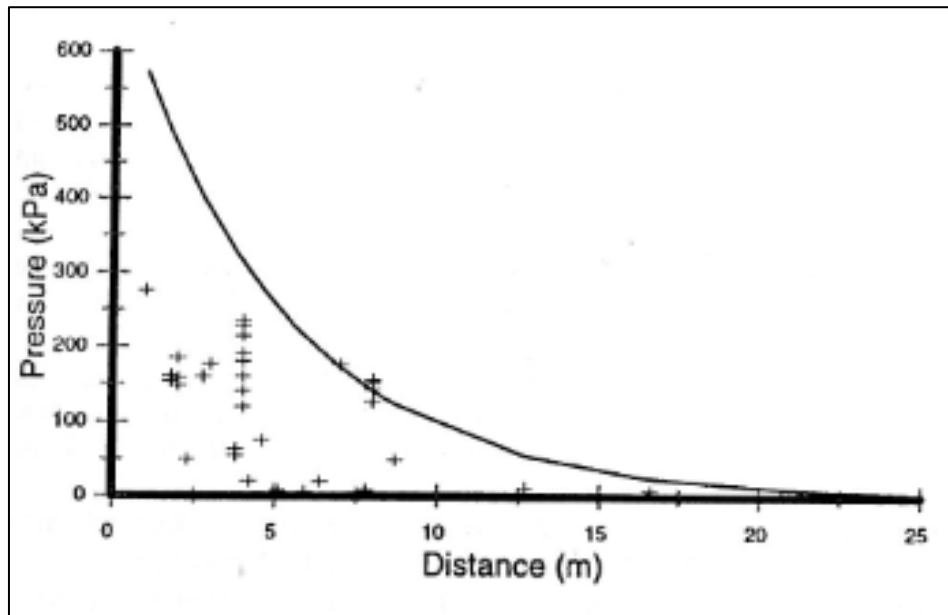
The monitoring showed high gas levels measured within 5 m of the blast and a decrease in gas pressure with an increased distance from the blasting area. The study indicates that low pressure has been measured at 15 – 16 m from the blasting bench, which is equivalent to approximately two burden distances from the blasted hole. McKenzie concluded that the gas flow has been observed for distances up to 20 m behind the blasthole patterns.

Figure 9 – Gas Pressure Measured versus Distance – Obtained from Literature Review (after McKenzie 1999)

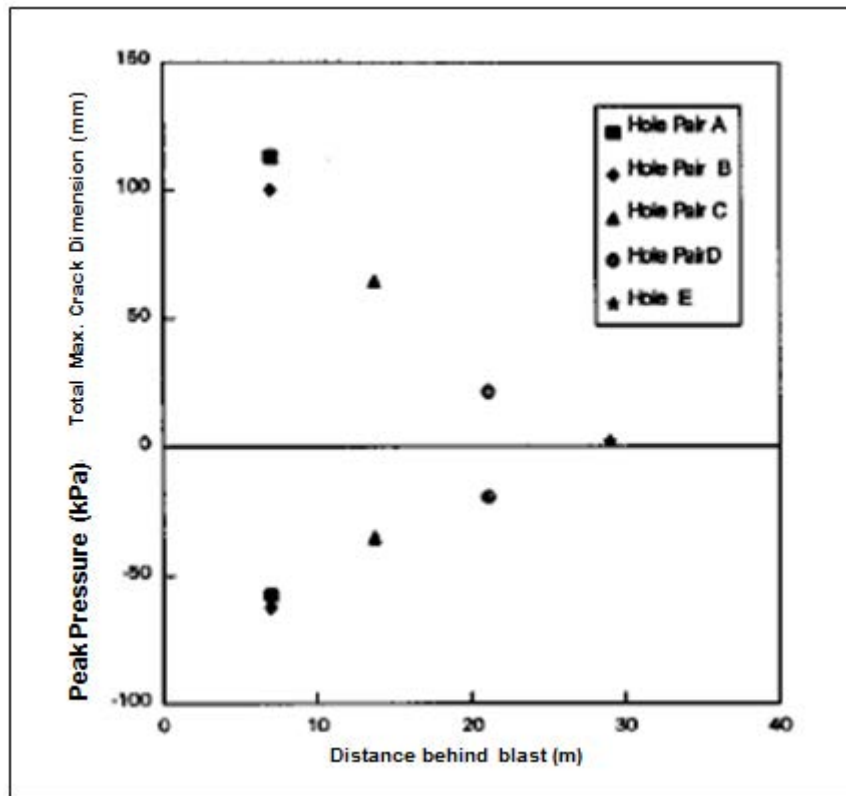
Figure 10 – Correlation of Negative Pressures and Visible Fractures (after Brent and Smith 1996)

The study revealed that there is a gradual decrease in crack dilation from approximately 60 mm at a distance of 15 m and approximately 20 mm at 20 m. The study concluded that at a distance of 30 m the impact of blasting dissipates, i.e. no measured negative gas pressure and marginal crack dilation. Therefore, the potential impact was limited to approximately 30 m.
