Arboricultural Impact Assessment

One Sydney Harbour
Barangaroo South
Development Application
Finalisation

Project No 5029/D/2016/A

One Sydney Harbour – Temporary drainage - Barangaroo South: Stage 1B

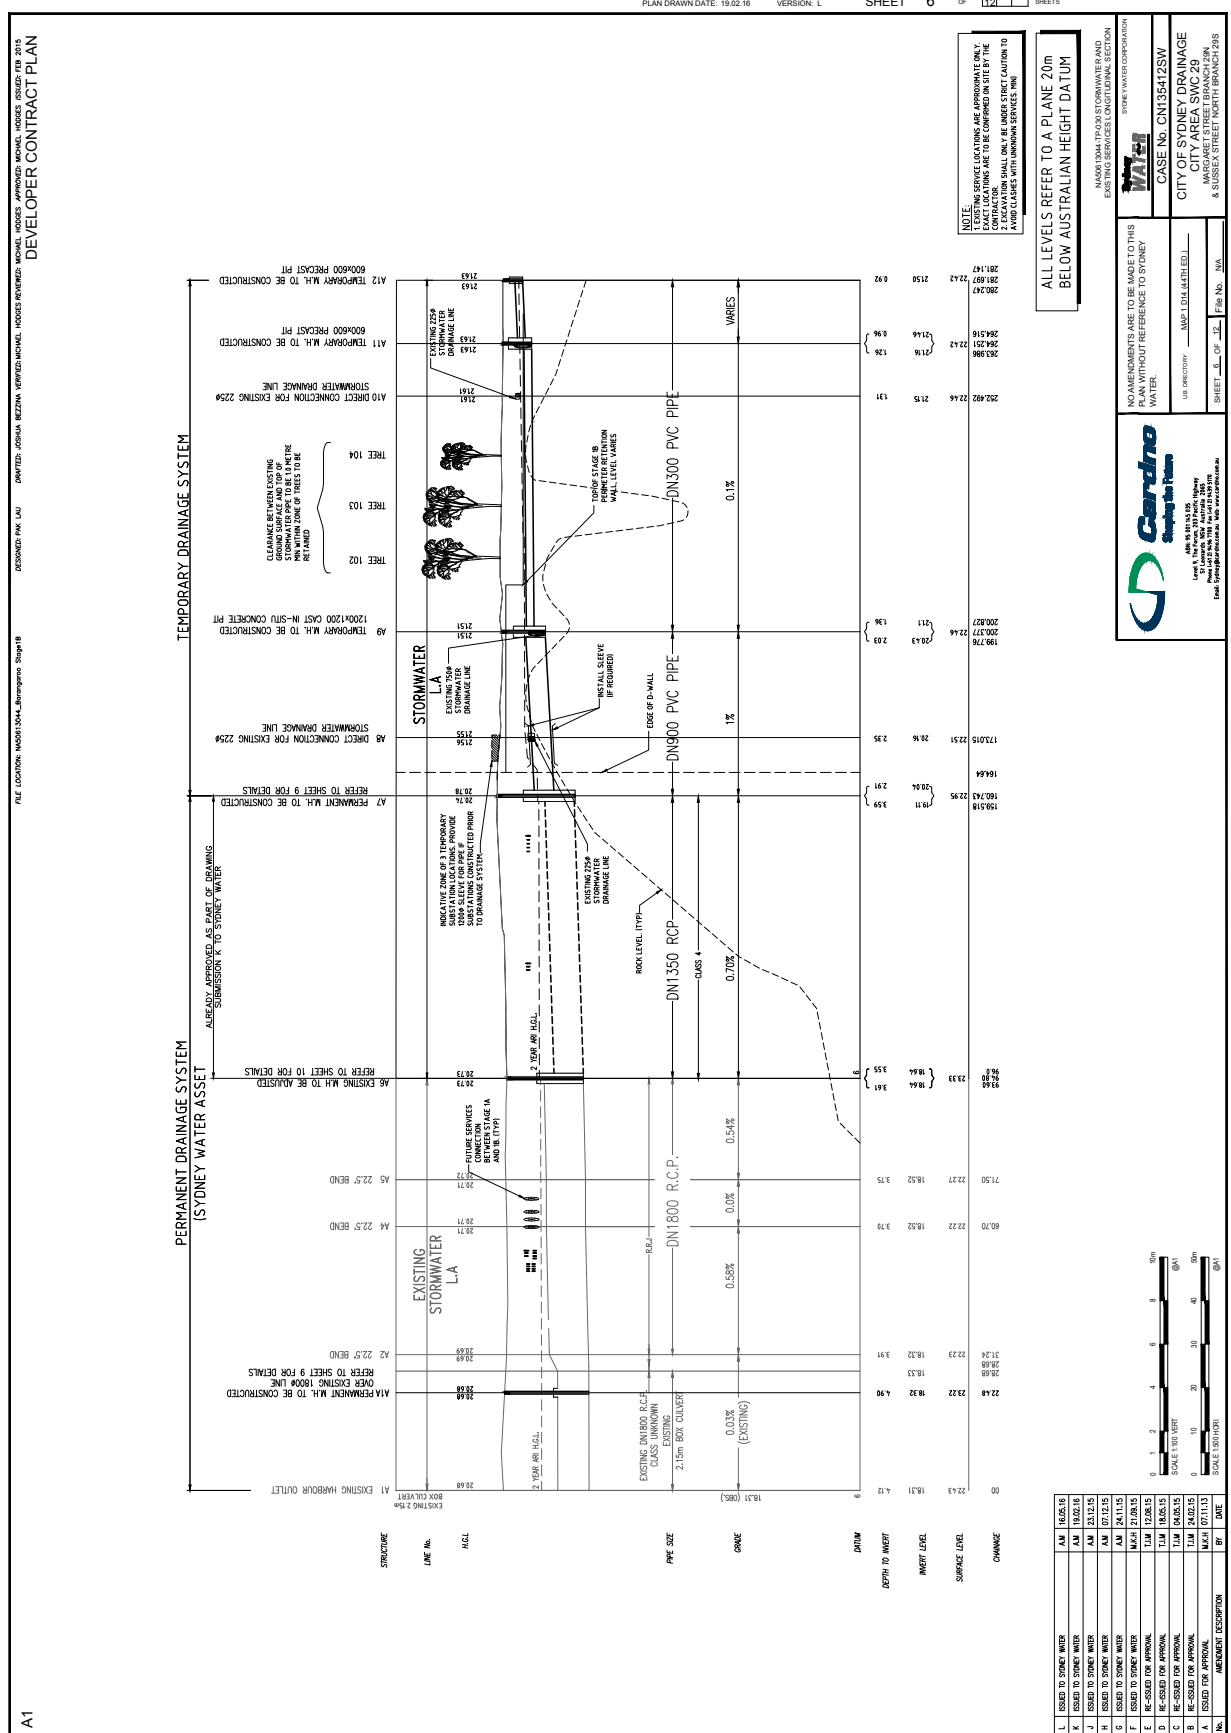
Plan of Proposed Works

Assessment of these plans in relation to tree protections requirements finds that the proposed temporary 300mm diameter pipeline Line A. (L .A) as noted on the attached plan, has works being perform with directional drilling at one metre below soil surface and entry and exits pits are 5 metres and outside most of the tree protection zones.

Should any large (10cm or greater) roots be found or tree health or stability become evident your project arborist must be consulted immediately.
