arboricultural impact assessment, proposed development fifteenth avenue commercial precinct, west hoxton

29th May 2015

prepared by Melanie Howden - Ass. Dip. Hort. (Haw. Ag. C.), SoA. Arb. MAIH, MIACA

drawing title
**existing site - tree locations &
reference numbers**

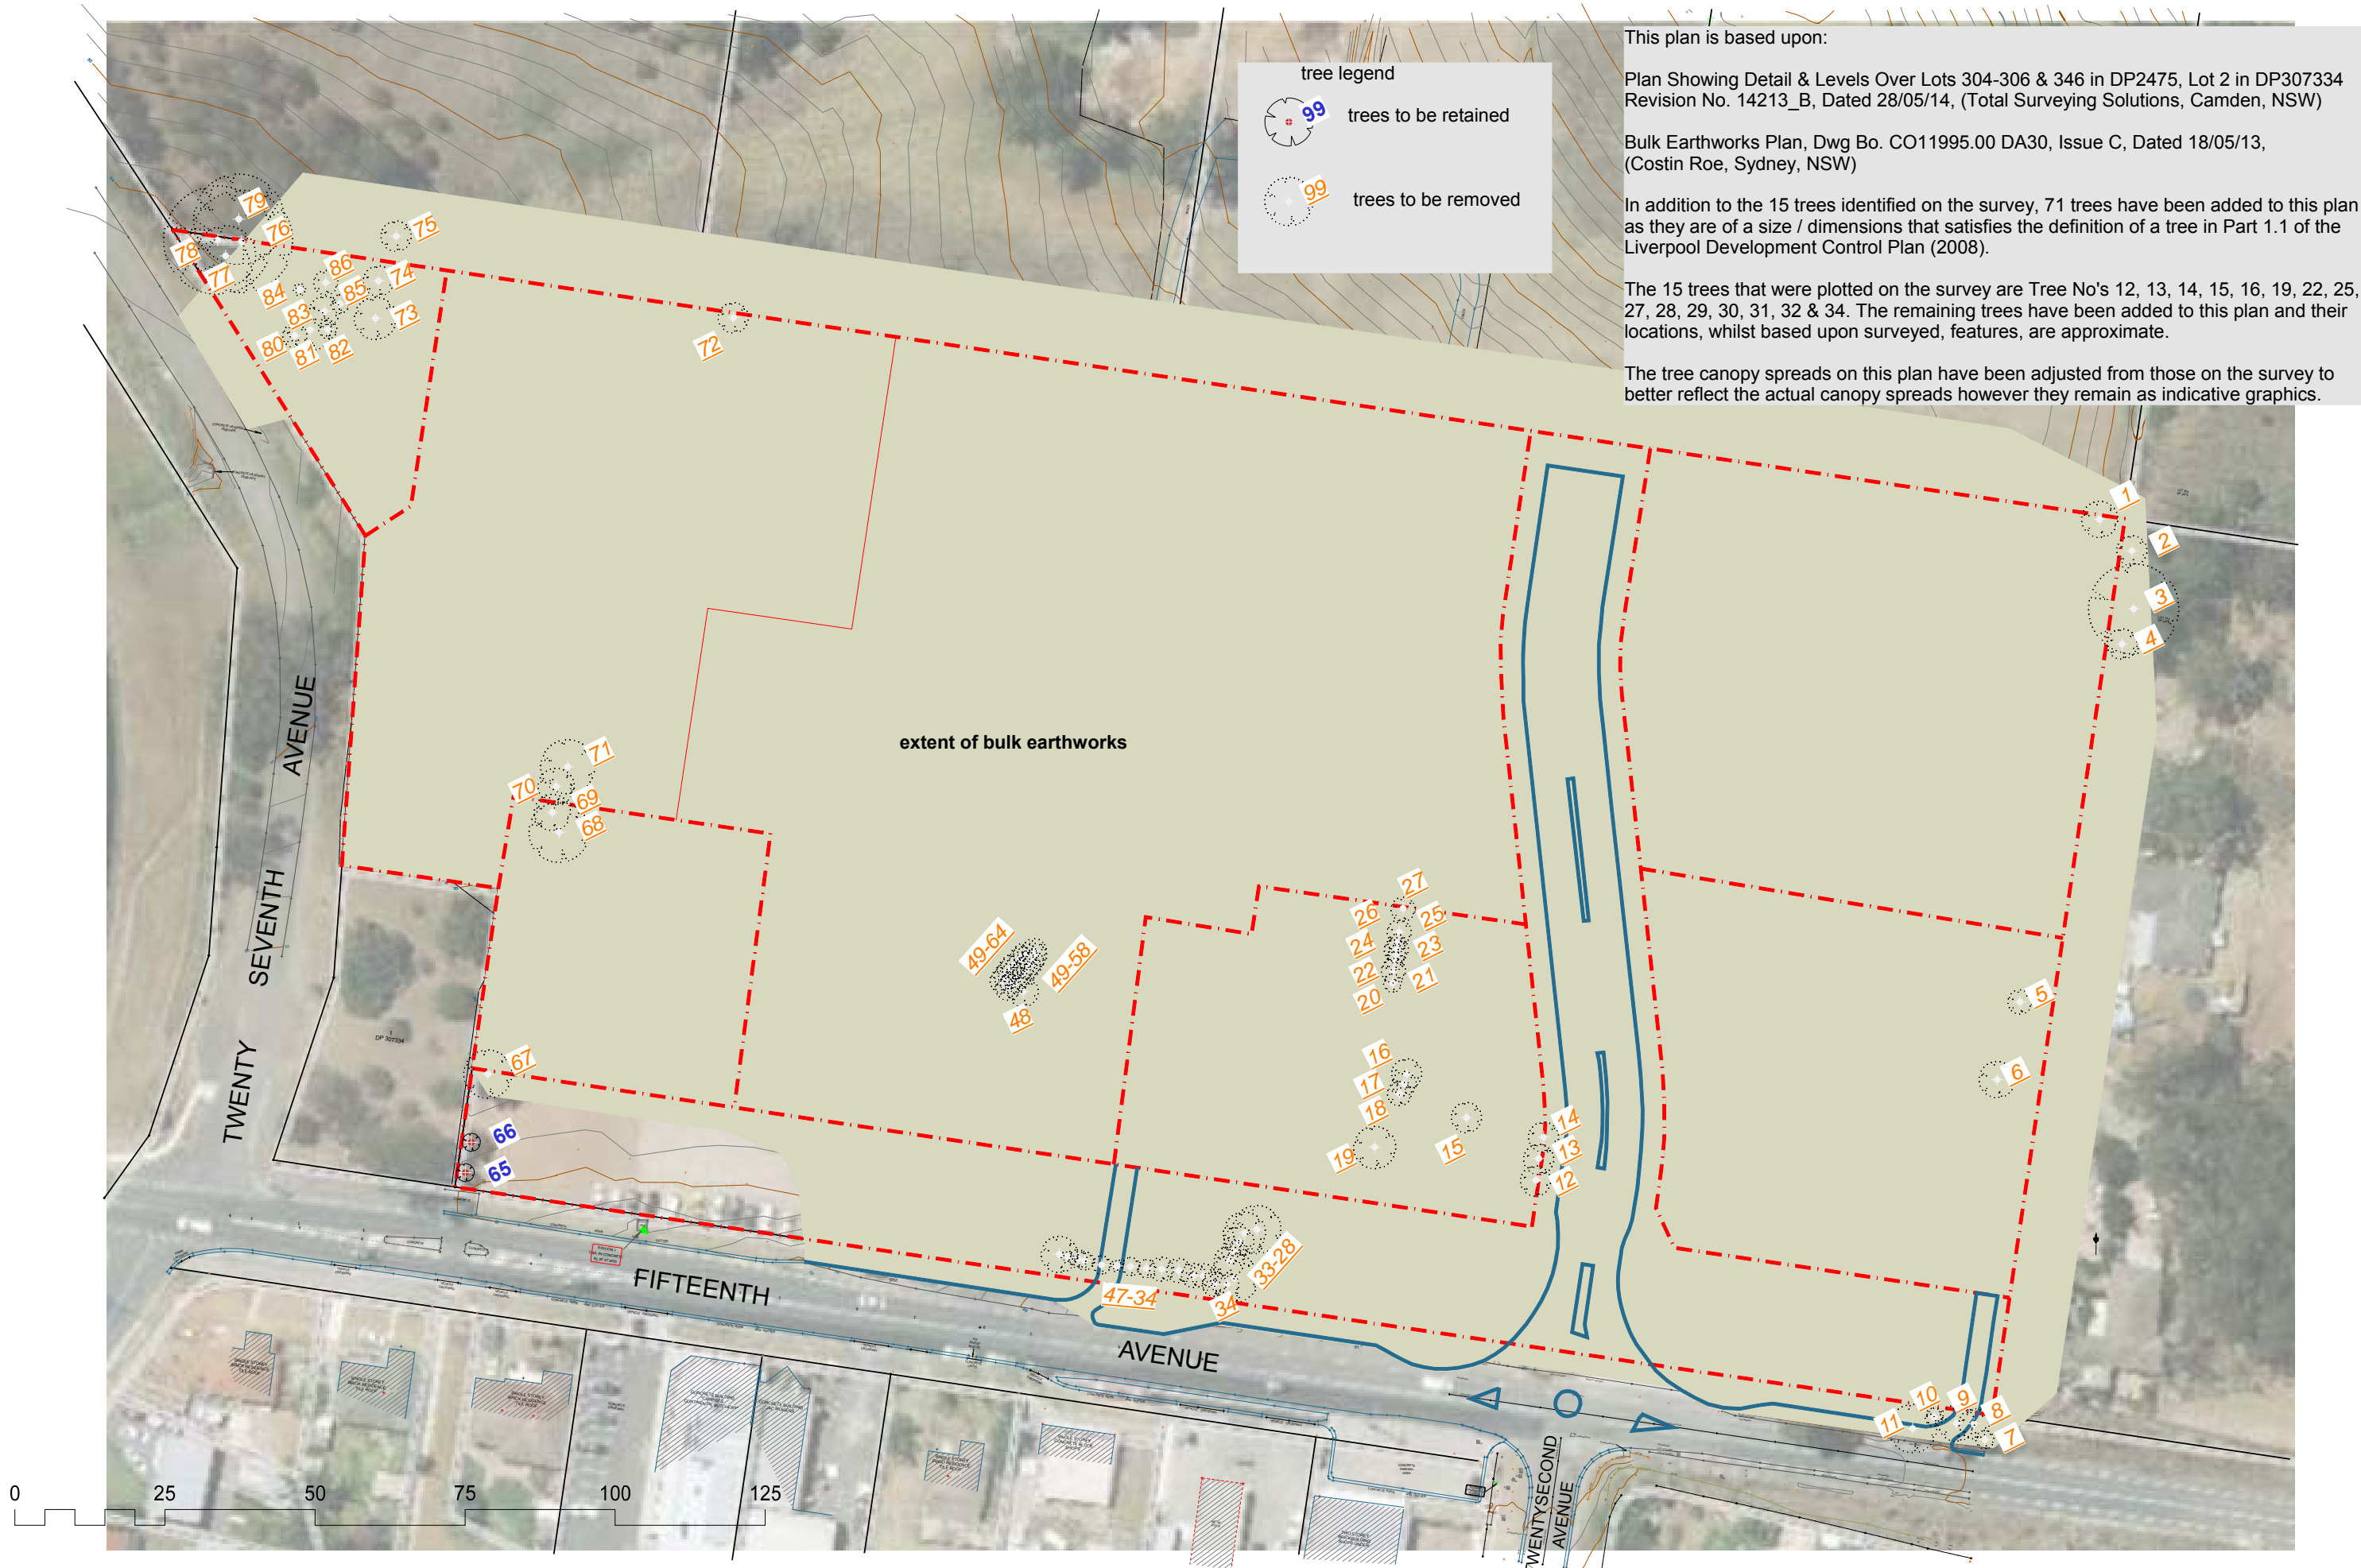
Figure 7.3 Trees along the road frontage looking east with Tree No. 47 in the foreground (left) with Tree No's 11, 10, 9, & 8 in the background centre right)
