Martins Creek Project Code 10475 Pavement Condition Survey Assessment

Martins Creek, Vacy, Paterson & Largs

NEW14P-0135-AB 30 April 2015

RE: MARTINS CREEK PROJECT – CODE 10475 PAVEMENT CONDITION SURVEY ASSESSMENT

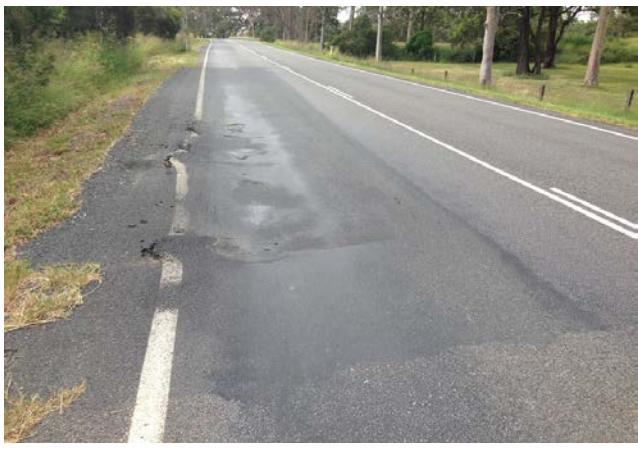
<u>PHOTO 7 - Ch. 5,270m</u> Remedial patching with deformation shoving in outer wheel path.

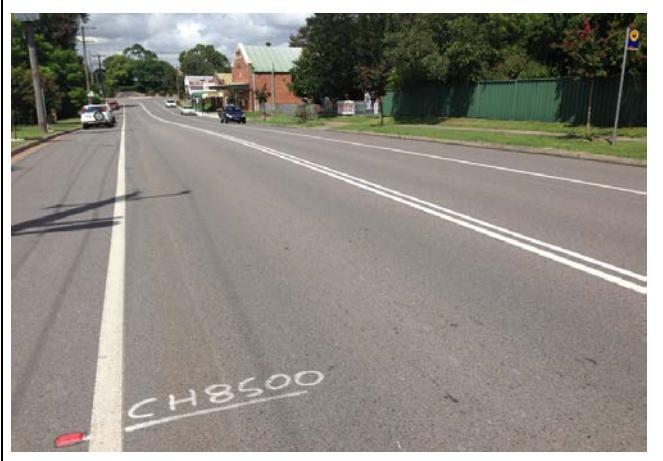
On approach into township of Paterson. Road pavement in poor condition. Extensive defects, expedient repairs in both lanes. Church Street to RHS similar poor pavement condition.

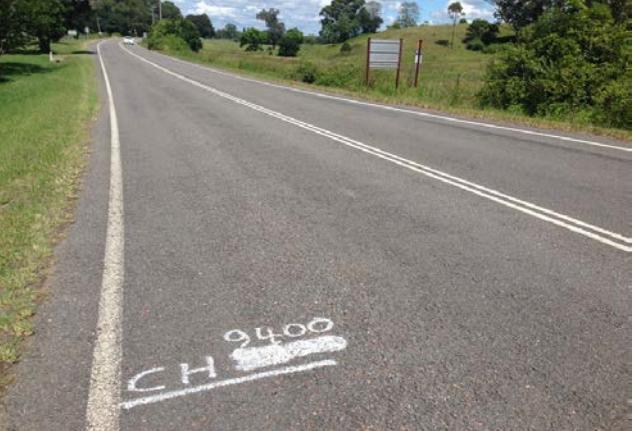
PHOTO 13 - Ch. 9,090m

Road pavement in poor condition. Extensive defects, expedient repairs and repeated failures through pavement in both lanes. Sloane Street to RHS similar poor pavement condition.

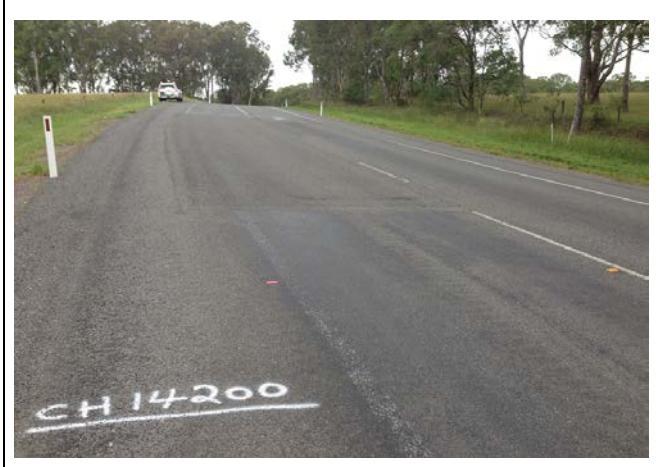
PHOTO 19 - Ch. 14,200m Remedial patching full width in both lanes of road pavement. Surface flushing on approach to patches.

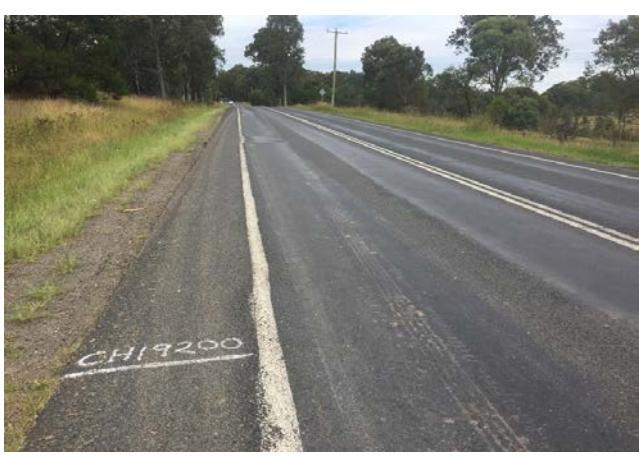
PHOTO 25 - Ch. 19,200m Surface flushing in inner and outer weel paths both lanes. Minor deformation shoving outer wheel path, edge of pavement.

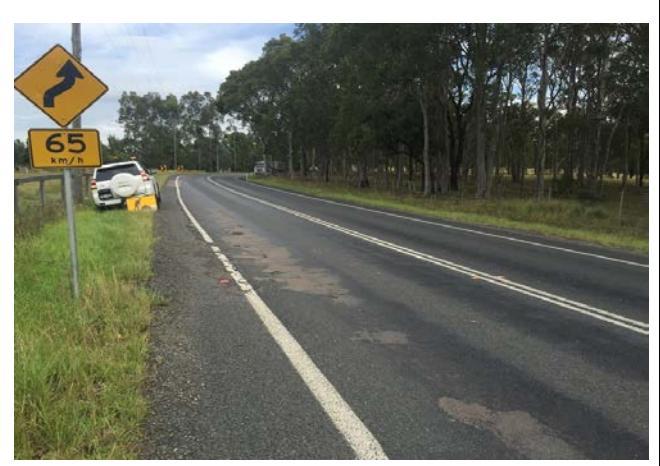
PHOTO 26 - Ch. 19,700m

Surface flushing in inner and outer weel paths both lanes. Deformation shoving, depressions, surface stripping and expedient patching visible in outer wheel path.

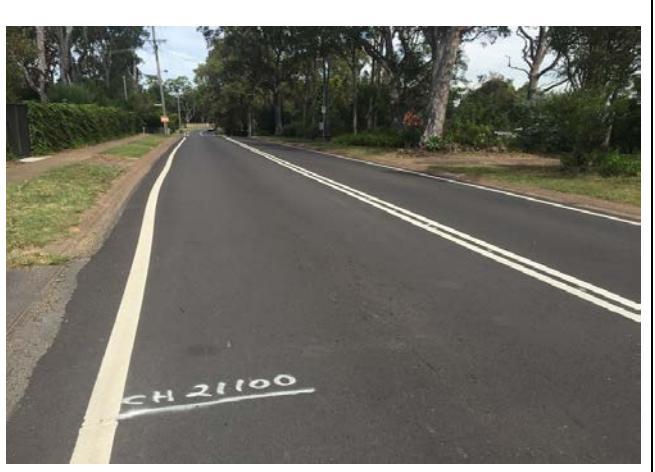
PHOTO 28 - Ch. 21,100m Road pavement in generally good condition. Relatively recent surface overlay or reconstruction.

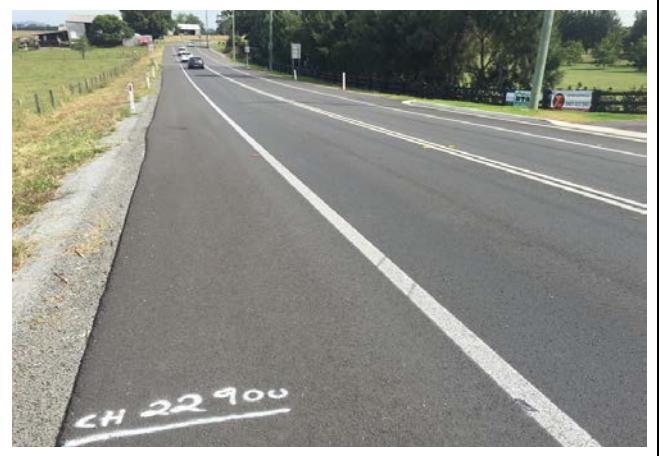
<u>PHOTO 30 - Ch. 22,900m</u> Road pavement in generally good condition.

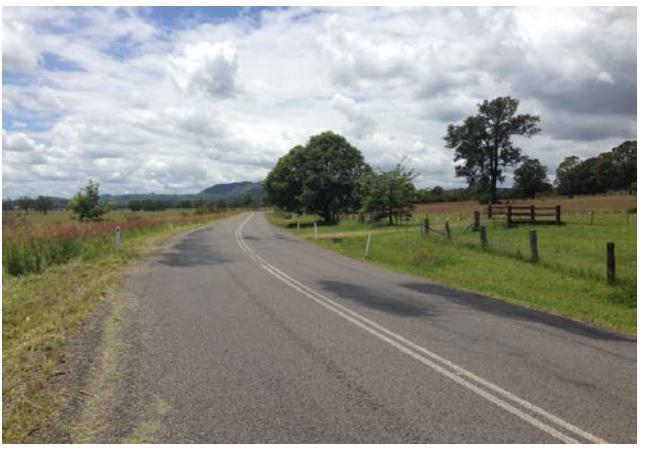
<u>PHOTO 3 - Ch. 1,700m</u> Deformation shoving in outer wheel paths, with surface polishing and expedient patching.

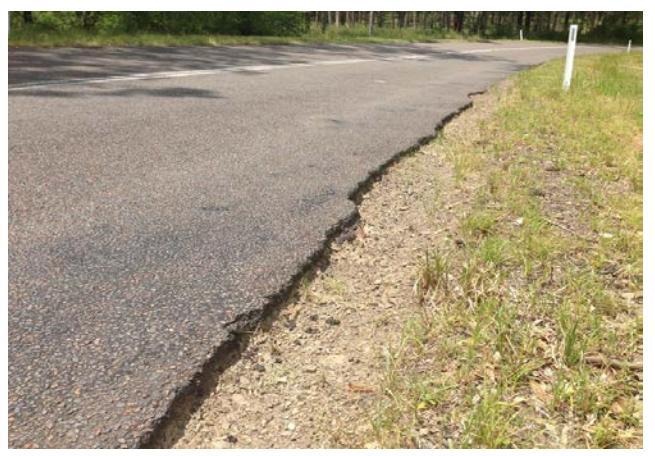
PHOTO 2 - Ch. 210m Edge drop along pavement shoulder.

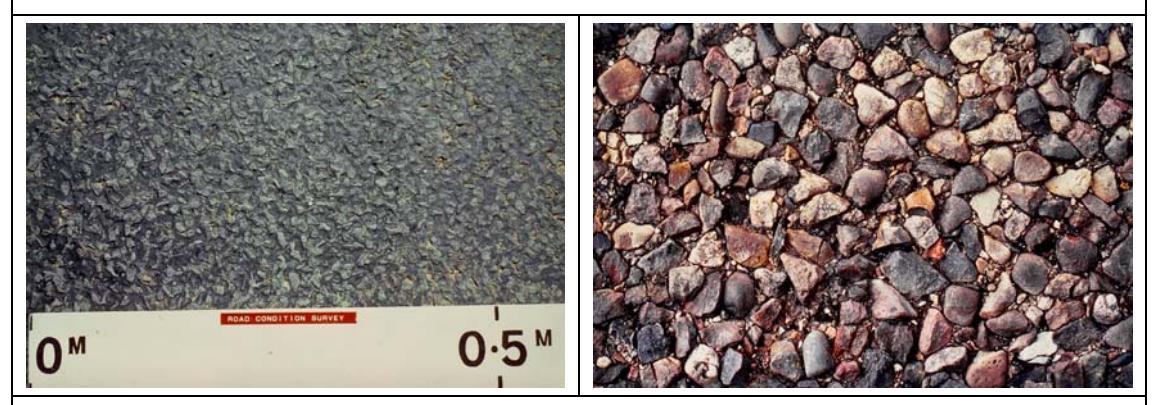
Polished areas will feel relatively smooth and will sometimes be noticeably shiny.

The degree of polishing cannot be quantified by observation.

#### Causes:

- inadequate resistance to polishing of surface aggregates, particularly by heavy traffic
- use of naturally smooth aggregates (e.g. water worn gravel).

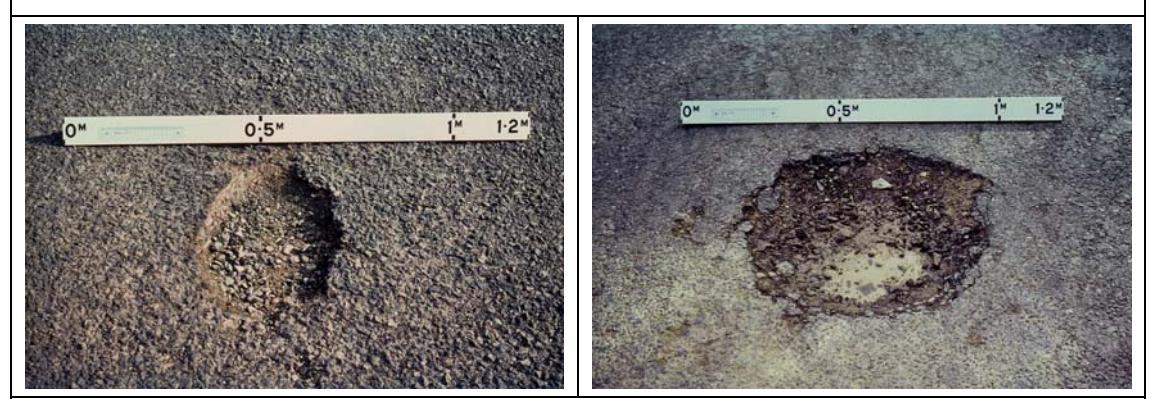
A steep-sided or bowl-shaped cavity extending into layers below the wearing course.

#### Causes:

- loss of surface material due to ravelling, stripping, cracking and/or delamination
- load-associated disintegration of the base
- 'pick-up' of bitumen wearing surface caused by binder adhesion to tyres
- moisture entry into a granular base through cracked surface course, resulting in localised softening
- poor quality base material.

- normally repaired by routine maintenance techniques
- reseal
- asphalt overlays.
