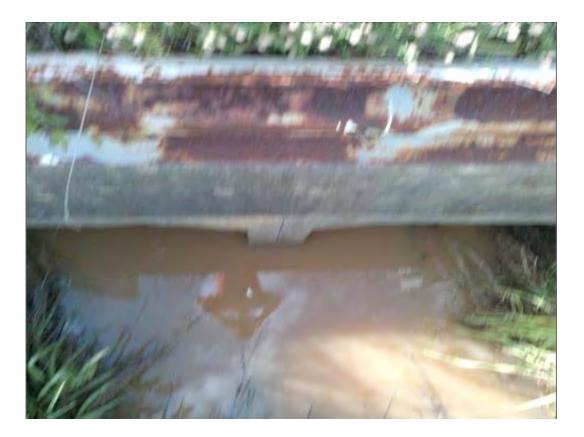
S075 – 2 by 1500mm Reinforced Concrete Box Culvert

2 of approximately 1500mm Reinforced Concrete Box Culvert Depth of Box Culvert unknown due to water flow Fair Condition and Serviceable

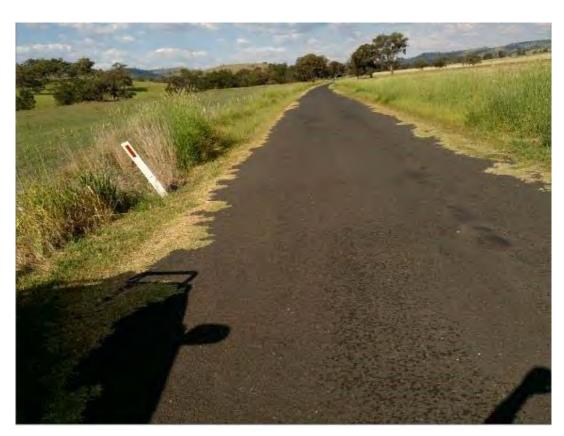
S076 - View to East

S076 - Coolah Creek Rd - 2500m West of Oakdale Rd Intersection 450mm Pipe Culvert with broken headwall

Moderate Condition and Serviceable

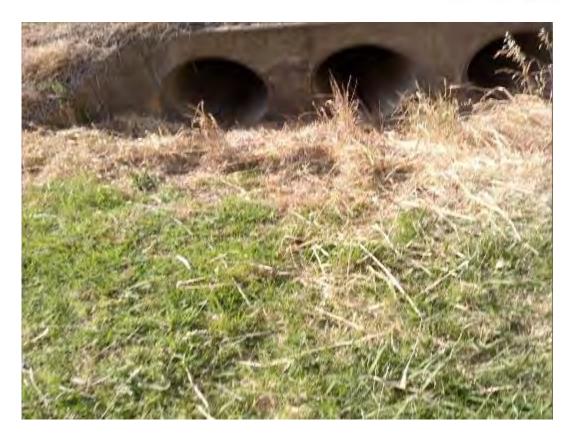
S077 – 3-900mm Pipe Culvert

S077 - Coolah Creek Rd - 4000m West of Oakdale Rd Intersection 3 of 900mm Pipe Culvert Fair Condition and Serviceable

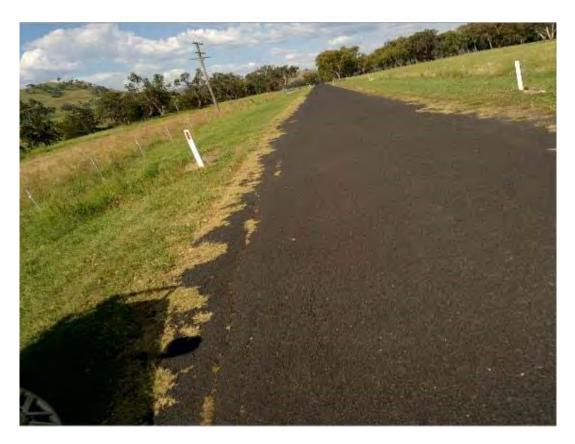
Concrete Causeway, 450mm Pipe Culvert, Moderate Condition and Serviceable

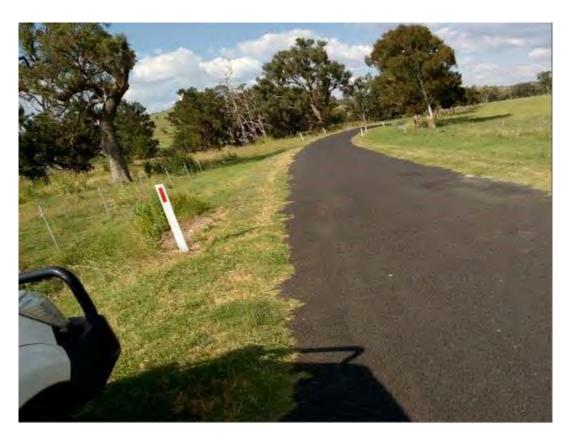
S079 - View to East

S079 – Coolah Creek Rd – 3000m East of Cooks Dr Intersection 525mm Pipe Culvert Fair Condition and Serviceable

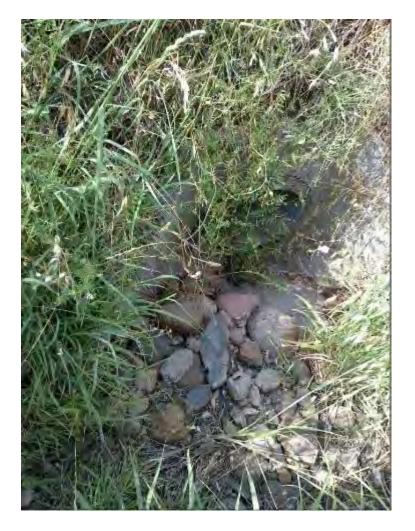
S080 – 450mm Pipe Culvert

S080 – Coolah Creek Rd - 2250m East of Coolah Creek Rd - Cooks Dr Intersection 450mm Pipe Culvert Fair Condition and Serviceable

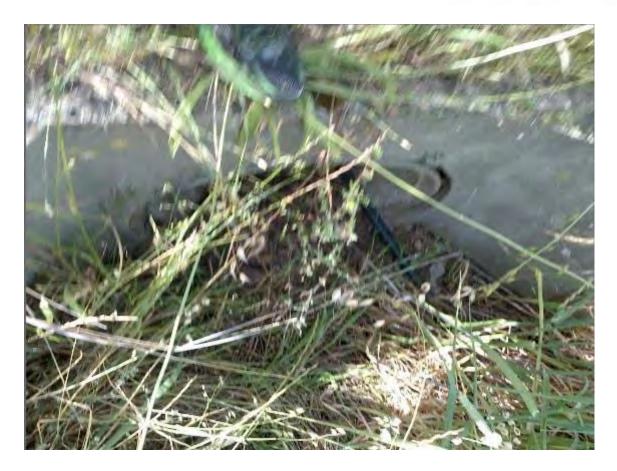
S081 - 600mm Pipe Culvert

S081 – Coolah Creek Rd - 1400m East of Coolah Creek Rd - Cooks Dr Intersection 600mm Pipe Culvert

Good Condition and Serviceable, may require some maintenance

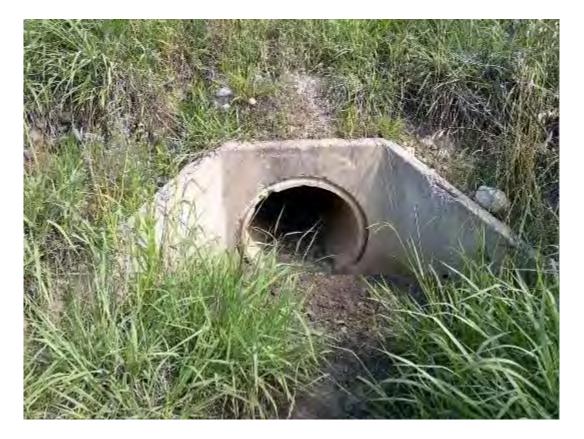
S082 – 600mm Pipe Culvert

S082 – Coolah Creek Rd - 1300m East of Coolah Creek Rd - Cooks Dr Intersection 600mm Pipe Culvert Good Condition and Serviceable

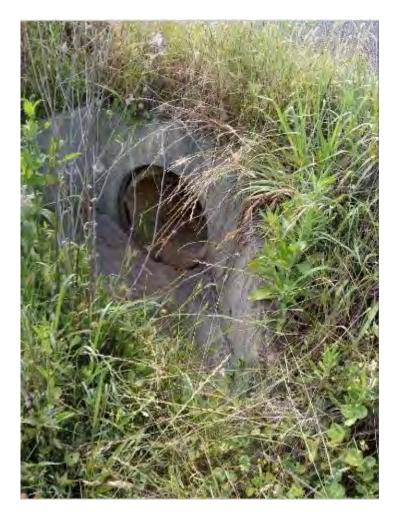
S083 - 450mm Pipe Culvert

S083 – Coolah Creek Rd - 1200m East of Cooks Dr Intersection 450mm Pipe Culvert Fair Condition and Serviceable

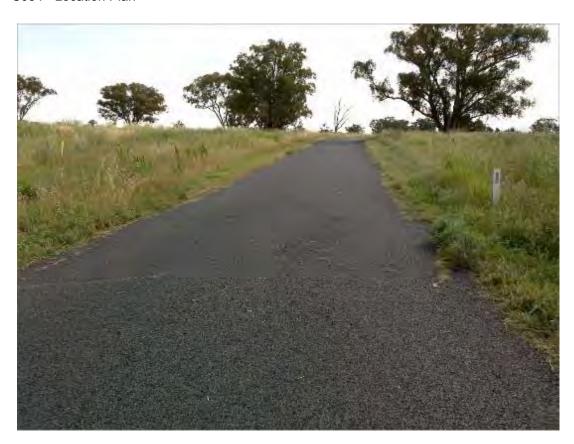
S084 – Coolah Creek Rd - 1000m East of Cooks Dr Intersection 600mm Pipe Culvert Moderate Condition and Serviceable

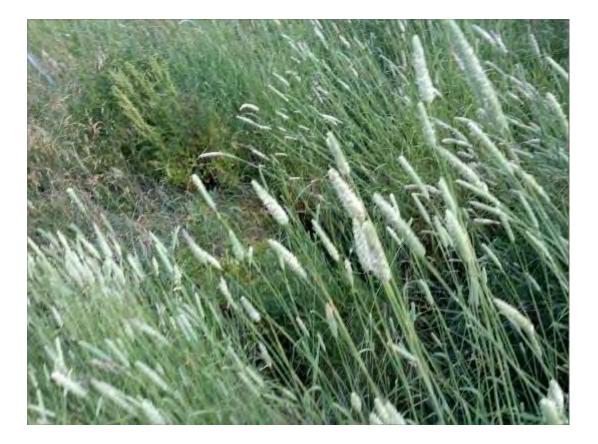
S085 - Pipe Culvert

Pipe Culvert of Unknown Dimensions Unknown Condition Maintenance required

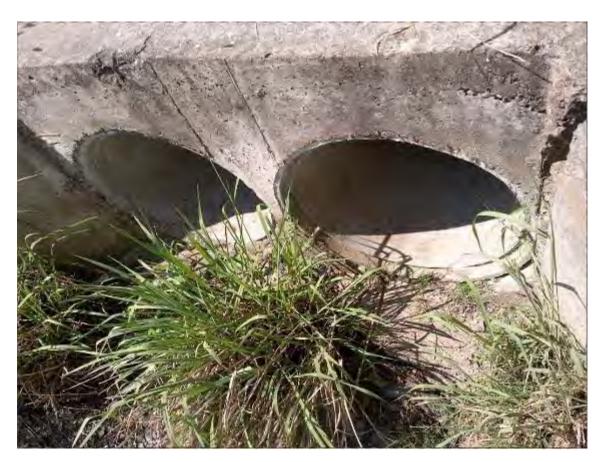
S086 - Dual 600mm Pipe Culvert

S086 – Cooks DrConcrete Causeway, Dual 600mm Pipe Culvert
Good Condition and Serviceable

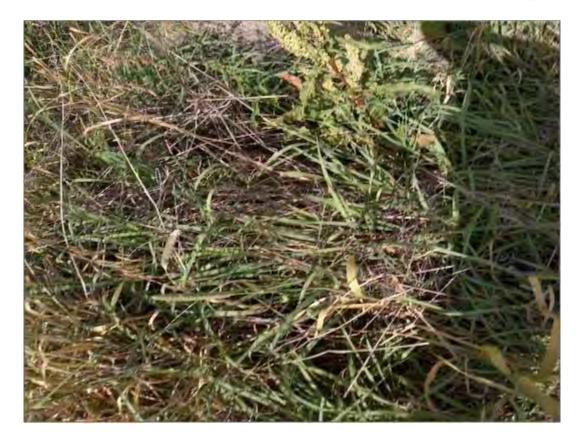
S087 - View of Hidden Culvert

Pipe Culvert Inaccessible at time of inspection Maintenance required

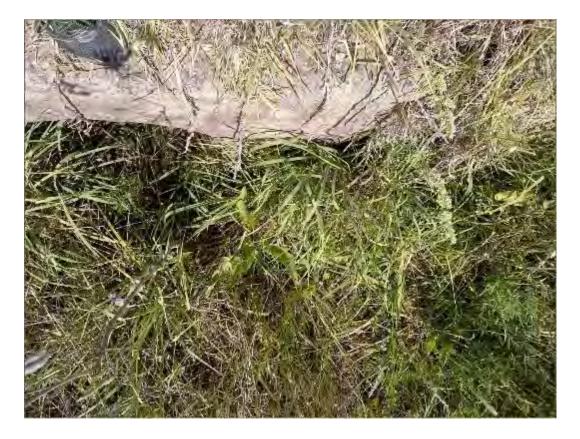
S088 - Dual 600mm Pipe Culvert

Dual 600mm Pipe Culvert

Fair Condition and Serviceable, may require some maintenance

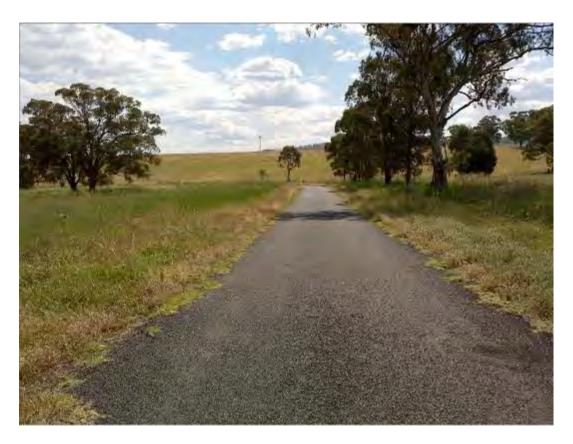
Dual 750mm-1200mm Reinforced Concrete Box Culvert with 3500mm bitumen seal Moderate Condition and Serviceable

S089 – View to West showing 3.5m Seal of Bitumen

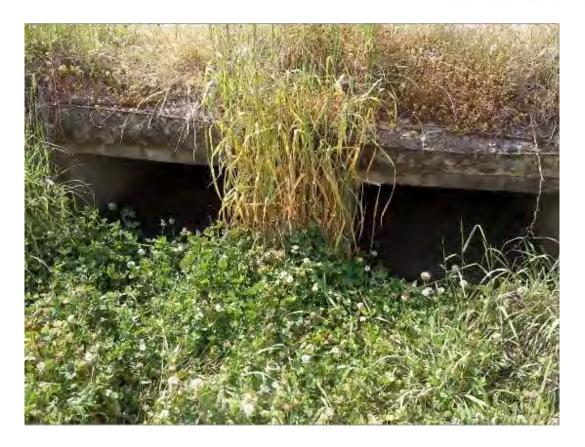
S089 – 2 of 750mm by 1200mm reinforced concrete box culvert

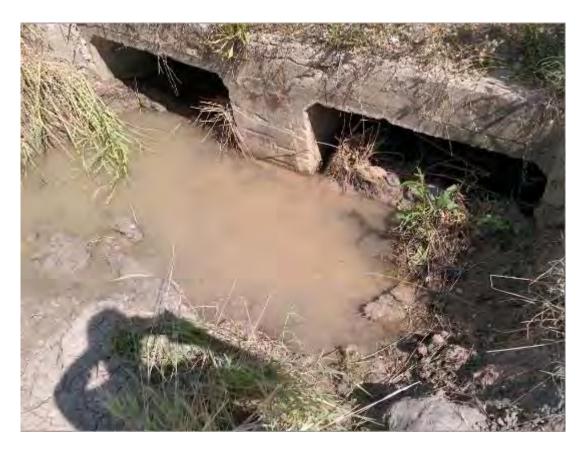
Fair Condition and Serviceable

S090 - Dual 750mm-1200mm Reinforced Concrete Box Culvert

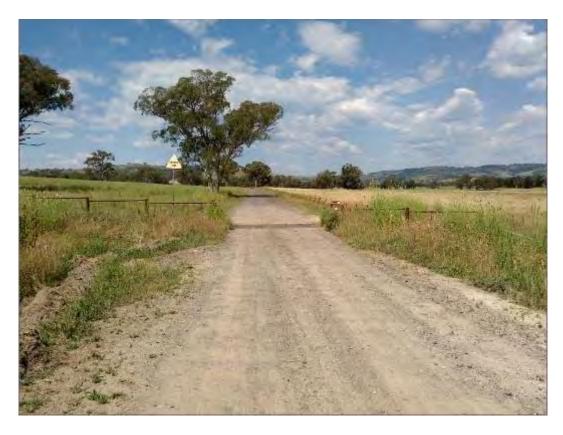
S092 - View to East

S092 – Gun dare Rd - 1350m East of Cooks Dr IntersectionCauseway with pipe culvert approximately 300mm in Diameter Moderate Condition and Serviceable

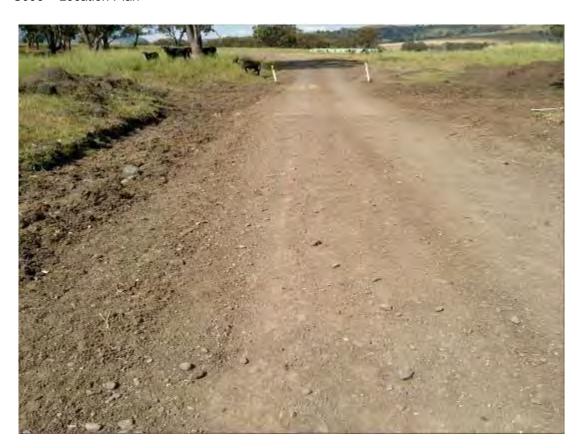
S093 - View to East

Causeway

Heavily silted at time of inspection, may require upgrade.

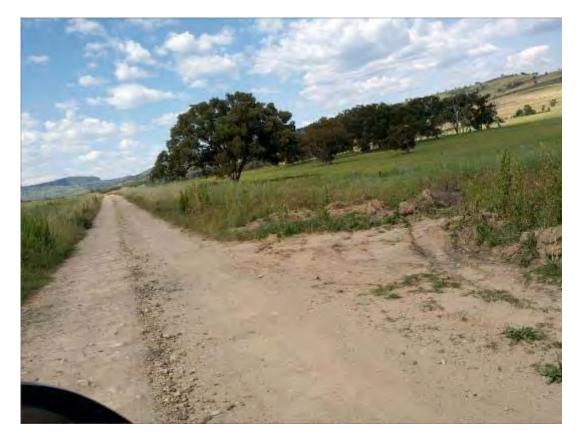
S094 - View to East

New Pipe Culvert required at this location

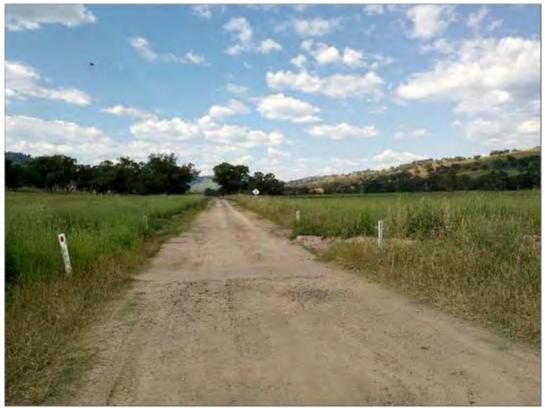
S095 - View to North

New causeway, may require upgrade Fair Condition and Serviceable

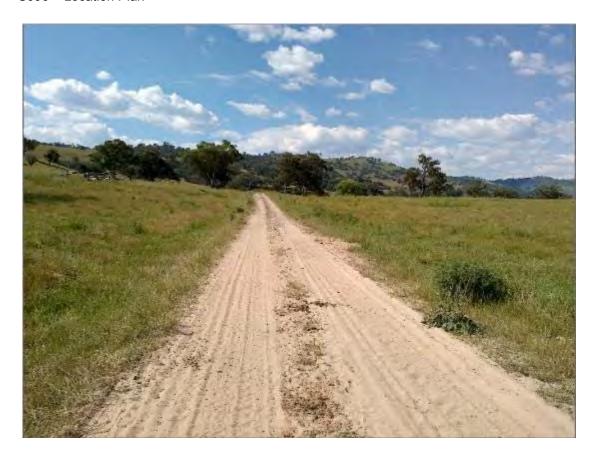
S096 - View to North

S096 - Gundare Rd - 3050m East of Cooks Dr IntersectionNew Pipe Culvert required

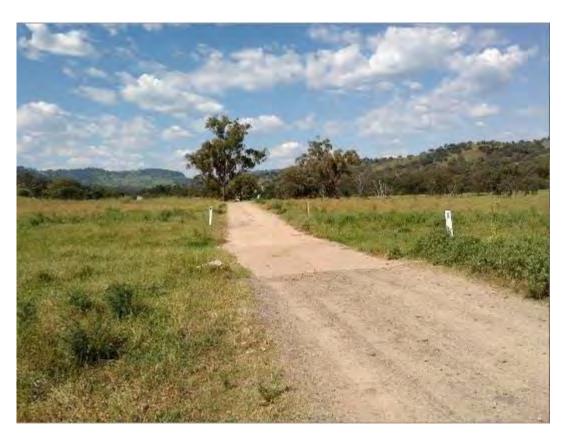
S098 - View to North

Causeway

Pipe culvert required for low flow.

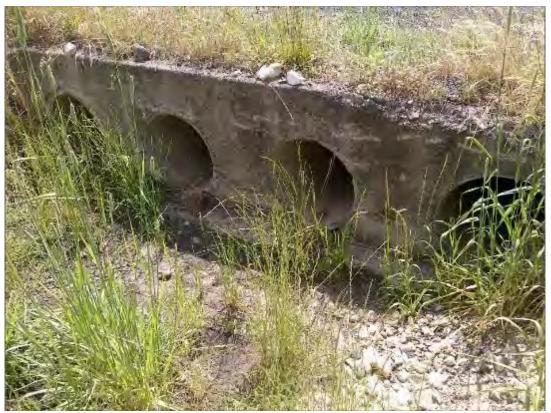
Concrete causeway, 4 of 450mm Pipe Culvert headwall broken Poor Condition and Serviceable, upgrade may be required

S099 - 4-450mm Pipe Culvert

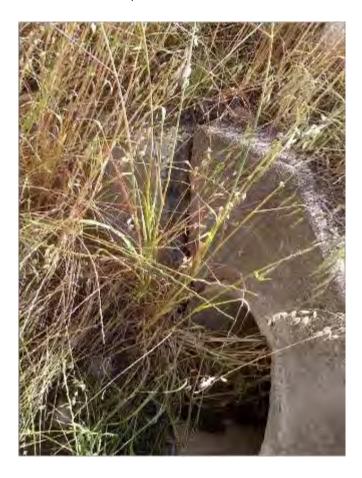
S099 - Broken Headwall

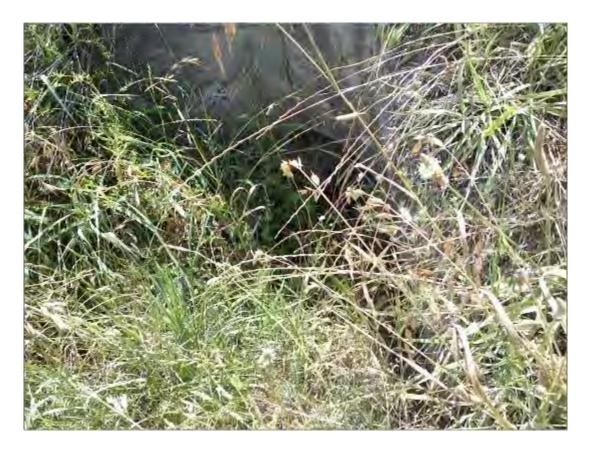
S101 – Coolah Creek Rd - 2800m North of Vinegaroy Road Intersection 450mm Pipe Culvert Fair Condition and Serviceable

S101 - 450mm Pipe Culvert

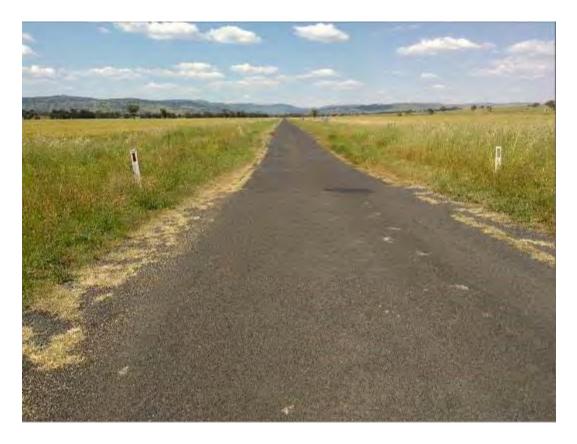
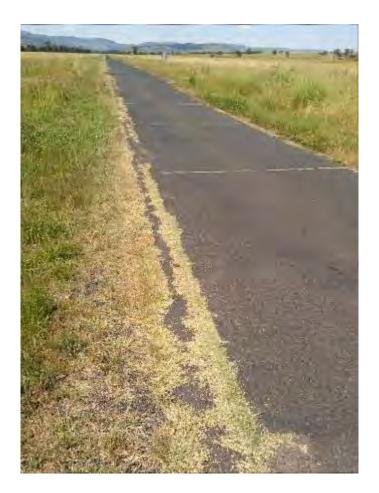
Causeway Vertical Geometry for HLP's to be verified by Survey May require upgrade

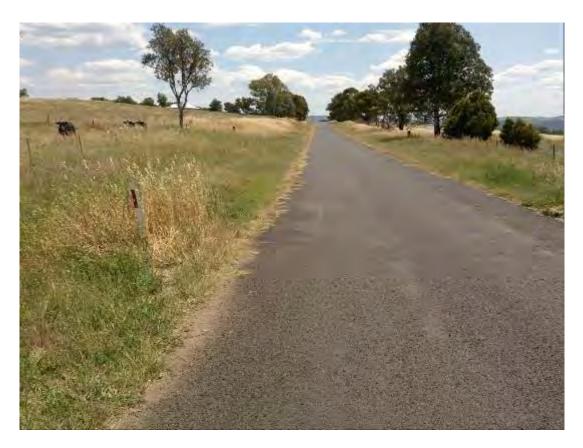
S103 - View to South

S103 – Coolah Creek Rd - 1000m North of Vinegory Rd 600mm Pipe Culvert, Fair Condition and Serviceable

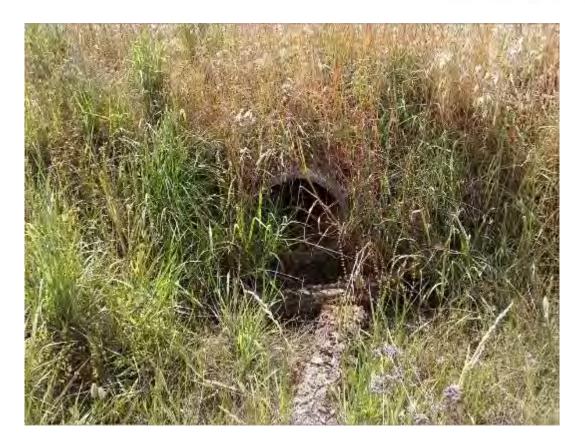
S103 - 600m Pipe Culvert

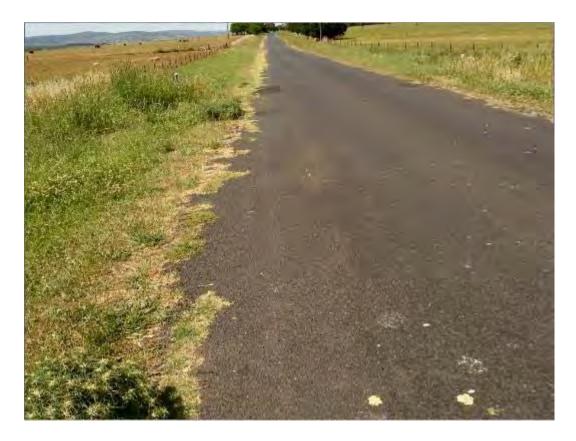
S014 - View to North

Pipe Culvert of Approximately 525mm in diameter Moderate Condition and Serviceable

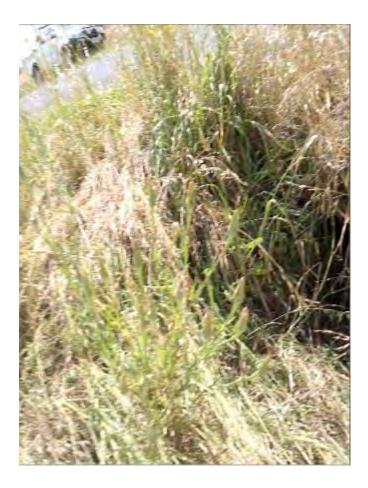
S104 – 525mm Pipe Culvert

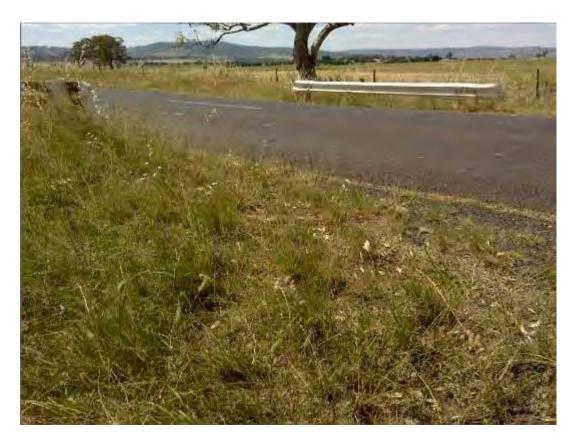
S105 - View to North

S105 – Vinegaroy Rd - 600m South of Coolah Creek Rd Intersection 450mm Pipe Culvert Moderate Condition and Serviceable

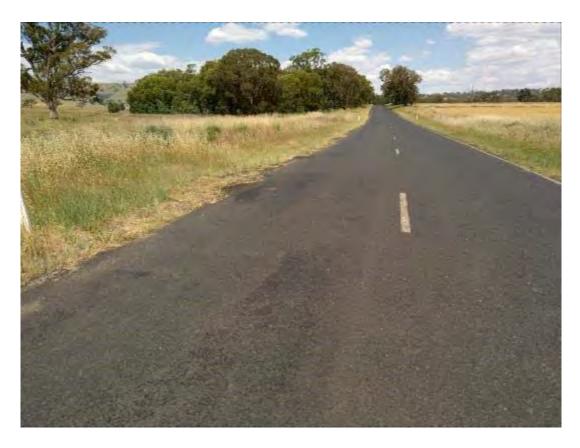
S106 - View to East

S106 – Vinegaroy Rd - 700m South of Coolah Creek Rd Intersection 3-450mm Pipe Culvert Good Condition and Serviceable

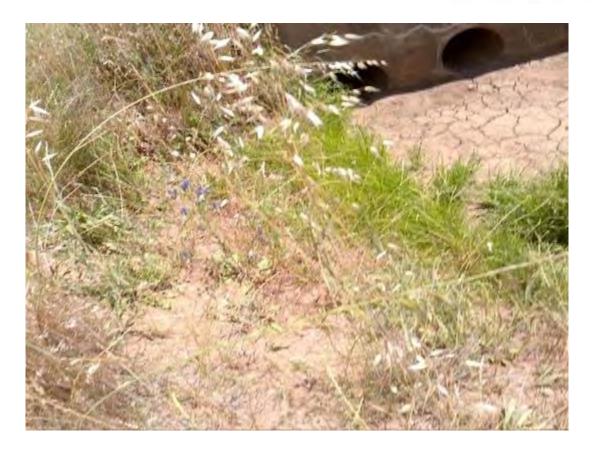
S106 - 3-450mm Pipe Culvert

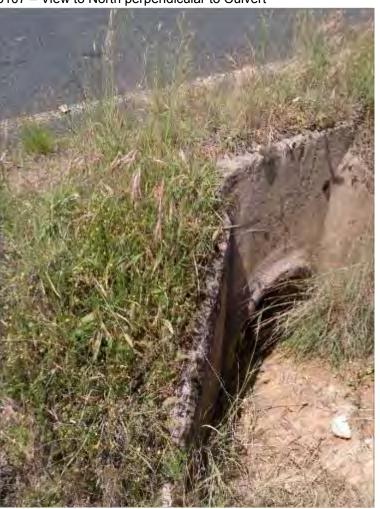
S107 – 600mm Pipe Culvert

S107 – Vinegaroy Rd - 900m South of Coolah Creek Rd Intersection 600mm Pipe Culvert Fair Condition and Serviceable,

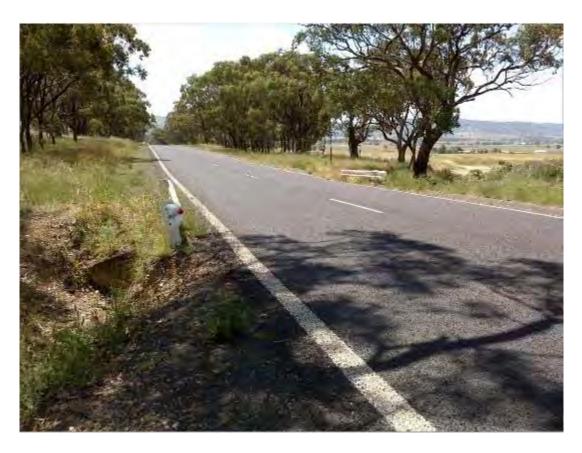
S108 - View to North

S108 - Vinegaroy Rd - 2000m South of Coolah Creek Rd Intersection 1050mm Pipe Culvert. Skewed across road alignment.

Fair Condition and Serviceable, Internal condition is also Fair

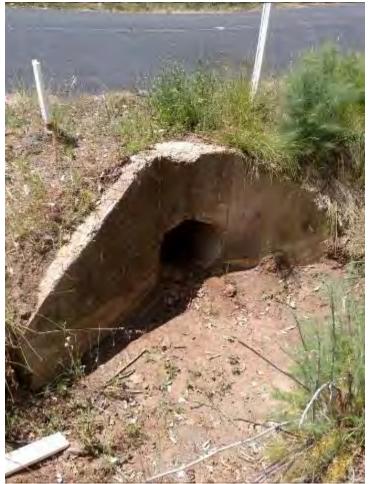
S109 - 600mm Blocked Pipe Culvert

600mm Pipe Culvert

Blocked, further inspection required of internal condition after blockage has been removed Moderate Condition and Serviceable

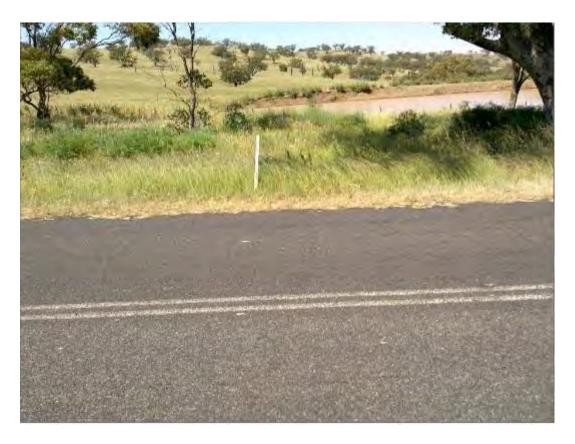
S110 – View to South

S110 - Vinegaroy Rd - 3900m East of Coolah Creek Intersection

Pipe Culvert of Approximately 450mm Unknown Condition

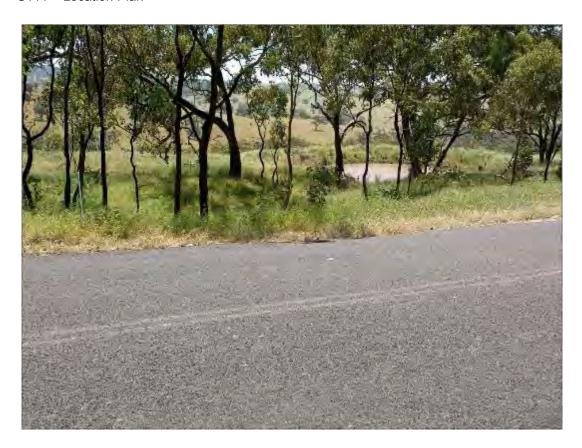
S111 - View to North

S111 – Vinegaroy Rd - 3200m South of Coolah Creek Intersection 600mm Corrugated Metal Pipe Inaccessible at time of inspection, condition unknown.

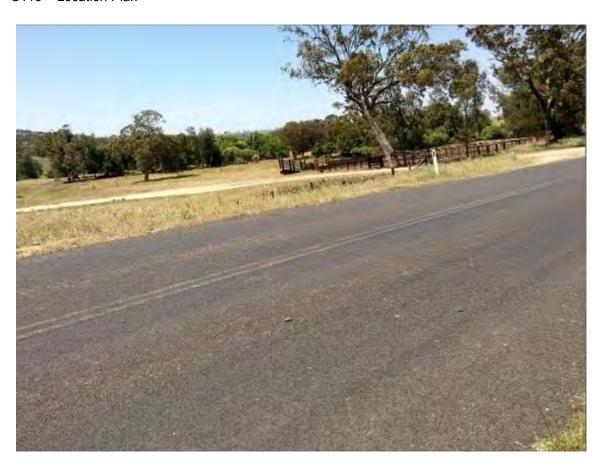
S113 – View to East
Level 2, 39 Sherwood Road mail@icubed.com.au P: 07 3870 8888 Toowong QLD 4066
www.icubed.com.au

S113 - Vinegaroy Rd - 5000m South from Coolah Town 600mm Pipe Culvert Unknown Condition

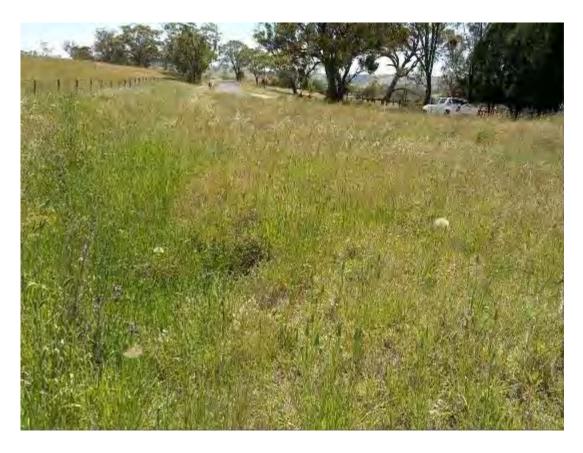
S114 – Vinegaroy Rd - 5600m South from Coolah Town 600mm Pipe Culvert Unknown Condition

S114 - View to North, 600mm Pipe Culvert

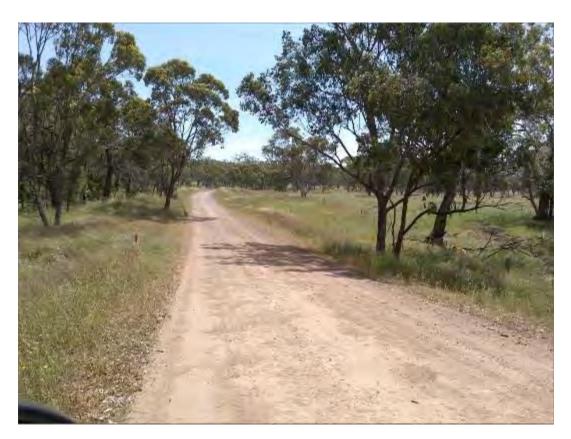
S115 - View to West

S115 - Coolah Rd - 1000m East of Vinegaroy Rd Intersection

Pipe Culvert of Unknown Dimensions Unknown Condition

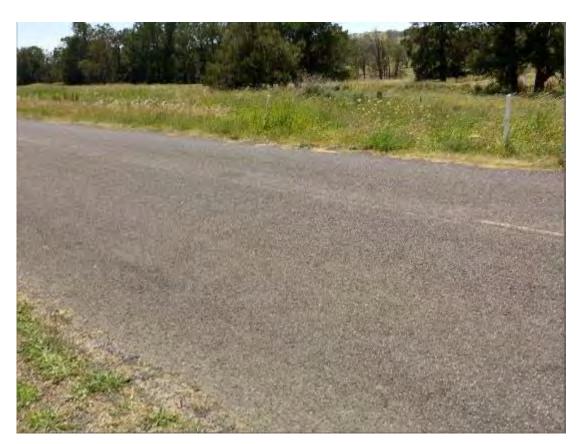
S116 - View to East

S116 - Vinegaroy Rd - 3300m North of Rotherwood Rd Intersection 3-750mm Pipe Culvert Moderate Condition and Serviceable

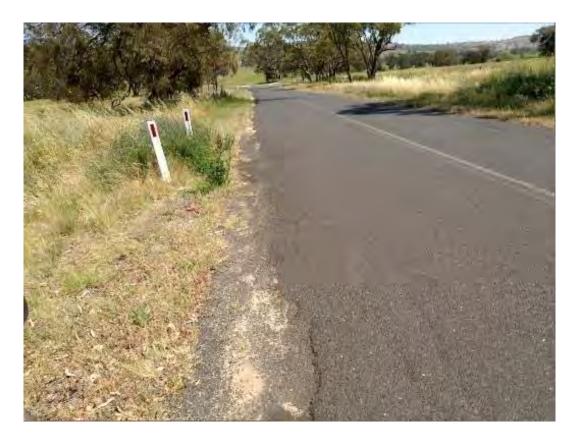
S118 - View to North

Moderate Condition and Serviceable

Fairly overgrown and requires maintenance. Further inspection of internal condition is required

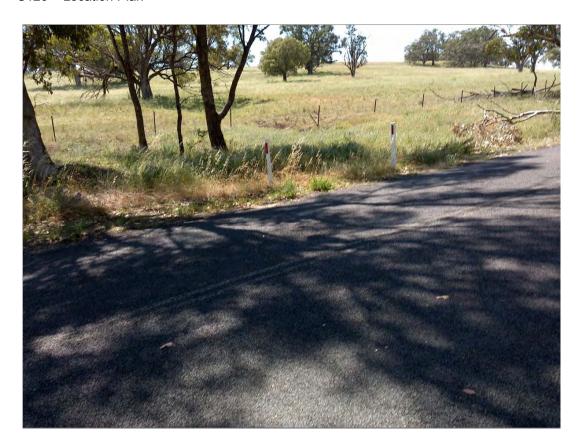
S120 - View to East

750mm Pipe Culvert

Moderate Condition and Serviceable, partially overgrown may require maintenance

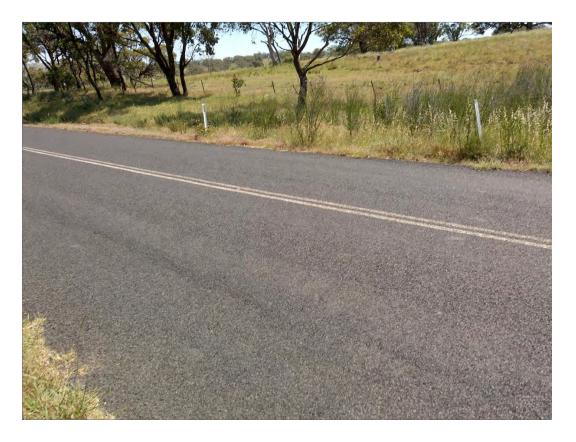
S121 - View to North

Moderate condition. Blocked and requiring maintenance.

Further inspection of internal condition is required

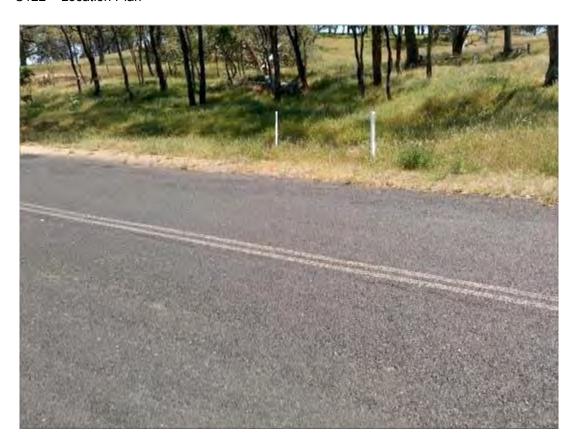
S122 - View to North

Dual 450mm Pipe Culvert Fair Condition and Serviceable

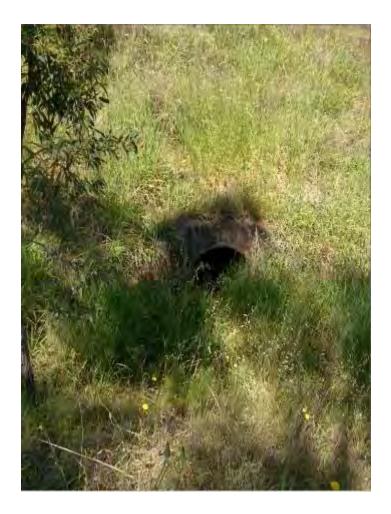
S123 - 1050mm Pipe Culvert

S123 – Vinegaroy Rd - 1250m North of Rotherwood Intersection 1050mm Pipe Culvert Fair Condition and Serviceable

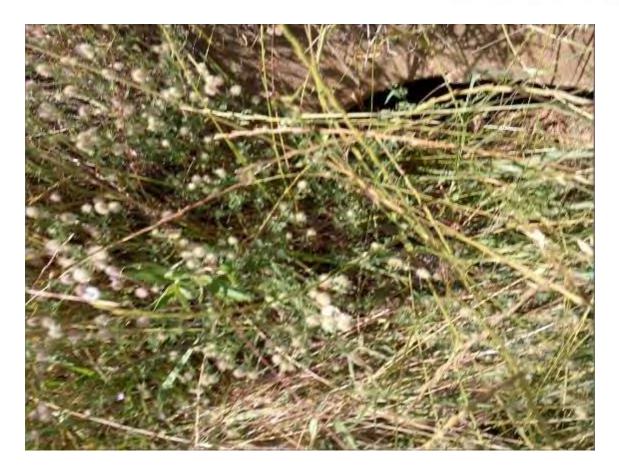
Blocked at time of inspection

Moderate Condition and Serviceable, maintenance required.

S125 -450mm blocked pipe culvert

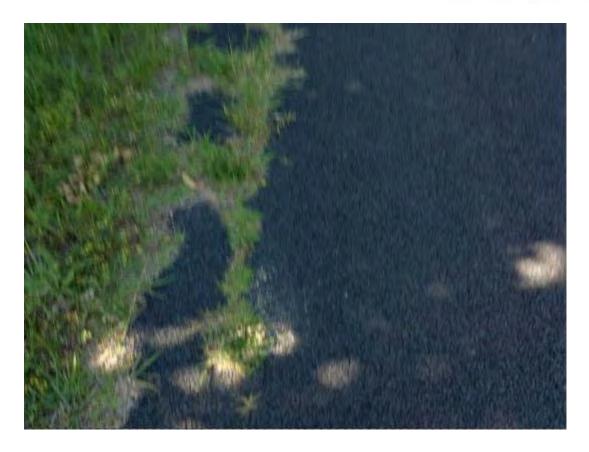
S126 - Moss growing into Road

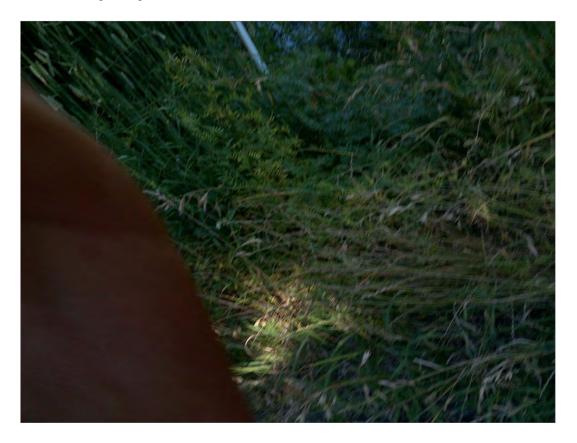
S126 – Turee Vale Rd - 600m North of Vinegaroy Rd IntersectionCulvert of unknown Dimensions Unknown Condition

S126 - Hidden Culvert

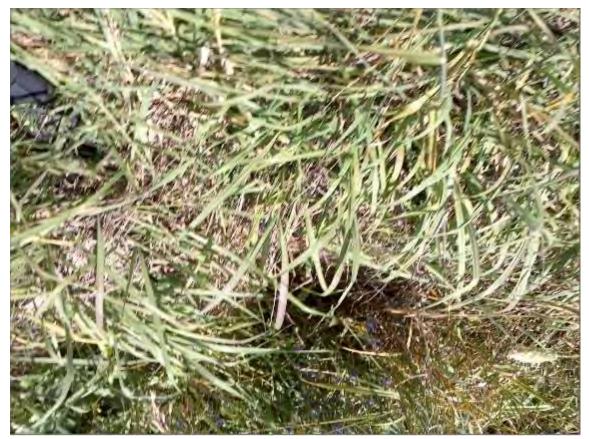
Pipe Culvert of Unknown Dimensions Unknown Condition

S127 – View looking to Pipe Culvert

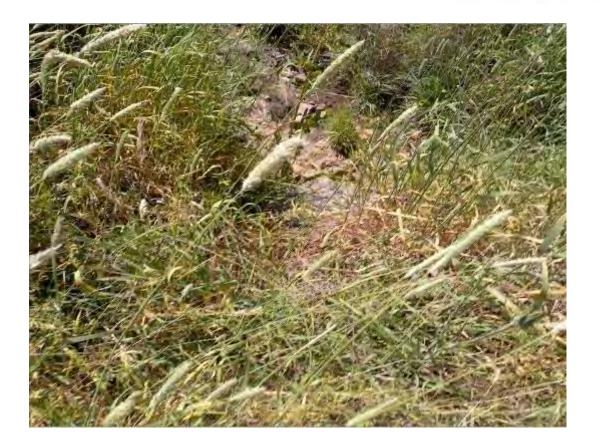
S133 – Turee Vale Rd - 2400m North of Vinegaroy Intersection 600mm Pipe Culvert with no headwall.

Moderate Condition and Serviceable

S133 – 600mm Pipe Culvert

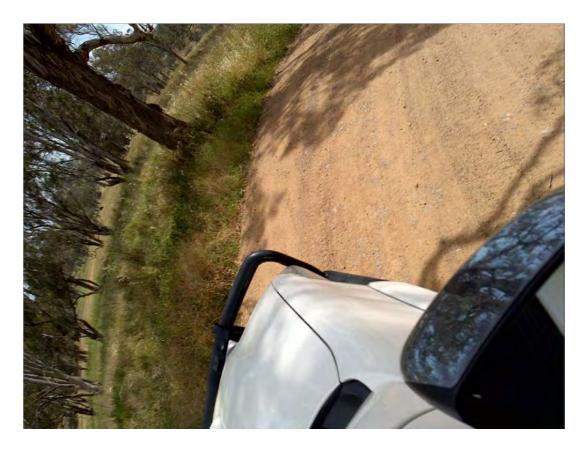
S134 - View to West

Pipe culvert is required at this location as water is evidently washing over the road

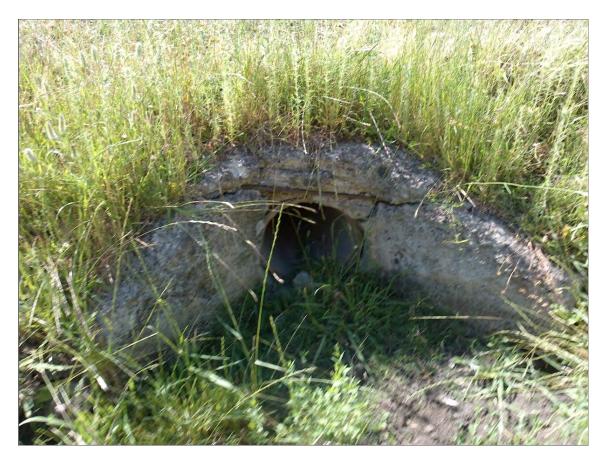
Cracked headwall may not last through life of project

Poor Condition and serviceable

S140 – 375mm Pipe Culvert

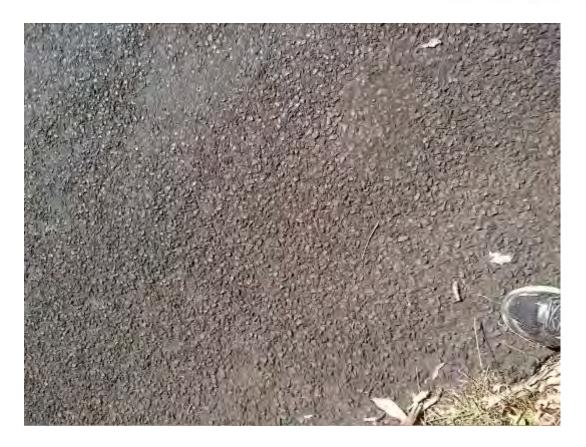
S141 - Parts of the Surface has been polished

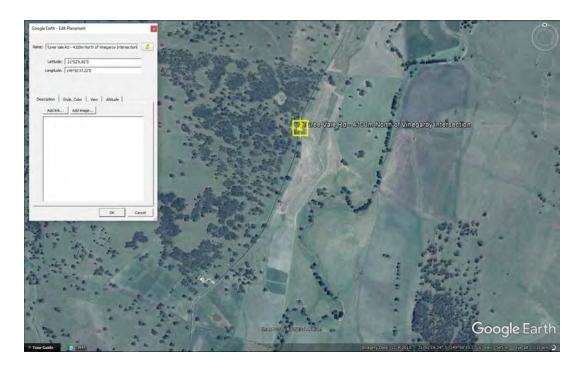
S142 - Location Plan

S142 – Turee Vale Rd - 4100m North of Vinegaroy Intersection 450mm Pipe Culvert Fair Condition and Serviceable

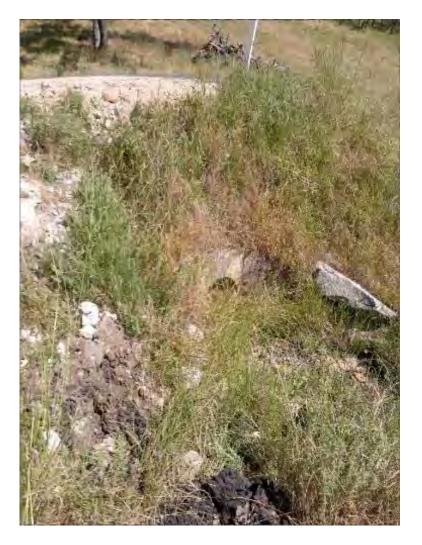
S142 - 450mm Pipe Culvert

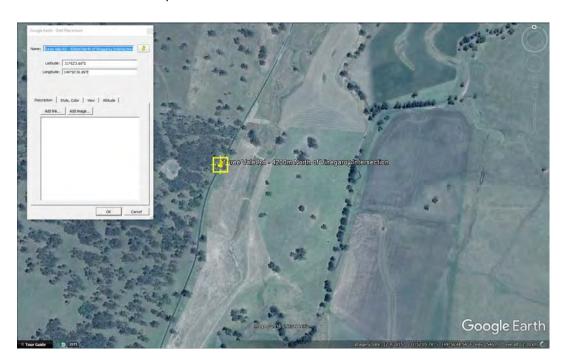
S143 - Location Plan

Pipe Culvert of Unknown Dimensions, Inaccessible at time of inspection. Unknown Condition

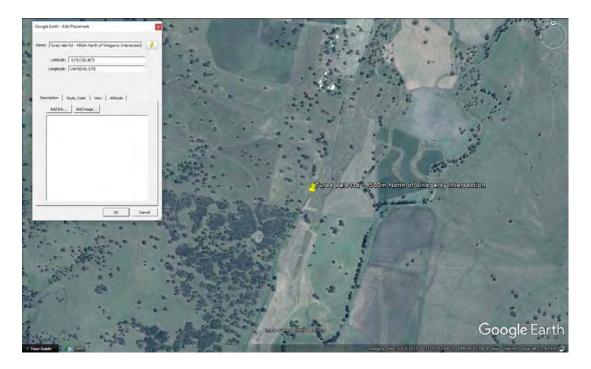
S144 - Location Plan

S144 – Turee Vale Rd - 4500m North of Vinegaroy IntersectionDual 450mm Pipe Culvert Unknown Condition

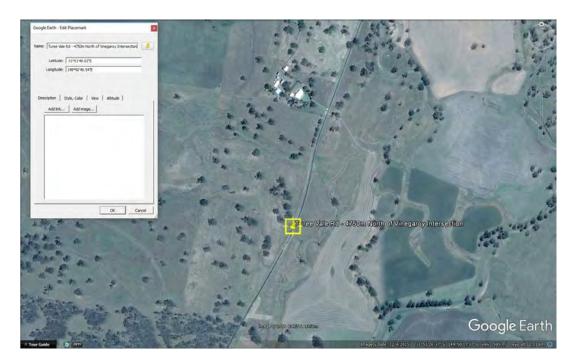
S145 - Location Plan

600mm Pipe Culvert, may require some Maintenance Moderate Condition and Serviceable

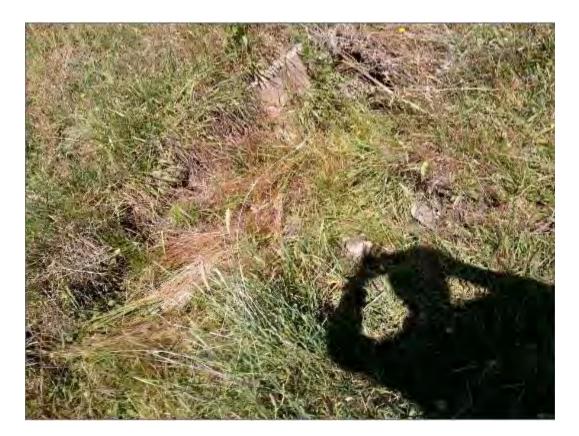
S145 - 600mm Pipe Culvert at top of Image

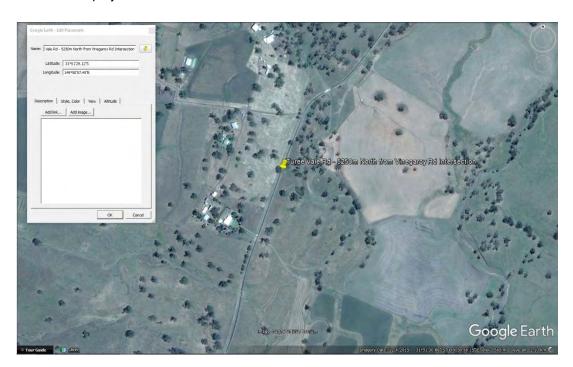
S145a - Location Plan

525mm Pipe Culvert

Location is of Poor Condition, Will require upgrade otherwise it will further degrade over the course of the project

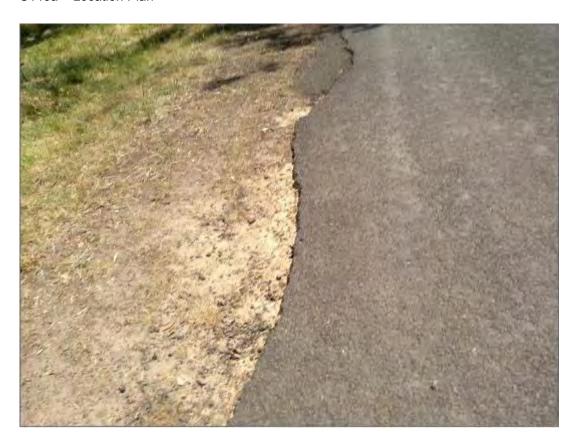
S145a – Road showing Edge Break

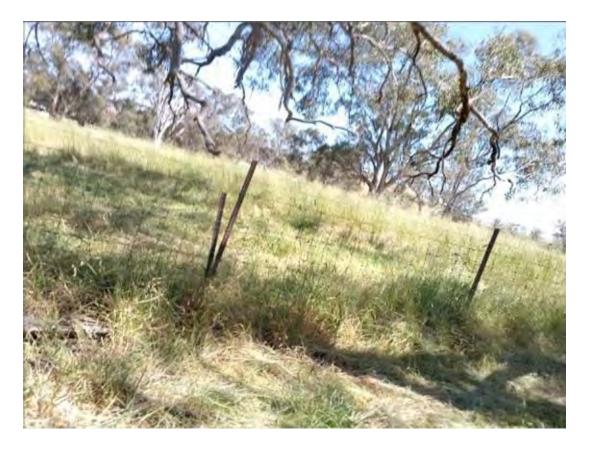
S145a - View towards 525mm Pipe Culvert

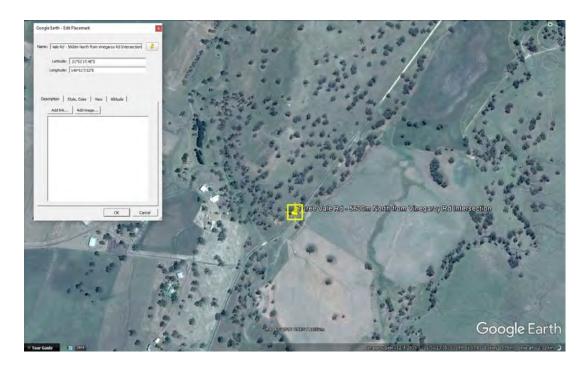
S146 - Location Plan

S146 – Turee Vale Rd - 5600m North from Vinegaroy Rd IntersectionPipe Culvert of unknown Dimensions Unknown Condition

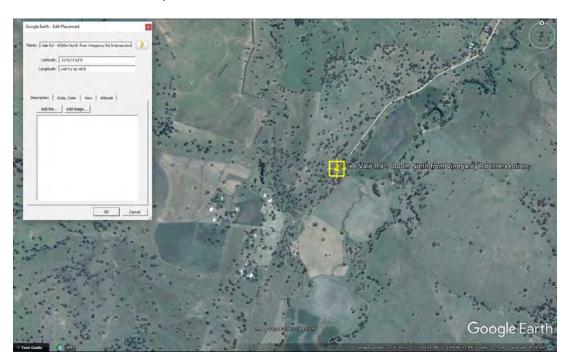
S147 – Location Plan

Pipe culvert of unknown dimensions Inaccessible at time of inspection

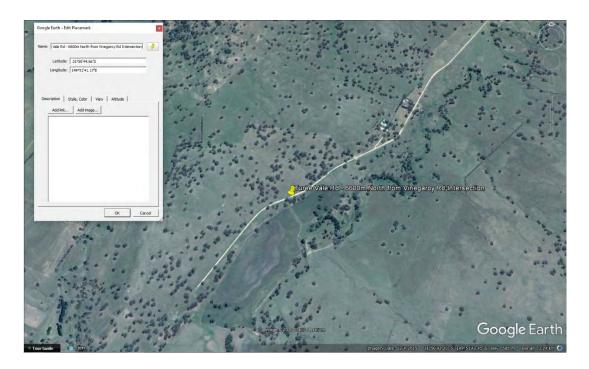
S148 - Location Plan

S148 – Turee Vale Rd - 6600m North from Vinegaroy Rd Intersection 375mm Pipe Culvert with no headwall Moderate Condition and Serviceable

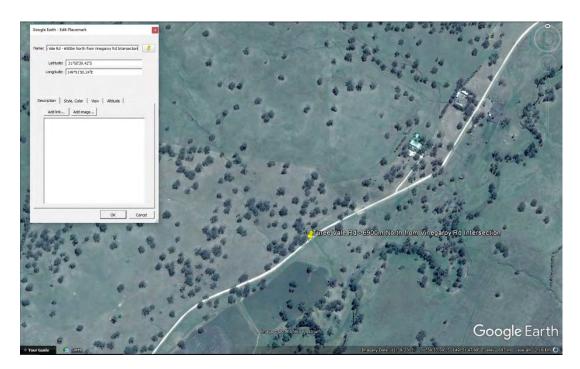
S149 - Location Plan

Causeway with no low flow pipe, Upgrade may be required Moderate Condition and Serviceable

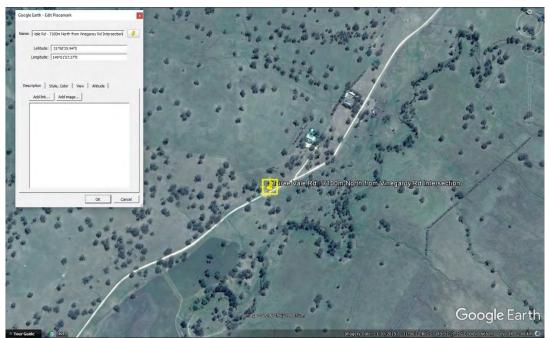
S150 - Location Plan

Pipe Culvert
Damaged inlet and outlet
Upgrade likely to be required.
Moderate Condition and Serviceable

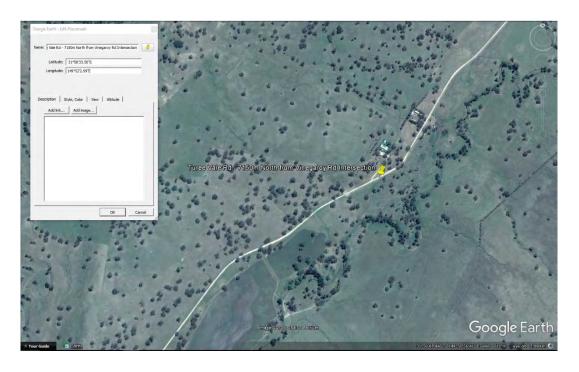
S151 - Location Plan

Blocked,

Will require Upgrade or maintenance

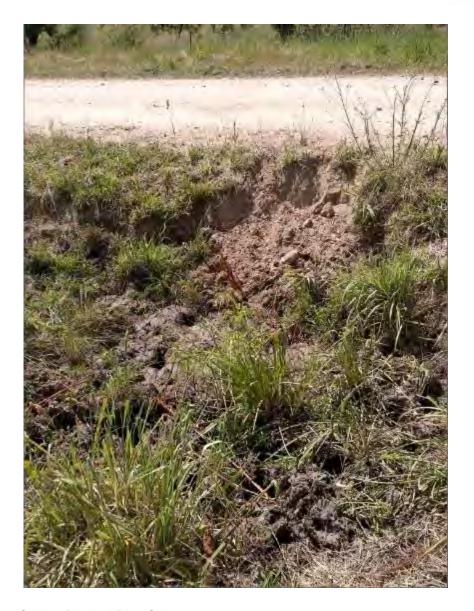
S151 - Blocked Pipe Culvert

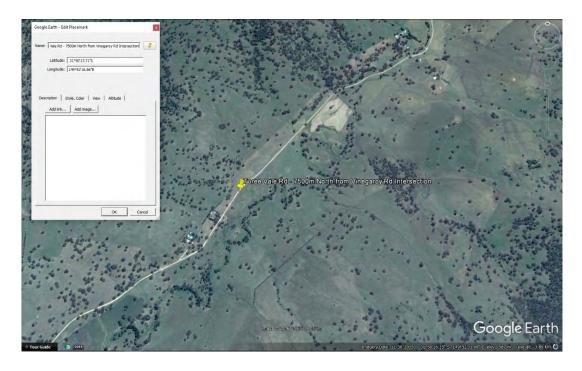
S152 - Location Plan

S152 – Turee Vale Rd - 7500m North from Vinegaroy Rd Intersection 525mm Pipe Culvert Unknown Condition and Serviceable

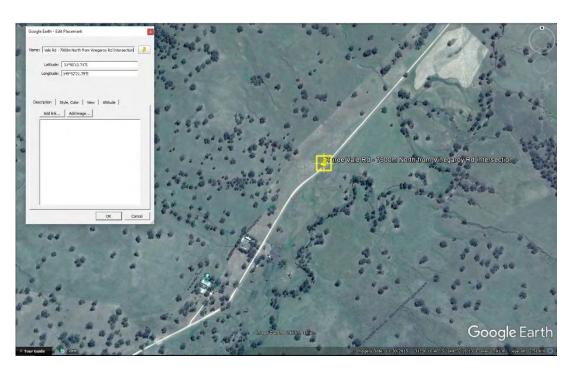
S153 - Location Plan

Causeway, 600mm Pipe Culvert Moderate Condition and Serviceable

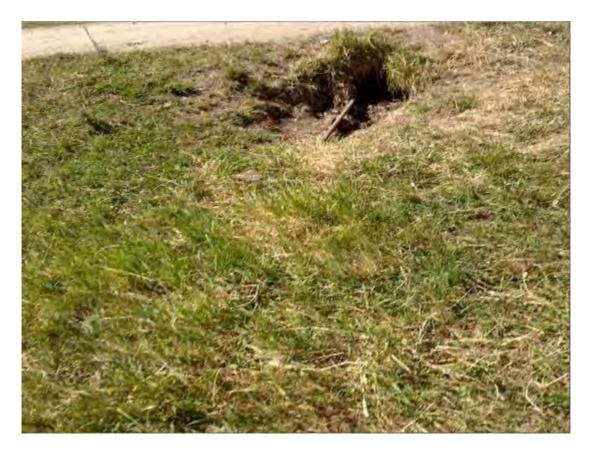
S153 – 600mm Pipe Culvert

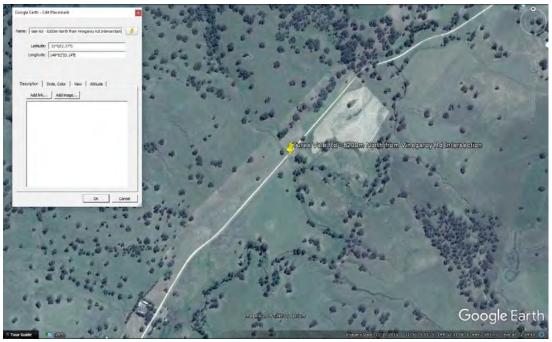
S154 - Location Plan

Causeway

Poor Condition and Serviceable,

Upgrade likely to be required.

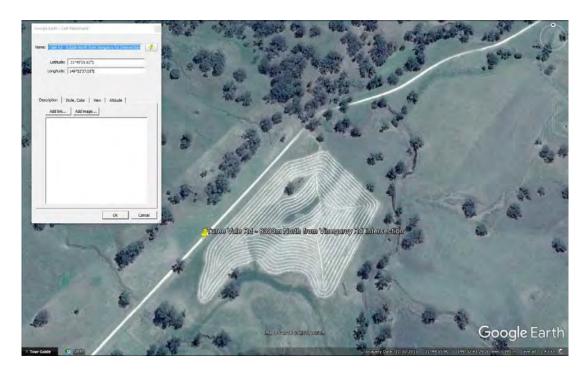
S155 - Location Plan

S155 – Turee Vale Rd - 8300m North from Vinegaroy Rd Intersection 450mm Pipe Culvert Fair Condition and Serviceable

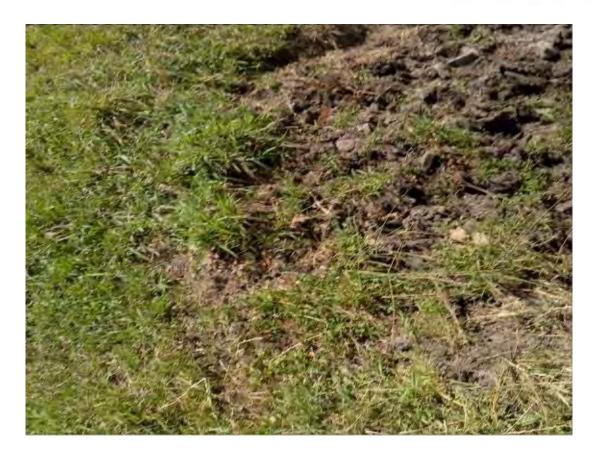
S155 - View over 450mm Pipe Culvert

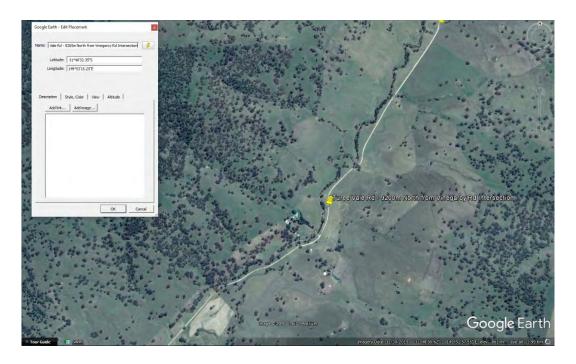
S156 - Location Plan

S156 - Turee Vale Rd - 9200m North from Vinegaroy Rd Intersection Causeway, 1500mm-600mm Reinforced Concrete Box Culvert

Good Condition and Serviceable

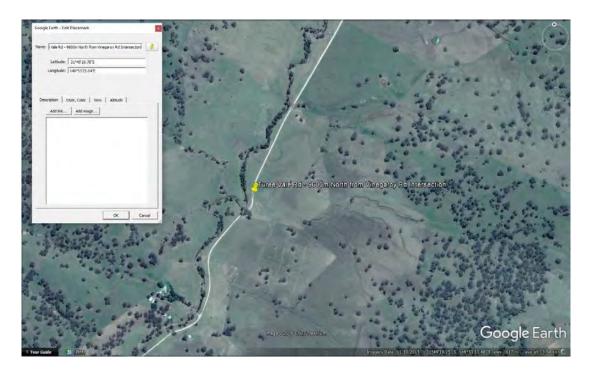
S157 - Location Plan

Causeway, a culvert will be needed for this location Poor Condition and Serviceable

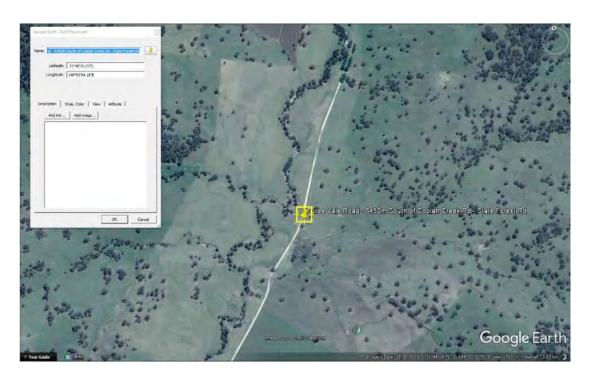
S158 - Location Plan

S158 - Turee Vale Road - 6450m South of Coolah Creek Rd - State Forest RdCauseway, A Culvert will be needed for this location Poor Condition and Serviceable

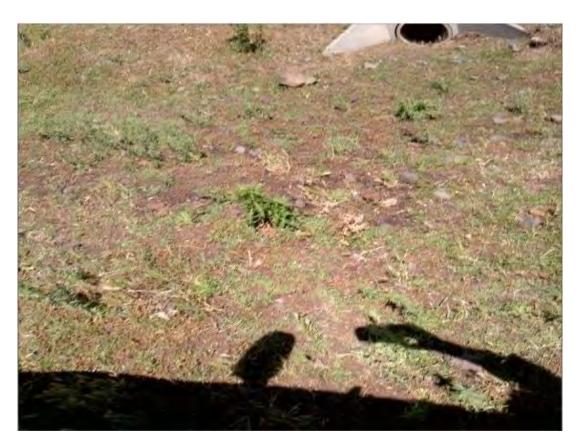
S159 – 450mm Pipe Culvert

S159 – Turee Vale Road - 6450m South of Coolah Creek Rd - State Forest Rd Causeway, 450mm Pipe Culvert Excellent Condition and Service

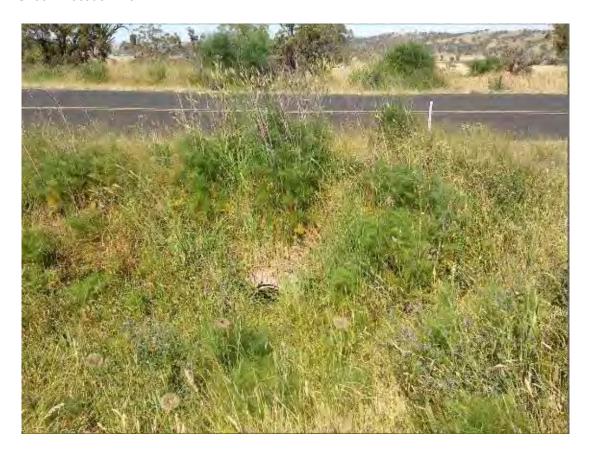
S160 – 450mm Pipe Culvert

450mm Pipe Culvert

Fair Condition and Serviceable, requires maintenance
