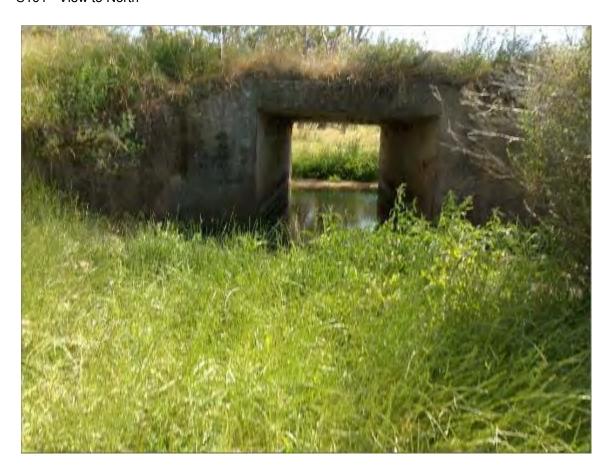
S161 - 1500mm Square Reinforced Concrete Box Culvert

Concrete causeway with bitumen seal Single Span 1500mm Square Reinforced Concrete Box Culvert Good Condition and Serviceable

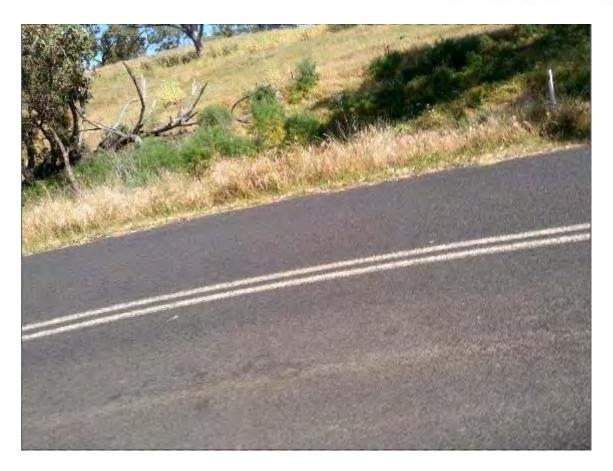
S162- View to West

Concrete culvert
Culvert inaccessible at time of inspection,
Dimensions unknown
Condition unknown

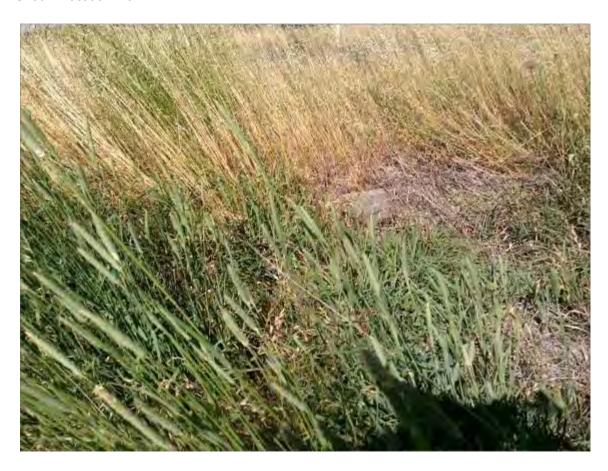
S163 – 600mm Pipe Culvert Level 2, 39 Sherwood Road Toowong QLD 4066

S163 – Vinegaroy Rd - 4350m North of Coolah Rd Intersection 600mm Pipe Culvert

Fair Condition and Serviceable

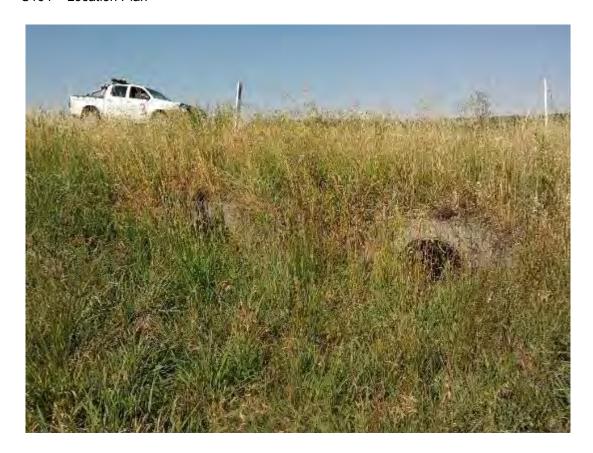
S164 - Dual 600m Pipe Culvert

Dual 600mm Pipe Culvert Good Condition and Serviceable

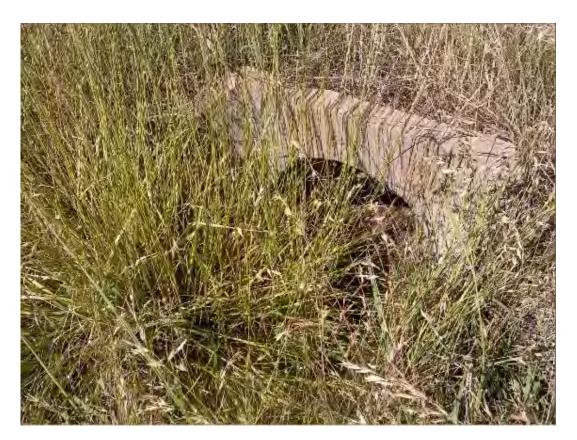
S166 - 750mm Pipe Culvert

S166 – Vinegaroy Rd - 1700m North of Coolah Rd Intersection 750mm Pipe Culvert Good Condition and Serviceable

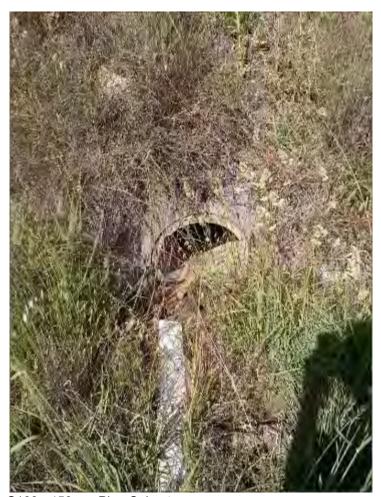
S168 - 450mm Pipe Culvert

S168 – Vinegaroy Rd - 1350m North of Coolah Rd Intersection 450mm Pipe Culvert Fair Condition and Serviceable

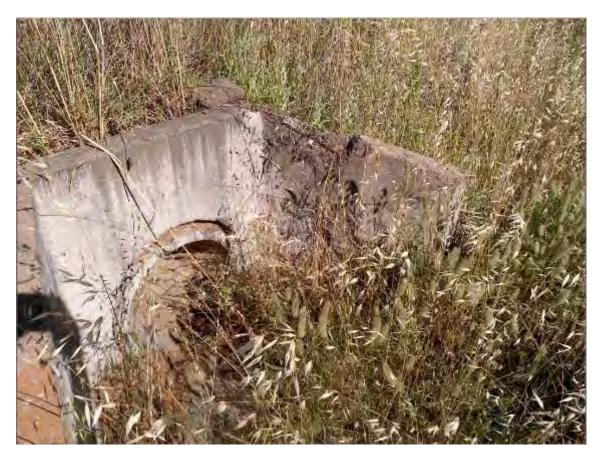
S169 - 450mm Pipe Culvert Level 2, 39 Sherwood Road Toowong QLD 4066

S169 – Vinegaroy Rd - 1200m North of Coolah Rd Intersection 450mm Pipe Culvert

Moderate Condition and Serviceable

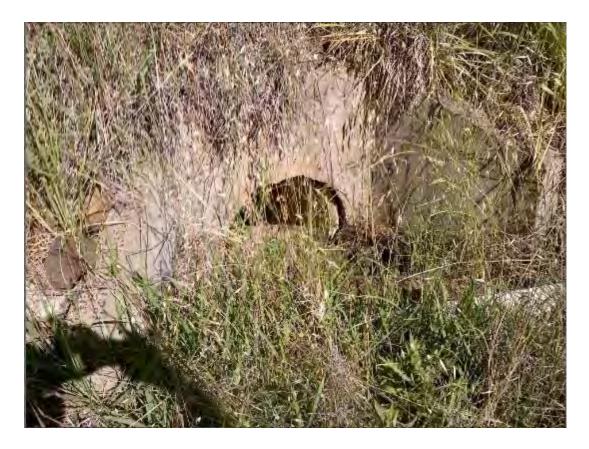
S170 - 600mm Pipe Culvert

S170 – Vinegaroy Rd - 1100m North of Coolah Rd Intersection 600mm Pipe Culvert Fair Condition and Serviceable

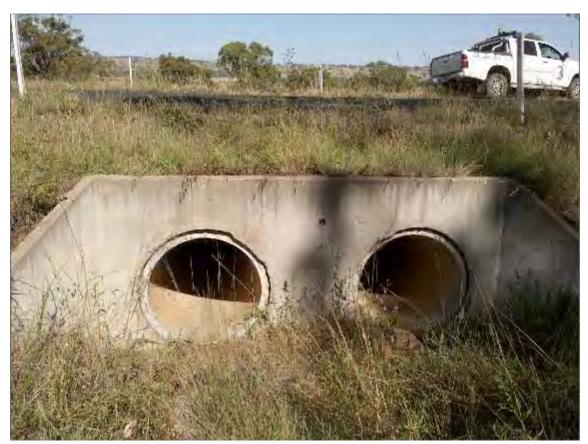
S171 - Dual 750mm Pipe Culvert

Dual 750mm Pipe Culvert Excellent Condition and Serviceable

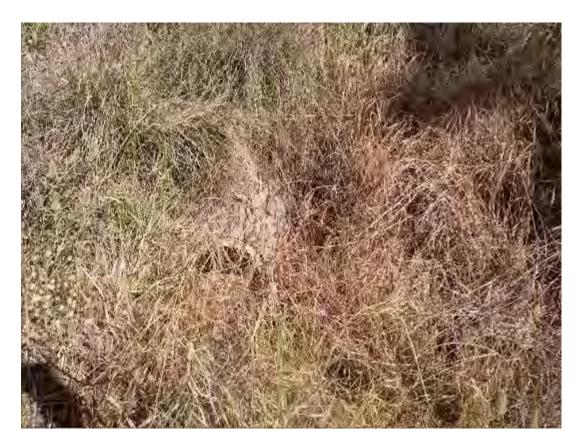
S172 – 600mm Pipe Culvert

S172 – Vinegaroy Rd - 800m North of Coolah Rd Intersection 600mm Pipe Culvert Fair Condition and Serviceable

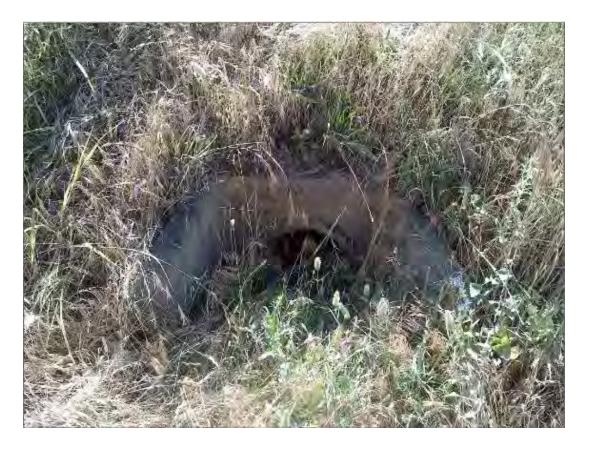
S173 – 300mm Pipe Culvert

S173 – Vinegaroy Rd - 400m South of Coolah Rd Intersection 300mm Pipe Culvert Fair Condition and Serviceable

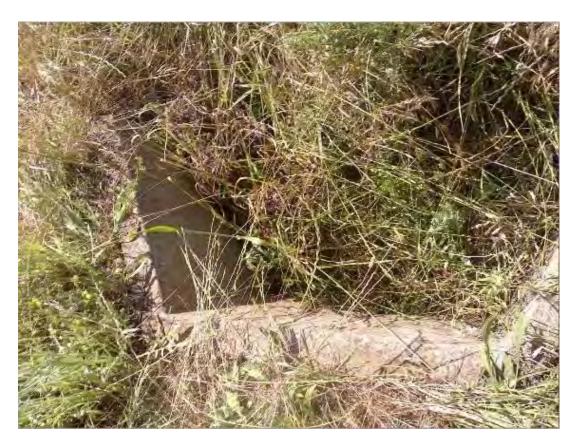
S174 – Top View of Culvert 450mm Pipe Culvert
Level 2, 39 Sherwood Road mail@icubed.com.au P: 07 3870 8888 Toowong QLD 4066
www.icubed.com.au

Moderate Condition and Serviceable,

Inaccessible at time of inspection, requires maintenance

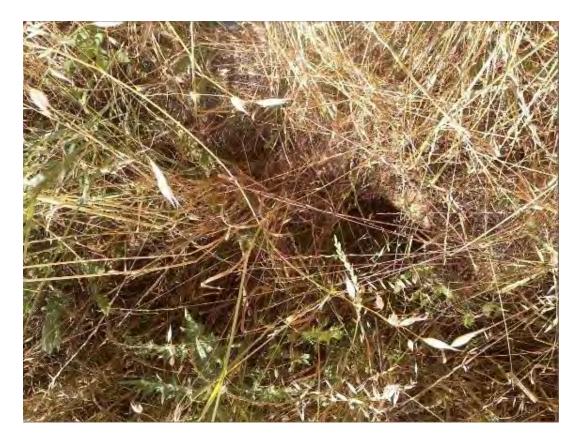
S175 – 450mm Pipe Culvert

S175 – Vinegaroy Rd - 2200m North of Golden Highway Intersection 450mm Pipe Culvert Moderate Condition and Serviceable,

Maintenance may be required

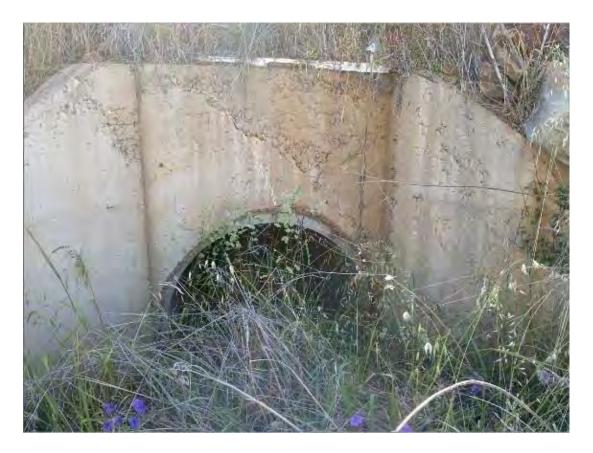
S176 - 1050mm Pipe Culvert

S176 – Vinegaroy Rd- 50m North of Golden Highway Intersection 1050mm Pipe Culvert Good Condition and Serviceable

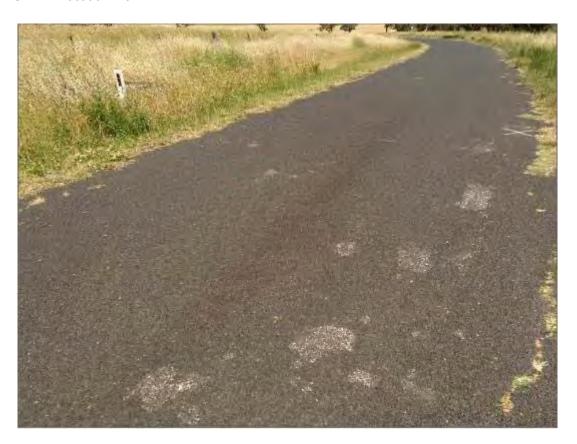
S177 – View to West Level 2, 39 Sherwood Road Toowong QLD 4066

Pipe Culvert of Unknown Dimensions Inaccessible at time of inspection Condition Unknown

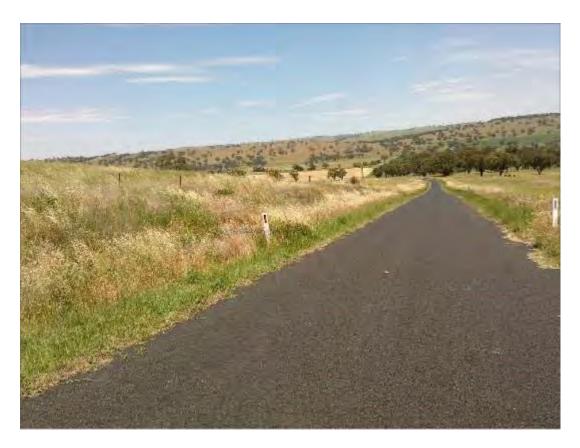
S179 – View to West

Pipe Culvert of unknown Dimensions Condition Unknown

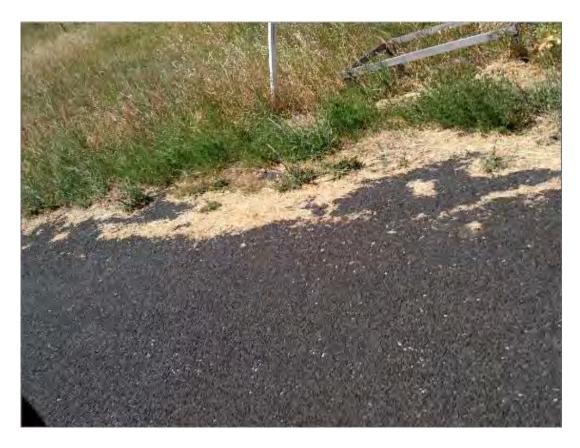
S180 - View of Culvert

Pipe Culvert of unknown Dimensions Condition Unknown

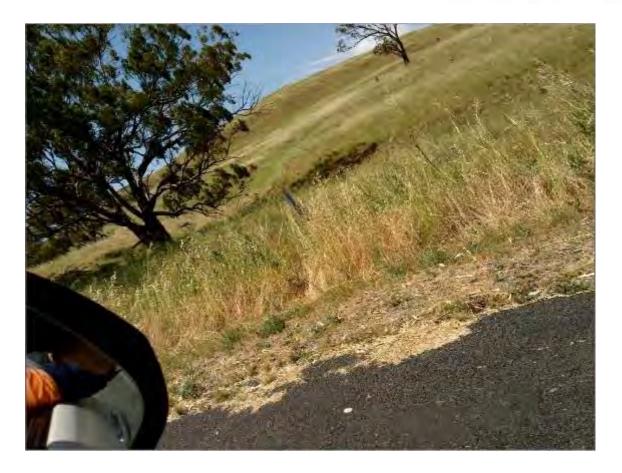
S181 - View towards Culvert

Pipe Culvert of Unknown Dimensions Unknown Condition

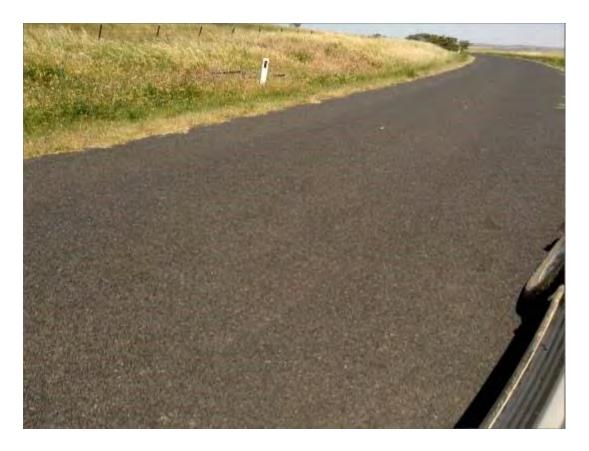
S182 - View to West

Pipe Culvert of Unknown Dimensions Condition Unknown

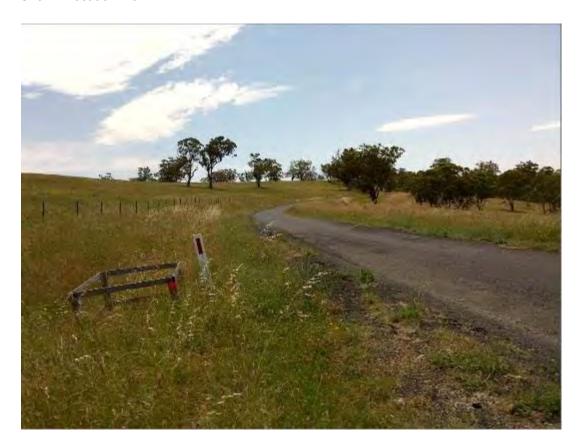
S184 – Rotherwood Rd - 2250m East of Vinegaroy Rd Intersection 750mm Pipe Culvert Fair Condition and Serviceable

S184 - 750mm Pipe Culvert

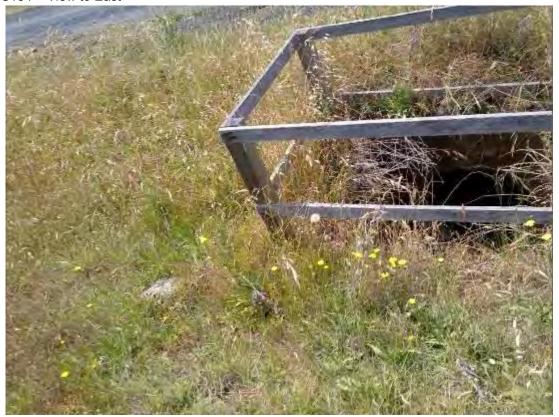
S184 – 750mm Pipe Culvert

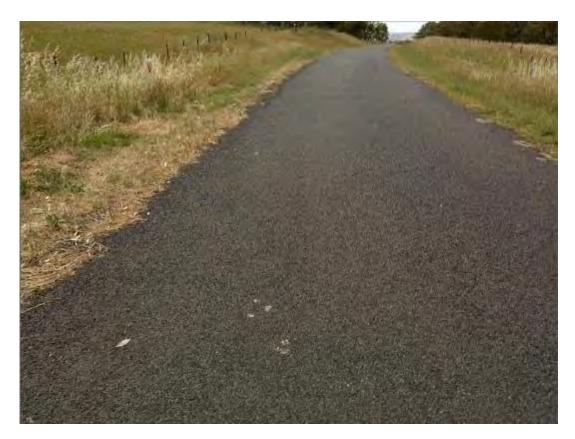
S185 - View to East

Unknown Condition

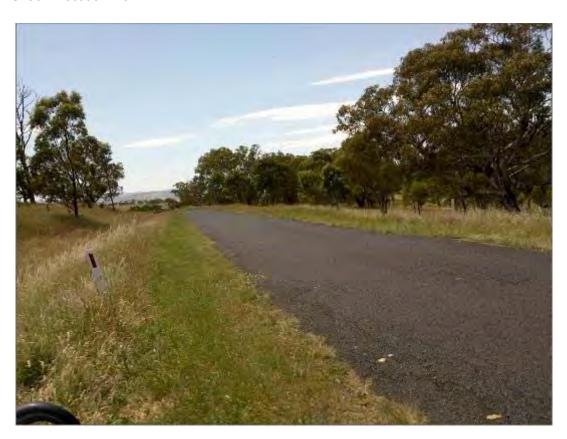
S186 - View to East

750mm Pipe Culvert with cracked headwall Moderate Condition and Serviceable

S186 - 750mm Pipe Culvert with cracked headwall

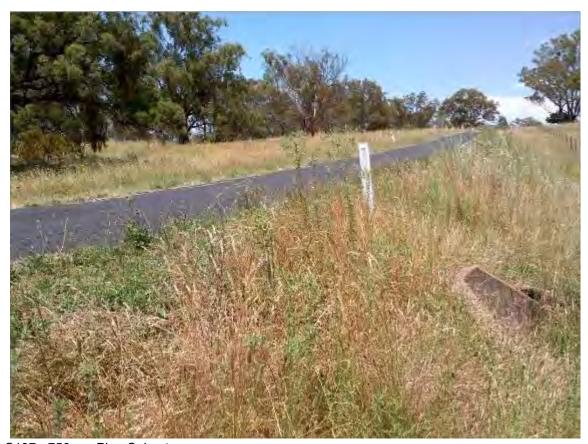
Approximately 750mm Pipe Culvert Fair Condition and Serviceable

S187 - 750mm Pipe Culvert

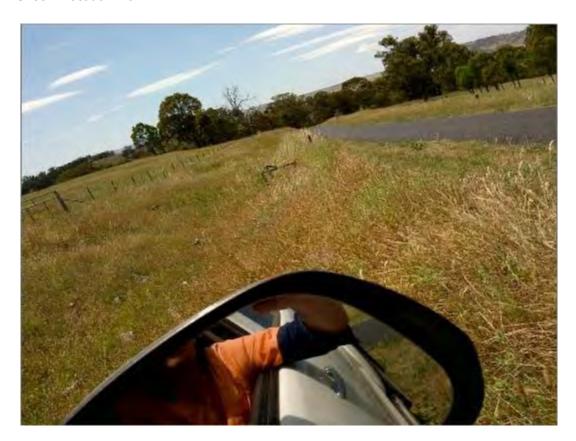
S188 - View to East

Unknown Condition

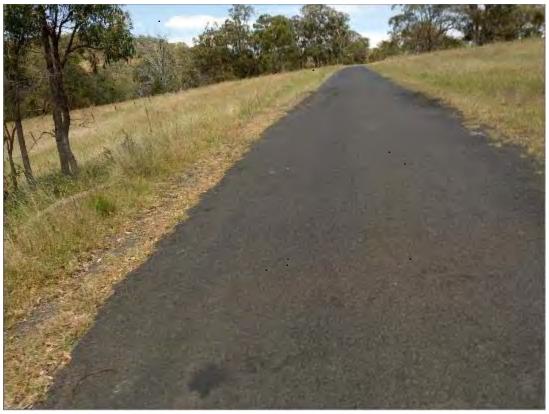
S189 - View to West

Fair Condition and Serviceable

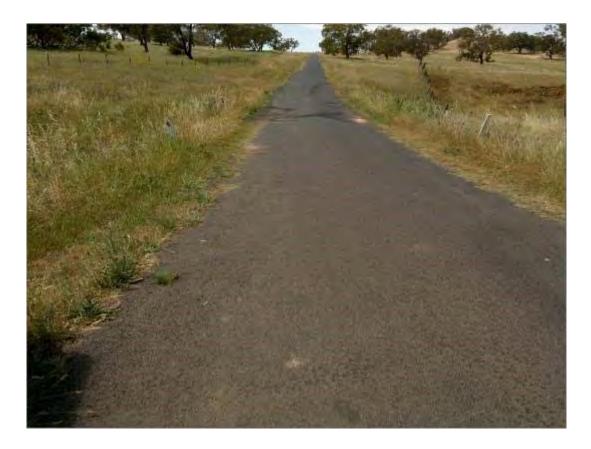
S190 - View to East

4-1200mm-900mm Reinforced Concrete Box Culvert

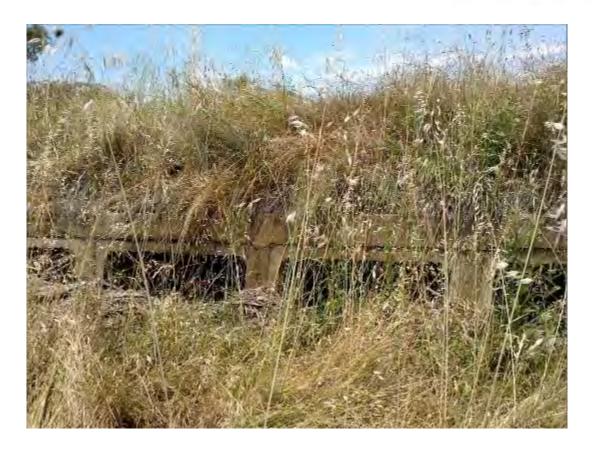
S190 - 4-1200mm-900mm Reinforced Concrete Box Culvert

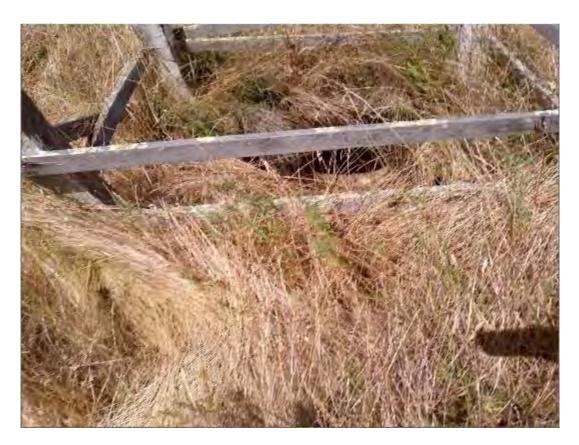
S191 – Rotherwood Rd - 3900m East of Vinegaroy Intersection 450mm Pipe Culvert Fair Condition and Serviceable

S191 - 450mm Pipe Culvert

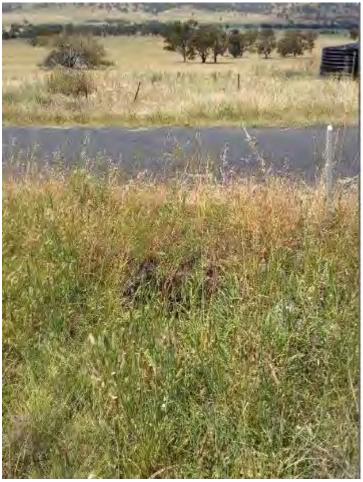
Fair Condition and Serviceable

S193 – 450mm pipe culvert

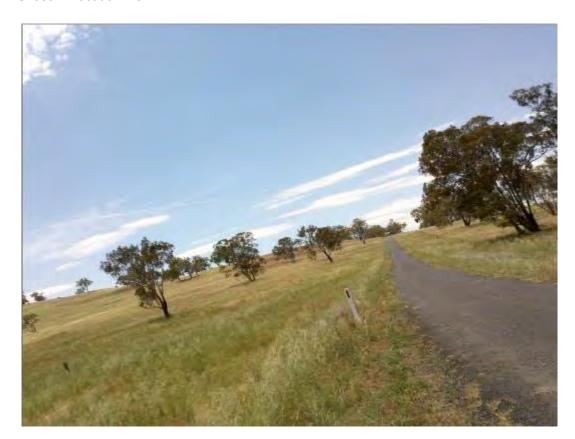
S193a – View to East

S193a – Rotherwood Rd - 3400m West of Yarrawonga Rd 675mm Pipe Culvert Good Condition and Serviceable

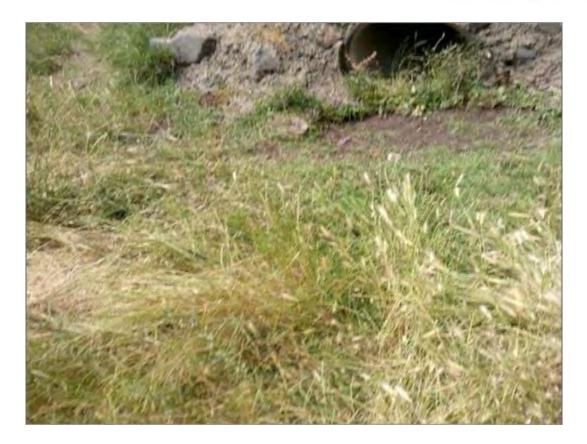
S193a - 675mm Pipe Culvert

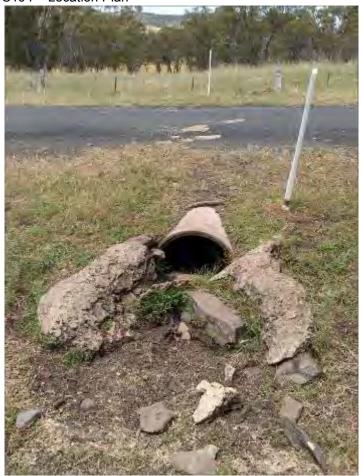
Moderate Condition and Serviceable

S194 – 600mm Pipe Culvert

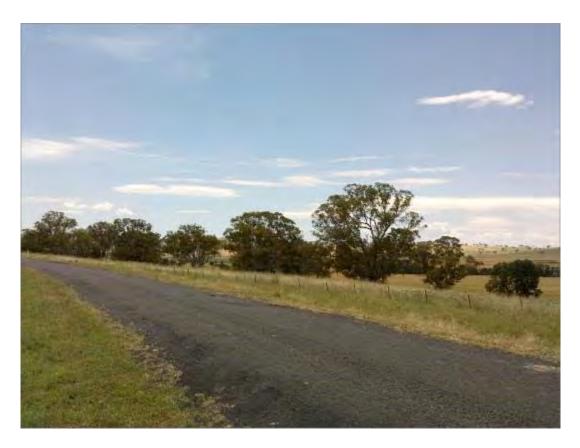
S195 - View to East

S195 – Rotherwood Rd - 2200m West of Yarrawonga Rd 600mm Pipe Culvert Fair Condition and Serviceable

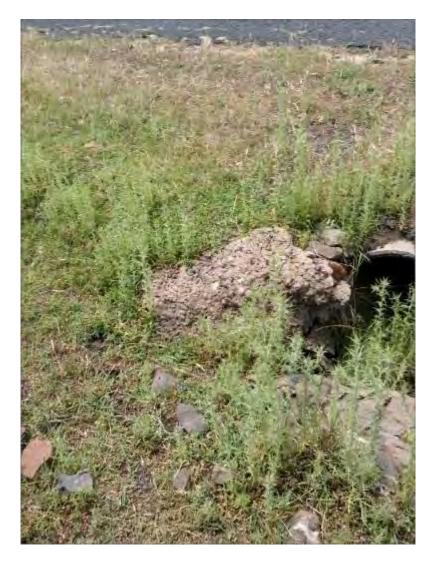
S195 – 600mm Pipe Culvert

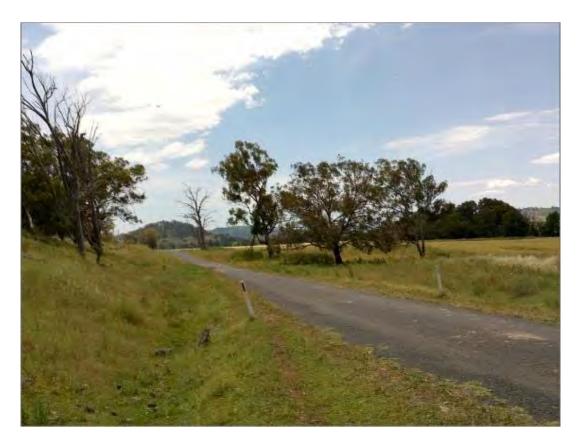
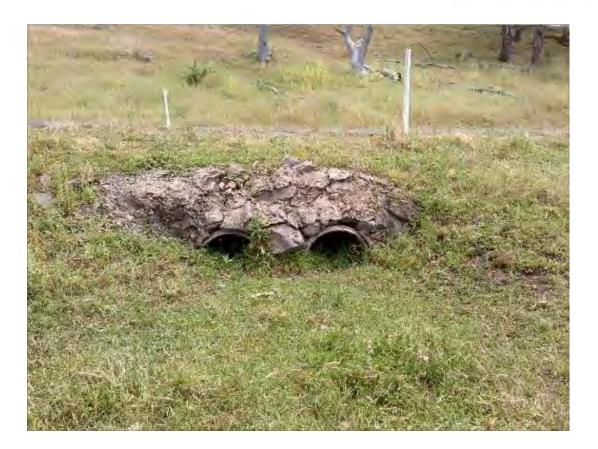
S196 - Dual -525mm Pipe Culvert

Dual -525mm Pipe Culvert Fair Condition and Serviceable

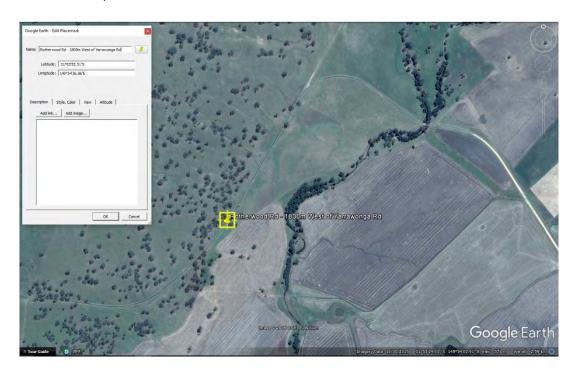
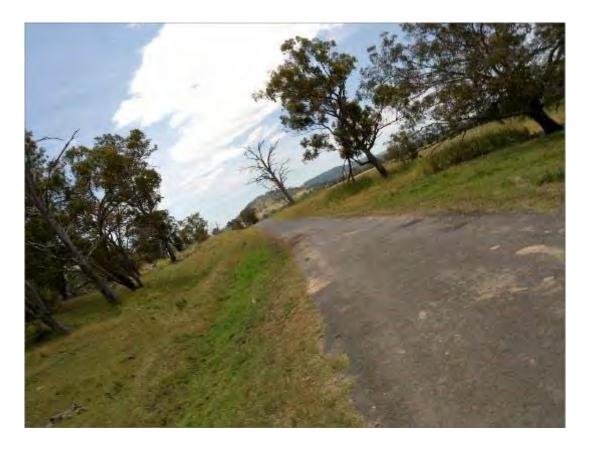
S197 - View to North

A Culvert is required for this location

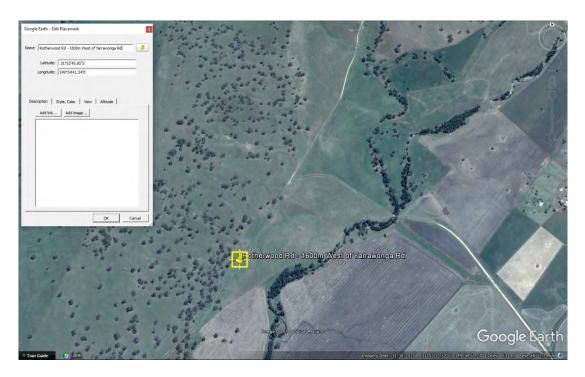
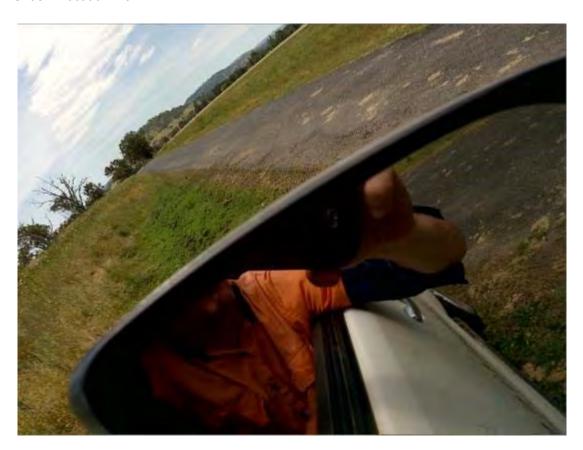
S198 - View to North

A Culvert is required for this location

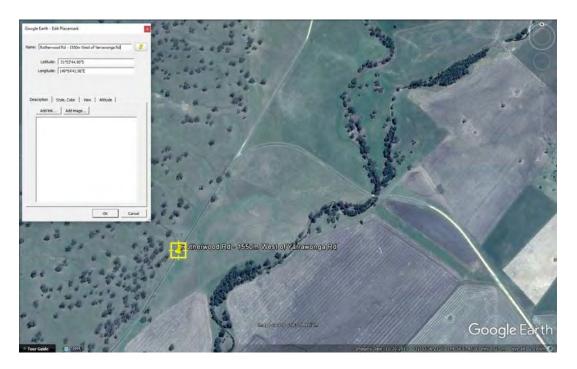
S199 - Location Plan

Dual – 600mm Pipe Culvert - Broken Poor Condition and Serviceable, Upgrade likely required.

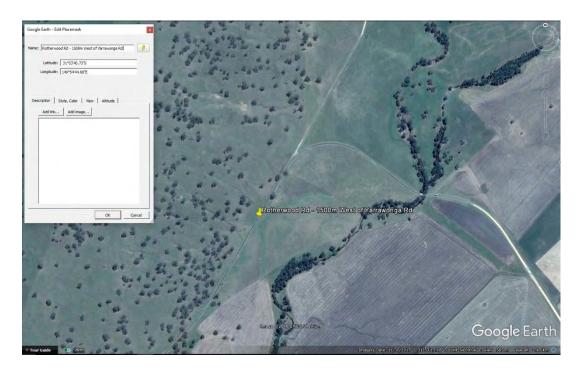
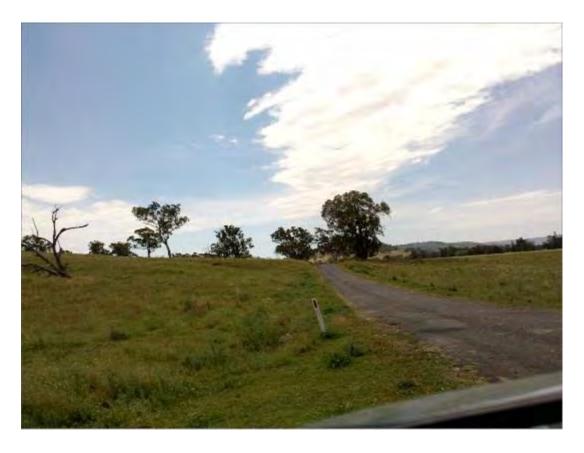
S200 - View to North

S200 – Rotherwood Rd - 1550m West of Yarrawonga RdDual – 600mm Pipe Culvert, Condition Unknown

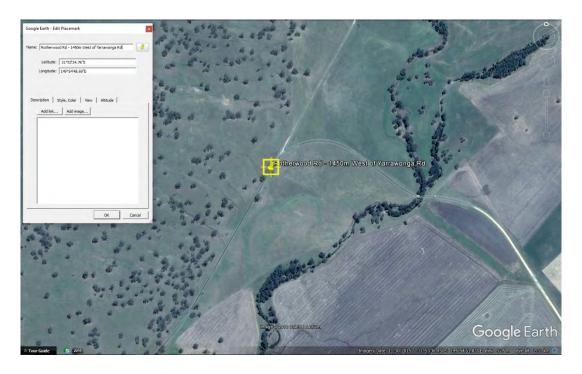
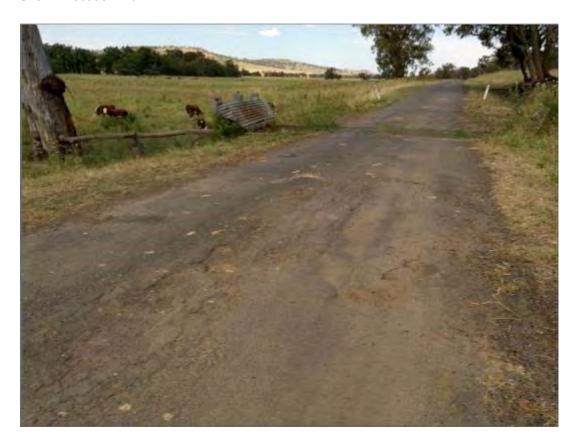
S201 - View to North, Location of Culvert Shown at Top Right of Image

S201 - Rotherwood Rd - 1450m West of Yarrawonga Rd 600mm Pipe Culvert including Grid,

Poor Condition and Serviceable, may require upgrade

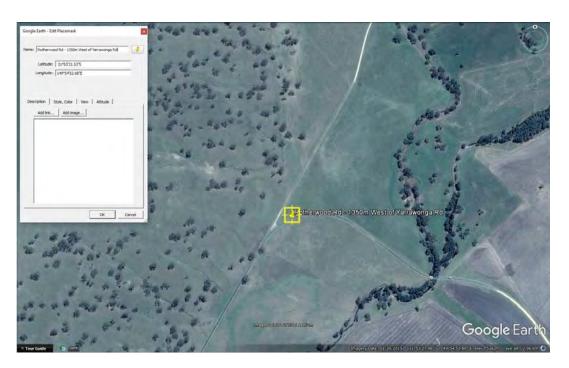
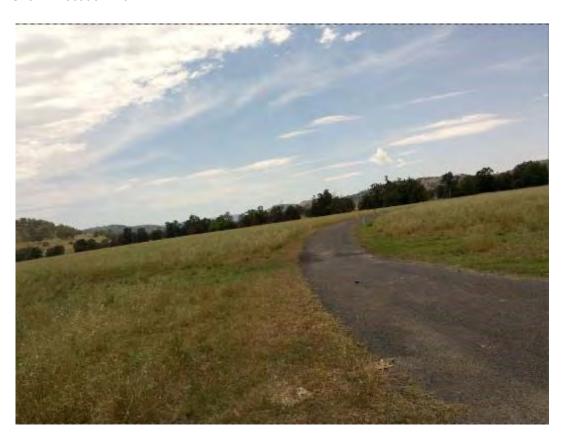
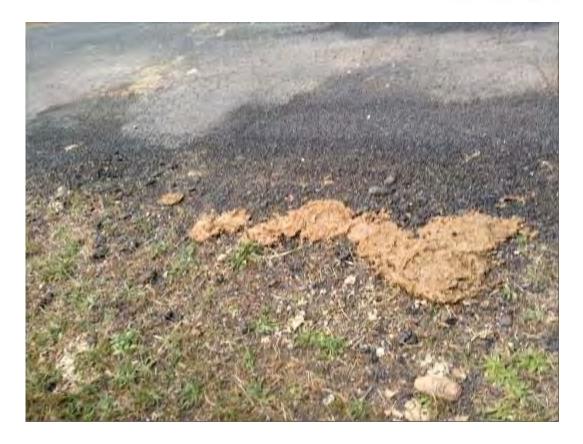
S202 – Evidence of Floodway

Bitumen floodway, Upgrade required Poor Condition and Serviceable

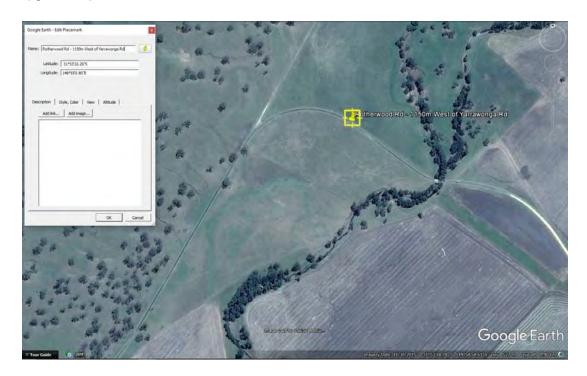
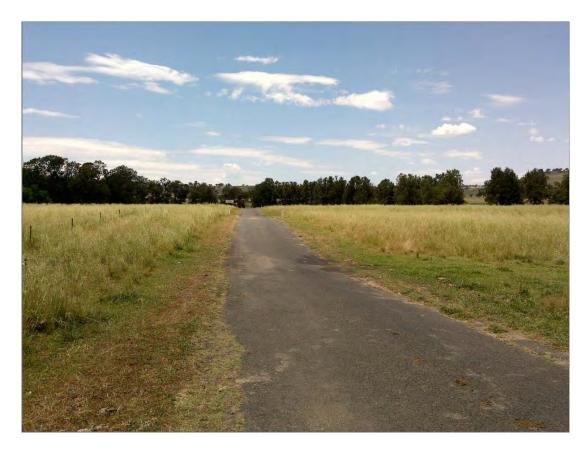
S203 - View to East

S203 – Rotherwood Rd - 1150m West of Yarrawonga RdBitumen floodway Road in Poor Condition,

Upgrade required

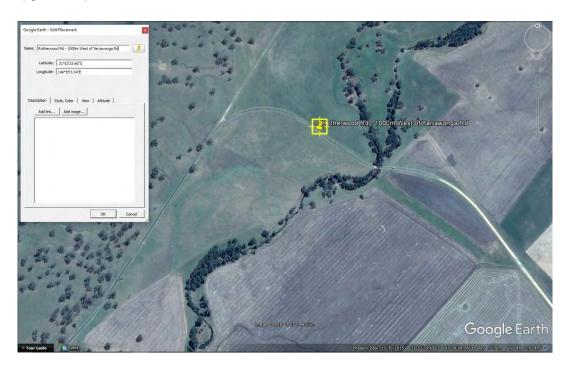
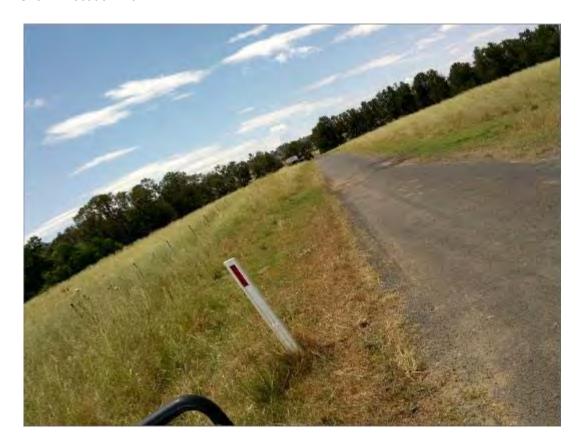
S204 - View to East

Bitumen floodway Road is in poor condition, Upgrade required

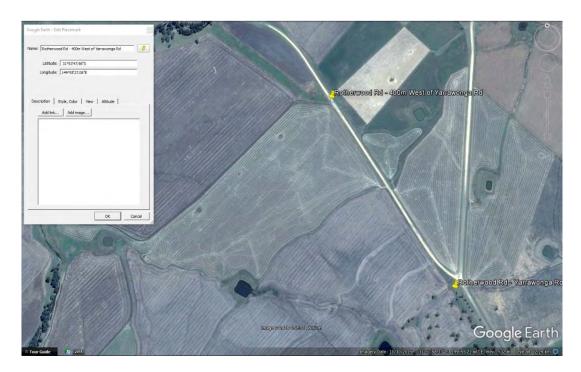
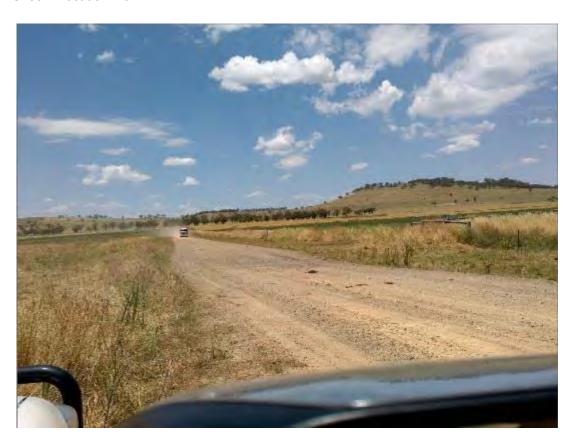
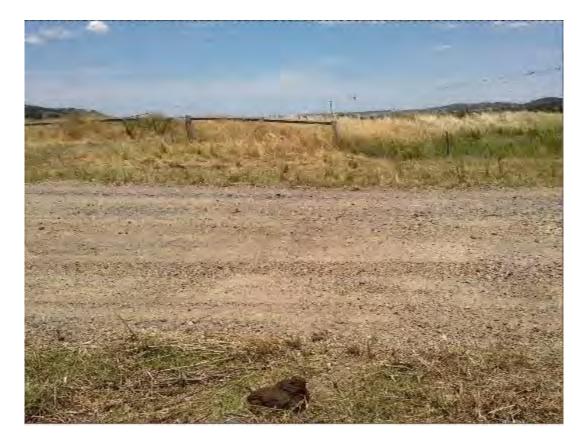
S205 – View of Floodway

Floodway Poor Condition, Upgrade likely required

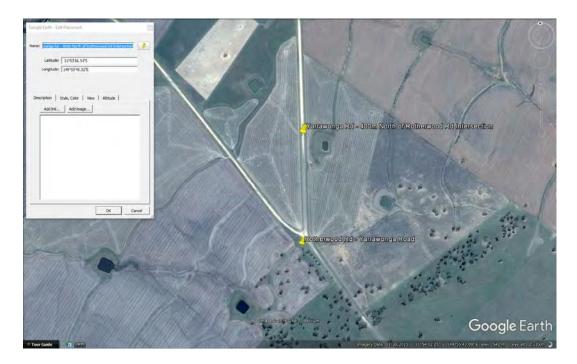
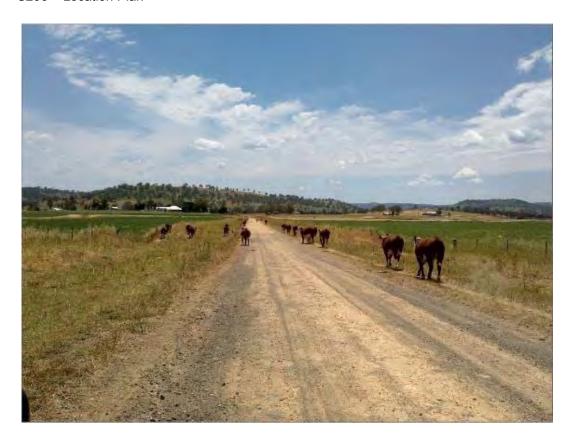
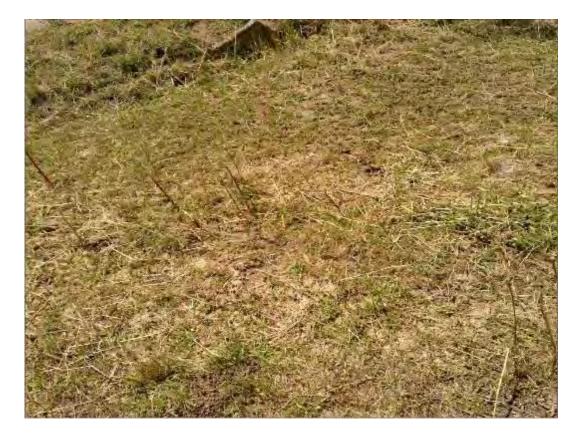
S206 - Culvert shown top of Image

S206 – Yarrawonga Rd - 400m North of Rotherwood Rd Intersection Culvert blocked, Dimensions Unknown

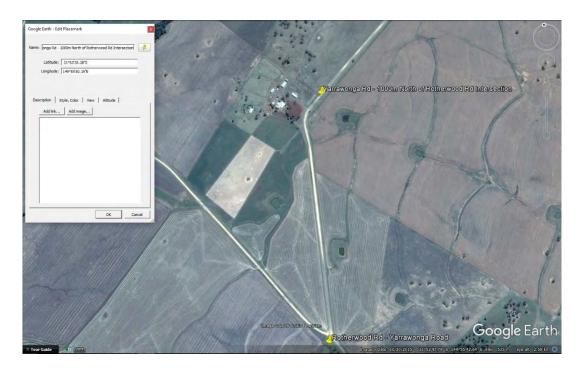
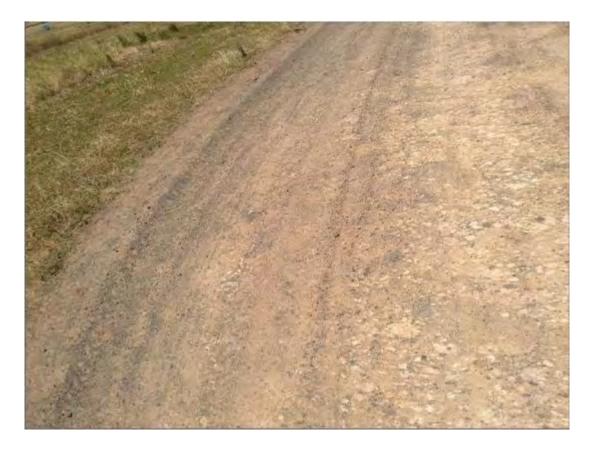
S208 - View towards culvert

S208 – Yarrawonga Rd - 1000m North of Rotherwood Rd IntersectionPipe Culvert of Unknown Dimension, Unknown Condition

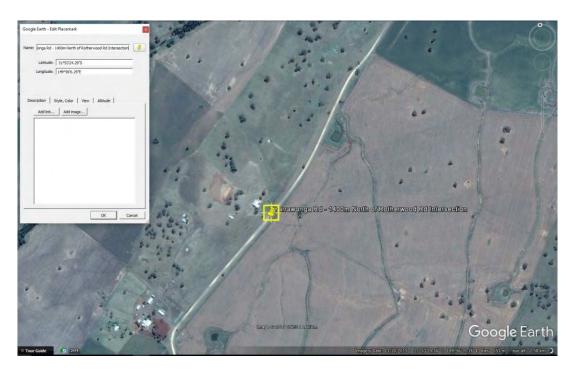
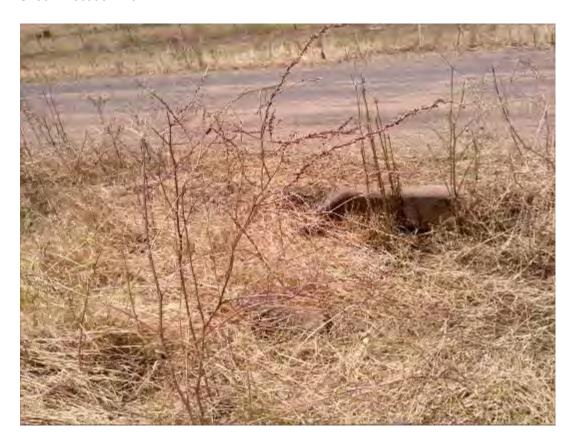
S209 - Blocked Pipe Culvert

Pipe Culvert is blocked

Poor Condition and Serviceable, will require maintenance or alternatively upgrade

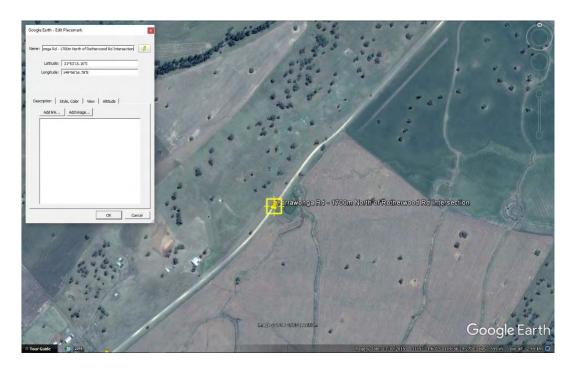
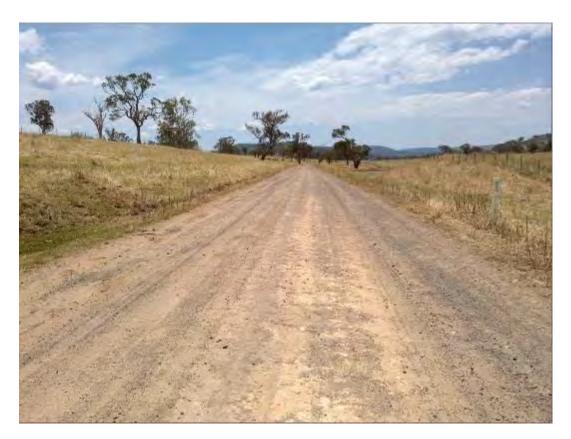
S210 - View to North

Blocked Pipe Culvert,

Unknown Condition, will require maintenance

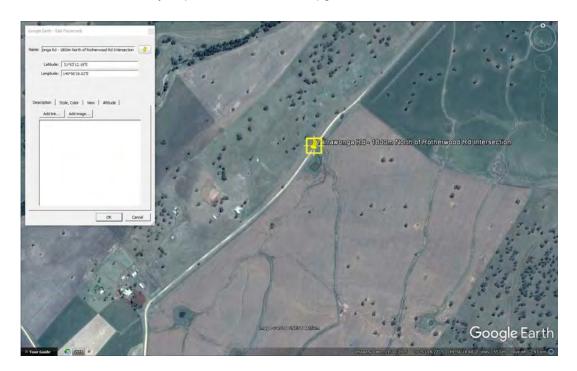
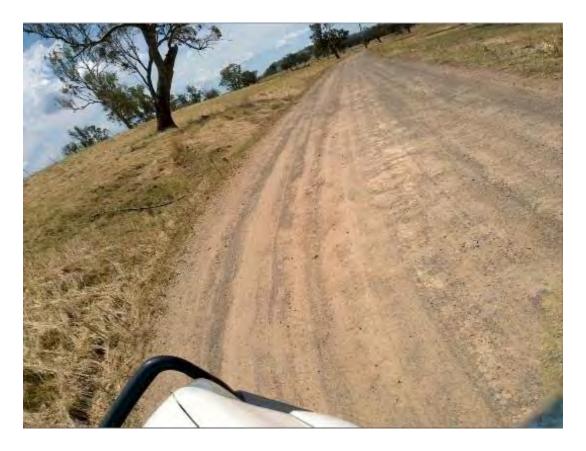
S211 - View to North

Blocked Pipe Culvert, no photo of culvert Unknown Condition, may require maintenance or upgrade

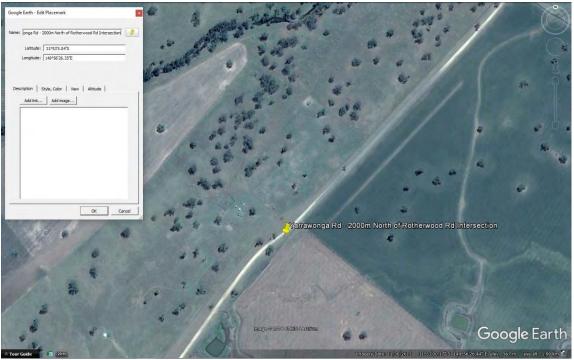
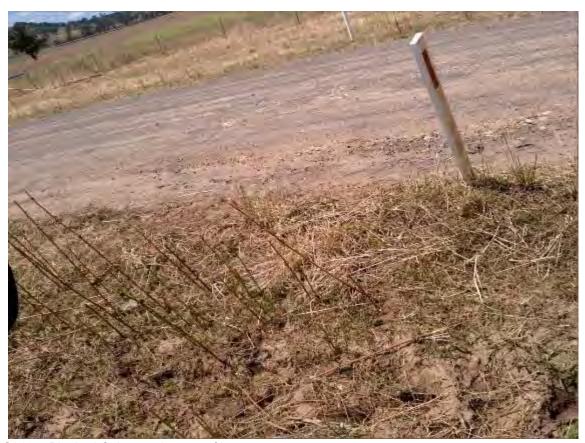
S212 - Blocked Culvert at bottom of image

Condition Unknown,

Will require maintenance or upgrade

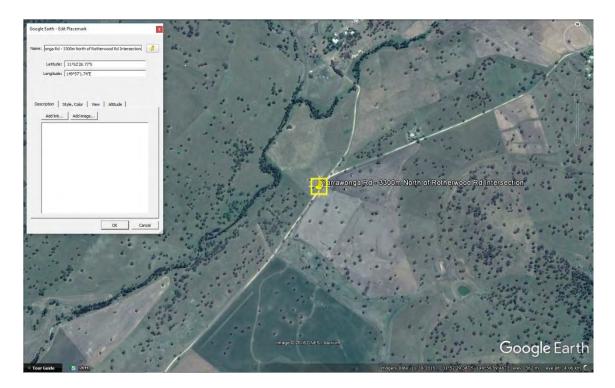
S213 - Location Plan

S213 - Yarrawonga Rd - 3300m North of Rotherwood Rd IntersectionNeed culvert for this Location

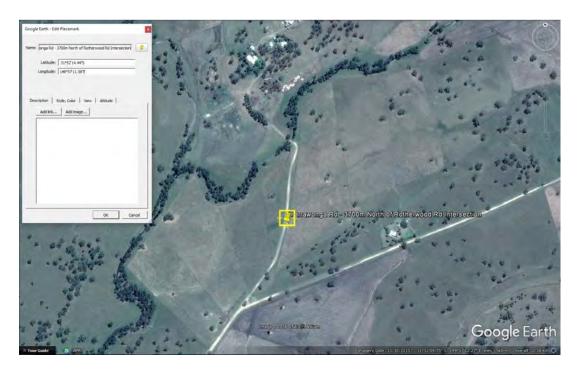
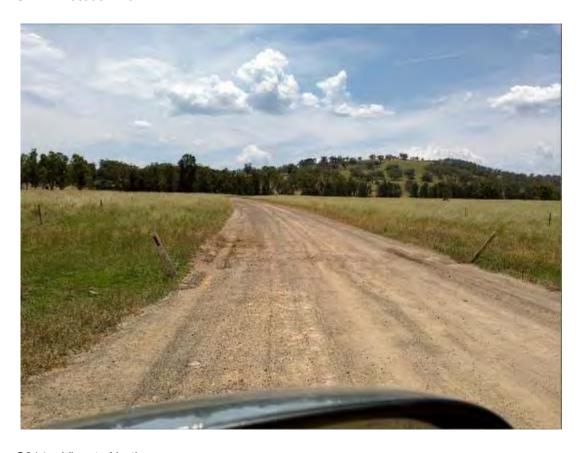
S214 - View to North

Blocked Pipe Culvert,

Condition Unknown, will require maintenance or upgrade

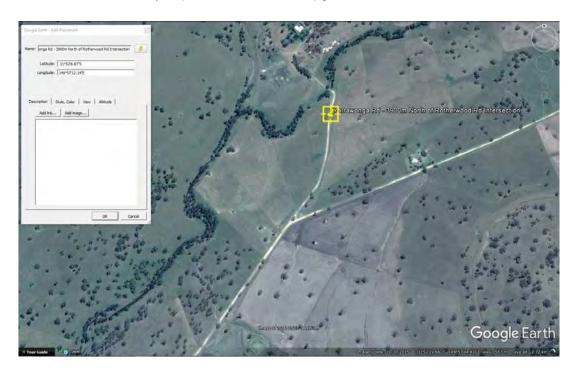
S215 - Location Plan

Blocked Pipe Culvert

Poor Condition, will likely require maintenance or upgrade

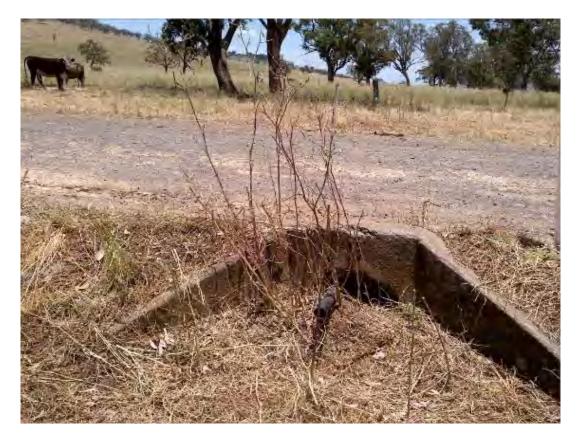
Blocked 450mm Pipe Culvert Poor Condition and Serviceable

S216 - Blocked 450mm Pipe Culvert

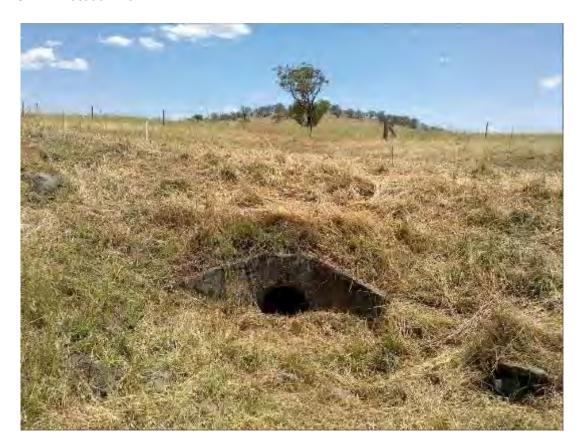
S217 – Rotherwood Rd - 900m South of Yarrawonga Intersection 450mm Pipe Culvert Fair Condition and Serviceable

S217 – 450mm Pipe Culvert

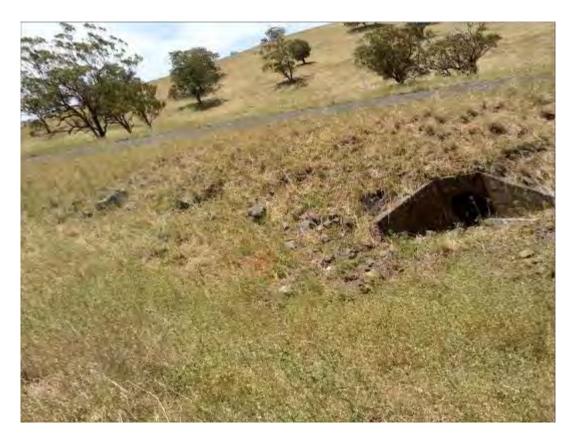
S219 – Rotherwood Rd -1900m South of Yarrawonga Intersection 600mm Pipe Culvert Good Condition and Serviceable

S219 – 600mm Pipe Culvert

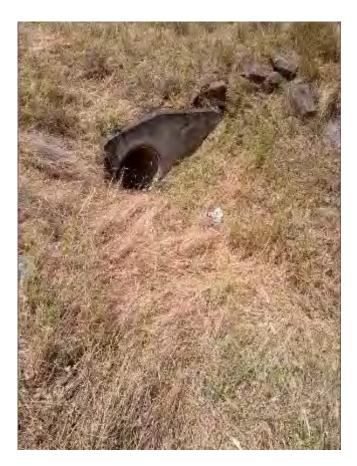
Good Condition and Serviceable

S220 - 675mm Pipe Culvert Level 2, 39 Sherwood Road Toowong QLD 4066

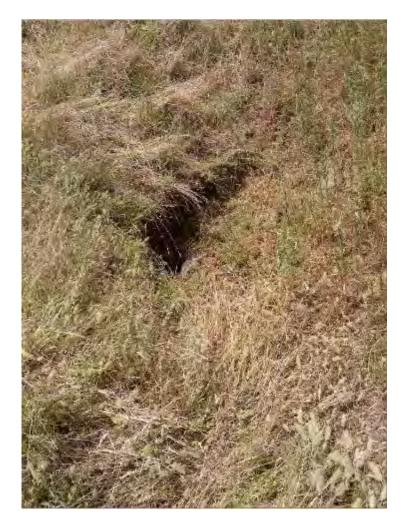
Moderate Condition and Serviceable, may require maintenance

S221 - 450mm Pipe Culvert

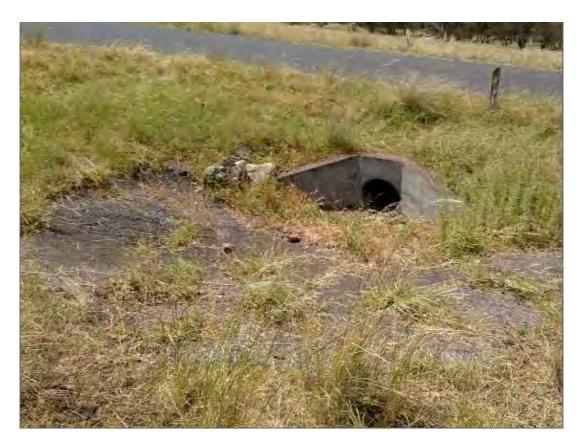
S224 - Rotherwood Road-2700m South of Yarrawonga Rd Intersection 450mm Pipe Culvert Good Condition and Serviceable

S224 - 450mm Pipe Culvert

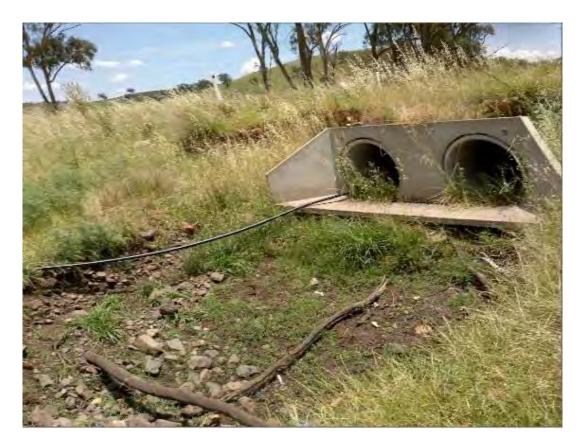
Dual -900mm Pipe Culvert with scoured headwall Fair Condition and Serviceable

S226 - Dual -900mm Pipe Culvert with scoured headwall

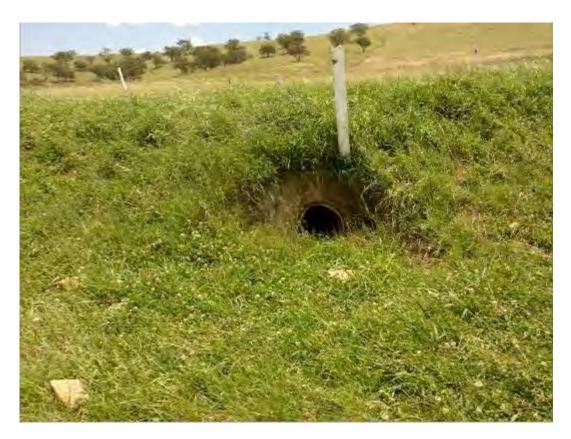
S227 – Rotherwood Road-4100m South of Yarrawonga Rd intersection 375mm Pipe Culvert Fair Condition and Serviceable

S227 – 375mm Pipe Culvert

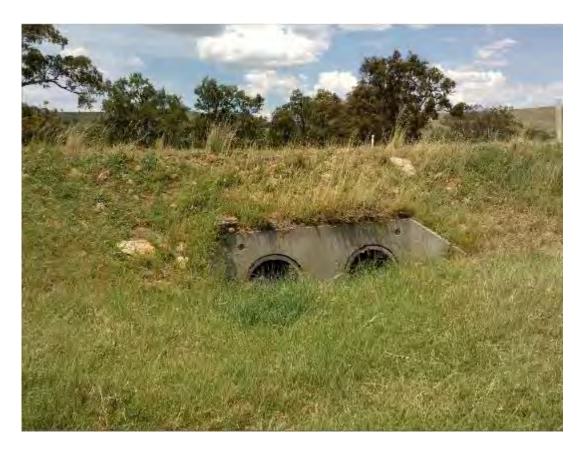
Dual – 750mm Pipe Culvert Fair Condition and Serviceable

S228 - Dual - 750mm Pipe Culvert

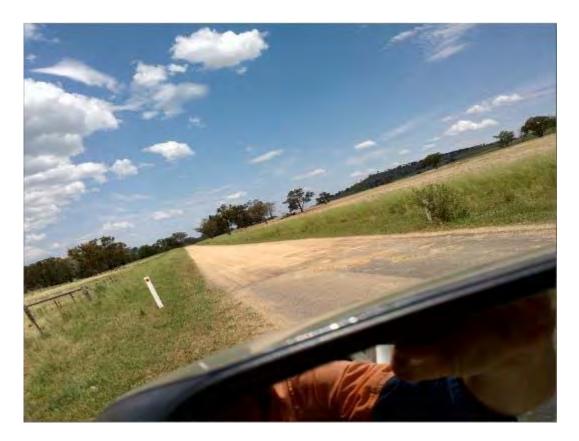
S229 - View to South

S229 – Rotherwood Road-4500m South of Yarrawonga Rd intersection End of bitumen seal,

Pipe Culvert needed for this location as there are a number of potholes due to water damage

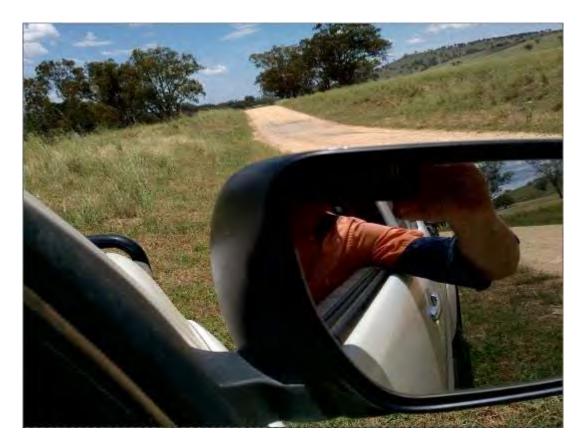
S231 - View to South

Poor Condition and Serviceable, may need to be upgraded

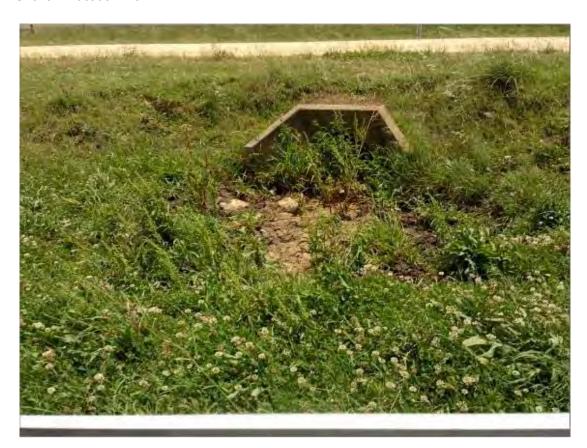
Fair Condition and Serviceable

S231a – 525mm Pipe Culvert
