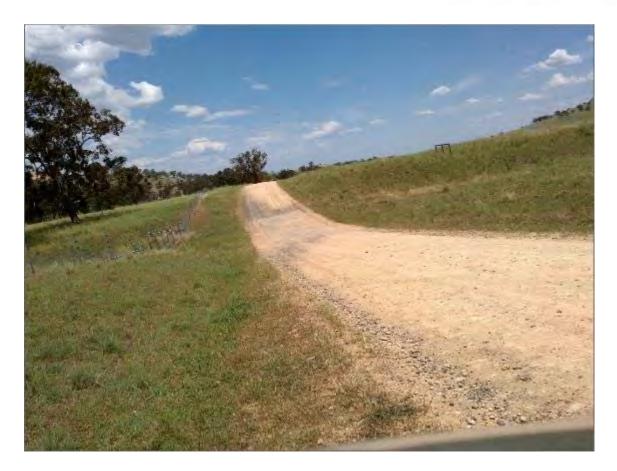
S232 - View to North and towards Location

Pipe Culvert of Unknown Dimensions Unknown Conditions

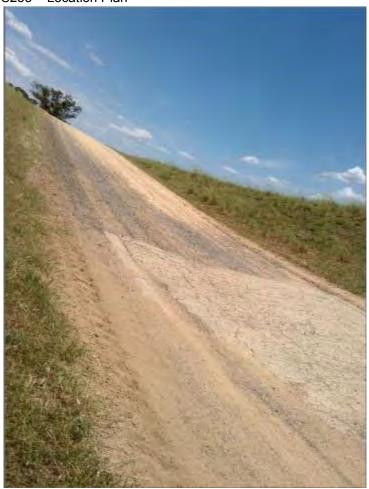
Causeway, may require upgrade Poor Condition and Serviceable,

S233 - Causeway in Poor Condition

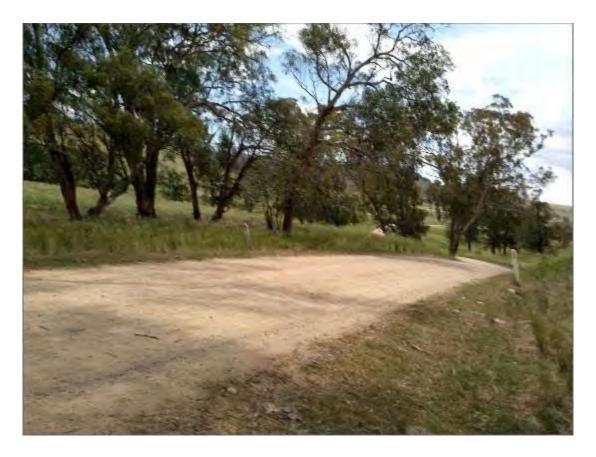
S234 - View to North

Pipe Culvert of unknown dimensions Moderate Condition and Serviceable

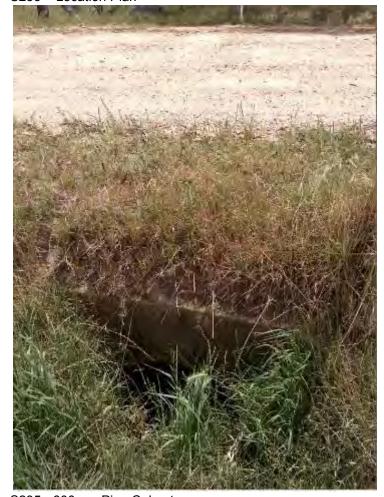
S235 - 600mm Pipe Culvert

S235 – Rotherwood Rd - 4600m North from Coolah Rd Intersection 600mm Pipe Culvert Moderate Condition and Serviceable

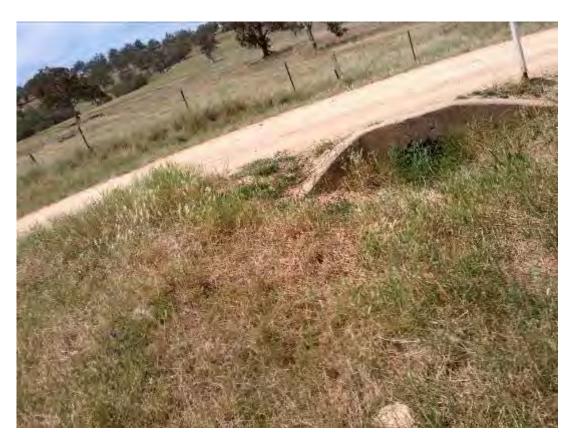
S236 – 450mm Pipe Culvert

450mm Pipe Culvert, Small crack on headwall Moderate Condition and Serviceable

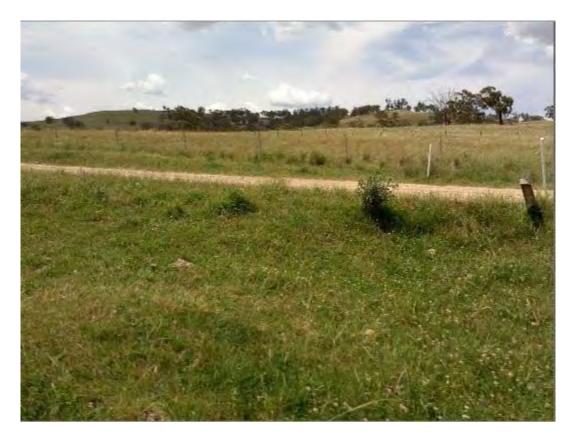
Poor Condition and Serviceable, Culvert is overgrown may require maintenance or upgrade

S237 - Overgrown Culvert on Right Side of image

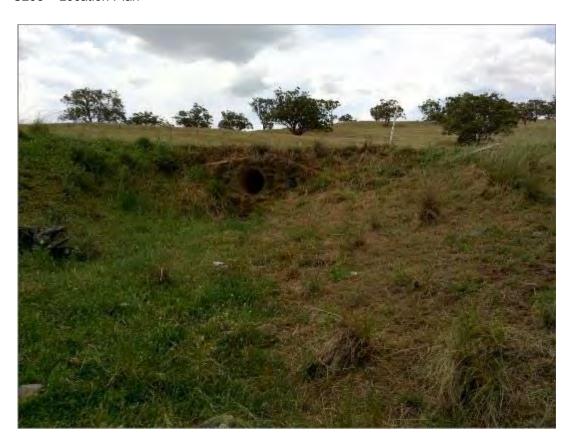
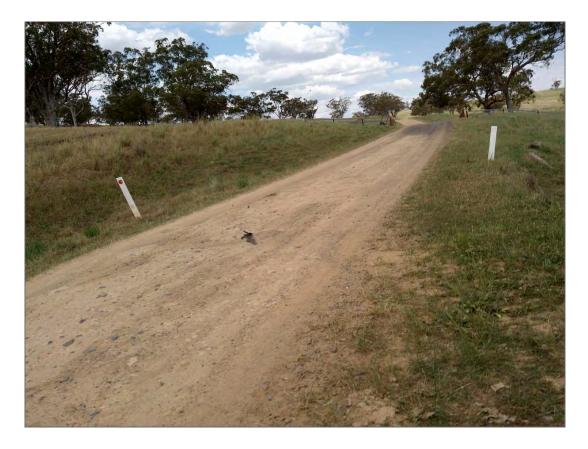
S238 – 750mm Pipe Culvert Level 2, 39 Sherwood Road Toowong QLD 4066

S238 – Rotherwood Rd - 3900m North of Coolah Rd Intersection 750mm Pipe Culvert Good Condition and Serviceable

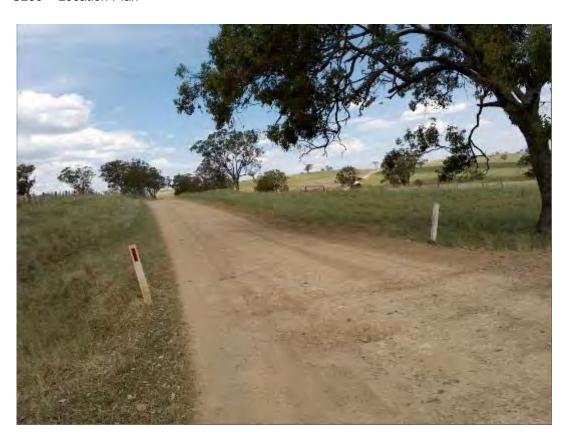
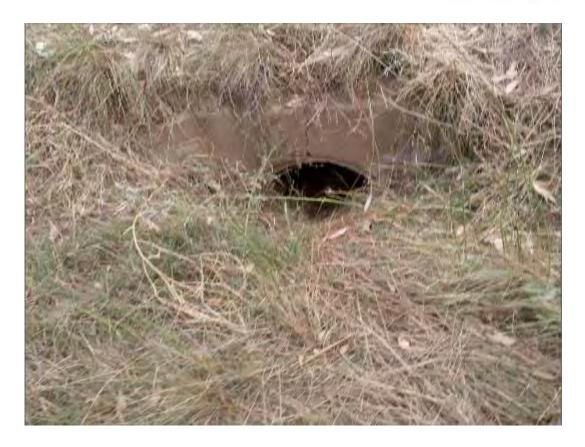
S239 - 525mm Pipe Culvert

525mm Pipe Culvert Fair Condition and Serviceable

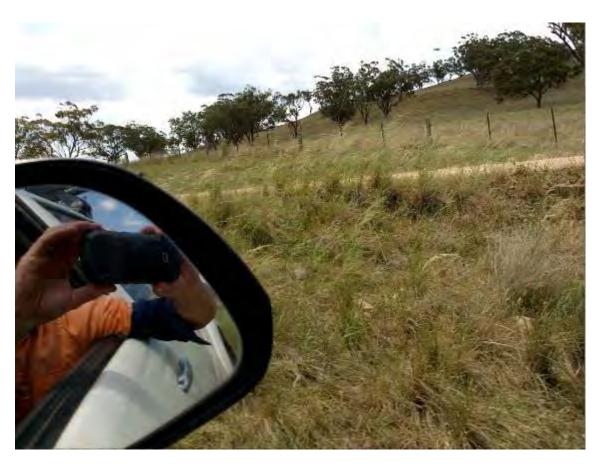
Pipe Culvert of Unknown Dimensions Moderate Condition and Serviceable

S240 – Pipe Culvert Top Right of Image Level 2, 39 Sherwood Road <u>mai</u> Toowong QLD 4066 www

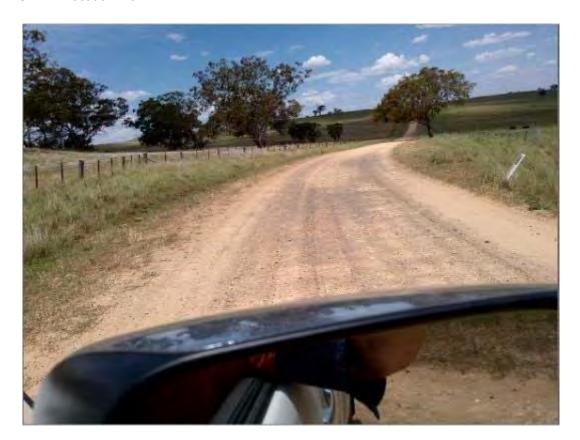
S241 - View to South

Pipe Culvert of Unknown Dimensions Moderate Condition and Serviceable

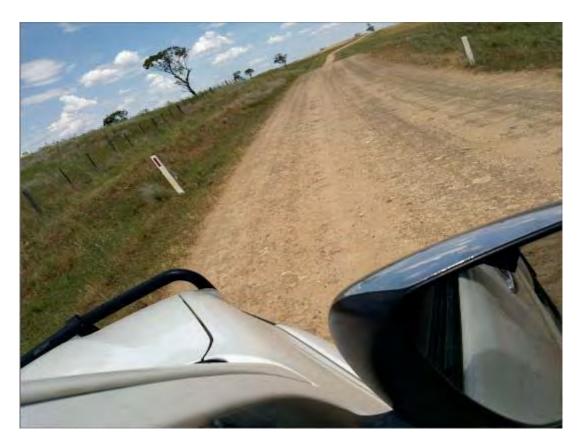
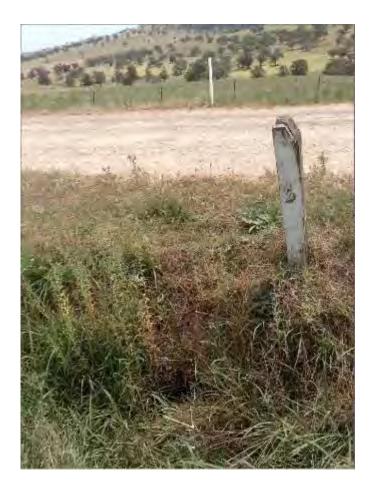
Pipe Culvert of Unknown Dimensions, Culvert is overgrown Moderate Condition and Serviceable, may require some maintenance

S242 – Overgrown Culvert

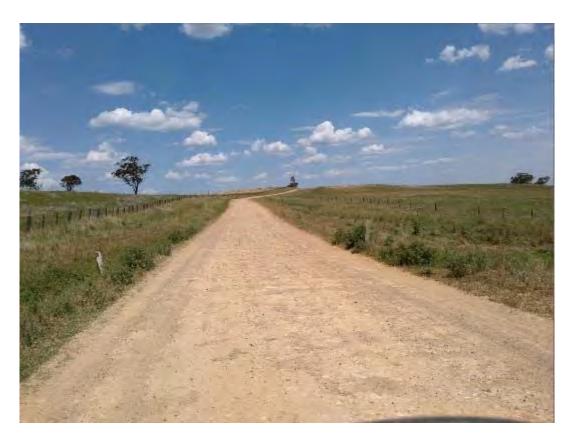
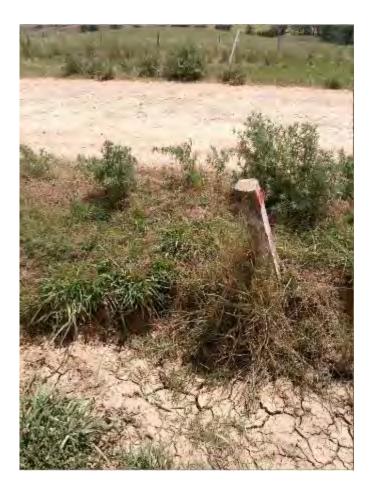
S243 – Rotherwood Rd - 2600m North of Coolah Rd Intersection Blocked Pipe Culvert, Moderate Condition

S243 - Blocked Pipe Culvert

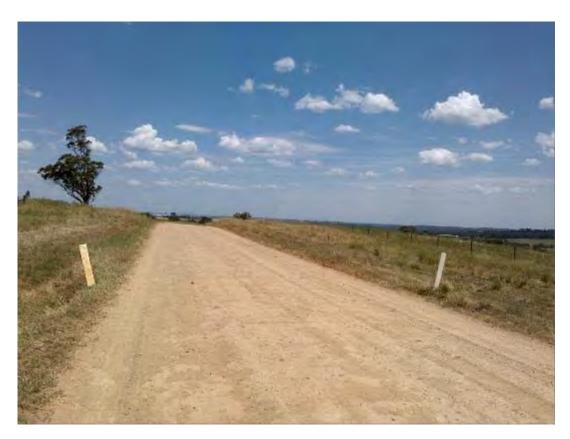
S244 – View to South

S244 – Rotherwood Rd - 2100m North of Coolah Rd Intersection 450mm Pipe Culvert, Unknown Condition

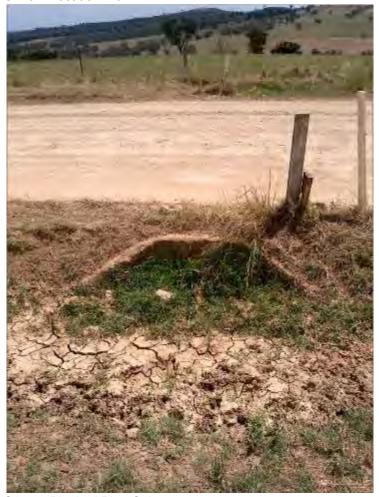
Blocked Pipe Culvert of unknown Dimensions Poor Condition, may require Maintenance or Upgrade

S245 - Blocked Pipe Culvert

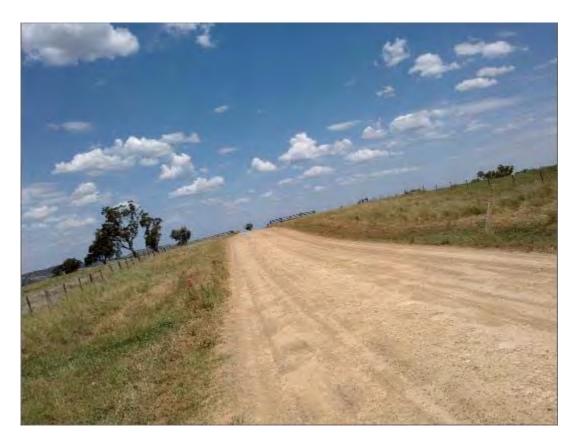
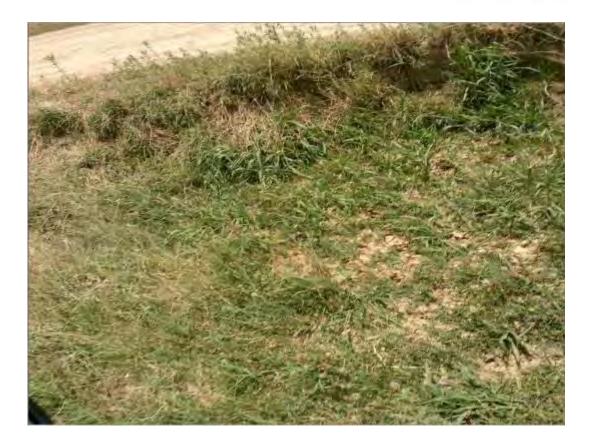
Blocked Pipe Culvert

Poor Condition and Serviceable, requires maintenance

S246 - Blocked Pipe Culvert

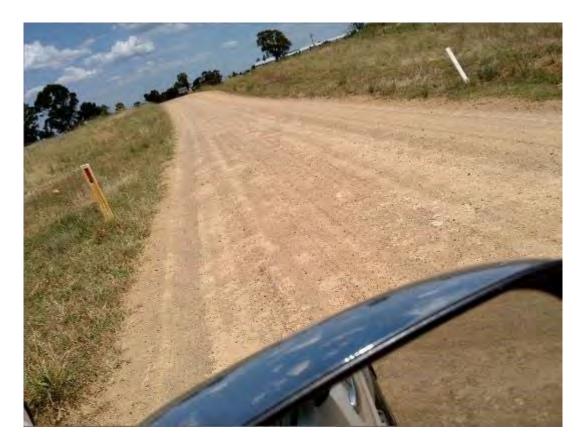
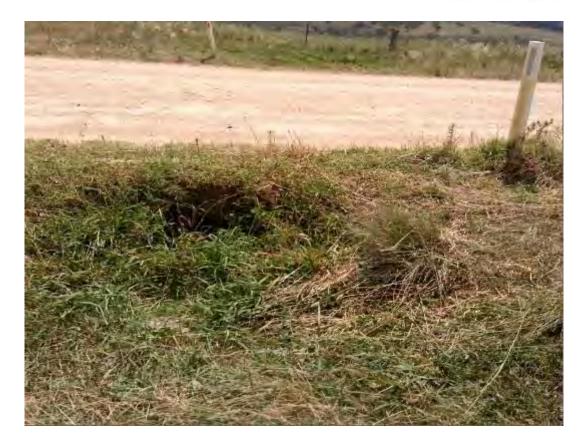
S247 – 450mm Pipe Culvert

450mm Pipe Culvert

Moderate condition and serviceable, requires maintenance.

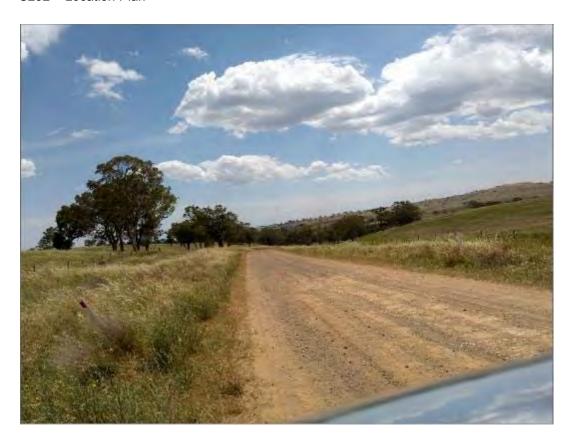
S252 - View to East

S252 – Coolah Rd - 700m East of Rotherwood Rd Intersection 600mm Pipe Culvert Condition Unknown

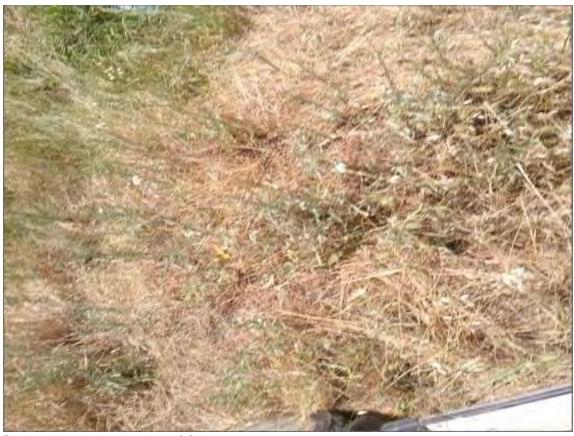
S253 - View in the direction of Culvert

S253 – Coolah Rd - 1000m East of Rotherwood Rd Intersection 750mm Pipe Culvert Condition Unknown

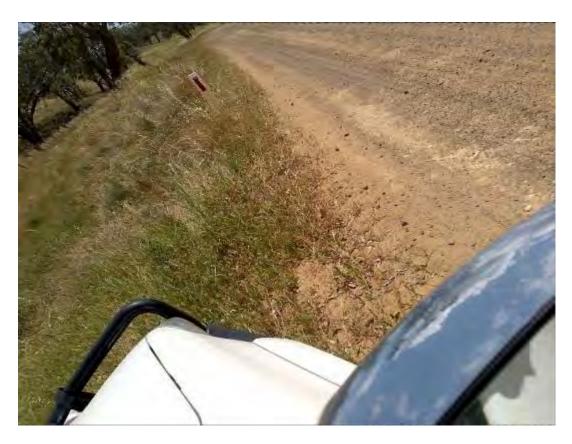
S254 - View to East

S254 – Coolah Rd - 1100m East of Rotherwood Rd Intersection 675mm Pipe Culvert Fair Condition and Serviceable

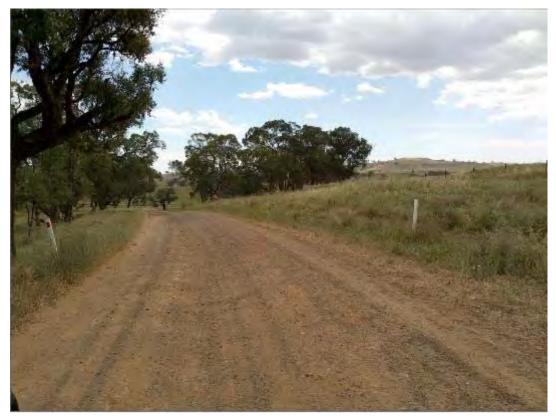
S254 - View to east

S254 - Coolah Rd - 1400m East of Rotherwood Rd Intersection

Pipe Culvert of Unknown Dimensions Unknown Conditions

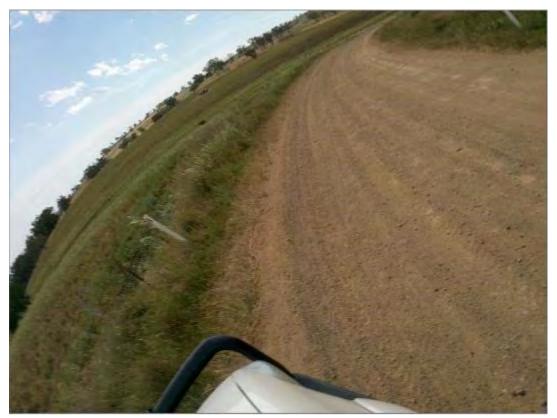
S255 - View to west

S255 - Coolah Rd - 1600m East of Rotherwood Rd Intersection

Pipe Culvert of Unknown Dimensions Unknown Condition

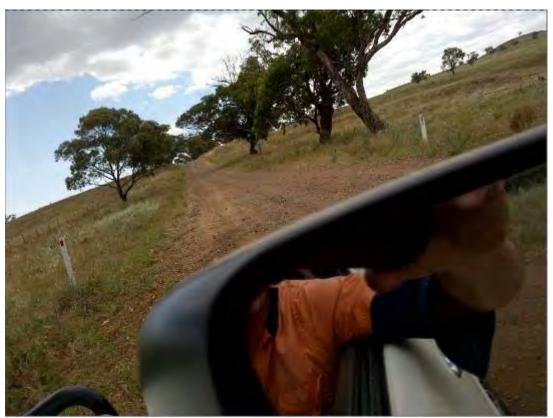
S256 - View to west

S256 - Coolah Rd - 2300m East of Rotherwood Rd Intersection

Pipe Culvert of Unknown Dimensions Unknown Condition

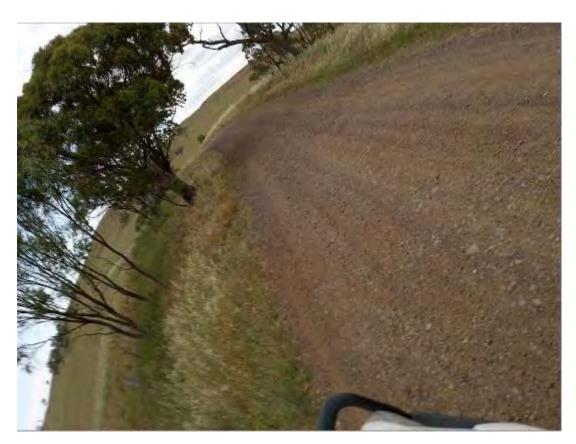
S257 - Coolah Rd - 3100m East of Rotherwood Rd Intersection

A Pipe Culvert is required for this Location, Location has a runoff path through it.

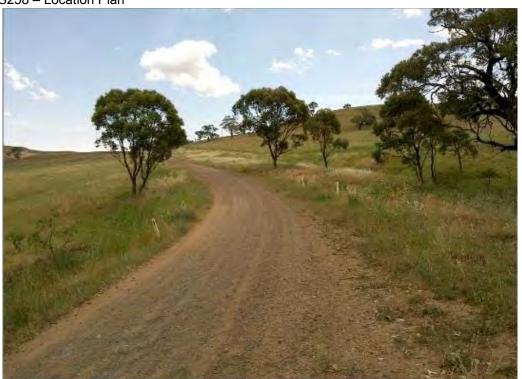
S258 - View to West towards location

S258 - Coolah Rd - 3300m East of Rotherwood Rd Intersection

Pipe Culvert of Unknown Dimensions Horizontal Geometry and Trees to be surveyed to verify against proposed transport configurations
