## Conservation Management Plan for Terrace Houses at Nos. 95-96 and 98-103 Darlington Road, Darlington

Prepared By:  
Janice Hogg  
Stela Rahman  
Mia Langejans  
Daniel O'Keefe  
Fatin Atiqah Abu Othman

June 2008

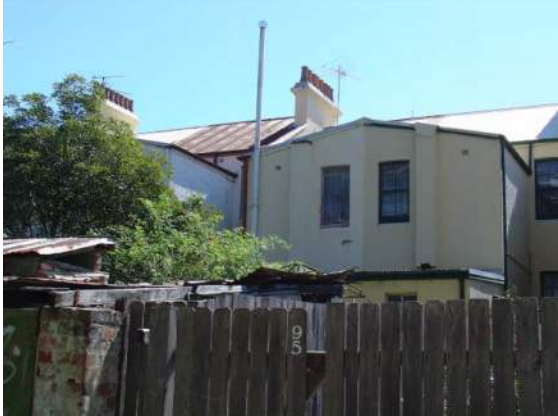
Original Fabric Element	Image
<p>Any outbuildings that may have existed have for the most part been demolished. The only remaining outbuilding still in existence is located at No. 98 and visible from the rear lane and No.99 boundary. It once served as a toilet for its residents.</p>

<p><b>Figure 4.8.</b> Rear view of terraces showing outbuilding in bottom left corner of photo behind terrace No. 98 Darlington Road. (Source: Janice Hogg, April 2008.)</p>

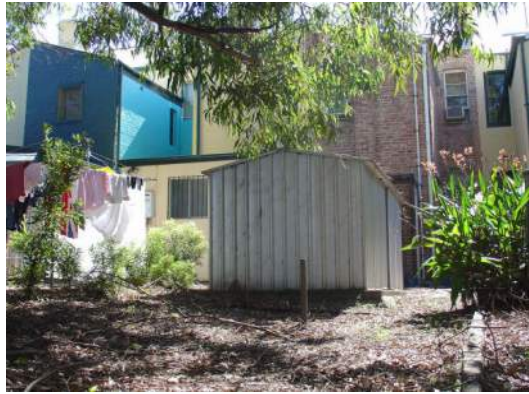
<p><b>Figure 4.11.</b> Small shed behind terrace No. 102 Darlington Road. (Source: Janice Hogg, April 2008.)</p>

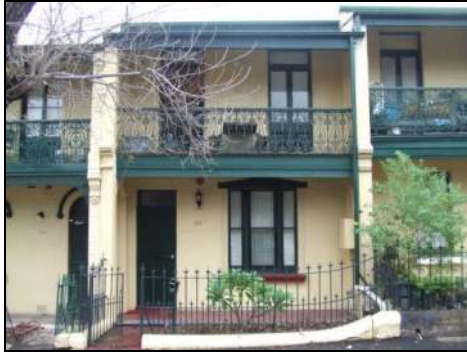
Figure APP.3.0 – No. 95 Front facade

ELEMENTS	FABRIC AND FINISHES	ALTERATIONS & ADAPTATIONS	CONDITION/ COMMENTS	AGE/ASSESSMENT OF ORIGINALITY	FABRIC SIGNIFICANCE	ESSENTIAL MAINTENANCE
Generally	Good condition. Figure APP.3.0					
Roof Cladding	Corrugated steel roofing	New roofing	Very good	New material*	Moderate	To be repainted periodically every 10 years
Walls

• Front	Brickwork. See Figure APP 3.0	Repainted	Fair. Cracks between adjoining wall between terraces	Original**	High	Repair cracking  To be repainted periodically every 10 years

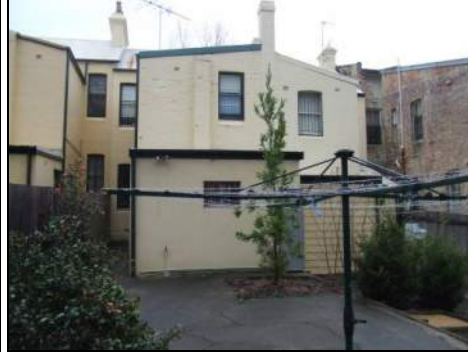
Figure APP.3.1 – No. 95 Rear elevation

• Rear	Brickwork. See Figure APP 3.1	Repainted	Fair. Surface damage on several bricks	Original**	High	Remove the damage brick and install something similar to original
Doors and architraves

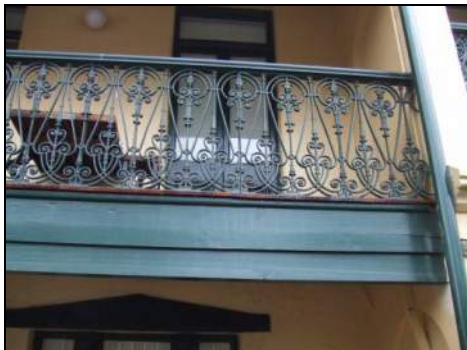
Figure APP.3.4 – Front balcony

• Lace on balcony	Cast iron lace. See Figure APP.3.4	Repainted	Good	Original**	High	No change
Front porch	Concrete slate. See Figure APP.3.5	Original tiles have been removed	Poor. Evident cracks in concrete and no finishing tiles	New material*	Little	Reinstate original or close to original

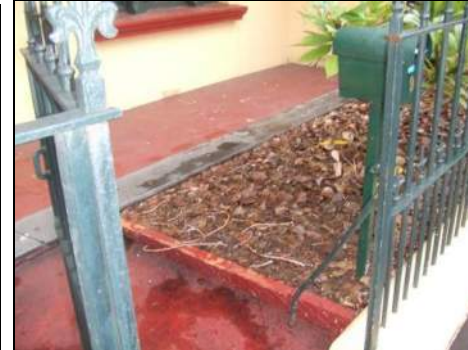
Figure APP.3.5 – No. 95 Front fence and veranda

Front garden						
• Edging tiles	Concrete block. See Figure APP.3.5	Newly installed	Poor. Visible cracks	New material*	Little	Remove and install original or something close to original edging tiles

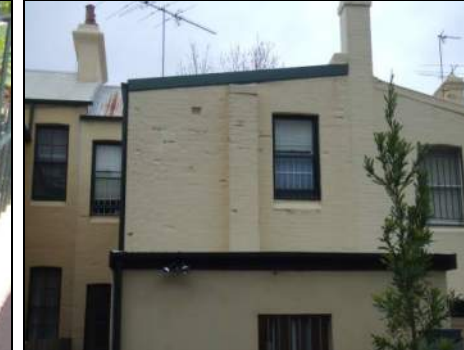
Figure APP.3.6 – No. 95 Rear window and chimney

Gutters and down pipes	Painted recessive colours	New guttering and down pipes	Good	New material*	Little	To be repainted periodically every 10 years
Fixtures	Extension (timber structure: laundry room). See Figure APP.3.6	New addition	Good	New material*	Little	To be removed
Chimney	Rear chimney. See Figure APP.3.6	Part removed below second level and above roofline.	Poor condition	Original**	High	Allow no further changes to rear chimney
Hard landscaping	Concrete area adjacent to rear laundry. See Figure APP.3.7	New addition. Detracts from the building, visible cracks.	Poor	New material*	Little	Repaired and painted to match front verandah or to be removed and replaced with original fabric or similar

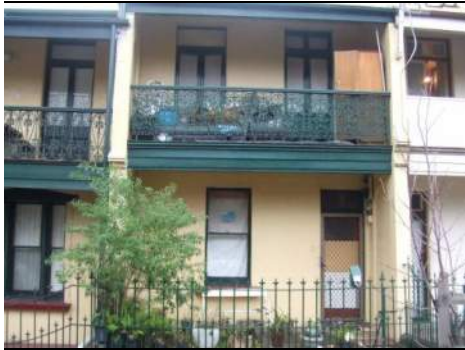
Figure APP 3.8 – No. 96 Front façade

ELEMENTS	FABRIC AND FINISHES	ALTERATIONS & ADAPTATIONS	CONDITION/ COMMENTS	AGE/ASSESSMENT OF ORIGINALITY	FABRIC SIGNIFICANCE	ESSENTIAL MAINTENANCE
Generally	See Figure APP 3.8					
Roof Cladding	Corrugated steel roofing	New roofing	Good	New material*	Moderate	To be repainted periodically every 10 years
Walls	Brickwork. See Figure APP 3.8	Painted	Good	Original**	High	To be repainted periodically every 10 years
Doors and architraves	Timber panel. See Figure APP 3.9	Painted	Good	New material*	High	To be repainted periodically every 10 years
Windows	Timber framed. See Figure APP 3.9	Painted	Good	Original**	High	To be repainted periodically every 10 years
Gutters and downpipes	Painted recessive colours	Painted	Good	New material*	Little	To be repainted periodically every 10 years
Fixtures

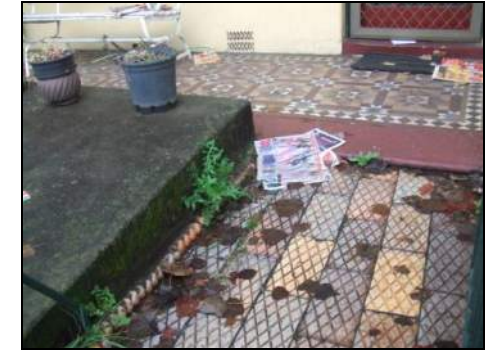
Figure APP 3.11 – No. 96 Front edging tiles

• Floorboard	Timber		Good	Original**	Moderate	No changes
Front porch	Encaustic tessellated tiles. See Figure APP 3.11	Intact	Good. Few cracked tiles.	Original**	High	Replace cracked tiles to match existing tiles
Front garden

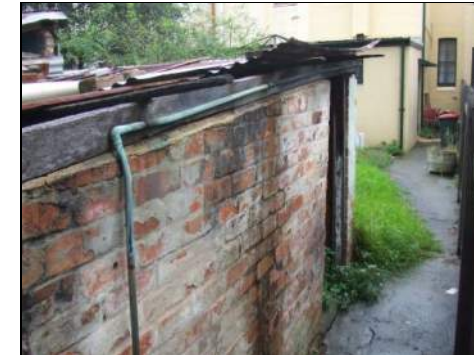
Figure APP 3.14 – No. 96 Rear brick outbuilding

Others	Brickwork of storage extension. See Figure APP 3.14	New addition	Poor. Very decayed, poses health and safety concerns	New material*	Little	To be removed

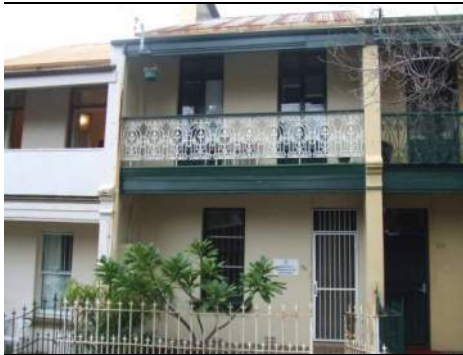
Figure APP 3.15 - No. 98 Front façade

FABRIC AND FINISHES	ALTERATIONS & ADAPTATIONS	CONDITION/ COMMENTS	AGE/ASSESSMENT OF ORIGINALITY	FABRIC SIGNIFICANCE	ESSENTIAL MAINTENANCE
Generally	See Figure APP 3.15					
Roof Cladding	Corrugated steel roofing. Figure APP 3.15	Poor addition	Poor. Heavily rusted. Detracts from character of building	New material*	Moderate	To be replaced with new roof. To be repainted periodically every 10 years
Wall	Brickwork . See Figure APP 3.15	Painted	Good	Original**	High	To be repainted periodically every 10 years
Doors and architraves • Front	Timber panel. See Figure APP 3.16	Painted	Good. Newly installed white security bars	New material*	Moderate	To be replaced with doors similar to original Victorian design. To be repainted periodically every 10 years
Windows • Front	Timber framed. Figure APP 3.16	Painted	Good	Original**	High	To be repainted periodically every 10 years
Gutters and down pipes	Painted recessive green colour	Painted	Good	New material*	Little	To be repainted periodically every 10 years

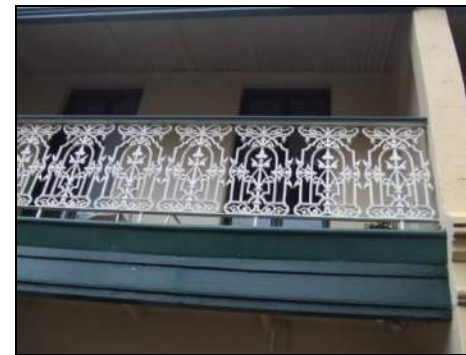
Figure APP 3.17 - No.98 Front balcony and lace

Fixtures • Lace on balcony  • floorboard	Timber railing. See Figure APP 3.17  Timber	Newly installed  No changes	Fair  Good	New material*  New material *	High  Moderate	Replace with something similar to original cast iron lace  No changes
Front porch	Encaustic tessellated tiles. See Figure APP 3.18	Intact	Poor. Large section of tile mosaic on the porch is filled with concrete	Original**	High	Replace or repair damaged tiles to match existing tiles

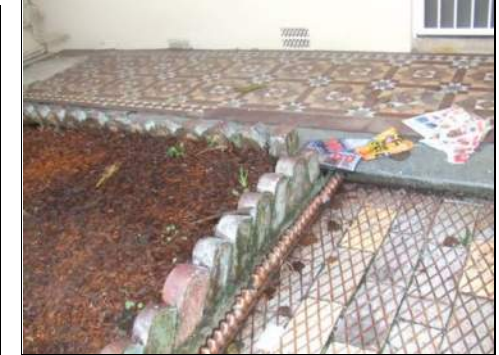
Figure APP 3.18 - No. 98 Front edging tiles

Front garden						
• Edging tiles	Ceramic bricks. See Figure APP 3.18	No changes	Good condition	Original**	High	No changes
• Garden bed	Soft landscaping	Raised	Fair	Original**	High	To be lowered to base of original tiles

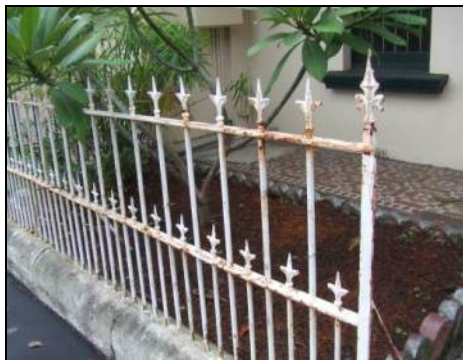
Figure APP 3.19 - No. 98 Front fence

• Fence	Wrought iron fence with cast iron finials See Figure APP 3.19	Painted	Poor – different colour, rusting heavily and painted white.	Original**	High	Recommend to paint recessive colour to match neighbouring terrace buildings. To be repainted periodically every 10 years
<b>REAR</b>						
Roof cladding	Corrugated steel roofing	New installation	Poor. Heavily rusted	New material*	Moderate	To be repainted periodically every 10 years
Walls	Painted yellow Figure APP 3.20	Painted bricks, not rendered	Good	Original**	High	To be repainted periodically every 10 years
Doors and architraves	Timber flush door	New doors	Good	New material*	High	To be repainted periodically every 10 years
Windows	Metal framed door	With bars, painted white	Fair	New material*	High	To be repainted periodically every 10 years
Gutters and down pipes	Painted white	New guttering and down pipes	Good	New material*	Little	To be repainted periodically every 10 years

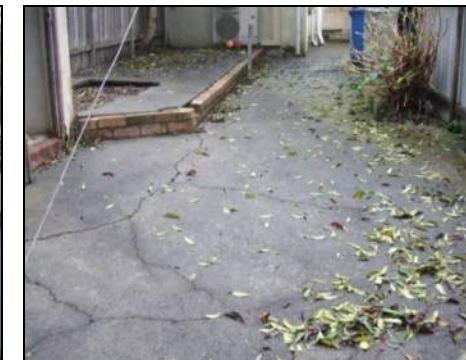
Figure APP 3.21 - No. 98 Rear hard landscaping

Chimney	Rear chimney	Partly removed	Fair	Original**	High	Allow no further changes to rear chimney
Hard landscaping	Cracked concrete Figure APP 3.21	No visible soft landscaping	Poor. Visible cracks	New material*	Little	Reinstate soft landscaping to part of the rear outdoor area and reinstate original hard landscaping if possible.
Others	Rear outbuilding (toilet) Figure APP 3.22	Brick building with corrugated iron roofing	Good	Original**	High	To be repaired and maintained

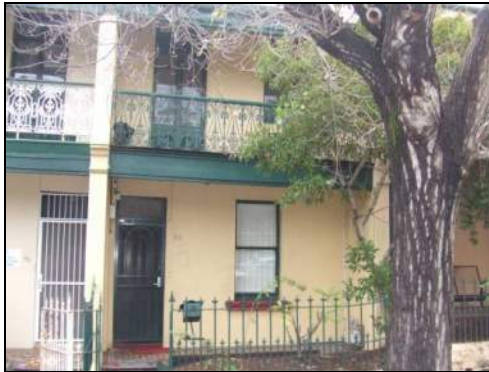
Figure APP 3.23 - No. 99 Front façade

ELEMENT	FABRIC AND FINISHES	ALTERATIONS & ADAPTATIONS	CONDITION/ COMMENTS	AGE/ASSESSMENT OF ORIGINALITY	FABRIC SIGNIFICANCE	ESSENTIAL MAINTENANCE
Generally	See Figure APP 3.23					
Roof Cladding	Corrugated steel roofing intact. See Figure APP 3.23	New roofing	Good	Original**	Moderate	To be repainted periodically every 10 years
Walls	Brickwork. See Figure APP 3.24	Repainted	Good	Original**	High	To be repainted periodically every 10 years
Doors and architraves	Timber panel. See Figure APP 3.24	New installation with bars and repainted	Good	New material*	High	To be repainted periodically every 10 years
Windows	Timber frame window. See Figure APP 3.24	Repainted	Fair – window sill is painted red, while window frame is painted green	Original**	High	The sill and the frame to be painted with same colour. To be repainted periodically every 10 years
Fixtures • Lace on balcony	Cast iron lace. See Figure APP 3.23	Repainted	Good	Original**	High	No changes

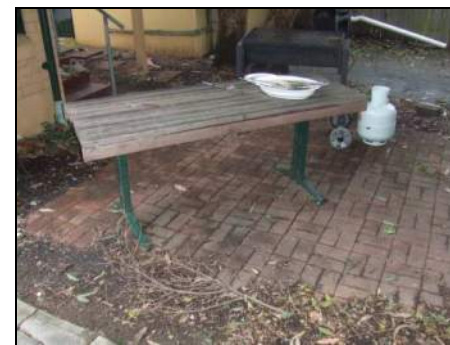
Figure APP 3.35 No. 100 Rear hard landscaping

Chimney	Rear chimney	Part removed below second level and above roofline.	Poor condition	Original**	High	Allow no further changes to rear chimney
Landscaping	Small paved area. See Figure APP 3.35	Intact	Good condition	Possibly original*	High	Allow no further changes to rear hard landscaping

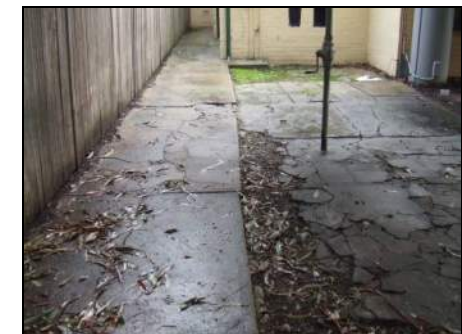
Figure APP 3.43 - No. 101 Hard landscaping

Fixtures	Clothesline	New addition	Good	New material*	Little	No changes
Chimney	Rear chimney	Intact	Good	New material*	High	Allow no further changes to rear chimney
Hard landscaping	Concrete area adjacent to rear laundry. See Figure APP 3.43	New addition	Good	New material*	Little	Reinstate soft landscaping, repair cracks in concrete or reinstate original brickwork.

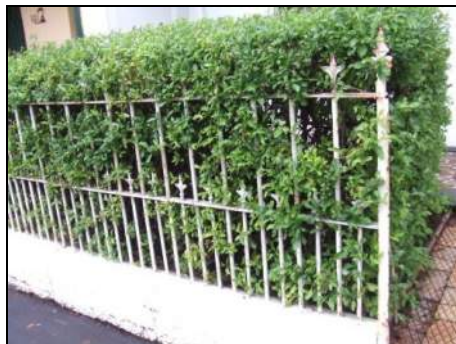
Figure APP 3.48 – No. 102 Front fence and hedge

• Garden bed						
• Fence	Wrought iron fence with cast iron finials . See Figure APP 3.48	Painted	Poor. Rusting heavily and painted white	Original**		Re-paint using recessive colour (green) to match surrounding terrace buildings. To be repainted periodically every 10 years
Other	Front sandstone plinth See Figures APP 3.48	Intact	Cracks in plinth due to foundation shift	Original**	Moderate	Repair cracks

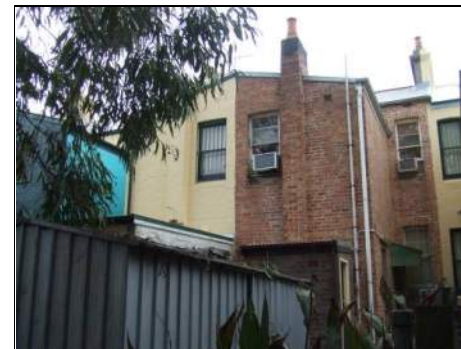
Figure APP 3.49 – No. 102 Rear Elevation and chimney

• Plinth						
<b>REAR</b>						
Roof cladding	Corrugated iron roofing	Partially intact	Poor. Heavily rusted	New material*	Moderate	To be removed and re-cladded
Walls	Red brickwork. See Figure APP 3.49	Unpainted	Poor. Inconsistent with surrounding terraces	Original**	High	Render and paint to match front façade. To be repainted periodically every 10 years
Door architraves	Rear door	Painted	Poor. Inconsistent	New material*	High	
Windows	3 visible windows. See Figures APP 3.49	Air-conditioning units installed in windows on the upper level	Poor	New material**	High	Air conditioning units to be removed from windows and installed in less visually intrusive location of terrace building
Gutters and down pipes	White guttering and down pipes. See Figure APP 3.49	Intact	Poor	New material*	Little	Paint recessive colour
Fixtures	Air – conditioner. See Figure APP 3.49	New addition	Visible on upper level	New material*	Little	Air conditioning unit to be removed and installed in less visually intrusive location of terrace building

Chimney	Intact chimney at rear of building. Shared chimney with No.101 on top of roof. See Figure APP 3.49	Intact	Good condition	Original**	High	No changes

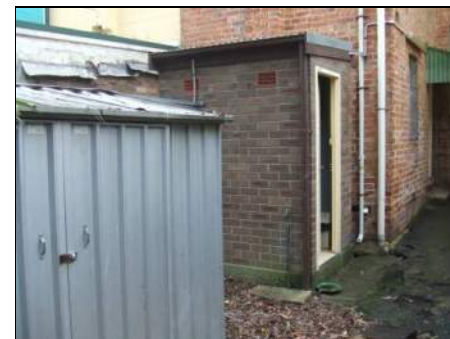
Figure APP 3.50 – No. 102 Outbuildings

Hard landscaping	Tarred bitumen adjacent to rear door and outbuilding 1	New addition	Good	New material*	Little	Repair where possible or replace with brick
• Outbuilding 1	Toilet . See Figures APP 3.50	Intact	Good	Original**	High	Repair and maintain
• Outbuilding 2	Aluminium garden shed. See Figures APP 3.50	New addition	Good . Obscures view to outbuilding 1	New material*	Little	Remove visually intrusive garden shed
Other	Rear fence. See Figures APP 3.51	New addition	Good	New material*	Moderate	No changes

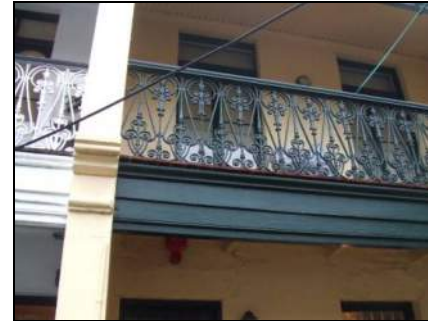
Figure APP 3.54 – No. 103 Front balcony and lace

Fixtures <ul style="list-style-type: none"> <li>• Lace on balcony</li> <li>• floorboard</li> </ul>	Cast iron See Figure APP 3.54	Painted	Good	Original**	High	No changes
	Timber See Figure APP 3.54	Intact	Good	New material*	Moderate	No changes
Front porch	Concrete paved area. Salt glazed stoneware paving (Original). See Figure APP 3.55	Intact	Poor. Visible cracks, with front porch painted red.	New material*	High	Repair or reinstate original mosaic tiles.
Front garden <ul style="list-style-type: none"> <li>• Edging tiles</li> <li>• Garden bed</li> <li>• Fence</li> </ul>	Ceramic. See Figure APP 3.55. See Figure APP 3.56	Raised	Good	Original**	High	To be lowered to base of original tiles Recommend to paint green and be same colour as the other fences
			Fair	Original**	High	
	Wrought iron fence with cast iron finials. Figure APP 3.51	Painted recessive colour		Original**	High

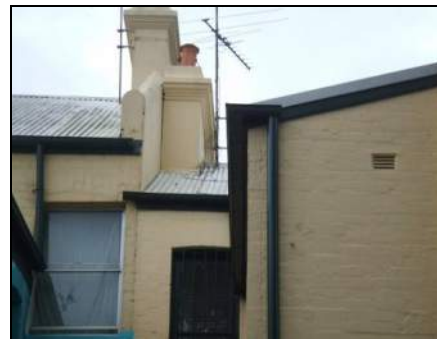
Figure APP 3.58 – No. 103 Chimney

Fixtures	Clothesline	New addition	Good	New material*	Little	No changes
Chimney	Large chimney on top of roof. See Figure APP 3.58	Intact	Good	Original**	High	No changes
Hard landscaping	Concrete area covering back area, small area for soft landscaping. See Figure APP 3.59	New addition	Good	New material*	Little	Repair cracks or replace with original brickwork.

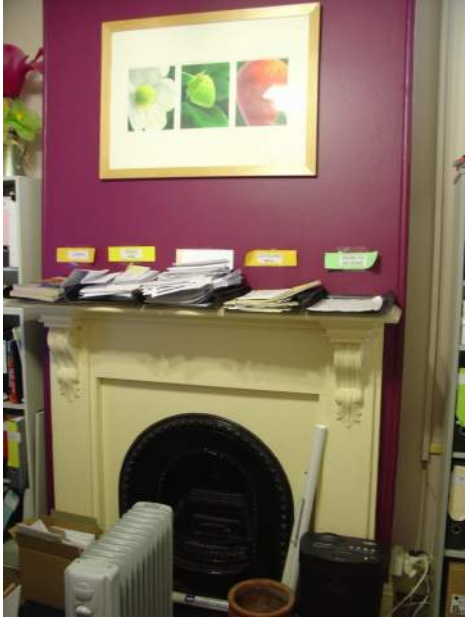
<p><b>Figure APP.4.2.</b> A non-working fireplace that gives the illusion of a working fireplace in terrace No. 102 Darlington Road. (Source: Janice Hogg, April 2008).</p>
<p>The banisters and bolster are in good condition; however some banisters are missing rungs as the staircase ascends. It appears that replacement rungs have not been attempted where missing material is evident, thus the banisters are comprised only of original fabric.</p>

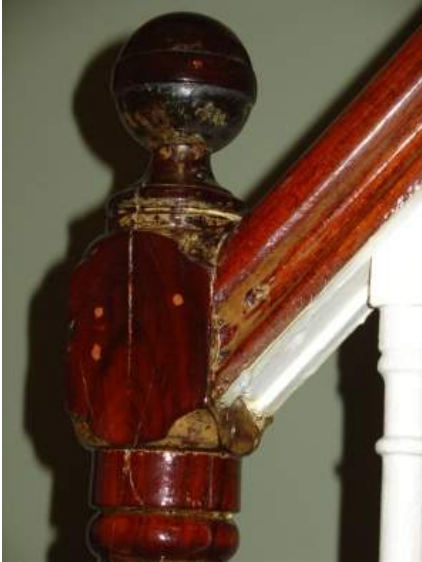
<p><b>Figure APP.4.4.</b> Detail of bevel post, hand rail and baluster of a typical stair in No. 102 Darlington Road. (Source: Janice Hogg, April 2008).</p>
<p>The double staircases have been retained in all of the buildings, as have the archways on the smaller staircase, both above the stair case and in the detailing on the wall. Some of the terraces have covered the exposed brick in the interior, whilst others have repainted it. The panelling in many of the terraces appears to be original. The floors are generally covered in carpeting which looks rather new judging by the wear and tear that it has accumulated. The viewed terraces have retained the skylight that above the staircase for added light.</p>

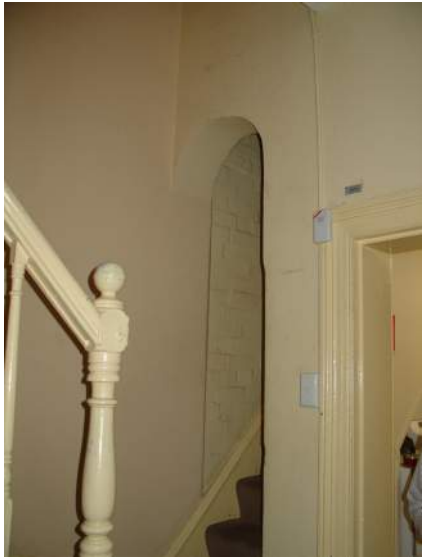
<p><b>Figure APP.4.5.</b> Double staircase, banister, archway carpeting, and joinery in terrace No. 101 Darlington Road. (Source: Janice Hogg, April 2008).</p>

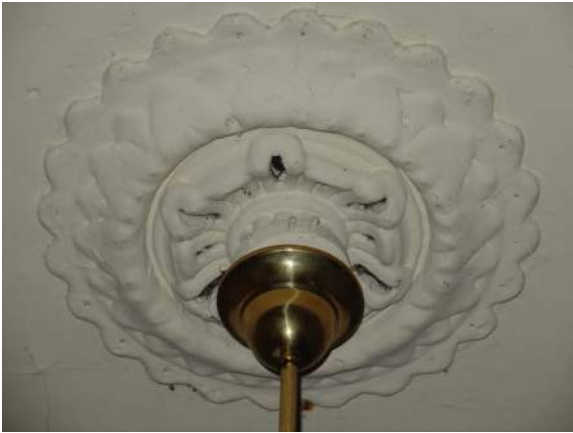
<p><b>Figure APP.4.7.</b> A ceiling rosette in terrace No. 101 Darlington Road. (Source: Janice Hogg. April, 2008).</p>
