**THE UNIVERSITY OF SYDNEY
DARLINGTON ROAD TERRACES
(14051)**

**9610
TERRACES EXTERNAL CONDITION
PROPOSED CONSERVATION SCHEDULE**

A visual façade inspection of the Darlington Road Terraces was conducted on 29/07/16 by AJ+C. There are 38 terraces in total, photographs of each terraces north façade and close ups to highlight their existing conditions and areas where repair work will be required.

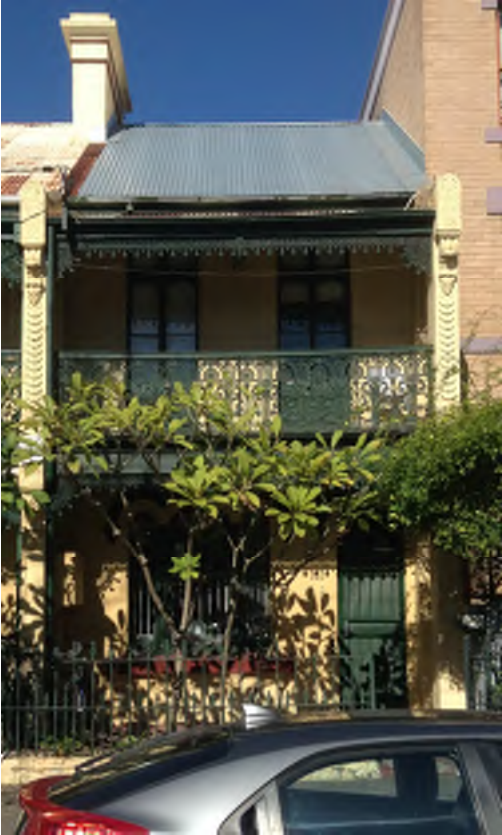
TERRACE NO.	ELEMENTS	CONDITIONS	COMMENTS	PHOTOS
131	1. Front fence + base and gate	B	Some finials on the fence are missing. Allow for replace to match.

2. Entry path	A		
	3. Garden	A		
	4. Porch	B		
	5. Doors and Windows	A		
	6. External walls	A		
	7. Verandah	A	Allow for removal of verandah gutter.	
	8. Balustrade	A		
	9. Gutters and downpipes	B		
	10. Roof sheeting	A

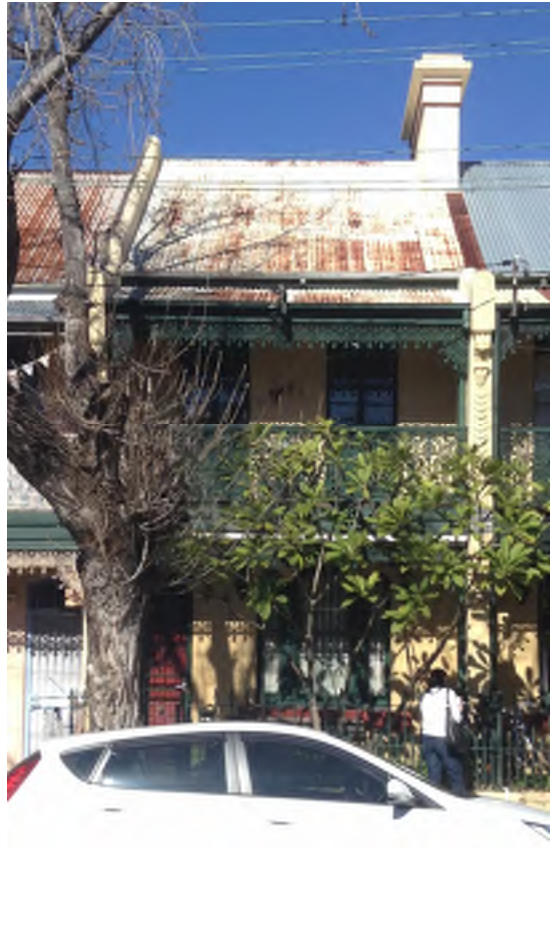
TERRACE NO.	ELEMENT	CONDITIONS	COMMENTS	PHOTOS
130	1. Front fence + base and gate	A	Some finials on the fence are missing. Allow for replace to match.

2. Entry path	A		
	3. Garden	A		
	4. Porch	B		
	5. Doors and Windows	A		
	6. External walls	A		
	7. Verandah	A		
	8. Balustrade	A		
	9. Gutters and downpipes	B		
	10. Roof sheeting	B

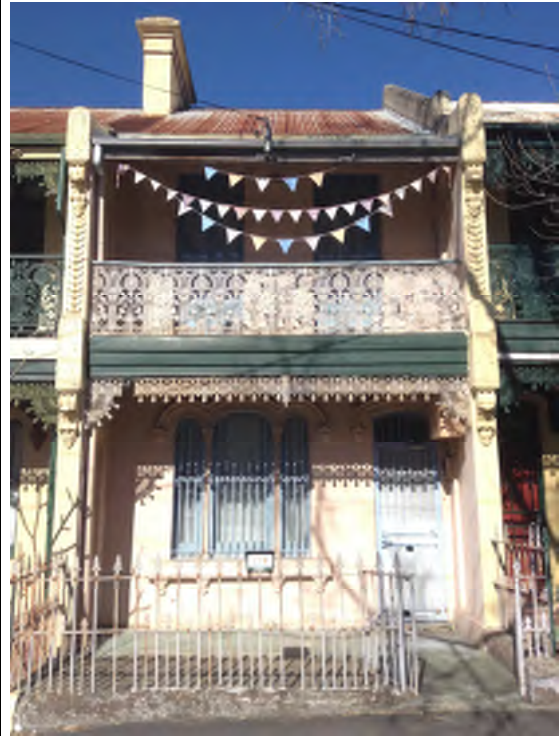
TERRACE NO.	ELEMENT	CONDITIONS	COMMENTS	PHOTOS
129	1. Front fence + base and gate	B	Some mid vertical post with finials on the fence are missing. Gate missing latch. Allow for replace to match.

2. Entry path	A		
	3. Garden	B		
	4. Porch	A		
	5. Doors and Windows	A		
	6. External walls	A		
	7. Verandah	A		
	8. Balustrade	A		
	9. Gutters and downpipes	B		
	10. Roof sheeting	B

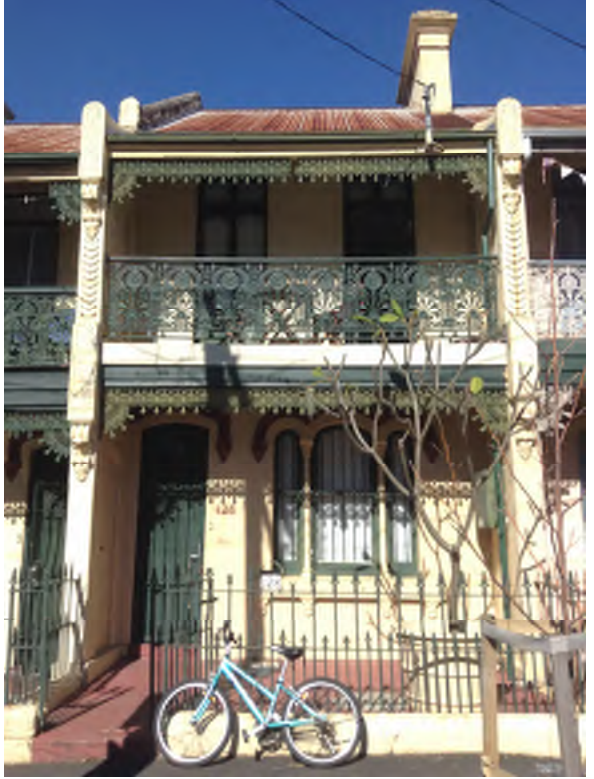
TERRACE NO.	ELEMENT	CONDITIONS	COMMENTS	PHOTOS
128	1. Front fence + base and gate	B	Some finials on the fence are missing. Allow for replace to match.

2. Entry path	A		
	3. Garden	B	Landscape architect to advise if existing tree in pot to be retained and replanted in new garden bed?	
	4. Porch	A		
	5. Doors and Windows	A		
	6. External walls	A		
	7. Verandah	A		
	8. Balustrade	A	Some lace work missing, allow for replace to match.	
	9. Gutters and downpipes	B		
	10. Roof sheeting	B

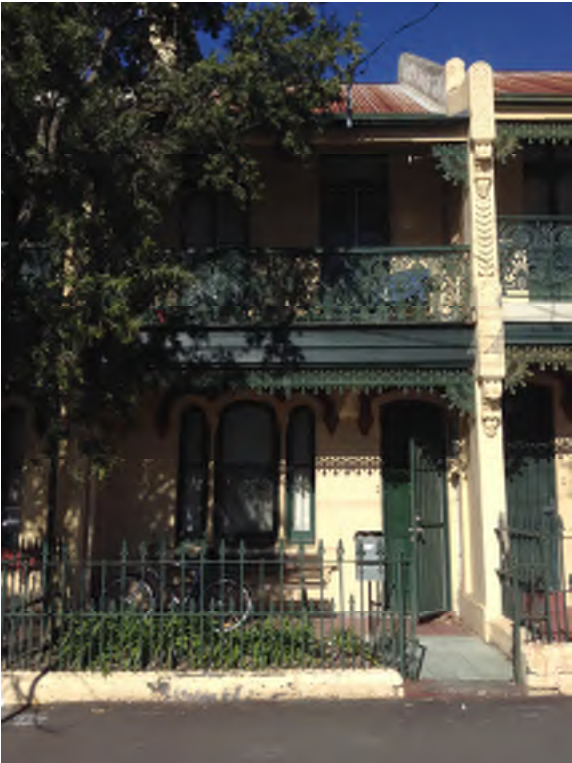
TERRACE NO.	ELEMENT	CONDITIONS	COMMENTS	PHOTOS
127	1. Front fence + base and gate	A	Some finials on the fence are missing. Allow for replace to match.

2. Entry path	A		
	3. Garden	A		
	4. Porch	A		
	5. Doors and Windows	A		
	6. External walls	B	Allow for repair of crack in party wall between No.126. (see photo below)- refer to engineer's detail.	
	7. Verandah	A		
	8. Balustrade	A	Upper level lace work missing, allow for new to match.	
	9. Gutters and downpipes	B		
	10. Roof sheeting	B

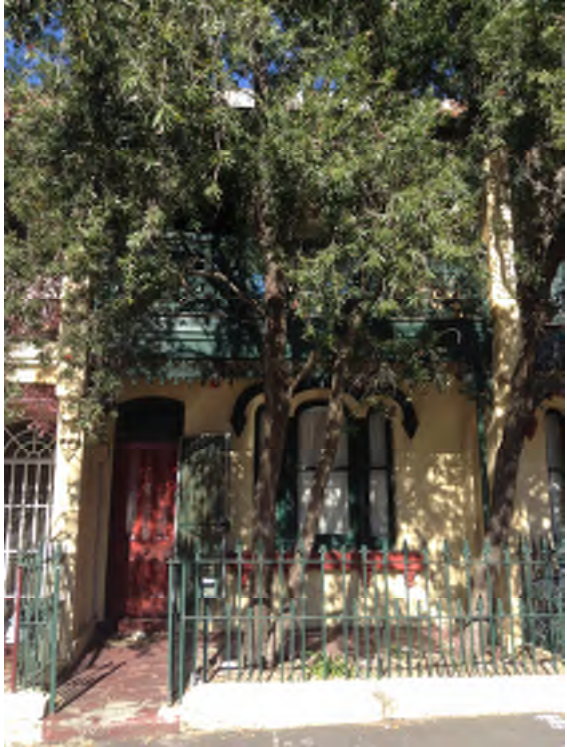
TERRACE NO.	ELEMENT	CONDITIONS	COMMENTS	PHOTOS
126	1. Front fence + base and gate	B	Some finials on the fence and mid vertical post are missing. Allow for replace to match.

2. Entry path	A		
	3. Garden	A	Allow for removal of 2 trees.	
	4. Porch	A		
	5. Doors and Windows	A		
	6. External walls	B	Allow for repair of crack in party wall between No.127. (see photo below)- refer to engineer's detail.	
	7. Verandah	A		
	8. Balustrade	A	Ground level lace work missing, allow for replace to match.	
	9. Gutters and downpipes	B	All for new fascia board.	
	10. Roof sheeting	B

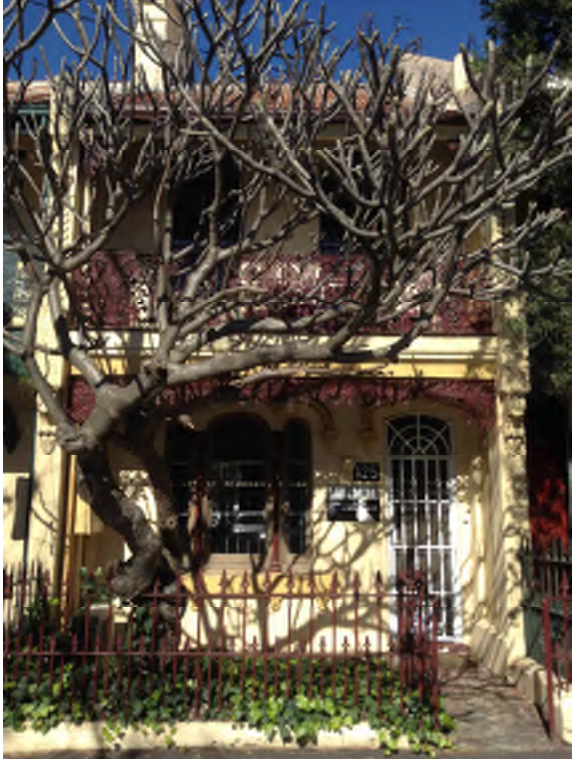
TERRACE NO.	ELEMENT	CONDITIONS	COMMENTS	PHOTOS
125 *	1. Front fence + base and gate	B	Remove portion of existing fence and all associated components to allow for 850mm clear opening. Remove party fence between No. 124. Refer to drawing for detail.

2. Entry path	B	Remove existing path, to allow for new accessible path. Refer to drawing for detail.	
	3. Garden	B	Remove existing tree to allow for new accessible ramp path. Refer to drawing for detail.

4. Porch	B	Remove portion of porch to allow for wheel chair turning circle at gate. Refer to drawing for detail.	
	5. Doors and Windows	A	Allow for removal of wrought iron security door and replace for new wrought iron security door to match Terrace no. 124.

6. External walls	A	Remove A/C unit and handover to University for storage.	
	7. Verandah	A		
	8. Balustrade	A	Upper level lace work missing, allow for replace to match.

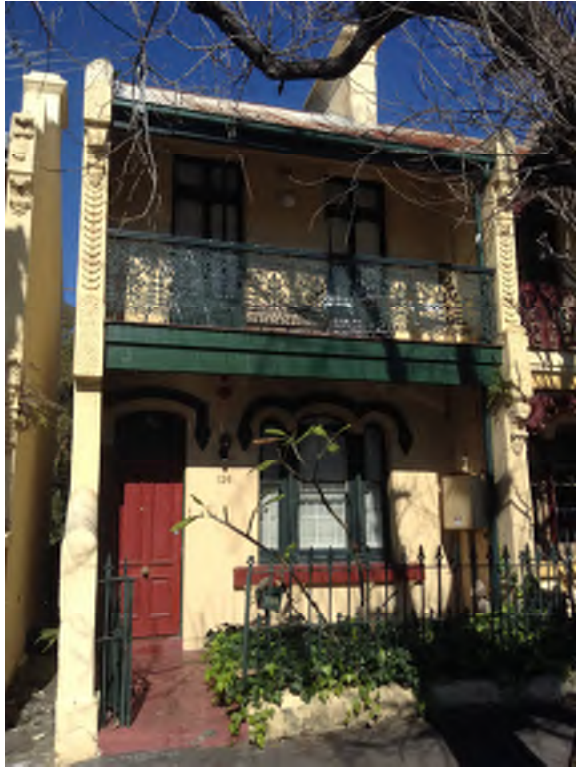
TERRACE NO.	ELEMENT	CONDITIONS	COMMENTS	PHOTOS
124 *	1. Front fence + base and gate	B	Block gate, allow for new accessible ramp path to continue through from Terrace No.125. Refer to drawing for detail.

2. Entry path	B	Remove existing path, allow for new accessible path to entry door. Refer to drawing for detail.	
	3. Garden	B	Allow for new accessible ramp path to continue through from Terrace No.125. Refer to drawing for detail.

4. Porch	B	Remove porch to allow for wheel chair turning circle at ramp landing to entry door. Refer to drawing for detail.	
	5. Doors and Windows	B	Remove front door + screen door and portion of existing wall to install new door and frame for wheel chair access. Refer to drawing for detail.

6. External walls	B	Remove portion of existing door, make good surround walls. Allow for repaint walls. Refer to drawing for detail.	
	7. Verandah	A		
	8. Balustrade	A

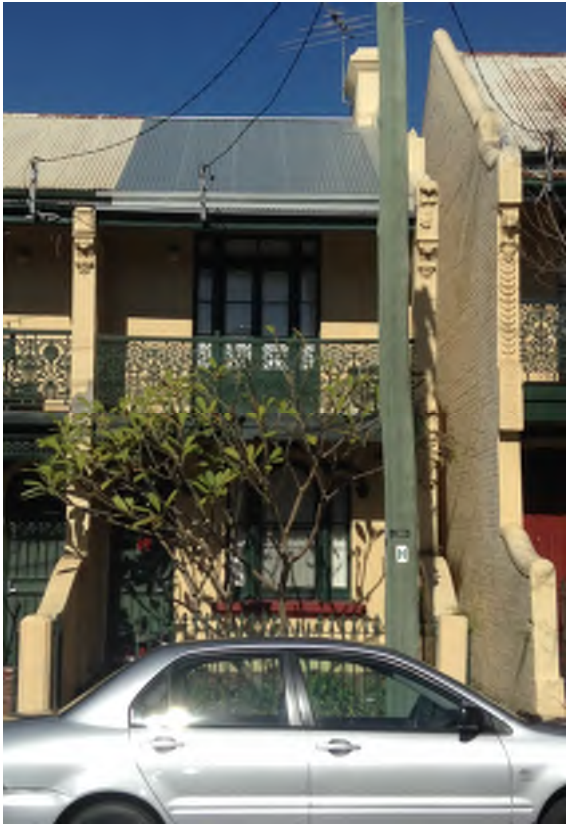
TERRACE NO.	ELEMENT	CONDITIONS	COMMENTS	PHOTOS
123	1. Front fence + base and gate	A	Some finials on the fence are missing. Allow for replace to match.

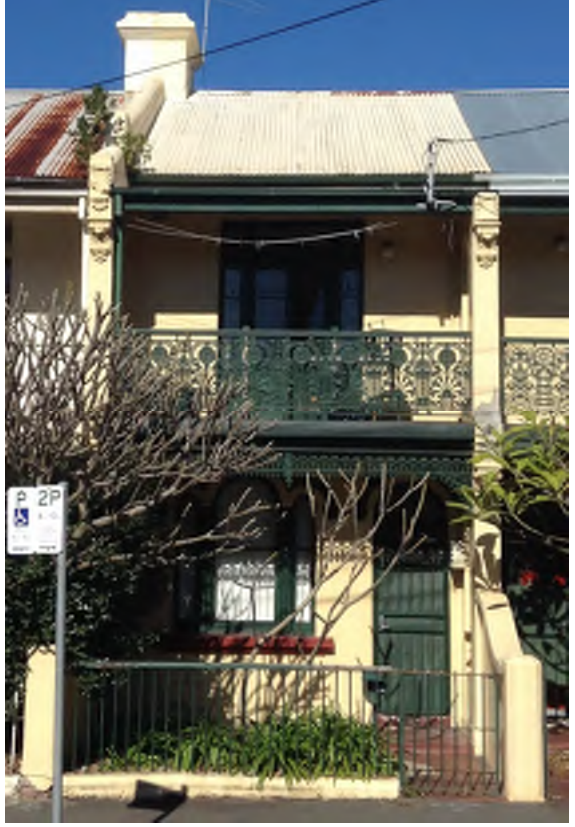
TERRACE NO.	ELEMENT	CONDITIONS	COMMENTS	PHOTOS
122	1. Front fence + base and gate	B	Remove rotten timber capping over fence. Allow for finials.

2. Entry path	B		
	3. Garden	A		
	4. Porch	B		
	5. Doors and Windows	A		
	6. External walls	B	Allow for repair of crack in party wall between No.121, see photos below - refer to engineers detail.	
	7. Verandah	A		
	8. Balustrade	A		
	9. Gutters and downpipes	A		
	10. Roof sheeting	A

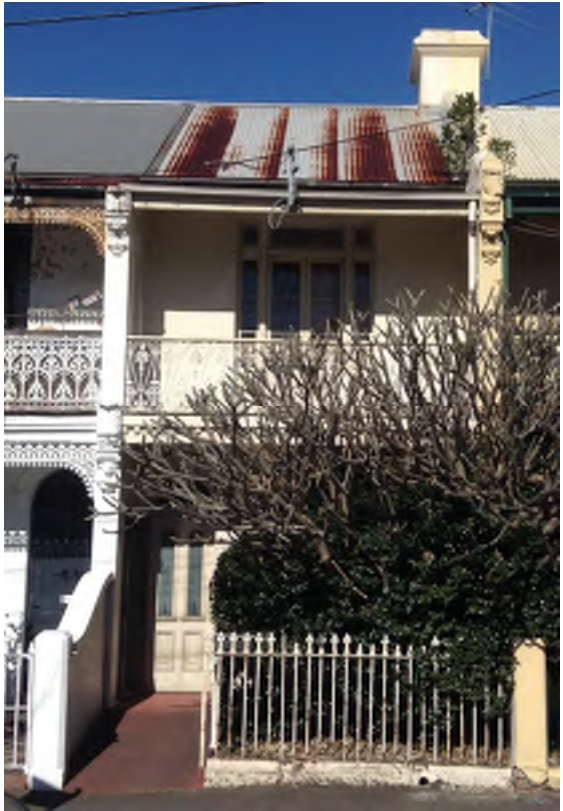
TERRACE NO.	ELEMENT	CONDITIONS	COMMENTS	PHOTOS
121	1. Front fence + base and gate	B	Repair render to party wall between No. 122.

2. Entry path	A	Allow for removal of railing along ramp.	
	3. Garden	A		
	4. Porch	A		
	5. Doors and Windows	A		
	6. External walls	B	Allow for repair of crack in party wall between No.122. (see photo below – refer to engineer’s detail.	
	7. Verandah	B		
	8. Balustrade	A		
	9. Gutters and downpipes	B		
	10. Roof sheeting	B

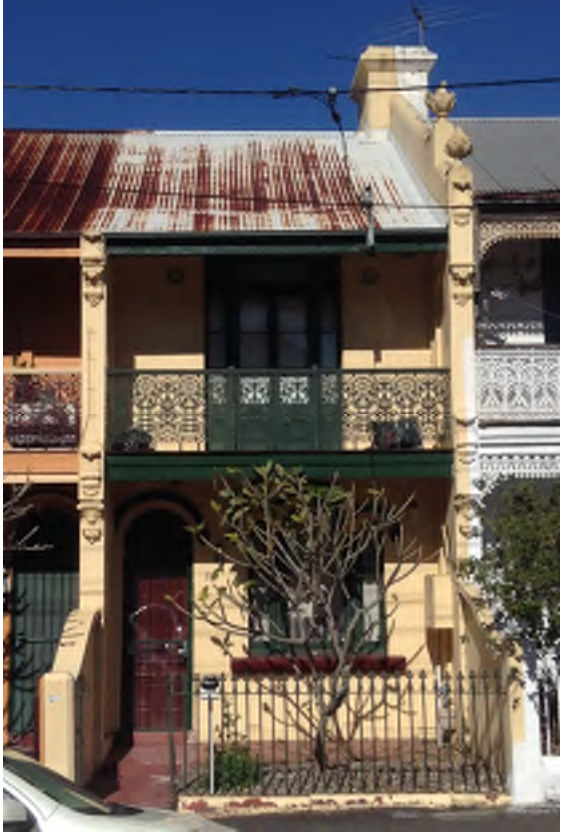
TERRACE NO.	ELEMENT	CONDITIONS	COMMENTS	PHOTOS
119	1. Front fence + base and gate	A

2. Entry path	A		
	3. Garden	A		
	4. Porch	A		
	5. Doors and Windows	A		
	6. External walls	B	Allow for repair of party wall between No.118 + 120. (wall disjointed with the house- see photos below - refer to engineers detail)	
	7. Verandah	A		
	8. Balustrade	A		
	9. Gutters and downpipes	B	Allow for new fascia board.	
	10. Roof sheeting	B

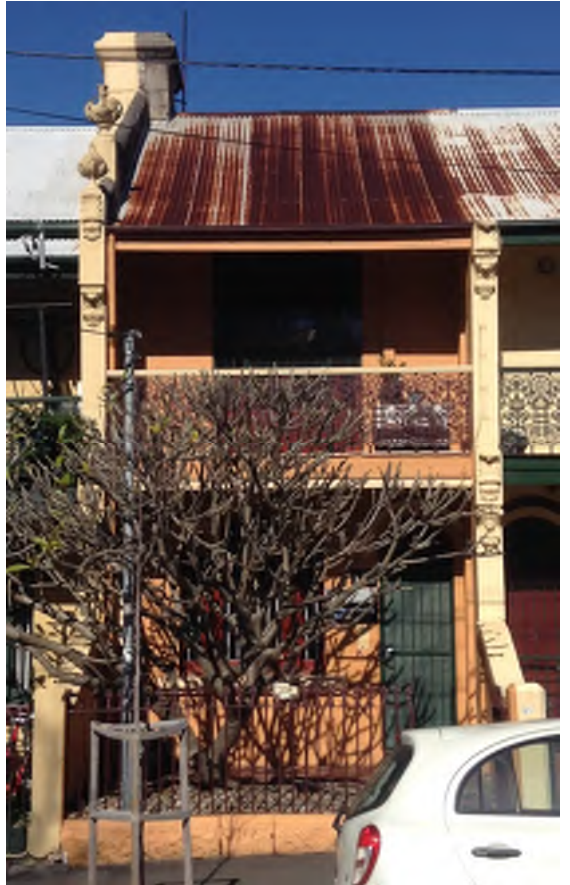
TERRACE NO.	ELEMENT	CONDITIONS	COMMENTS	PHOTOS
118	1. Front fence + base and gate	A

2. Entry path	A		
	3. Garden	A		
	4. Porch	A		
	5. Doors and Windows	A		
	6. External walls	B	Allow for repair of party wall between No.119. (wall disjointed with the house- refer to engineers detail)	
	7. Verandah	B		
	8. Balustrade	A		
	9. Gutters and downpipes	B		
	10. Roof sheeting	B

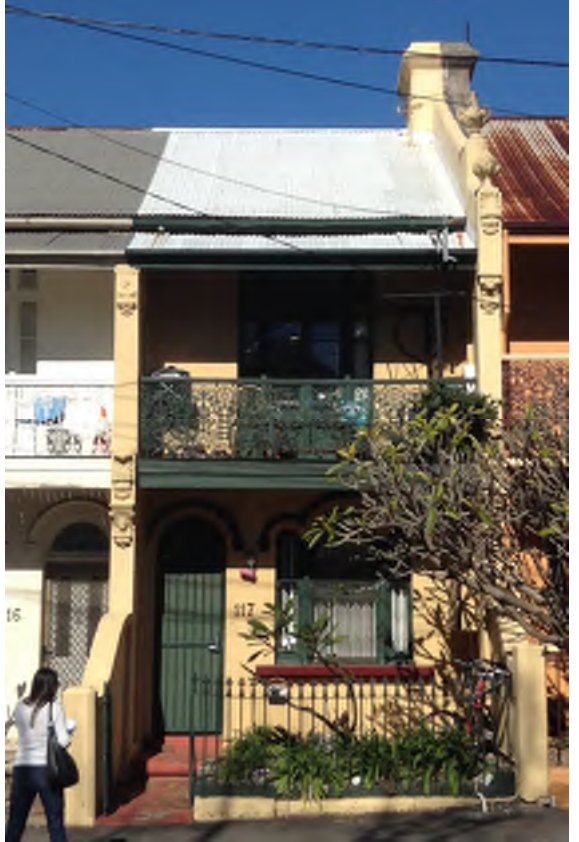
TERRACE NO.	ELEMENT	CONDITIONS	COMMENTS	PHOTOS
117	1. Front fence + base and gate	B

2. Entry path	B		
	3. Garden	A	Allow for lower garden bed level.	
	4. Porch	A		
	5. Doors and Windows	A		
	6. External walls	A		
	7. Verandah	A		
	8. Balustrade	A		
	9. Gutters and downpipes	B		
	10. Roof sheeting	B

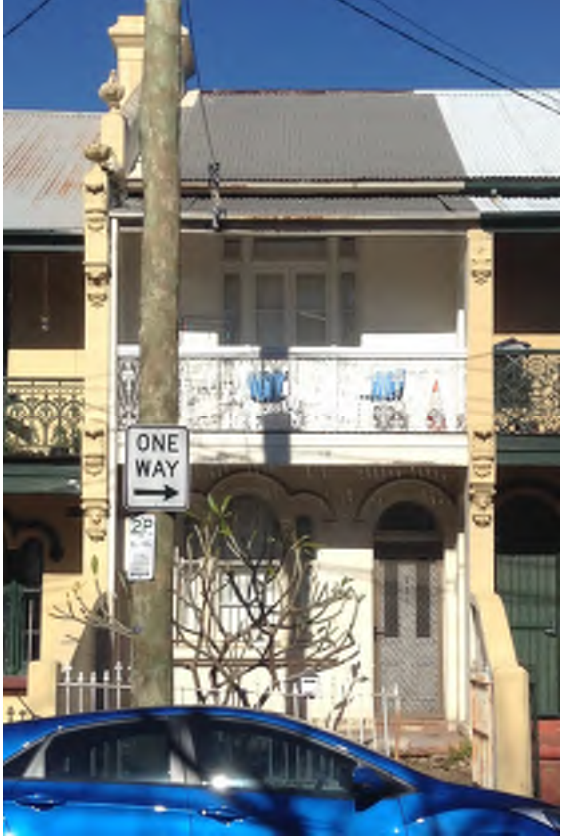
TERRACE NO.	ELEMENT	CONDITIONS	COMMENTS	PHOTOS
116	1. Front fence + base and gate	B	Allow to replace base wall and replace fence, retain gate. Allow for removal of finials for re-use on existing gate.

2. Entry path	B	Remove existing brick path and allow for new concrete slab.	
	3. Garden	A		
	4. Porch	B		
	5. Doors and Windows	A		
	6. External walls	B	Allow for repair of low party wall between No.117. (crack between low wall and the house- see photo below - refer to engineers detail)	
	7. Verandah	A		
	8. Balustrade	A		
	9. Gutters and downpipes	B		
	10. Roof sheeting	B

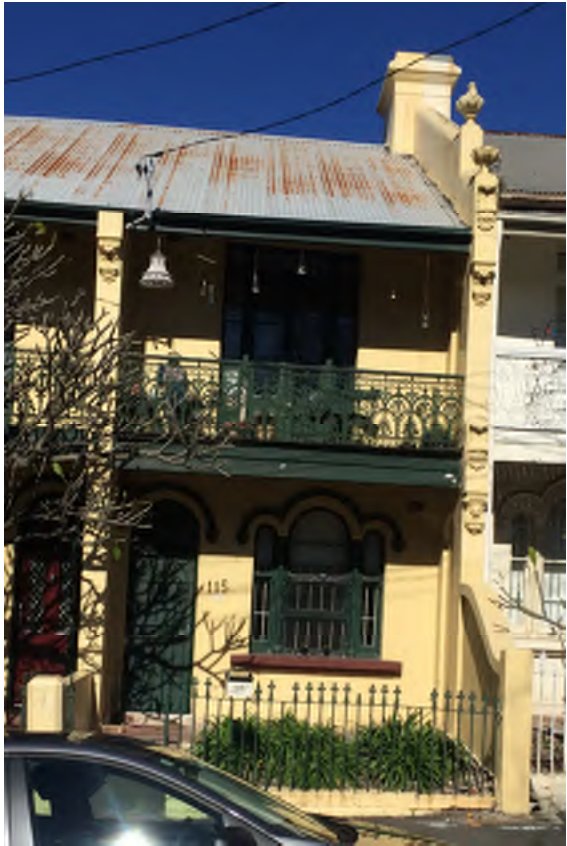
TERRACE NO.	ELEMENT	CONDITIONS	COMMENTS	PHOTOS
115	1. Front fence + base and gate	B	Some finials are missing, allow for replace to match.

2. Entry path	B	Allow for repair crack in garden bed wall along path way and step to porch.	
	3. Garden	A		
	4. Porch	B		
	5. Doors and Windows	A		
	6. External walls	B	Allow for repair of low party wall between No.114. (crack between low wall and the house- refer to engineers detail)	
	7. Verandah	A		
	8. Balustrade	A		
	9. Gutters and downpipes	B		
	10. Roof sheeting	B

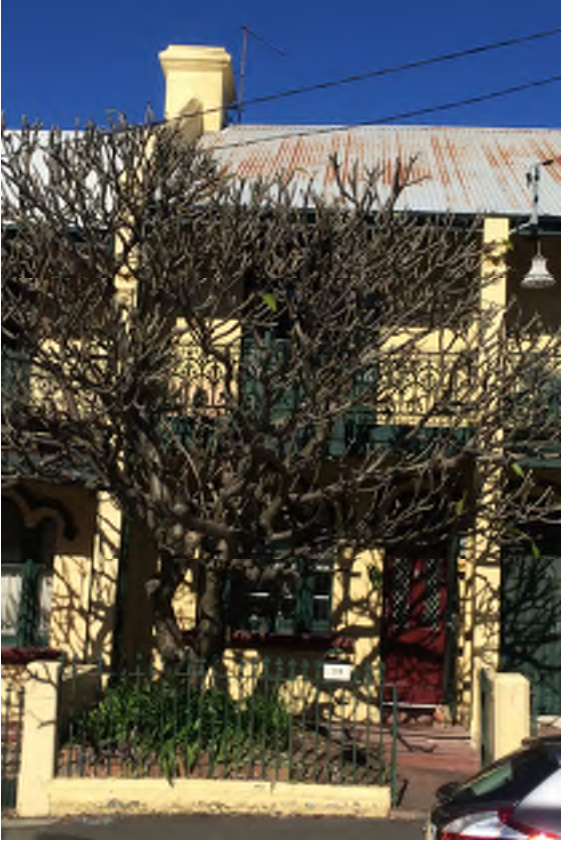
TERRACE NO.	ELEMENT	CONDITIONS	COMMENTS	PHOTOS
114	1. Front fence + base and gate	B	Some finials are missing, allow for replace to match.

2. Entry path	A		
	3. Garden	B	Allow to lower garden bed level.	
	4. Porch	B		
	5. Doors and Windows	A		
	6. External walls	B	Allow for repair of low party wall between No.115. (crack between low wall and the house- see photo below- refer to engineers detail)	
	7. Verandah	A		
	8. Balustrade	A		
	9. Gutters and downpipes	B		
	10. Roof sheeting	B

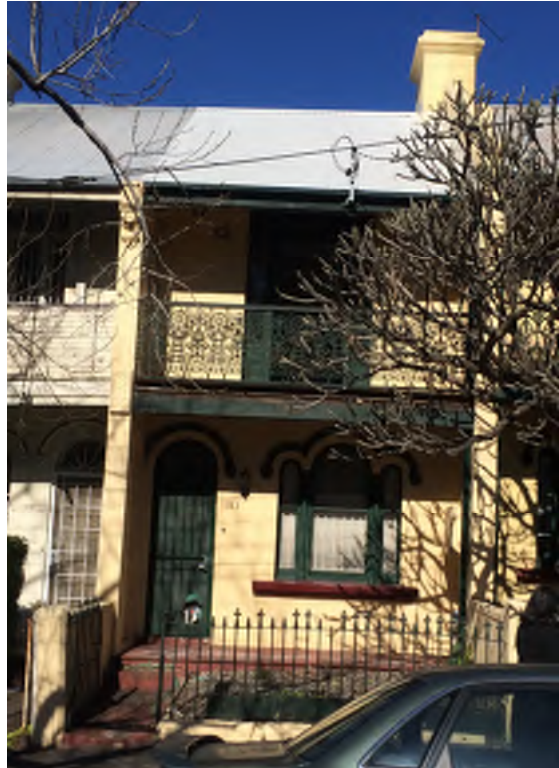
TERRACE NO.	ELEMENT	CONDITIONS	COMMENTS	PHOTOS
113	1. Front fence + base and gate	B	Some finials are missing, allow for replace to match.

2. Entry path	B		
	3. Garden	B	Allow to lower garden bed level.	
	4. Porch	A		
	5. Doors and Windows	A		
	6. External walls	B	Allow for repair of low party wall between No.114. (crack between low wall and the house and up at the balustrade level - refer to engineers detail). Allow for patch above entry door and repaint all walls.	
	7. Verandah	A	Allow for new cover board below balustrade.	
	8. Balustrade	A		
	9. Gutters and downpipes	A		
	10. Roof sheeting	A

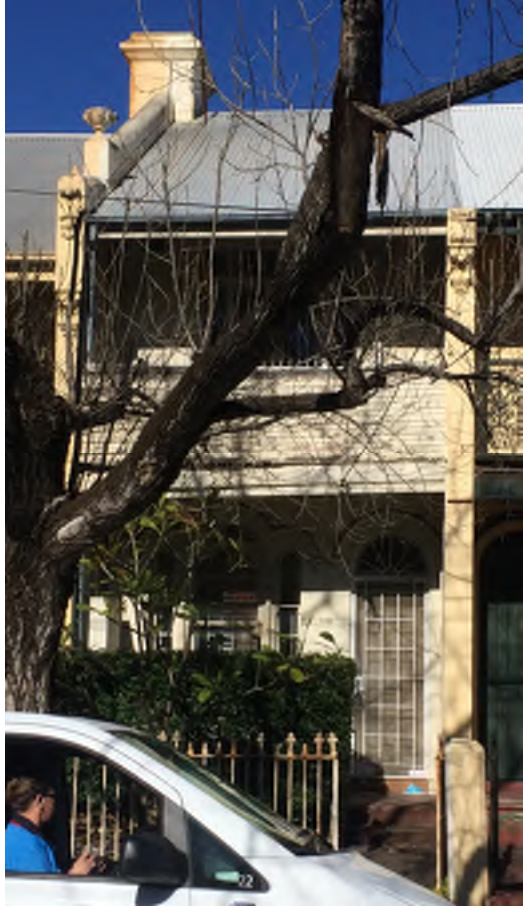
TERRACE NO.	ELEMENT	CONDITIONS	COMMENTS	PHOTOS
112	1. Front fence + base and gate	B	Some finials are missing, allow for replace to match.

2. Entry path	A		
	3. Garden	A	Allow for removal of hedges.	
	4. Porch	A		
	5. Doors and Windows	A		
	6. External walls	B	Allow for repair crack in low party wall between No.113 & 111 – see photos below -refer to engineers detail).	
	7. Verandah	B	Remove existing verandah and allow to match adjoining neighbor (No 113)	
	8. Balustrade	B	Remove existing timber balustrade panels, install cast iron lace balustrade panels to match adjoining neighbour (No. 113) lace balustrade, raise height to meet compliance.	
	9. Gutters and downpipes	A		
	10. Roof sheeting	A

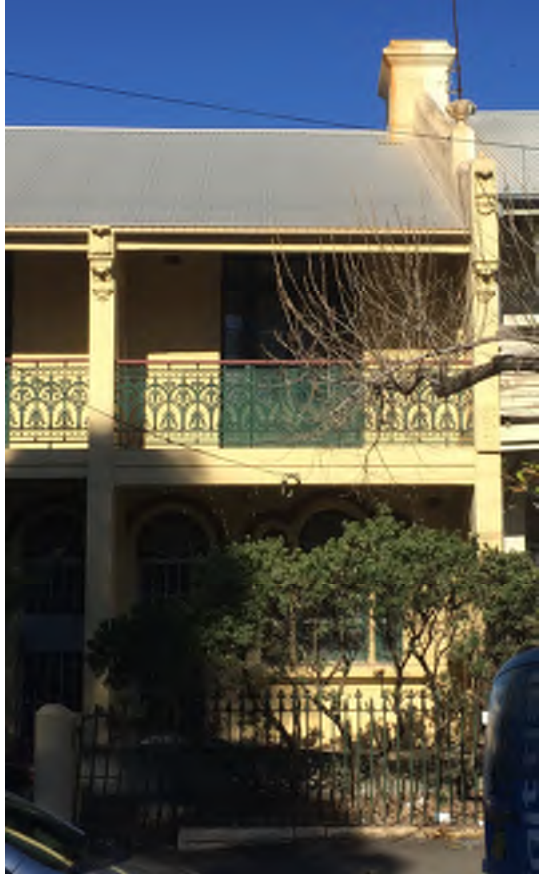
TERRACE NO.	ELEMENT	CONDITIONS	COMMENTS	PHOTOS
111	1. Front fence + base and gate	B	Some finials are missing, allow for replace to match.

2. Entry path	B	Remove existing ramp and allow for new concrete path. Refer to drawing for detail.	
	3. Garden	B	Remove existing ramp and allow for new garden bed. Refer to drawing for detail.	
	4. Porch	B	Remove existing ramp and allow for new concrete porch. Refer to drawing for detail.	
	5. Doors and Windows	A		
	6. External walls	B	Allow for repair crack in low party wall between No.113 & 111 –see photos below - refer to engineers detail).	
	7. Verandah	A		
	8. Balustrade	A		
	9. Gutters and downpipes	A		
	10. Roof sheeting	A

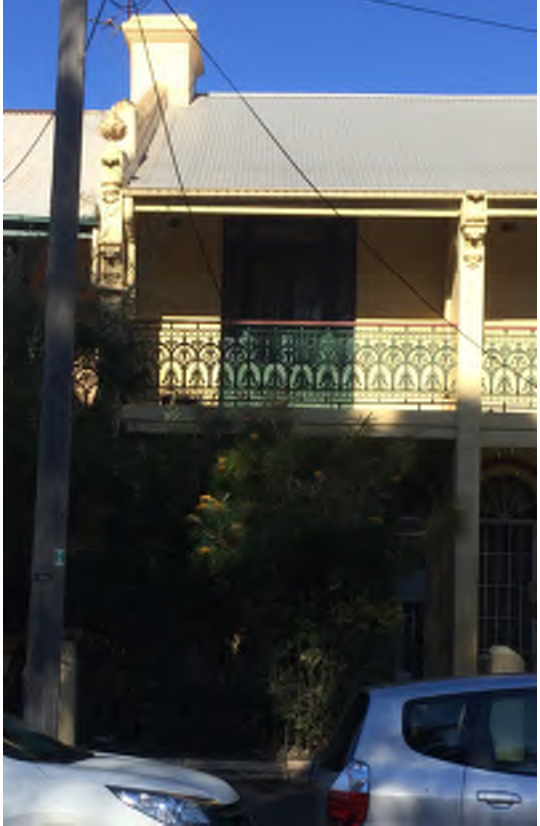
TERRACE NO.	ITEMS	CONDITIONS	COMMENTS	PHOTOS
110	1. Front fence + base and gate	B	Some finials are missing, allow for replace to match.

2. Entry path	A	Remove tactile indicator tiles, allow to patch and repaint.	
	3. Garden	A		
	4. Porch	B	Remove tactile indicator tiles and allow to patch and paint finish.	
	5. Doors and Windows	A		
	6. External walls	B	Allow to extend party (low level) wall between No.111. see photo below – refer to engineer’s detail.	
	7. Verandah	A		
	8. Balustrade	A		
	9. Gutters and downpipes	A		
	10. Roof sheeting	A

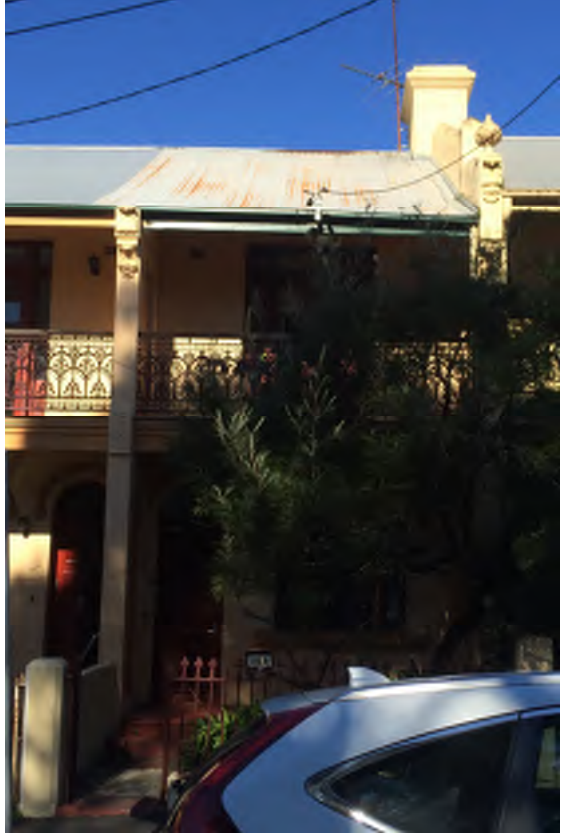
TERRACE NO.	ITEMS	CONDITIONS	COMMENTS	PHOTOS
109	1. Front fence + base and gate	B	Some finials are missing, allow for replace to match.

2. Entry path	B		
	3. Garden	A	Allow for removal of bottle brush tree, retain frangipani.	
	4. Porch	A		
	5. Doors and Windows	A		
	6. External walls	B	Allow for repair of low party wall between No.110. (crack between low wall and the house – see photos below - refer to engineers detail).	
	7. Verandah	A		
	8. Balustrade	A		
	9. Gutters and downpipes	B		
	10. Roof sheeting	B

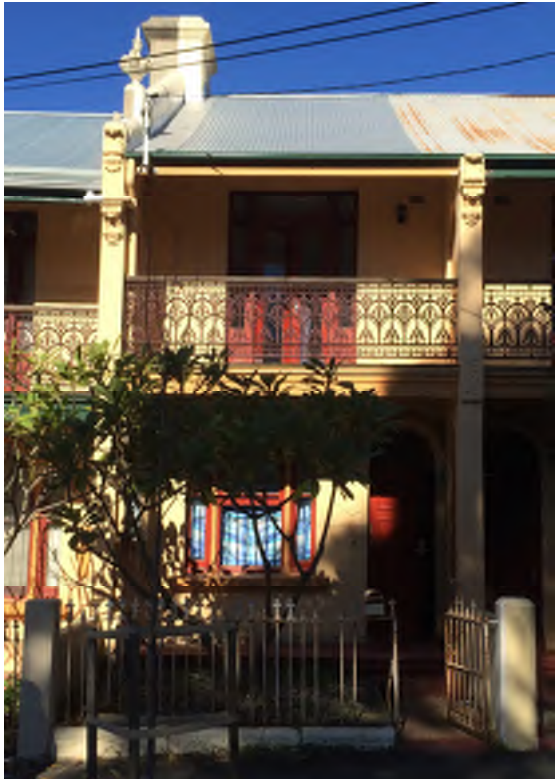
TERRACE NO.	ELEMENT	CONDITIONS	COMMENTS	PHOTOS
108	1. Front fence + base and gate	B	Some finials and vertical rods are missing. Allow for replace to match.

2. Entry path	B		
	3. Garden	A		
	4. Porch	A		
	5. Doors and Windows	B		
	6. External walls	B	Allow for repair crack in low party wall between No.109 – see photos below - refer to engineers detail). Remove wall railing.	
	7. Verandah	A		
	8. Balustrade	A		
	9. Gutters and downpipes	A		
	10. Roof sheeting	A

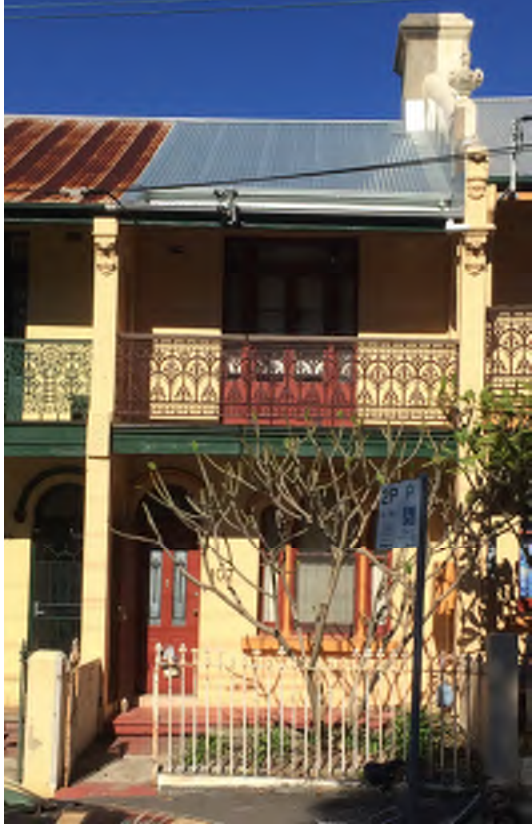
TERRACE NO.	ELEMENT	CONDITIONS	COMMENTS	PHOTOS
107	1. Front fence + base and gate	B	Some finials are missing, allow for replace to match.

2. Entry path	B		
	3. Garden	A	Allow to lower garden bed level.	
	4. Porch	A		
	5. Doors and Windows	A		
	6. External walls	B	Allow for repair crack in low party wall between No.108 + 106- see photo below - refer to engineers detail).	
	7. Verandah	A		
	8. Balustrade	A		
	9. Gutters and downpipes	A		
	10. Roof sheeting	A

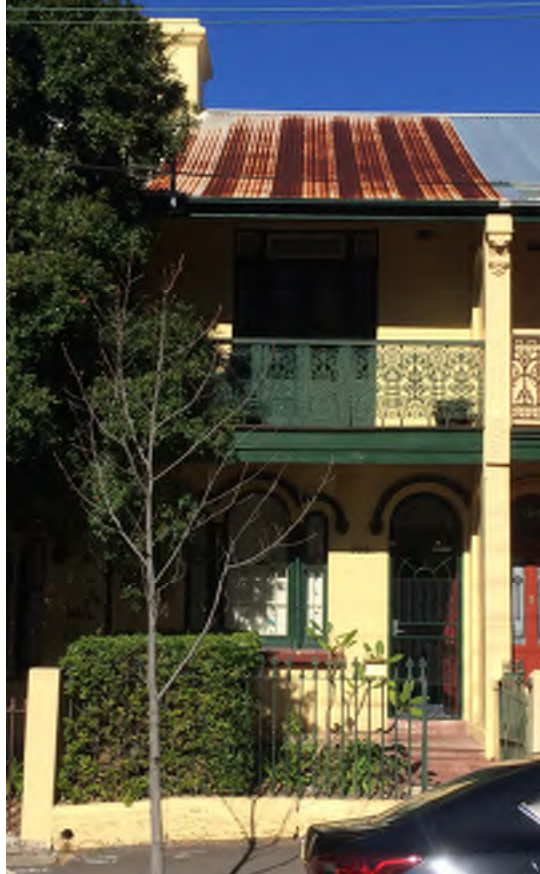
TERRACE NO.	ELEMENT	CONDITIONS	COMMENTS	PHOTOS
106	1. Front fence + base and gate	B	Some finials are missing, allow for replace to match.

2. Entry path	B		
	3. Garden	A	Remove hedge, retain frangipani	
	4. Porch	A		
	5. Doors and Windows	A		
	6. External walls	A		
	7. Verandah	A		
	8. Balustrade	A		
	9. Gutters and downpipes	B		
	10. Roof sheeting	B

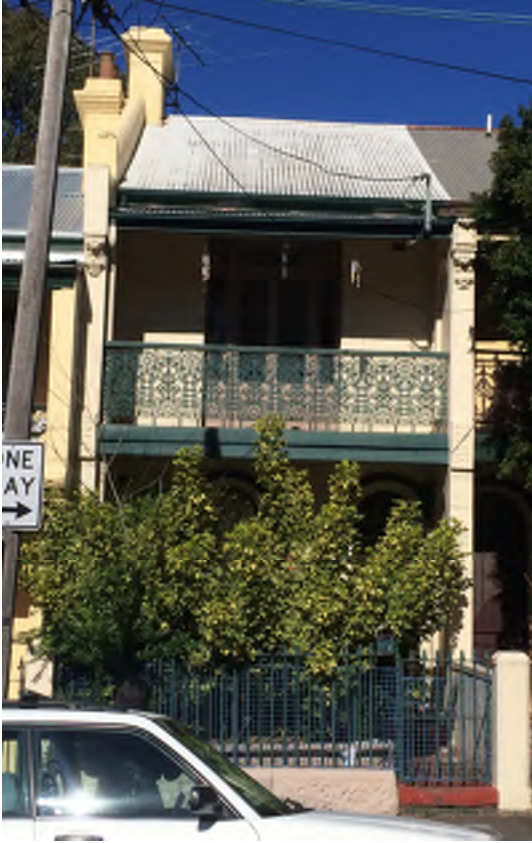
TERRACE NO.	ELEMENT	CONDITIONS	COMMENTS	PHOTOS
104	1. Front fence + base and gate	B

2. Entry path	A		
	3. Garden	B	Allow for removal of existing tree as advised by landscape architect.	
	4. Porch	B		
	5. Doors and Windows	A		
	6. External walls	B	Allow for repair crack in low party wall between No.105 + 104- refer to engineers detail).	
	7. Verandah	A		
	8. Balustrade	A		
	9. Gutters and downpipes	A		
	10. Roof sheeting	A

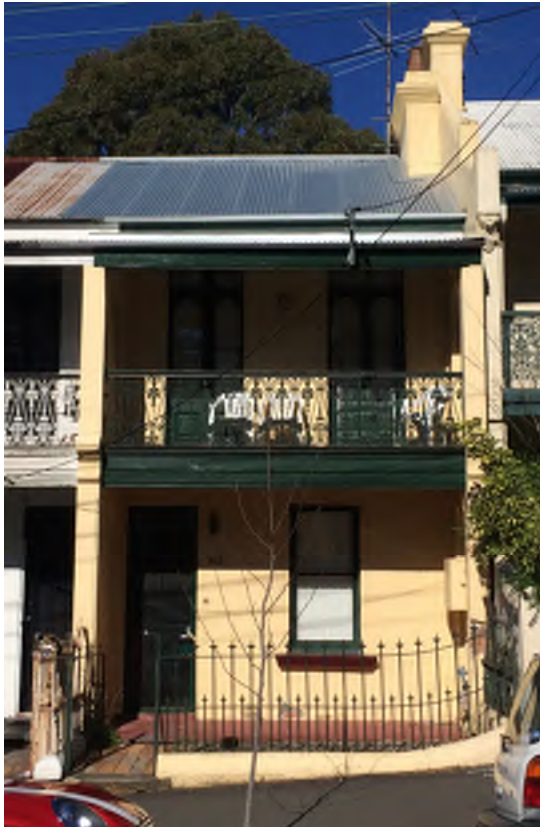
TERRACE NO.	ELEMENT	CONDITIONS	COMMENTS	PHOTOS
103 *	1. Front fence + base and gate	B	Remove portion of existing fence and all associated components to allow for 850mm clear opening. Remove party fence between No. 102. Refer to drawing for detail.

2. Entry path	B	Remove existing path, refer to drawing for new accessible path.	
	3. Garden	B	Allow for new accessible path. Refer to drawing for detail.	
	4. Porch	A		
	5. Doors and Windows	A		
	6. External walls	B	Allow for repair crack in party wall between No.104 – see photo below -refer to engineers detail).	
	7. Verandah	A		
	8. Balustrade	A		
	9. Gutters and downpipes	A		
	10. Roof sheeting	A

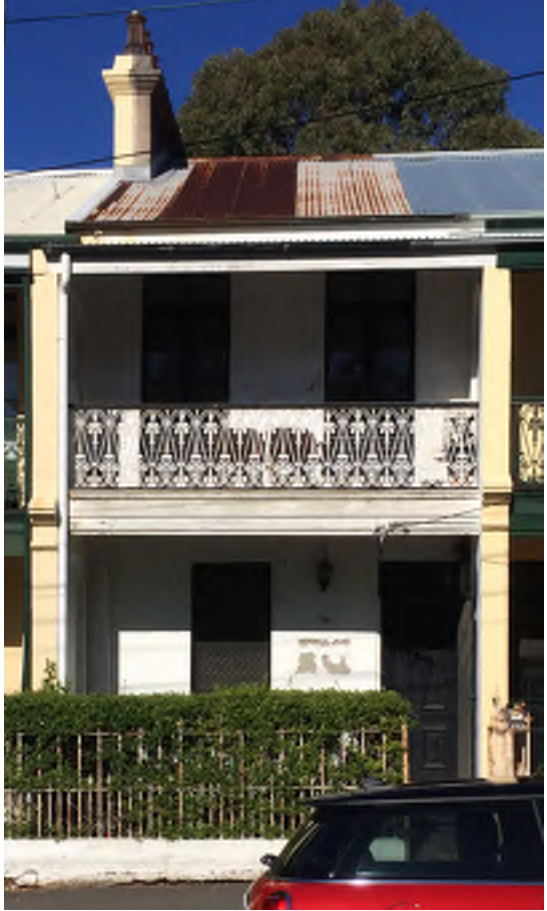
TERRACE NO.	ELEMENT	CONDITIONS	COMMENTS	PHOTOS
102 *	1. Front fence + base and gate	B	Block gate, allow for new accessible ramp path to continue through from Terrace No.103. Refer to drawing for detail.

2. Entry path	B	Remove existing path, allow for new accessible path to entry door. Refer drawing for new path.	
	3. Garden	B	Allow for new accessible path. Refer to drawing for detail.

4. Porch	B	Allow for new accessible path. Refer to drawing for detail. Allow to replace tessellated tiles.	
	5. Doors and Windows	B	Remove front door + screen door and portion of existing wall to install new door and frame for wheel chair access. Refer drawing for detail.

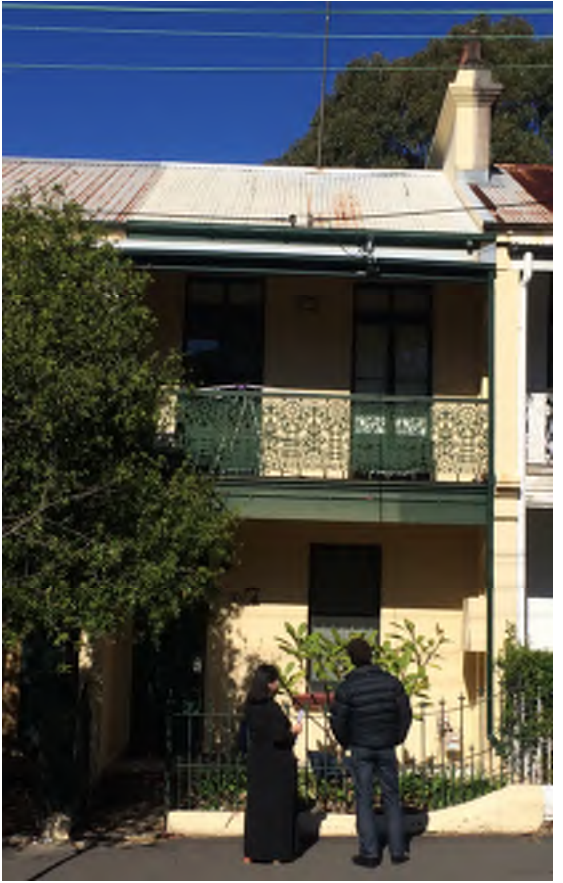
TERRACE NO.	ELEMENT	CONDITIONS	COMMENTS	PHOTOS
101 *	1. Front fence + base and gate	B	Remove portion of existing fence and all associated components to allow for 850mm clear opening

2. Entry path	B	Remove and store existing pavers and rope edging strip for reuse. refer to drawing for new accessible path.	
	3. Garden	B	Allow for new accessible path, refer to drawing for detail.	
	4. Porch	B	Allow for new accessible path, refer to drawing for detail.	
	5. Doors and Windows	B	Remove front door + screen door and portion of existing wall to install new door and frame for wheel chair access.	
	6. External walls	B	Allow for repair crack in party wall between No.100 - refer to engineers detail). Allow for repaint all walls.	
	7. Verandah	A	Allow for new cover boards to match.	
	8. Balustrade	A		
	9. Gutters and downpipes	B		
	10. Roof sheeting	B

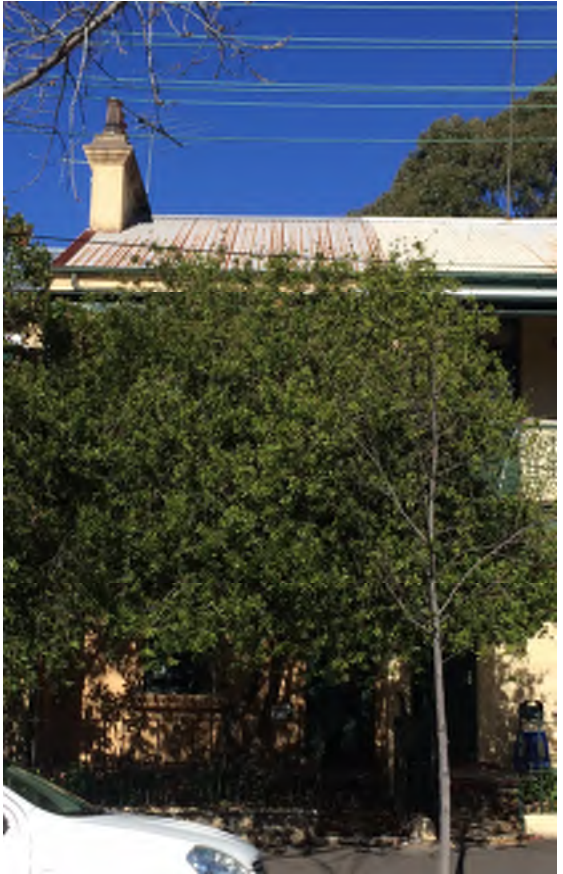
TERRACE NO.	ELEMENT	CONDITIONS	COMMENTS	PHOTOS
100	1. Front fence + base and gate	B

2. Entry path	B		
	3. Garden	B	Allow for removal of existing tree as advised by landscape architect.	
	4. Porch	A		
	5. Doors and Windows	A		
	6. External walls	A		
	7. Verandah	B	Allow for new cover boards to match.	
	8. Balustrade	A		
	9. Gutters and downpipes	B		
	10. Roof sheeting	B

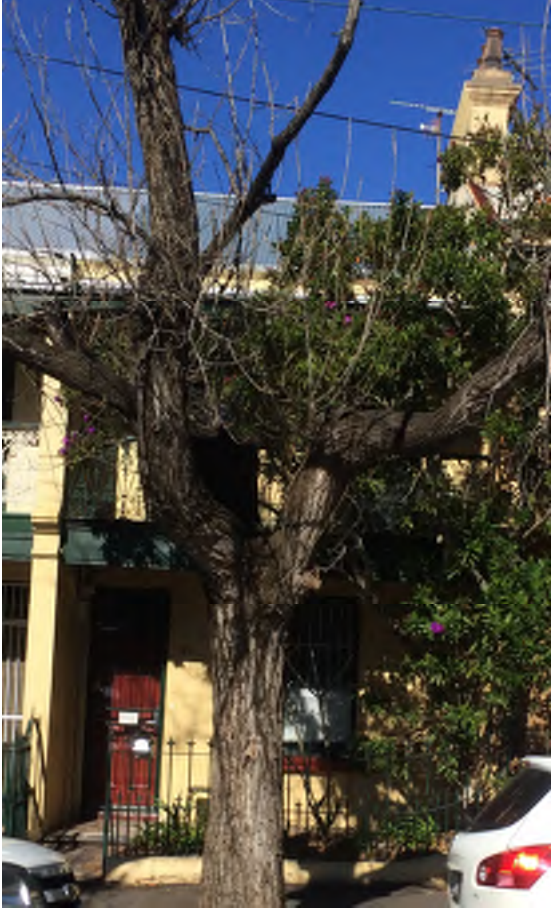
TERRACE NO.	ELEMENT	CONDITIONS	COMMENTS	PHOTOS
99	1. Front fence + base and gate	A

2. Entry path	A		
	3. Garden	A		
	4. Porch	A	Tessellated tiles to existing porch.	
	5. Doors and Windows	A		
	6. External walls	B	Allow for repair crack in party wall between No.98 - refer to engineers detail).	
	7. Verandah	A		
	8. Balustrade	A		
	9. Gutters and downpipes	A		
	10. Roof sheeting	A

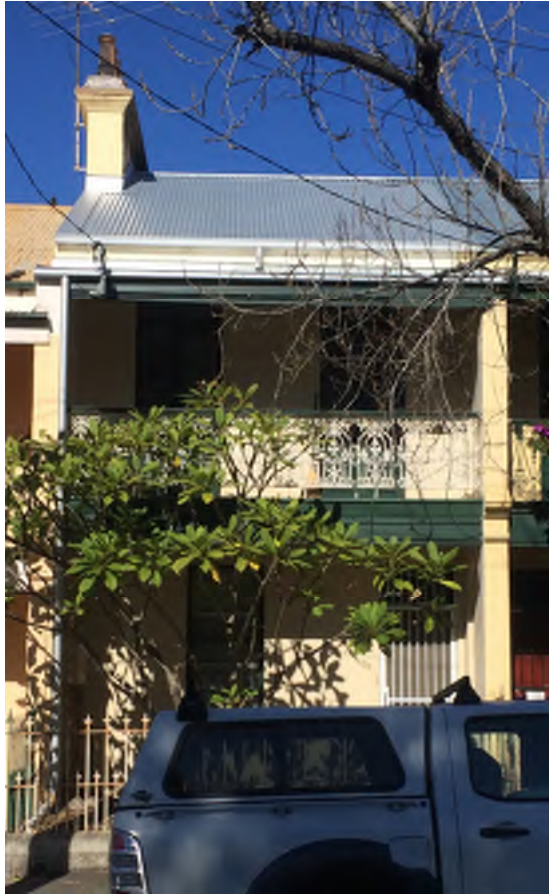
TERRACE NO.	ELEMENT	CONDITIONS	COMMENTS	PHOTOS
98	1. Front fence + base and gate	A

2. Entry path	A		
	3. Garden	A		
	4. Porch	B	Allow to replace and fix down any loose tessellated tiles.	
	5. Doors and Windows	A		
	6. External walls	A		
	7. Verandah	A		
	8. Balustrade	A		
	9. Gutters and downpipes	A		
	10. Roof sheeting	A

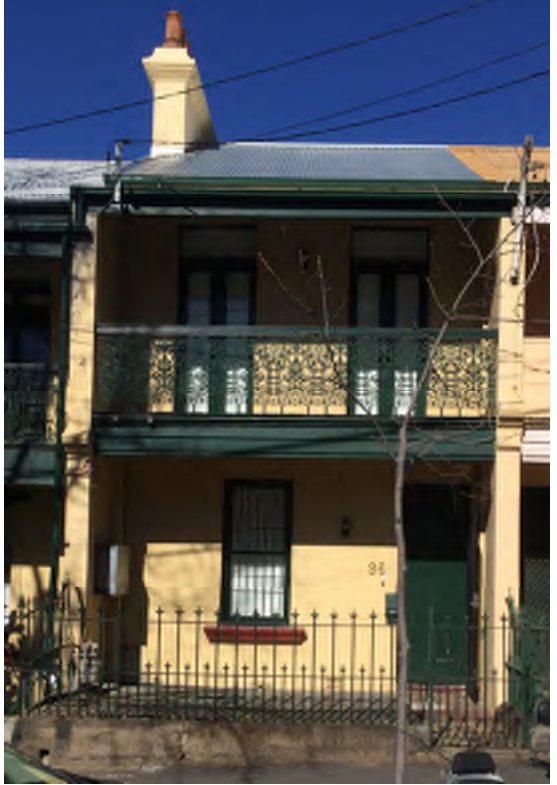
TERRACE NO.	ELEMENT	CONDITIONS	COMMENTS	PHOTOS
96	1. Front fence + base and gate	A

2. Entry path	B		
	3. Garden	B		
	4. Porch	B	Allow to replace and fix down any loose tessellated tiles.	
	5. Doors and Windows	A		
	6. External walls	A		
	7. Verandah	A		
	8. Balustrade	A		
	9. Gutters and downpipes	A		
	10. Roof sheeting	A

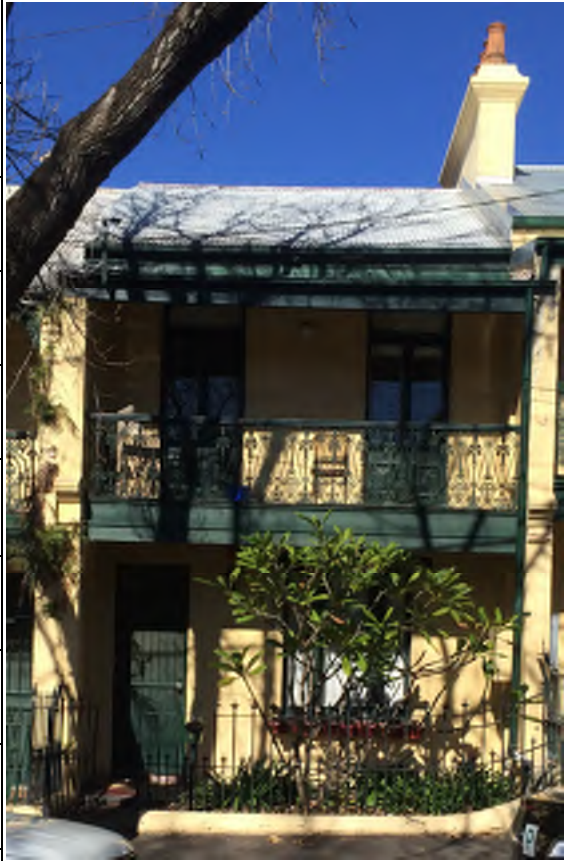
TERRACE NO.	ELEMENT	CONDITIONS	COMMENTS	PHOTOS
95	1. Front fence + base and gate	B	Allow for repair to damaged fence and base wall between No. 96.

2. Entry path	A		
	3. Garden	A		
	4. Porch	A		
	5. Doors and Windows	A		
	6. External walls	B	Allow for repair damaged party wall and decorative moulding between No. 96. – refer to engineer's detail.	
	7. Verandah	A		
	8. Balustrade	A		
	9. Gutters and downpipes	B		
	10. Roof sheeting	B

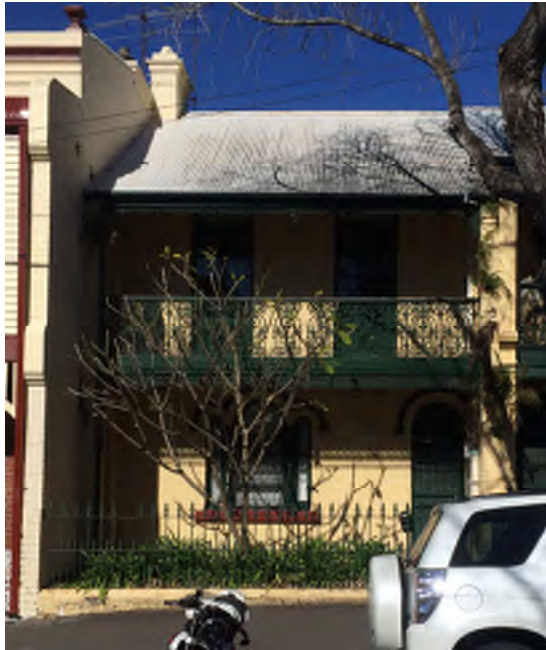
TERRACE NO.	ELEMENT	CONDITIONS	COMMENTS	PHOTOS
94 *	1. Front fence + base and gate	B	Remove portion of existing fence and all associated components to allow for 850mm clear opening. Refer to drawing for detail.

2. Entry path	B	Remove existing path, refer to drawing for new accessible path.	
	3. Garden	A	Allow for new accessible path. Refer to drawing for detail.	
	4. Porch	B	Tessellated tiles to existing porch. Allow for new accessible path. Refer to drawing for detail. TBC with Heritage if new access path require to reuse tessellated tiles?	
	5. Doors and Windows	B	Remove front door + screen door and portion of existing wall to install new door and frame for wheel chair access. Refer drawing for detail	
	6. External walls	B	Remove portion of existing door, make good surround walls.	
	7. Verandah	A		
	8. Balustrade	A		
	9. Gutters and downpipes	A		
	10. Roof sheeting	A

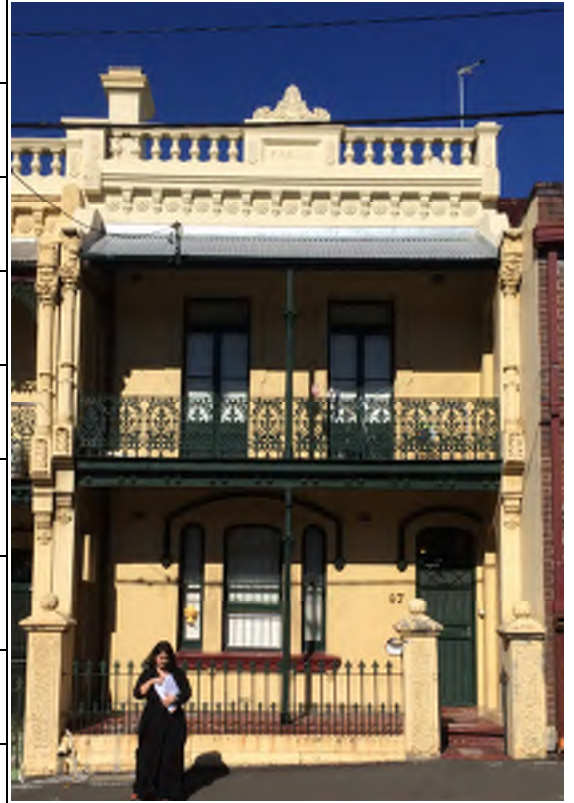
TERRACE NO.	ELEMENT	CONDITIONS	COMMENTS	PHOTOS
87	1. Front fence + base and gate	A

2. Entry path	A		
	3. Garden	-	No new garden to front façade.	
	4. Porch	B		
	5. Doors and Windows	A		
	6. External walls	B	Repair crack in low party wall between 86.	
	7. Verandah	A		
	8. Balustrade	A		
	9. Gutters and downpipes	A		
	10. Roof sheeting	A

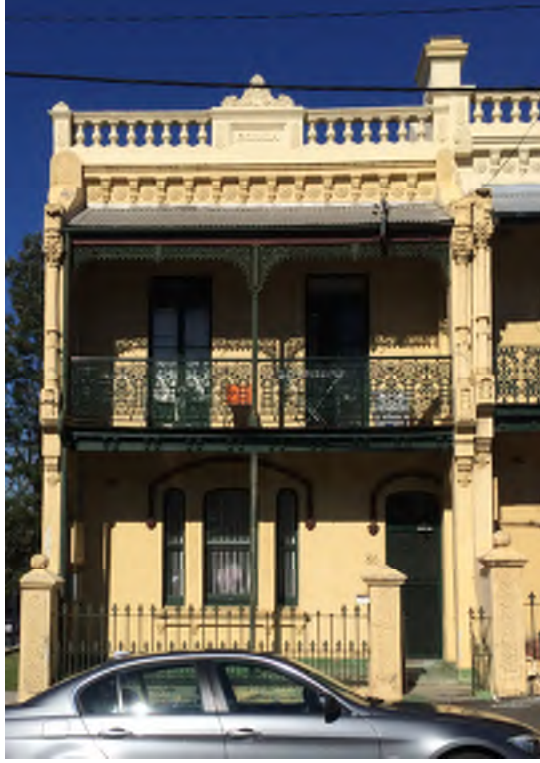
TERRACE NO.	ELEMENT	CONDITIONS	COMMENTS	PHOTOS
86	1. Front fence + base and gate	A

2. Entry path	A		
	3. Garden	-	No new garden to front façade.	
	4. Porch	B		
	5. Doors and Windows	A		
	6. External walls	B	Repair crack in low party wall between 87.	
	7. Verandah	A		
	8. Balustrade	A		
	9. Gutters and downpipes	A		
	10. Roof sheeting	A
