## 4 PHYSICAL DESCRIPTION OF THE SITE

### 4.1 General External Description

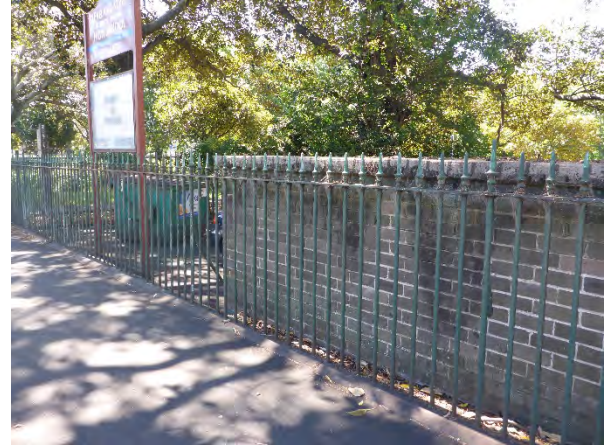
The site is located below street level and features stone retaining walls with a modern palisade fencing extending along Chalmers Street. The fencing along Cleveland Street is of earlier origin and it is noted that the paint finish on this fence is deteriorating and there is some rusting, including where it is set into the stone pier and blowing out the stonework (refer Figure 4.15). Heavy stone piers are located at intervals where the fencing terminates.

FIGURE 4.3 EARLY PALISADE FENCE SET INTO STONE BASE EXTENDING ALONG THE CLEVELAND STREET BOUNDARY.

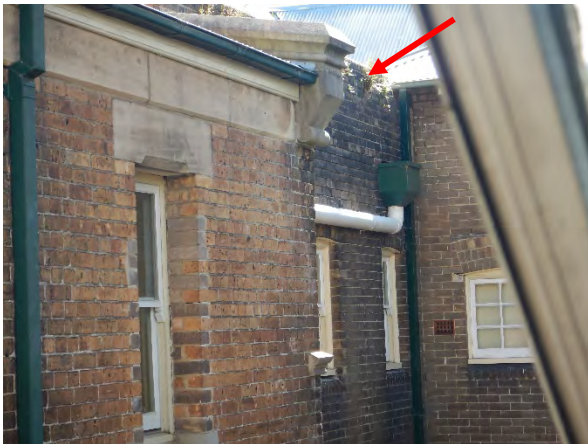
Some self-seeded vegetation and biological growth is also present on the brick masonry at the upper level building, noted on the north façade. External painted finishes on window frames and doors are deteriorating and will require renewal in the medium term to protect the timber fabric.

FIGURE 4.14 VEGETATION GROWING ON THE UPPER LEVEL OF THE BUILDING (SHOWN BY RED ARROW).

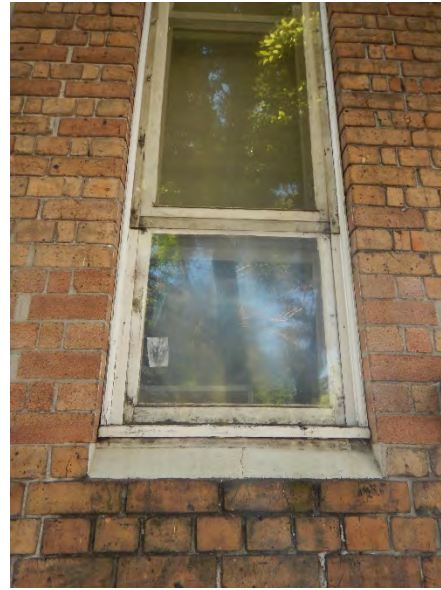
FIGURE 4.17 EXTERNAL PAINTED TIMBER SURFACES WILL REQUIRE REPAINTING IN THE MEDIUM TERM TO PROTECT TIMBER FABRIC. SHOWN IS A WINDOW OF THE CLEVELAND ST ELEVATION.

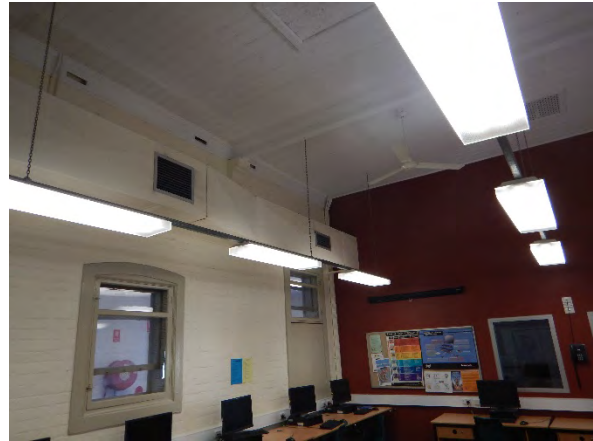
There is only limited air conditioning within the building, which is provided via a suspended duct that extends east west towards the southern end only of Buildings 1A and 1B. A limited number of rooms also contain a wall mounted air conditioning unit, including some that also include the duct. The majority of rooms, including those with air conditioning, include ceiling fans to provide air circulation, with the exception of the corridors, where no air modification/circulation provisions are present. There are some examples of wall mounted heaters, however this is not typical within Building 1.

FIGURE 4.19 AIR CONDITIONING DUCT, WHICH IS TYPICAL IN ROOMS ALIGNED ADJACENT TO CLEVELAND STREET. NOTE ALSO THE CEILING FAN, WHICH IS TYPICAL THROUGHOUT BUILDING 1.

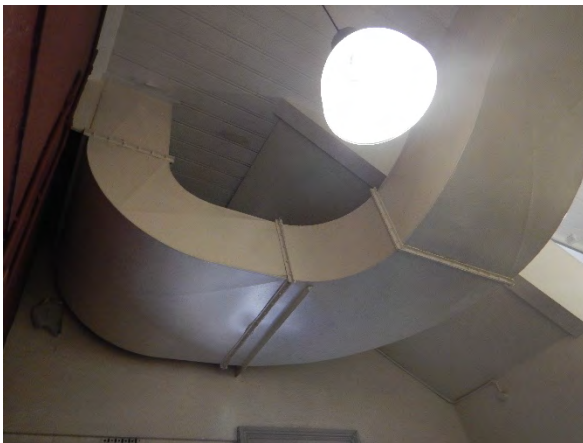
FIGURE 4.20 AIR CONDITIONING DUCTWORK WITHIN SOUTHERN STAIRWELL (SPACE 130).

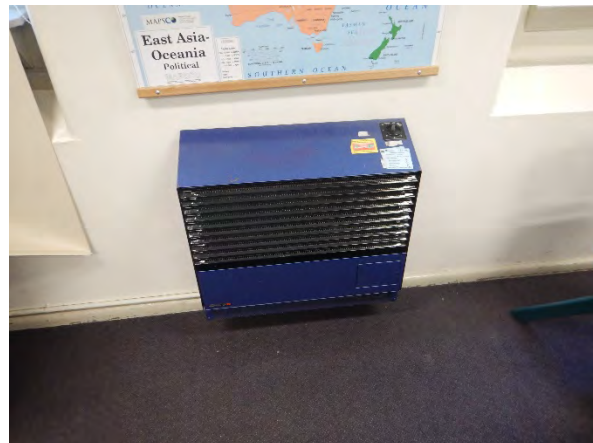
FIGURE 4.21 EXAMPLE OF HEATING UNIT INSTALLED WITHIN A LIMITED NUMBER OF ROOMS.

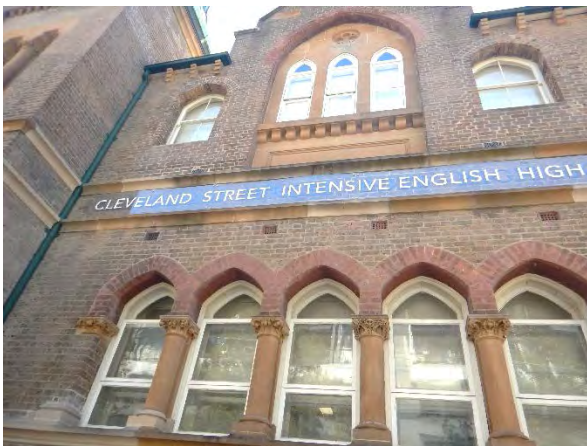
The eastern Chalmers Street facades of Buildings 2A and 2B are in good overall condition owing to façade conservation works implemented by DPWS earlier this century. There is some evidence of staining on the sandstone base wall, including the splayed course owing to build-up of pollutants over time and also in areas around the base of the downpipes. The downpipes do appear sound and it is likely that the staining remains from failure of previous rainwater installations. The stonework of the front façade will require desalination in the medium to long term.

FIGURE 4.33 DETAIL VIEW SHOWING THE GOOD CONDITION OF THE FABRIC ON THE CHALMERS STREET ELEVATION.

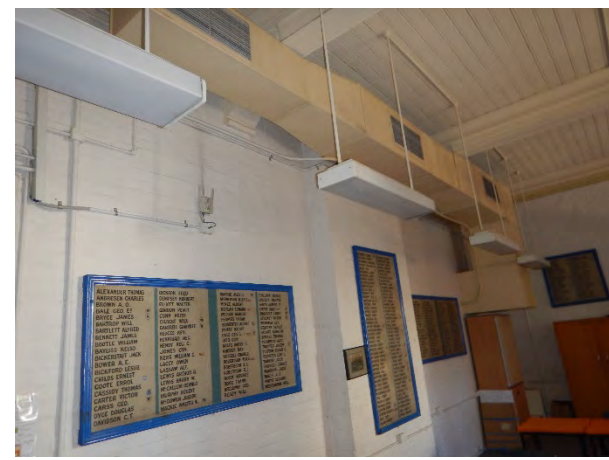
There is only limited air conditioning within the building, which is provided via a suspended duct evident in the major ground floor space of Building 2B. The duct has been present for some time and its operation was not confirmed on site. The recently refurbished reception and staff area was closed at the time of inspection and the presence of air conditioning has not been confirmed. A number of classrooms contain ceiling fans, however these are not present in the circulation areas.

FIGURE 4.44 AIR CONDITIONING DUCT AND SUSPENDED SERVICES IN CLASSROOM (ROOM G212).

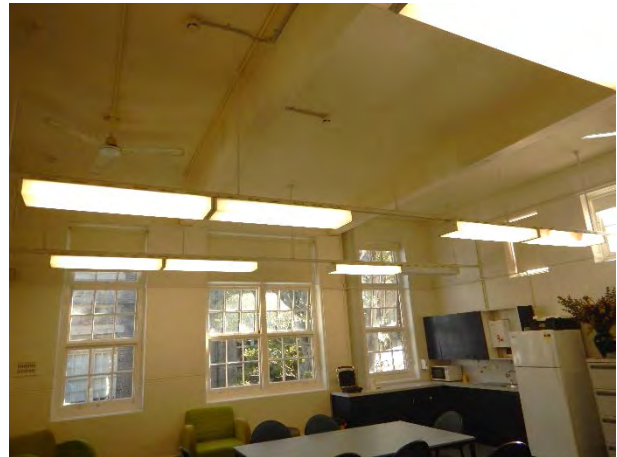
FIGURE 4.56 VIEW OF TYPICAL INTERIOR (THIS EXAMPLE SHOWS STAFF AREA) SHOWING SURFACE MOUNTED SERVICES INCLUDING CEILING FANS AND LIGHTS.
