Re: DoE ISHS: HazMat

Hazardous Materials Risk Assessment
Department of Education
Cleveland Street Intensive English High School
Corner Chalmers and Cleveland Streets, Surry Hills NSW 2010

Our Reference: C107471 : J141683

Date: January 2016

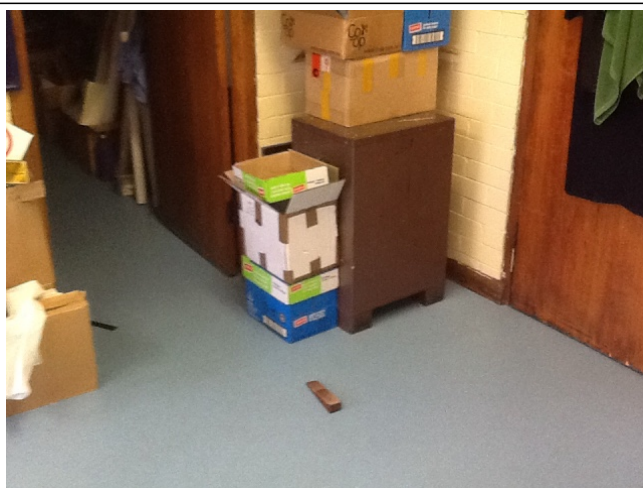
Photo No: J141683-8288-Photo107
Result: Asbestos - Presumed Positive
Building/Level: Building 4-Level Two
Room/Location: 4R3017 (Art)-Various Throughout
Feature/Material: Heater-Insulation

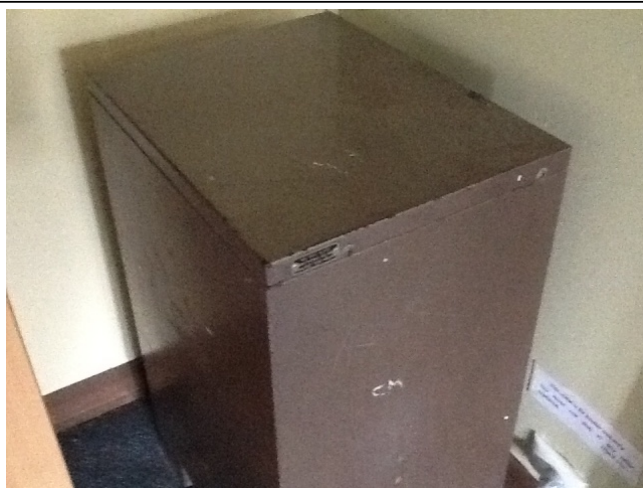
Photo No: J141683-8288-Photo139
Result: Asbestos - Presumed Positive
Building/Level: Building 4-Level Three
Room/Location: 4R3002-Classroom-Various Throughout
Feature/Material: Heater-Insulation

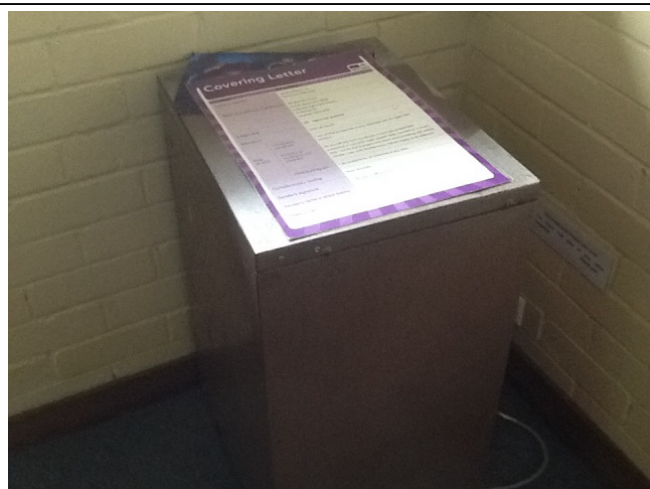
Photo No: J141683-8288-Photo135
Result: Asbestos - Presumed Positive
Building/Level: Building 4-Level Three
Room/Location: 4R3004-Classroom-Various Throughout
Feature/Material: Heater-Insulation

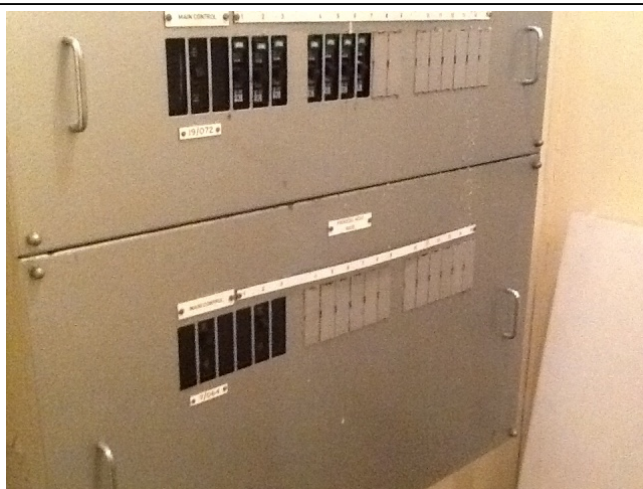
Photo No: J141683-8288-Photo150
Result: Asbestos - Presumed Positive
Building/Level: Building 4-Level Three
Room/Location: 4R3007-Electrical Switchboard-East
Feature/Material: Electrical - Switch Board-Compressed Bituminous Electrical Panel

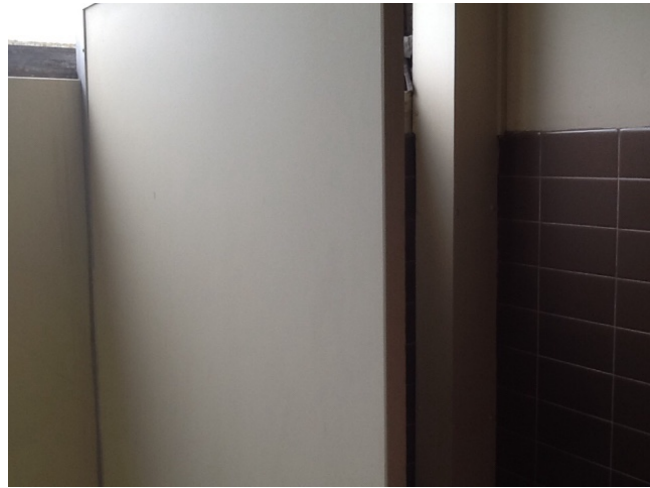
Photo No: J141683-8288-Photo149
Result: Asbestos - Previously Sampled Positive
Building/Level: Building 4-Level Three
Room/Location: 4R3010-Toilet-Throughout
Feature/Material: Cubicle Partitions-Compressed Cement Sheet
