ARBORICULTURAL IMPACT ASSESSMENT REPORT

SITE ADDRESS	W6A and W6B Arts Precinct, Macquarie University
CLIENT	Macquarie University
REPORT PREPARED BY	Australian Tree Consultants Pty Ltd
DATE	18 April 2017

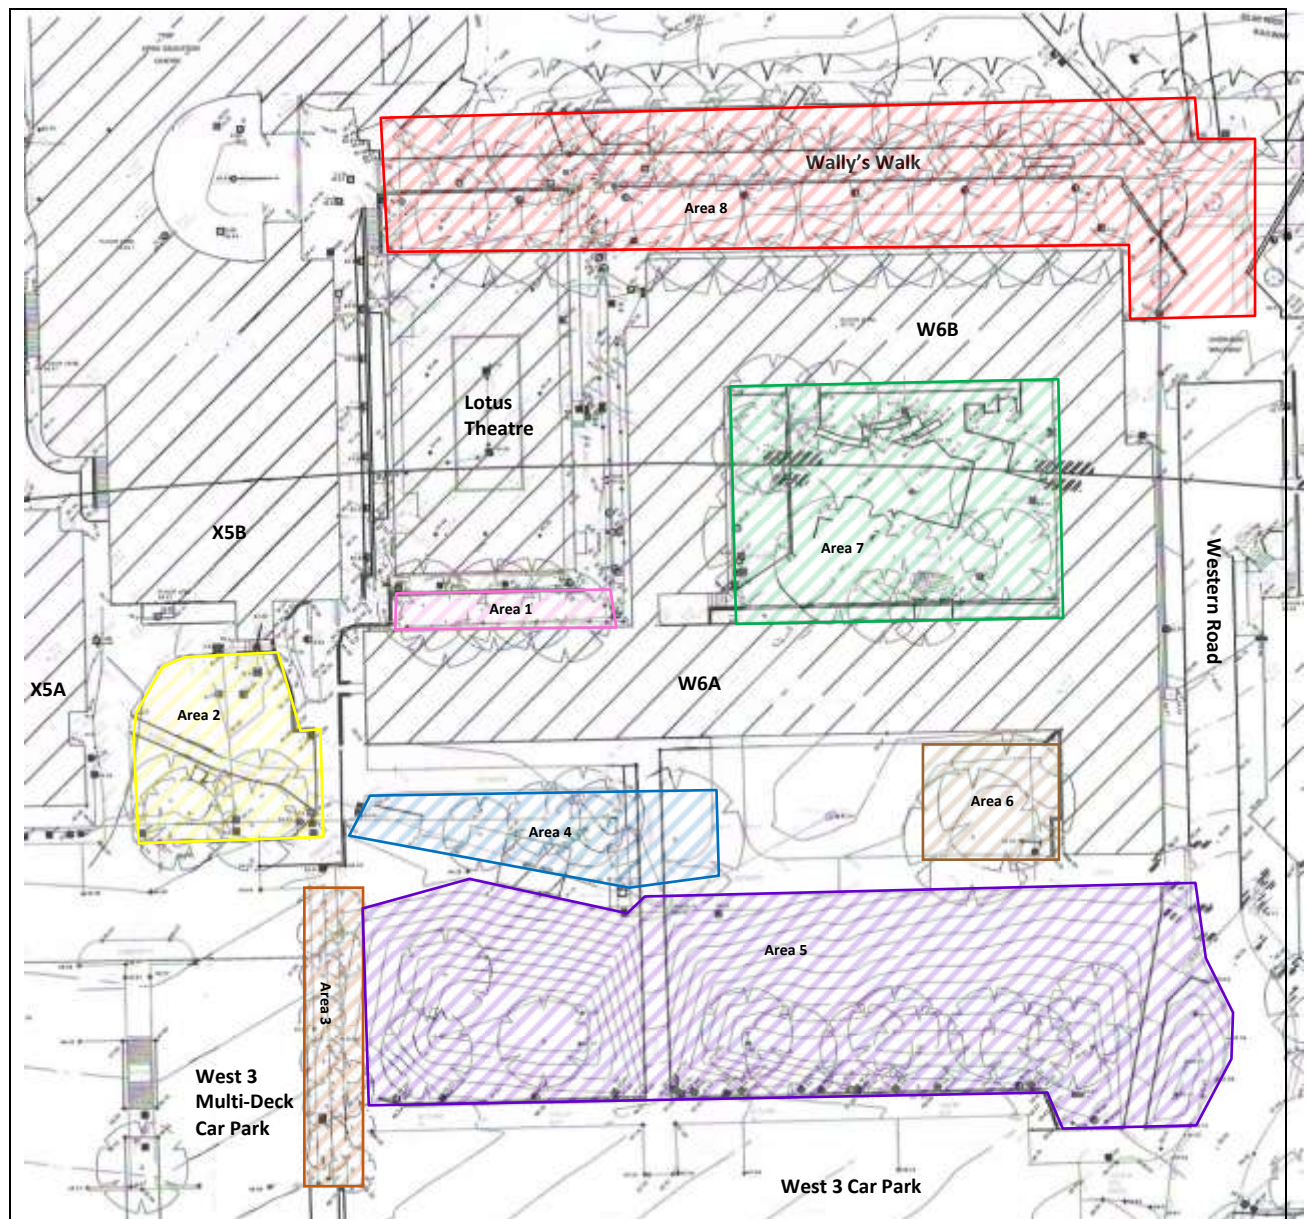
Due to the nature of the existing plantings and the proposed works, this report will refer to relevant areas and blocks of trees. For ease of reference, these areas will be identified by their location. Image 2 below, details the location and designated title for each area discussed.
