**Tahmoor Coal Pty Ltd**

# QUARTERLY PROGRESS REPORT

**Myrtle Creek CMAP & Redbank Creek CMAP**

**June 2020**

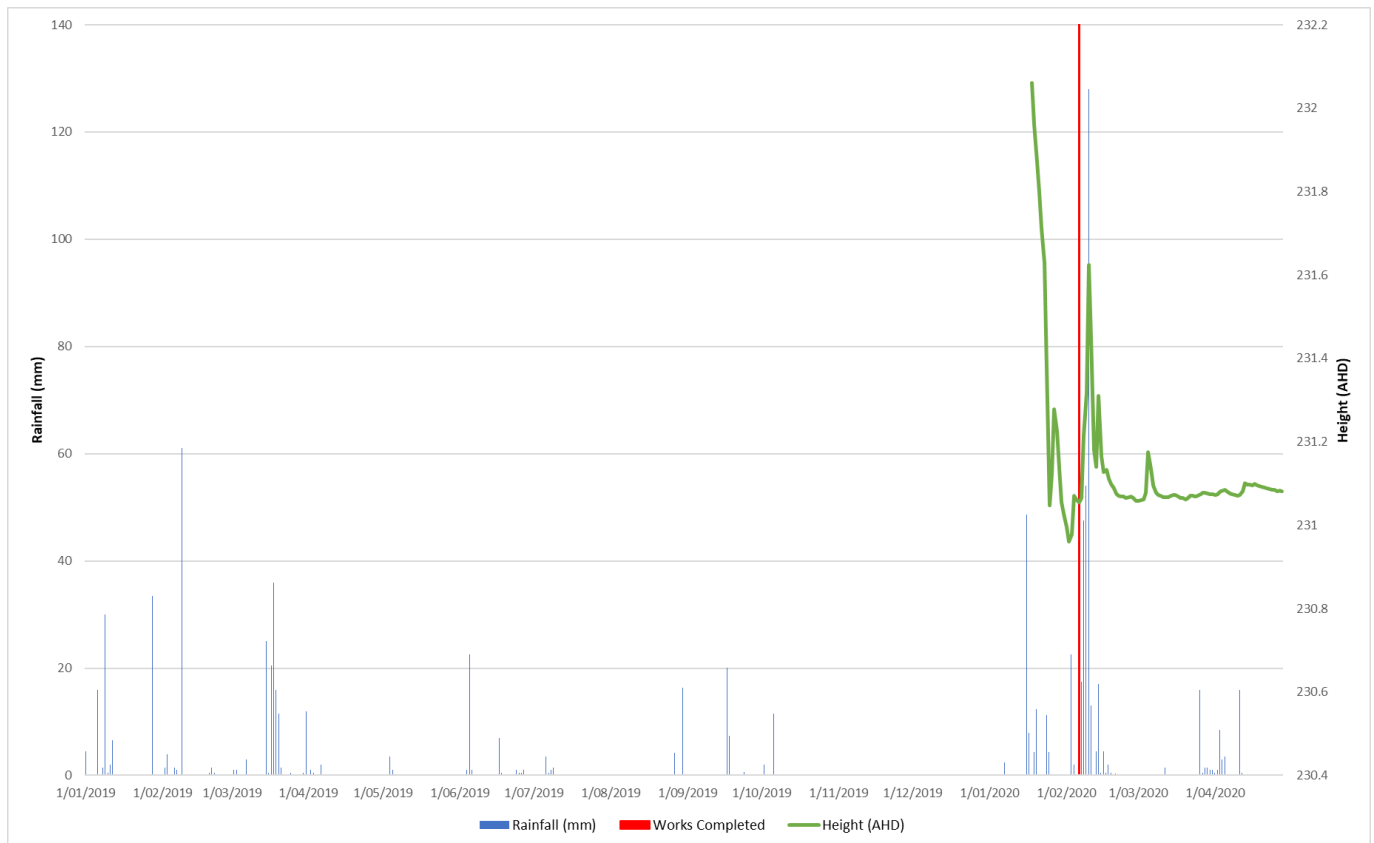
**Figure 2: Myrtle Creek M5 – Pool 23 Level Monitoring**

Level monitoring is conducted at *Myrtle 5* which is located within Pool 23. **Figure 2** illustrates pool height level at Pool 23 with rainfall. Rainfall data is collected from the weather station located at Pool 23 from 11 October 2019 onwards and Tahmoor Coal mine site from 2010. Pool height is

measured as zero if the monitoring equipment is not submerged in water. Prior to remediation works, rain events in 2019 had no noticeable impact to Pool 23 height due to subsidence impacts and its inability to competently hold water, hence no pool level was recorded. It can be observed, that following remediation works, Pool 23 has effectively filled to its full level which has since been sustained.

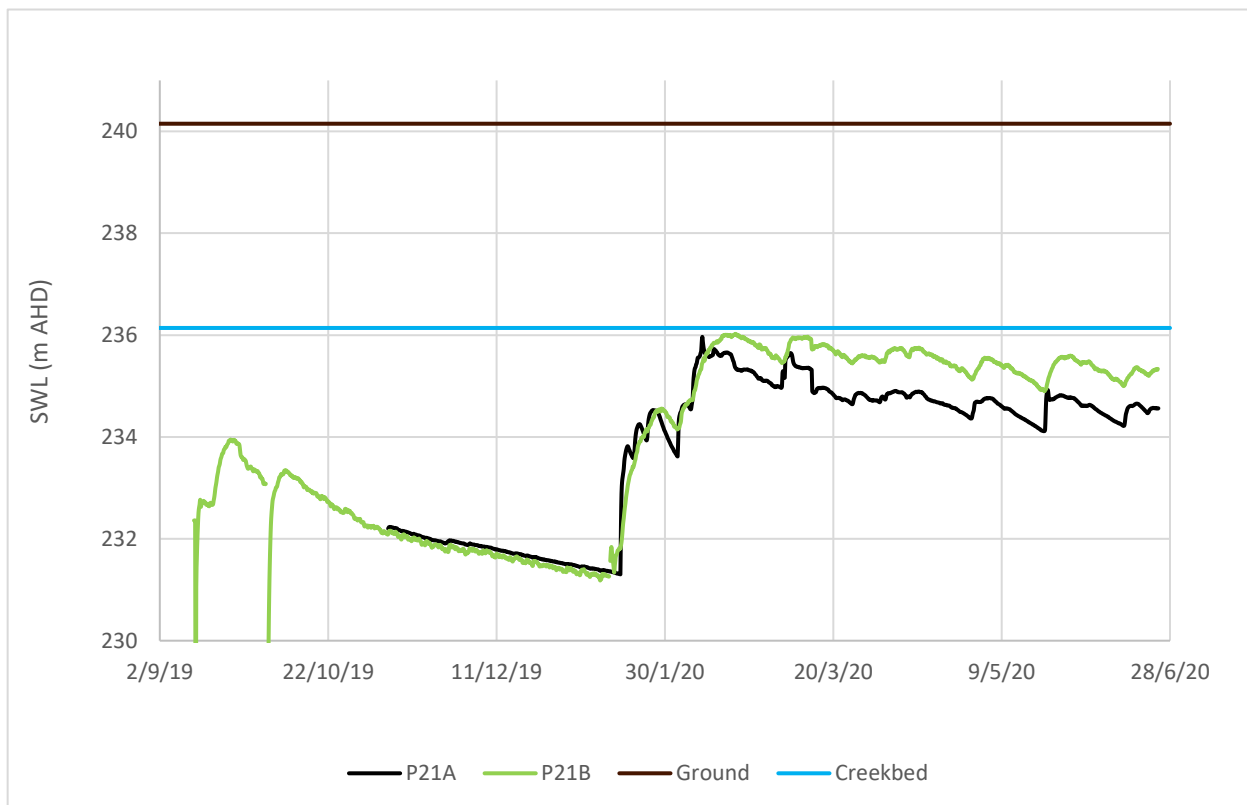
**Figure 4: Standing Water Level at P21**

**Figure 4 and 5** shows the standing groundwater level at locations near Pool 20. It can be observed that the water level sits at approximately 1 m below the creek level at P21, suggesting a losing system at this location, while it sits more than 2m above the creek level at P22, suggesting a gaining system at this location. The controlling rock bar at Pool 20, which is proposed to be remediated as part of Stage 2 sits between these two monitoring points. As the groundwater is at or above the creek level, it is anticipated that a grout curtain wall will have a positive effect on returning pool holding capacity at Pool 20.

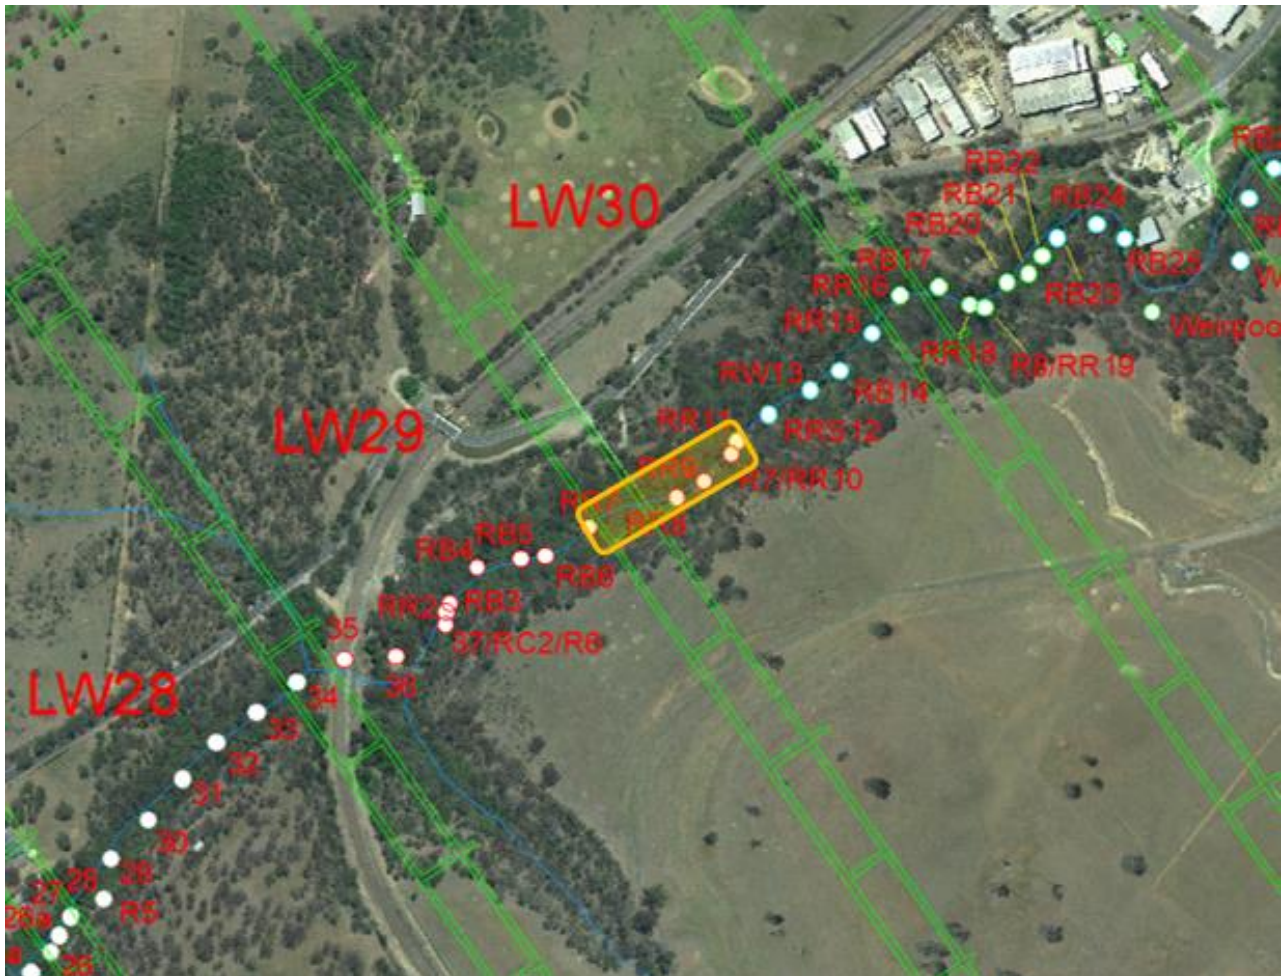
**Figure 6: Redbank Creek Remediation Sites**

Remediation of 5 pools at Redbank Creek (RR7, RR8, RR9, RR10 and RR11) commenced in February 2020 and were completed in early May 2020. All pools were located within an exposed sandstone shelf that had been impacted by subsidence (see **Figure 6**). Remediation efforts were aimed at increasing pool holding capacity at individual pools and to return surface flow after future rock bar grout curtain works upstream. The works carried out at each pool included:

- RR9 – Grout Grid Pattern, 1 m deep, 12 m x 12 m;
- RR10 – Grout Grid pattern, 1 m deep, 12 m x 14 m; and
- RR11 – Grout Curtain, 2 m deep, 16 m wide.

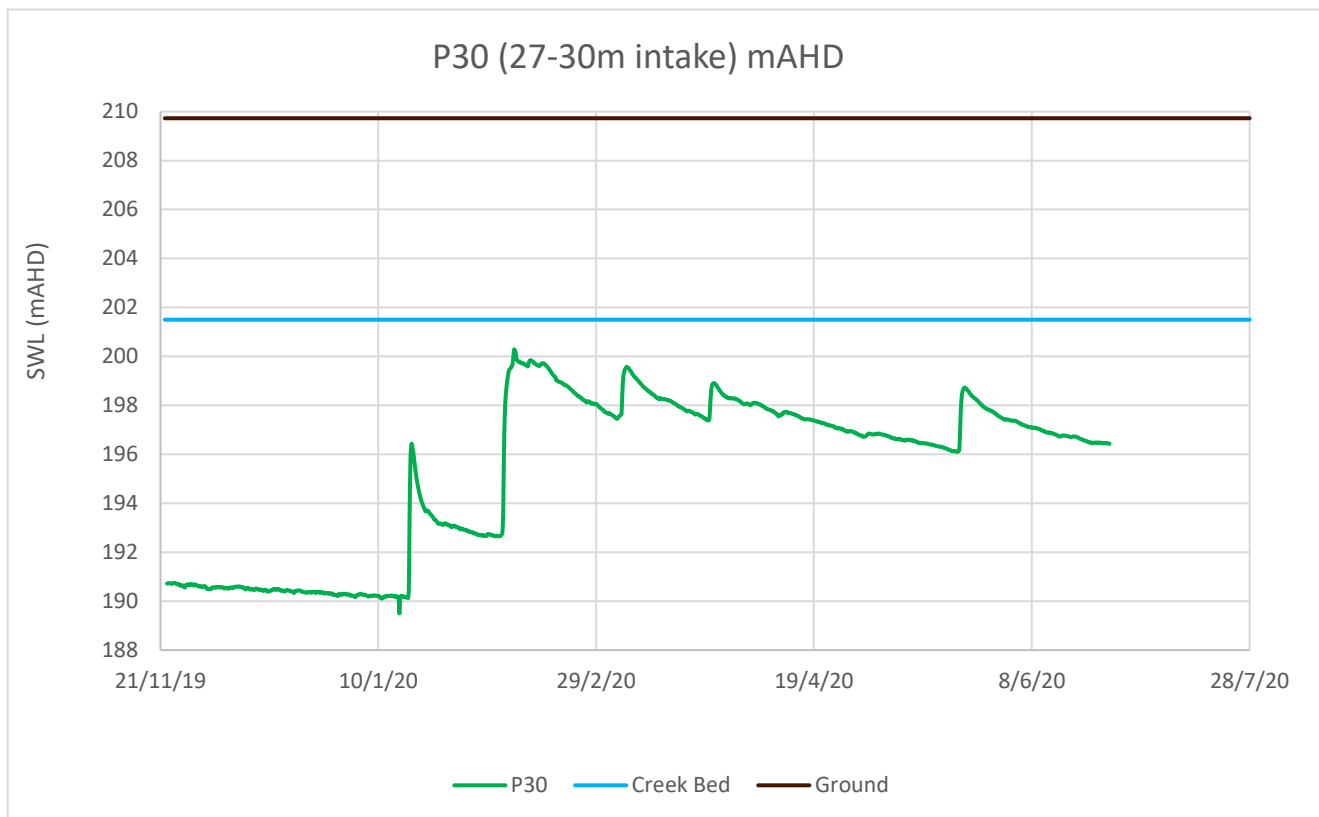
**Figure 9: Standing Groundwater Level at P30 (Redbank Creek)**

**Figure 9** illustrates the standing groundwater level at P30 relative to the creek bed. P30 is located within close proximity to Weir Pool / 26 and shows that the groundwater level is approximately 4 m below the creek bed. **Figure 10** illustrates the standing groundwater level at P33 relative to the creek bed. P33 is located within close proximity to Weir Pool / 26 and shows that the groundwater level varies approximately 2 m above and below the creek bed. The groundwater level determines the effectiveness of a grout curtain at varying depths.

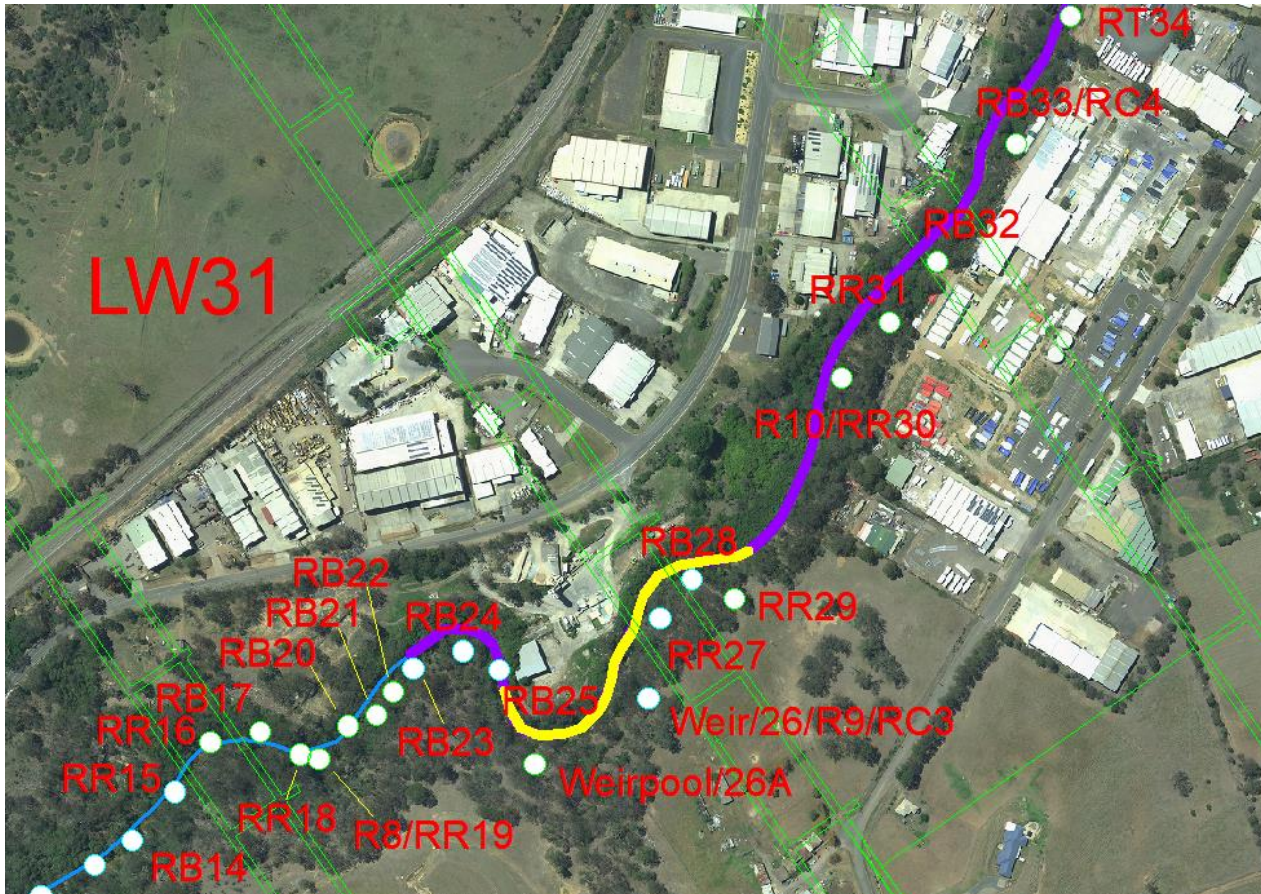
Figure 12: Anticipated remediated pool holding areas (yellow) and current pool holding areas (purple)

Shallow pattern grouting works will target the base of Pools 27, 28 and 29 to increase pool holding capacity. The pools immediately upstream (RB23, RB24 and RB25) and pools immediately downstream of Pool 29 do not appear to have been affected by subsidence. It is anticipated that these works will provide connective flow from RB23 to Pool 30, and into the reach of Redbank Creek that has not been undermined. **Figure 12** illustrates the proposed return to flow and pool holding capacity at Weir Pool / 26 and pools 27 to 29. Works will be conducted in parallel with each other and commence on 6 July 2020 and be completed in October 2020.
