HAZARDOUS MATERIALS SURVEY JHHIP PROJECT, JOHN HUNTER HOSPITAL CAMPUS

Prepared for HEALTH INFRASTRUCTURE Prepared by RCA Australia RCA ref 14399A-401/2 April 2021

HAZARDOUS MATERIALS SURVEY JOHN HUNTER HEALTH AND INNOVATION PRECINCT PROJECT

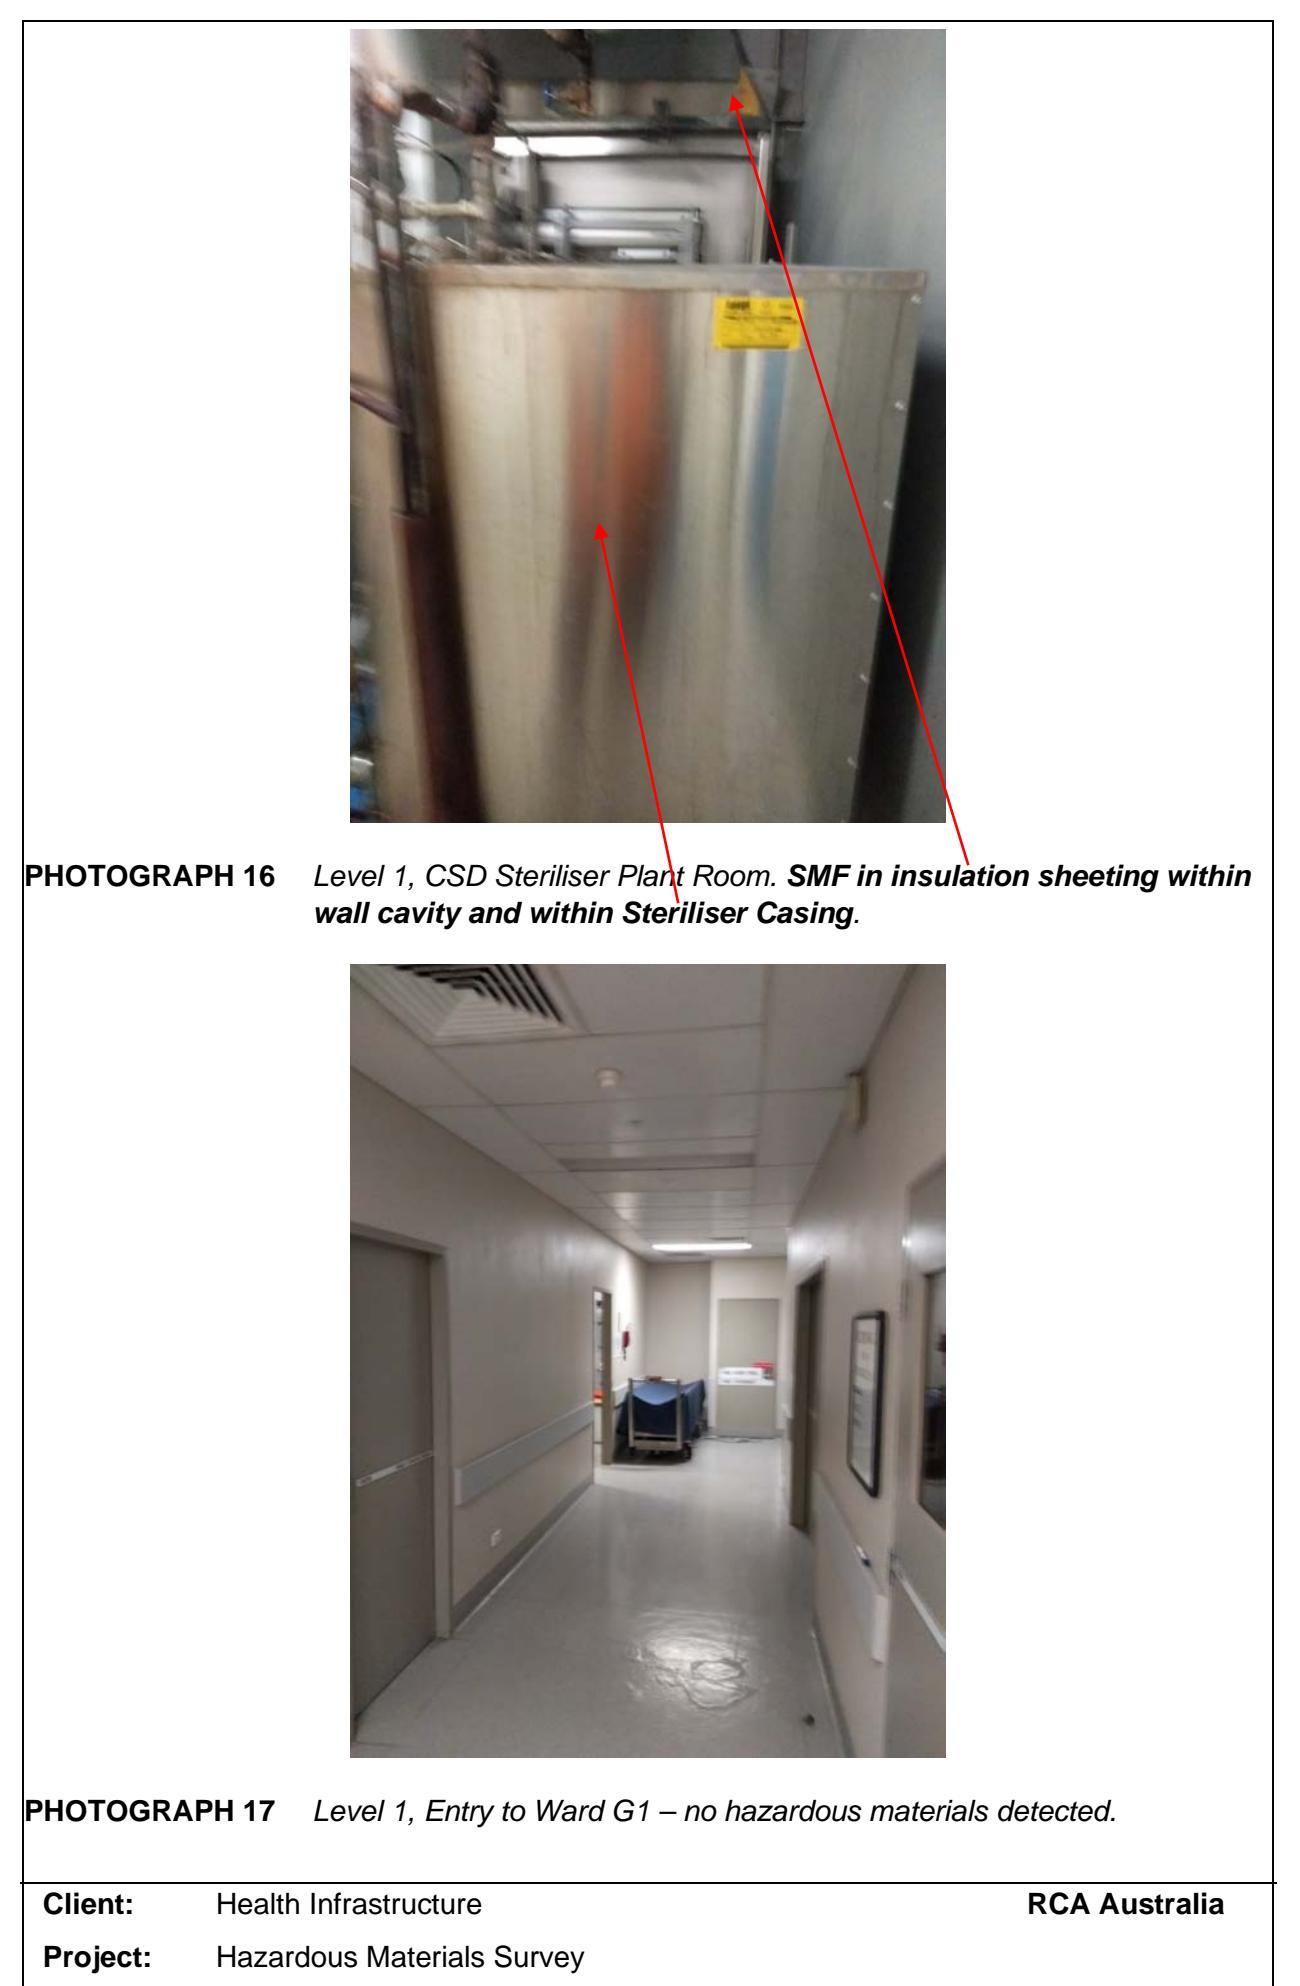
JHH Level	Area/ room	Floor	Walls	Ceiling	Other
0	Mortuary (Photograph 18)	N/A	N/A	N/A	N/A
1	CSD	N/A	N/A	N/A	SMF within equipment in steriliser plant room: pipe lagging (refer to Photograph 15), sheets inside steriliser (as advised by site personnel) and insulation in wall panel (refer to Photograph 16).
2	All	N/A	N/A	N/A	Ceiling cavity has ductwork which has insulation similar to Level 3 ductwork, therefore SMF.
3	NICU	N/A	N/A	N/A	SMF within duct insulation in ceiling cavity (refer to Photograph 1).
3	ICU/PICU	N/A	Blue paint on the fire door (refer to Photograph 5) of room no. 3149 was sampled (JH-1) for LBP: results in Table 2 below confirm not lead based paint.	N/A	SMF within insulation sheets in ceiling cavity (refer to Photograph 4).
3	Operating theatres	N/A	N/A	N/A	Some of the fluorescent ceiling lights may have fittings that contain PBC materials (as advised by site personnel) (refer to Photograph 6 and more details in Section 4).

PHOTOGRAPH 15 Level 1, CSD Steriliser Plant Room. SMF in pipe lagging insulation.

- SMF is to be considered a potentially hazardous material and inhalation and contact minimised. The SMF is to be bagged in heavy duty plastic bags / wrap as close as practicable to the location it is situated and mitigation measures to minimise the potential for it to be blown around are to be implemented.

- The bags are to be sealed prior to moving.
- Personnel handling this material are to wear a face mask and disposable clothing to reduce the risk of inhalation and dermal contact and the area is to be vacuumed to remove potential stray fibres prior to the commencement of other works.
