arboricultural impact assessment & moreton bay fig management plan

AIA-01

Revision A, Issued for Development Application
15 August, 2019

Site 2A and 2B, Sydney Olympic Park

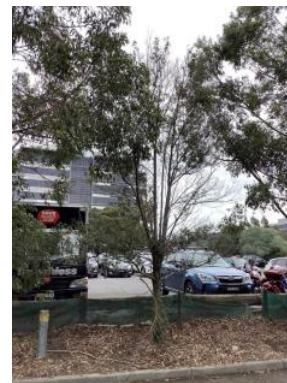
ID # 024

Species: *Acmena smithii*

Current Form: Poor
Current Vigour: Poor
Age Class: Semi-mature
SULE: Medium (15-40 years)

Retention Value: Low

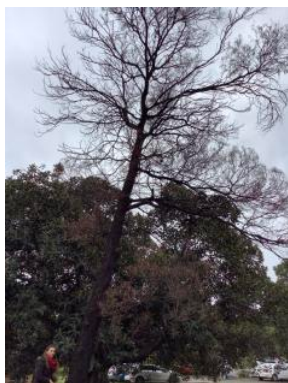
ID # 033

Species: *Acacia parramattensis*

Current Form: Poor
Current Vigour: Dead
Age Class: Dead
SULE: Remove (<5 years)

Retention Value: V Low / Remove

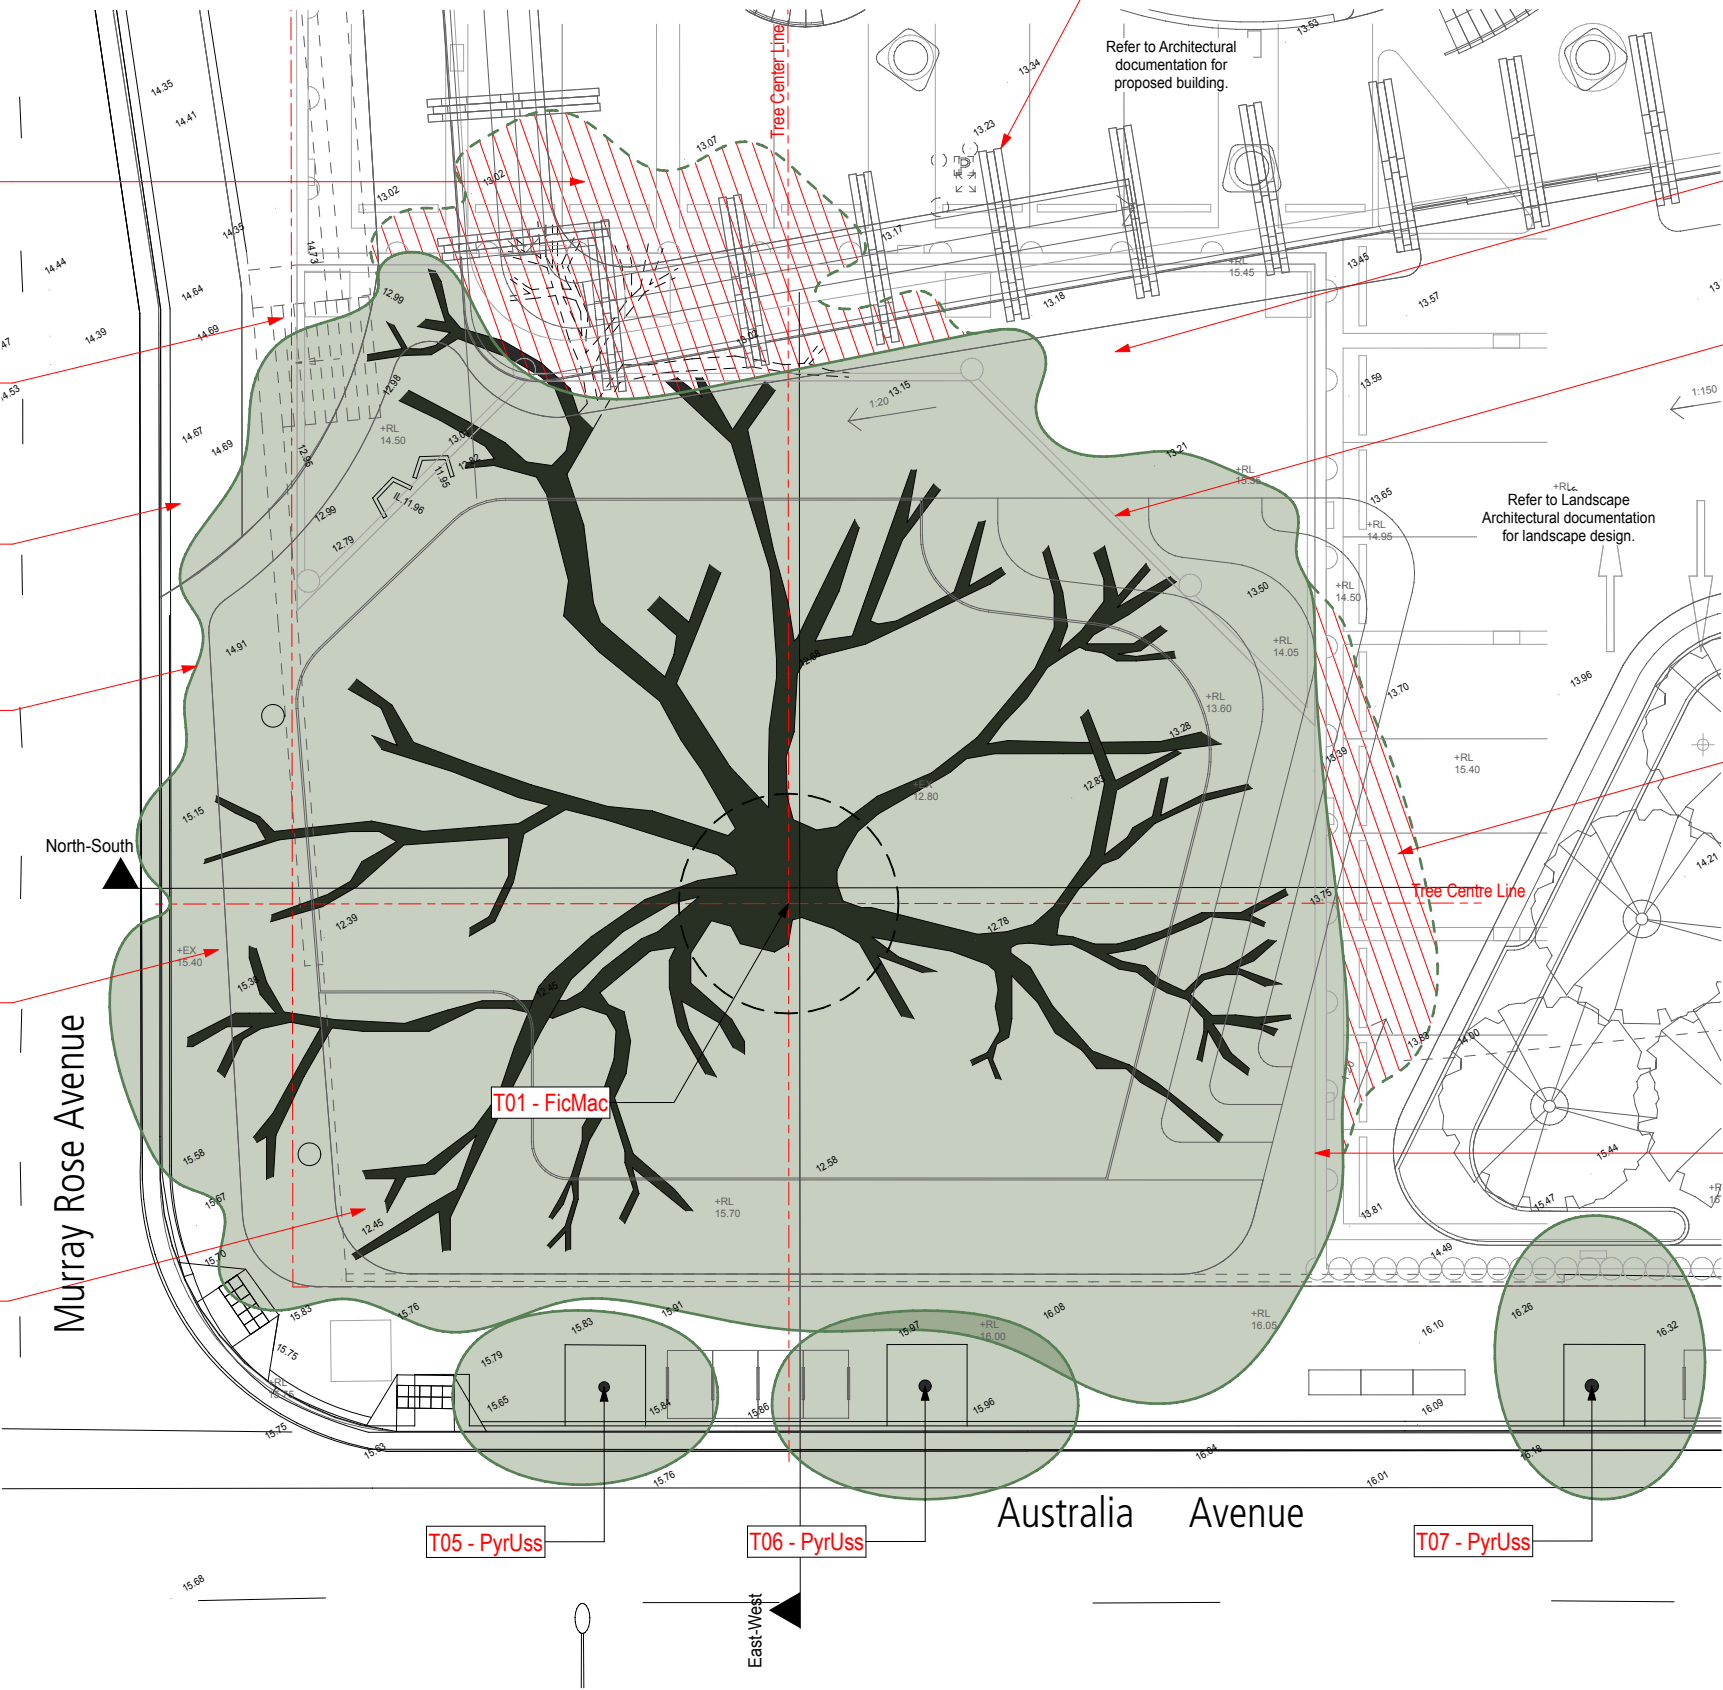
5.7 *Ficus macrophylla* – Canopy Impact Plan

Judicious canopy pruning is to be undertaken selectively and incrementally under the direction of the Project Arborist. This small portion of the canopy is to be pruned for access and construction clearances. Approx. 3-4% of total canopy.

Extent of basement piled wall.

Canopy and branches extending beyond the TPZ fencing are not to be damaged or removed during construction. Any pruning required for clearance to final build facades or scaffold is to be approved and supervised by Project Arborist. Piling is to be completed with low height piling rigs when under canopy. Refer to TIP.
