Preliminary Arboricultural Report

Tweed Valley Hospital Project

17 October 2018

Preliminary Arboricultural Report relating to four (4) individual trees and 150+ hedgerow trees located at 771 Cudgen Road Kingscliff NSW

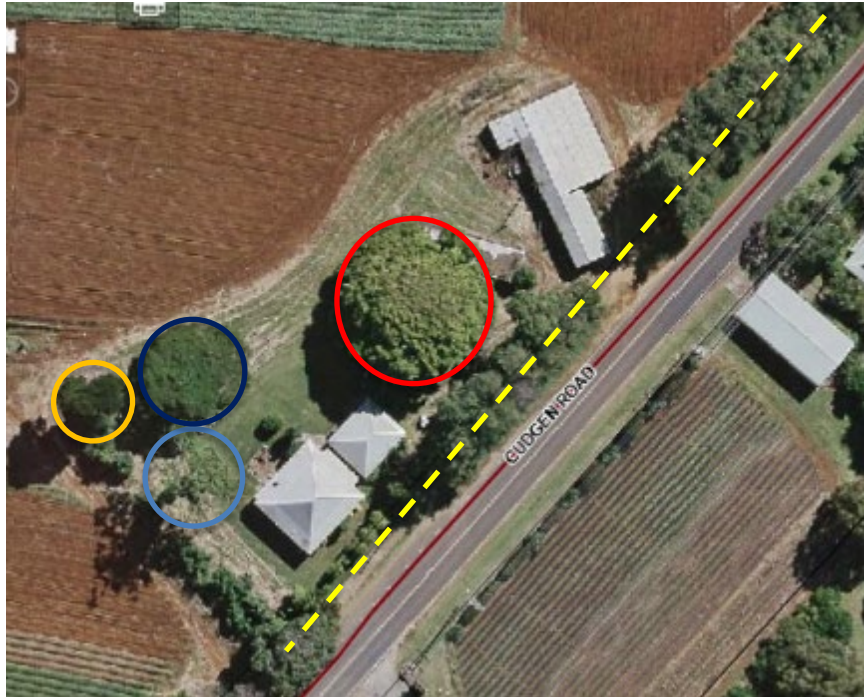
Figure 4. The location of the four (4) individual site trees around the existing house site and the line of windbreak trees. Tree 1 – light blue circle, Tree 2 – orange circle, Tree 3 – purple circle, Tree 4 – red circle, Windbreak and regenerating trees – yellow dash line. Source: Image obtained from Tweed Shire Council LEP mapping tool, August 2018. Coloured circles and lines placed by the author.

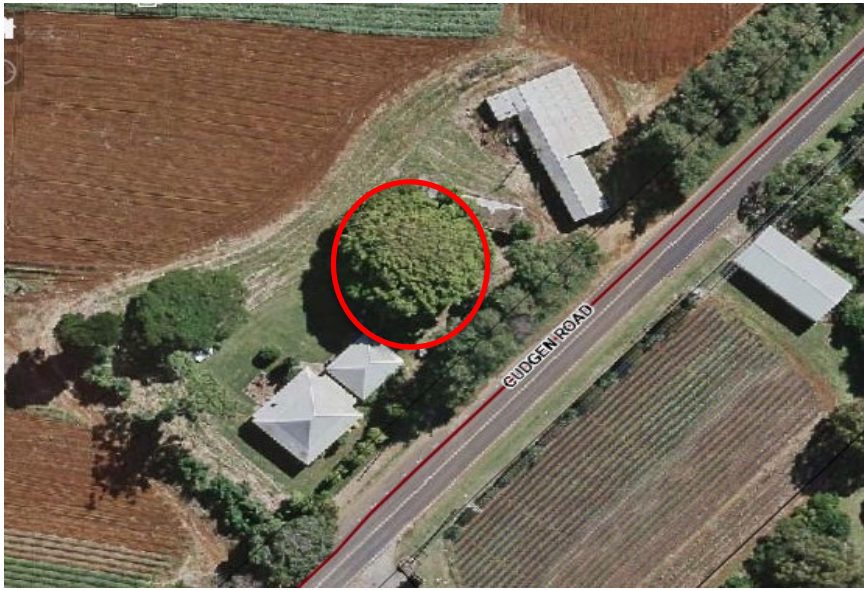
5.2.2 The one (1) Category A Tree was tree number 4.

Figure 5. Aerial image showing the location of High Retention Value Trees. Tree attributes are to be obtained from the Appendix C – Preliminary Tree Assessment Data. Source: image obtained from Tweed Shire Council LEP mapping tool, August 2018. Coloured circle placed by the author

- 5.2.3 Tree 4 was a *Ficus benjamina* (Weeping Fig). The tree was located adjacent to Cudgen road, immediately east of the existing house structure. The tree was large and well established for its species and formed a significant feature within the landscape (see Figure 6).
- 5.2.4 Tree 4 was of good health and fair structure and had an estimated life expectancy of greater than 25 years (25–50 years). The lower trunk structure was a mass of competing stems typical of the species (see Figure 7).
- 5.2.5 The TPZ for Tree 4 is 15m, and the SRZ is 3.9m, measured at a radial distance from the centre of the trunk.

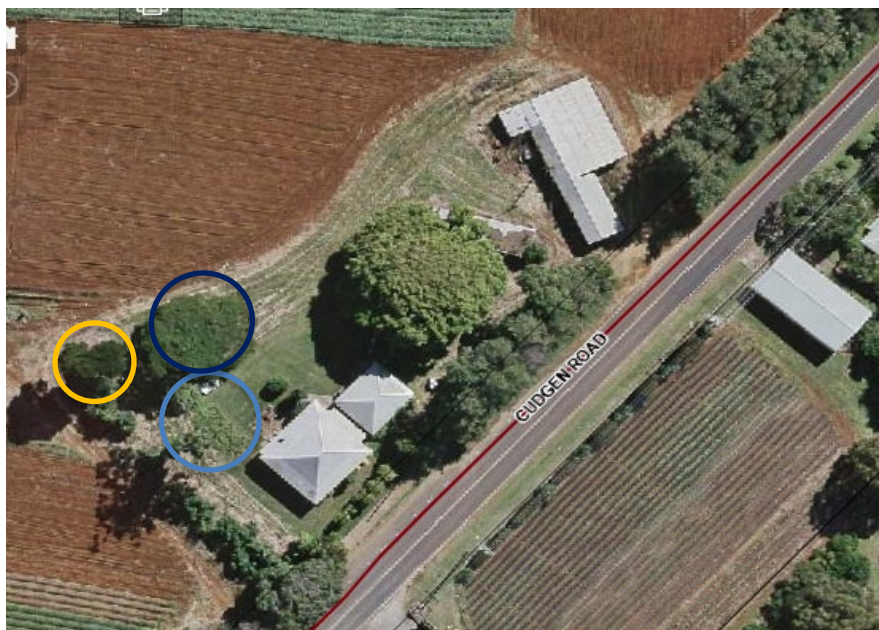
5.3.2 Category B Trees were numbered; 1, 2 & 3 (see Figure 8).

Figure 8. Aerial image showing location of three (3) Moderate Retention Value Trees. Tree 1 – light blue circle, Tree 2 – orange circle, Tree 3 – purple circle. Tree attributes are to be obtained from the Appendix C – Preliminary Tree Assessment Data.
Source: image obtained from Tweed Shire Council LEP mapping tool, August 2018. Coloured circles placed by the author

- 5.3.3 Tree 1 was a *Ficus obliqua* (Small Leafed Fig). The tree was considered to be in good health with a fair structure. The tree canopy had a significantly crown bias to the east, attributed to suppression from an adjacent, previously removed tree, which detracted from its overall visual / aesthetic appearance (see Figure 9).
- 5.3.4 The tree had established over and around a decaying stump, from the previously removed tree, causing cavities and uneven growth with the basal area and structural roots. Overall structural stability was not considered to be compromised, at the time of inspection, and root growth of this kind was considered typical of the species. A large European bees' nest was observed within the basal hollows of the tree.
- 5.3.5 The TPZ for Tree 1 is 12m, and the SRZ is 4.4m, measured at a radial distance from the centre of the trunk.

- 5.3.6 Tree 2 was a *Cupaniopsis anacardioides* (Tuckeroo). The tree was of a large size for the species and considered in good health with a fair structure. The tree canopy had a significantly crown bias to the north east, attributed to suppression from an adjacent previously removed tree, which detracted from its overall visual / aesthetic appearance (see Figures 10 and 11). Several wounds from previous lateral branch failures were observed within the crown.
- 5.3.7 The TPZ for Tree 2 is 7.2m, and the SRZ is 2.8m, measured at a radial distance from the centre of the trunk.

- 5.3.8 Tree 3 was a *Delonix regia* (Poinciana). The tree was of a moderate height for the species and was in good health with a fair structure. Several included unions between co-dominant stems were observed. Although these unions were considered stable at the time of assessment they could detract from the tree's long-term structural stability.
- 5.3.9 The TPZ for Tree 3 is 9.4m, and the SRZ is 3.4m, measured at a radial distance from the centre of the trunk.

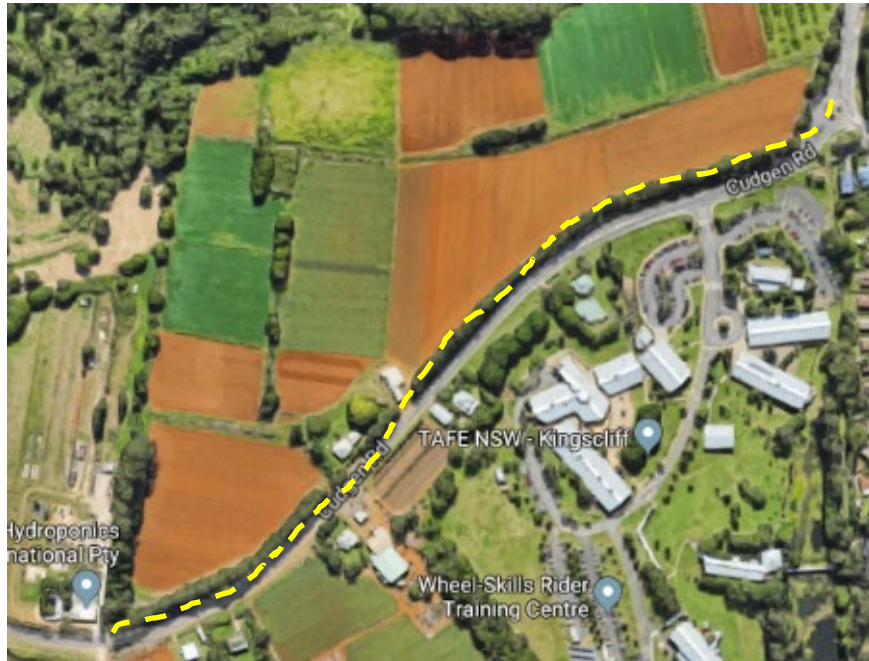
- 5.4.1 The wind break / hedge trees described in Section 4.4.5 of this report, including the various associated regenerating / understory trees, were considered Category C Trees. Trees in this category are typically of low quality with an estimated remaining life expectancy of 5–15 years, or young trees that are easily replaceable, may have poor health and/or structure, are easily replaceable, or are of undesirable species and do not warrant design consideration.
- 5.4.2 Category C trees are identified as wind break and regenerating trees within Appendix C of this report.

Figure 13. Aerial image showing location of Low Retention Value wind break and regenerating trees. The tree locations are identified by the yellow dash line. Source: image obtained from Tweed Shire Council LEP mapping tool, August 2018. Line placed by the author

- 5.4.3 The line of wind break trees on the boundary of Cudgen Road were identified as *Pinus elliottii* (Slash Pine), of which there were over 150 individual trees (estimated), planted at 3-4m spacings. The DBH of the larger trees was observed to be approximately 40cm (at 1.4m above ground level) with estimated heights of between 15–20m.
- 5.4.4 *Pinus elliottii* (Slash Pine) is regarded as an environmental weed in Queensland and New South Wales (BCC website – 2018) with a variety of control recommendations.
- 5.4.5 The trees provide some screen value between the site and neighbouring properties, however ease of growth (possible weedy tendencies), limited ULE and species type resulted in a classification of Low Retention Value.
- 5.4.6 The average TPZ for the *Pinus elliottii* (Slash Pine) was 4.8m, measured at a radial distance from the centre trunk.

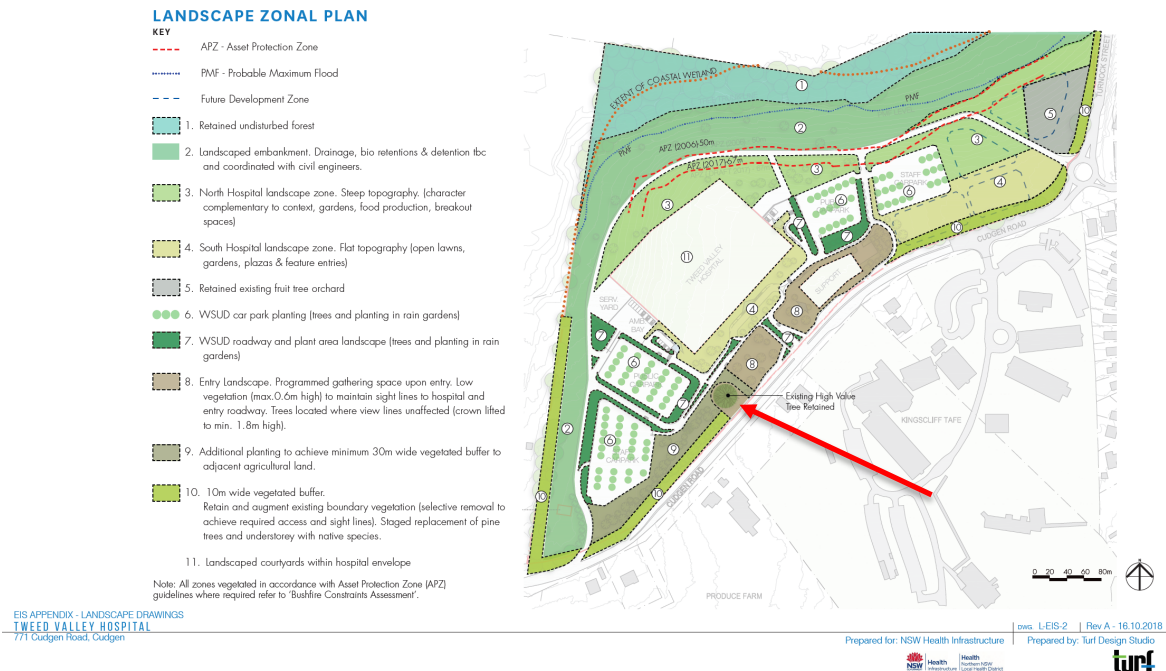
- 6.2.6 Based on the recently released draft 'Concept Landscape Zonal Plan' (Figure 16) the removal of a number of individual subject trees, along with sections of the existing roadside windbreak trees, was considered likely due to major encroachments potentially occurring during the proposed road construction works. This presumption was supported by a review the draft 'Tree Removal and Preservation Plan' (Figure 17).

Figure 16. Concept Zonal Landscape Plan. The location of Tree 4 is identified with a red arrow.
Source: Provided by TSA Management, 16 October 2018

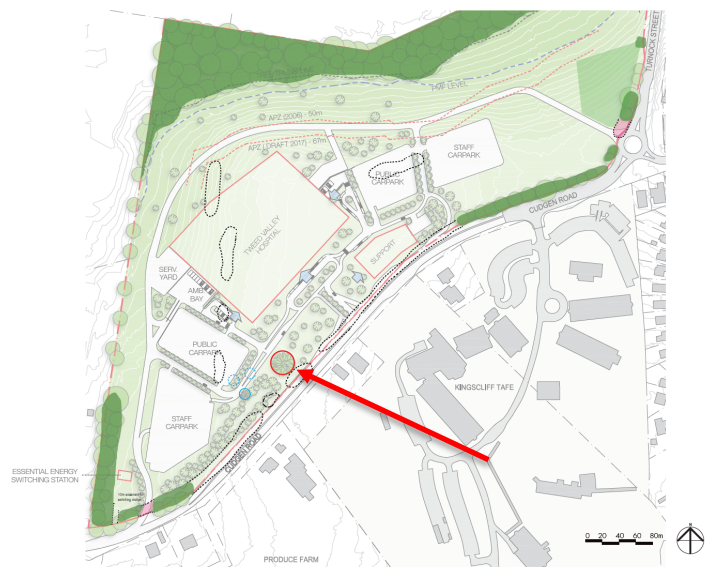
Figure 17. Concept 'Tree Removal and Preservation Plan'. The location of Tree 4 is identified with a red arrow.
Source: Provided by TSA Management, 16 October 2018
