Health Infrastructure

Hazardous Building Materials Assessment

December 2018

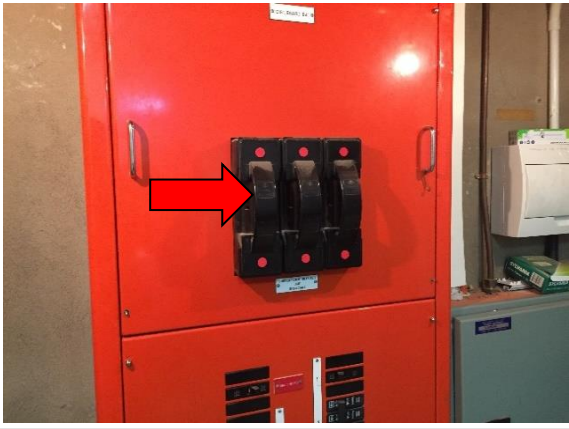
Primary Location	Secondary Location	Description	Photograph No.	Sample Number	Sample Results	Approx. Quantity	Friability	Condition	Accessibility	Action Rating	Photograph	Recommendations
Internal, room 1121	In service HRC fuses	Internal millboard membrane	3	Visual observation	Assumed to contain Asbestos	Multiple units	Y	G	VL	Very Low

Maintain in good condition if to remain in-situ. Remove under controlled friable asbestos removal conditions prior to disturbance, refurbishment or demolition works by a Class A (friable) licensed asbestos removal contractor.
Internal, room 1121	MDI units	Mastic	4	Refer 84427	Chrysotile Asbestos Detected	3 units	Y	G	VL	Very Low

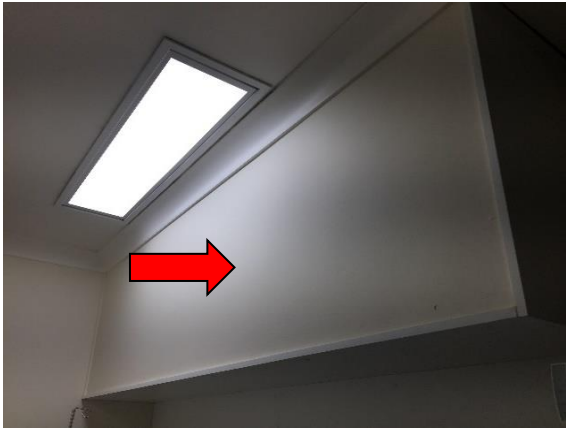
Primary Location	Secondary Location	Description	Photograph No.	Sample Number	Sample Results	Approx. Quantity	Friability	Condition	Accessibility	Action Rating	Photograph	Recommendations
Internal, recovery store room	Bulk head	Fibre cement sheet	16	84447	Chrysotile Asbestos Detected	N/A	N	G	L	Very low

Maintain in current condition if to remain in-situ. Remove under controlled non-friable asbestos removal conditions prior to disturbance by refurbishment or demolition works by a Class B (non-friable) licensed asbestos removal contractor.
Internal, room 1092	Ceiling lining	Fibre cement sheet	17	84449	Chrysotile Asbestos Detected	5m ²	N	G	VL	Very Low

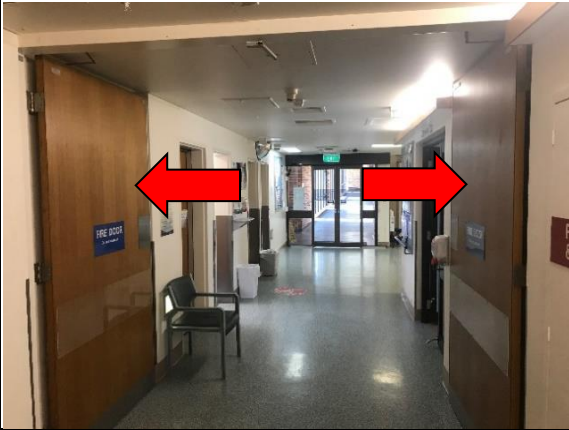
Primary Location	Secondary Location	Description	Photograph No.	Sample Number	Sample Results	Approx. Quantity	Friability	Condition	Accessibility	Action Rating	Photograph	Recommendations
Internal, corridor 1080, adjacent lift	Double fire doors (unlabelled)	Door core insulation	19	Visual observation	Assumed to contain Asbestos	2 units	Y	G	H	Medium

Investigate internal components of fire doors when building is in vacant possession. If asbestos containing door core insulation is identified, remove under controlled friable asbestos removal conditions prior to refurbishment or demolition works by a suitably licensed asbestos removal contractor.
Internal, LG plantroom	Red/brown gaskets throughout	Gaskets	8	84463, 69318	Chrysotile Asbestos Detected	2 units	Y	G	L	Low

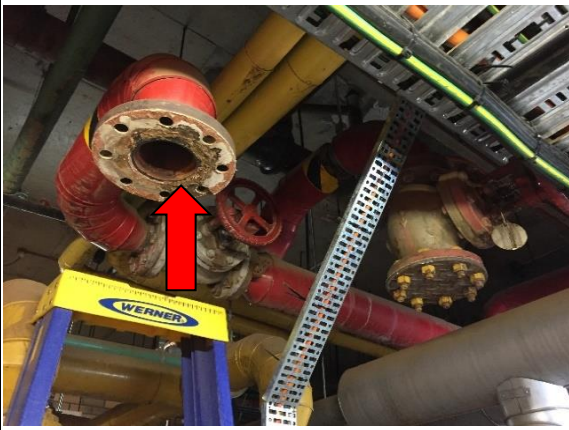
ACM onsite found to be in friable and poor condition, such as the exposed gasket to LG plantroom of Building No.1, and the pipe lagging debris to sub floor areas of Building No.17, must be addressed immediately; access to the areas must be restricted and the material removed as soon possible by a suitably licensed asbestos removalist contractor.

Internal, LG plantroom	Exposed red gasket	Gasket	9	69319	Chrysotile Asbestos Detected	1 unit	Y	P	L	Medium

Restrict access to area. Remove under controlled friable asbestos removal conditions by a Class A (friable) licensed asbestos removal contractor.

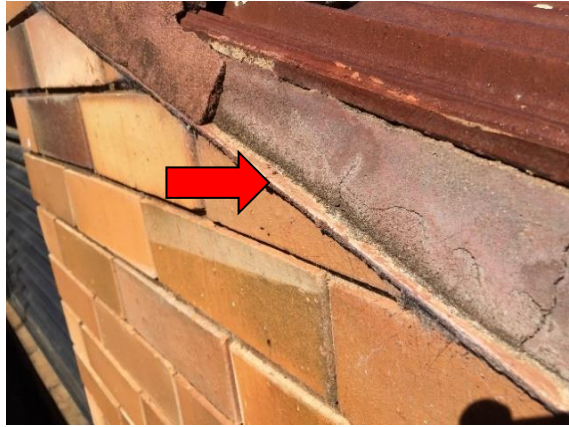
Primary Location	Secondary Location	Description	Photograph No.	Sample Number	Sample Results	Approx. Quantity	Friability	Condition	Accessibility	Action Rating	Photograph	Recommendations
Building No. 2, General Ward Block												
External, rooftop	Gable verge linings	Fibre cement sheet	21	69329	Chrysotile Asbestos Detected	N/A	N	G	VL	Very Low

Maintain in good condition if to remain in-situ. Remove under controlled non-friable asbestos removal conditions prior to disturbance by refurbishment or demolition works by a Class B (non-friable) licensed asbestos removal contractor.
External, rooftop	HVAC ductwork join	Mastic	23	69328	Chrysotile Asbestos Detected	N/A	N	G	L	Very low

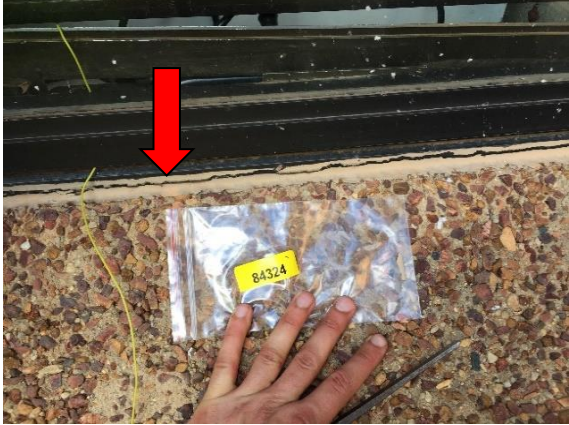
External, throughout	Building joint to window frames	Mastic	24	84324	Chrysotile Asbestos Detected	N/A	N	G	L	Very low

Maintain in current condition if to remain in-situ. Remove under controlled non-friable asbestos removal conditions prior to disturbance by refurbishment or demolition works by a Class B (non-friable) licensed asbestos removal contractor.

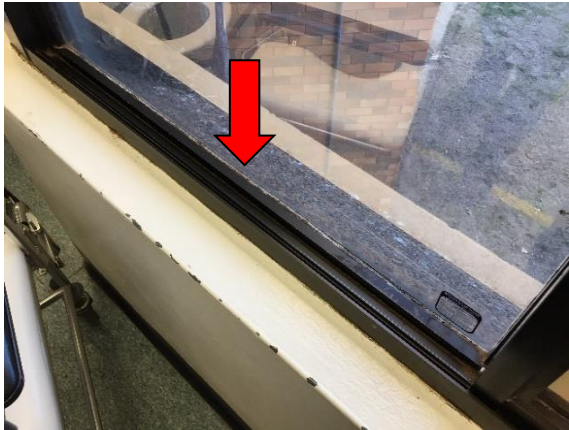
Primary Location	Secondary Location	Description	Photograph No.	Sample Number	Sample Results	Approx. Quantity	Friability	Condition	Accessibility	Action Rating	Photograph	Recommendations
Internal/ External , sporadic throughout	Windows	Caulking	32	Refer 84452, 84446, 84429	Chrysotile Asbestos Detected	N/A	N	G	L	Very Low

<p>Sample collected from this block did not contain asbestos, but due to age and appearance of the window caulking, this material should be assumed to be asbestos containing. Assess windows individually to distinguish old (asbestos containing caulking) windows from new.</p> <p>Remove windows whole without direct disturbance to caulking under controlled non-friable asbestos removal conditions prior to refurbishment or demolition works by a Class B (non-friable) licensed asbestos removal contractor.</p> <p>If scraping out of caulking is undertaken as the removal method, this should be done under friable asbestos controls by a Class A (friable) licensed asbestos removal contractor</p>

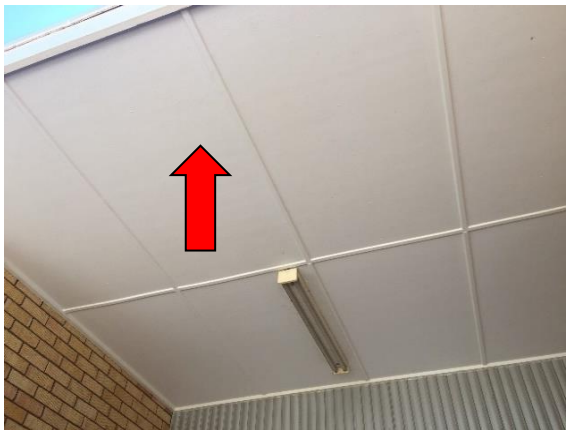
Building No. 4, Nurse Education												
The assessment of this building was a visual inspection only, as per Scope of Works												
External, entry	Awning	Fibre cement sheet	33	Visual observation	Assumed to contain Asbestos	4m ²	N	G	L	Very Low

<p>Maintain in good condition if to remain in-situ. Confirm status and remove under controlled non-friable asbestos removal conditions prior to disturbance by refurbishment or demolition works by a Class B (non-friable) licensed asbestos removal contractor.</p>

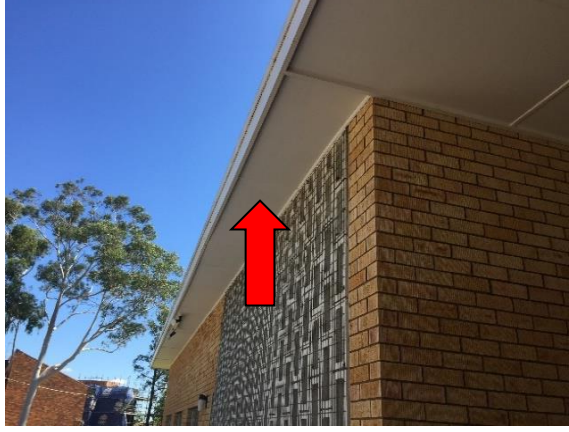
Primary Location	Secondary Location	Description	Photograph No.	Sample Number	Sample Results	Approx. Quantity	Friability	Condition	Accessibility	Action Rating	Photograph	Recommendations
External, perimeter	Eaves	Fibre cement sheet	34	Visual observation	Assumed to contain Asbestos	50m ²	N	G	L	Very Low

Maintain in good condition if to remain in-situ. Confirm status and remove under controlled non-friable asbestos removal conditions prior to disturbance by refurbishment or demolition works by a Class B (non-friable) licensed asbestos removal contractor.
External, switchboard	Backing panel	Bituminous board	35	Visual observation	Assumed to contain Asbestos	1 unit	N	G	VL	Very Low

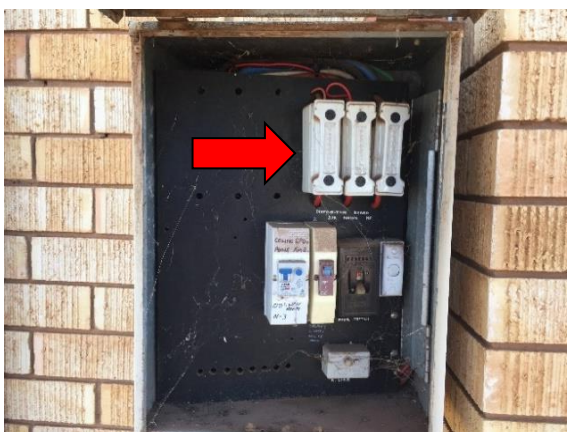
External, switchboard	In service HRC fuses	Internal millboard membrane	36	Visual observation	Assumed to contain Asbestos	3 units	Y	G	VL	Very Low

Maintain in good condition if to remain in-situ. Remove under controlled friable asbestos removal conditions prior to disturbance, refurbishment or demolition works by a Class A (friable) licensed asbestos removal contractor.

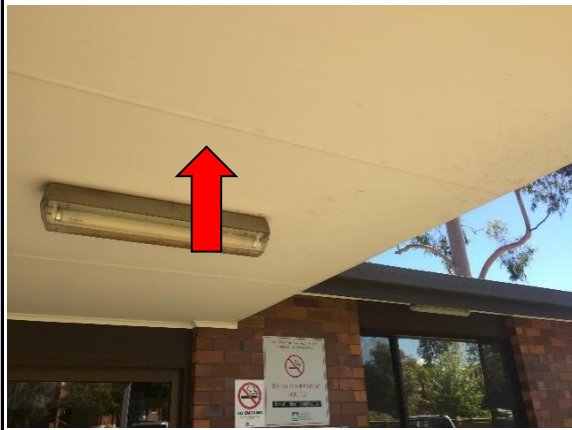
Primary Location	Secondary Location	Description	Photograph No.	Sample Number	Sample Results	Approx. Quantity	Friability	Condition	Accessibility	Action Rating	Photograph	Recommendations
Building No. 5, Dentistry												
The assessment of this building was a visual inspection only, as per Scope of Works												
External, entry	Awning	Fibre cement sheet	37	Visual observation	Assumed to contain Asbestos	4m ²	N	G	L	Very Low

Maintain in good condition if to remain in-situ. Confirm status and remove under controlled non-friable asbestos removal conditions prior to disturbance by refurbishment or demolition works by a Class B (non-friable) licensed asbestos removal contractor.
External, perimeter	Eaves	Fibre cement sheet	38	Visual observation	Assumed to contain Asbestos	50m ²	N	G	L	Very Low

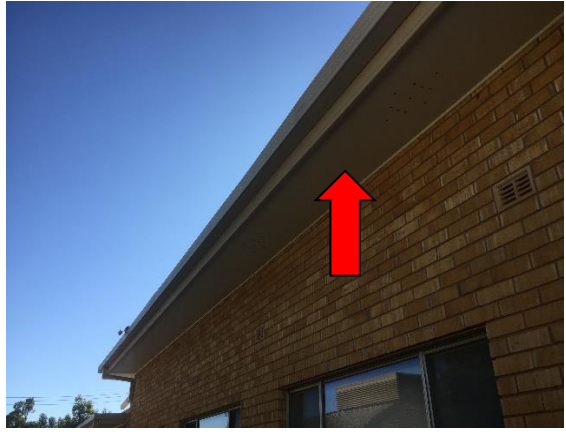
Primary Location	Secondary Location	Description	Photograph No.	Sample Number	Sample Results	Approx. Quantity	Friability	Condition	Accessibility	Action Rating	Photograph	Recommendations
Building No. 6, Maternity Unit												
External, throughout	Eaves	Fibre cement sheet	39	82596	Chrysotile & Amosite Asbestos Detected	100m ² +	N	G	VL	Very Low

Remove under controlled non-friable asbestos removal conditions prior to disturbance by refurbishment or demolition works by a Class B (non-friable) licensed asbestos removal contractor.
External, entry	Awning panels	Fibre cement sheet	40	82596	Chrysotile Asbestos Detected	50m ²	N	G	VL	Very Low

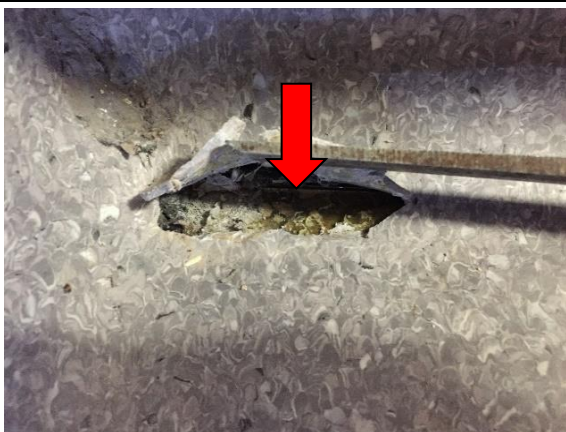
Maintain in good condition if to remain in-situ. Remove under controlled non-friable asbestos removal conditions prior to disturbance by refurbishment or demolition works by a Class B (non-friable) licensed asbestos removal contractor.
Internal, throughout (concealed)	'Pebble' look beige floor covering	Paper backed vinyl floor sheeting	41	Refer 84450	Chrysotile Asbestos Detected	200m ² +	Y	F	L	Low

Maintain enclosed and in good condition if to remain in-situ. Remove under controlled friable asbestos removal conditions prior to disturbance, refurbishment or demolition works by a Class A (friable) licensed asbestos removal contractor.

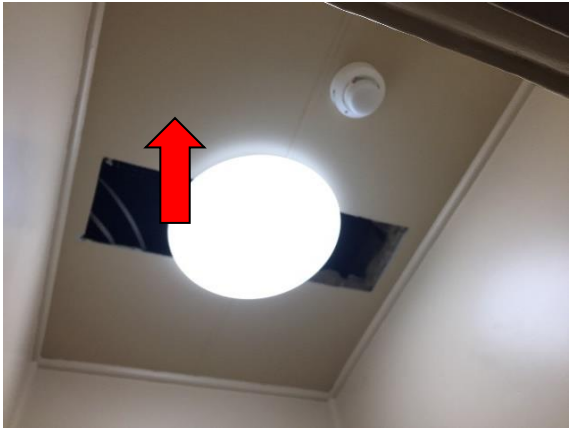
Primary Location	Secondary Location	Description	Photograph No.	Sample Number	Sample Results	Approx. Quantity	Friability	Condition	Accessibility	Action Rating	Photograph	Recommendations
Internal, rooms 4013 and 4014	Ceiling lining	Fibre cement sheet	42	84337	Chrysotile Asbestos Detected	4 m ²	N	G	L	Very Low

Maintain in good condition if to remain in-situ. Remove under controlled non-friable asbestos removal conditions prior to disturbance by refurbishment or demolition works by a Class B (non-friable) licensed asbestos removal contractor.
Internal, room 4045	Infill panel above and below windows	Fibre cement sheet	43	84339	Chrysotile Asbestos Detected	30 m ²	N	G	L	Very Low

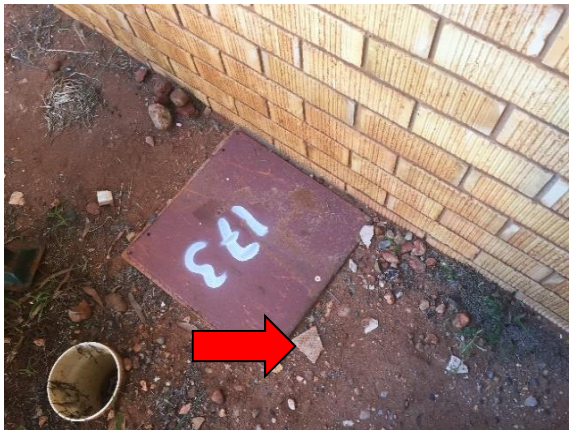
Building No. 16, Doctors Rooms												
External, south elevation	Debris to ground	Fibre cement sheet	44	82591	Chrysotile Asbestos Detected	<1 m ²	N	P	L	Low

Remove under controlled non-friable asbestos removal conditions by a Class B (non-friable) licensed asbestos removal contractor.

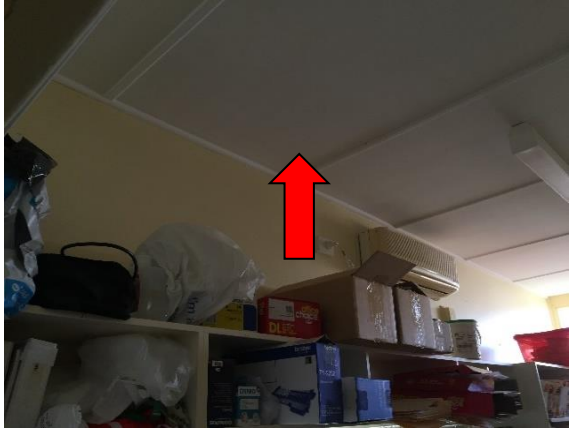
Primary Location	Secondary Location	Description	Photograph No.	Sample Number	Sample Results	Approx. Quantity	Friability	Condition	Accessibility	Action Rating	Photograph	Recommendations
Internal, room 1739	Ceiling lining	Fibre cement sheet	48	84431	Chrysotile Asbestos Detected	10 m ²	N	G	L	Very Low

Maintain in good condition if to remain in-situ. Remove under controlled non-friable asbestos removal conditions prior to disturbance by refurbishment or demolition works by a Class B (non-friable) licensed asbestos removal contractor.
Internal, room 1739	Wall lining	Fibre cement sheet	49	84432	Chrysotile Asbestos Detected	10 m ²	N	G	L	Very Low

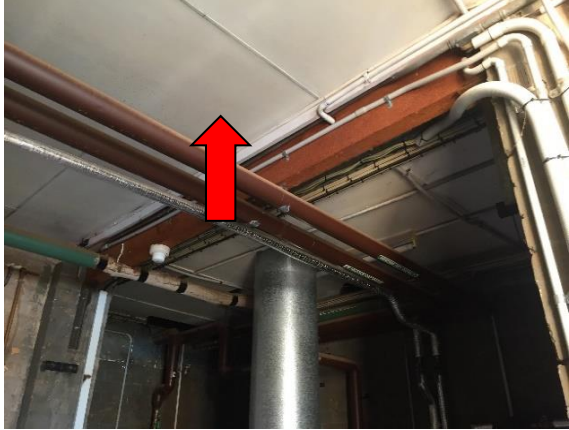
Maintain in good condition if to remain in-situ. Remove under controlled non-friable asbestos removal conditions prior to disturbance by refurbishment or demolition works by a Class B (non-friable) licensed asbestos removal contractor.
Internal, room 1740	Ceiling lining	Fibre cement sheet	50	84396	Chrysotile & Amosite Asbestos Detected	20 m ²	N	F	L	Very Low

Maintain in good condition if to remain in-situ. Remove under controlled non-friable asbestos removal conditions prior to disturbance by refurbishment or demolition works by a Class B (non-friable) licensed asbestos removal contractor.

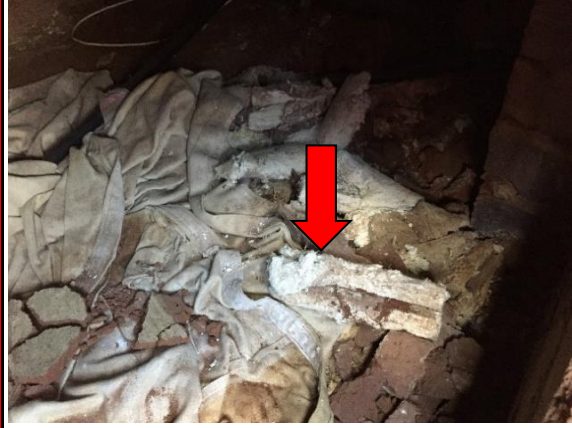
Primary Location	Secondary Location	Description	Photograph No.	Sample Number	Sample Results	Approx. Quantity	Friability	Condition	Accessibility	Action Rating	Photograph	Recommendations
Building No. 17, Specialist Clinics												
External, sub floor	Pipe lagging debris	Insulation material	51	84440	Chrysotile & Amosite Asbestos Detected	N/A	Y	P	L	High

Restrict access to entire subfloor area immediately. Remove under controlled friable asbestos removal conditions by a Class A (friable) licensed asbestos removal contractor.
External, sub floor	Packers	Fibre cement sheet	52	Visual observation	Assumed to contain Asbestos	N/A	N	F	VL	Very Low

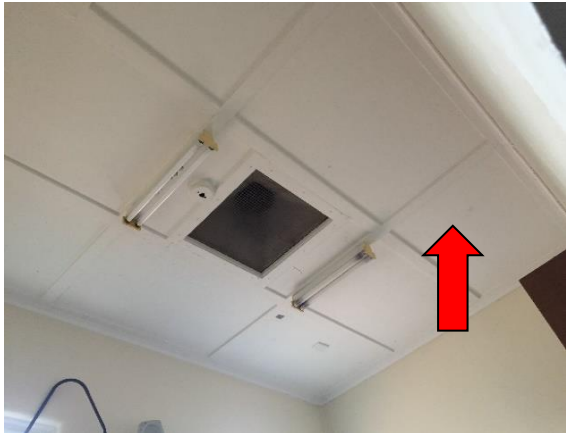
Internal, room 1713	Ceiling lining	Fibre cement sheet	55	84419	Chrysotile Asbestos Detected	15 m ²	N	F	L	Very Low

Maintain in good condition if to remain in-situ. Remove under controlled non-friable asbestos removal conditions prior to disturbance by refurbishment or demolition works by a Class B (non-friable) licensed asbestos removal contractor.

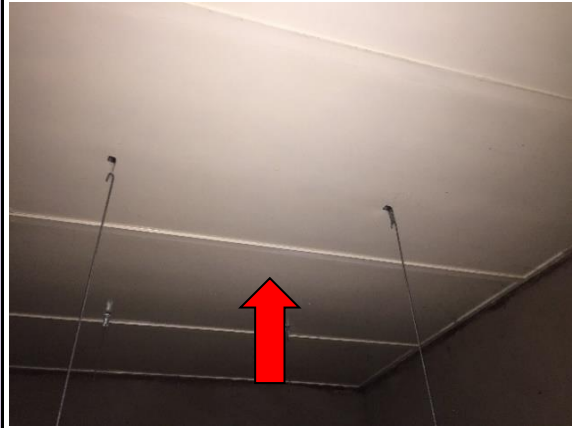
Primary Location	Secondary Location	Description	Photograph No.	Sample Number	Sample Results	Approx. Quantity	Friability	Condition	Accessibility	Action Rating	Photograph	Recommendations
Internal, rooms 1701, 1702, 1703 & 1704	Concealed ceiling lining	Fibre cement sheet	56	Refer 84419	Chrysotile Asbestos Detected	40 m ²	N	F	L	Very Low

Maintain in good condition if to remain in-situ. Remove under controlled non-friable asbestos removal conditions prior to disturbance by refurbishment or demolition works by a Class B (non-friable) licensed asbestos removal contractor.
Building No. 20, Dietics												
Internal, room 6003 and adjoining corridor	Beige floor covering	Vinyl floor tiles	57	84406	Chrysotile Asbestos Detected	20m ²	N	F	L	Low

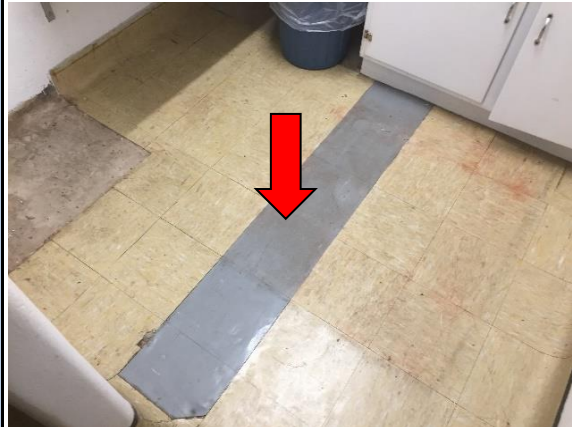
Internal, room 6003	Grey floor covering	Vinyl floor tiles	58	84405	Chrysotile Asbestos Detected	1m ²	N	F	L	Low

Seal exposed edges and maintain in good condition if to remain in-situ. Remove under controlled non-friable asbestos removal conditions prior to disturbance by refurbishment or demolition works by a Class B (non-friable) licensed asbestos removal contractor.

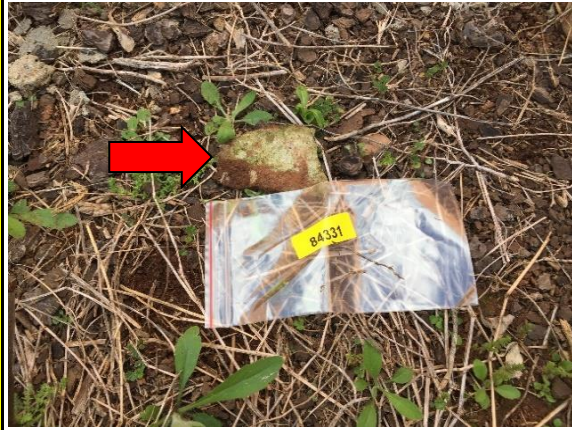
Primary Location	Secondary Location	Description	Photograph No.	Sample Number	Sample Results	Approx. Quantity	Friability	Condition	Accessibility	Action Rating	Photograph	Recommendations
Building No. 28, Office												
Within the scope and limitations of this survey, no asbestos containing materials were identified or suspected.												
Building No. 29, Kiosk												
External, between adjacent buildings	Debris to ground	Fibre cement sheet	64	84331	Chrysotile, Amosite & Crocidolite Asbestos Detected	<1 m ²	N	G	M	Medium

Remove under controlled non-friable asbestos removal conditions by a Class B (non-friable) licensed asbestos removal contractor.
Internal/ external	Windows	Caulking	65	84402	Chrysotile Asbestos Detected	N/A	N	G	L	Very Low

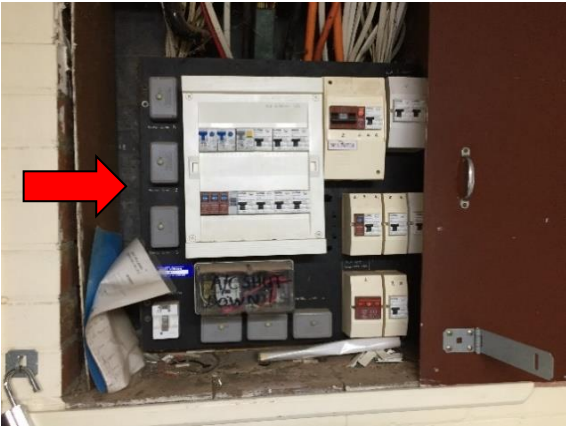
Internal, adjacent building No.19	Switchboard	Bituminous backing board	70	Visual observation	Assumed to contain Asbestos	1 unit	N	VG	L	Very Low

<p>Maintain in good condition if to remain in-situ. Remove under controlled non-friable asbestos removal conditions prior to disturbance by refurbishment or demolition works by a Class B (non-friable) licensed asbestos removal contractor.</p>

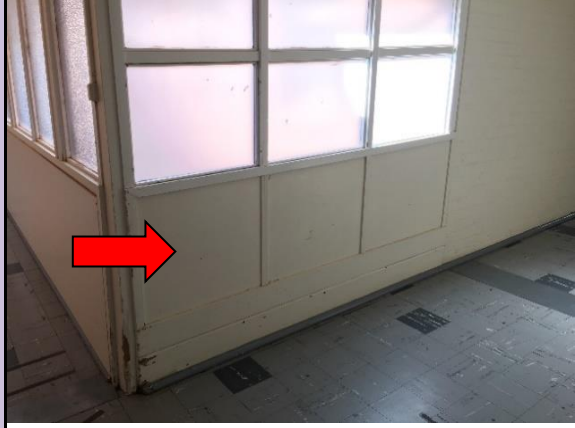
Maintain in good condition if to remain in-situ. Remove under controlled non-friable asbestos removal conditions prior to disturbance by refurbishment or demolition works by a Class B (non-friable) licensed asbestos removal contractor.
Internal, adjacent building No.19	Wall lining to both sides of corridor	Fibre cement sheet	73	84423	Chrysotile Asbestos Detected	20 m ²	N	VG	L	Very Low

Maintain in good condition if to remain in-situ. Remove under controlled non-friable asbestos removal conditions prior to disturbance by refurbishment or demolition works by a Class B (non-friable) licensed asbestos removal contractor.

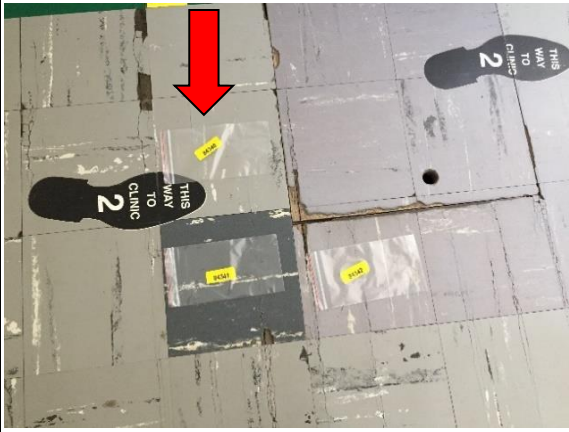
Primary Location	Secondary Location	Description	Photograph No.	Sample Number	Sample Results	Approx. Quantity	Friability	Condition	Accessibility	Action Rating	Photograph	Recommendations
Internal, throughout	Light grey floor covering	Vinyl floor tiles	74	84340	Chrysotile Asbestos Detected	150 m ²	Y	F	L	Low

Seal broken or exposed edges and maintain in good condition if to remain in-situ. Remove under controlled non-friable asbestos removal conditions prior to disturbance by refurbishment or demolition works by a Class B (non-friable) licensed asbestos removal contractor.
Internal, throughout	Black floor covering	Vinyl floor tiles	75	84341	Chrysotile Asbestos Detected	20 m ²	Y	F	L	Low

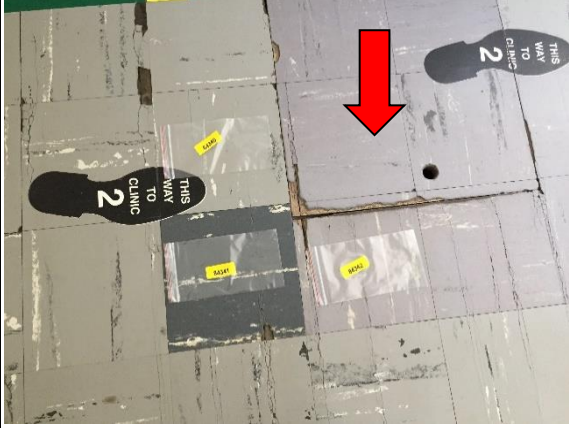
Internal, throughout	Blue grey floor covering	Vinyl floor tiles	76	84342	Chrysotile Asbestos Detected	20 m ²	Y	F	L	Low

Seal broken or exposed edges and maintain in good condition if to remain in-situ. Remove under controlled non-friable asbestos removal conditions prior to disturbance by refurbishment or demolition works by a Class B (non-friable) licensed asbestos removal contractor.

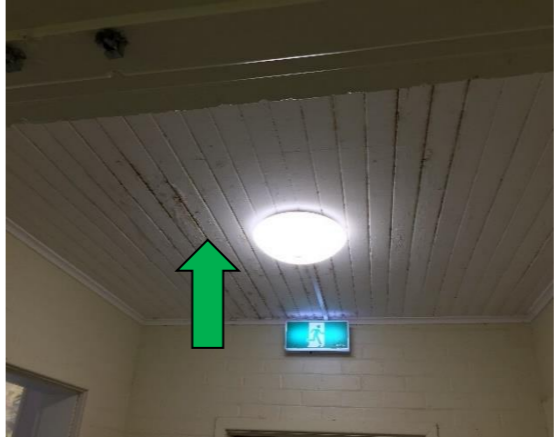
RESULT >0.1% lead content, remove flaking sections and over paint with a lead-free paint. Remove under controlled conditions in accordance with AS/NZS 4361.2:2017 Guide to hazardous paint management - Lead paint in residential, public and commercial buildings prior to renovation or demolition works.
Internal, room 1724	Timber ceiling	White paint system	10	84420	<0.1% Lead content	30 m ²	U	Av	N/A	L	Low

RESULT <0.1% lead content, not lead-containing paint as described in AS/NZS 4361.2:2017 Guide to hazardous paint management - Part 2: Lead paint in residential, public and commercial buildings.

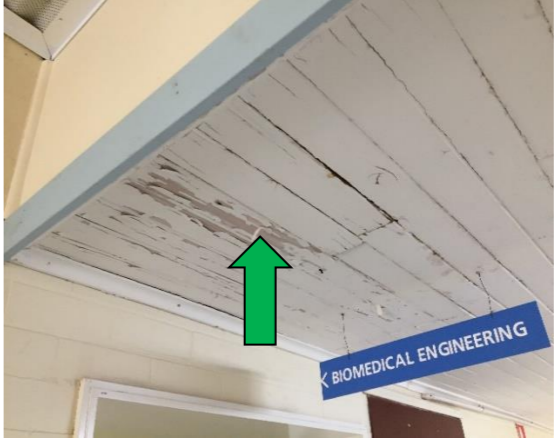
Primary Location	Secondary Location	Description	Photograph No.	Sample Number	Sample Results	Approx. Quantity	Surface Treatment	Extent of Damage	Friability	Likelihood of Disturbance	Action Rating	Photograph	Recommendations
Internal, corridor adjacent to building	Timber ceiling	White paint system	12	84420	<0.1% Lead content	30 m ²	U	Av	N/A	L	Low

RESULT <0.1% lead content, not lead-containing paint as described in AS/NZS 4361.2:2017 Guide to hazardous paint management - Part 2: Lead paint in residential, public and commercial buildings.
Internal, corridor adjacent to building and room 1701	Walls and ceiling	Yellow paint system	13	84424	>0.1% Lead content	15 m ²	U	Av	N/A	L	Low

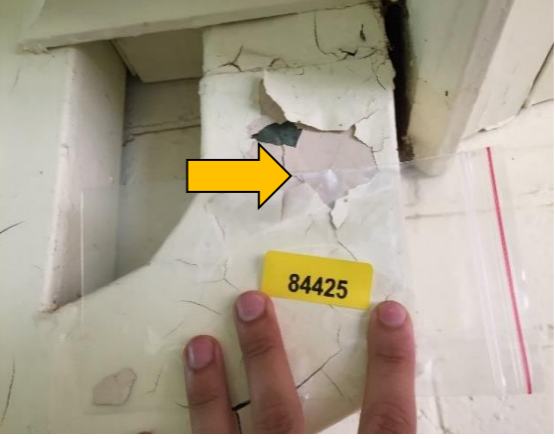
Internal, corridor adjacent to building and room 1701	Walls and ceiling	Beige undercoat	14	84425	>0.1% Lead content	15 m ²	U	Av	N/A	L	Low

RESULT >0.1% lead content, remove flaking sections and over paint with a lead-free paint. Remove under controlled conditions in accordance with AS/NZS 4361.2:2017 Guide to hazardous paint management - Part 2: Lead paint in residential, public and commercial buildings prior to renovation or demolition works.

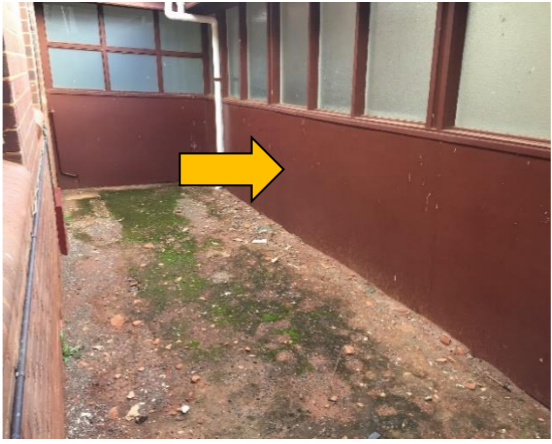
Primary Location	Secondary Location	Description	Photograph No.	Sample Number	Sample Results	Approx. Quantity	Surface Treatment	Extent of Damage	Friability	Likelihood of Disturbance	Action Rating	Photograph	Recommendations
Building No.20, Dietics													
External, throughout	Trim and lower walls	Maroon paint system	15	Refer 82521	>0.1% Lead content	1 m ²	U	Av	N/A	L	Low

RESULT >0.1% lead content, maintain in current condition, over paint with a lead-free paint as part of ongoing maintenance. Remove under controlled conditions in accordance with AS/NZS 4361.2:2017 Guide to hazardous paint management - Part 2: Lead paint in residential, public and commercial buildings prior to renovation or demolition works.
Internal, room 6001	Windows	Blue paint system	16	84409	>0.1% Lead content	1 m ²	U	Av	N/A	L	Low

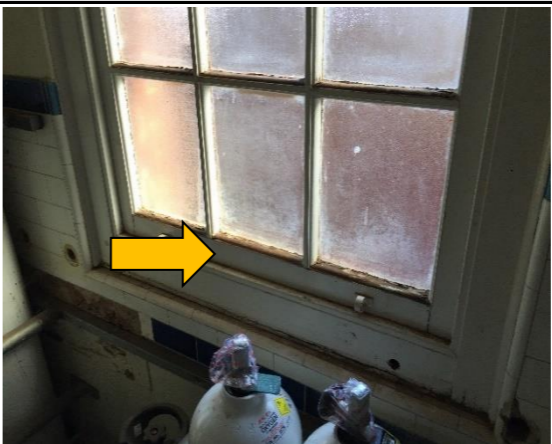
Internal, room 6001	Windows	White paint system	17	84410	>0.1% Lead content	1 m ²	U	Av	N/A	L	Low

RESULT >0.1% lead content, maintain in current condition, over paint with a lead-free paint as part of ongoing maintenance. Remove under controlled conditions in accordance with AS/NZS 4361.2:2017 Guide to hazardous paint management - Part 2: Lead paint in residential, public and commercial buildings prior to renovation or demolition works.

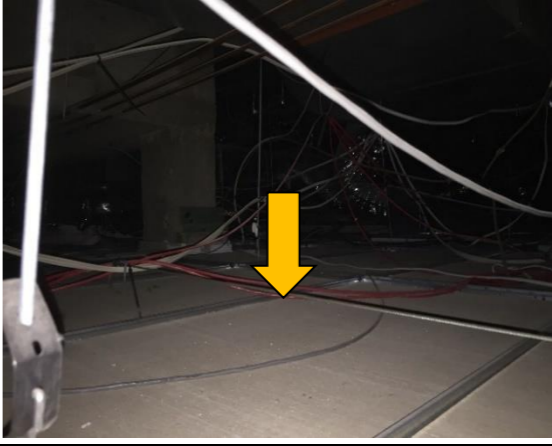
Internal, ground	Ceiling cavity	Dust to surfaces	21	84448	64 mg/kg lead content	1000 m ²	U	P	F	L	Low

Results is <300 mg/kg guideline for residential or childcare sites based on the soil contamination criteria of the <i>National Environment Protection Measure 2013</i> . Due to the non homogenous nature of lead in dust contamination and the age of the building, undertake task specific risk assessment and remove under controlled conditions in accordance with AS 4361.2, Guide to Hazardous Paint Management - 2017 Part 2: Public, residential and commercial buildings prior to disturbance
Internal, rooftop plantroom	Throughout	Dust to surfaces	22	69324	140 mg/kg lead content	300 m ²	U	P	F	L	Low	 	Results is <300 mg/kg guideline for residential or childcare sites based on the soil contamination criteria of the <i>National Environment Protection Measure 2013</i> . Due to the non homogenous nature of lead in dust contamination and the age of the building, undertake task specific risk assessment and remove under controlled conditions in accordance with AS 4361.2, Guide to Hazardous Paint Management - 2017 Part 2: Public, residential and commercial buildings prior to disturbance

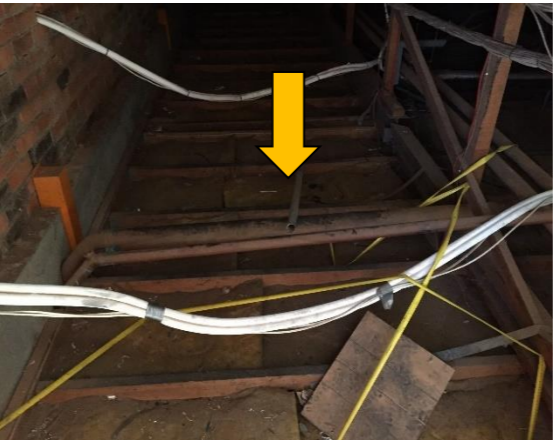
Primary Location	Secondary Location	Description	Photograph No.	Sample Number	Sample Results	Approx. Quantity	Surface Treatment	Extent of Damage	Friability	Likelihood of Disturbance	Action Rating	Photograph	Recommendations
Building No.2, General Ward Block													
Internal, level 1	Ceiling cavity	Dust to surfaces	23	69331	23 mg/kg lead content	300 m ²	U	P	F	L	Low

Results is <300 mg/kg guideline for residential or childcare sites based on the soil contamination criteria of the <i>National Environment Protection Measure 2013</i> . Due to the non homogenous nature of lead in dust contamination and the age of the building, undertake task specific risk assessment and remove under controlled conditions in accordance with AS 4361.2, Guide to Hazardous Paint Management - 2017 Part 2: Public, residential and commercial buildings prior to disturbance
Building No.6, Maternity Unit

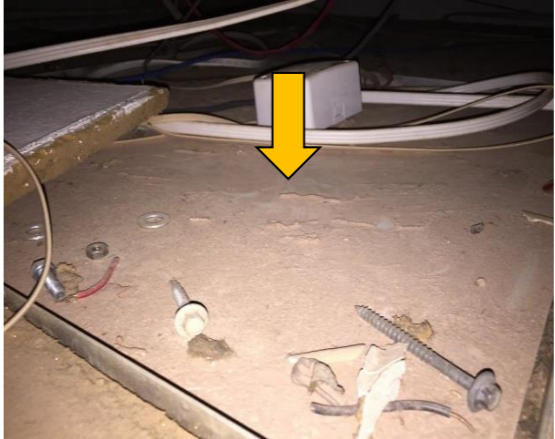
Internal, throughout	Ceiling cavity	Dust to surfaces	24	84336	1,400 mg/kg lead content	300 m ²	U	P	F	L	Low

Results is >300 mg/kg guideline for residential or childcare sites based on the soil contamination criteria of the <i>National Environment Protection Measure 2013</i> . Due to the non homogenous nature of lead in dust contamination and the age of the building, undertake task specific risk assessment and remove under controlled conditions in accordance with AS 4361.2, Guide to Hazardous Paint Management - 2017 Part 2: Public, residential and commercial buildings prior to disturbance
Building No.20, Dietics (and surrounding buildings No.16, No.17, No.19, No.28 & No.29)													
Internal, throughout	Ceiling cavity	Dust to surfaces	25	84411	200 mg/kg lead content	500 m ²	U	P	F	L	Low

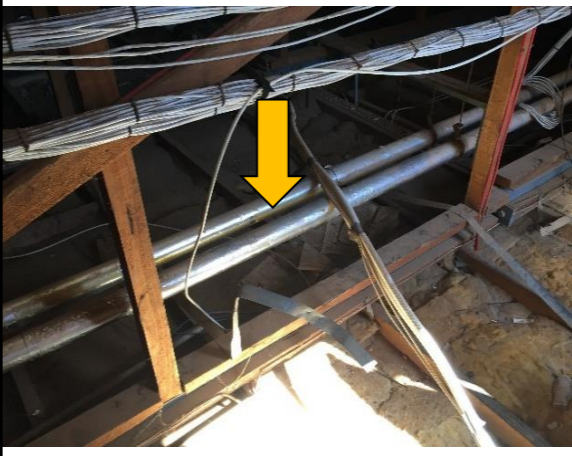
Primary Location	Secondary Location	Description	Photograph No.	Sample Number	Sample Results	Approx. Quantity	Surface Treatment	Extent of Damage	Friability	Likelihood of Disturbance	Action Rating	Photograph	Recommendations
Internal, ceiling cavity level 1	Pipe insulation	Internal insulation	38	Visual Observation	Suspected SMF	N/A	S	G	F	L	Low

Maintain in current condition if to remain in-situ. Remove under controlled SMF conditions as per the Code of Practice for the Safe Use of Synthetic Mineral Fibres [NOHSC: 2006 (1990)].
Internal, ceiling cavity level 1	Batting	Insulation	39	Visual Observation	Suspected SMF	N/A	U	G	F	L	Low

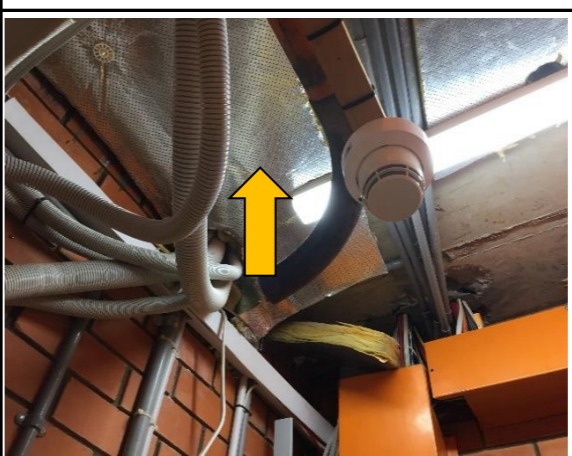
Maintain in current condition if to remain in-situ. Remove under controlled SMF conditions as per the Code of Practice for the Safe Use of Synthetic Mineral Fibres [NOHSC: 2006 (1990)].
Internal, room 2002	Foil lined ceiling sarking	Insulation	40	Visual Observation	Suspected SMF	N/A	S	G	F	L	Low

Maintain in current condition if to remain in-situ. Remove under controlled SMF conditions as per the Code of Practice for the Safe Use of Synthetic Mineral Fibres [NOHSC: 2006 (1990)].

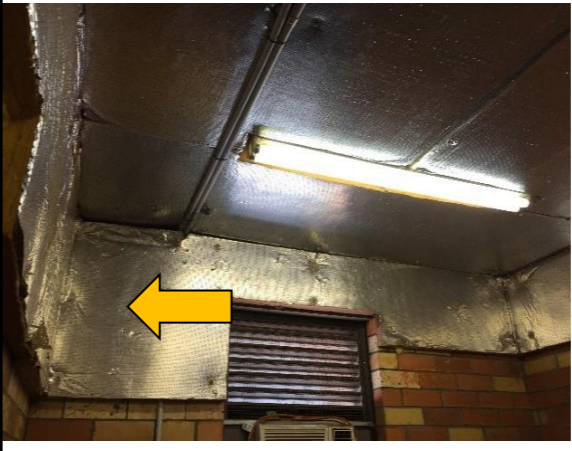
Primary Location	Secondary Location	Description	Photograph No.	Sample Number	Sample Results	Approx. Quantity	Surface Treatment	Extent of Damage	Friability	Likelihood of Disturbance	Action Rating	Photograph	Recommendations
Internal, room 2026	Foil lined ceiling and upper wall sarking	Insulation	41	Visual Observation	Suspected SMF	N/A	S	G	F	L	Low

Maintain in current condition if to remain in-situ. Remove under controlled SMF conditions as per the Code of Practice for the Safe Use of Synthetic Mineral Fibres [NOHSC: 2006 (1990)].
Internal, room 2126	Foil lined ceiling sarking	Insulation	42	Visual Observation	Suspected SMF	N/A	S	G	F	L	Low

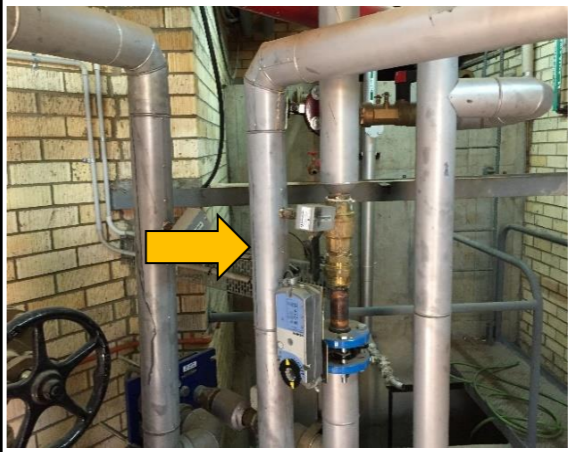
Maintain in current condition if to remain in-situ. Remove under controlled SMF conditions as per the Code of Practice for the Safe Use of Synthetic Mineral Fibres [NOHSC: 2006 (1990)].
Internal, sub corridor plantroom	Pipe insulation	Internal insulation	43	Visual Observation	Suspected SMF	N/A	S	G	F	L	Low

Maintain in current condition if to remain in-situ. Remove under controlled SMF conditions as per the Code of Practice for the Safe Use of Synthetic Mineral Fibres [NOHSC: 2006 (1990)].

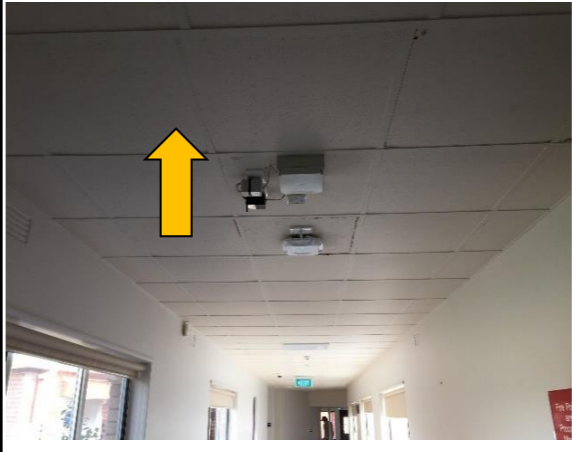
Primary Location	Secondary Location	Description	Photograph No.	Sample Number	Sample Results	Approx. Quantity	Surface Treatment	Extent of Damage	Friability	Likelihood of Disturbance	Action Rating	Photograph	Recommendations
Building No.5, Dentistry													
Internal, ceiling cavity	Batting	Insulation	47	Suspected	Suspected SMF	N/A	U	G	F	L	Low	Suspected only, not observed	Maintain in current condition if to remain in-situ. Remove under controlled SMF conditions as per the Code of Practice for the Safe Use of Synthetic Mineral Fibres [NOHSC: 2006 (1990)].
Building No.6, Maternity Unit													
Internal, throughout	Ceiling	Compressed ceiling tiles	48	Visual Observation	Suspected SMF	50 m ²	S	G	F	L	Low

Maintain in current condition if to remain in-situ. Remove under controlled SMF conditions as per the Code of Practice for the Safe Use of Synthetic Mineral Fibres [NOHSC: 2006 (1990)].

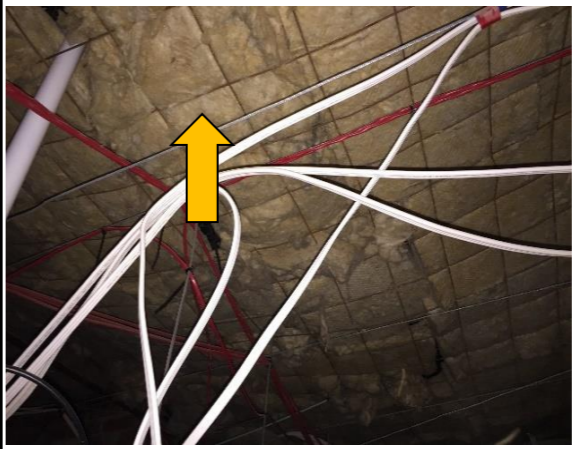
Internal, ceiling cavity	Batting	Insulation	49	Visual Observation	Suspected SMF	N/A	U	G	F	L	Low

Maintain in current condition if to remain in-situ. Remove under controlled SMF conditions as per the Code of Practice for the Safe Use of Synthetic Mineral Fibres [NOHSC: 2006 (1990)].

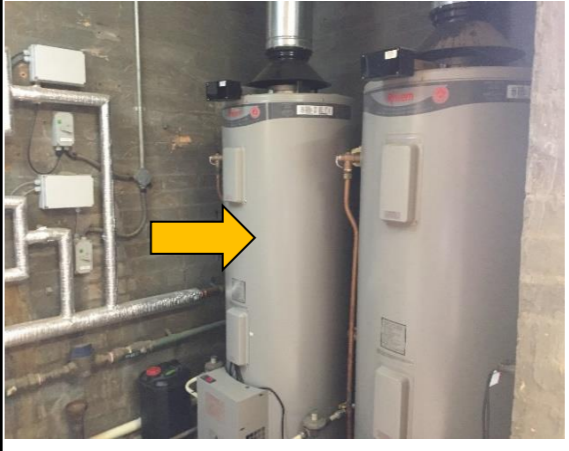
Primary Location	Secondary Location	Description	Photograph No.	Sample Number	Sample Results	Approx. Quantity	Surface Treatment	Extent of Damage	Friability	Likelihood of Disturbance	Action Rating	Photograph	Recommendations
Building No.16, Doctors Offices													
Internal, room 1740	Hot water unit	Internal insulation	50	Visual Observation	Suspected SMF	2 units	S	G	F	L	Low

Maintain in current condition if to remain in-situ. Remove under controlled SMF conditions as per the Code of Practice for the Safe Use of Synthetic Mineral Fibres [NOHSC: 2006 (1990)].
Internal, room 1740	Pipework insulation	Internal insulation	51	Visual Observation	Suspected SMF	N/A	S	G	F	L	Low	 	Maintain in current condition if to remain in-situ. Remove under controlled SMF conditions as per the Code of Practice for the Safe Use of Synthetic Mineral Fibres [NOHSC: 2006 (1990)].
Internal, ceiling cavity	Batting	Insulation	52	Suspected	Suspected SMF	N/A	U	G	F	L	Low	Suspected only, not observed	Maintain in current condition if to remain in-situ. Remove under controlled SMF conditions as per the Code of Practice for the Safe Use of Synthetic Mineral Fibres [NOHSC: 2006 (1990)].

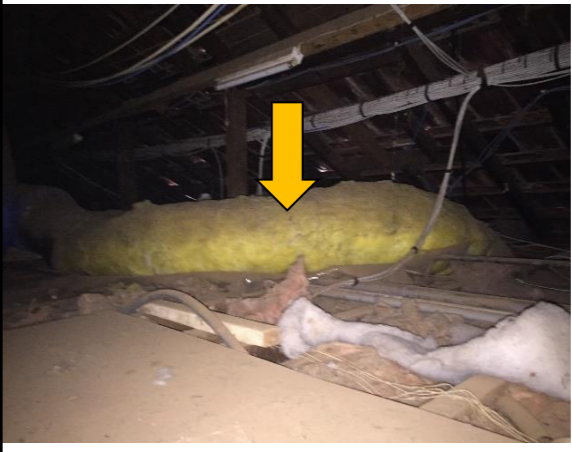
Primary Location	Secondary Location	Description	Photograph No.	Sample Number	Sample Results	Approx. Quantity	Surface Treatment	Extent of Damage	Friability	Likelihood of Disturbance	Action Rating	Photograph	Recommendations
Internal, ceiling cavity	Batting	Insulation	56	Visual Observation	Suspected SMF	N/A	U	G	F	L	Low

Maintain in current condition if to remain in-situ. Remove under controlled SMF conditions as per the Code of Practice for the Safe Use of Synthetic Mineral Fibres [NOHSC: 2006 (1990)].
Building No.19, Biomed													
Internal, rooms 1802, 1703, 1704	Ceiling	Compressed ceiling tiles	57	Visual Observation	Suspected SMF	50 m ²	S	G	F	L	Low

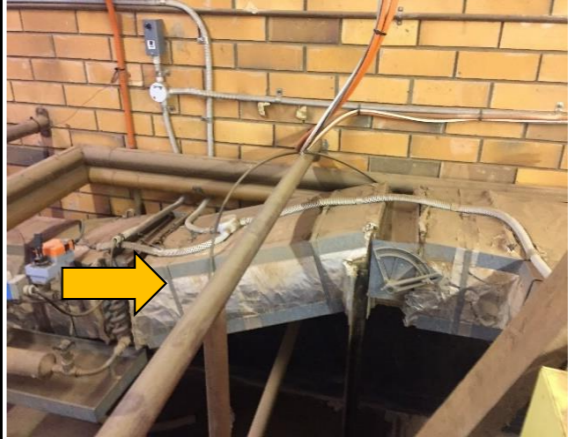
Primary Location	Secondary Location	Description	Photograph No.	Sample Number	Sample Results	Approx. Quantity	Surface Treatment	Extent of Damage	Friability	Likelihood of Disturbance	Action Rating	Photograph	Recommendations
Interior, ceiling cavity	Ductwork	Internal insulation	65	Visual Observation	Suspected SMF	N/A	S	Av	F	L	Low

Maintain in current condition if to remain in-situ. Remove under controlled SMF conditions as per the Code of Practice for the Safe Use of Synthetic Mineral Fibres [NOHSC: 2006 (1990)].
Interior, ceiling cavity	Battling	Insulation	66	Visual Observation	Suspected SMF	50 m ²	S	Av	F	L	Low

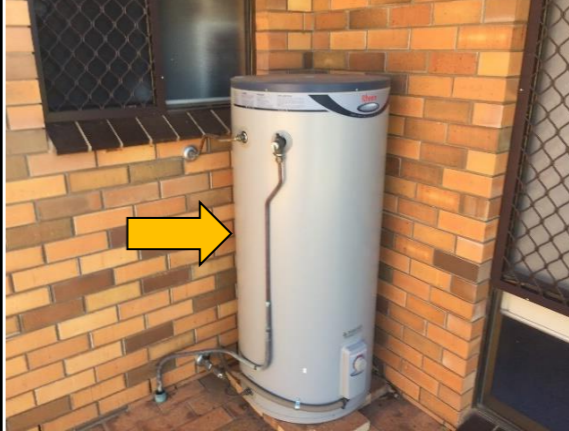
Maintain in current condition if to remain in-situ. Remove under controlled SMF conditions as per the Code of Practice for the Safe Use of Synthetic Mineral Fibres [NOHSC: 2006 (1990)].
Building No.25, TRACS													
Exterior, room 2106	Hot water unit	Internal insulation	67	Visual Observation	Suspected SMF	1 unit	S	G	F	L	Low

Maintain in current condition if to remain in-situ. Remove under controlled SMF conditions as per the Code of Practice for the Safe Use of Synthetic Mineral Fibres [NOHSC: 2006 (1990)].

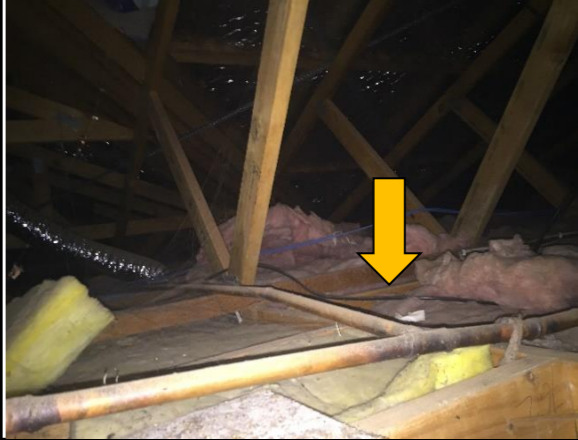
Primary Location	Secondary Location	Description	Photograph No.	Sample Number	Sample Results	Approx. Quantity	Surface Treatment	Extent of Damage	Friability	Likelihood of Disturbance	Action Rating	Photograph	Recommendations
Building No.27, Staff Accommodation Units													
Internal, ceiling cavity	Batting	Insulation	71	Visual Observation	Suspected SMF	300 m ²	U	Av	F	L	Low

Maintain in current condition if to remain in-situ. Remove under controlled SMF conditions as per the Code of Practice for the Safe Use of Synthetic Mineral Fibres [NOHSC: 2006 (1990)].
Internal, ceiling cavity	Foil lined roof sarking	Insulation	72	Visual Observation	Suspected SMF	30 m ²	S	Av	F	L	Low

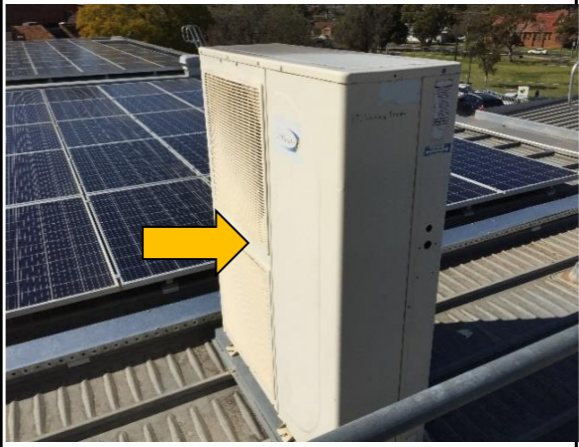
Primary Location	Secondary Location	Description	Photograph No.	Sample Number	Sample Results	Approx. Quantity	Surface Treatment	Extent of Damage	Friability	Likelihood of Disturbance	Action Rating	Photograph	Recommendations
Ozone Depleting Substance (ODS)													
Building No.1, Main Service Building & Emergency Department													
External, rooftop	'Ultimate' AC unit	Unknown refrigerant	77	Visual Observation	ODS Refrigerant	1 unit	-	-	-	-	-

No data was visible at the time of the assessment. Confirm status of suspected ozone depleting substances identified in the assessment.
External, adjacent main entrance	'Hitachi' AC unit'	R22 refrigerant	78	Visual Observation	ODS Refrigerant	1 unit	-	-	-	-	-

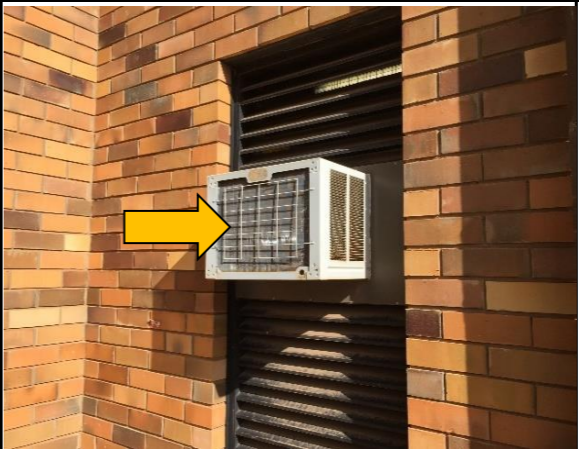
Building No.2, General Ward Block													
External, room 2002	'LG' AC unit'	R22 refrigerant	79	Visual Observation	ODS Refrigerant	1 unit	-	-	-	-	-

Hydrochlorofluorocarbon (HCFC), ozone depleting substances identified in the assessment that require removal during refurbishment or demolition works should be appropriately decanted and disposed of by a licensed contractor in accordance with the Ozone Protection and Synthetic Greenhouse Gas Management Amendment Regulation 2012.

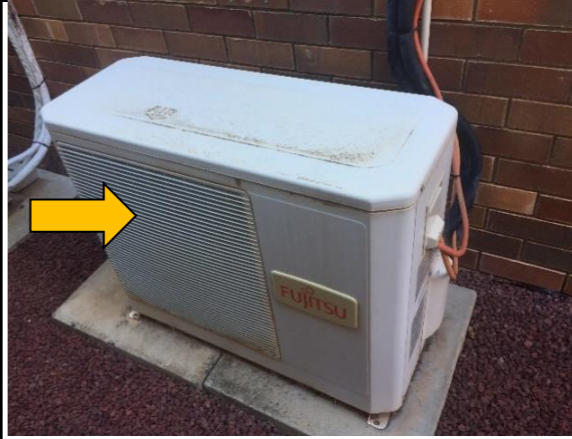
Primary Location	Secondary Location	Description	Photograph No.	Sample Number	Sample Results	Approx. Quantity	Surface Treatment	Extent of Damage	Friability	Likelihood of Disturbance	Action Rating	Photograph	Recommendations
Building No.22, Medical Imaging													
External, east and west elevations	'Fujitsu' AC unit'	R22 refrigerant	83	Visual Observation	ODS Refrigerant	2 units	-	-	-	-	-

Hydrochlorofluorocarbon (HCFC), ozone depleting substances identified in the assessment that require removal during refurbishment or demolition works should be appropriately decanted and disposed of by a licensed contractor in accordance with the Ozone Protection and Synthetic Greenhouse Gas Management Amendment Regulation 2012.
External, west elevation	'Sanyo AC unit'	R22 refrigerant	84	Visual Observation	ODS Refrigerant	1 unit	-	-	-	-	-

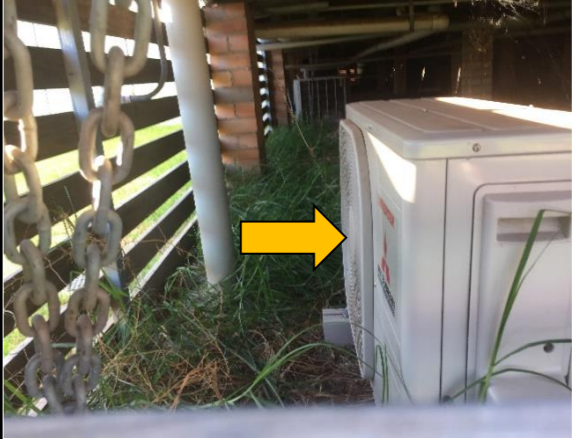
External, sub floor	Inaccessible units/ information labels	Unknown refrigerant	85	Visual Observation	ODS Refrigerant	5 units	-	-	-	-	-

No data was visible at the time of the assessment. Confirm status of suspected ozone depleting substances identified in the assessment.

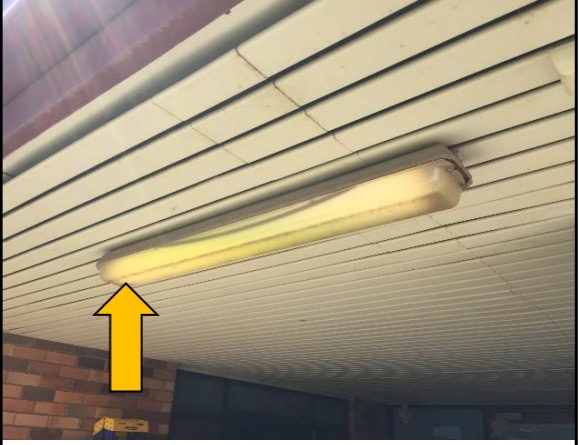
Primary Location	Secondary Location	Description	Photograph No.	Sample Number	Sample Results	Approx. Quantity	Surface Treatment	Extent of Damage	Friability	Likelihood of Disturbance	Action Rating	Photograph	Recommendations
Polychlorinated Biphenyls (PCB)													
<i>Throughout, all areas</i>													
Throughout	Operational open and cased light fittings	Capacitors	86	Visual Observation	Suspected PCB capacitors	Multiple	-	-	-	-	-

PCB-containing capacitors are suspected due to age & appearance of electrical fittings. Remove and dispose of in accordance with the Polychlorinated Biphenyls Management Plan, Revised Edition April 2003.
