Appendix A: Study Reach Maps

Appendix B: Field Data Sheets

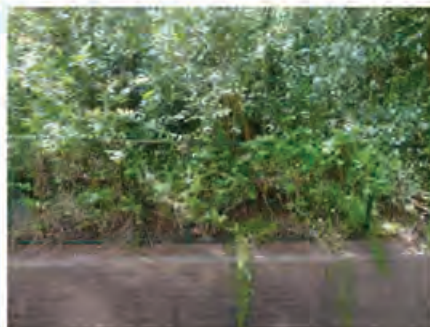
Spatial Integrity - Only small patches of well-separated native vegetation remain

Nativeness - One or more strata dominated by exotic species, 'high threat' species present

Structural Integrity - One stratum missing or extra, cover within remaining strata 50% lower or higher than natural

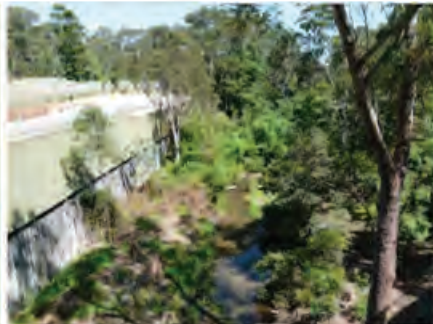
Spatial Integrity - Width reduced by up to 1/3 and/or some breaks in continuity

Nativeness - One or more strata dominated by exotic species, 'high threat' species present

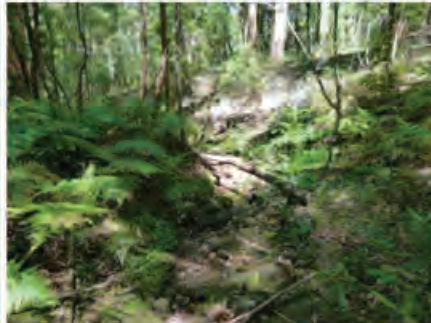
Spatial Integrity - No or little evidence of broadscale loss of native vegetation

Nativeness - Vegetation predominantly native, few weeds and no 'high threat' species

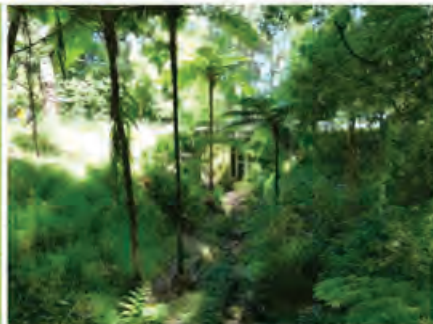
Spatial Integrity - Width reduced by up to 1/3 and/or some breaks in continuity

Nativeness - Exotic species present but not dominating any strata, 'high threat' species rare

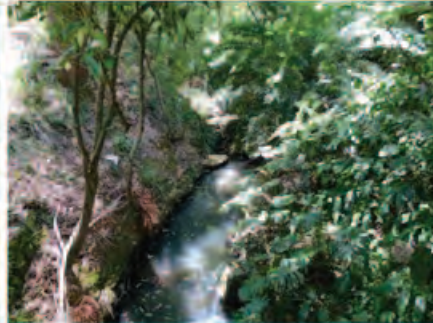
Hydrology - Medium size intermittent creek; urban catchment

Physical form - Steep incised toe of banks; banks 30-70°; 25% undercut; culvert downstream

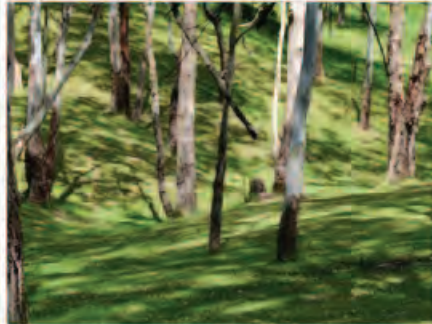
Hydrology - Small headwater drainage line; urban catchment

Physical form - Depression drainage gully with no defined channel in upper reach; gentle banks stabilised by lawn; no erosion

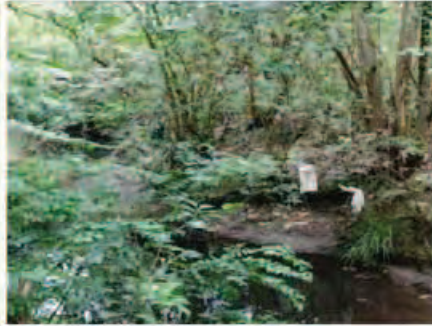
Spatial Integrity - About 50% of the native vegetation remains, either in strips or patches

Nativeness - Most strata dominated by exotic species, 'high threat' species abundant

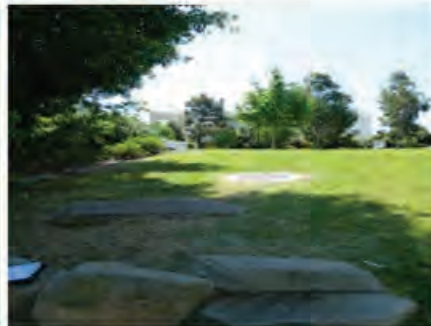
Spatial Integrity - About 50% of the native vegetation remains, either in strips or patches

Nativeness - Vegetation predominantly native, few weeds and no 'high threat' species

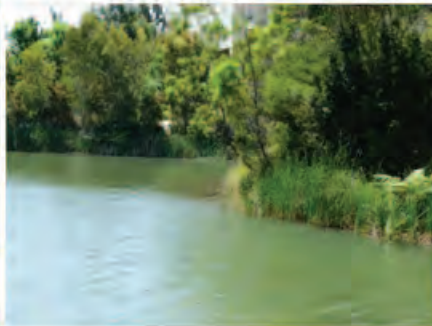
Hydrology - Artificial lake with upper reaches piped; urban catchment

Physical form - Banks gentle and stabilised by rock armour; creek upstream of lake is piped under landscaped ponds and urban land

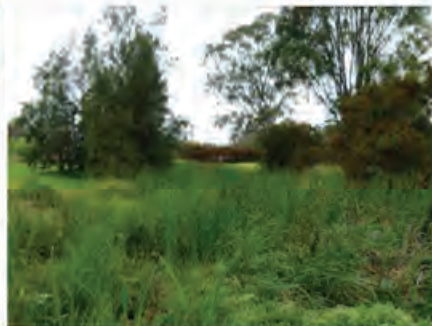
Spatial Integrity - Only small patches of well-separated native vegetation remain

Nativeness - Few native species remaining, cover dominated by exotic species

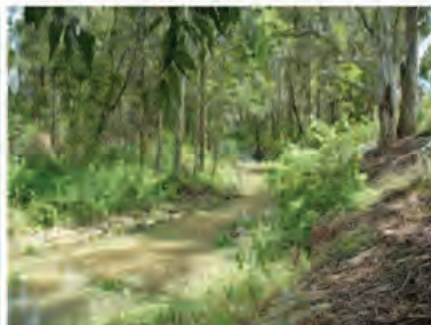
Spatial Integrity - About 50% of the native vegetation remains, either in strips or patches

Nativeness - One or more strata dominated by exotic species, 'high threat' species present

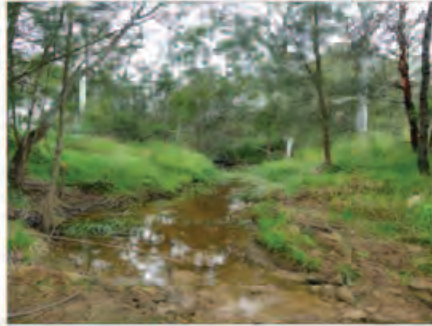
Hydrology - Medium size creek with two instream dams; urban/rural catchment

Physical form - Variable bank slope <30-70°; 20% undercut, 5% slumped; culverts upstream and downstream

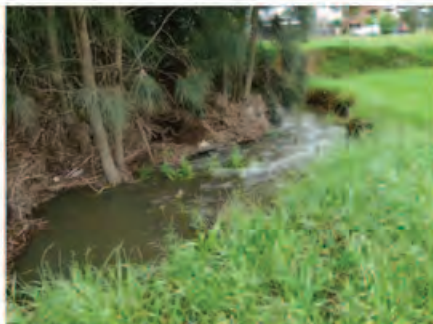
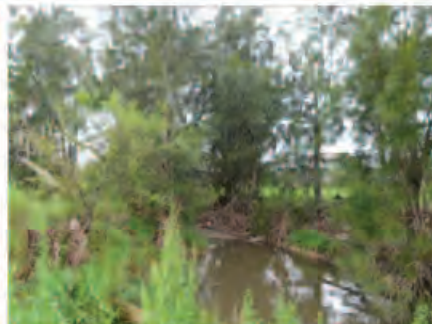
Hydrology - Medium size creek with two dams and several piped tributaries; urban/rural catchment

Physical form - Variable bank slope 30-90°; 70% undercut, 10% slumped; culverts upstream and downstream; numerous inflowing pipes to eroded pools

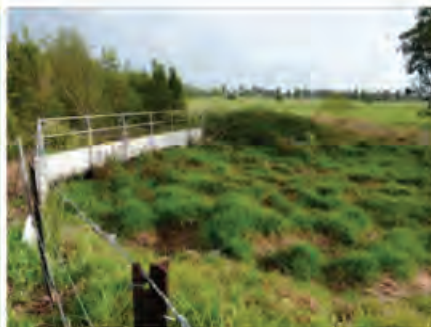
Spatial Integrity - Only small patches of well-separated native vegetation remain

Nativeness - Most strata dominated by exotic species, 'high threat' species abundant

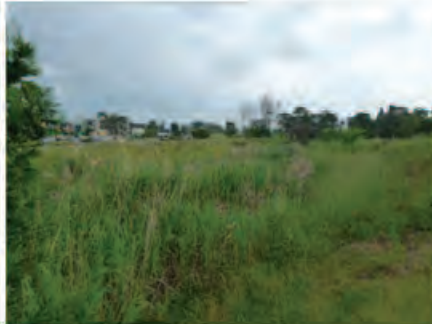
Hydrology - Small headwater creek; urban catchment

Physical form - Steep banks >70°; 25% undercut; 10% slumped; culverts upstream
