Project 81719.13
29 October 2019
R.001.docx
MPG

Pavement Condition and Dilapidation Survey
Proposed New Maitland Hospital
Metford Road, Metford

Douglas Partners Geotechnics Environment Groundwater		Dilapidation Survey Clubhouse and Surrounds New Maitland Hospital, Metford Client: Multiplex Constructions	Project: 81719.13 Page: 1 Rev: 0 Date: 23-Oct-19
Table 1 - List of Observed Defects and General Conditions Photographs			
Defect No.	Description	Photo No.	
	Clubhouse	1	
1	Paint on northern wall of detached shed	2	
2	Damage to gutter on shed	3	
3	Paint blue and white on asphalt surrounds	4	
4	Post missing	5	
5	Cracking in concrete southern end	6	
6	Cracking in concrete apron (near changeroom entry)	7	
7	More cracking in concrete apron (near changeroom entries)	8	
8	Crack in concrete near inspection point	9	
9	Damage to guttering	10	
10	Crack in concrete apron northern end	11	
11	soil exposed near water tank	12

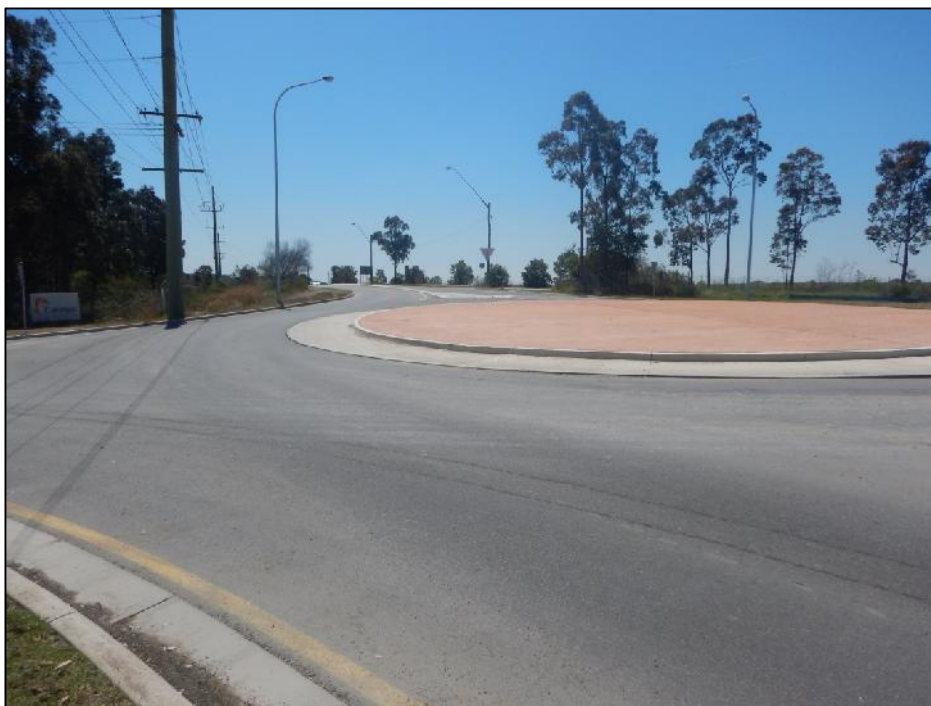
Figure 5: Existing roundabout

The pavement is generally in a good condition. Minor defects within the adjacent kerb and gutter and road side service lids were noted as well as minor bleeding / stone loss within the asphalt wearing course.

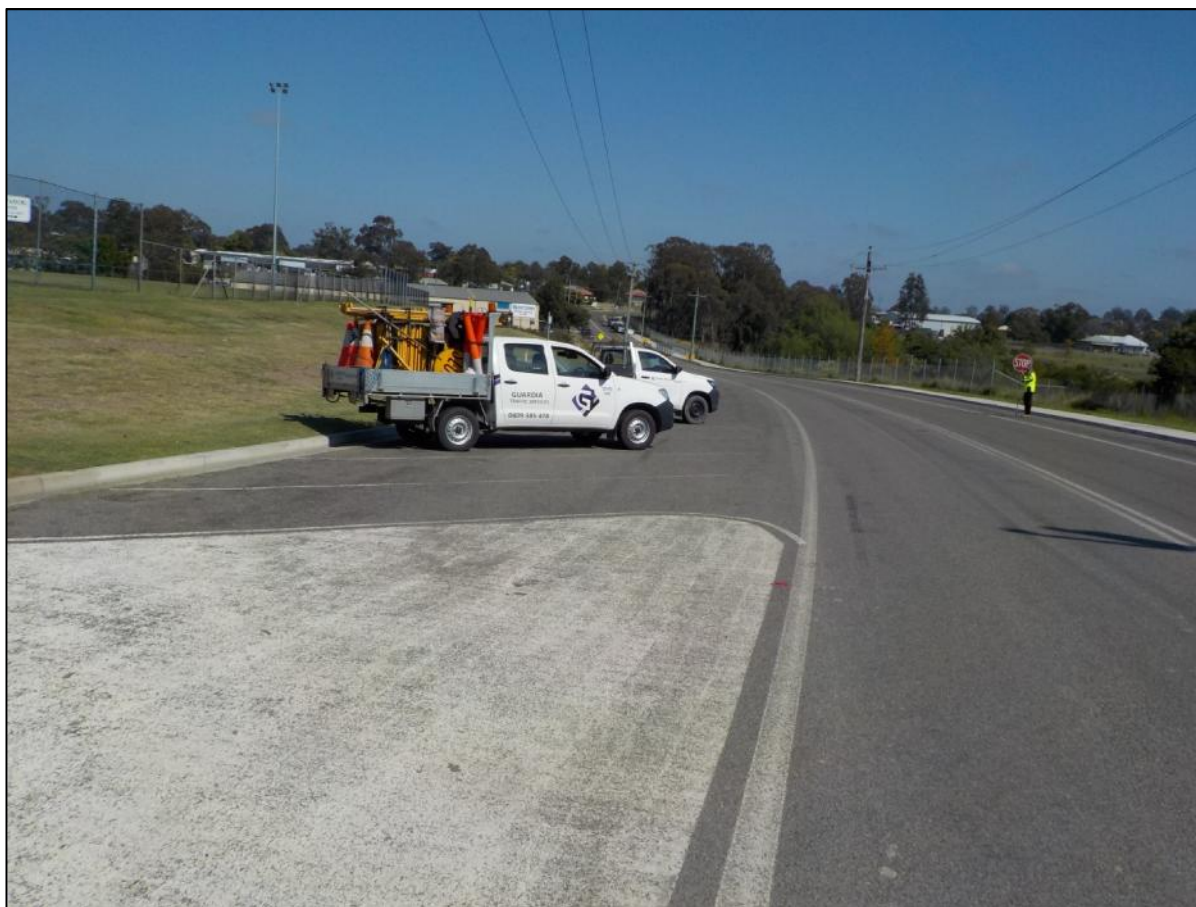
Figure 7: View of car parking area along Fieldsend Street

The pavement is generally in a reasonable to good condition with some defects in the pavement surface including minor rutting, stone loss and areas on the edge of the pavement where grass is growing through the wearing course. Minor defects were also observed within the adjacent kerb and gutter and road side service lids.

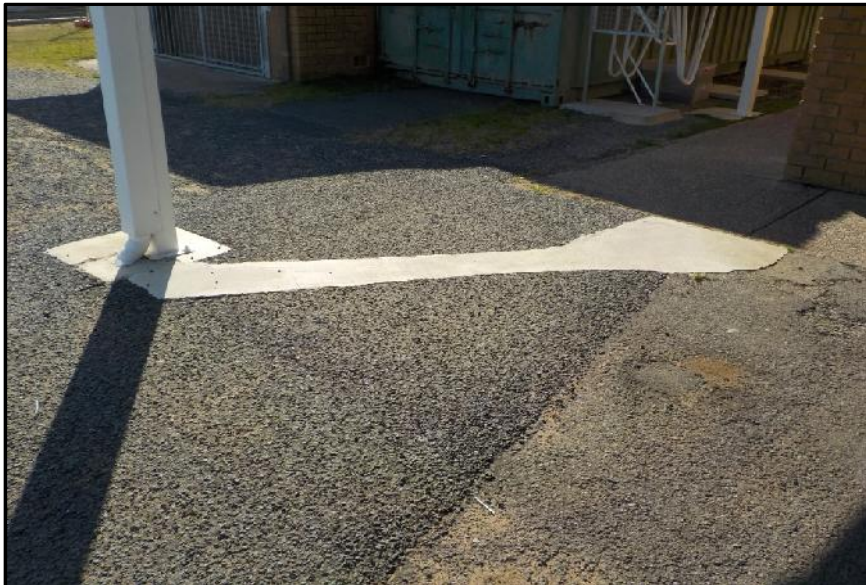
Photo 30B

-	Repaired drainage / patched concrete	30B

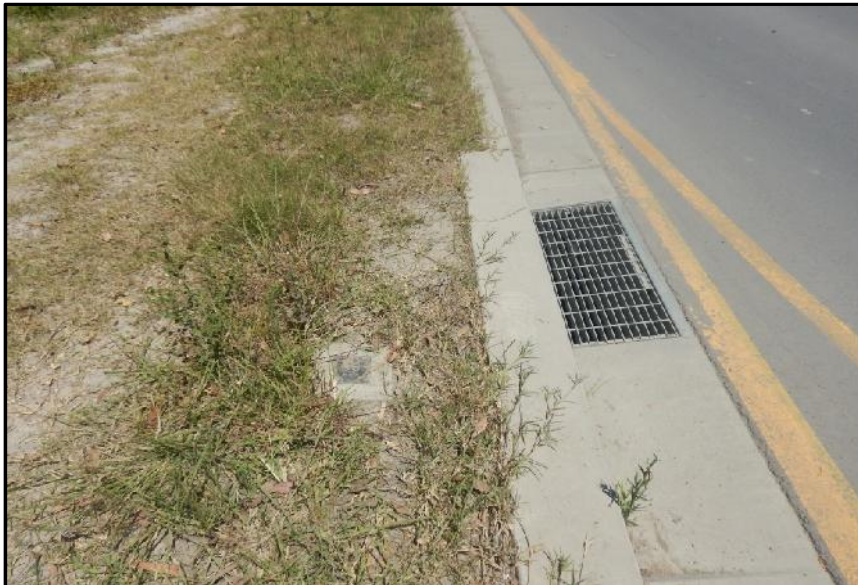
Photo 80

Defect No.	Description	Photo No.
-	View of road	62
-	View of road	63
40	Loose SSM marker	63A
-	Telstra pit	63B
-	Telstra pit	63C
-	View of roundabout	64
41	Expansion strip coming out of median	65
42	Loose SSM marker	65A
43	Cracking in kerb	66
44	Change of seal	67
45	Loose SSM cover	68
46	Tar on old turning lane	69
47	Crack in median	70
48	Patch	71
-	Paton, general view	71A
-	General view from CH 380 facing south	72
49	Paton, change in seal	72A
50	Oil mark on road	73
-	Optus pit cover	73A
51	Cracking in kerb	74
-	Gas service marker	74A
52	Loose SSM marker	74B
53	Depression in road	75
54	Minor stone loss	76
55	Raised edge on change of seal	77
56	Crack in kerb	78
-	Stormwater grate	78A
-	Exposed hydrant point	78B
57	Dirt on road	79
-	Stormwater inlet	79A
-	Gas marker	79B
-	Pole	79C
-	Electrical column	79D
-	Loose SSM, stormwater inlet	80
58	Longitudinal cracking	80A

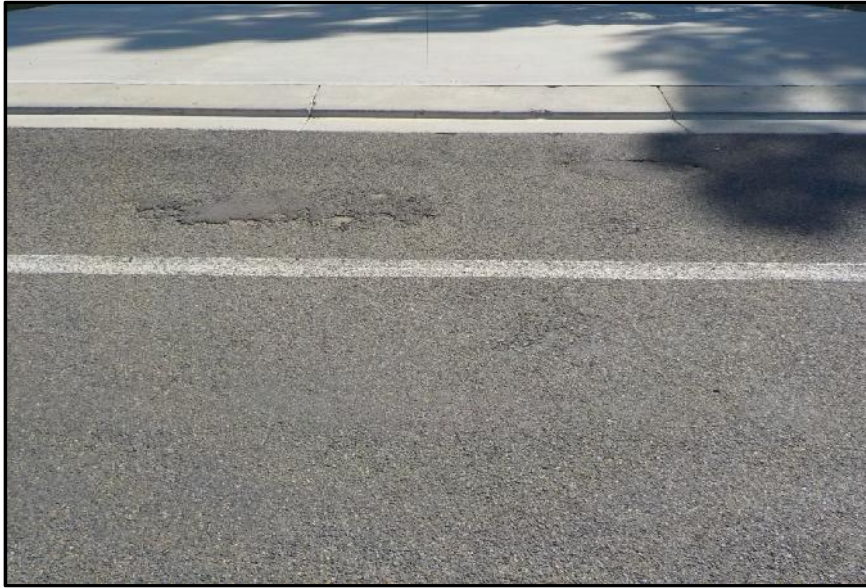
-	General view facing south	91	
-	General view facing south	91A	
-	General view facing west	92	
-	General view facing east	93	
67	Patched driveway	94	
-	Change of seal	95	
68	Patches	96	
69	Cracking in concrete	97	
70	Cracking in culvert which is also clogged	98	
71	Cracking in culvert	99	
72	Cracking in concrete	100	
73	Flushing	100A

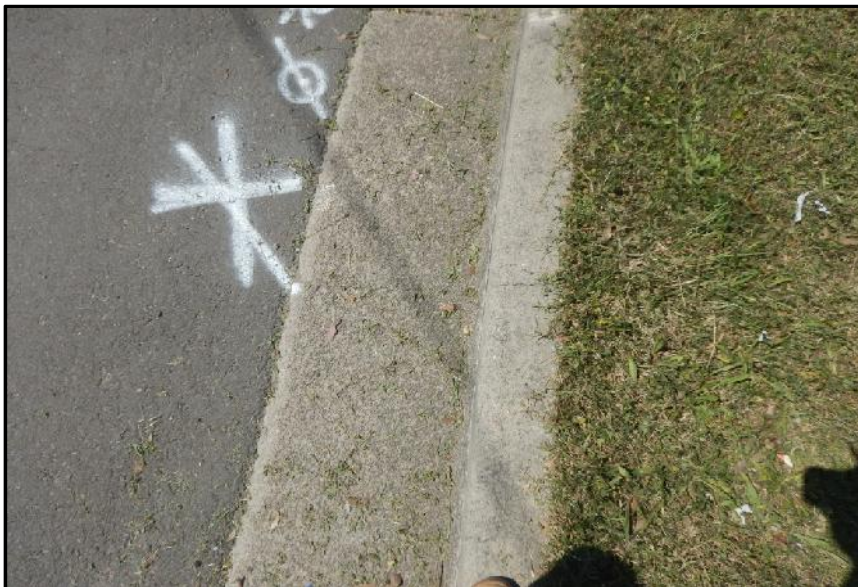
Photo 116

Defect No.	Description - PGH Access Road	Photo No.
-	General view of pavement	115
84	Cracking in kerb	116
85	Grass in pavement/kerb, whole section	117
86	Cracking in kerb	118
87	Poor drainage / sediments Ch20 to Ch 60	119
88	Meandering cracking	120

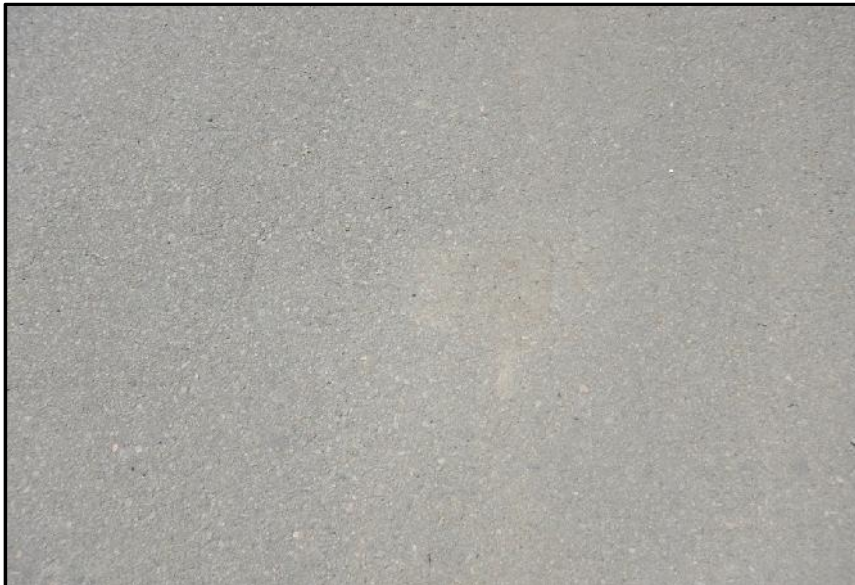
Photo 122

-	General view of pavement - facing north	121
89	Depression in road	122
90	Multiple transverse cracks in concrete drain	123
91	Sediment in drain	124
-	General view - facing north	125
92	Minor stone loss	126
93	Telstra Pit - Broken corner	127
94	Depression crocodile cracking	128
95	Longitudinal cracking	129
96	Depression and cracking	130
97	Driveway - vegetation in joints	131
98	Depression and cracking	132
99	Cracking in kerb	133
100	Depression and crocodile cracking	134

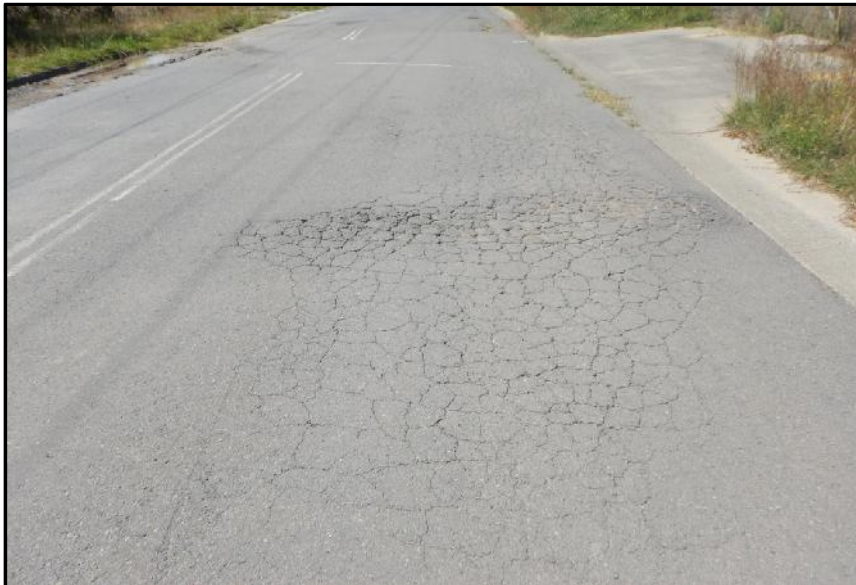
Photo 136

-	Hydrant	135
101	Depression and crocodile cracking	136
102	Cracked concrete driveway	137
103	Heaving / shoving / pothole	138
104	Patches / Potholes	139
105	Shoving and edge cracking	140
106	Patch, crocodile cracking on western edge	141

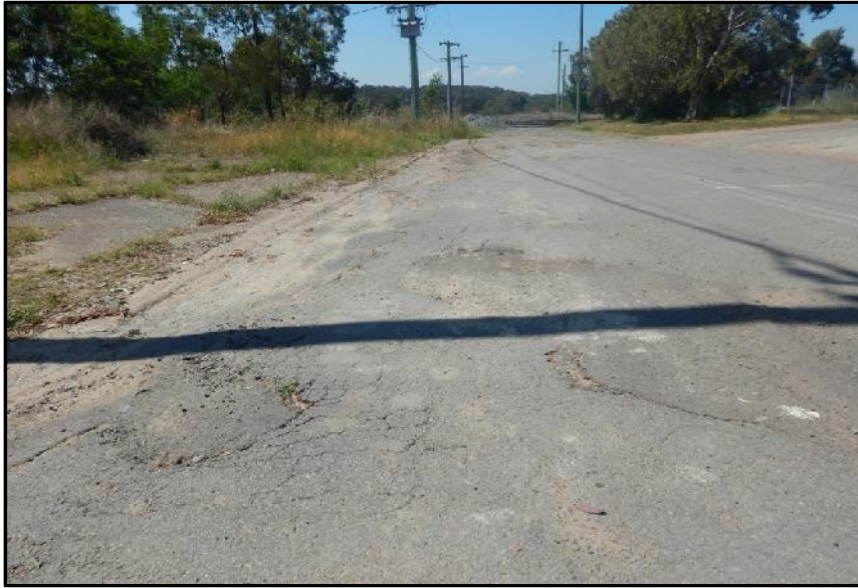
Photo 143

-	Hydrant	142
107	From Ch 260 to Ch 300, multiple large potholes	143
108	Cracking and edge deterioration	144
109	Cracked concrete driveway	145
110	Joint scour - concrete driveway	146
