4. ROAD SAFETY

Item 5.4.1. Brayton Road, and item 5.4.2. Ambrose/Red Hills Road, extracted from the *Traffic Impact Statement* (007, App F, page 44) dated 23 September 2020 are false and, in our opinion, a deliberate attempt to mislead.

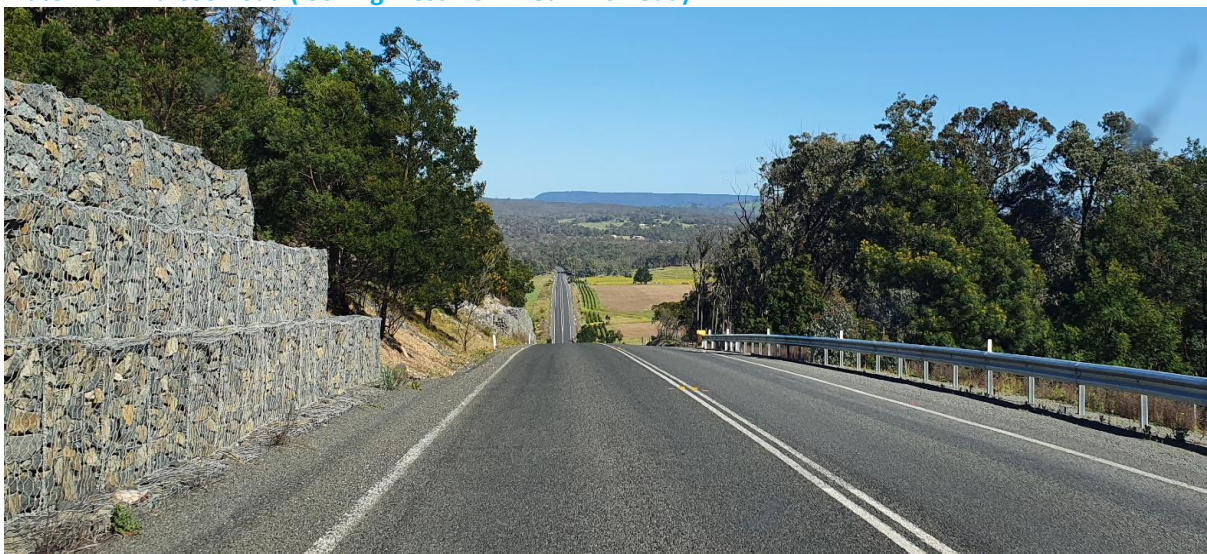
Plate 2.3 Ambrose Road (looking west from Red Hills Road)

Plate 2.3 below is a shot discreetly taken in order not to show any damage however it does give an indication of just how steep the road is and why so many loaded trucks have difficulty in climbing the hill, as indicated in Figure 4-7 of the *Road Safety Assessment (App F.2)* below.

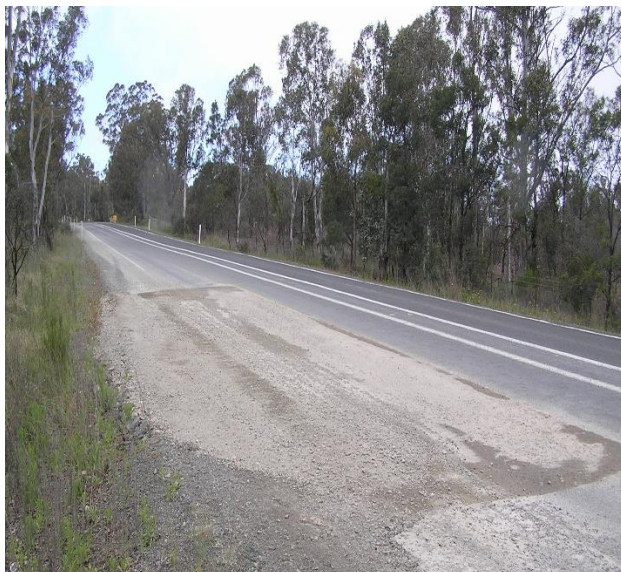
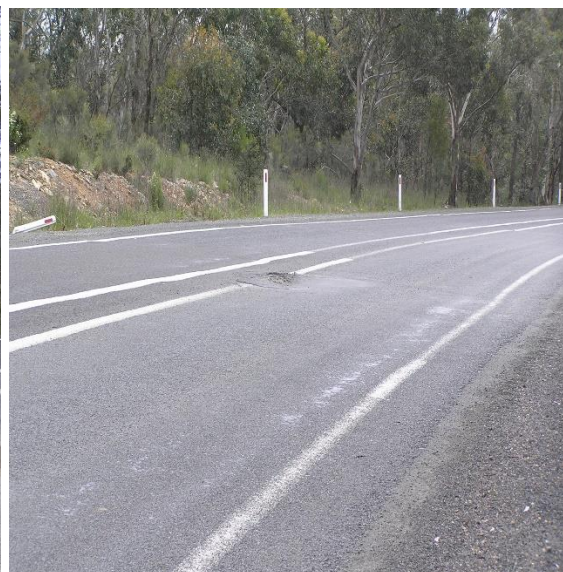
Photo #26 – Brayton Road_Oct 2021

The primary haulage route has remained in an ongoing state of disrepair, no sooner was it upgraded that it required patching, then resealing in October/November 2019, and more patching over and over again. Given the history and number of repairs and maintenance to the primary haulage route, we believed that the rehabilitation works carried out in April 2021 would also be short-lived. We were convinced that additional works would be required, once again, far sooner than expected as has been the case, not just in the past 3 years, but ever since operations at Gunlake Quarries commenced in 2007. As predicted, further roadworks are required to repair even more damage to the pavement, as per photos #26 to # below taken in October 2021.

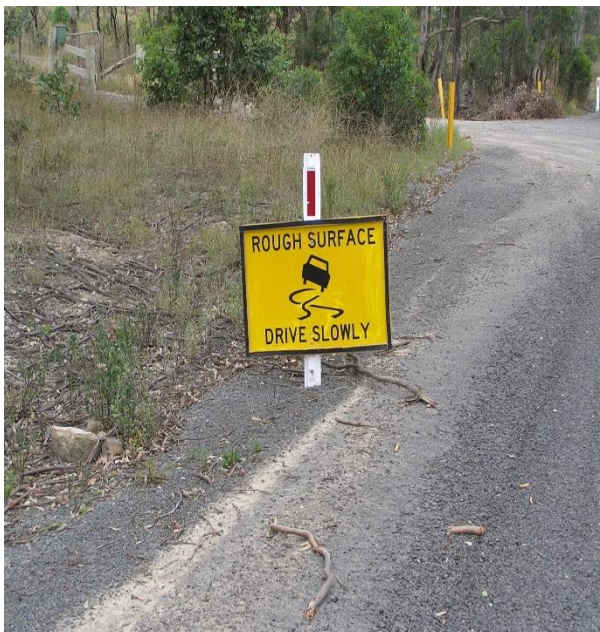
This constant damage to the roads' pavement lends further justification to the need for a transport options review which, in our opinion, ought to be carried out prior to any increases in truck movements to what has already been approved. Apart from the ongoing need to repair damage, there are aspects to the Primary Haulage Route that are quite dangerous, such as blind crests, tight bends, floodways and narrowing of the road over culverts. An example of some of the many warning signs appear in photos below:

Photo #38 – Warning sign approaching a bend on Brayton Road

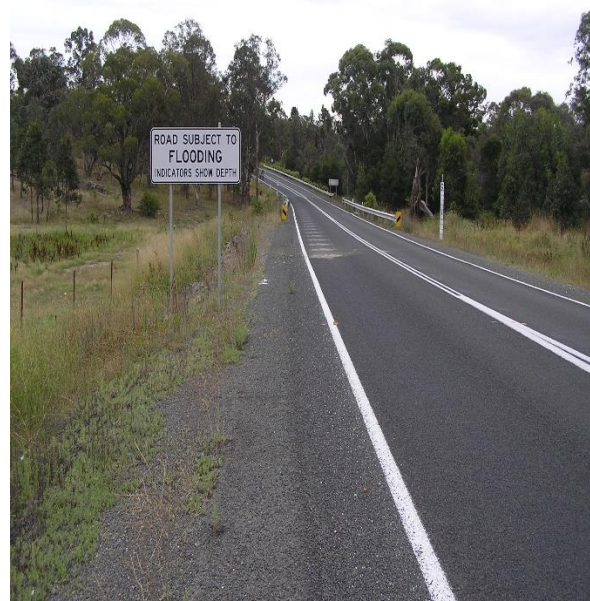
Photo #39 – Flood warning sign and depth indicator on Ambrose Road

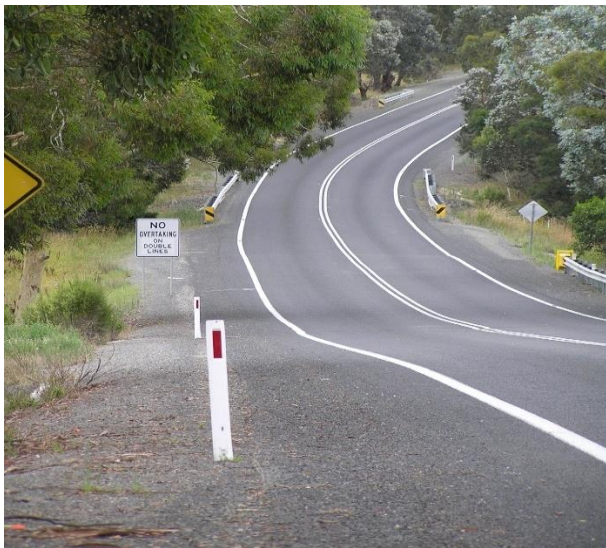
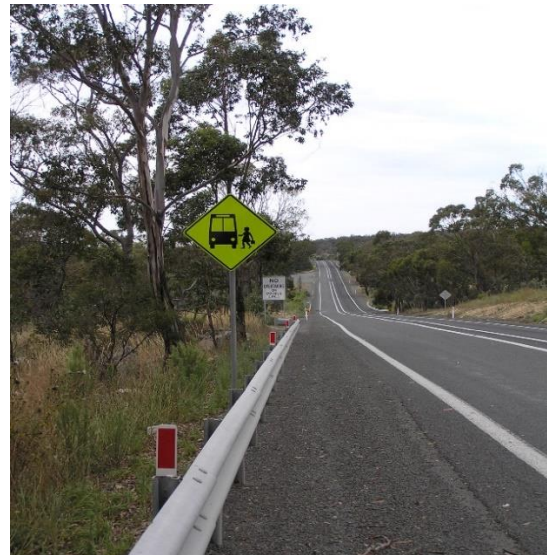
Brayton Road is also a dedicated school bus route with several pick-up spots along its length and signs have been installed at appropriate points warning motorists to take care. This is quite normal and common however what could not be considered at all normal is the installation of **'No overtaking on double lines'**. (See photos #40 - #42 below). It appears impatience on the part of some motorists may be the reason for the number of times we observe trucks being overtaken. The need to advise motorists of a fundamental road traffic rule is beyond belief and only accentuates the risks associated with travelling along both Brayton and Ambrose Roads. Reducing the speed limit to 80km/h for all vehicles may go some way to raising the level of safety nevertheless, we fear that reducing the speed limit is unlikely to be heeded by the few reckless drivers that also appear to take no notice of 'no overtaking on double lines'. Should the Continuation Project be approved allowing 750 truck movements per day, with an estimation of 40 trucks being loaded per hour at times, this would mean there could be **one truck every 45 seconds** on the road. The potential for a major traffic incident occurring as a result of quarry trucks in convoy, is quite alarming. As you can see from the photos, there is very little room for error and in some places, absolutely **NOWHERE TO GO** to avoid a collision in the event of an oncoming vehicle being on the wrong side of the road.

Photos #40 and #41 – 'No overtaking on double lines' signs on Brayton Road

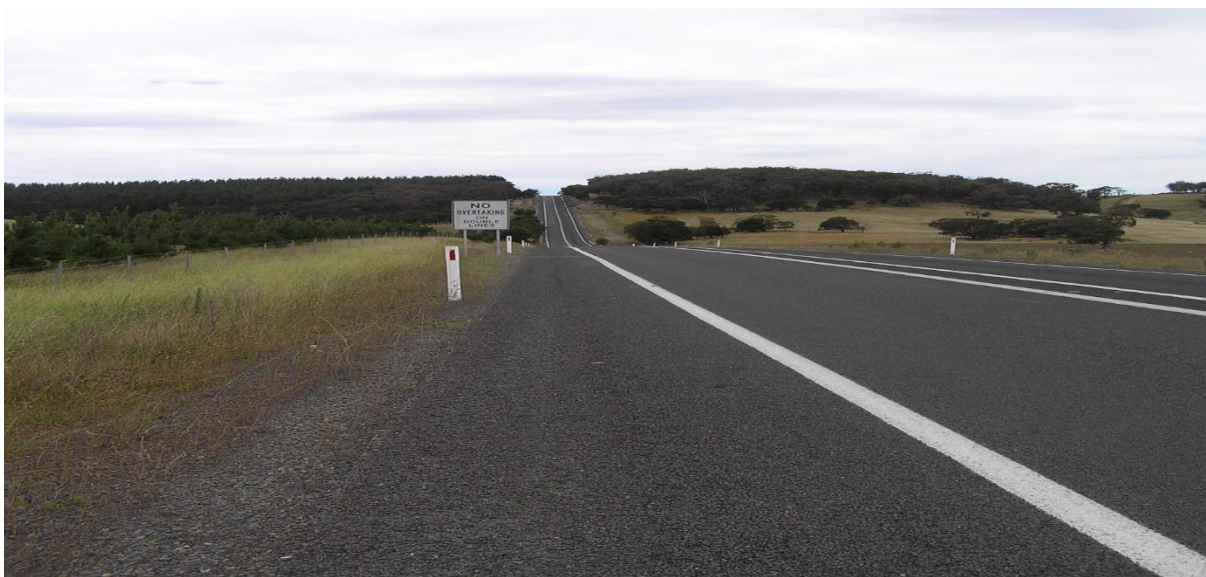
Photo #42 – 'No overtaking on double lines' sign on Ambrose Road

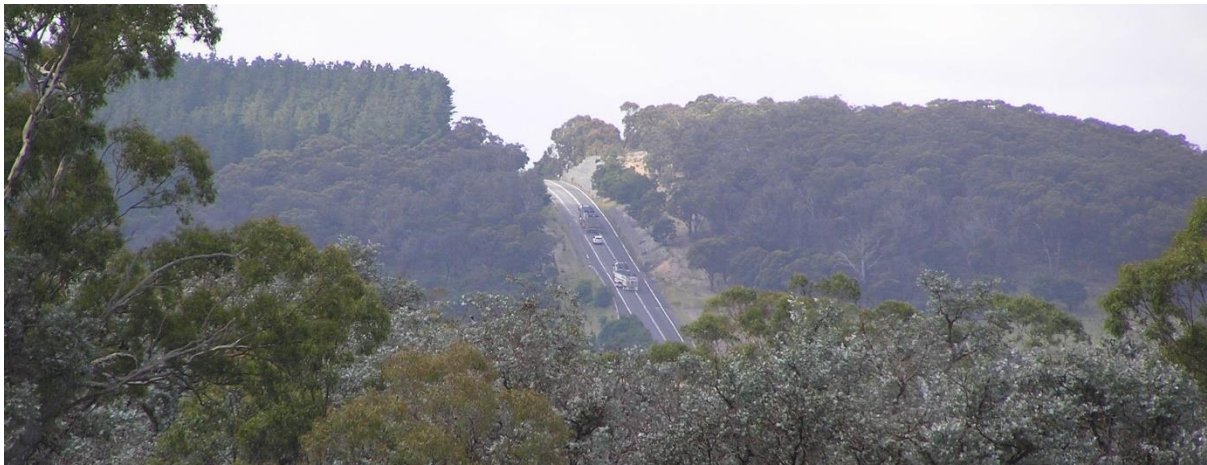
At approximately 12pm, 11 March 2021, it was observed from Brayton Road, that a quarry truck, which was about halfway up Ambrose Road hill, appeared to be stationary. Behind this was another quarry truck, also stationary, with very little distance between the two. Also observed was a ute near the first truck however, shortly afterwards, the truck at the rear had moved on. (Please see photo #1 below). As you will see in photo #2, the broken-down truck appears to have attempted to reverse downhill however the trailer 'jack-knifed' across the centre line resulting in partially blocking the westbound lane.

Photo #1 _Truck breakdown_Ambrose Road_11Mar21

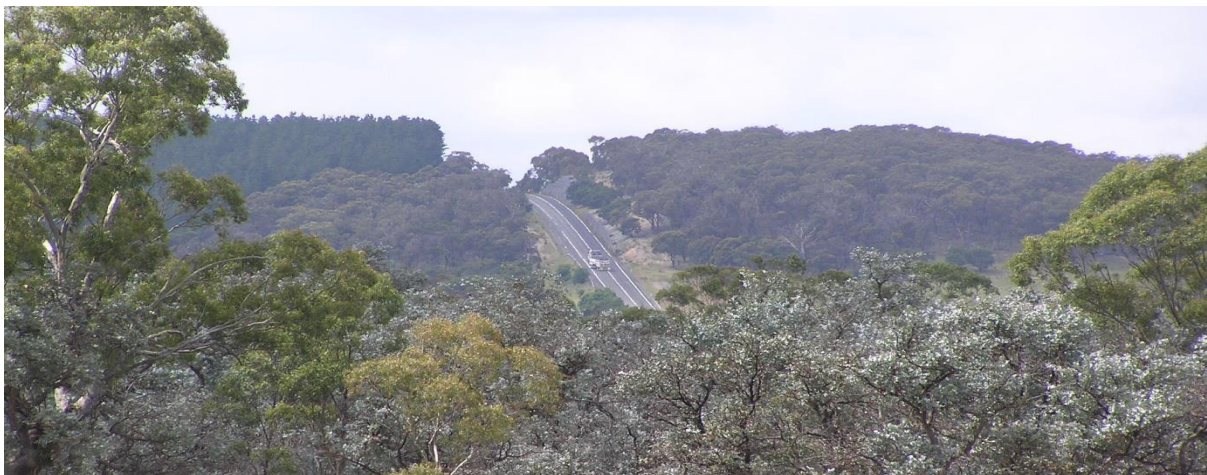
Photo #2 _Truck breakdown_Ambrose Road_11Mar21

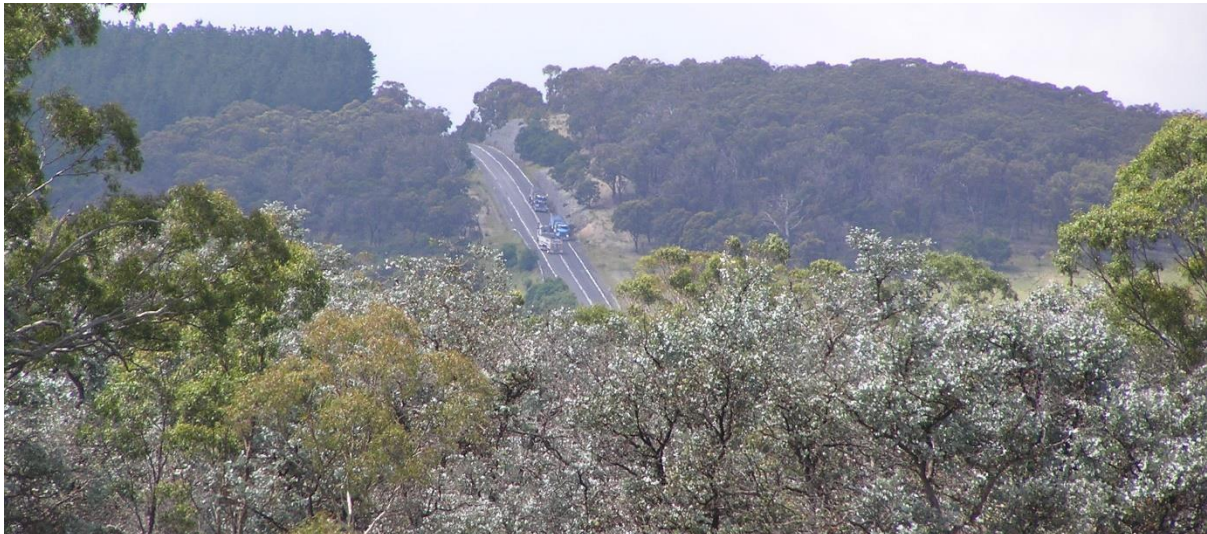
As events unfolded and before police assistance arrived, not only were trucks and other traffic being allowed to continue to use Ambrose Road, but also, at one point, two quarry trucks passed the broken-down truck, in tandem. (Please see photos #3 and #4). We are aware that in the past the dangers of quarry trucks using the primary haulage route, in particular Ambrose Road, have been dismissed by Gunlake representatives as being of little consequence and even non-existent. We can assure you that this is certainly not the case, as the attached photos show. This particular incident cannot be denied by Gunlake as their involvement was clearly obvious, including Gunlake-owned quarry trucks, (see photo #5) and, in our opinion, ought not to have been attended to by Gunlake staff alone. The fact that the call for police assistance was left up

Photo #3_Truck breakdown_Ambrose Road_11Mar21

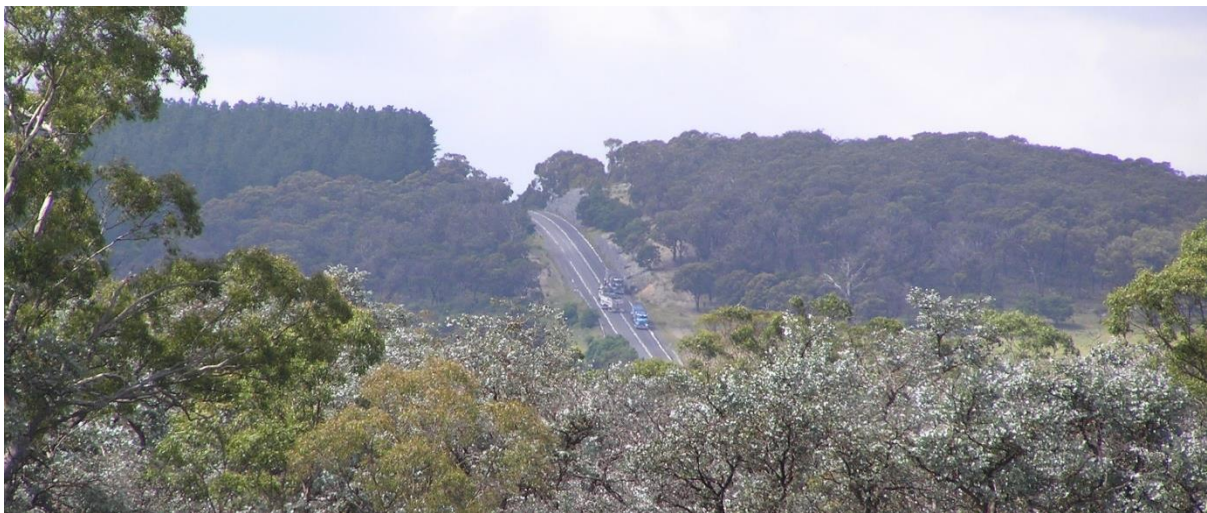
Photo #4_Truck breakdown_Ambrose Road_11Mar21

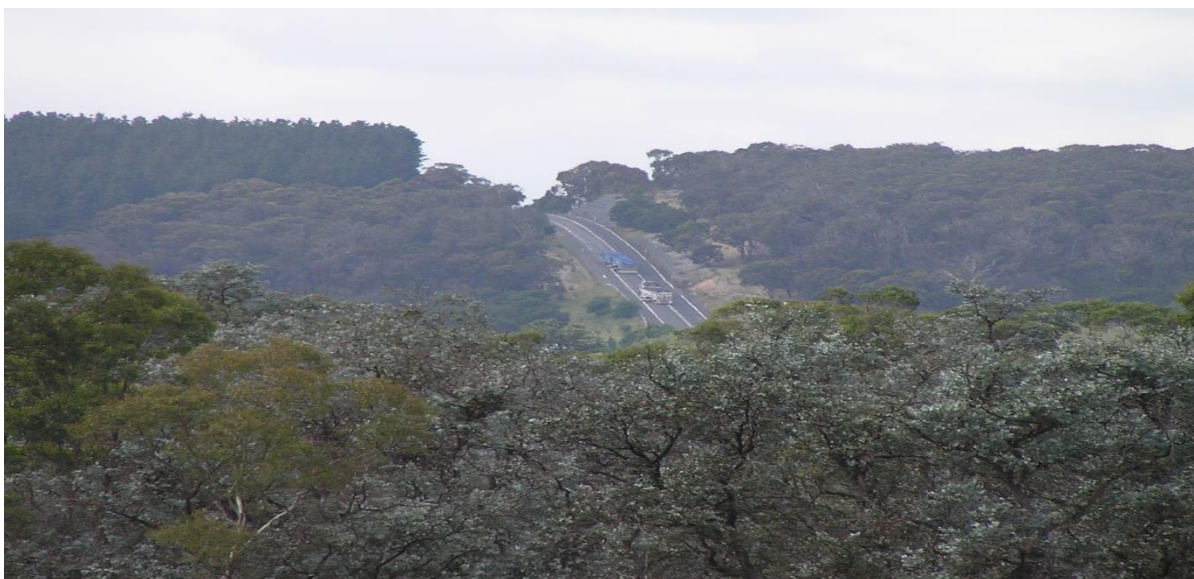
Photo #5_Truck breakdown_Ambrose Road_11Mar21

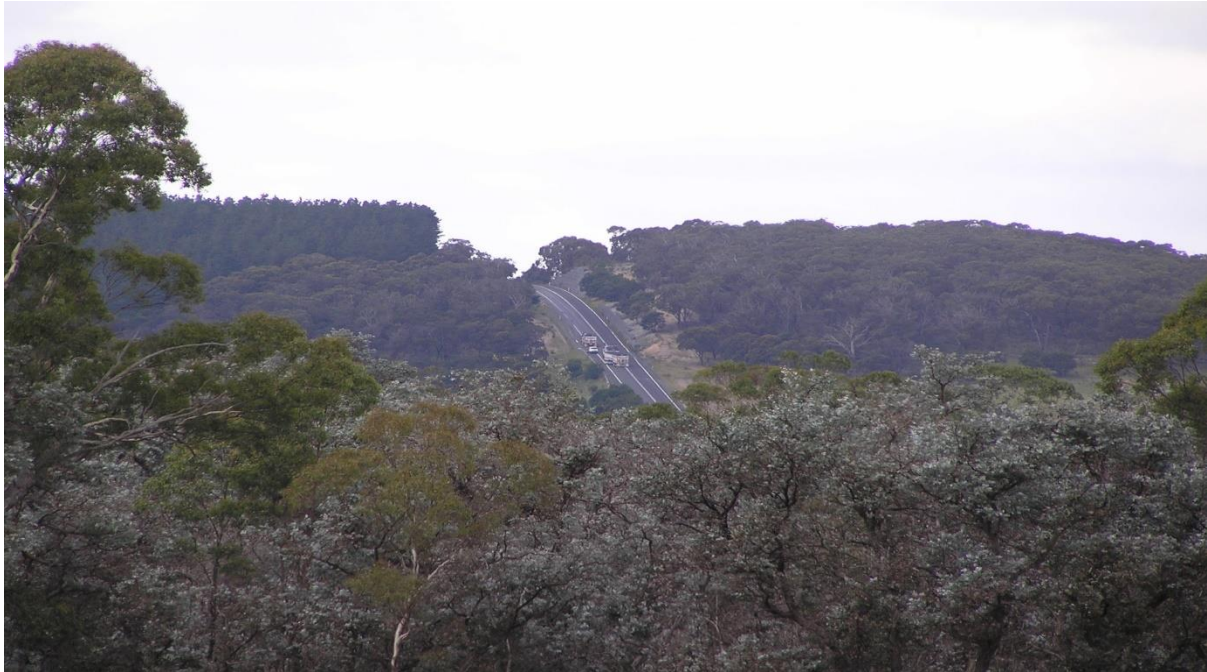
At around 2:20pm, after some mechanical assistance was rendered to the truck (see photo #6), it was able to be moved uphill towards the highway. The road was then clear and traffic once again flowed freely. A phone call and subsequent report of the above situation was forwarded to Goulburn Mulwaree Council Director of Planning and Environment, in order that Council be kept abreast of such occurrences as they happen. We decided that photographic evidence would also assist in supporting our concerns surrounding the safety issues associated with the primary haulage route.

Photo #6_Truck Breakdown_Ambrose Road_11Mar21
