KINCOPPAL-ROSE BAY SCHOOL

PRELIMINARY (STAGE 1) SITE INVESTIGATION

PROPOSED DEVELOPMENT AT KINCOPPAL-ROSE BAY SCHOOL

Date: 14 May 2021
Ref: E32915BArpt-Rev1

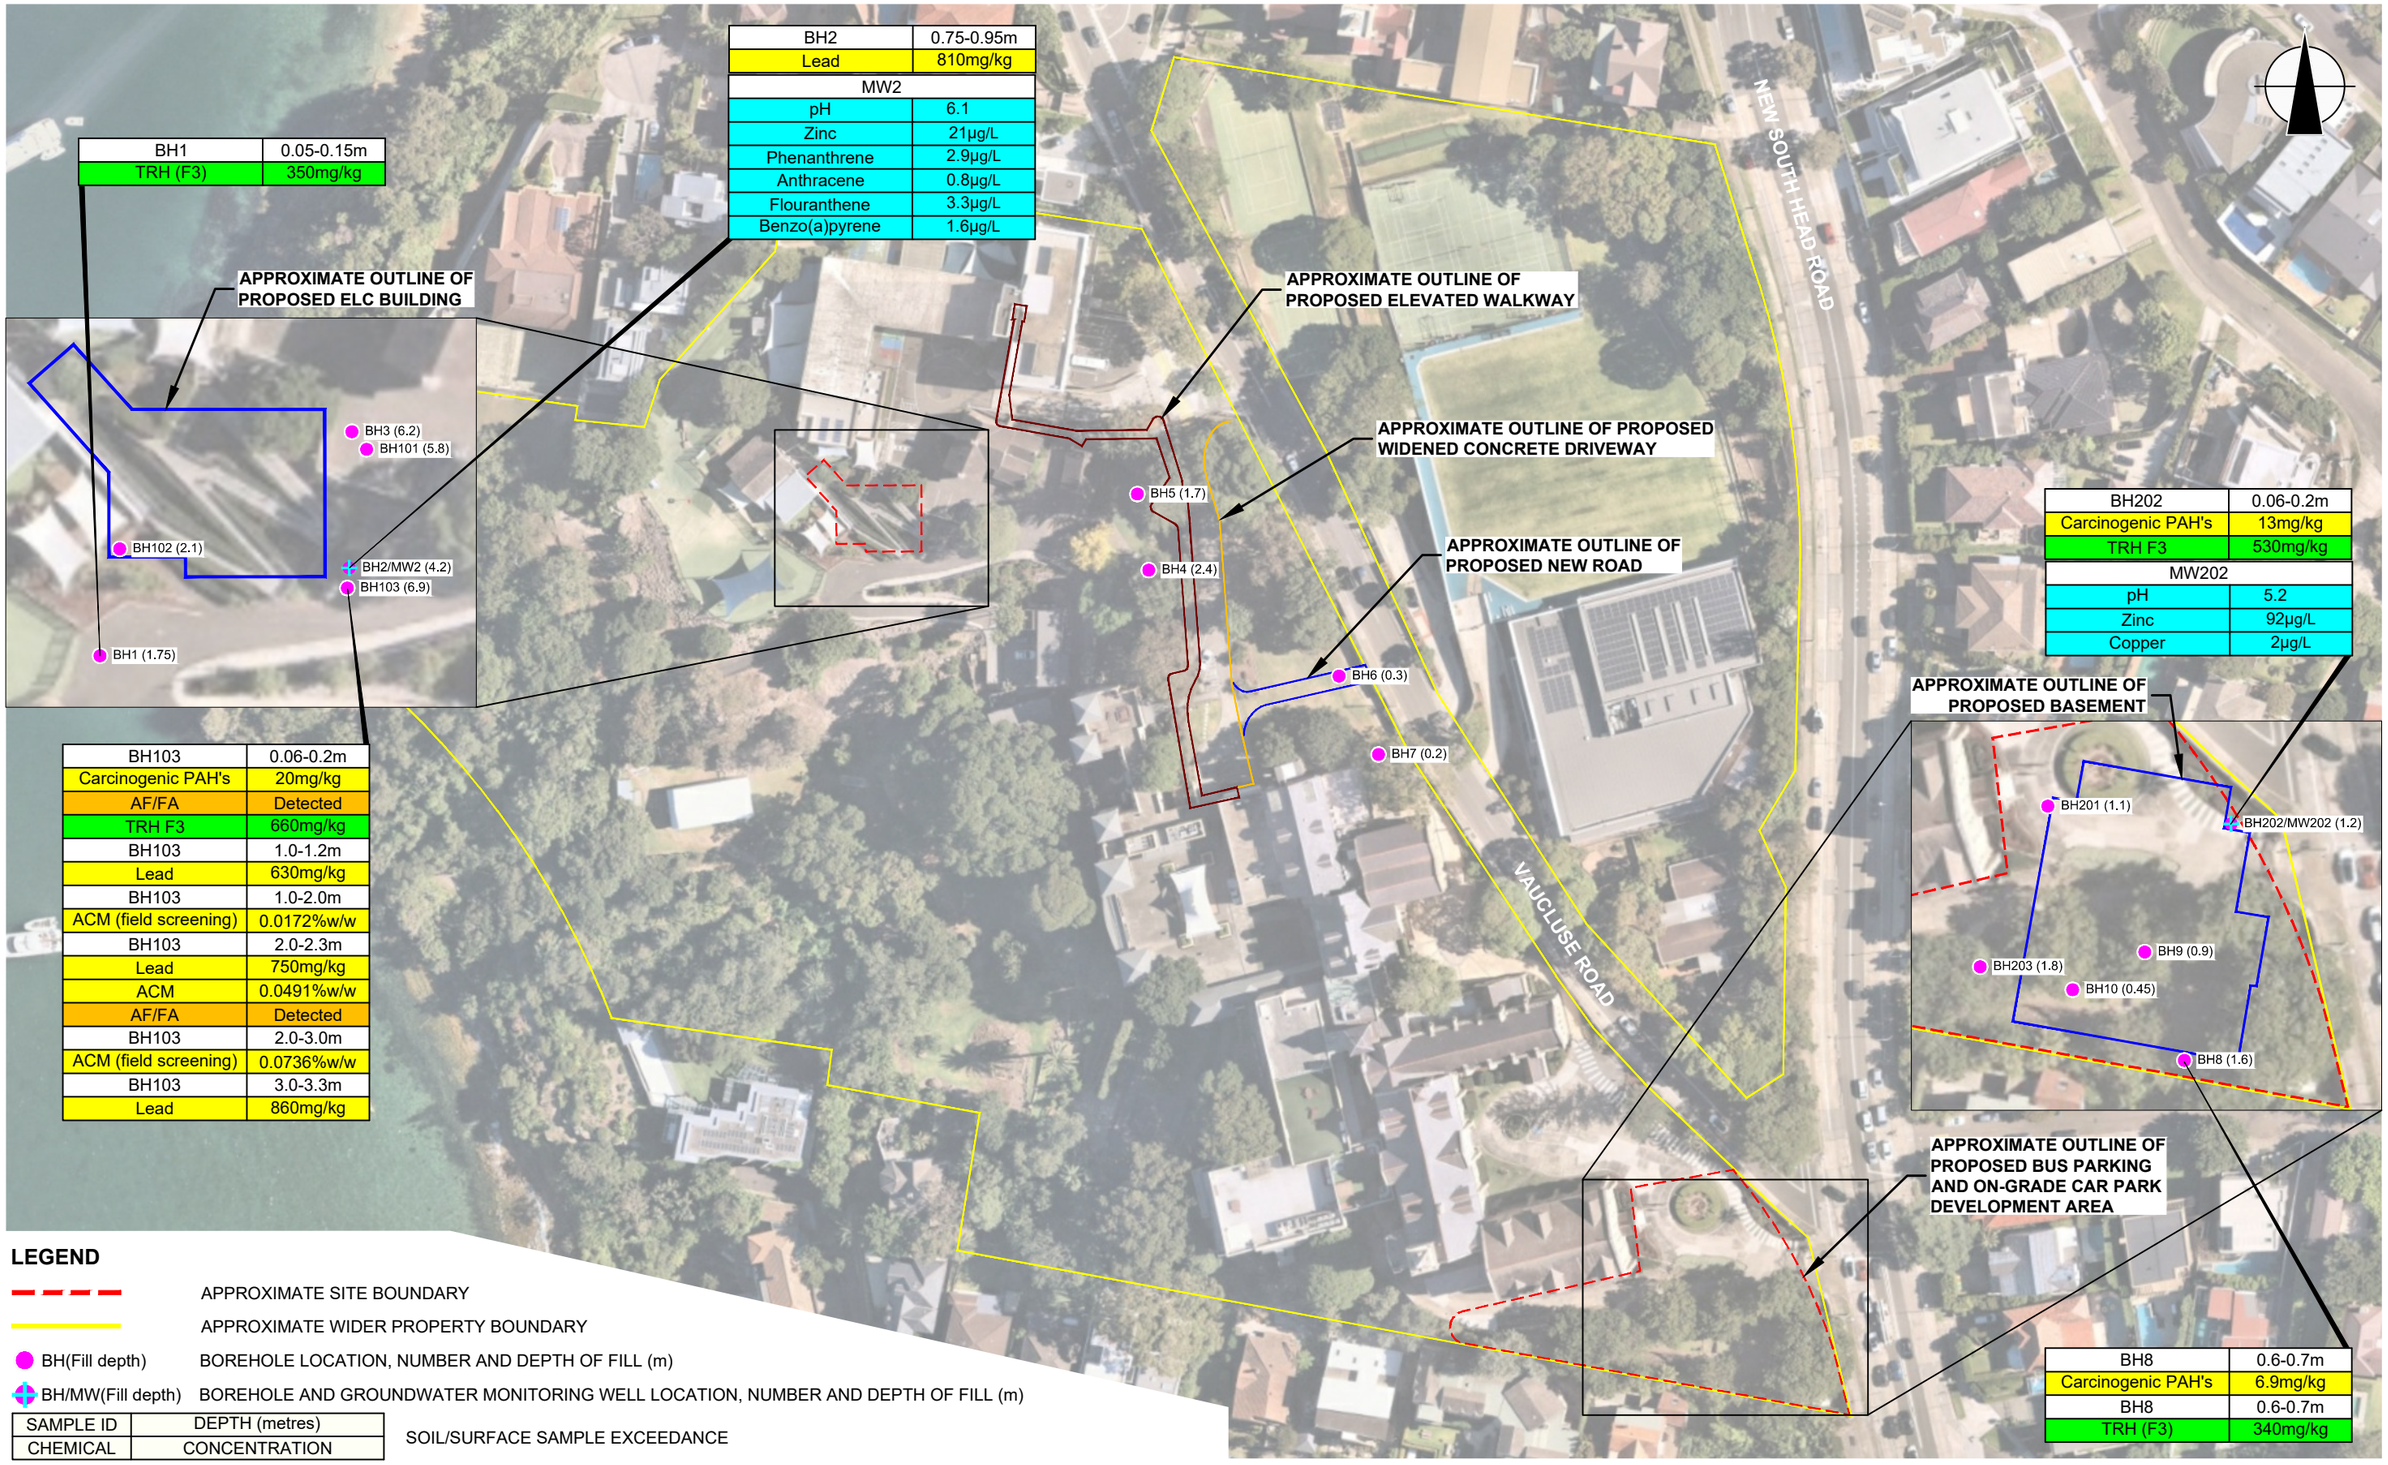
BH1	0.05-0.15m
TRH (F3)	350mg/kg

BH2	0.75-0.95m
Lead	810mg/kg
MW2	
pH	6.1
Zinc	21µg/L
Phenanthrene	2.9µg/L
Anthracene	0.8µg/L
Flouranthene	3.3µg/L
Benzo(a)pyrene	1.6µg/L
