## **DENDROBIUM MINE AND CORDEAUX COLLIERY ANNUAL REVIEW FY21**

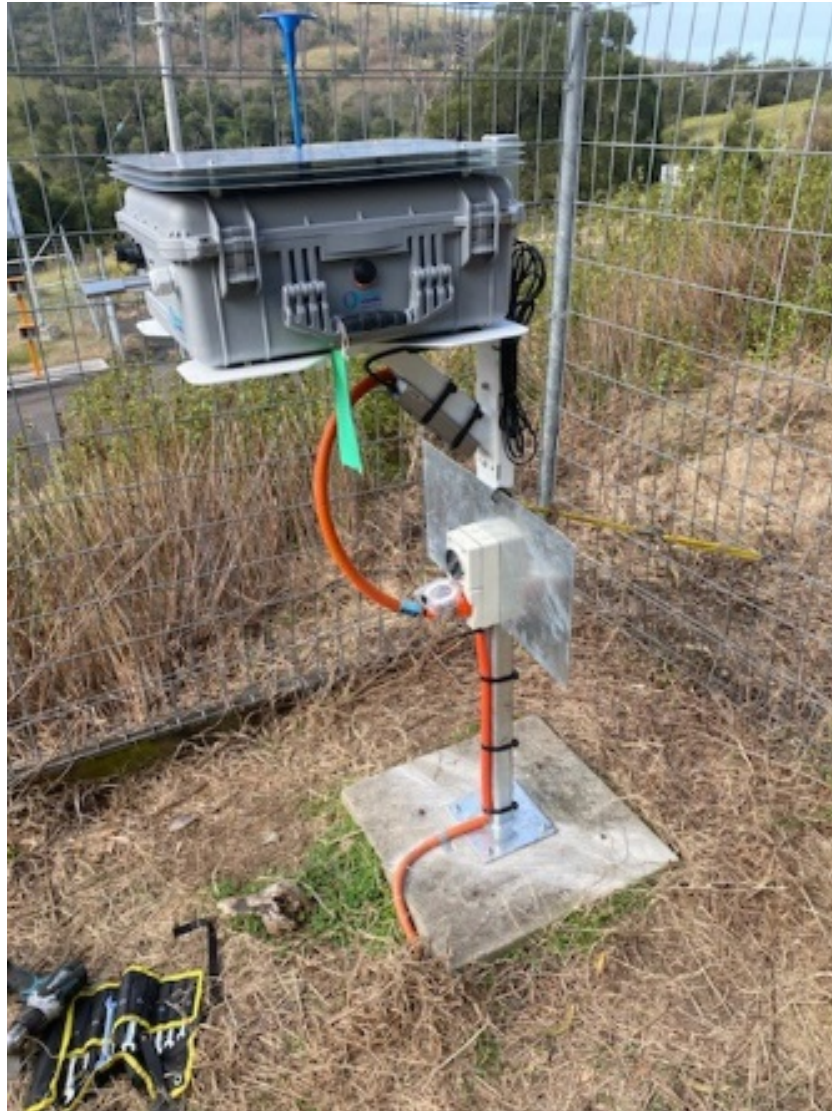
In July 2021, Dendrobium's EPL was amended to include the use of real-time air quality optical photometers and remove the requirement to monitor air quality using DDGs and HVAS. In the next reporting period, DDG and HVAS monitoring will be decommissioned in place for real-time monitoring. Photometers were installed and commenced monitoring on 15 July 2021. The photometer installed at the KVCLF is shown in Plate 2.

**Plate 2: Photometer dust monitor located at the KVCLF**

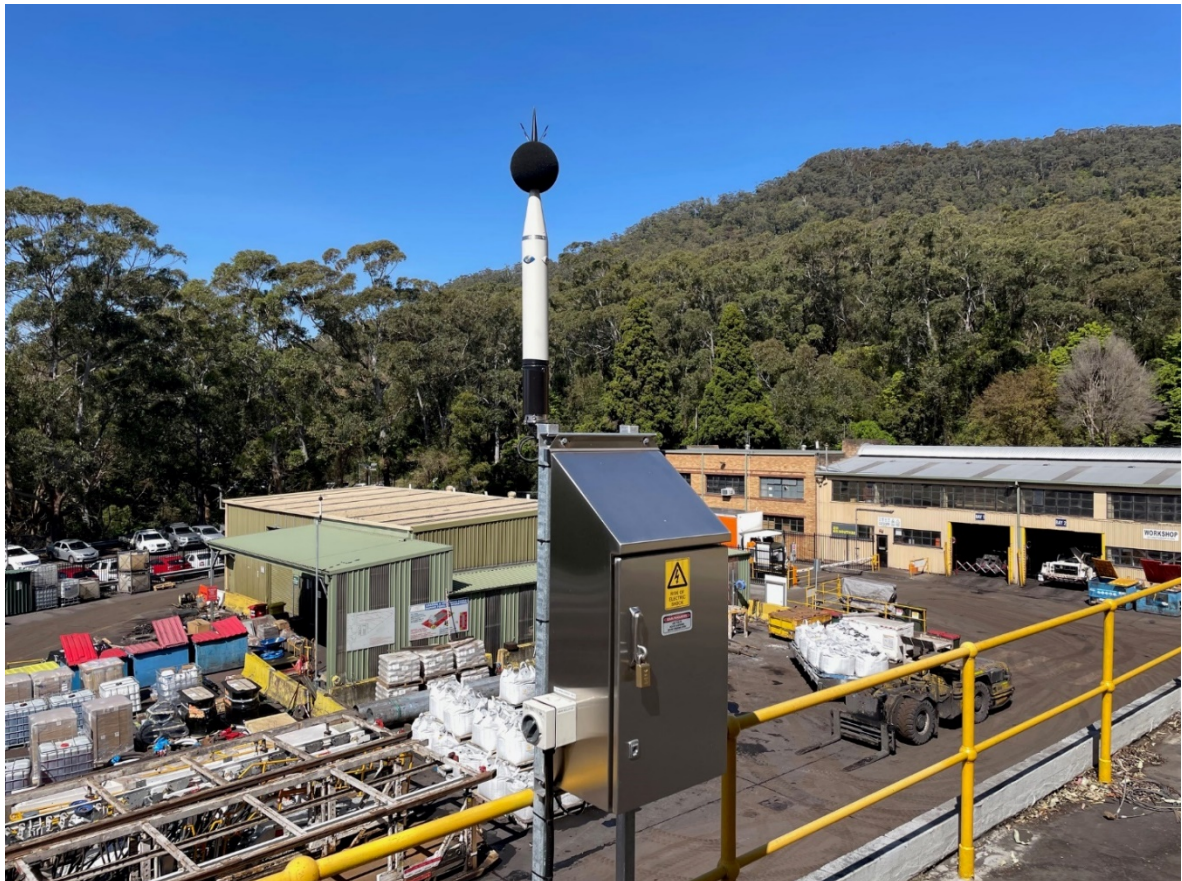
The DNMS is comprised of five loggers that provide coverage of the Pit Top entrance, workshop and warehouse areas and Portal Road. The loggers record data on a continuous basis, and will assist IMC to identify activities, events and locations that contribute to the site noise level 15-minute average. One of the noise loggers is shown in Plate 3.

**Plate 3: Real-time noise monitor on roof of Operations Building (Pit Top)**
