Detailed Site
Investigation

Detailed Site Investigation
MACH Energy Australia
Mount Pleasant Operation Rail
Modification

(Report: J000373 – Tier 1 Detailed Site Investigation 2.0)

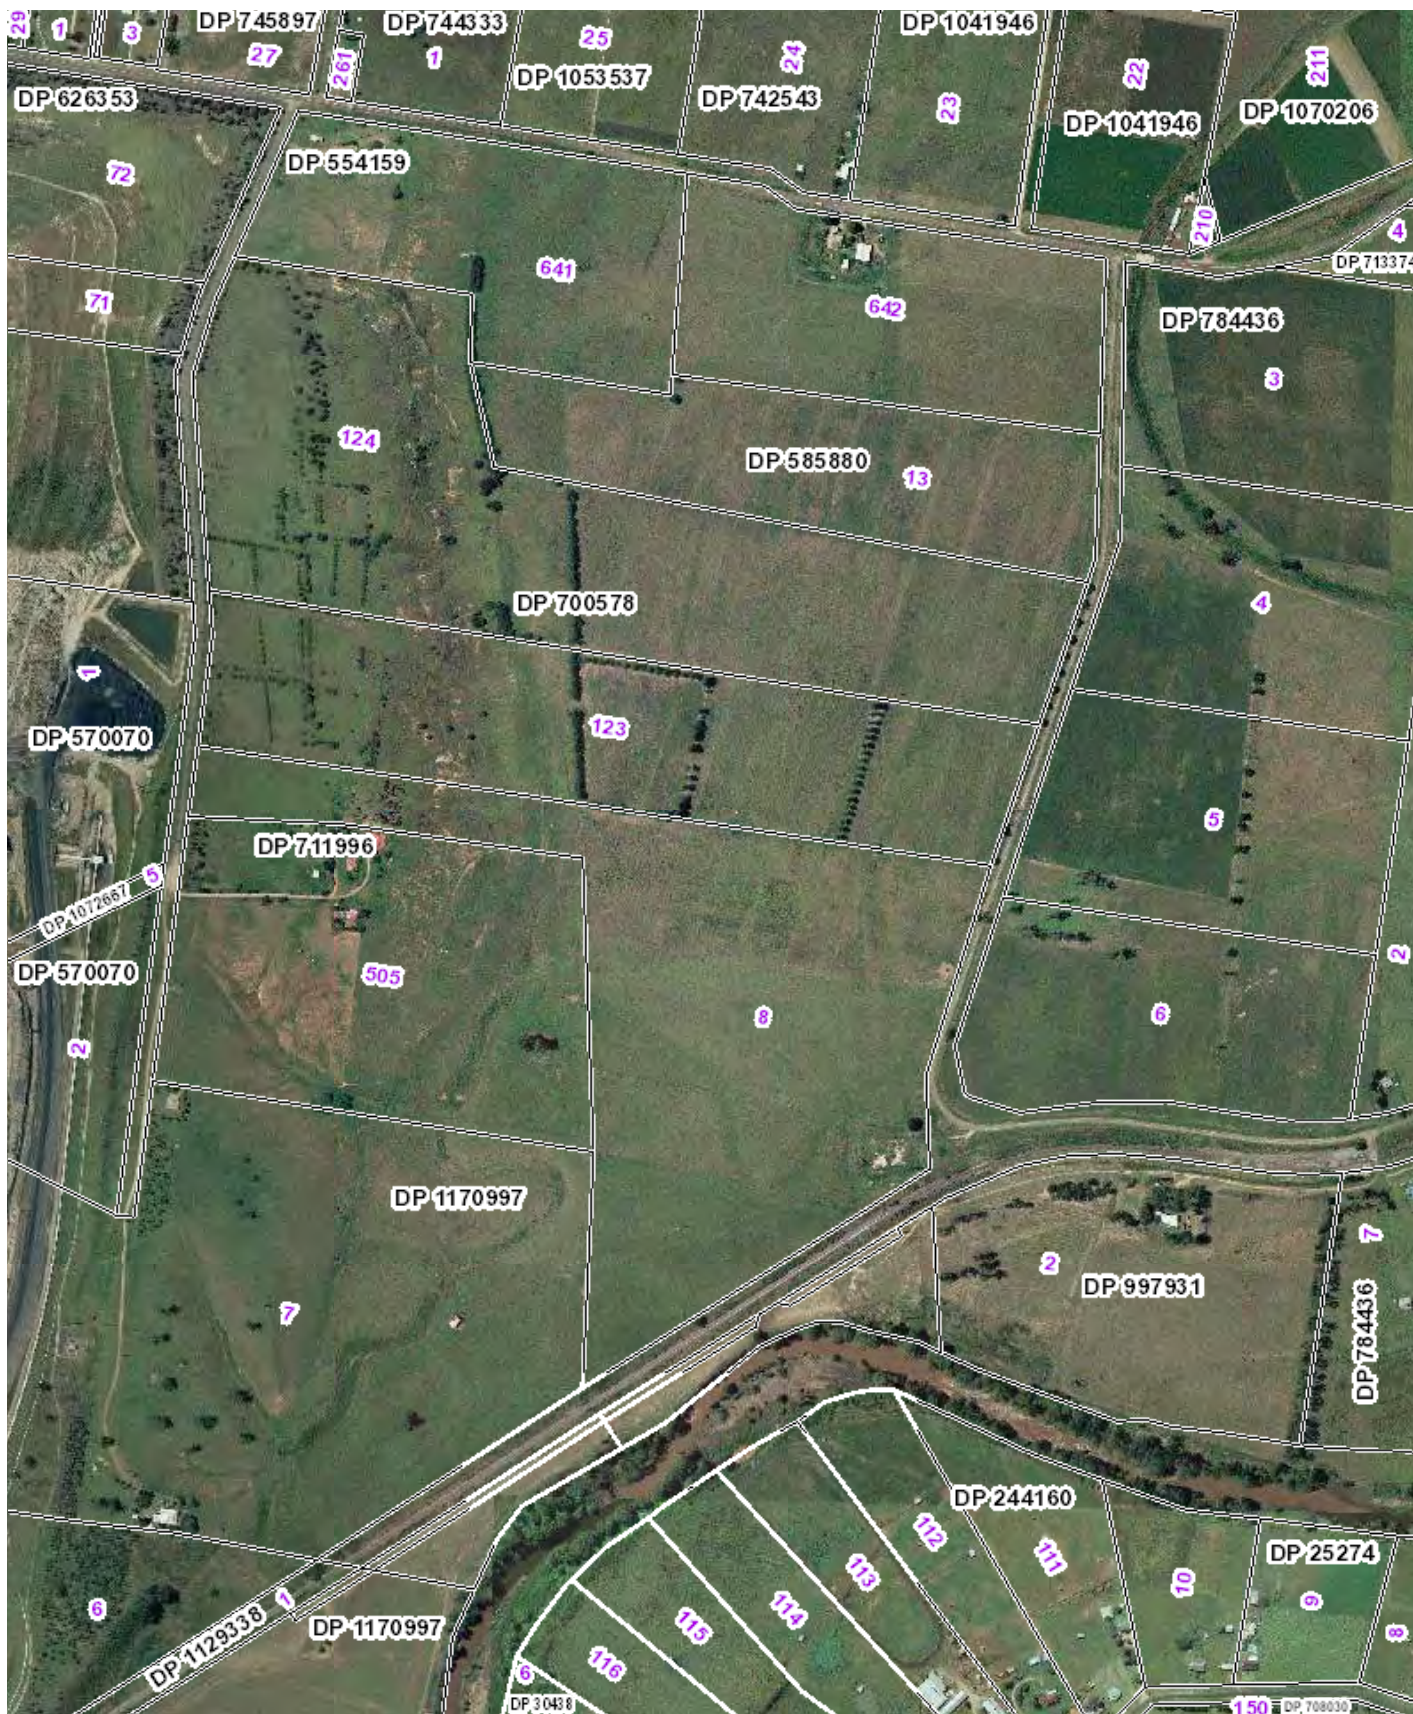
Location: Mount Pleasant Operation Water Pipeline NSW (Project: J000373)

The map displays a network of land parcels, roads, and a water pipeline. Key features include:

- Land Parcels:** Numerous parcels are labeled with their DP (Deeds Plan) numbers, such as DP 554140, DP 544039, DP 1041946, DP 1070206, DP 713374, DP 784436, DP 780673, DP 112792, DP 1137094, DP 77091, DP 745369, DP 668247, DP 99792, DP 585880, DP 700578, DP 1053537, DP 742543, and DP 554159.
- Roads:** WYBONG ROAD and LOGGERS LANE are visible.
- Water Pipeline:** A winding pipeline is shown, likely the Mount Pleasant Operation Water Pipeline.
- Land Use:** The map shows various land use patterns, including agricultural fields, forests, and some built-up areas.

The investigation area for this assessment comprises the extent of the Modification Area, including the rail loop and spur, the water pipeline and electricity transmission line. SESL has been advised that the proposed Modification components along Wybong Road fall within the currently approved mining lease area, and do not require any contamination investigation as part of this assessment. In addition, the area that falls within the existing railway easement has been excluded from the current investigation, given the disturbed nature of this land. Lots and Deposited Plans (DPs) within the area of the Modification are listed in Table 1 and the extent of the areas investigated are shown in Figure 2. Figure 2a provides the detail of the land title information.

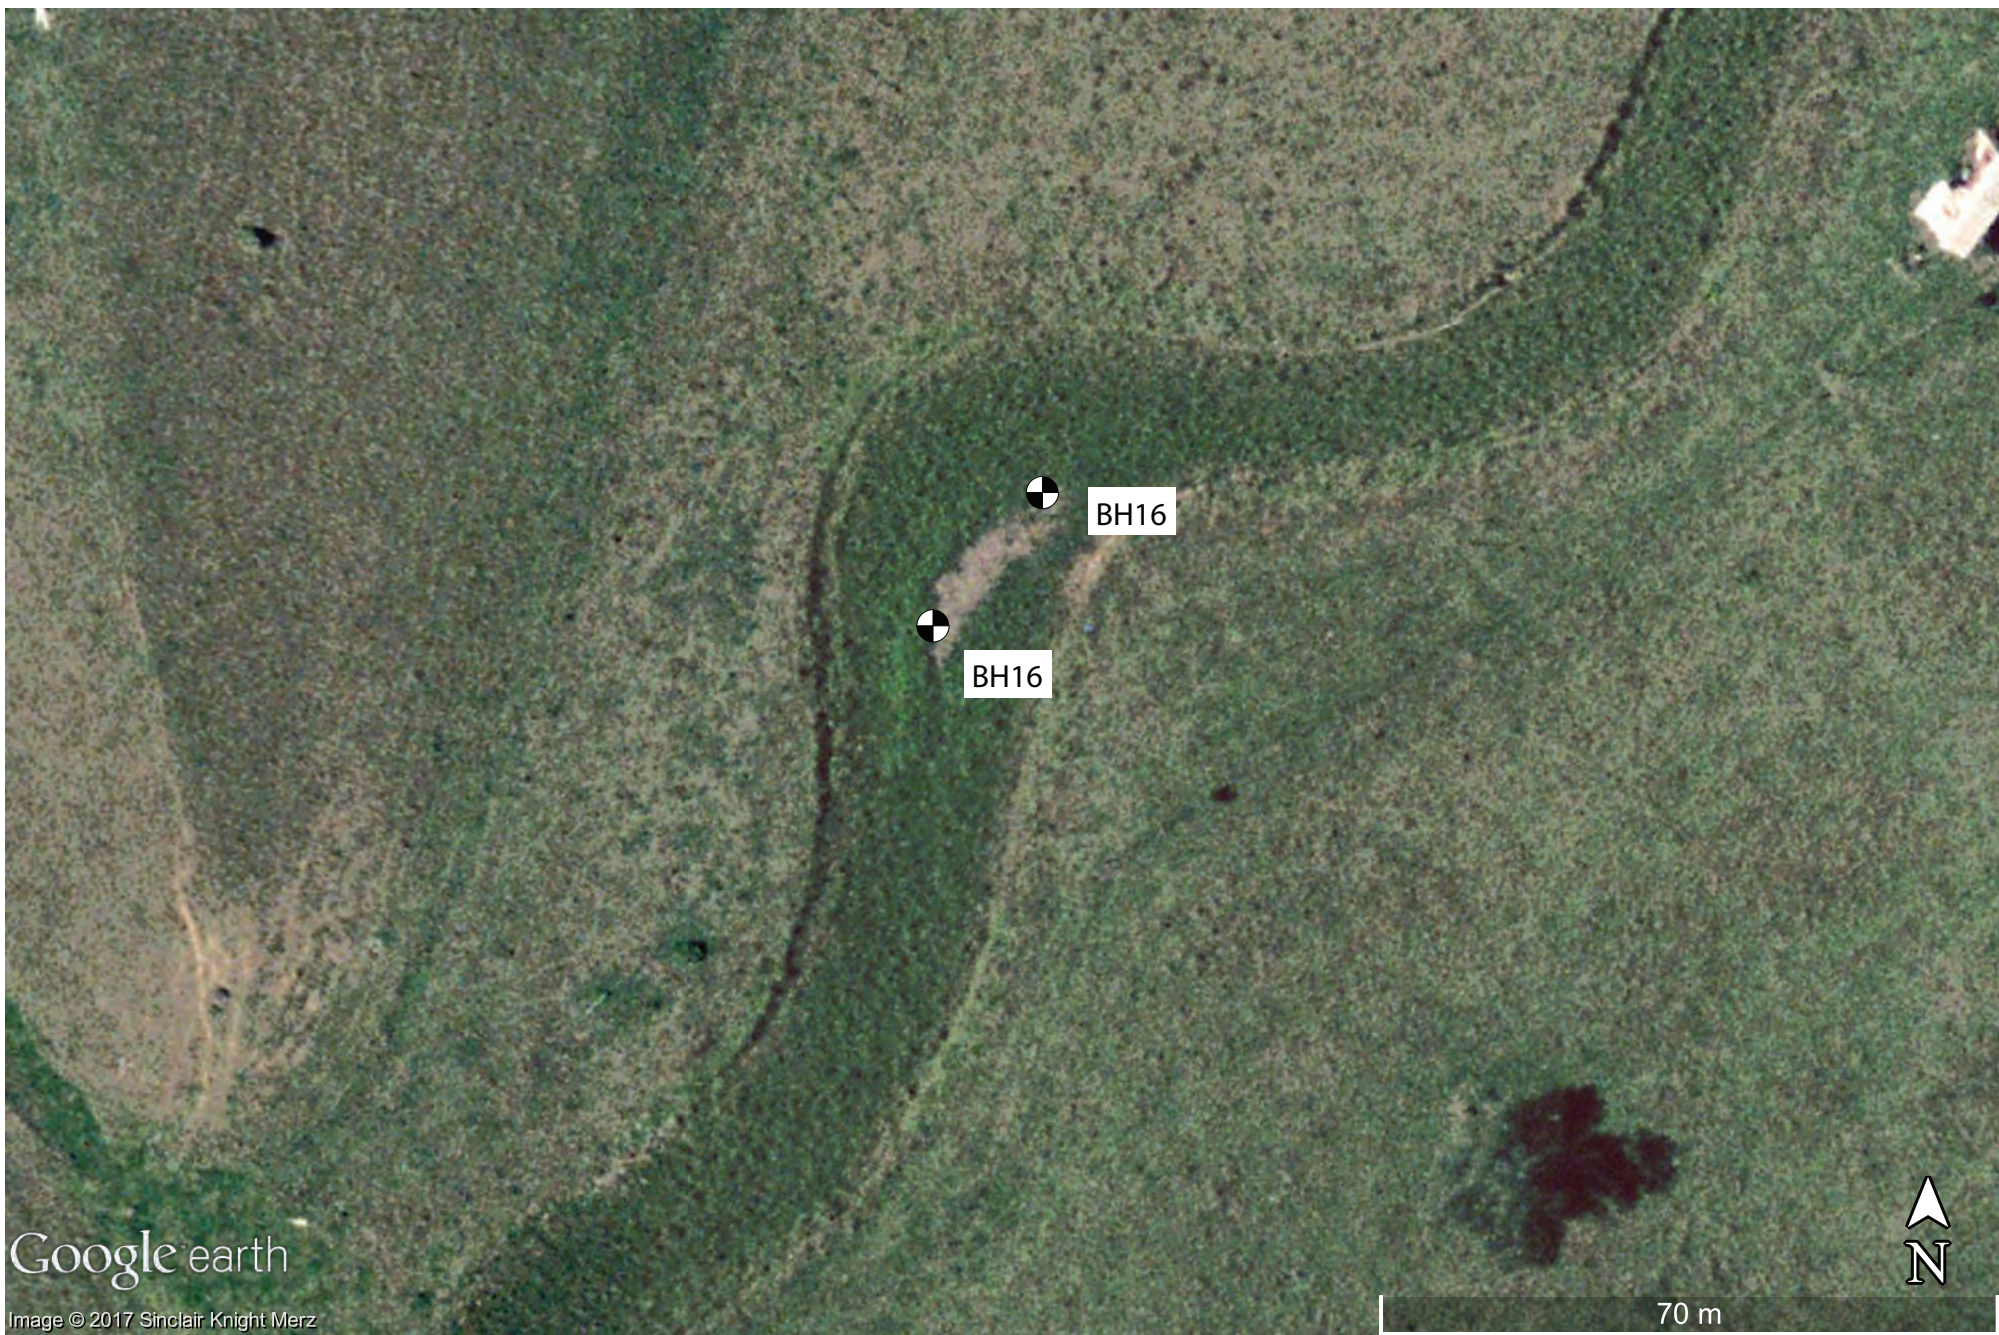
Title: Figure 4e: Sample Locations
Location: Mount Pleasant
Project: J000373 - Detailed Site Investigation
Date: 09/12/2017

Borehole Locations

Sampling density for this investigation was based on professional discretion, with consideration to the potential contamination risk associated with each feature of interest. Rational for sampling is discussed in Table 8 below. Locations of the samples are presented in Figures 4a to 4i. Site Photographs are presented in Appendix A.

- visual inspection for contamination during the site walkover;
- samples were collected within areas proposed for development;
- sample collection was conducted on a judgemental based sample regime (See Figures 4a-4i);
- soil samples were recovered from each sample location using hand equipment (hand auger); and
- soil samples were collected in 150 mL glass jars.

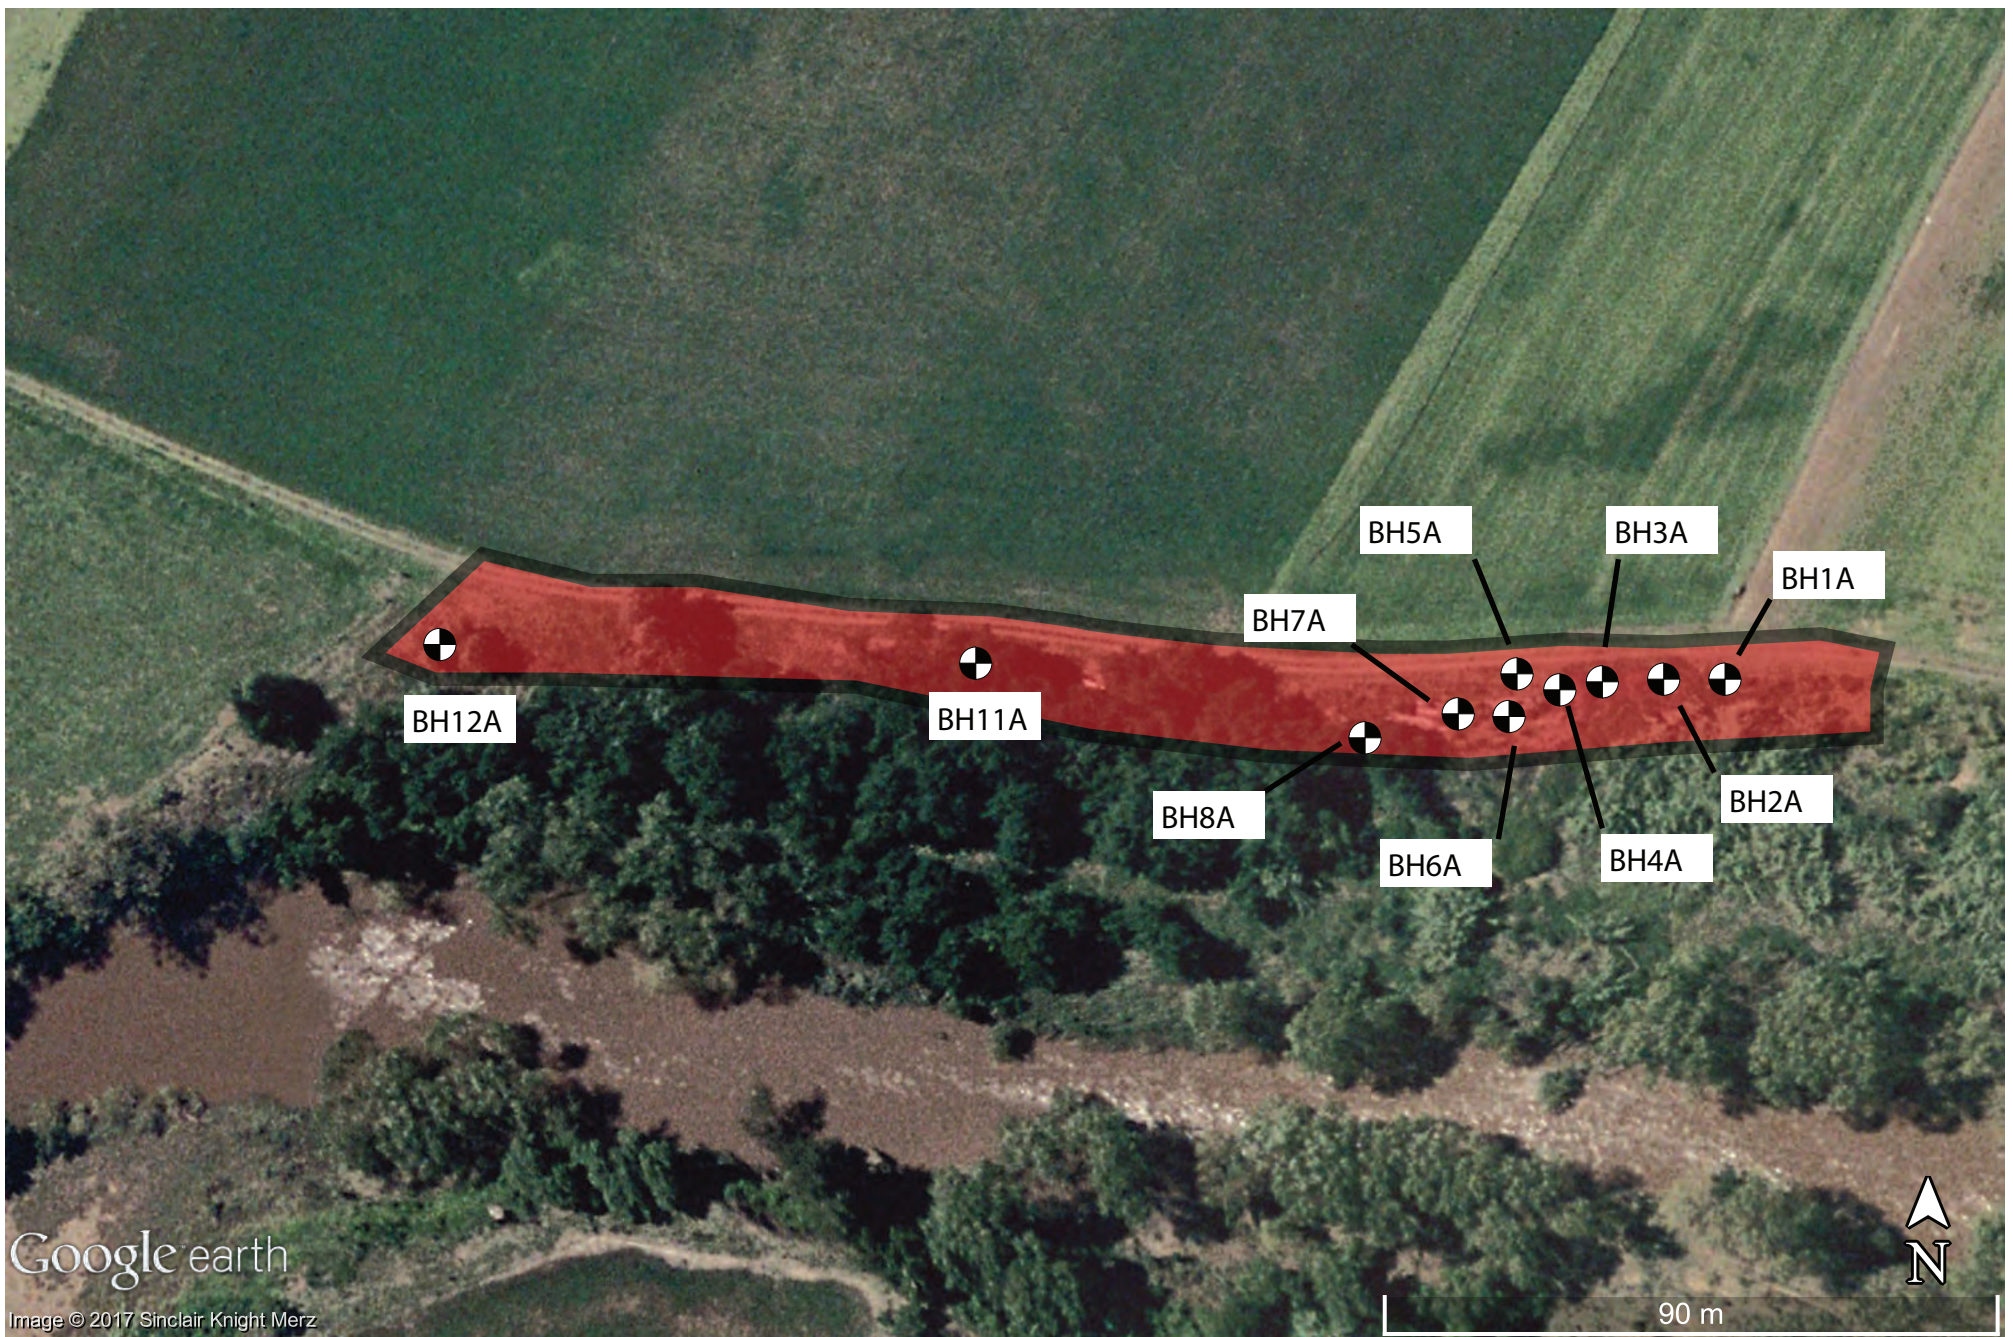
Title: Figure 4h: Sample Locations

Identified Fill Materials

Fill material was identified in isolated areas across the Modification Area and surrounds. Specifically, fill materials were identified within the vicinity of Feature of Interest 18 and Feature of Interest 22 (refer to Figures 4f & 4h).
