Snowy 2.0 Transmission Connection Project

Supplementary Landscape and Visual Impact Assessment

P000014 | REV 01

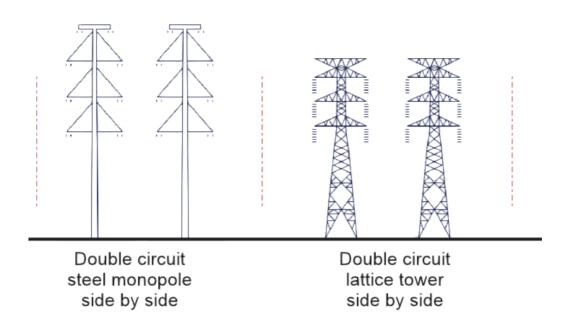
Figure 2-1Transgrid Tower Designs - modified from https://www.transgrid.com.au/media/b2hpaiso/high-voltage-transmission-line-factsheet.pdf

The project assessed as part of the EIS considered double circuit steel lattice towers. A second option available for part of the alignment is double circuit steel monopoles. Figure 2-1 shows the design and scale considerations of structure types and transmission line designs available to the project.

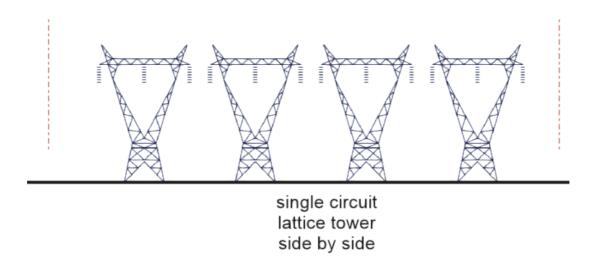
Figure 2-2 single circuit configuration - modified from https://www.transgrid.com.au/media/b2hpaiso/high-voltage-transmission-line-factsheet.pdf

A single circuit design may assist to reduce the overall height of structures. This is achieved by 'flattening' transmission wire across a wider easement rather that 'stacking' the wires vertically through a double circuit configuration. To achieve this, a single circuit transmission line would however require four towers side by side within a wider easement, approximately double the width of a double circuit option. This is shown in Figure 2-2 below.

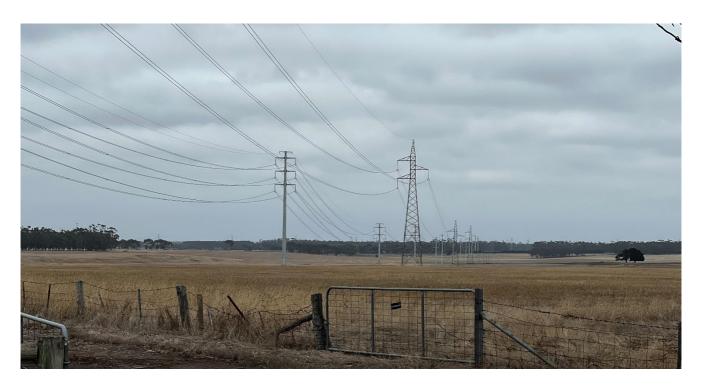
Figure 2-3 Steel monopole added through line duplication

Similarly, a change in structure types over short distances (e.g. steel lattice towers to steel monopoles poles or double circuit to single circuit design) or the addition of steel monopoles to a view that includes existing lattice towers may also contribute to visual clutter. Similarly, the addition of monopoles to sensitive or key views that already includes lattice towers within existing transmission connections may assist to highlight or emphasise the addition of new project elements to an area. Figure 2-3 shows one such example where a steel monopole has been added to a section of duplicated transmission.

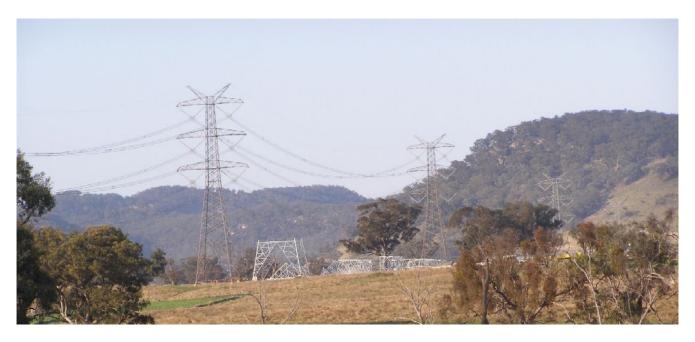
Figure 2-4 New galvanised structure adjacent to existing structure

Figure 2-4 shows an example of partially constructed galvanised steel structure adjacent to an existing aged in place lattice tower.

The freshly galvanised coating of the new structure is more apparent than the existing transmission line which has been allowed to dull naturally. This example also demonstrates ability for duller structures to be visually absorbed when viewed against a backdrop of vegetated and cleared hills. This is further demonstrated by the tower to the right of the view.

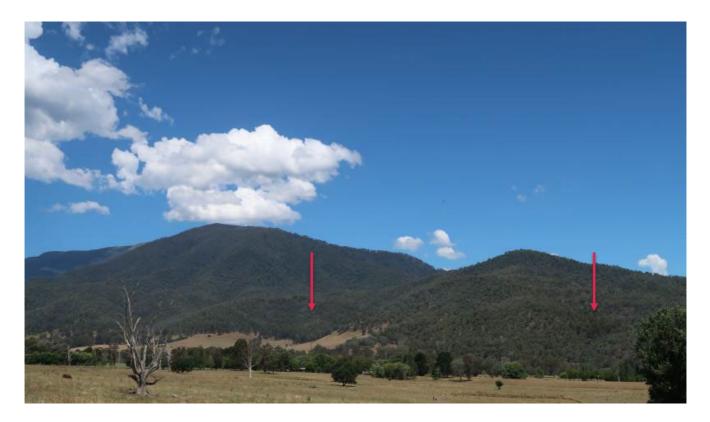
Figure 2-5 220 kV Dartmouth - Mount Beauty transmission line - Alpine National Park (Source Tetra Tech Coffey)

Another method that can assist with structures to visually "blend" with background elements is by painting the structures a similar colour to the vegetated hills. In areas such as the KNP, dark or olive greens are typically applied. Figure 2-5 shows the existing 220 kV Dartmouth - Mount Beauty transmission line within the Alpine National Park near Mount Beauty.

The lattice towers, which are low in the landscape and painted olive green. In this view the towers are barely discernible. Figure 2-6 shows another example from a similar location of the same alignment.

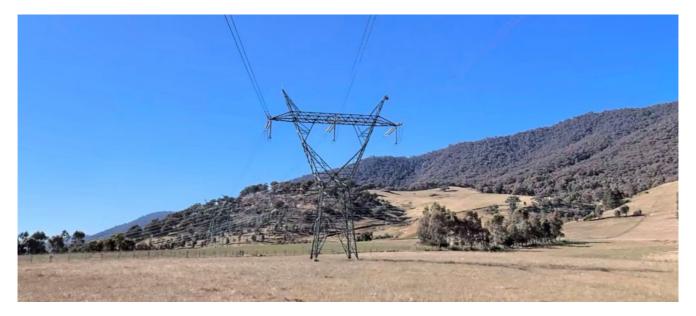
Figure 2-6Figure 3-5 Painted lattice structures

The painted lattice tower is just visible where the background vegetation comprised cleared grasses.

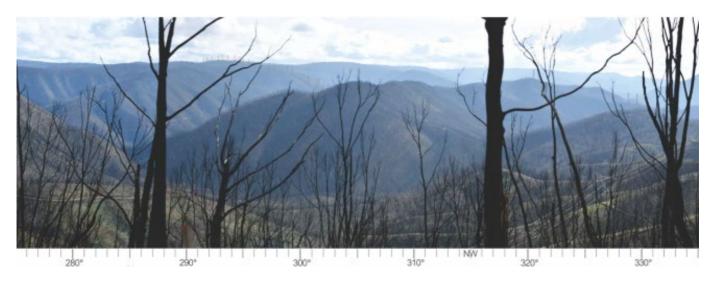
Figure 3-4 The project with dull lattice structures

The nearby towers within Line 2 are visible to the right of the view. The projects dull grey lattice towers contrast the skyline in the background of the view. The dull grey lattice towers are less noticeable when viewed against the hilly backdrop as the transmission line descends into the valley in the background of the view.

The first view (Figure 3-4) shows the structures as a dull grey, galvanised lattice tower. The second view (Figure 3-5) shows the view with the lattice towers painted Olive Green. While the third view (Figure 3-6) shows the steel monopoles also painted olive green.

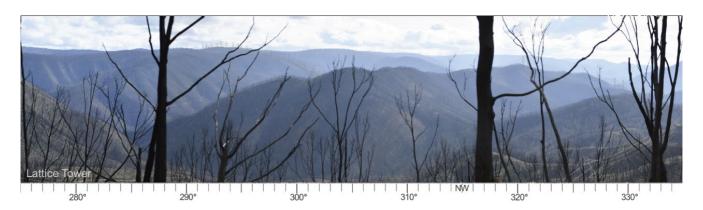
Figure 3-5 The project - Lattice Tower - Olive Green

Figure 3-5 shows the project alignment with lattice towers painted olive green.

In this view, the nearby towers within Line 2 are still visible to the right. Similar to dull grey towers, the painted lattice towers also contrast against the skyline in the background of the view. The painted lattice towers are no less noticeable when viewed against the hilly backdrop where the transmission line descends into the valley.

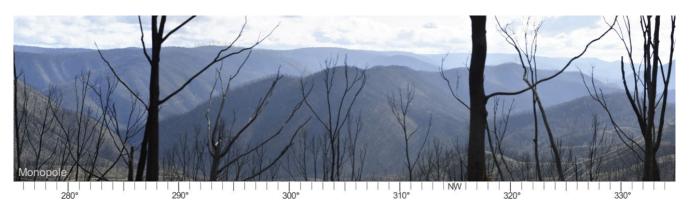
Figure 3-6 The project - Steel Monopole - Olive Green

Figure 3-6 shows the project alignment with painted steel monopoles.

Nearby towers associated with Line 2 are still visible to the right. Similar to the dull grey and painted lattice towers, the steel monopoles are noticeable where they contrast against the skyline in the background of the view and similarly noticeable where the painted steel monopoles descend into the valley.

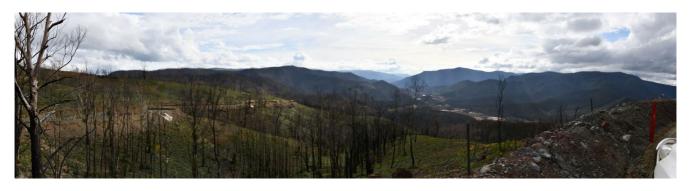
Figure 3-8 Ravine Road looking west to north, post-bushfires

The existing Line 2 transmission infrastructure is partially screened and filtered in views by existing vegetation. Figure 3-8 shows a similar view following the 2019 Dunn's Road bushfires. Following the bushfires, the existing transmission infrastructure is visible through the bared trunks of remnant trees.

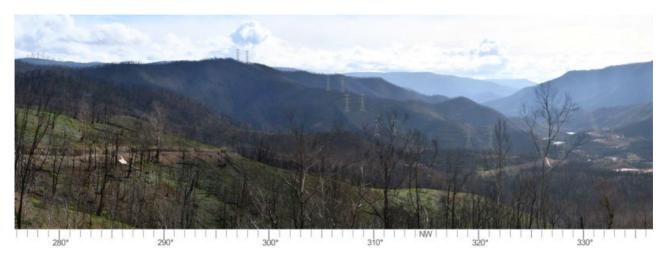
Figure 3-10 The project with dull lattice structures

Figure 3-10 shows an enlargement of the photomontage showing the project alignment as a dull galvanised lattice tower.

The dull grey lattice towers contrast the skyline and the darker hilly backdrop modified in this view by bushfires.

The first view (Figure 3-10) shows the structures as a dull grey, galvanised lattice tower. The second view (Figure 3-11) shows the view with the lattice towers painted Olive Green. While the third view (Figure 3-12) shows the steel monopoles also painted olive green.

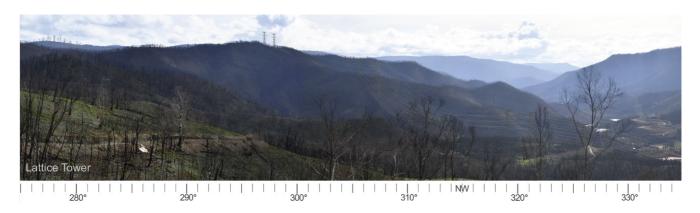
Figure 3-11 The project - Lattice Tower - Olive Green

Figure 3-11 shows the same view, with the lattice towers painted olive green.

The lattice towers are still noticeable features in view where they silhouette or contrast with background elements in the view. Painted towers are less noticeable when viewed against the darkened hills modified by fire.

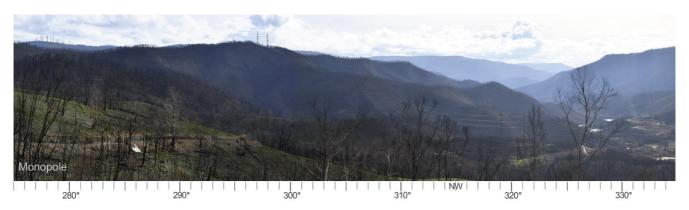
Figure 3-12 The project - Steel Monopole - Olive Green

Figure 3-12 shows the same view modified to include steel monopoles painted olive green.

The painted steel monopoles are visually less cluttered than lattice towers. There are however still noticeable features in view where they silhouette or contrast with background elements in the view, and less noticeable when viewed against the darkened hills modified by fire.

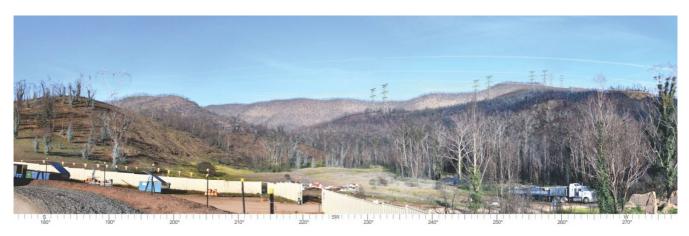
Figure 3-16 Project with dull lattice structures

The proposed towers visible to the left of the existing transmission tower to the south of the campground are visible, albeit filtered by regrowth on the nearby rise. The lattice towers visible to the southwest contrast the skyline and hilly backdrop previously modified by fire.

The first view (Figure 3-16) shows the structures as a dull grey, galvanised lattice tower. The second view (Figure 3-17) shows the view with the lattice towers painted Olive Green. While the third view (Figure 3-18) shows the steel monopoles also painted olive green. In all views, existing lattice towers within Line 2 transmission lines are visible to the left of the view.

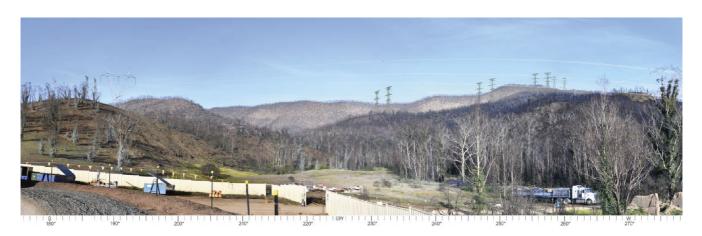
Figure 3-17 The project - Lattice Tower - Olive Green

Figure 3-17 shows the same view, with the lattice towers painted olive green.

The lattice towers are still noticeable features in view where they silhouette or contrast with background elements in the view, and less noticeable when viewed against the hilly backdrop.

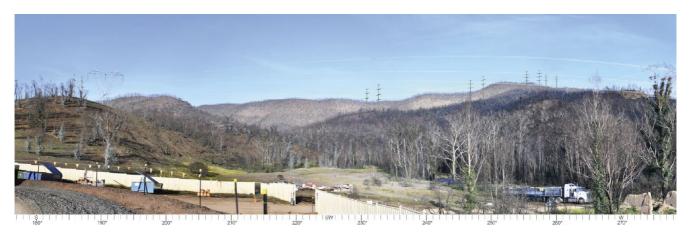
Figure 3-18 The project - Steel Monopole - Olive Green

Figure 3-18 shows the same view modified to include steel monopoles painted olive green.

Similar to the observations made at VP 9, the steel monopole configuration is visually less cluttered than the painted lattice towers, the painted steel monopoles are still visually noticeable features in views.

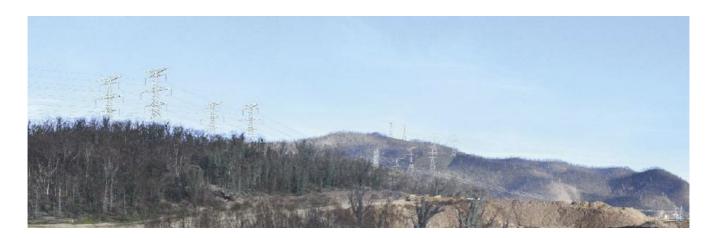
Figure 3-24 The project with dull lattice structures

Figure 3-24 shows an enlargement of the photomontage showing the project alignment as a dull galvanised lattice tower.

The lattice towers contrast the skyline and hilly backdrop previously modified by fire. Towers seen in the left of the view are less noticeable when viewed against a clear sky as opposed to the darker background comprising hills, re-growth and silver tree trunks. The cleared easement under the project transmission line is also noticeable.

The first view (Figure 3-24) shows the structures as a dull grey, galvanised lattice tower. The second view (Figure 3-25) shows the view with the lattice towers painted olive green. While the third view (Figure 3-26) shows the steel monopoles also painted olive green. In all views, existing lattice towers within Line 2 transmission lines re visible to the left of the view.

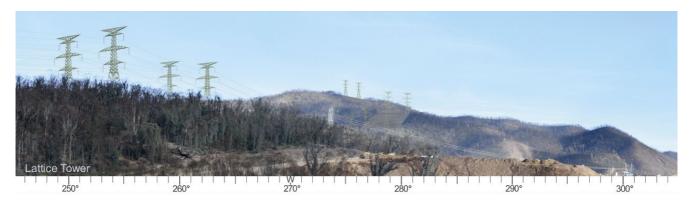
Figure 3-25 The project - Lattice Tower - Olive Green

Figure 3-25 shows the same view, with the lattice towers painted olive green.

In this view, the darker painted lattice towers are more noticeable where they contrast against the lighter skies, and less obvious when viewed against the hills darkened by the recent bush fires. The cleared easement under the transmission line in the background of the view is also noticeable.

The view shown at Viewpoint 12 – Mine Clearing Road included the panorama looking south-east through west. The photomontage shown at Figure 3-25 of Viewpoint 12 showed an enlargement of the view looking directly west. This enlargement is reproduced below.

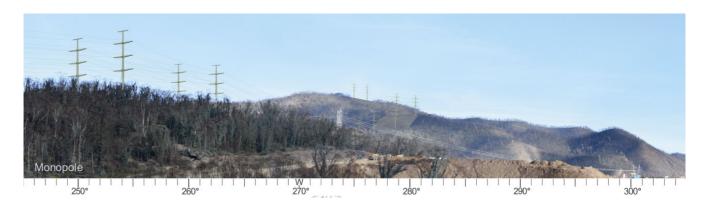
Figure 3-26 The project - Steel Monopole - Olive Green

The steel monopole configuration is visually less cluttered than lattice towers. In this view, the monopoles are still noticeable where they contrast against the lighter skies, and less obvious when viewed against the hills darkened by the recent bush fires. Similar to the observations made at Viewpoint 11, introduction of monopoles to views that include lattice towers must also consider visual clutter. Although this is not as prominent in this particular view, this is more noticeable from other locations where lattice towers are more noticeable.

Figure 3-26 shows the same view modified to include steel monopoles painted olive green.

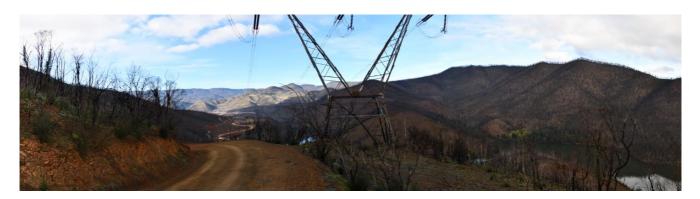
Figure 3-28 shows a similar view following the bushfires. In this altered view post bushfires, the existing transmission lines, access roads and other features are visible through the bared trunks of remnant trees. These exposed views would be temporary only and available until vegetation recovers.

Figure 3-28 VP 9 – Lobs Hole – Power Line Road looking south, post-bushfires

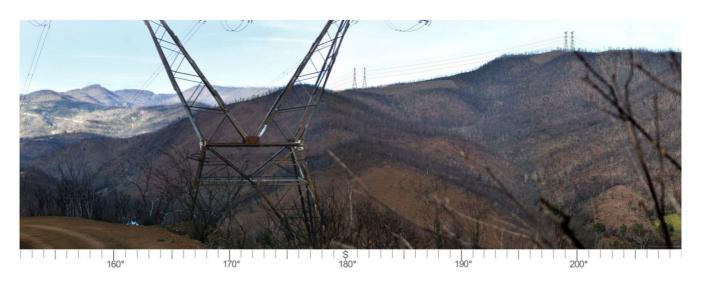
Figure 3-30 shows an enlargement of the photomontage showing the project alignment with dull galvanised lattice tower.

Figure 3-30 The project with dull lattice structures

The lattice towers contrast the skyline and hilly backdrop previously modified by fire. Figure 3-31 shows the same view, with the lattice towers painted olive green.

The first view (Figure 3-30) shows the structures as a dull grey, galvanised lattice tower. The second view (Figure 3-31) shows the view with the lattice towers painted olive green. While the third view (Figure 3-32) shows the steel monopoles also painted olive green. In all views, existing lattice towers within the existing Line 2 transmission lines are visible to the left of the view.

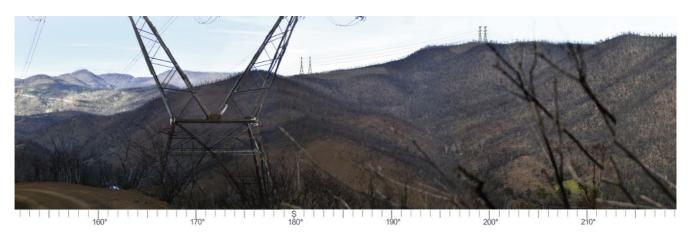
Figure 3-31 The project - Lattice Tower - Olive Green

The lattice towers are still noticeable features in view where they silhouette or contrast with the sky.

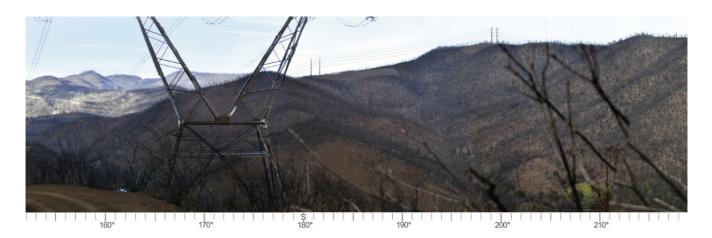
Figure 3-32 The project alignment - Steel Monopole - Olive Green

The steel monopole configuration is visually less cluttered than the painted lattice towers, the painted steel monopoles are still visually noticeable features in views.

Figure 3-32 shows the same view modified to include steel monopoles painted olive green.

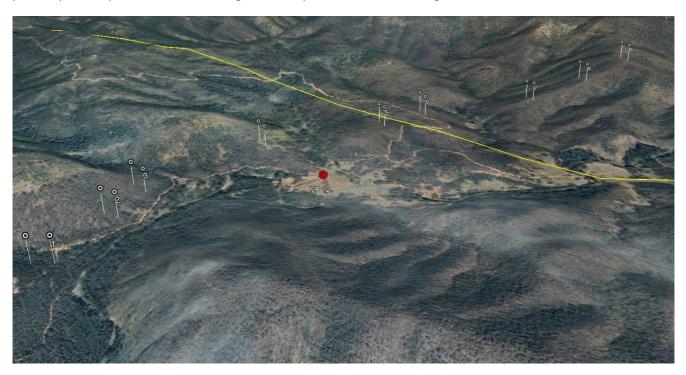
Figure 5-1 shows the numbered structure pairs of the project in proximity to Lobs Hole Ravine Campground and their proximity to Viewpoint 12 – Mine Clearing Road. The yellow line shows the alignment of Line 2 is also shown.

Figure 5-1 Numbered structure pairs

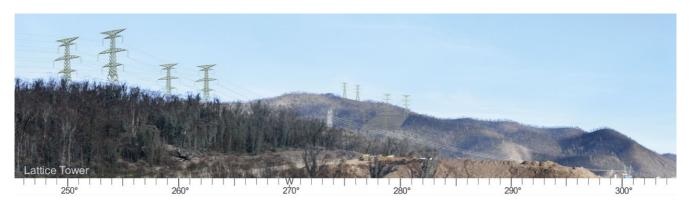
Figure 5-2 The project - Lattice Towers - Olive Green

This view also demonstrated the obviousness of painted structures when viewed against the sky. This same view also demonstrated the contrast of the existing naturally weathered dull-grey lattice towers within Line 2 when viewed against a contrasting backdrop of vegetated hills. The cleared easement under the transmission line in the background of the view is also noticeable.

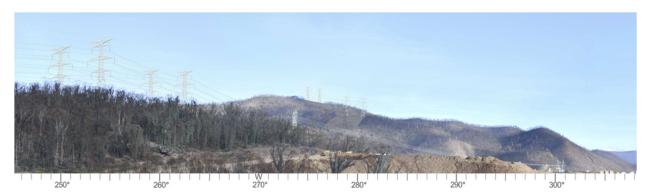
Figure 5-3 shows the same view modified to show elevated towers to be pre-dulled galvanised steel, and structures that are lower in the landscape to be painted olive green.

Figure 5-3 Galvanised and painted towers

Lattice towers on elevated and prominent locations, even those that are nearby are less apparent when left galvanised but pre-treated to remove the sheen of hot-dip galvanised steel. Similar reductions are gained through painting of lattice towers viewed against a vegetated backdrop. This reduction would also be partly contributed to through distance.
