Dewatering Management Plan

2 Mandala Parade, Castle Hill NSW

Report No: E24724.E16_Rev0

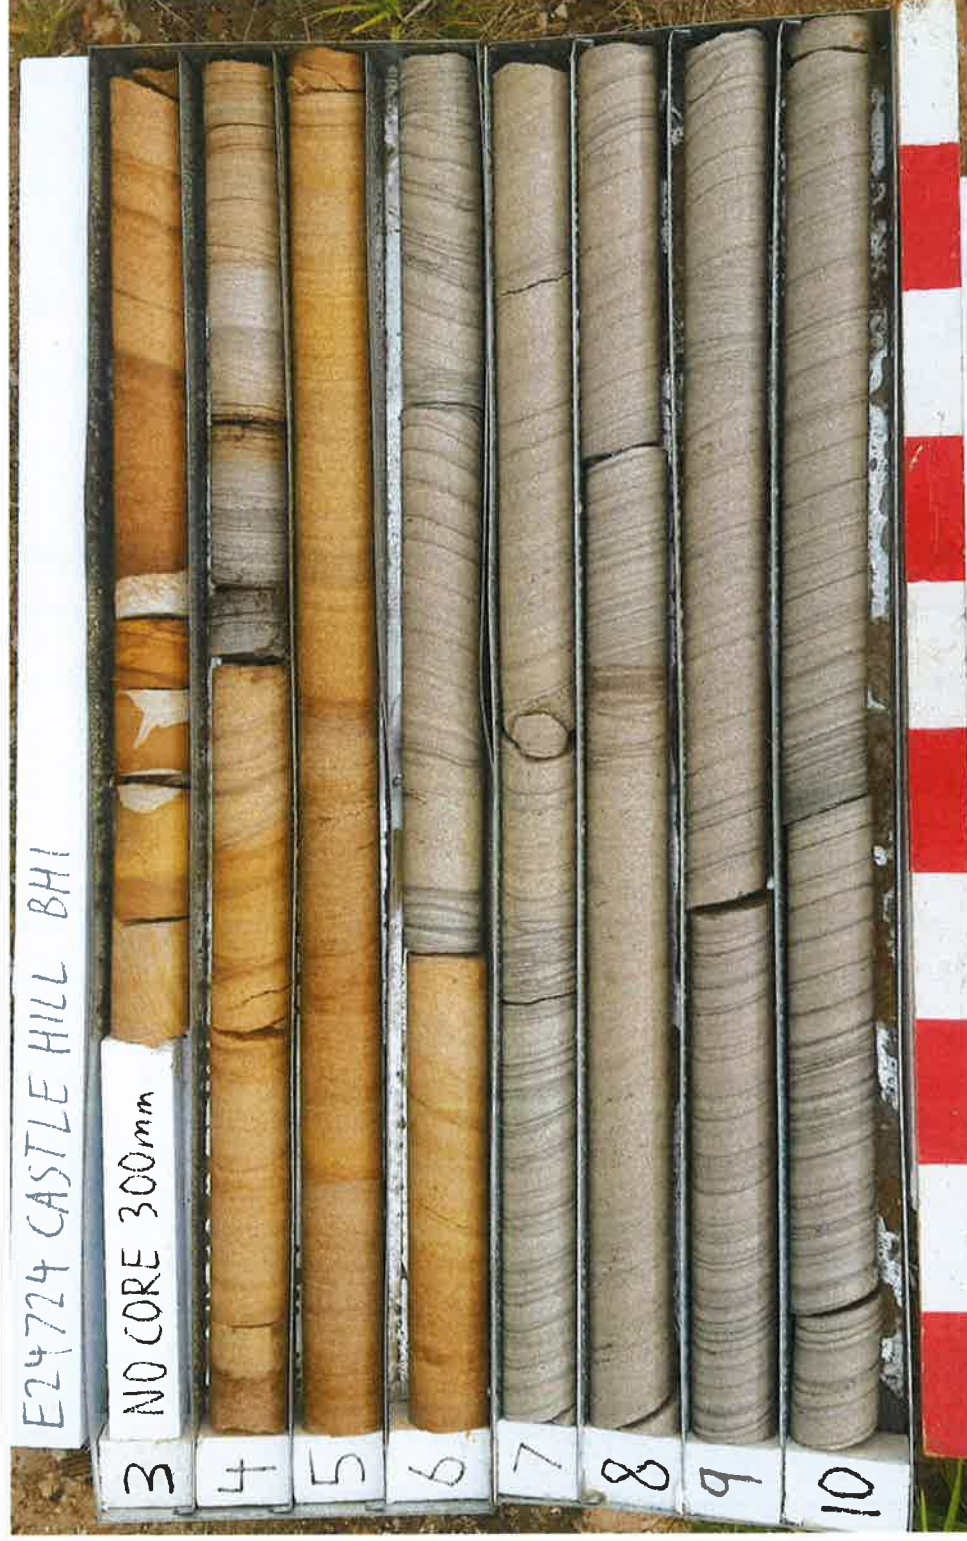
Surface RL ≈ 96.5m
Inclination -90°
Box 1-2 of 11

Depth Range 3.0m to 11.0m BEGL
Contractor Hagstrom
Drill Rig Hydrapower Scout V (DR011)
Logged DS **Date** 09 / 07 / 2020
Checked SR **Date** 24 / 08 / 2020

CORE PHOTOGRAPH OF BOREHOLE: BH1

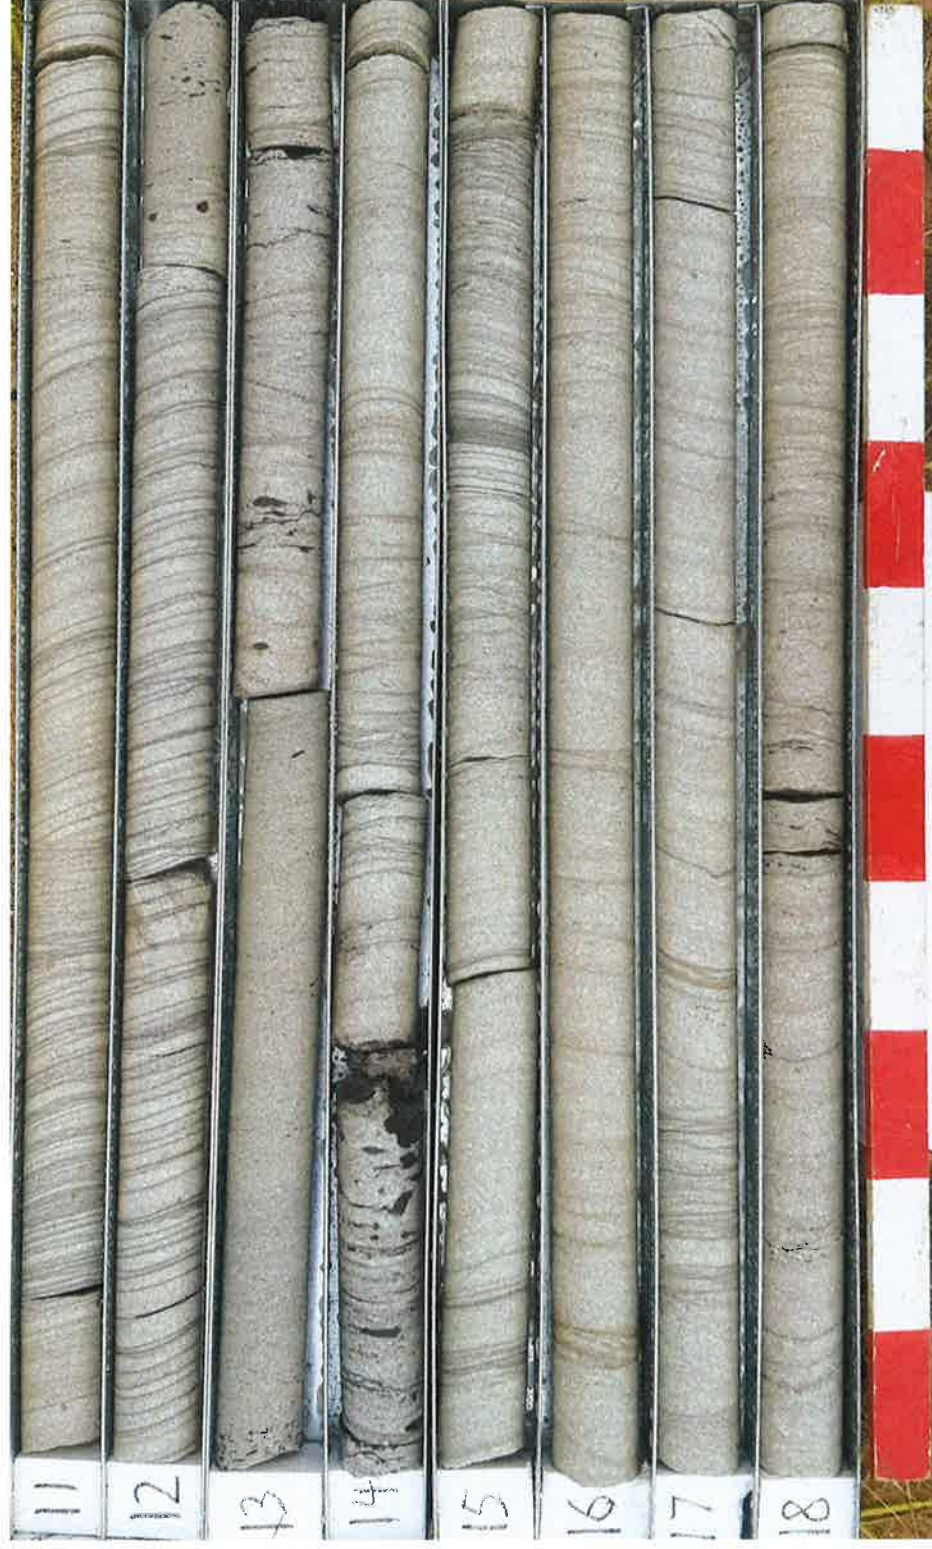
Surface RL ≈ 96.5m
Inclination -90°
Box 3-4 of 11

Depth Range 11.0m to 19.0m BEGL
Contractor Hagstrom
Drill Rig Hydrapower Scout V (DR011)
Logged DS **Date** 09 / 07 / 2020
Checked SR **Date** 24 / 08 / 2020

CORE PHOTOGRAPH OF BOREHOLE: BH1

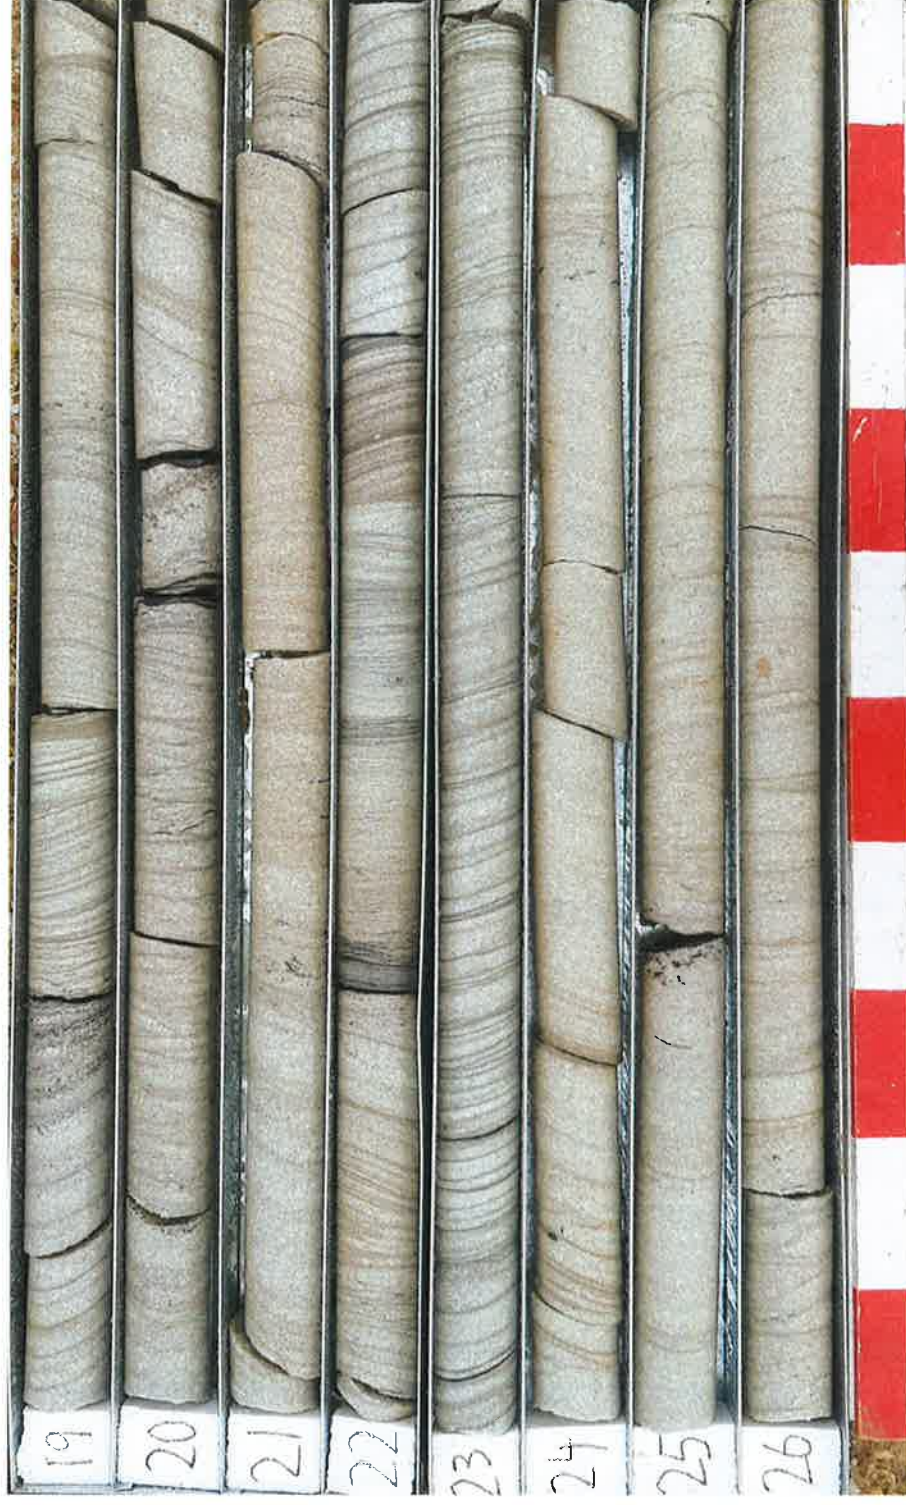
Project	Proposed Development	Depth Range	19.0m to 27.0m BEGL
Location	2 Mandala Parade, Castle Hill NSW	Contractor	Hagstrom
Position	See Figure 2	Drill Rig	Hydrapower Scout V (DR011)
Job No.	E24724.G03_Rev1	Logged	DS
Client	Deicorp Projects Showground P/L	Date	09 / 07 / 2020
		SR	24 / 08 / 2020
		Box	5-6 of 11
		Inclination	-90°
		Surface RL	≈ 96.5m

CORE PHOTOGRAPH OF BOREHOLE: BH1

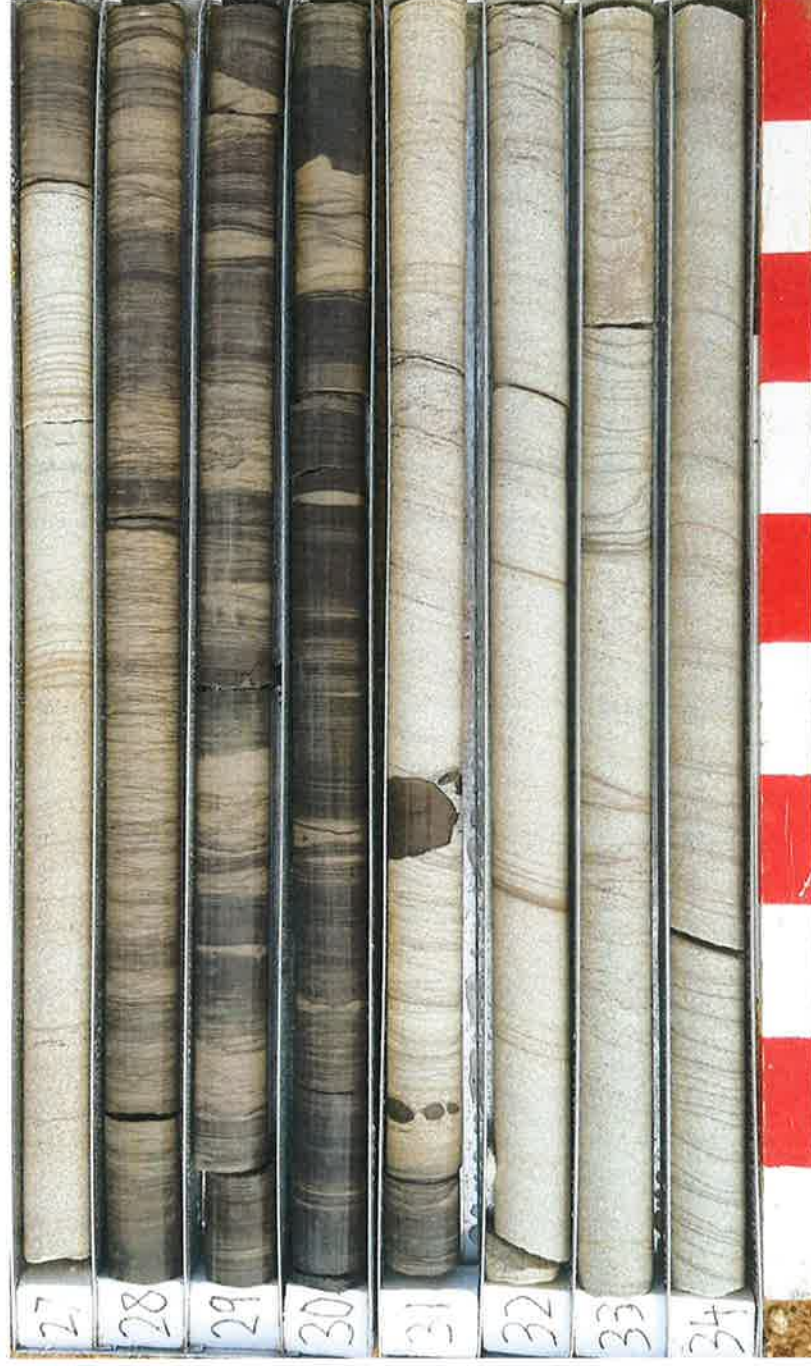
Project	Proposed Development	Depth Range	27.0m to 35.0m BEGL
Location	2 Mandala Parade, Castle Hill NSW	Contractor	Hagstrom
Position	See Figure 2	Drill Rig	Hydrapower Scout V (DR011)
Job No.	E24724.G03_Rev1	Logged	DS
Client	Deicorp Projects Showground P/L	Date	09 / 07 / 2020
		Box	7-8 of 11
		Checked	SR
		Date	24 / 08 / 2020

CORE PHOTOGRAPH OF BOREHOLE: BH1

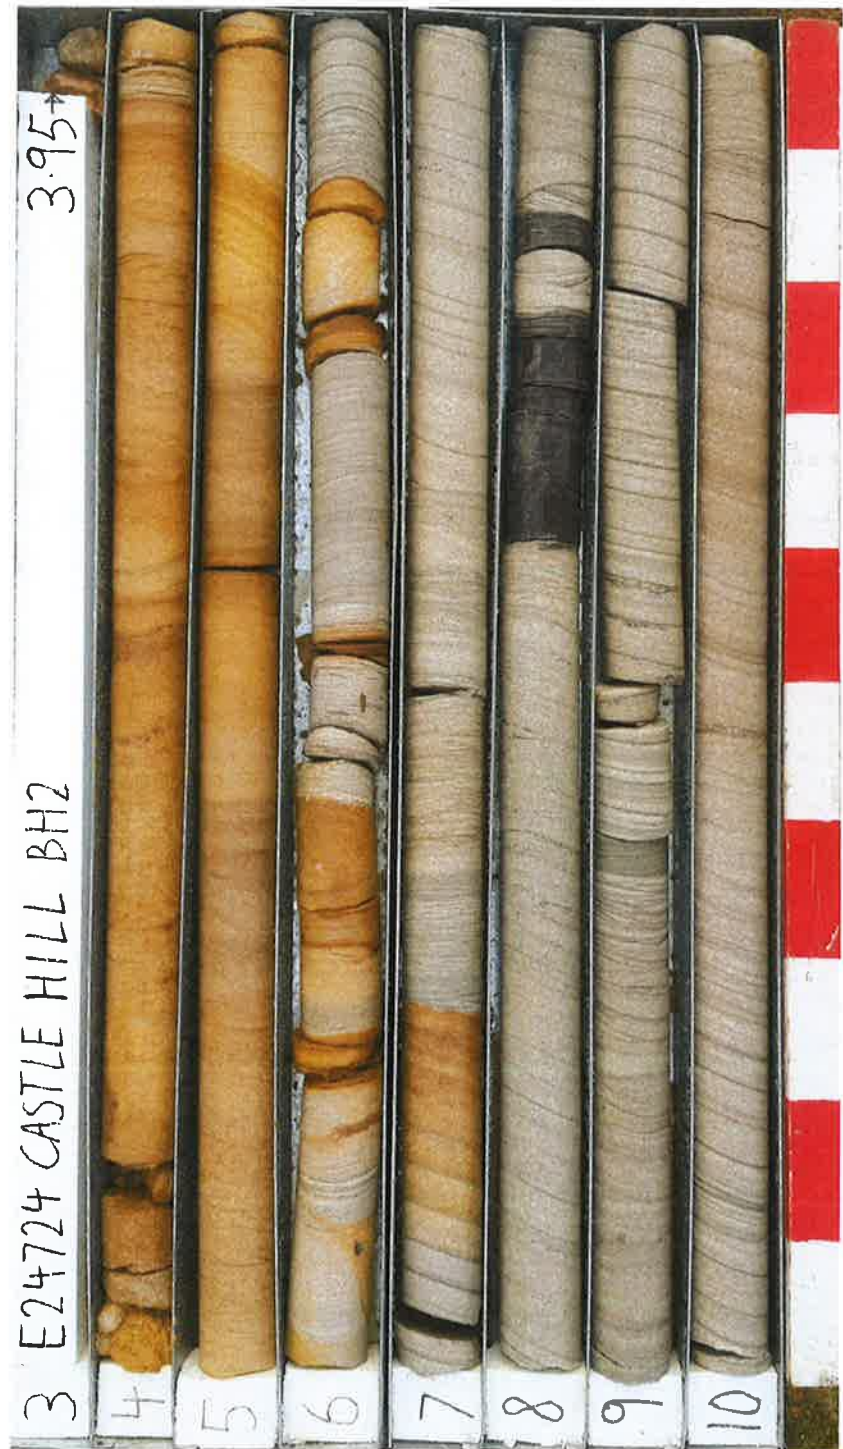
Project	Proposed Development			Depth Range	3.95m to 11.0m BEGL		
Location	2 Mandala Parade, Castle Hill NSW			Contractor	Hagstrom		
Position	See Figure 2			Drill Rig	Hydrapower Scout V (DR011)		
Job No.	E24724.G03_Rev1			Logged	DS	Date	10 / 07 / 2020
Client	Deicorp Projects Showground P/L			Checked	SR	Date	24 / 08 / 2020

CORE PHOTOGRAPH OF BOREHOLE: BH2

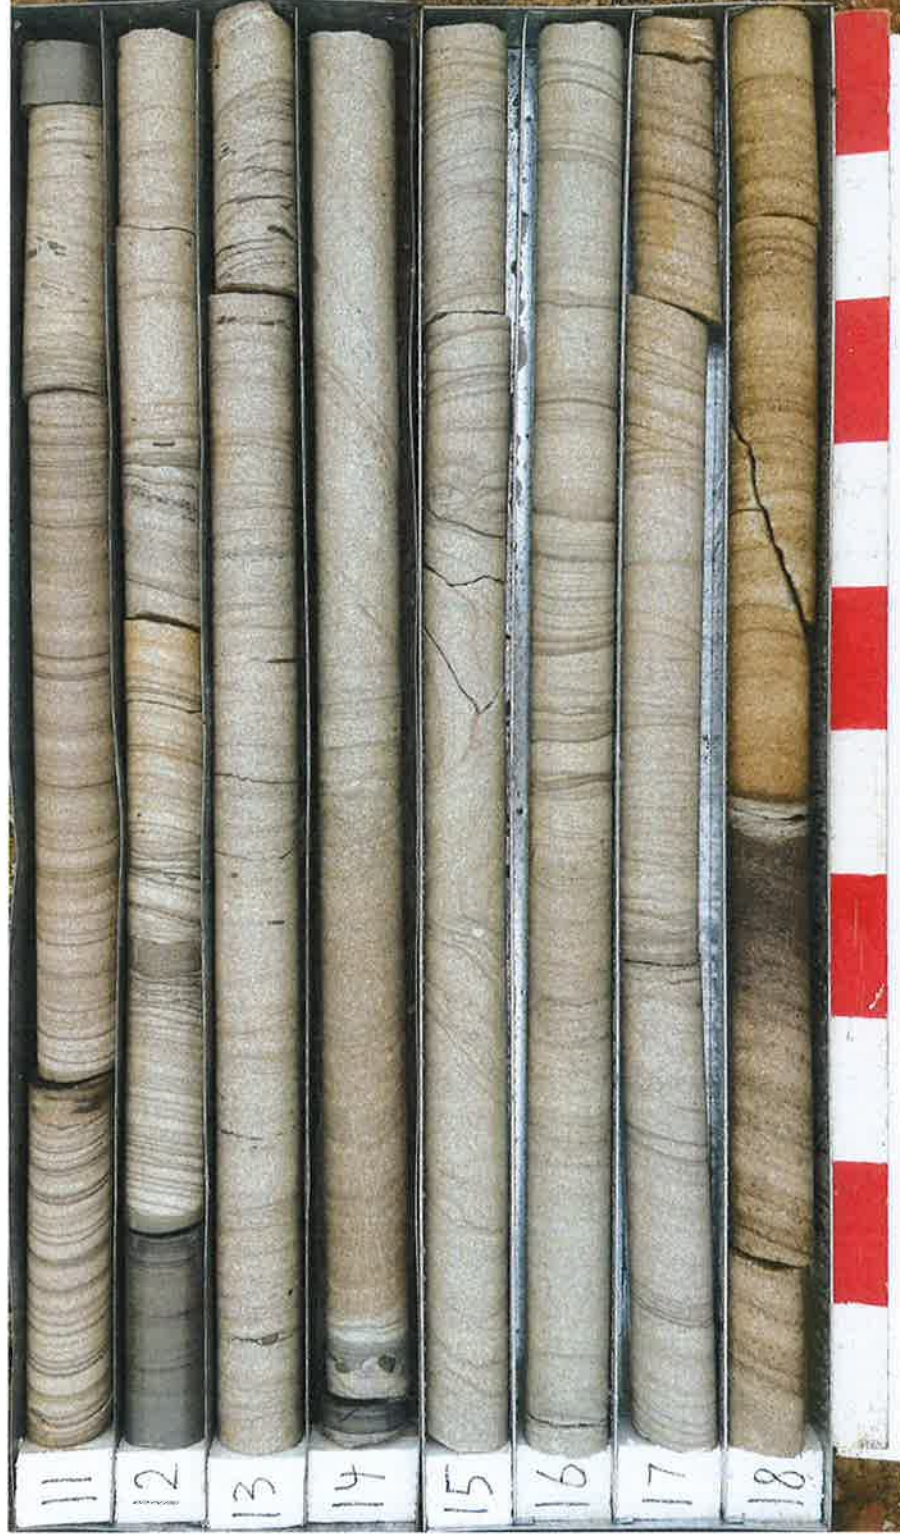
Project	Proposed Development	Depth Range	11.0m to 19.0m BEGL
Location	2 Mandala Parade, Castle Hill NSW	Contractor	Hagstrom
Position	See Figure 2	Drill Rig	Hydropower Scout V (DR011)
Job No.	E24724.G03_Rev1	Logged	DS
Client	Deicorp Projects Showground P/L	Date	10 / 07 / 2020
		SR	SR
		Checked	Date
			24 / 08 / 2020

Surface RL $\approx 95.1\text{m}$
Inclination -90°
Box 3-4 of 11

CORE PHOTOGRAPH OF BOREHOLE: BH2

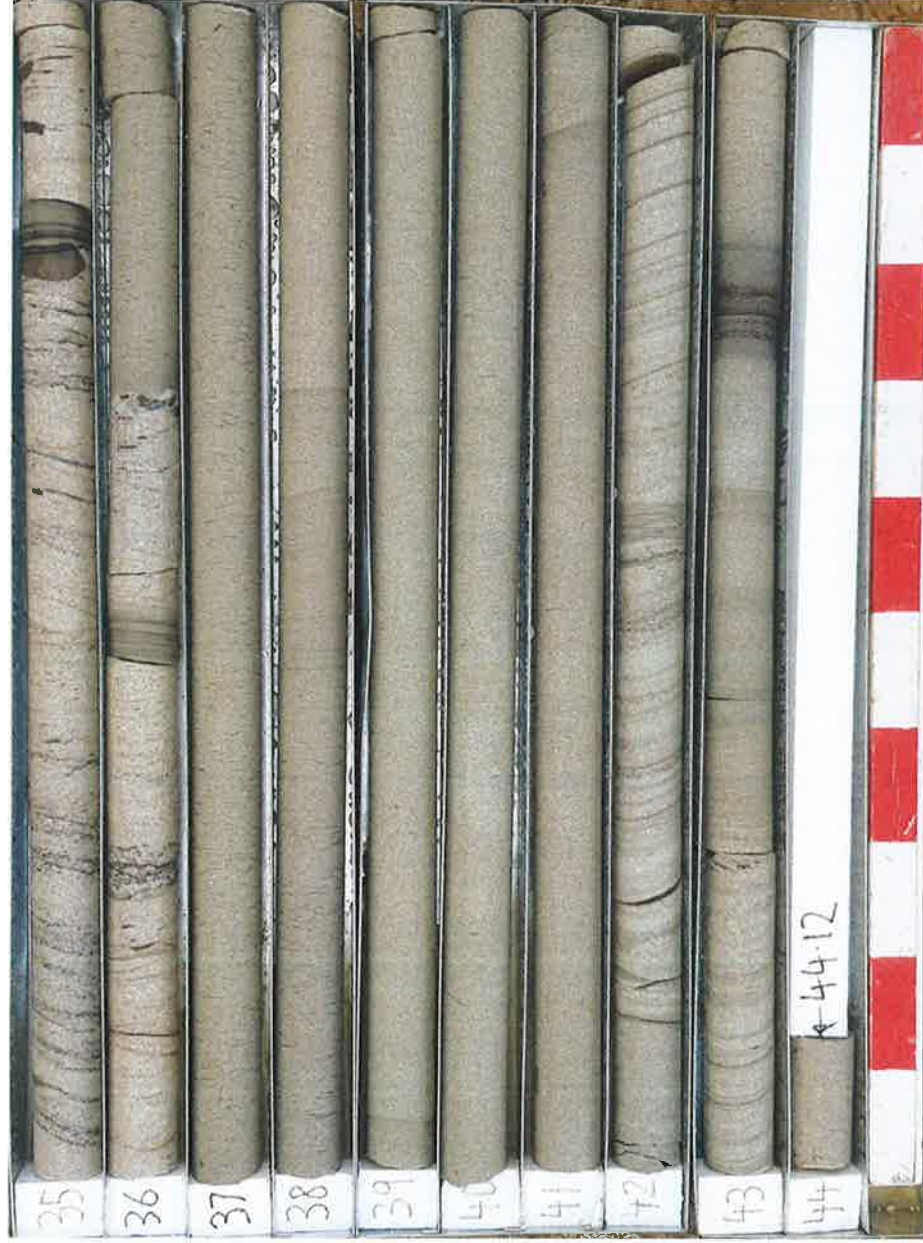
Project	Proposed Development	Depth Range	35.0m to 44.12m BEGL
Location	2 Mandala Parade, Castle Hill NSW	Contractor	Hagstrom
Position	See Figure 2	Drill Rig	Hydrapower Scout V (DR011)
Job No.	E24724.G03_Rev1	Logged	DS
Client	Deicorp Projects Showground P/L	Date	10 / 07 / 2020
		Box	9-11 of 11
		Checked	SR
		Date	24 / 08 / 2020

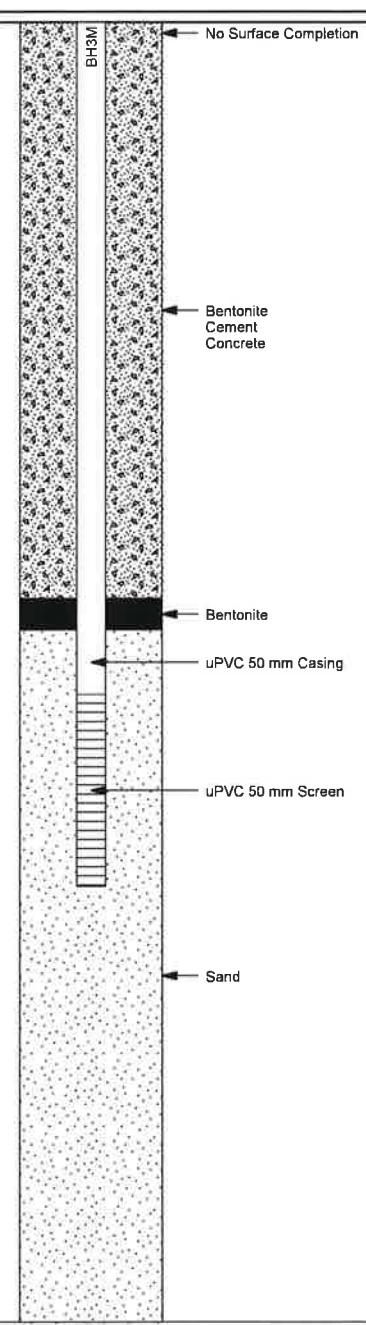
METHOD	WATER	DEPTH (m)	RL (m AHD)	GRAPHIC LOG	SOIL/ROCK MATERIAL DESCRIPTION	PIEZOMETER CONSTRUCTION DETAILS			
						ID BH3M	Type Standpipe	Stick Up & RL -1.00 m 92.00 m	Tip Depth & RL 27.00 m 64.00 m
ADIT	100% RETURN	NMLC

<p>No Surface Completion</p> <p>Bentonite Cement Concrete</p> <p>Bentonite</p> <p>uPVC 50 mm Casing</p> <p>uPVC 50 mm Screen</p> <p>Sand</p>			
					<p>FILL: Silty CLAY; low plasticity, brown-dark grey to dark brown, with sub-rounded to angular, sandstone and igneous gravel and sand, trace rubber fragments.</p> <p>SANDY CLAY; medium plasticity, pale grey and orange-brown, fine to medium grained sand, grading to extremely weathered sandstone.</p> <p>SANDSTONE; fine to medium grained, pale grey and orange-brown, medium to thickly bedded, with dark grey siltstone laminations, iron stained.</p> <p>From 4.9 to 10.53 m, pale grey.</p> <p>From 10.3 m, sandstone, fine to medium grained, brown and pale grey, medium to thickly bedded, with dark grey siltstone laminations.</p> <p>From 18.65 m, pale grey.</p> <p>From 20.0 m, sandstone, fine to medium grained, pale grey, medium to thickly bedded, with dark grey siltstone laminations.</p> <p>LAMINITE; fine to medium grained, pale grey sandstone (70%) interbedded with dark grey siltstone (30%), medium bedded.</p> <p>SANDSTONE; fine to medium grained, pale grey, medium to thickly bedded, with dark grey siltstone laminations.</p> <p>From 30.0 m, sandstone, fine to medium grained, pale grey, medium to thickly bedded, with dark grey siltstone laminations.</p> <p>From 40.0 m, sandstone, fine to medium grained, pale grey, medium to thickly bedded, with dark grey siltstone laminations.</p> <p>Hole Terminated at 40.56 m T/C Bit Refusal on Sandstone. Target Depth Reached.</p>

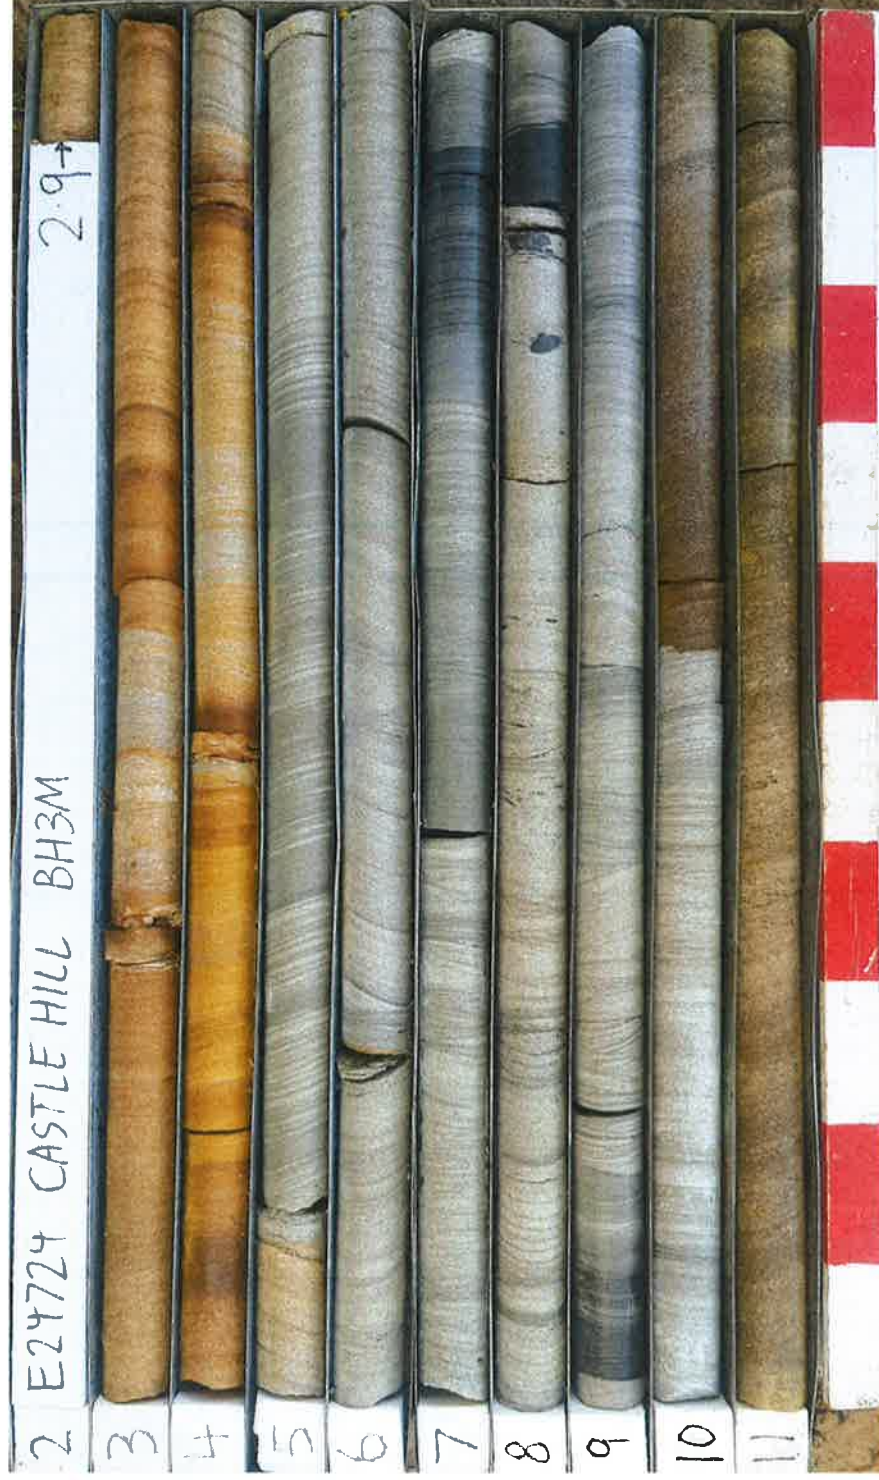
Project	Proposed Development	Depth Range	2.9m to 12.0m BEGL
Location	2 Mandala Parade, Castle Hill NSW	Contractor	Hagstrom
Position	See Figure 2	Drill Rig	Hydrapower Scout V (DR011)
Job No.	E24724.G03_Rev1	Logged	DS
Client	Deicorp Projects Showground P/L	Date	14 / 07 / 2020
		SR	SR
		Checked	Date
			24 / 08 / 2020

CORE PHOTOGRAPH OF BOREHOLE: BH3M

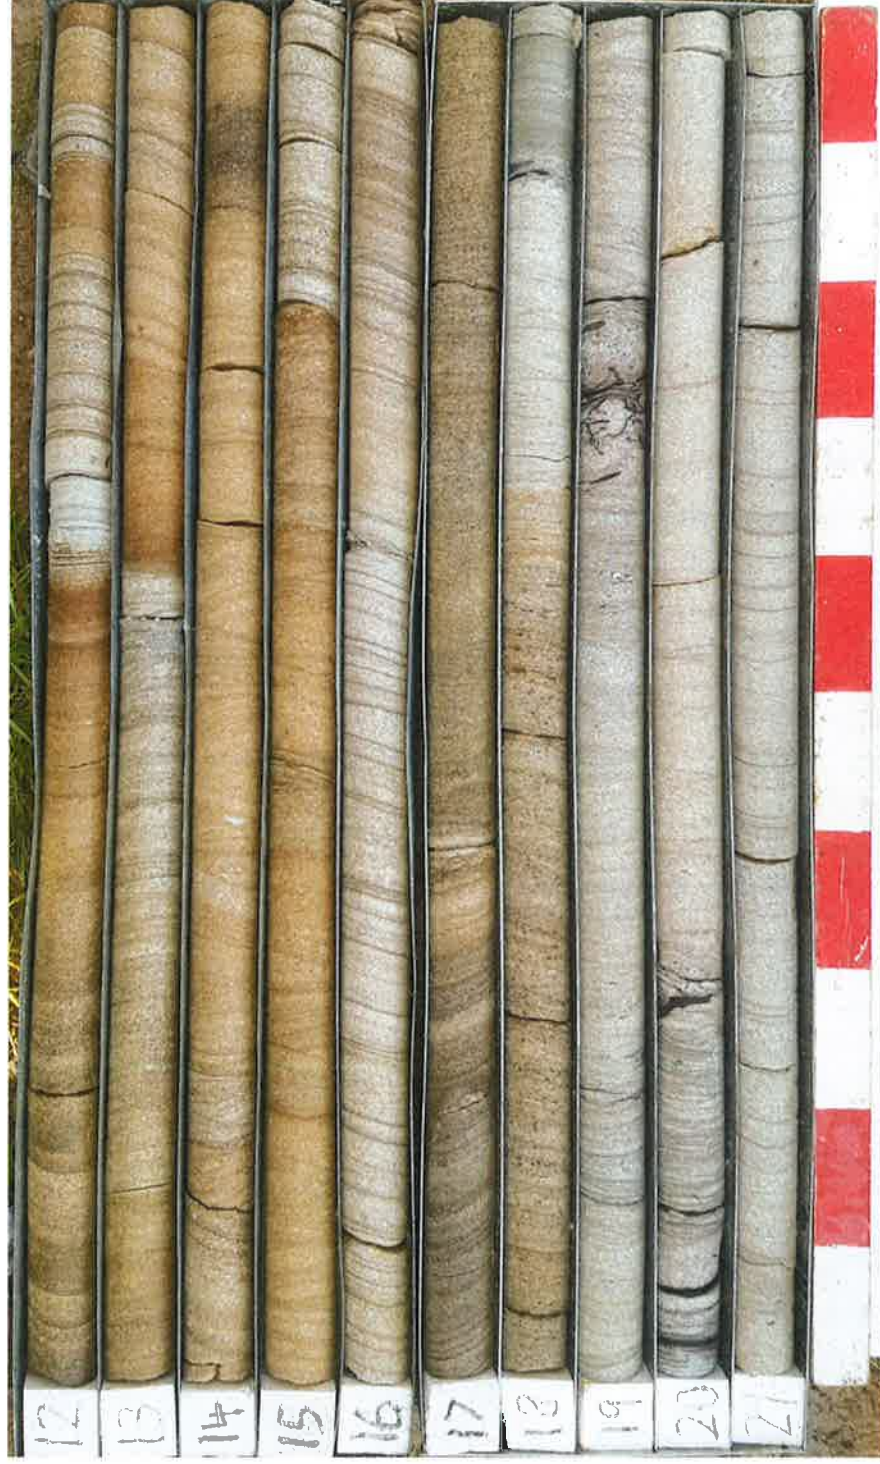
Project	Proposed Development	Depth Range	12.0m to 22.0m BEGL
Location	2 Mandala Parade, Castle Hill NSW	Contractor	Hagstrom
Position	See Figure 2	Drill Rig	Hydrapower Scout V (DR011)
Job No.	E24724.G03_Rev1	Logged	DS
Client	Deicorp Projects Showground P/L	Date	14 / 07 / 2020
		SR	SR
		Checked	Date
			24 / 08 / 2020
		Surface RL	≈ 91.0m
		Inclination	-90°
		Box	3-4 of 8

CORE PHOTOGRAPH OF BOREHOLE: BH3M

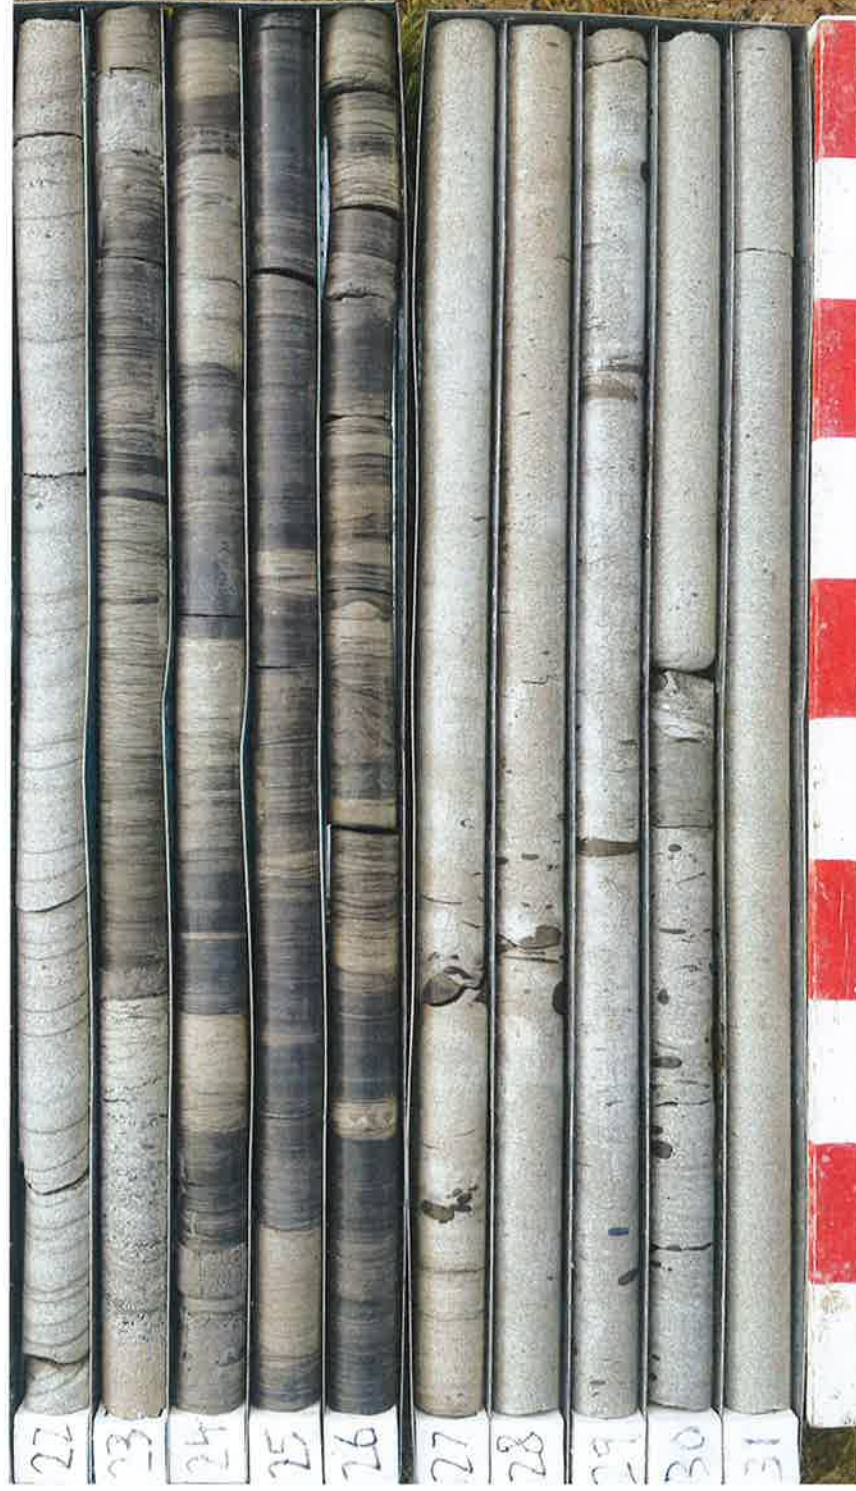
Project	Proposed Development	Depth Range	22.0m to 32.0m BEGL
Location	2 Mandala Parade, Castle Hill NSW	Contractor	Hagstrom
Position	See Figure 2	Drill Rig	Hydrapower Scout V (DR011)
Job No.	E24724.G03_Rev1	Logged	DS Date 14 / 07 / 2020
Client	Deicorp Projects Showground P/L	Checked	SR Date 24 / 08 / 2020
		Surface RL	≈ 91.0m
		Inclination	-90°
		Box	5-6 of 8

CORE PHOTOGRAPH OF BOREHOLE: BH3M

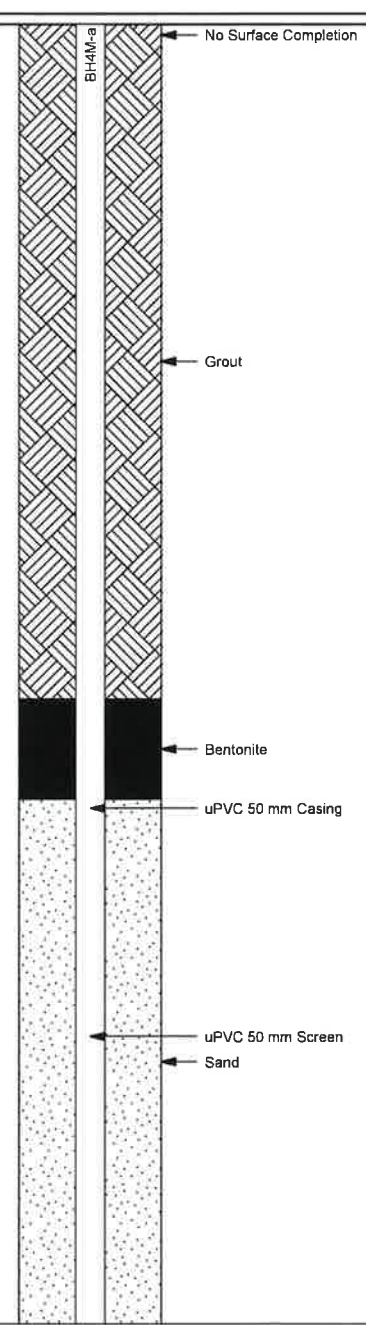
METHOD	WATER	DEPTH (m)	RL (m AHD)	GRAPHIC LOG	SOIL/ROCK MATERIAL DESCRIPTION	PIEZOMETER CONSTRUCTION DETAILS			
						ID	Type	Stick Up & RL	Tip Depth & RL
						BH4M-a	Standpipe	0.69 m 97.31 m	7.70 m 90.30 m
AD/T	GWNE	0	98		FILL: Silty SAND; fine to medium grained, brown, with clay and concrete fragments.

1	97		From 1.1 m, orange-brown, with medium sandstone gravel.				
					From 1.6 m, grey.				
		2	96		FILL: Silty CLAY; medium plasticity, red mottled grey-brown, with sub-angular to sub-rounded gravel.				
		3	95						
NMLC	70% RETURN	4	94		Silty CLAY; medium plasticity, red mottled grey.				
					Sandy CLAY; medium plasticity, pale grey and orange-brown, fine to medium grained sand, grading to extremely weathered sandstone.				
		5	93		SANDSTONE; fine to medium grained, grey and orange-brown, thinly bedded, with dark grey siltstone laminations, iron stained.				
		6	92						
		7	91						
		8	90		Hole Terminated at 7.70 m T/C Bit Refusal. Target Depth Reached.

- Groundwater in monitoring well BH3M-a and BH5M was noted to be light brown, with low to medium turbidity, while in BH4M-a, groundwater was noted to be brown, with medium to high turbidity;
- No sufficient water was in monitoring well BH7M for sampling and field observation;
- No olfactory or visual evidence of contamination was noted in the monitoring wells;
- No sheens were noted within the groundwater of any monitoring well sampled; and
- Additional round of sampling of BH4M-a recorded the groundwater in this well was noted to be light brown, with low to medium turbidity on 18 August 2020.

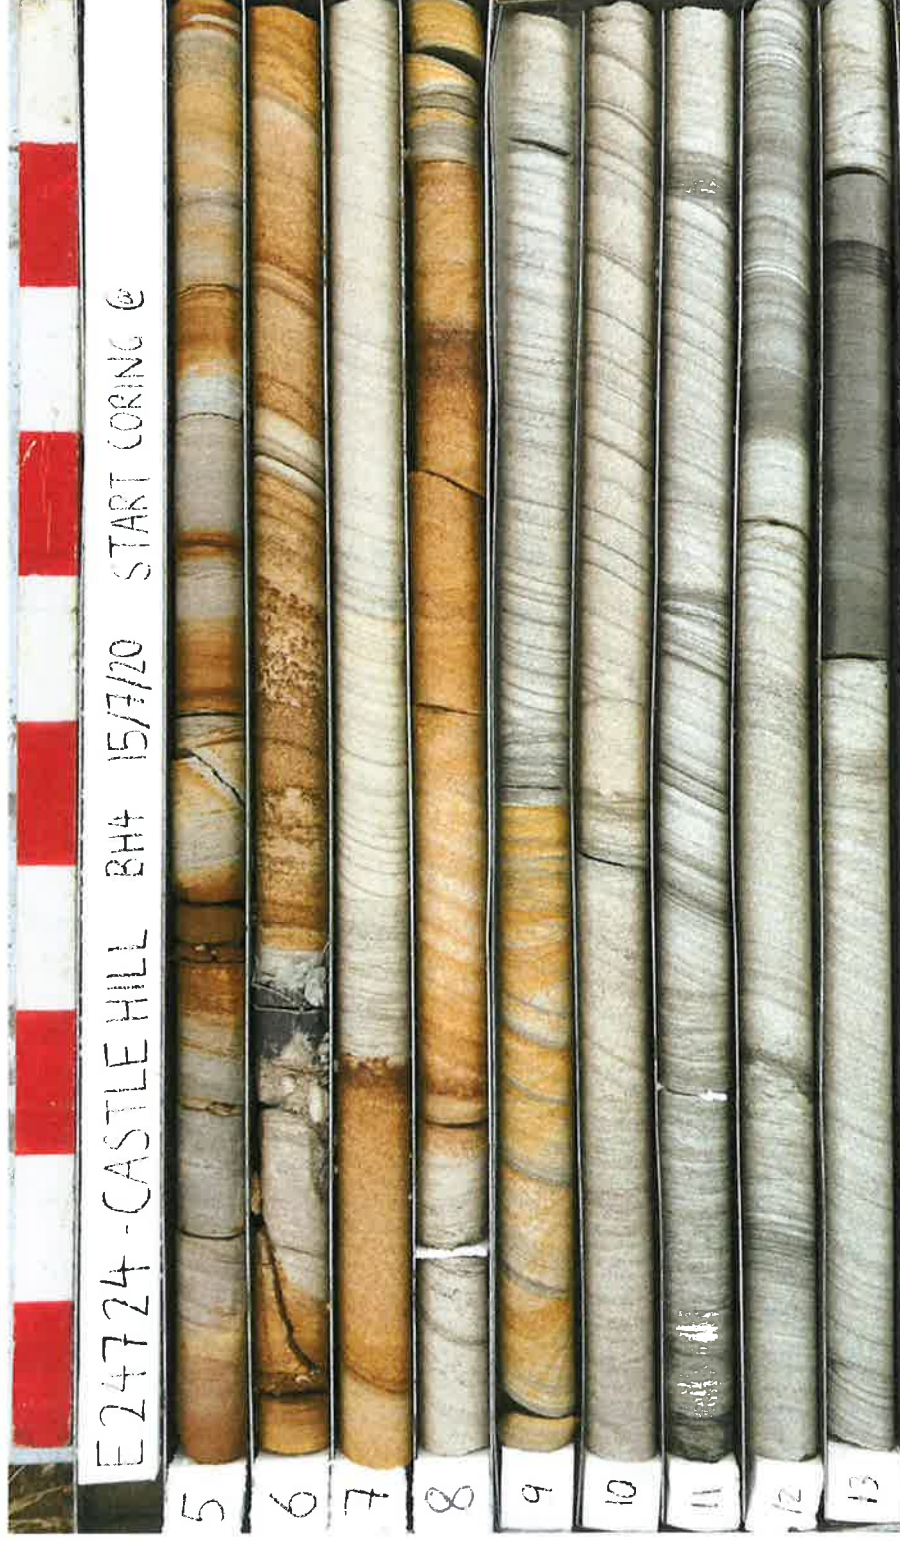
Project	Proposed Development	Depth Range	5.0m to 14.0m BEGL
Location	2 Mandala Parade, Castle Hill NSW	Contractor	Geosense Drilling
Position	See Figure 2	Drill Rig	Hanjin DB8
Job No.	E24724.G03_Rev1	Logged	SL
Client	Deicorp Projects Showground P/L	Date	14 / 07 / 2020
		SR	24 / 08 / 2020
		Box	1-2 of 9

CORE PHOTOGRAPH OF BOREHOLE: BH4M

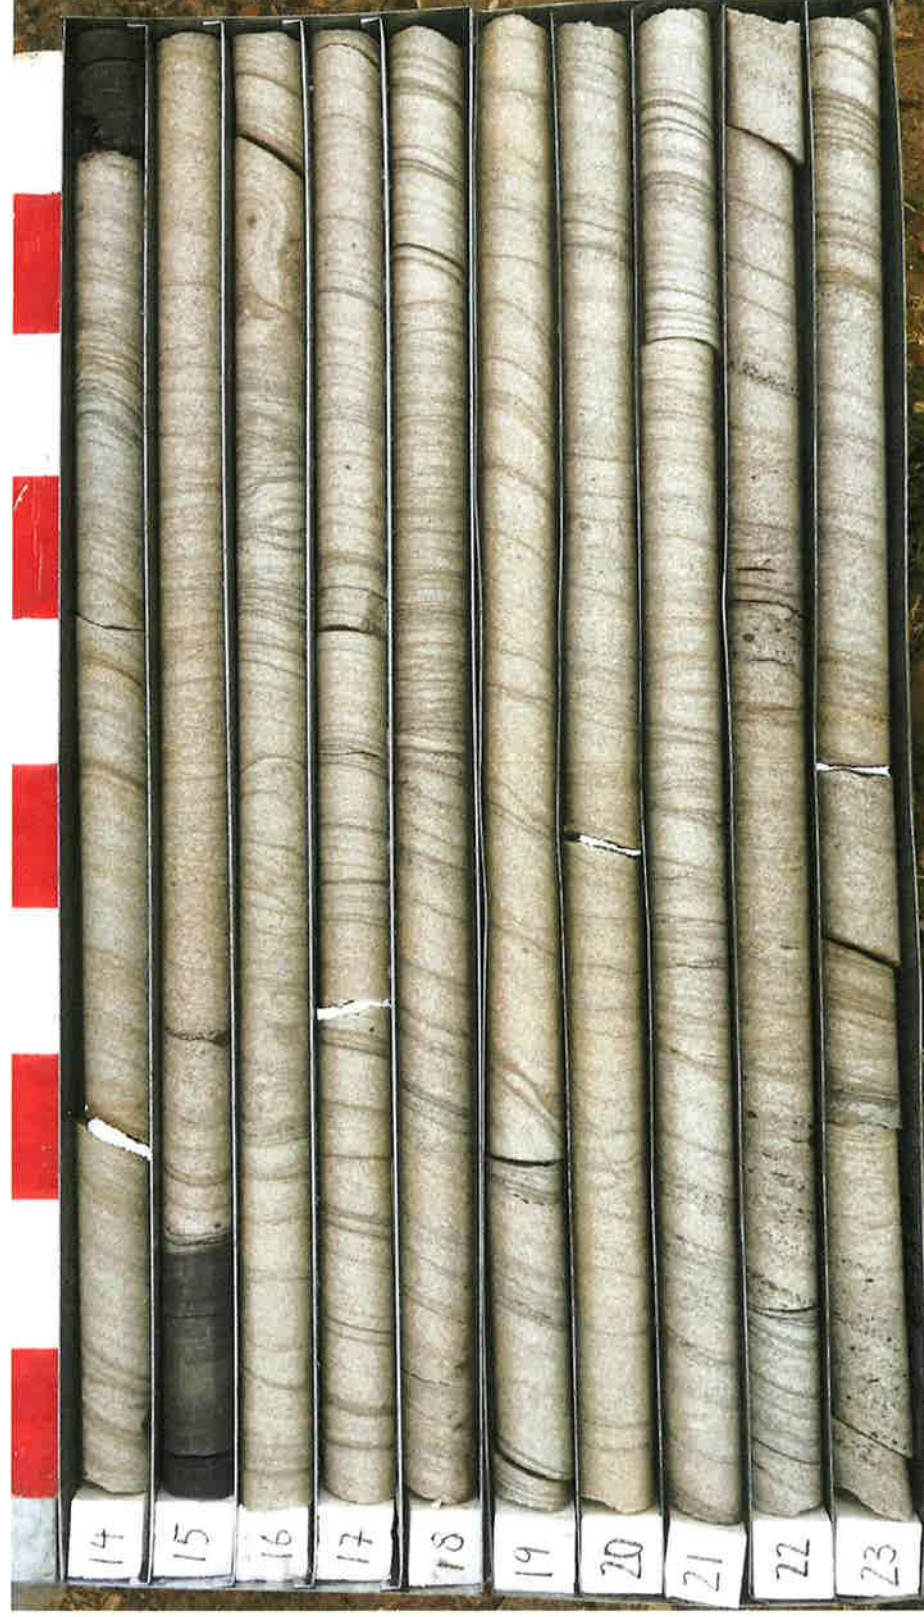
Project	Proposed Development	Depth Range	14.0m to 24.0m BEGL
Location	2 Mandela Parade, Castle Hill NSW	Contractor	Geosense Drilling
Position	See Figure 2	Drill Rig	Hanjin DB8
Job No.	E24724.G03_Rev1	Logged	SL
Client	Deicorp Projects Showground P/L	Date	14 / 07 / 2020
		SR	24 / 08 / 2020
		Box	3-4 of 9
		Inclination	-90°
		Surface RL	≈ 98.0m

CORE PHOTOGRAPH OF BOREHOLE: BH4M

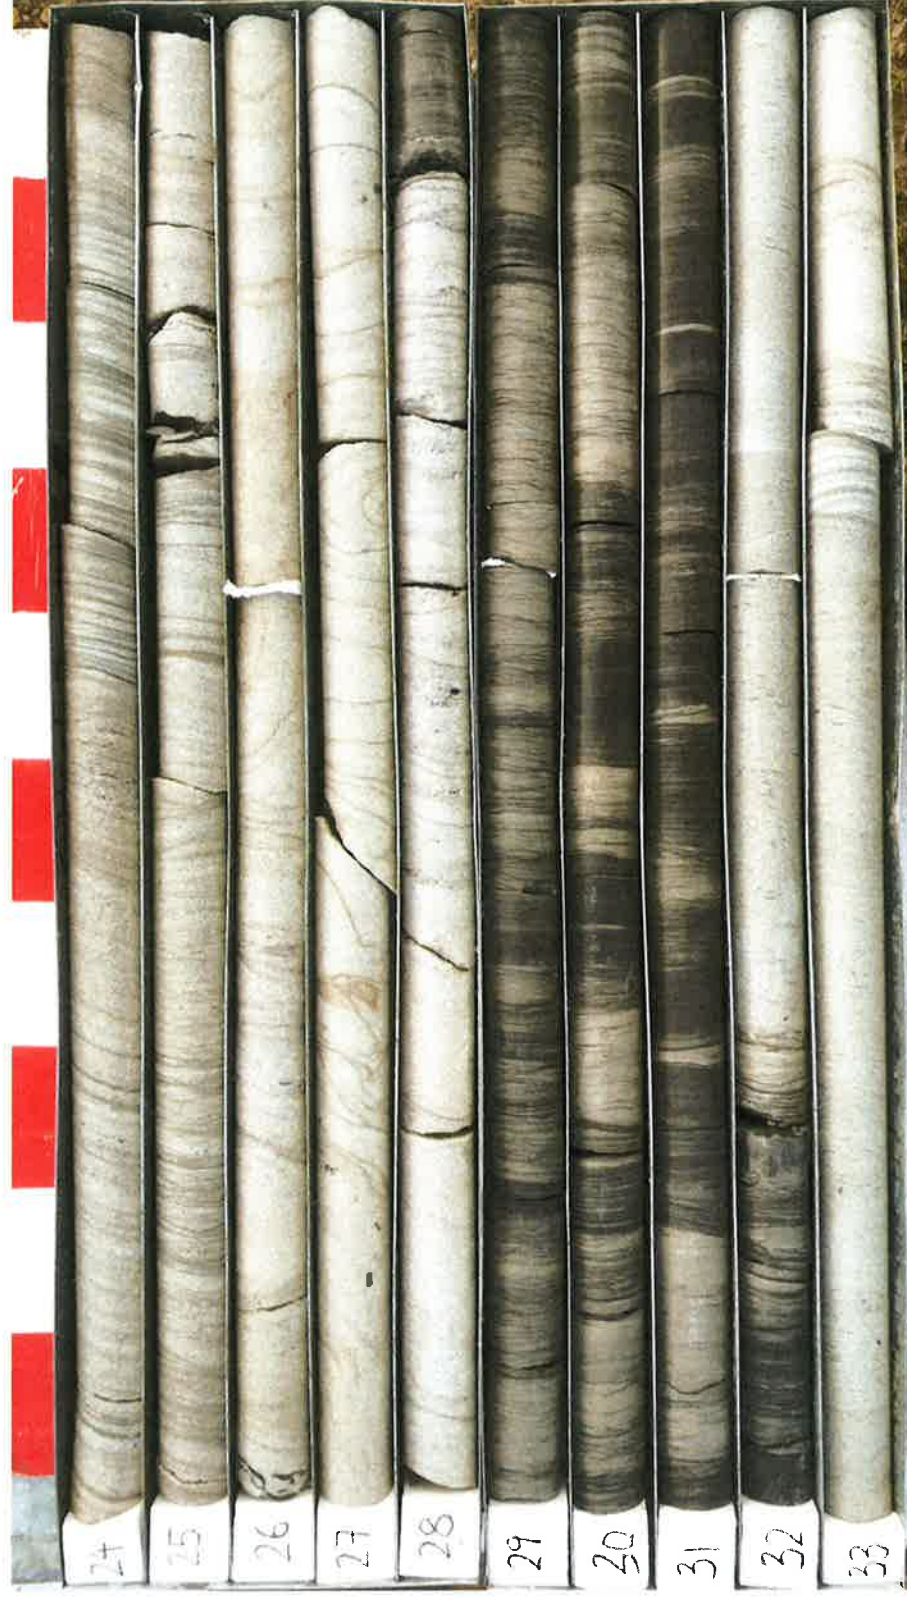
Project	Proposed Development	Depth Range	24.0m to 34.0m BEGL
Location	2 Mandala Parade, Castle Hill NSW	Contractor	Geosense Drilling
Position	See Figure 2	Drill Rig	Hanjin DB8
Job No.	E24724.G03_Rev1	Logged	SL
Client	Deicorp Projects Showground P/L	Date	14 / 07 / 2020
		SR	24 / 08 / 2020
		Box	5-6 of 9
		Inclination	-90°
		Surface RL	≈ 98.0m

CORE PHOTOGRAPH OF BOREHOLE: BH4M

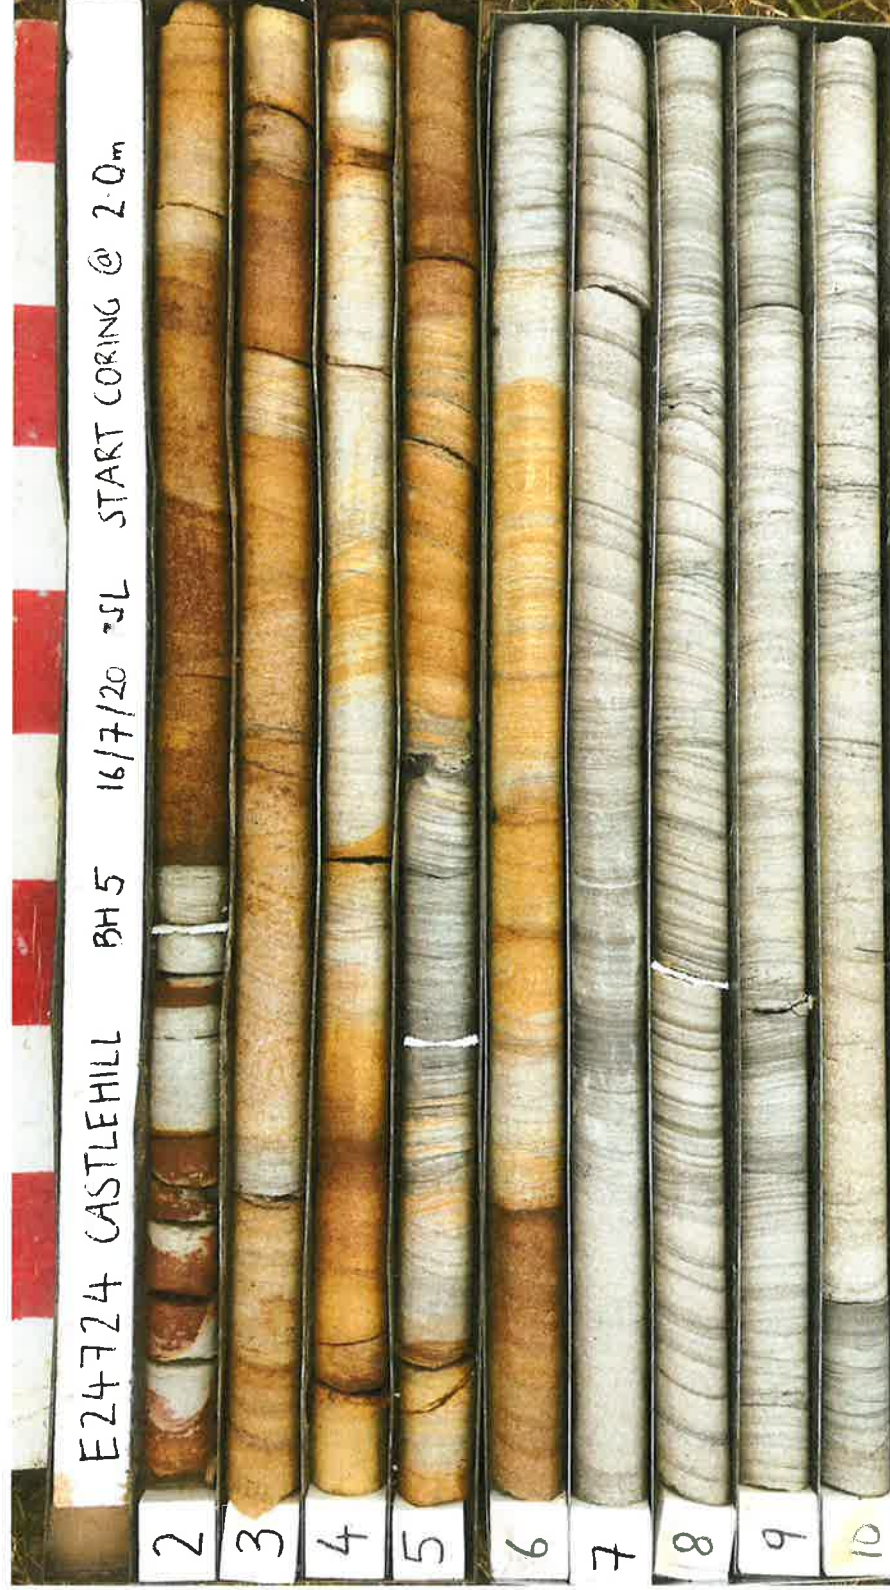
Project	Proposed Development	Depth Range	2.0m to 11.0m BEGL
Location	2 Mandala Parade, Castle Hill NSW	Contractor	Geosense Drilling
Position	See Figure 2	Drill Rig	Hanjin DB8
Job No.	E24724.G03_Rev1	Logged	SL
Client	Deicorp Projects Showground P/L	Date	16 / 07 / 2020
		SR	24 / 08 / 2020
		Box	1-2 of 9
		Surface RL	≈ 94.1m
		Inclination	-90°

CORE PHOTOGRAPH OF BOREHOLE: BH5M
