Dewatering Management Plan

2 Mandala Parade, Castle Hill NSW

Report No: E24724.E16_Rev0

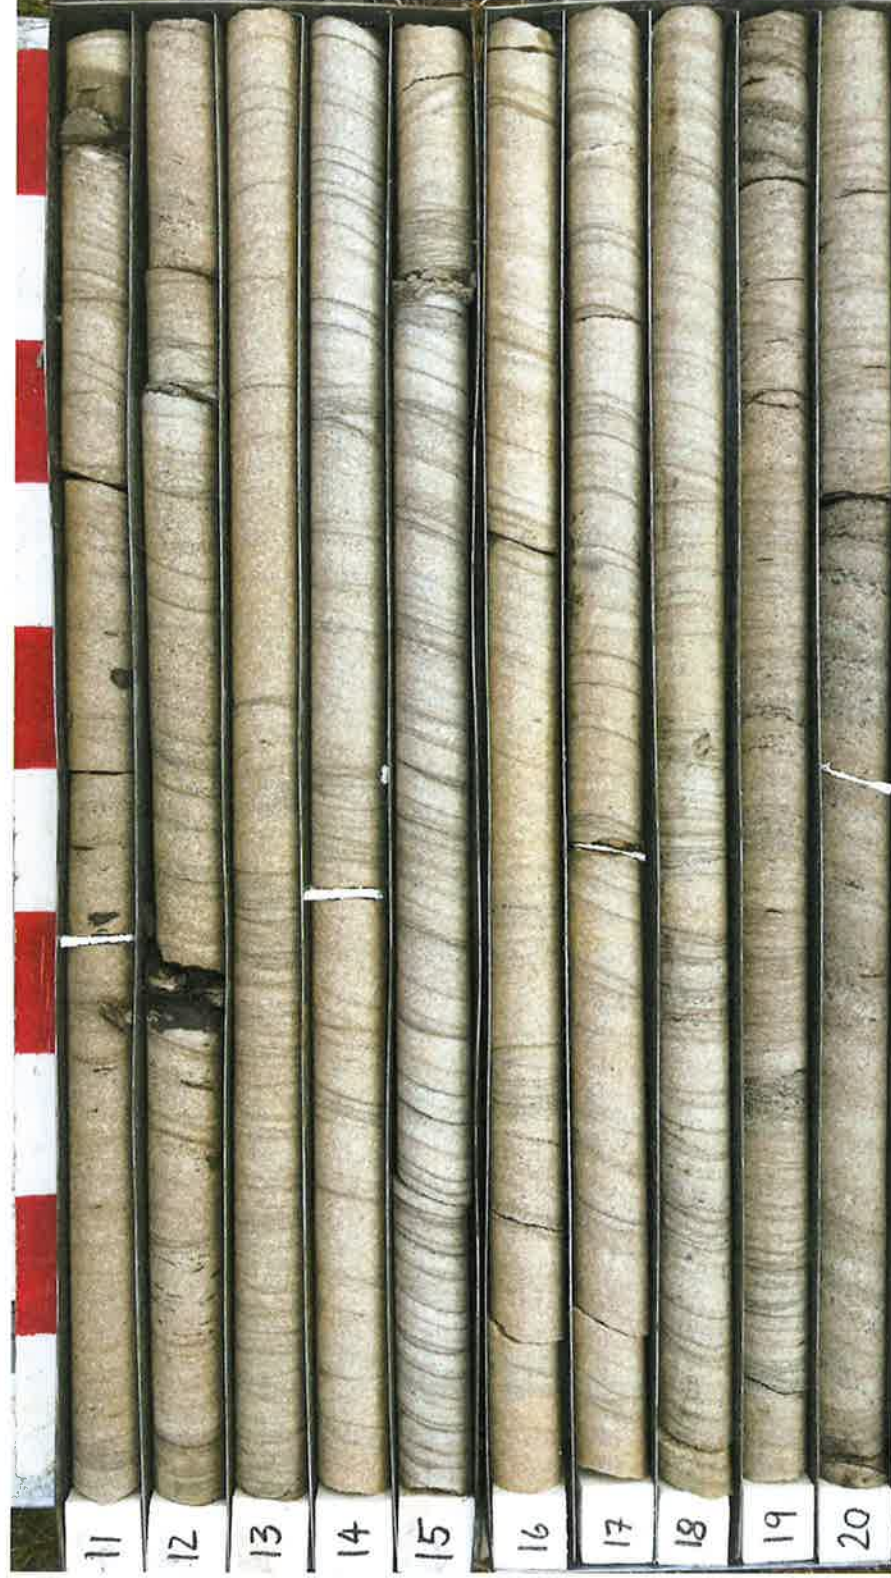
CORE PHOTOGRAPH OF BOREHOLE: BH5M

Project	Proposed Development	Depth Range	11.0m to 21.0m BEGL
Location	2 Mandala Parade, Castle Hill NSW	Contractor	Geosense Drilling
Position	See Figure 2	Drill Rig	Hanjin DB8
Job No.	E24724.G03_Rev1	Logged	SL Date 16 / 07 / 2020
Client	Deicorp Projects Showground P/L	Checked	SR Date 24 / 08 / 2020
		Surface RL	≈ 94.1m
		Inclination	-90°
		Box	3-4 of 9

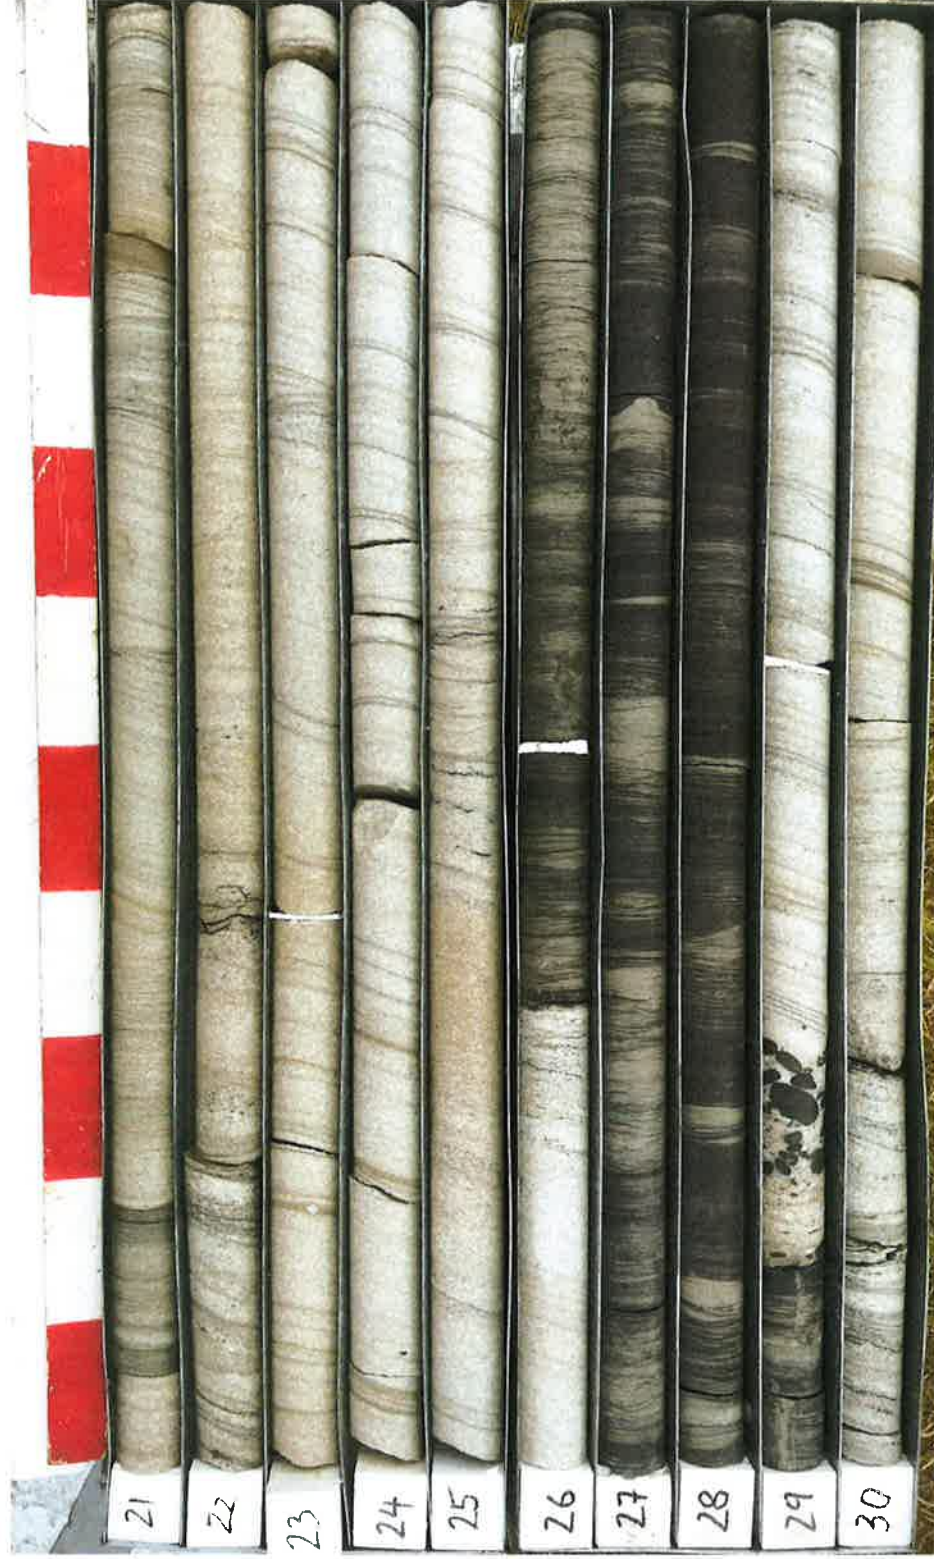
CORE PHOTOGRAPH OF BOREHOLE: BH5M

Surface RL $\approx 94.1\text{m}$
Inclination -90°
Box 5-6 of 9

Depth Range 21.0m to 31.0m BEGL
Contractor Geosense Drilling
Drill Rig Hanjin DB8
Logged SL **Date** 16 / 07 / 2020
Checked SR **Date** 24 / 08 / 2020

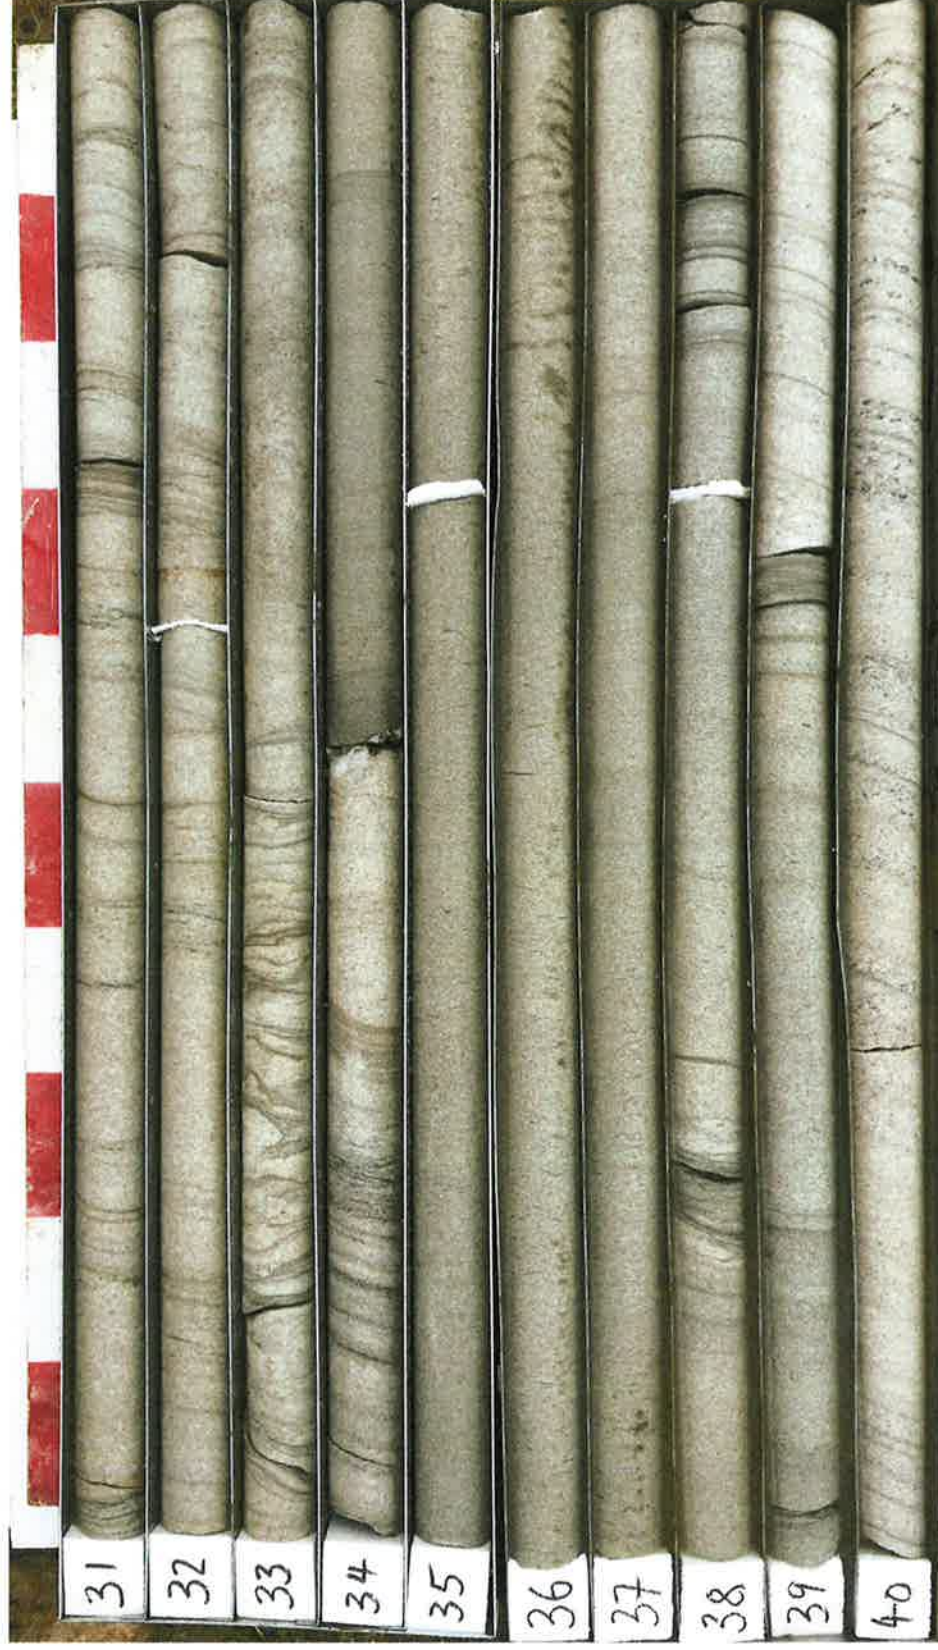
CORE PHOTOGRAPH OF BOREHOLE: BH5M

Surface RL \approx 94.1m
Inclination -90°
Box 7-8 of 9

Depth Range 31.0m to 41.0m BEGL
Contractor Geosense Drilling
Drill Rig Hanjin DB8
Logged SL **Date** 16 / 07 / 2020
Checked SR **Date** 24 / 08 / 2020

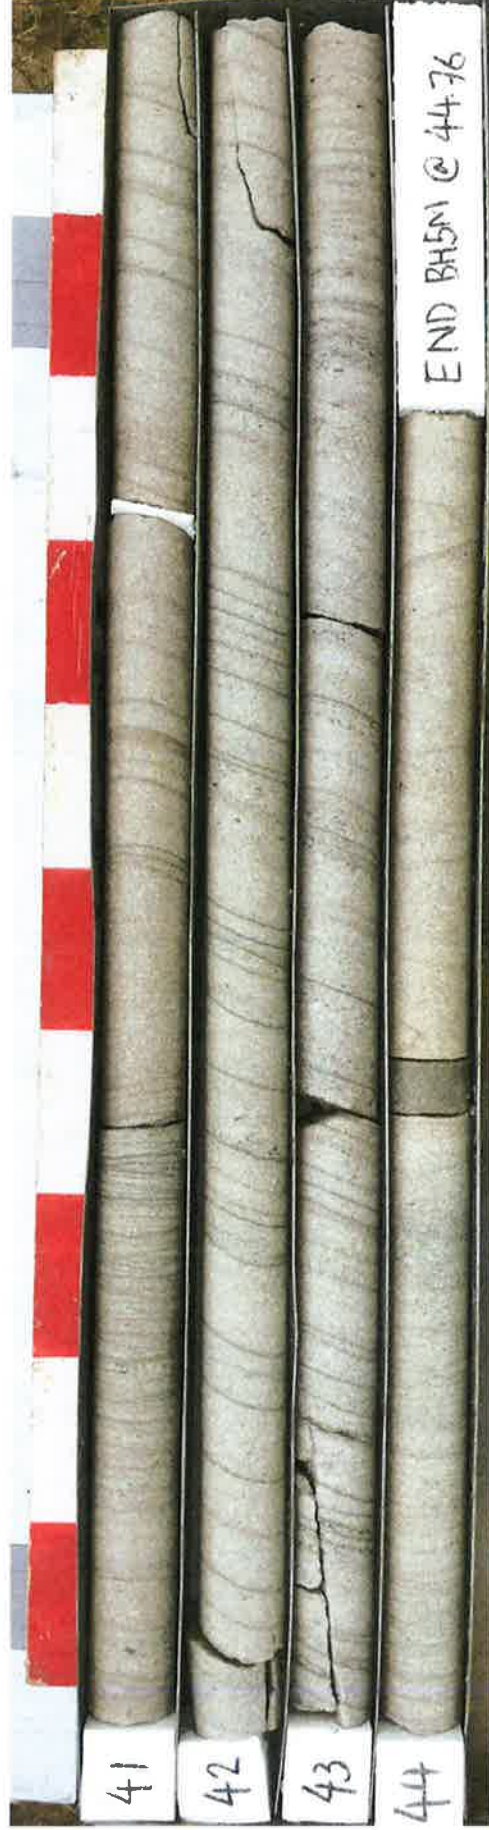
CORE PHOTOGRAPH OF BOREHOLE: BH5M

Project	Proposed Development	Depth Range	41.0m to 44.76m BEGL
Location	2 Mandala Parade, Castle Hill NSW	Contractor	Geosense Drilling
Position	See Figure 2	Drill Rig	Hanjin DB8
Job No.	E24724.G03_Rev1	Logged	SL
Client	Deicorp Projects Showground P/L	Date	16 / 07 / 2020
		Box	9 of 9
		Checked	SR
		Date	24 / 08 / 2020

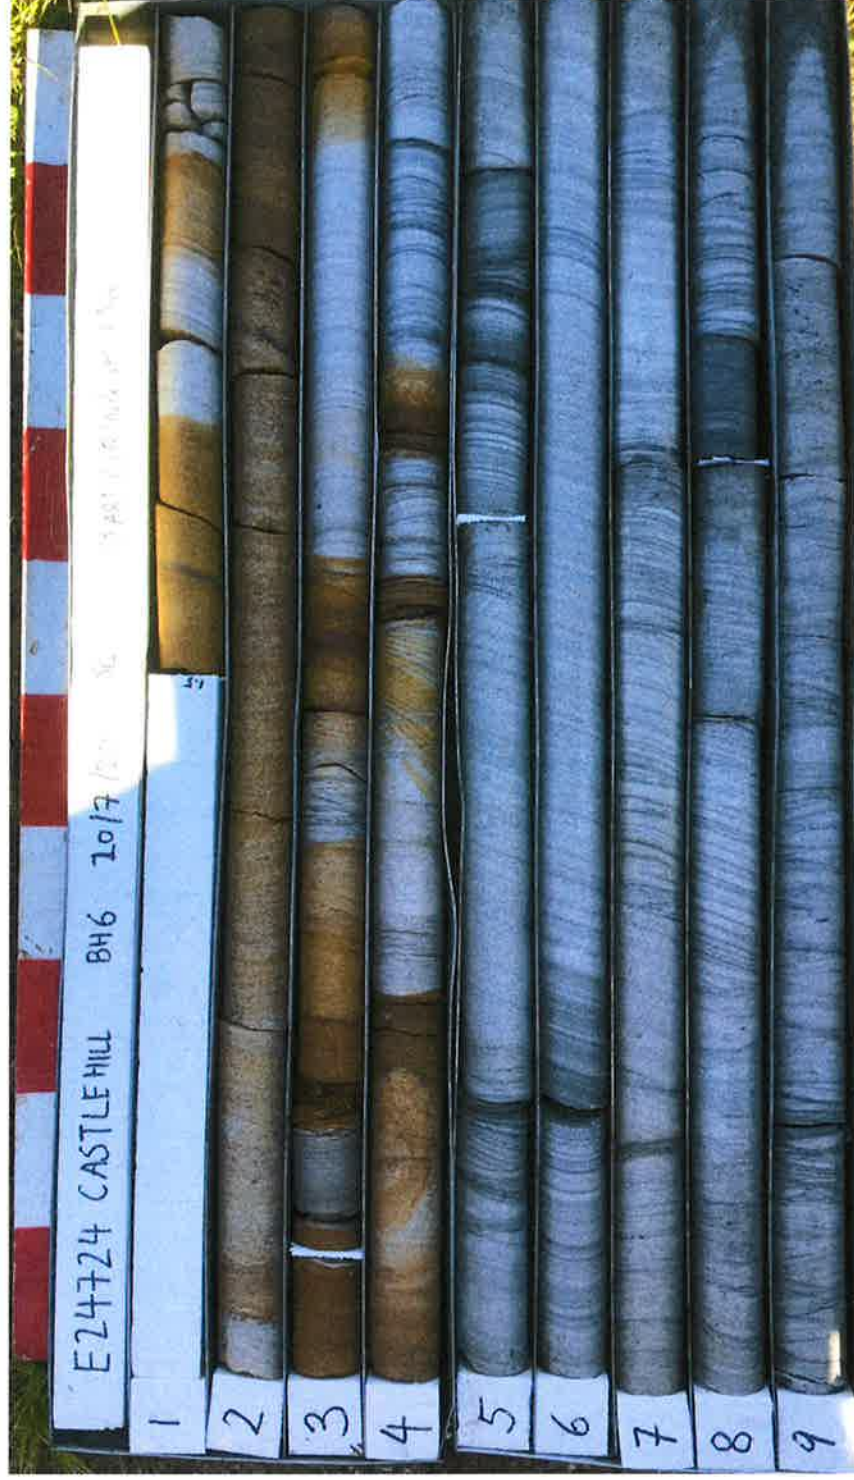
CORE PHOTOGRAPH OF BOREHOLE: BH6

Project	Proposed Development	Depth Range	1.5m to 10.0m BEGL
Location	2 Mandala Parade, Castle Hill NSW	Contractor	Geosense Drilling
Position	See Figure 2	Drill Rig	Hanjin DB8
Job No.	E24724.G03_Rev1	Logged	SL
Client	Deicorp Projects Showground P/L	Date	20 / 07 / 2020
		SR	24 / 08 / 2020
		Box	1-2 of 7
		Inclination	-90°
		Surface RL	≈ 90.8m

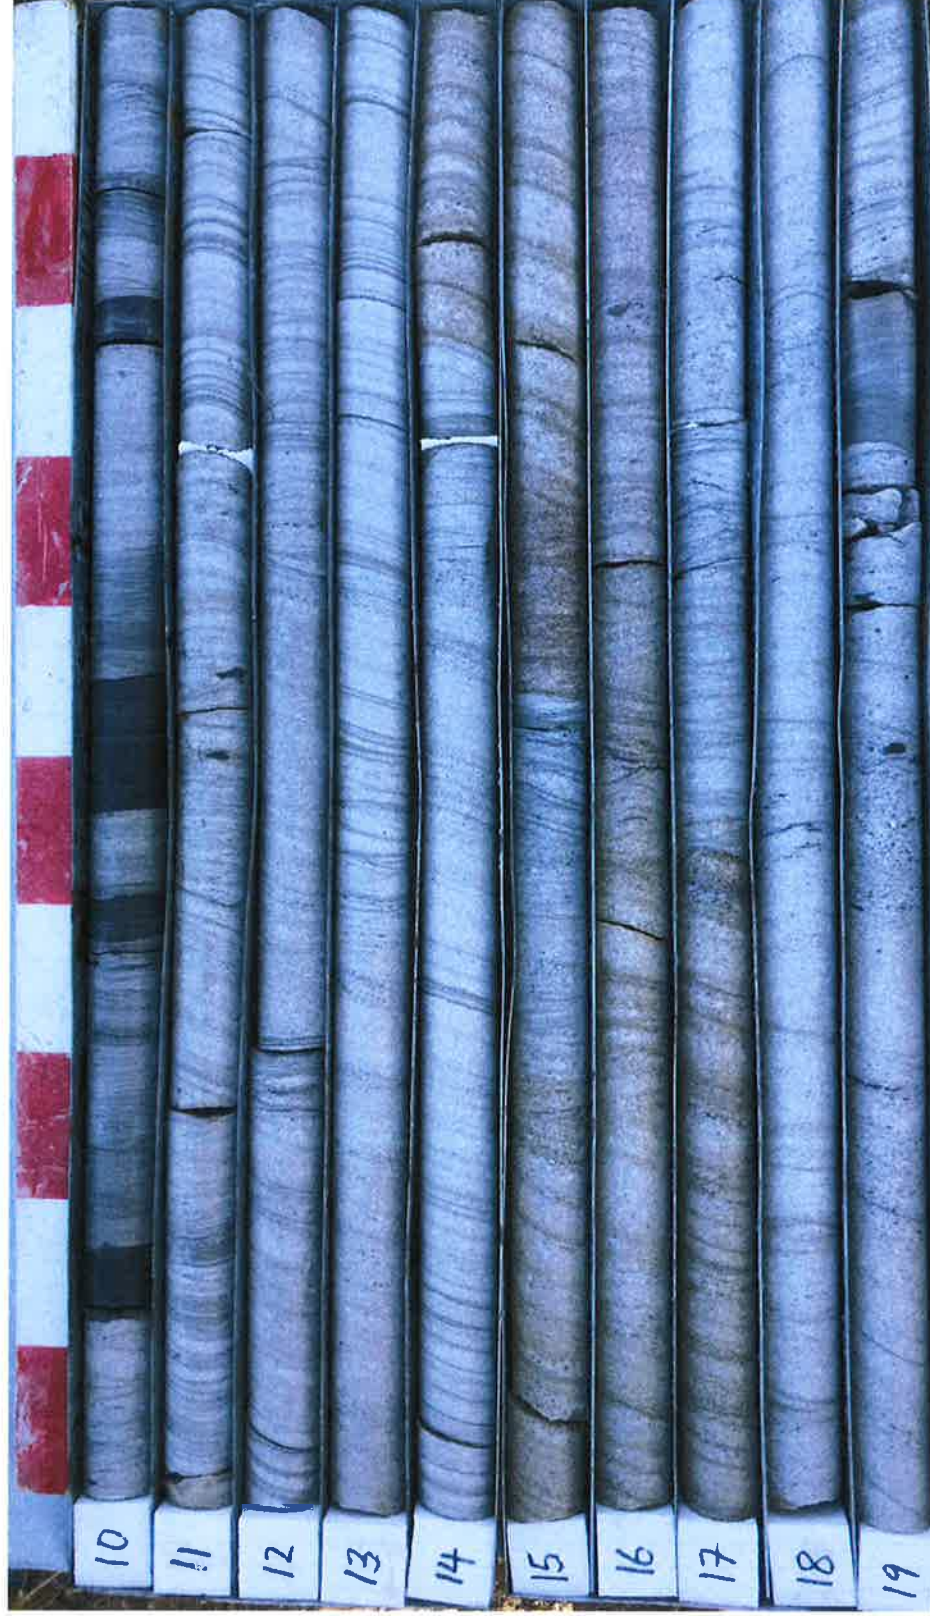
CORE PHOTOGRAPH OF BOREHOLE: BH6

Project	Proposed Development	Depth Range	10.0m to 20.0m BEGL
Location	2 Mandala Parade, Castle Hill NSW	Contractor	Geosense Drilling
Position	See Figure 2	Drill Rig	Hanjin DB8
Job No.	E24724.G03_Rev1	Logged	SL Date 20 / 07 / 2020
Client	Deicorp Projects Showground P/L	Checked	SR Date 24 / 08 / 2020
		Surface RL	≈ 90.8m
		Inclination	-90°
		Box	2-3 of 7

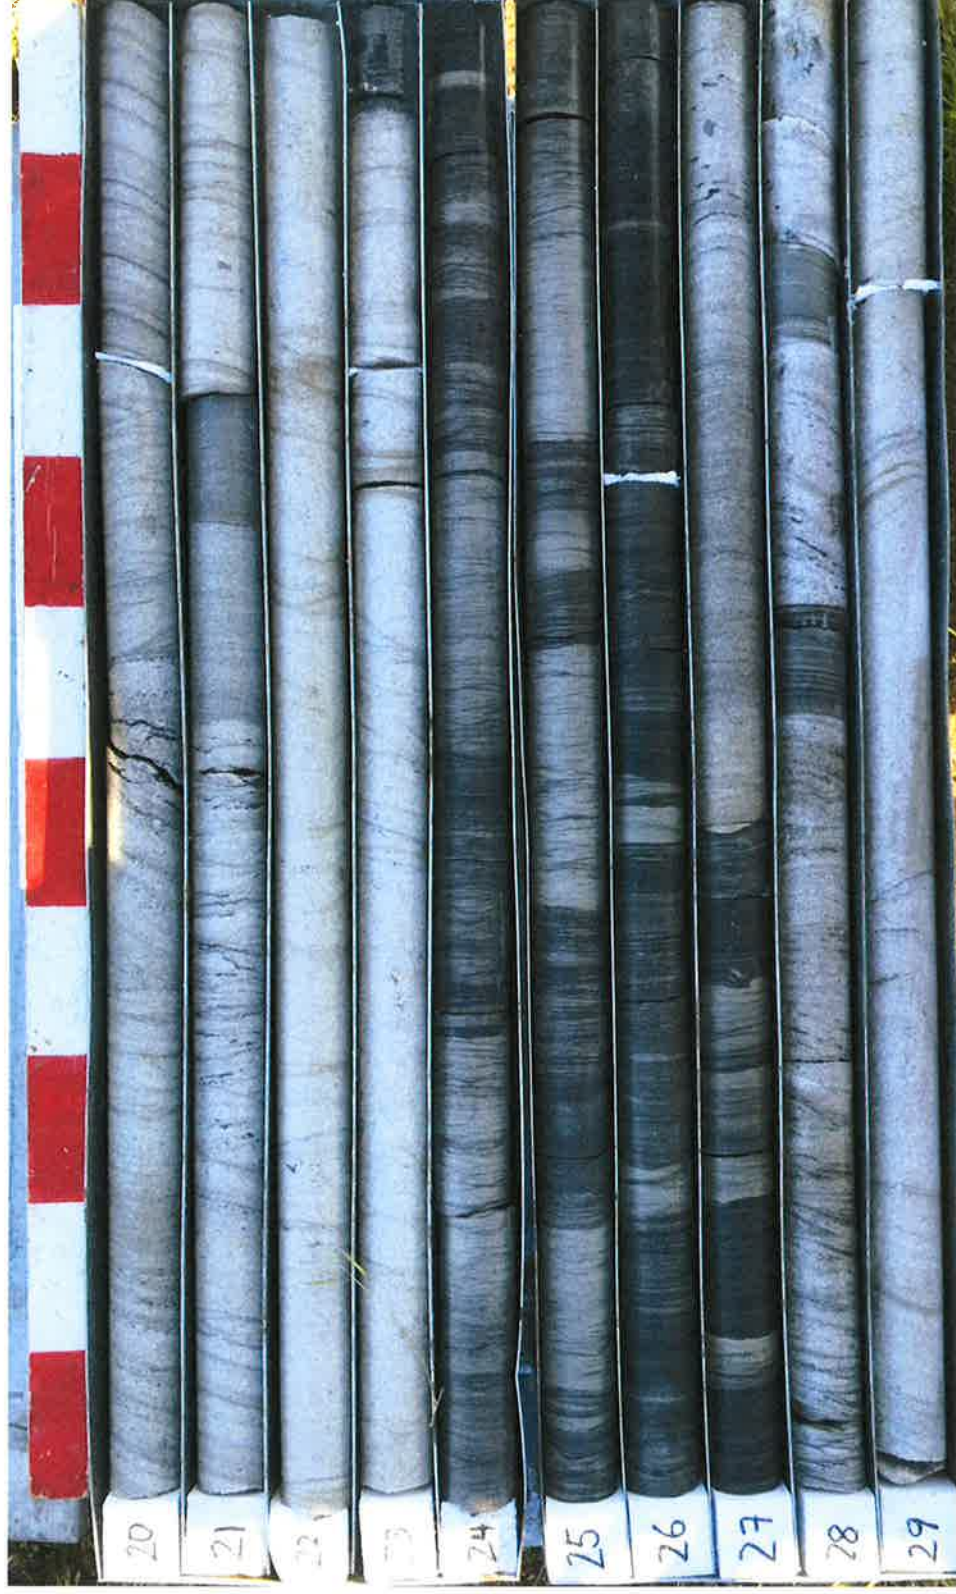
CORE PHOTOGRAPH OF BOREHOLE: BH6

Surface RL ≈ 90.8m
Inclination -90°
Box 4-5 of 7

Depth Range 20.0m to 30.0m BEGL
Contractor Geosense Drilling
Drill Rig Hanjin DB8
Logged SL **Date** 20 / 07 / 2020
Checked SR **Date** 24 / 08 / 2020

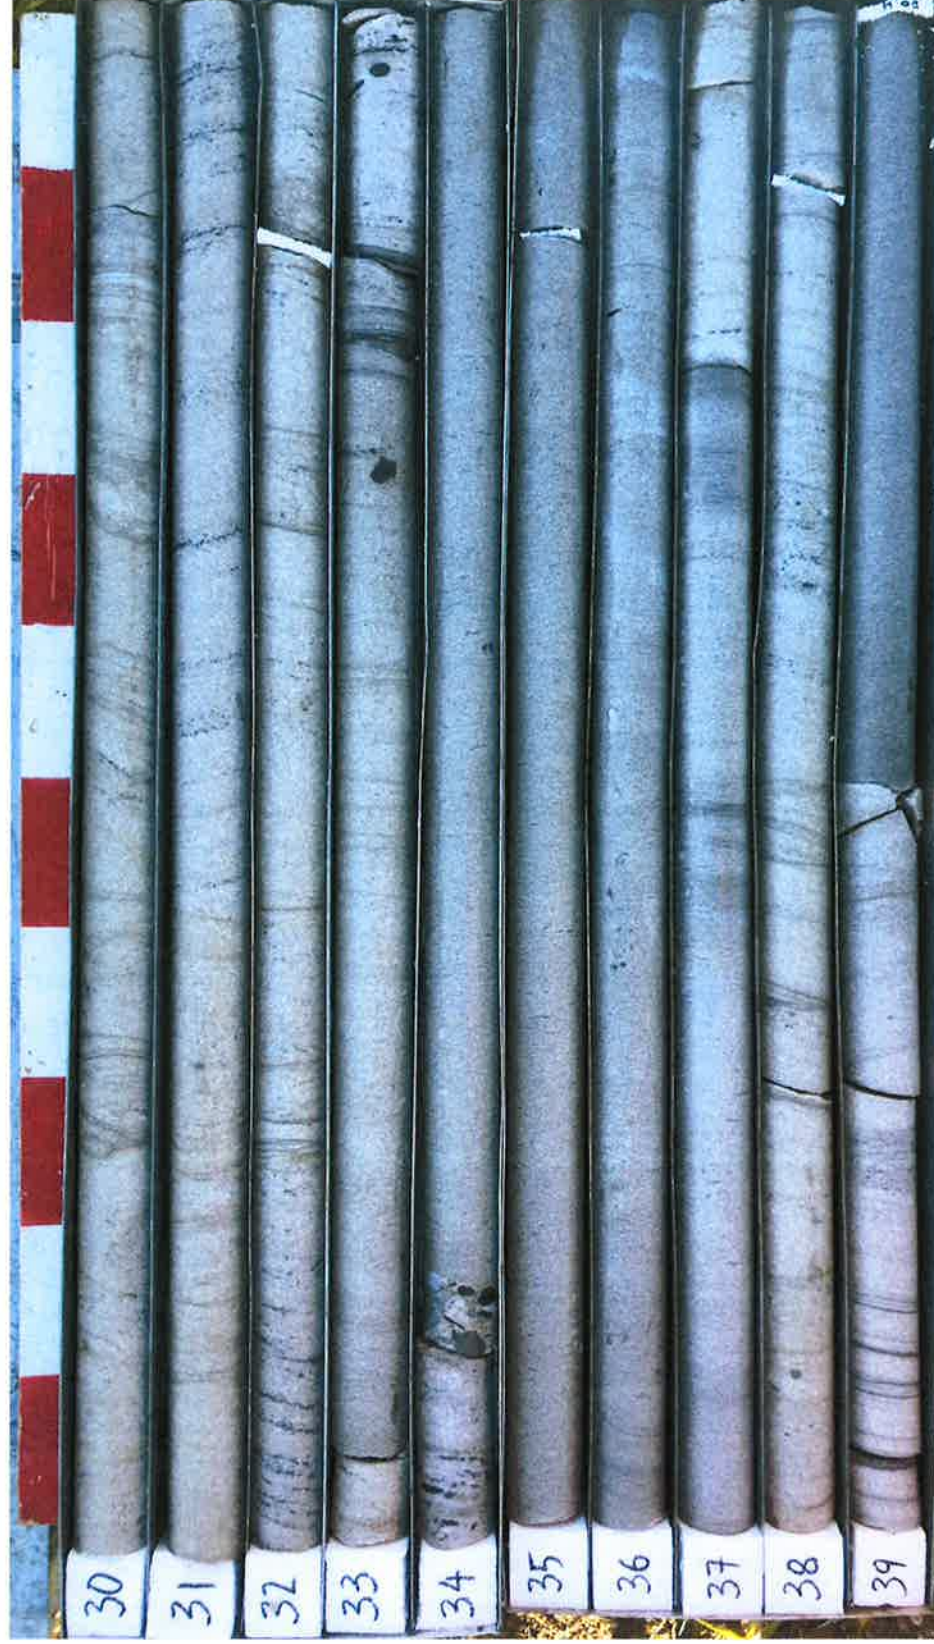
CORE PHOTOGRAPH OF BOREHOLE: BH6

Project	Proposed Development	Depth Range	30.0m to 40.0m BEGL
Location	2 Mandala Parade, Castle Hill NSW	Contractor	Geosense Drilling
Position	See Figure 2	Drill Rig	Hanjin DB8
Job No.	E24724.G03_Rev1	Logged	SL
Client	Deicorp Projects Showground P/L	Date	20 / 07 / 2020
		SR	24 / 08 / 2020
		Box	6-7 of 7
		Inclination	-90°
		Surface RL	≈ 90.8m
