Preliminary Remediation Action Plan

Cockle Bay Park Redevelopment 241-249 Wheat Road, Sydney

> Prepared for **DPT Operator Pty Ltd**

> > Project 202546.03 May 2022

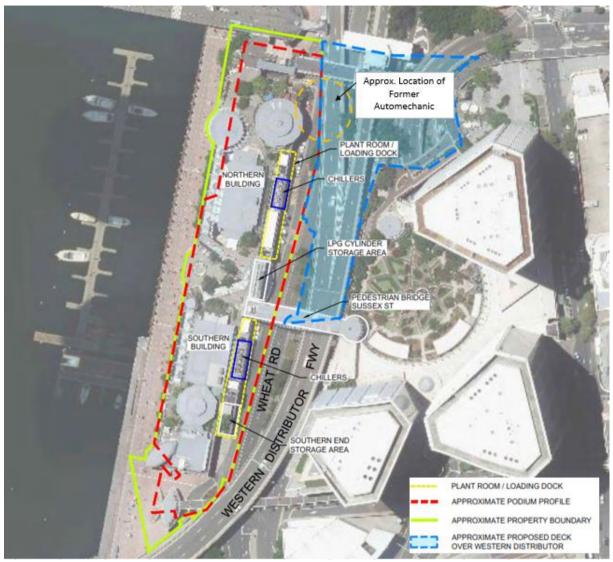
Figure 1: Site Location

The main site features and the site boundary are shown on Figure 1.

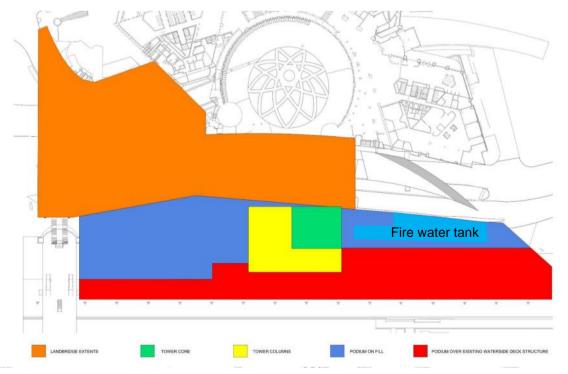
**Figure 2: Proposed Development**

The broad elements of the proposed development are presented in **Figure 2**.

The proposed scope of works includes the demolition of the existing Cockle Bay Wharf building and pedestrian bridge for the progression of a new proposed development. The existing Cockle Bay Wharf deck structure along the Harbour foreshore will be retained and used as a platform for the construction of the proposed podium structure. The proposed development includes several major components with proposed foundations as summarised below:

- Podium structure on Cockle Bay Wharf:
  - o Low rise retail podium structure on Cockle Bay Wharf;
  - o Reinforced concrete columns with an estimated column working load of 5 MN;
  - o Superstructure proposed to be transferred at ground level onto a regular pile foundation grid.

- o 43 storey high rise commercial office tower located on the east side of the podium;
- o Reinforced concrete columns with an estimated column working load of 130 MN;
- o Columns proposed to be founded on pile groups of large diameter socketed in high strength rock with tower core to be founded on a piled 1.5 m deep raft; and
- o Raking piles proposed to be used to support lateral tower forces.
- Land bridge spanning across the existing Western Distributor:
  - Deck structure connecting the new podium structure on Cockle Bay Wharf with the existing Darling Park towers;
  - o The deck structure will cover the area of Western Distributor between the new development and the Darling Park towers:
  - Reinforced concrete columns with an estimated column working load of 35 MN and ultimate horizontal impact load of 2.7 MN; and
  - o Proposed to be founded on pile or pad foundations.

It is understood that a bulk excavation to approximately 6 m depth will also be required towards the southern end of the proposed development to accommodate a large in-ground fire water tank.
