# Greenwich Hospital Redevelopment– Detailed Design (SSD-13619238)

## Submission

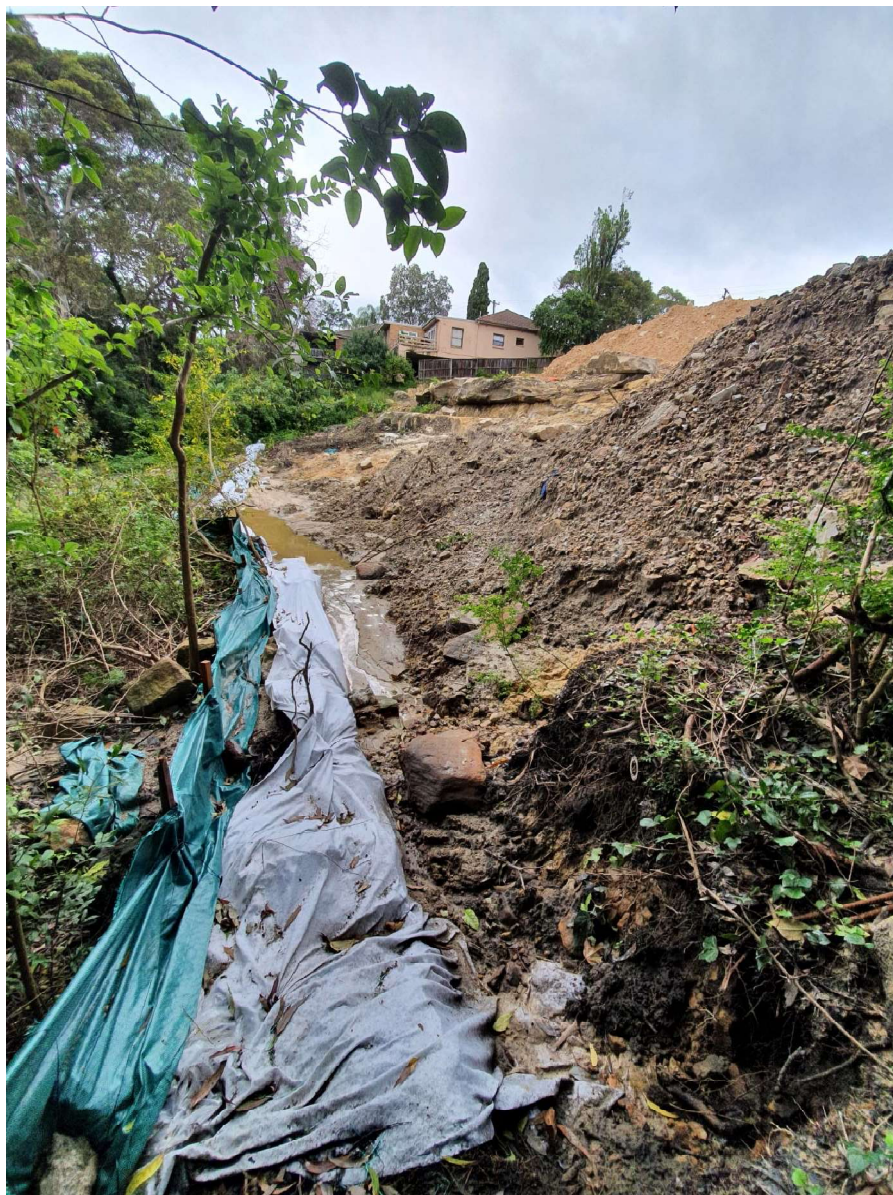
**Photo1:** Steep slope of unconsolidated excavated rock and sediment with a totally inadequate low silt fence on the edge of bushland reserve

In recent years, Lane Cove has experienced major impacts on bushland, including a Threatened Ecological Community, from uncontrolled sediment flows off two large developments on steep sites above bushland. It is critical that Erosion and Sediment Control Plans are clearly specified in DA documents, and for development above bushland on steep slopes these plans must upgrade the controls to a minimum of two high steel fences, approx. two metres apart lined with silt fabric to a height of one metre. Photo 1 in the appendix to this submission shows the inadequacy of regular sediment controls on one of the recent Lane Cove development sites. Photo 2 shows single steel fencing put in place after the inadequate original controls were overwhelmed and sediment spread through the bush on a wide front below the site. However, the original inadequate fencing still forms the second layer and should be replaced with the higher and stronger steel version. This double fencing should be mandatory on such steep sites and it must be in place on such sites before disaster strikes.

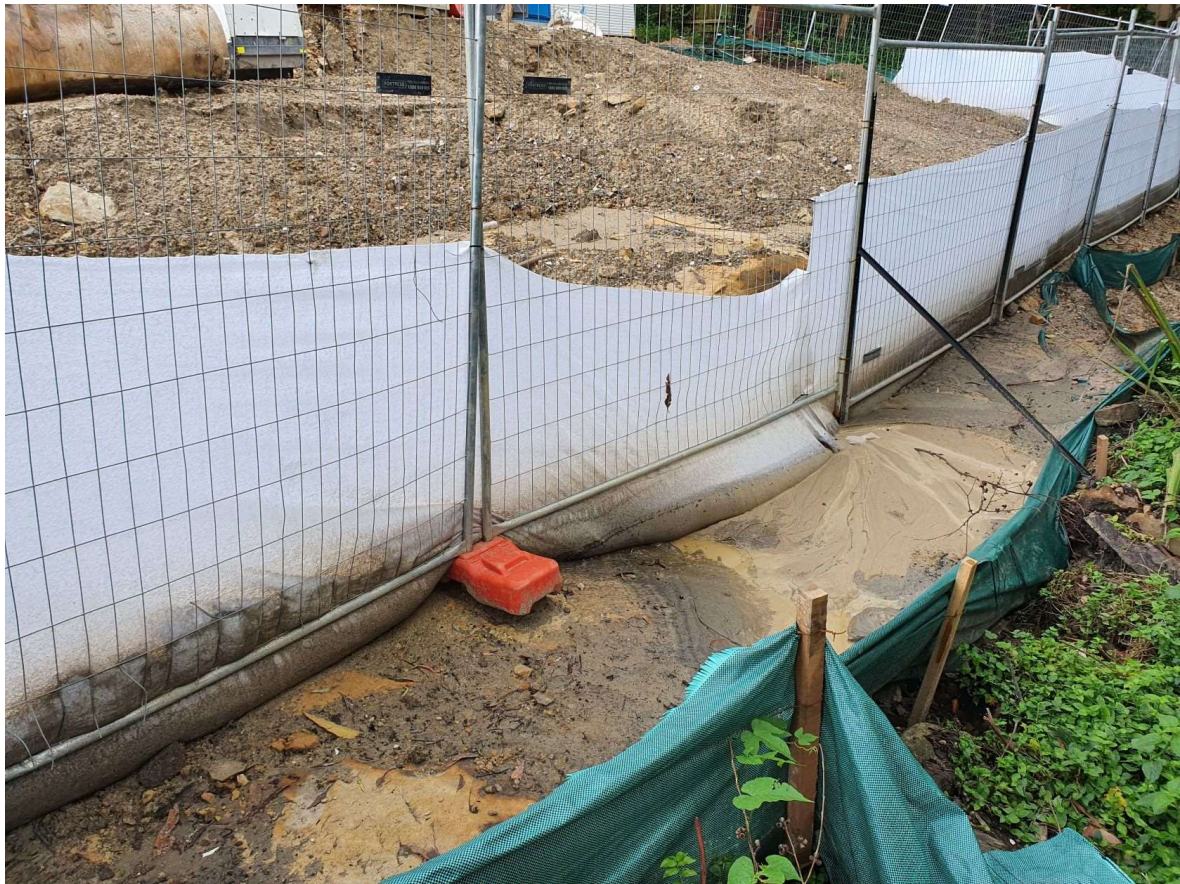
**Photo 2:** A single layer fabric-lined steel fence can also be breached in extreme weather. A second layer is required to act as a failsafe. For either fence on a steep slope the traditional low green fencing is totally inadequate.

- The *Construction Management Plan* mentions an ESCP on p.27 and at 4.4.6.9, p31 but these only pertain to drain protection and truck washing.
- The *Stormwater Management Plan* shows details for Erosion and Sediment Control for Stage 3 in a plan on p.18. this includes a perimeter sediment control fence for the entire Stage 3 works, accompanied by a drawing with some details of this fence. While specifications indicate a stronger fence than the sediment fencing in Appendix Photo 1, as a single fence apparently less than a metre high, it would not be enough to hold the sediment flows we have seen from the site in Photos 1 and 2. ***The fencing should be higher and the controls strengthened to a double fence across the bushland slope portion of the perimeter.***
