Ad-hoc ceiling system test report

Test standard: Sections 2 and 4 of AS 1530.4:2014

Test sponsor: Built Pty Ltd

Product: Coke breeze arch

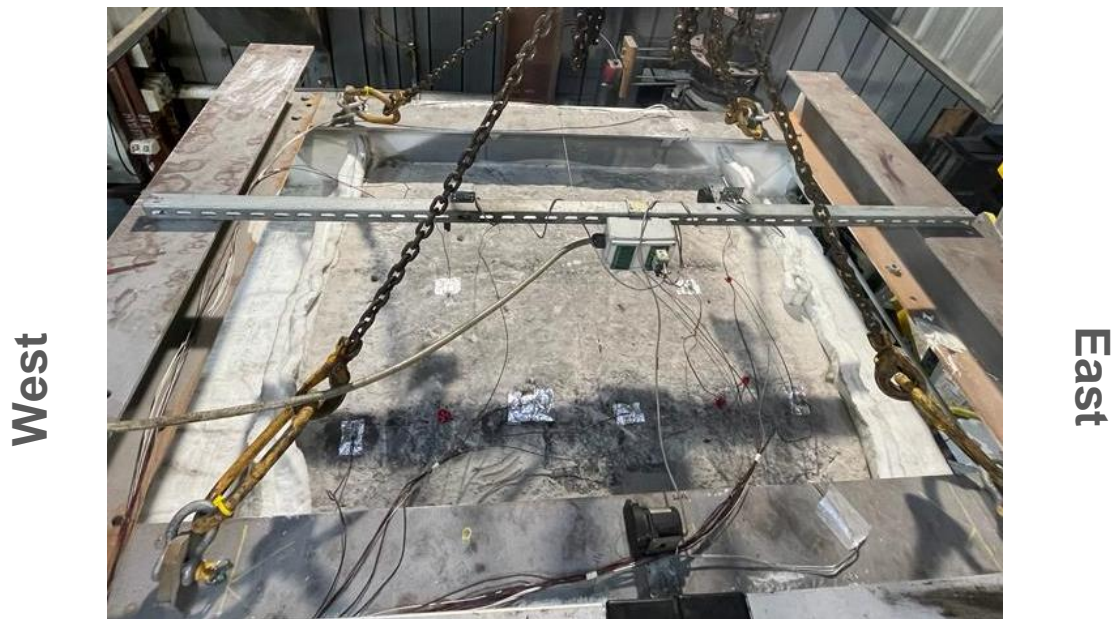
Figure 18 Unexposed face of the specimen before the start of the test

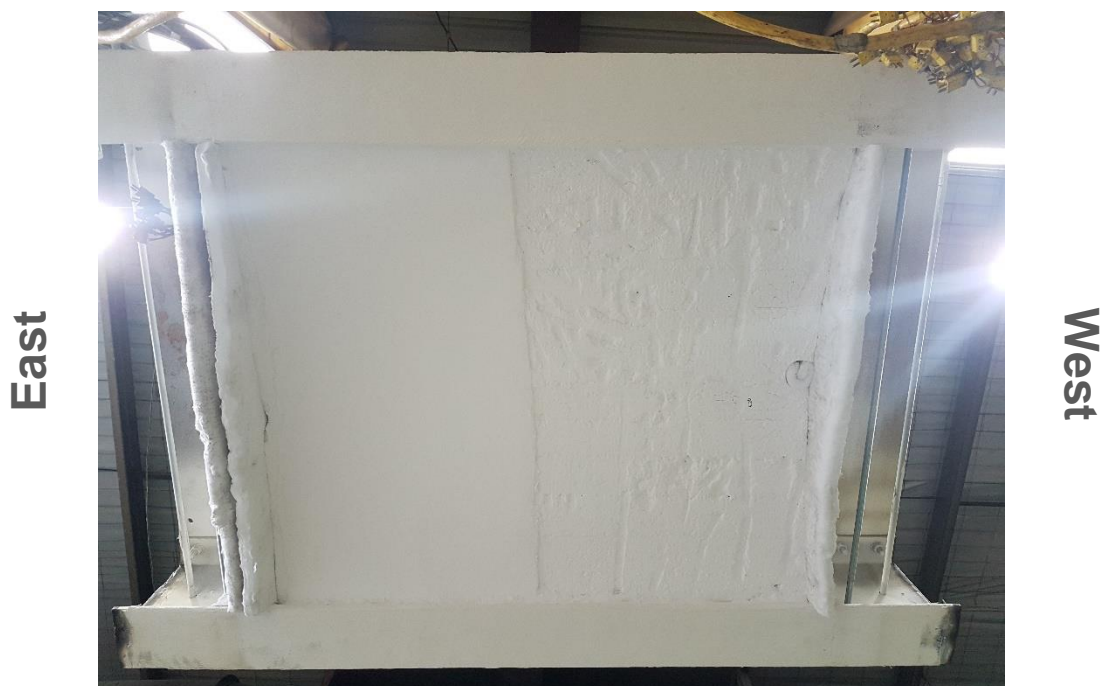
Figure 19 Exposed face of the specimen before the start of the test

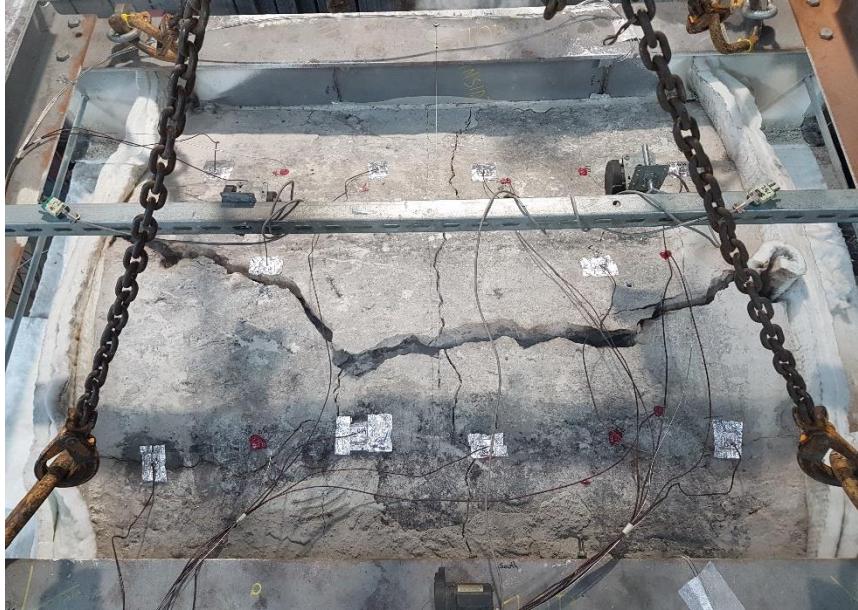
Figure 20 Unexposed face of the specimen at the end of the test

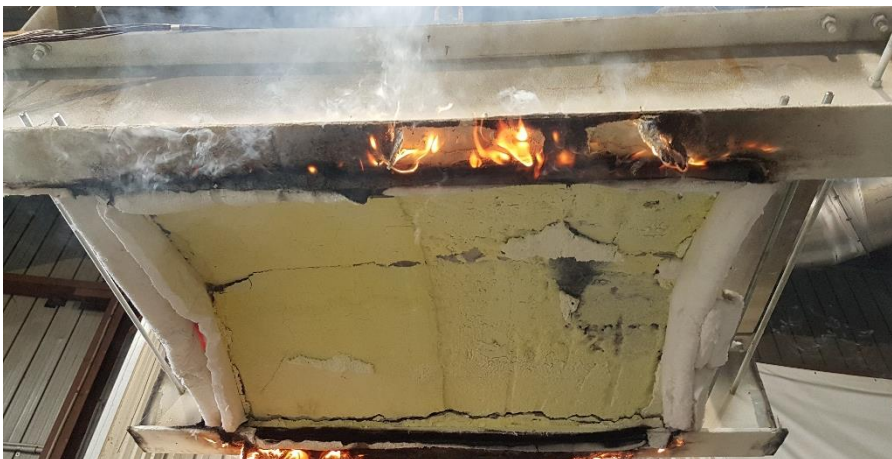
Figure 21 Exposed face of the specimen at the end of the test
