# Technical Note – 85-97 Waterloo Road Macquarie Park – Concept Design Stage Impact Assessment

Project Number	S23030
Client	Goodman
Date	12 June 2024
Document Number	GEO-MEM-001
Revision	A
Prepared By	Fergus Cheng / Mihimal Kadurugamuwa
Reviewed By	Bach Trang

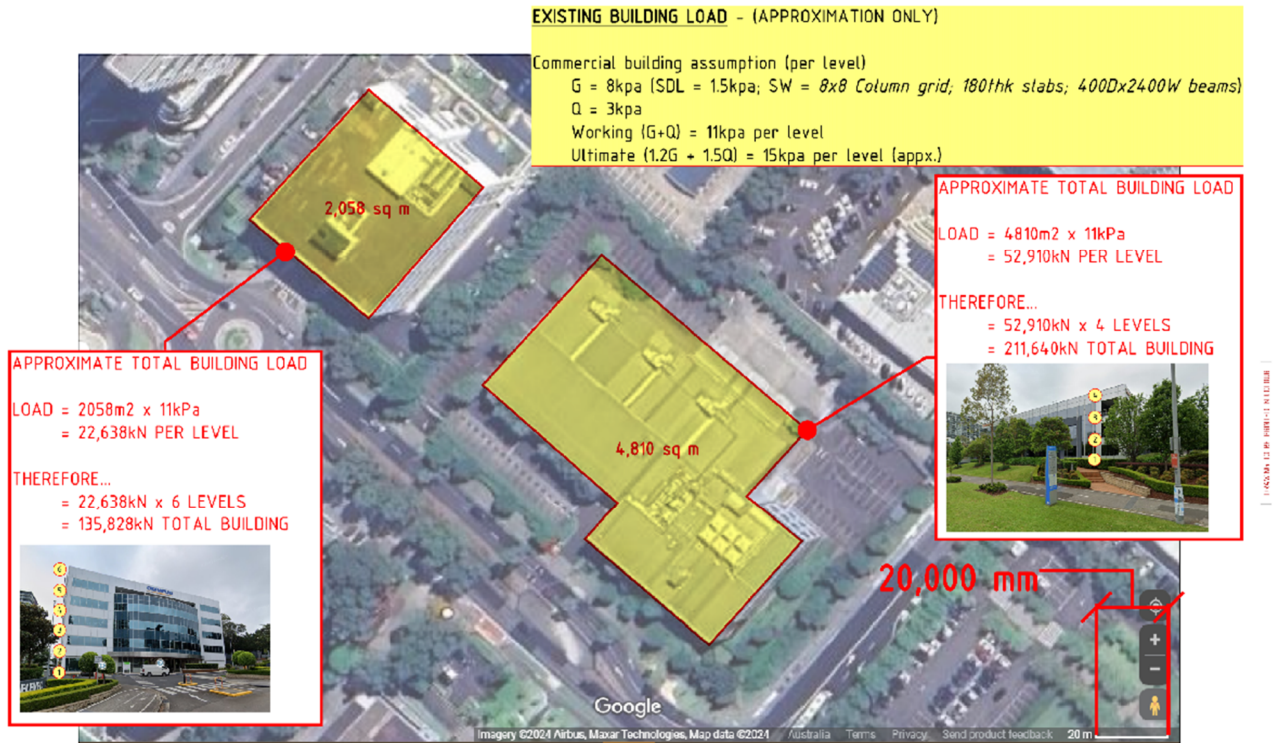
Figure 3: Loads from the Existing Building

All the building loads have been provided by the structural engineer on the project. For the two existing buildings on site, it was estimated that they are applying building loads of 66 kPa and 44 kPa onto the existing ground. This has been rationised and 66 kPa has been adopted in the analysis. The new buildings will apply an estimated load of 225 kPa at the basement level. A markup showing the existing building and their loads is provided as Figure x.

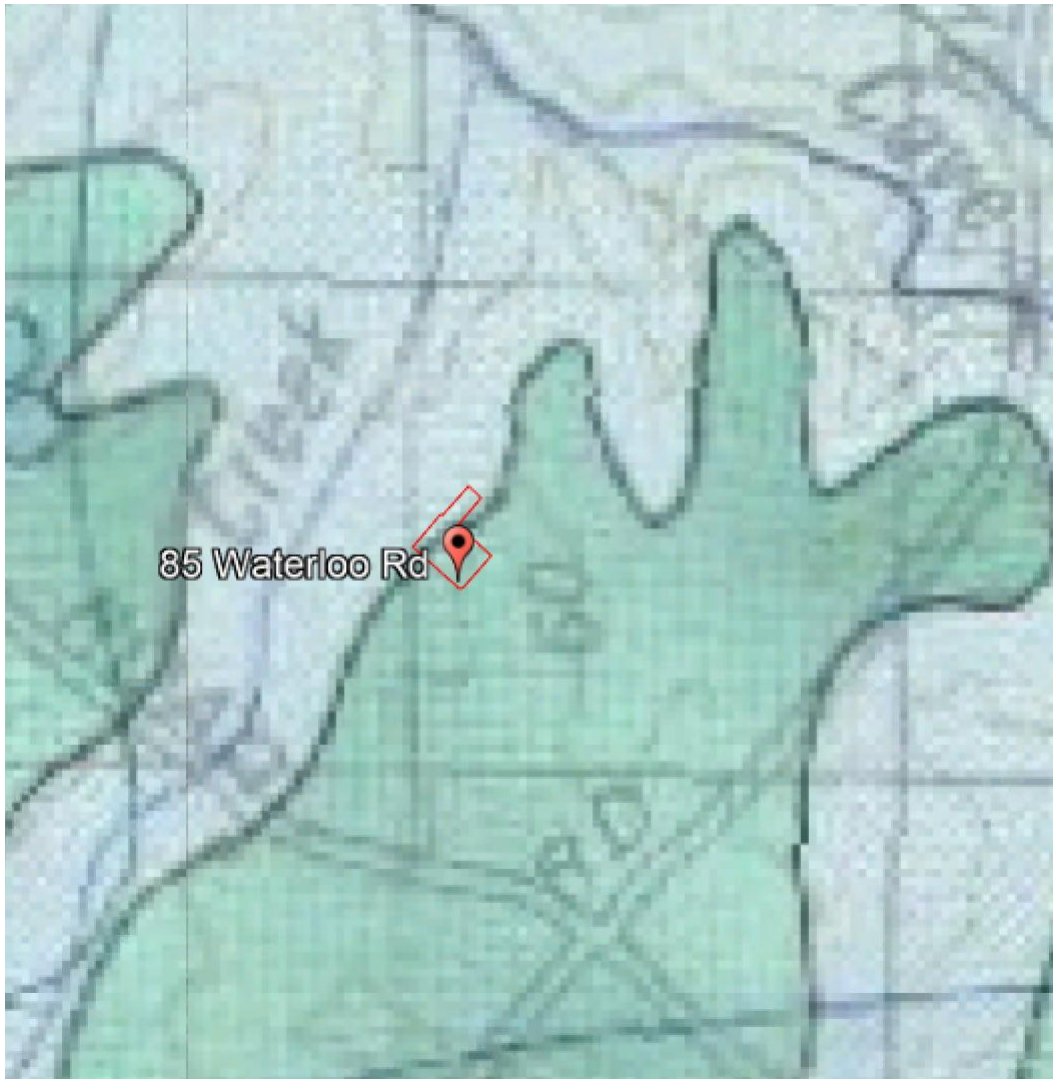
**Inset 1: Sydney geological map indicating approximate site location**

The 1:100,000 Sydney Geological Map indicates the site is underlain by Ashfield Shale of the Wianamatta group (Rwa) which consist of black to dark-grey Shale and Laminite and Hawkesbury Sandstone (Rh) which consist of medium to coarse grained quartz sandstone, very minor shale and laminite lenses. The published information is consistent with the subsurface conditions encountered in the field investigation.

Inset 1 presents an indicative site locality on the geological map.

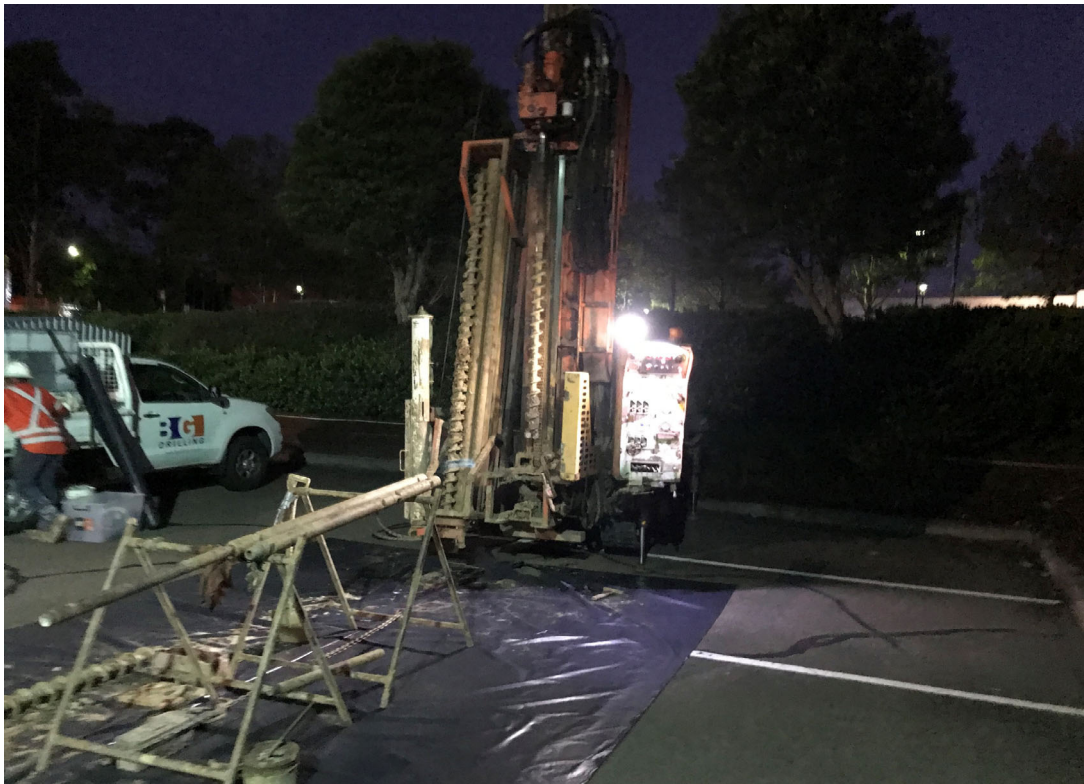
Photo 4 - Setting up the drilling rig -Hanjin D8

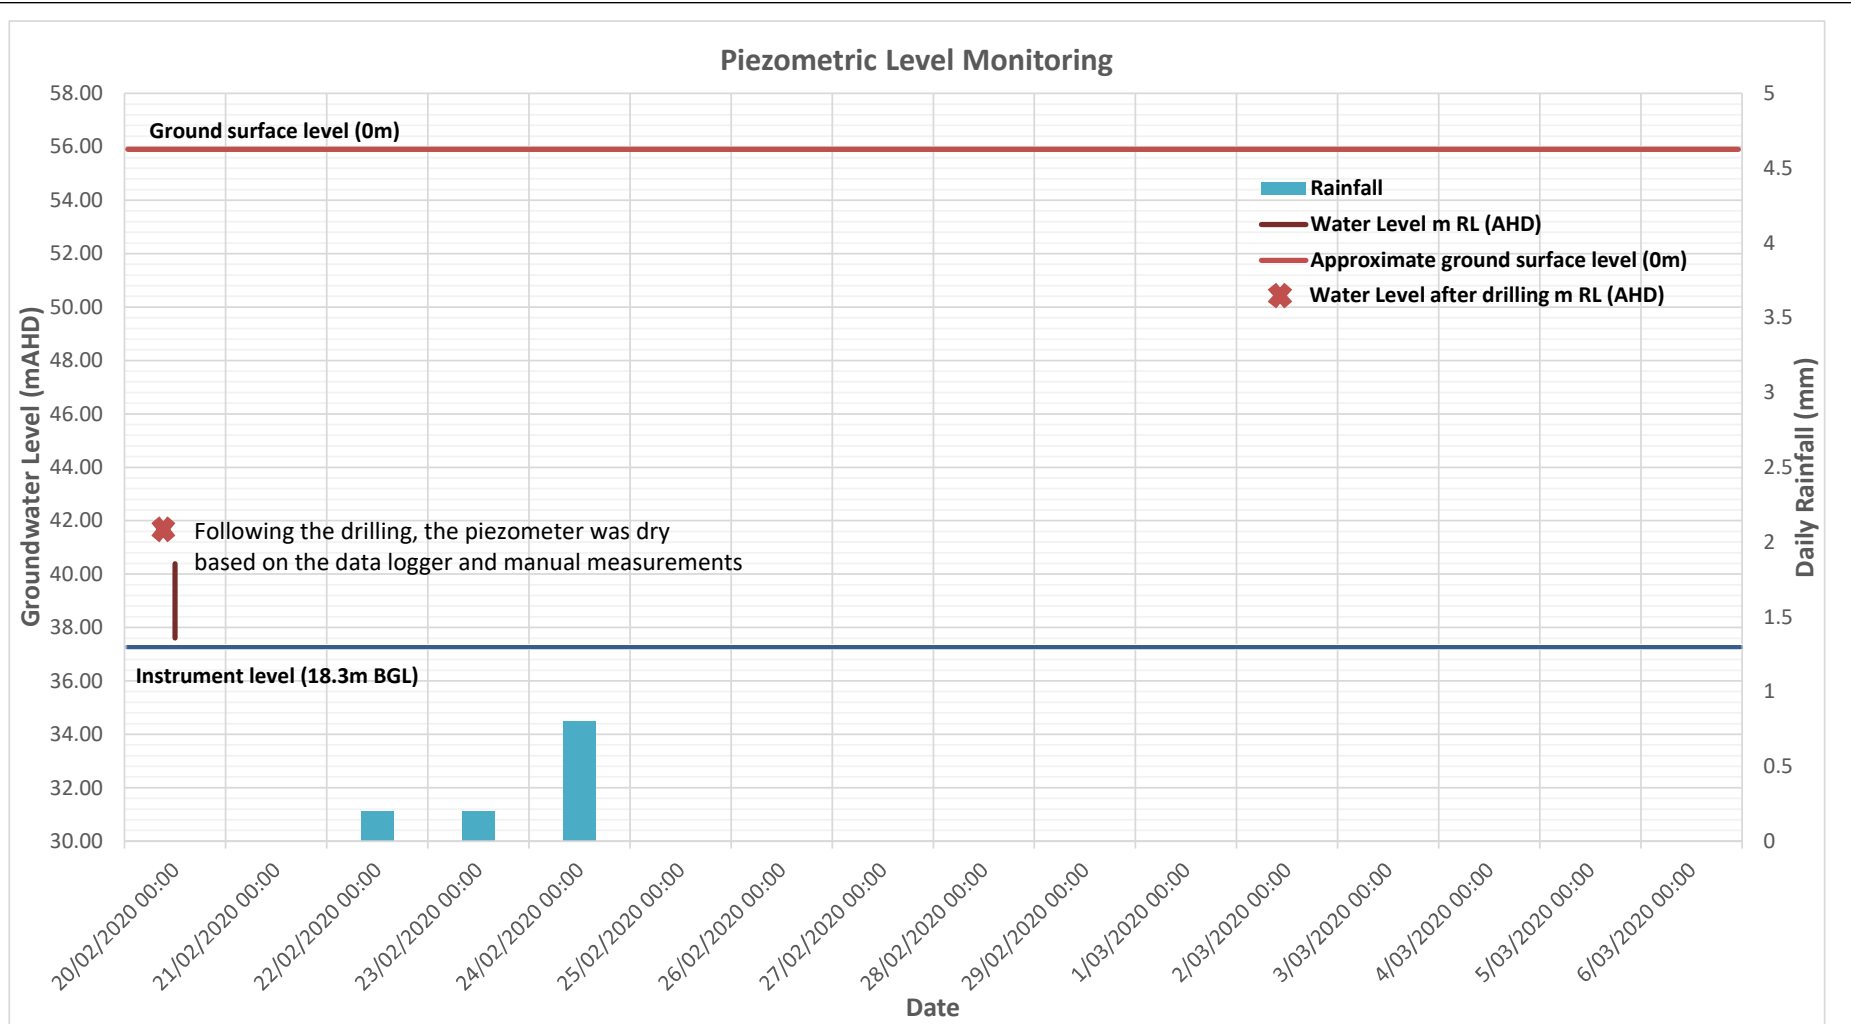
COMMENTS: Water level after installation 20/02/2020 (3.00pm) - depth 14.20 mm (BGL)

1. Screened lithology: Hawkesbury Sandstone
2. Instrument RL (m AHD): 37.6 (18.3 m BLG)
3. Measured water level (using tape measure) on 20/02/2020 3:00 AM: RL 41.7 m AHD (14.2 m BLG)
4. Rainfall data source: Macquarie Park (Willandra Village), New South Wales  
Station number: 066156
5. Data logger installed on 20/02/2020 3:00AM

Measurements of the water level were taken at 1.0-hour intervals from 20 February 2020 to 06 March 2020 in BH03 (standpipe piezometer). The water level in BH03 had changed during this period and no water was found over the monitoring period. Figure 3 presents the results of groundwater level monitoring in the standpipe piezometer (BH03). Monitoring will continue for the next 3 months.

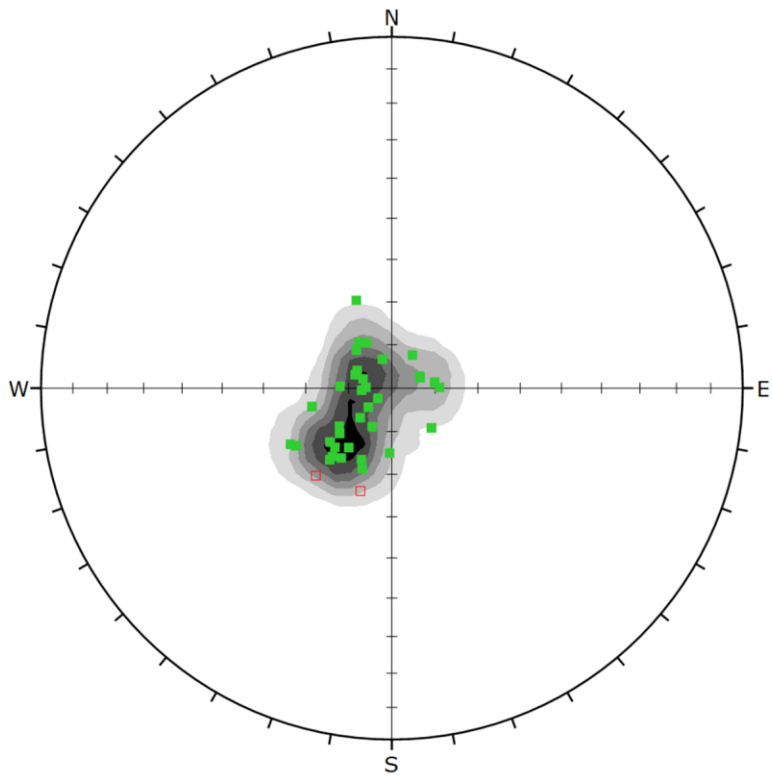
**North datum:** True North  
**Borehole Dip/Azi:** -90° / -  
**Defect Type:** Bedding, Bedding Shear

Symbol	TYPE	Quantity
■	BP	35
□	BSH	2

<b>Plot Mode</b>	Pole Vectors
<b>Vector Count</b>	37 (37 Entries)
<b>Hemisphere</b>	Lower
<b>Projection</b>	Equal Area

Figure 4 presents stereoplots with the orientation of identified geological structures. A large bedding related shear was interpreted to have been encountered in BH03 at approximately 16 to 17 m depth (approx. dip 25° to 27° and dip direction 17° to 41°). Some of the observed geological structures are inferred to be associated with the shear including joints and seams. There is some remaining uncertainty as to the large-scale orientation of this structure which can't be reliably obtained through a single borehole. PSM shall be requested to review the proposed basement (layout, depth, locations, etc.) against the geological structures when the basement details are available. If the geotechnical structure is critical to the design, further investigations may be required.

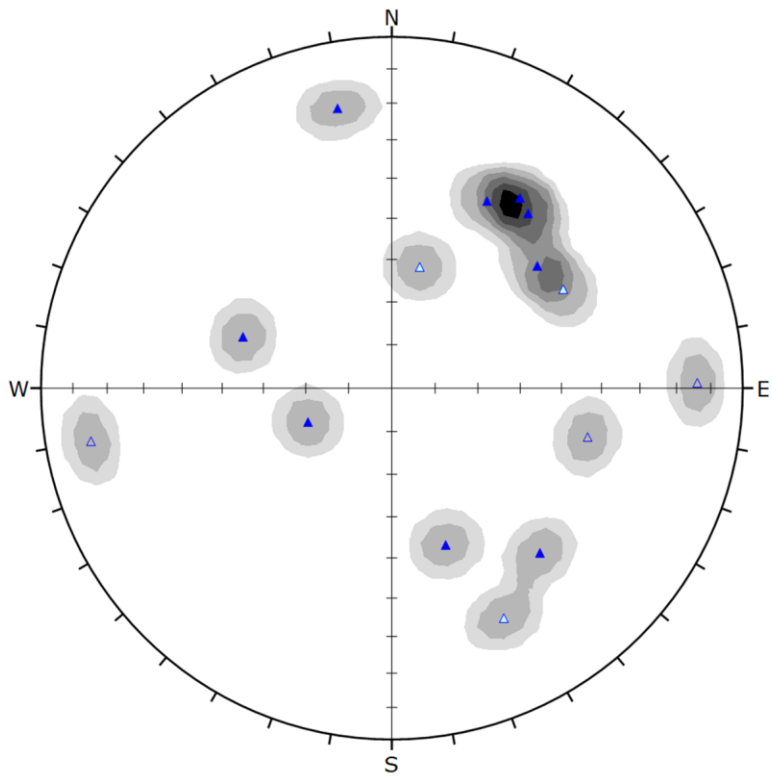
**North datum:** True North  
**Borehole Dip/Azi:** -90° / -  
**Defect Type:** Joints /Joints Clay Infill /Joints Healed

Symbol	TYPE	Quantity
▲	JT	9
△	JTC	3
△	JTH	3

<b>Plot Mode</b>	Pole Vectors
<b>Vector Count</b>	15 (15 Entries)
<b>Hemisphere</b>	Lower
<b>Projection</b>	Equal Area

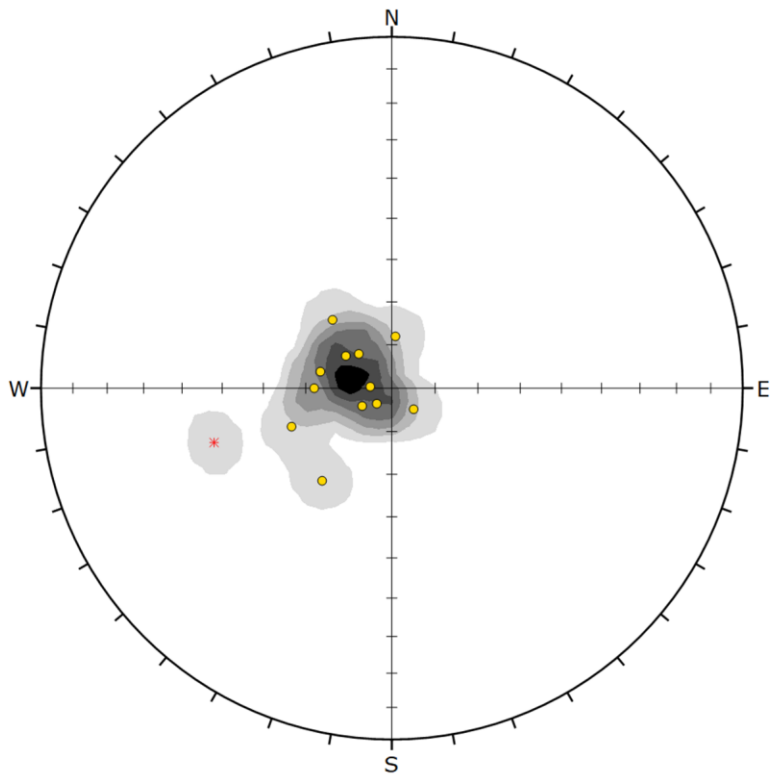
**North datum:** True North  
**Borehole Dip/Azi:** -90° / -  
**Defect Type:** Seam, Shears

Symbol	TYPE	Quantity
●	SM	12
*	SS	1

<b>Plot Mode</b>	Pole Vectors
<b>Vector Count</b>	13 (13 Entries)
<b>Hemisphere</b>	Lower
<b>Projection</b>	Equal Area

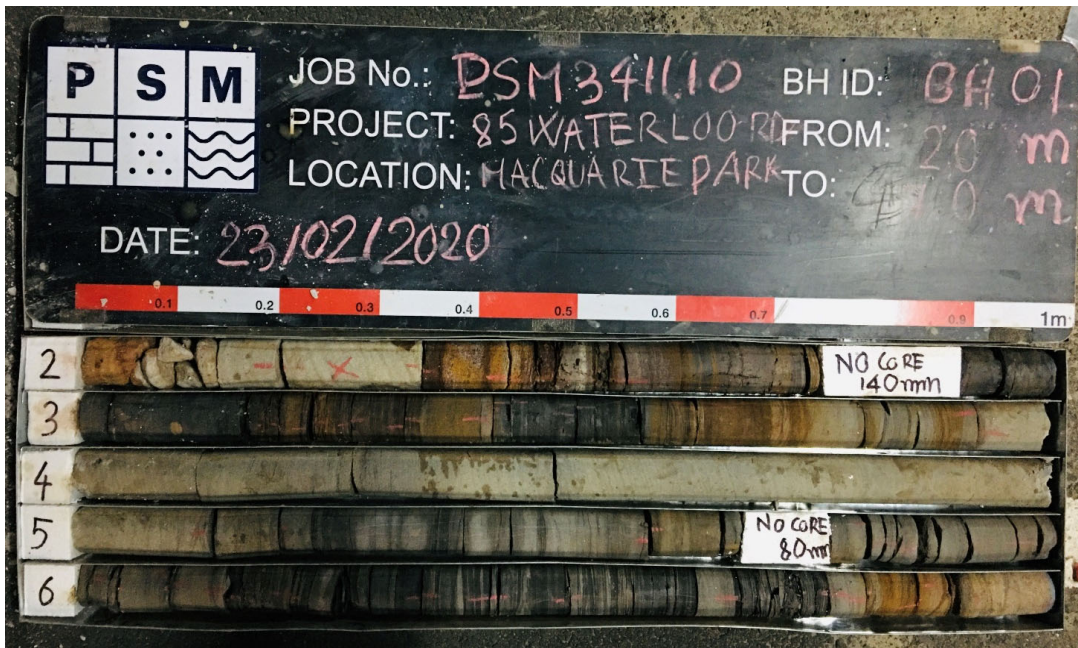
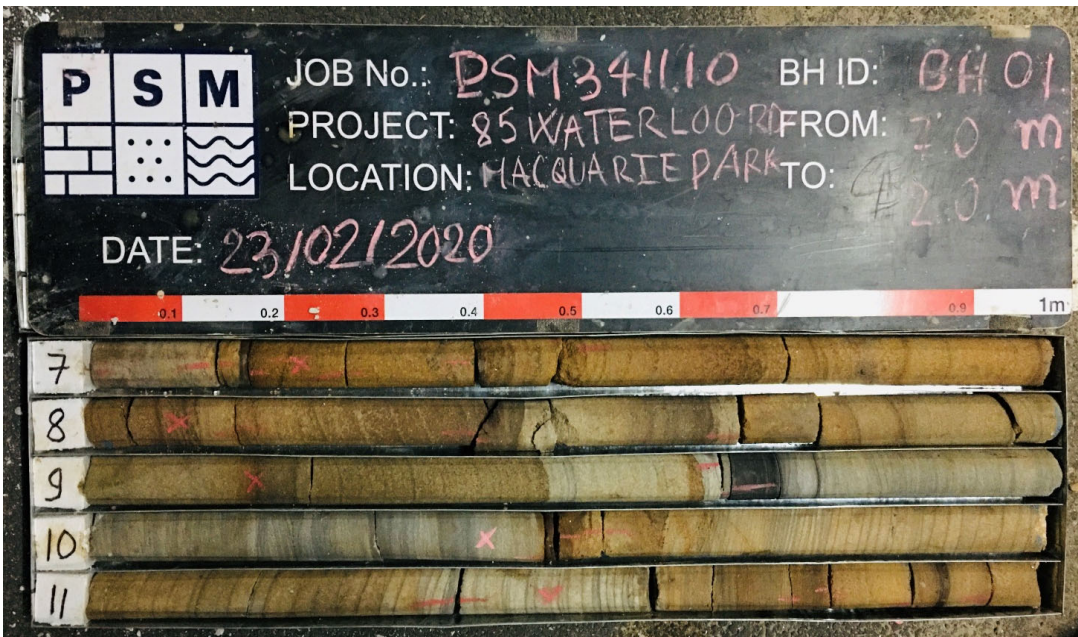
Goodman  
 85 Waterloo Road  
 Macquarie Park, NSW  
 GEOTECHNICAL INVESTIGATION  
 CORE PHOTOGRAPHY - BH01\_(1)

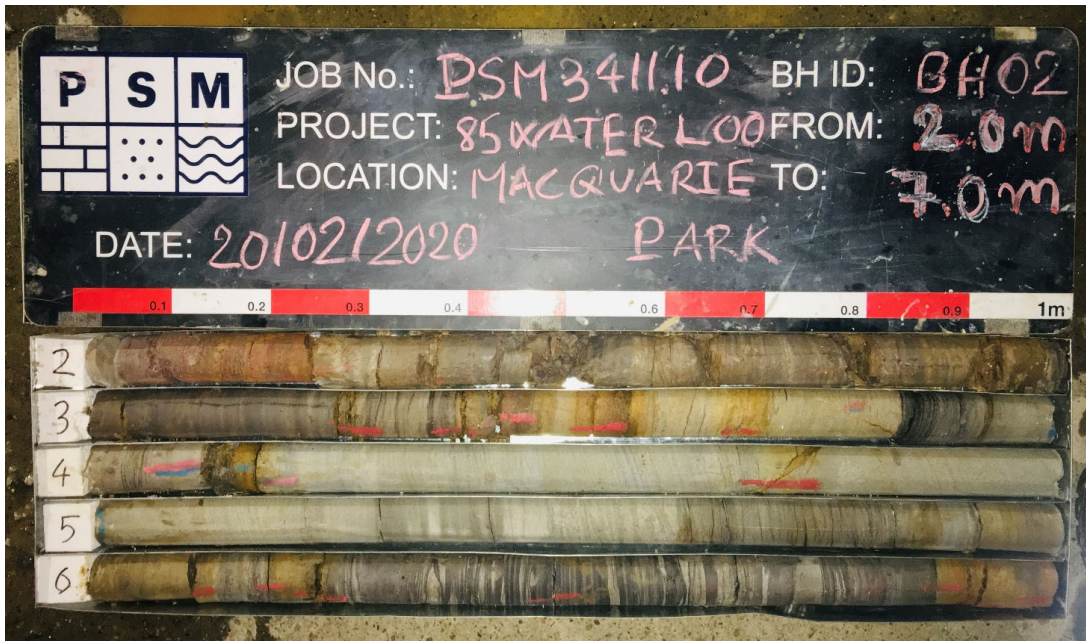
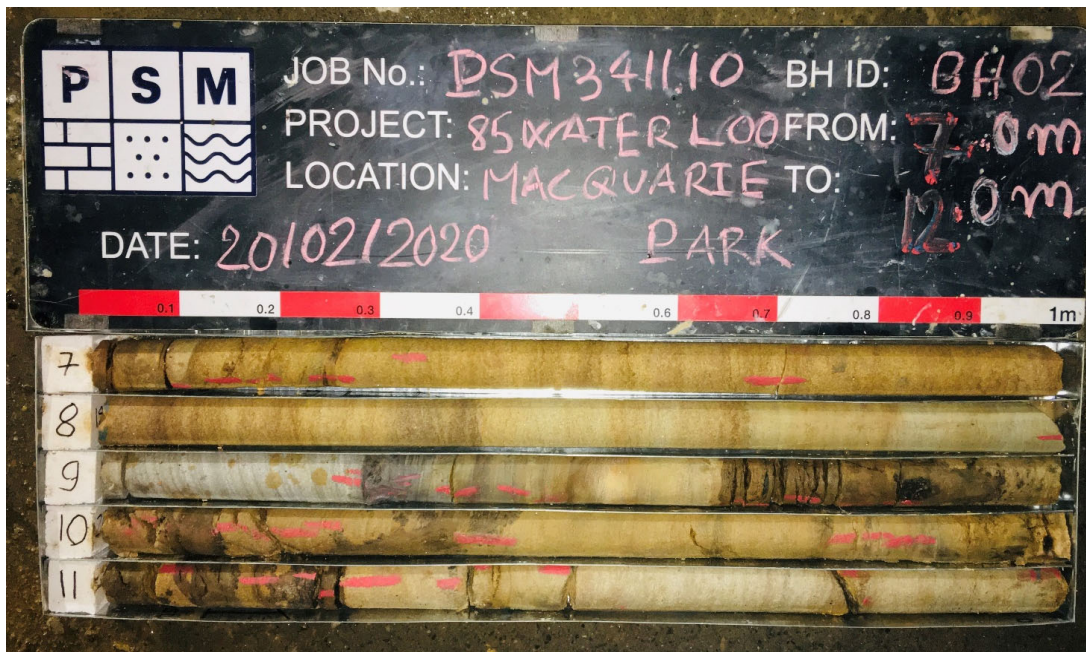
**Goodman**  
**85 Waterloo Road**  
**Macquarie Park, NSW**  
**GEOTECHNICAL INVESTIGATION**  
**CORE PHOTOGRAPHY - BH02\_(1)**

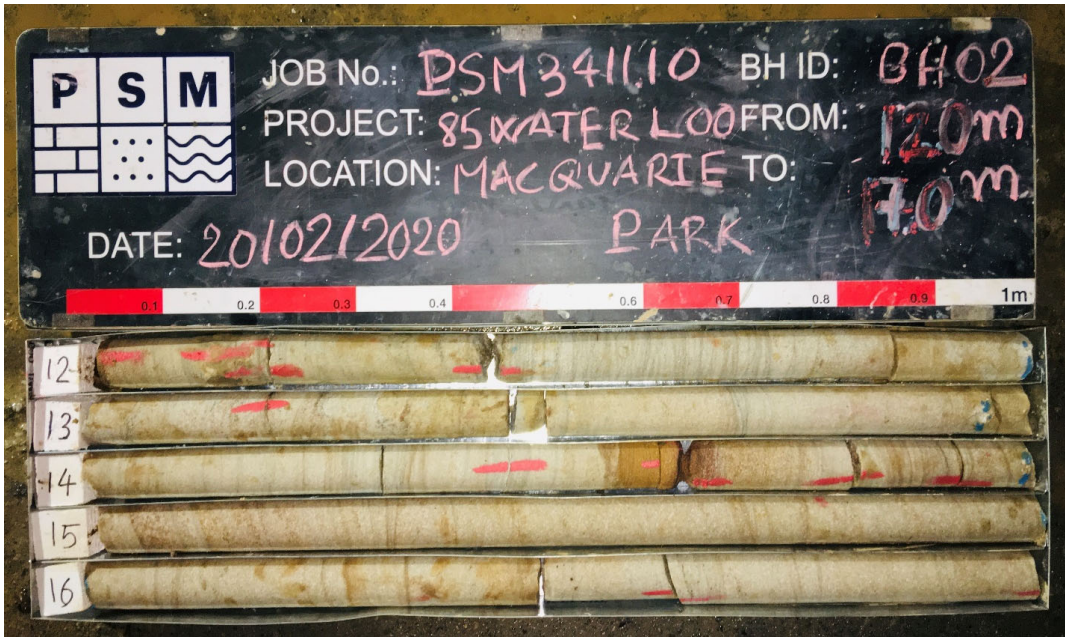
**Goodman**  
**85 Waterloo Road**  
**Macquarie Park, NSW**  
**GEOTECHNICAL INVESTIGATION**  
**CORE PHOTOGRAPHY - BH02\_(2)**

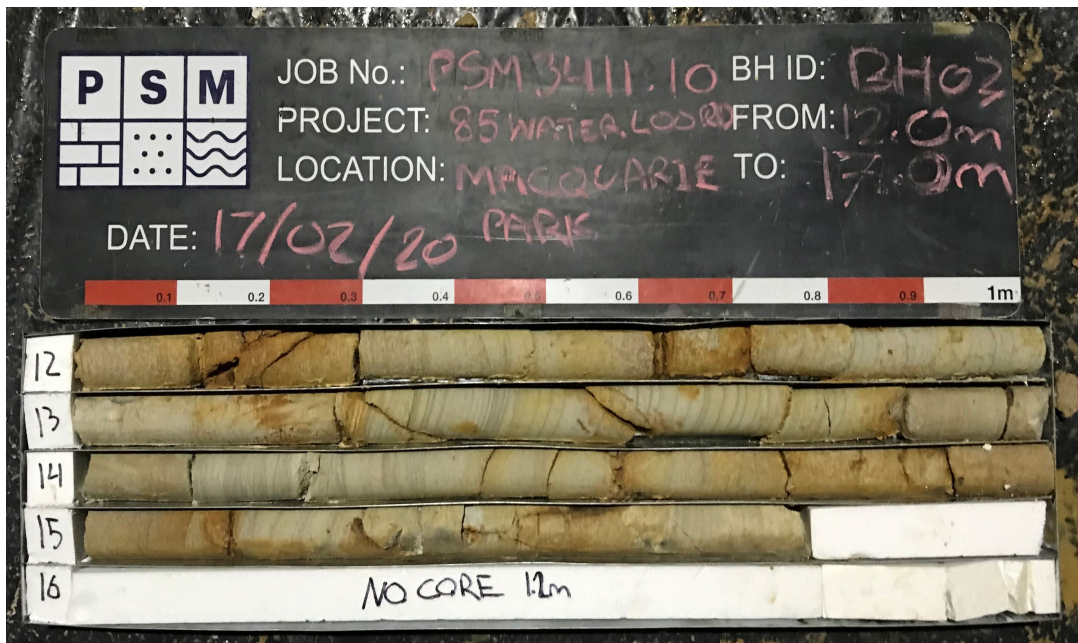
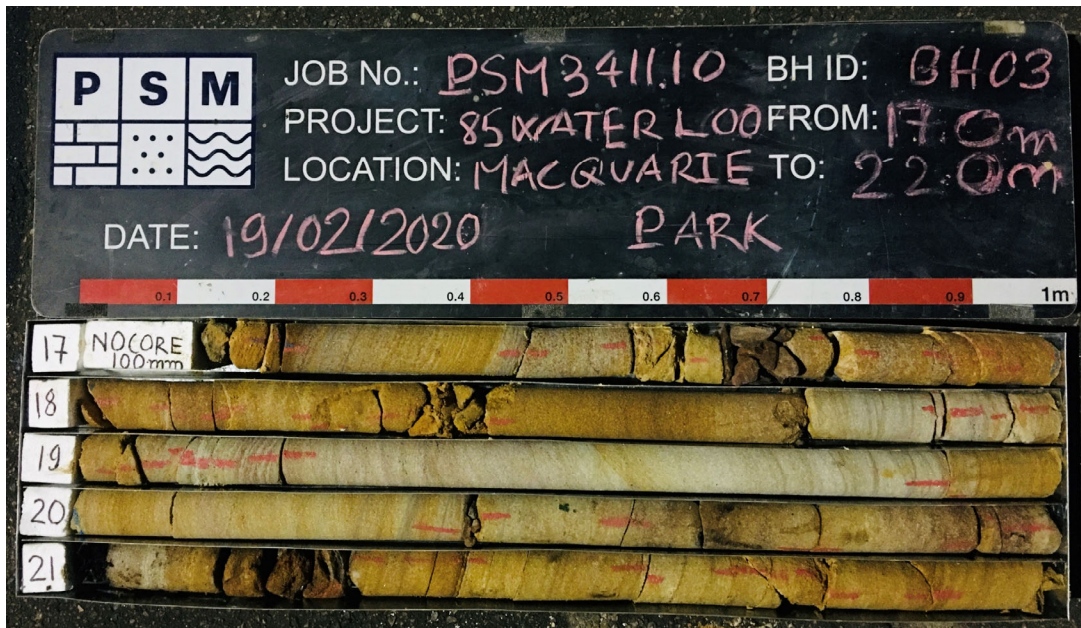
**Goodman**  
**85 Waterloo Road**  
**Macquarie Park, NSW**  
**GEOTECHNICAL INVESTIGATION**  
**CORE PHOTOGRAPHY - BH03\_(2)**

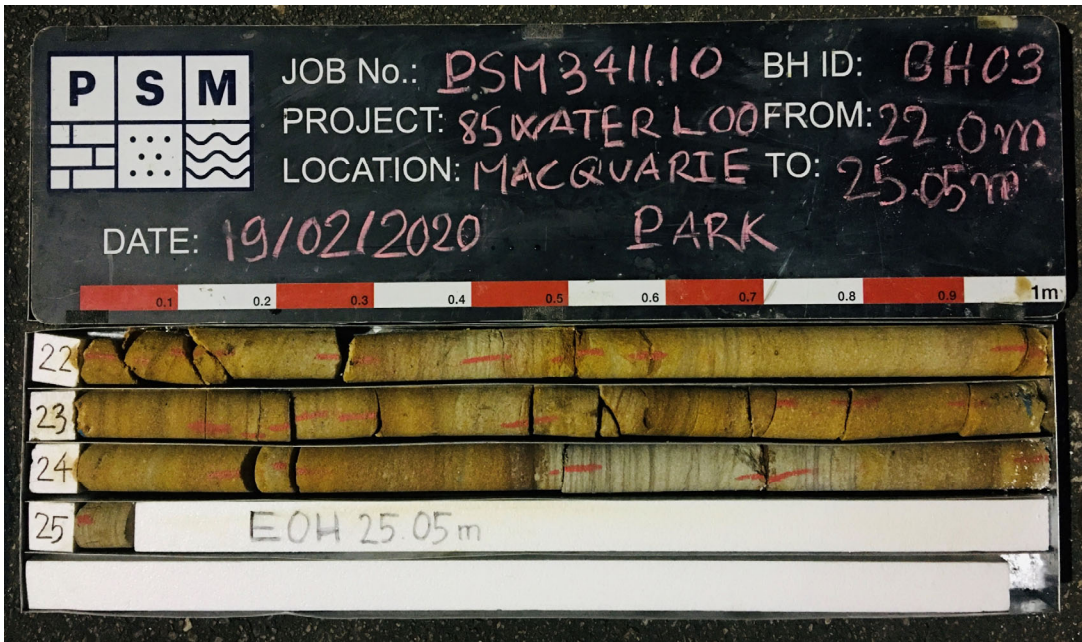
**Goodman**  
**85 Waterloo Road**  
**Macquarie Park, NSW**  
**GEOTECHNICAL INVESTIGATION**  
**CORE PHOTOGRAPHY - BH03\_(3)**

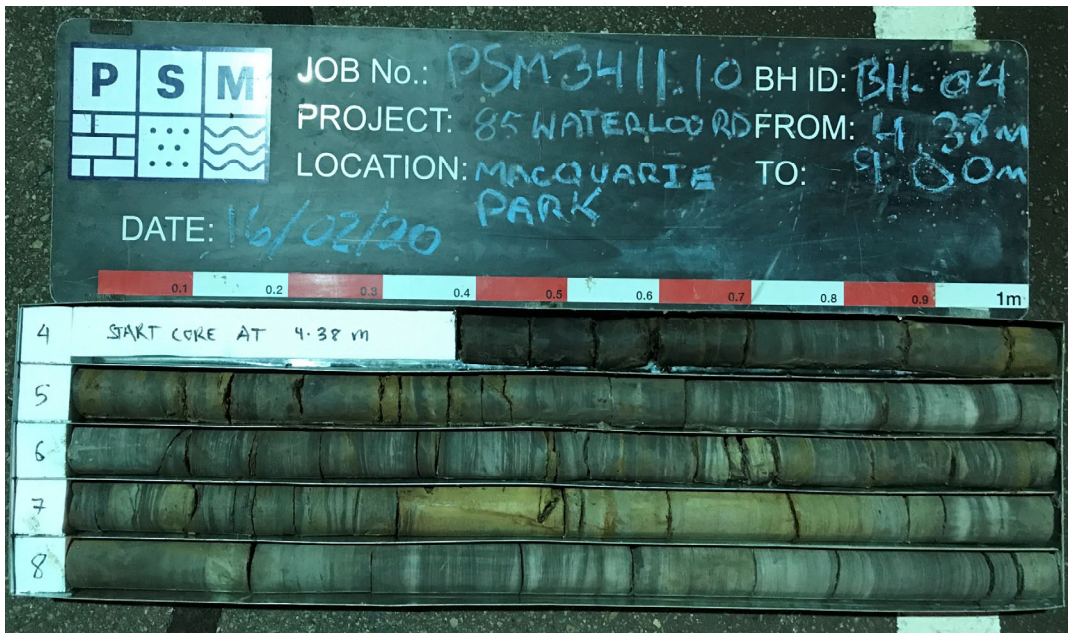
<b>Goodman</b> <b>85 Waterloo Road</b> <b>Macquarie Park, NSW</b> <b>GEOTECHNICAL INVESTIGATION</b> <b>CORE PHOTOGRAPHY - BH04_(1)</b>	
PSM3411-104L	Appendix B

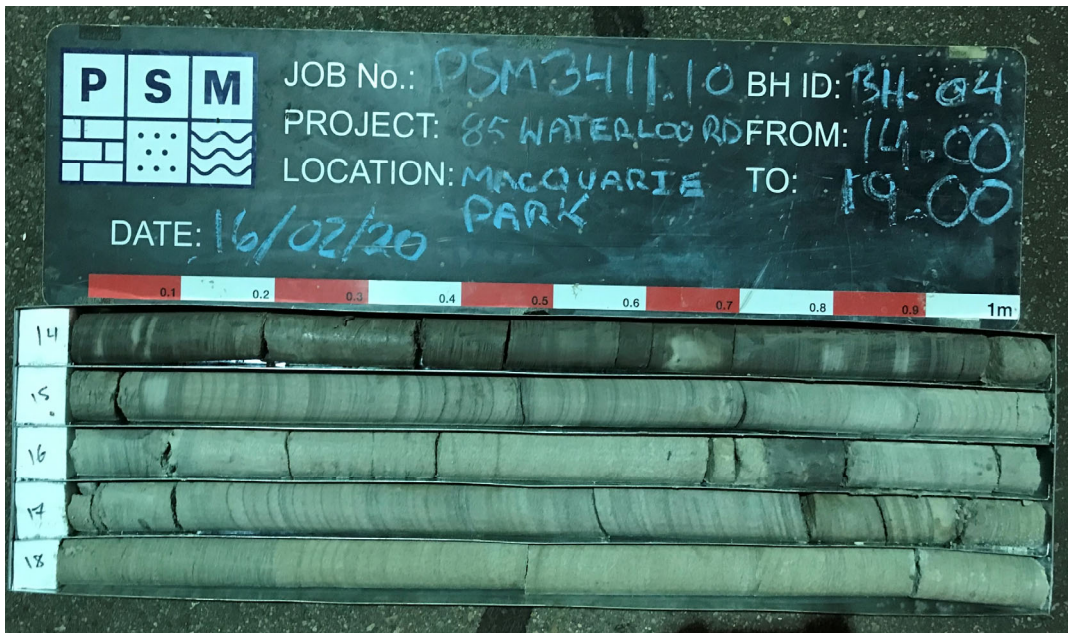
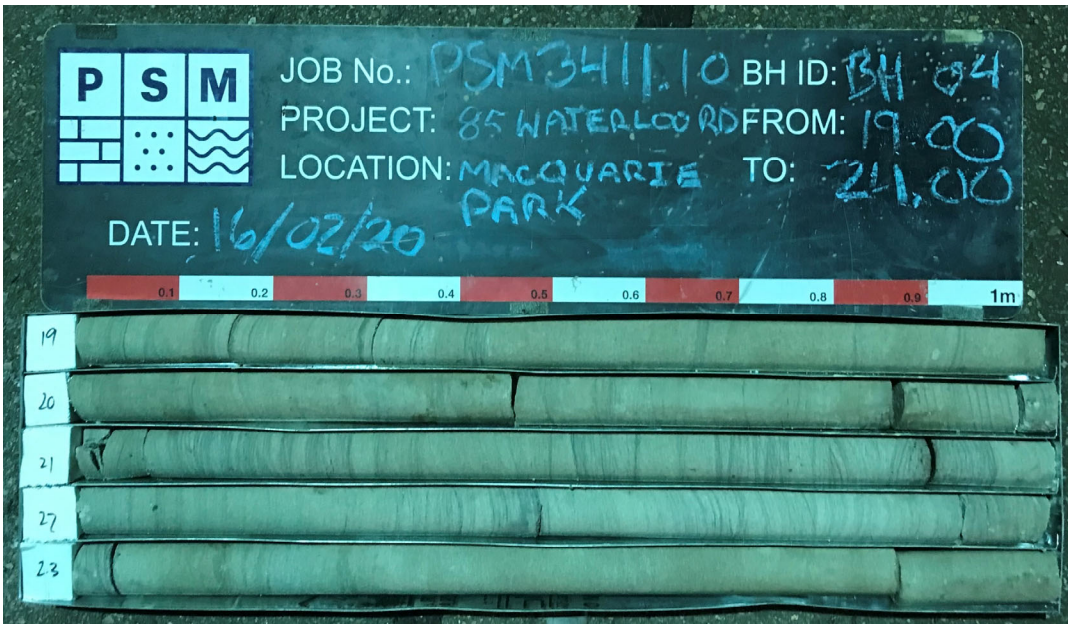
Goodman  
 85 Waterloo Road  
 Macquarie Park, NSW  
 GEOTECHNICAL INVESTIGATION  
 CORE PHOTOGRAPHY - BH04\_(2)

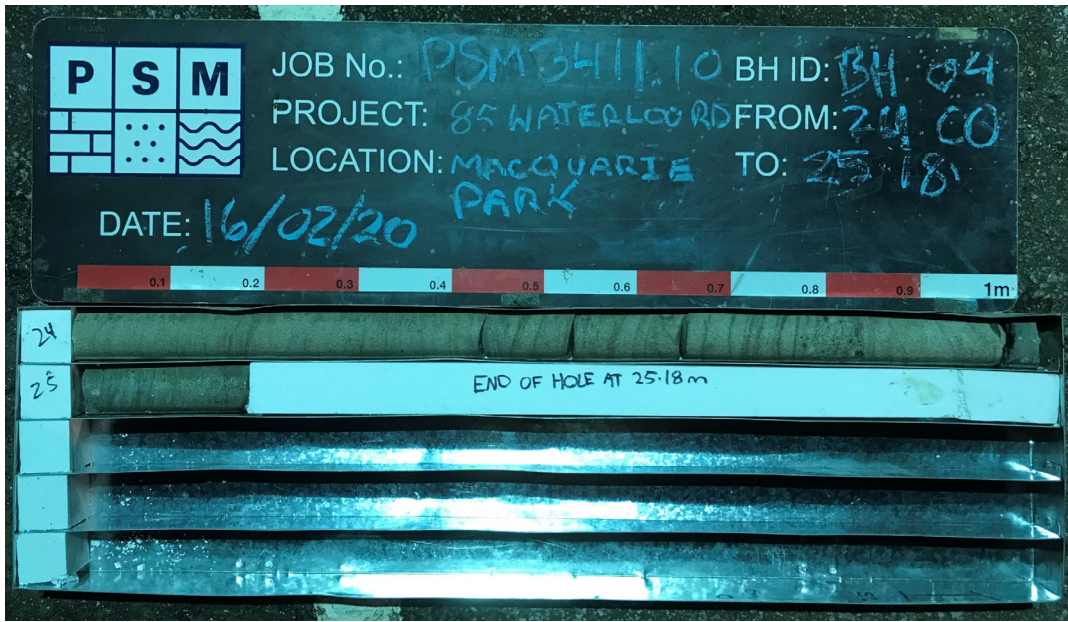
<b>Goodman</b> <b>85 Waterloo Road</b> <b>Macquarie Park, NSW</b> <b>GEOTECHNICAL INVESTIGATION</b> <b>CORE PHOTOGRAPHY - BH04_(3)</b>	
PSM3411-104L	Appendix B
