Waste Management Facility, 2-4 Hale St, Botany Landscape Concept Design Report

Arboricultural Impact Assessment and Management Plan

2-4 Hale Street, Botany.

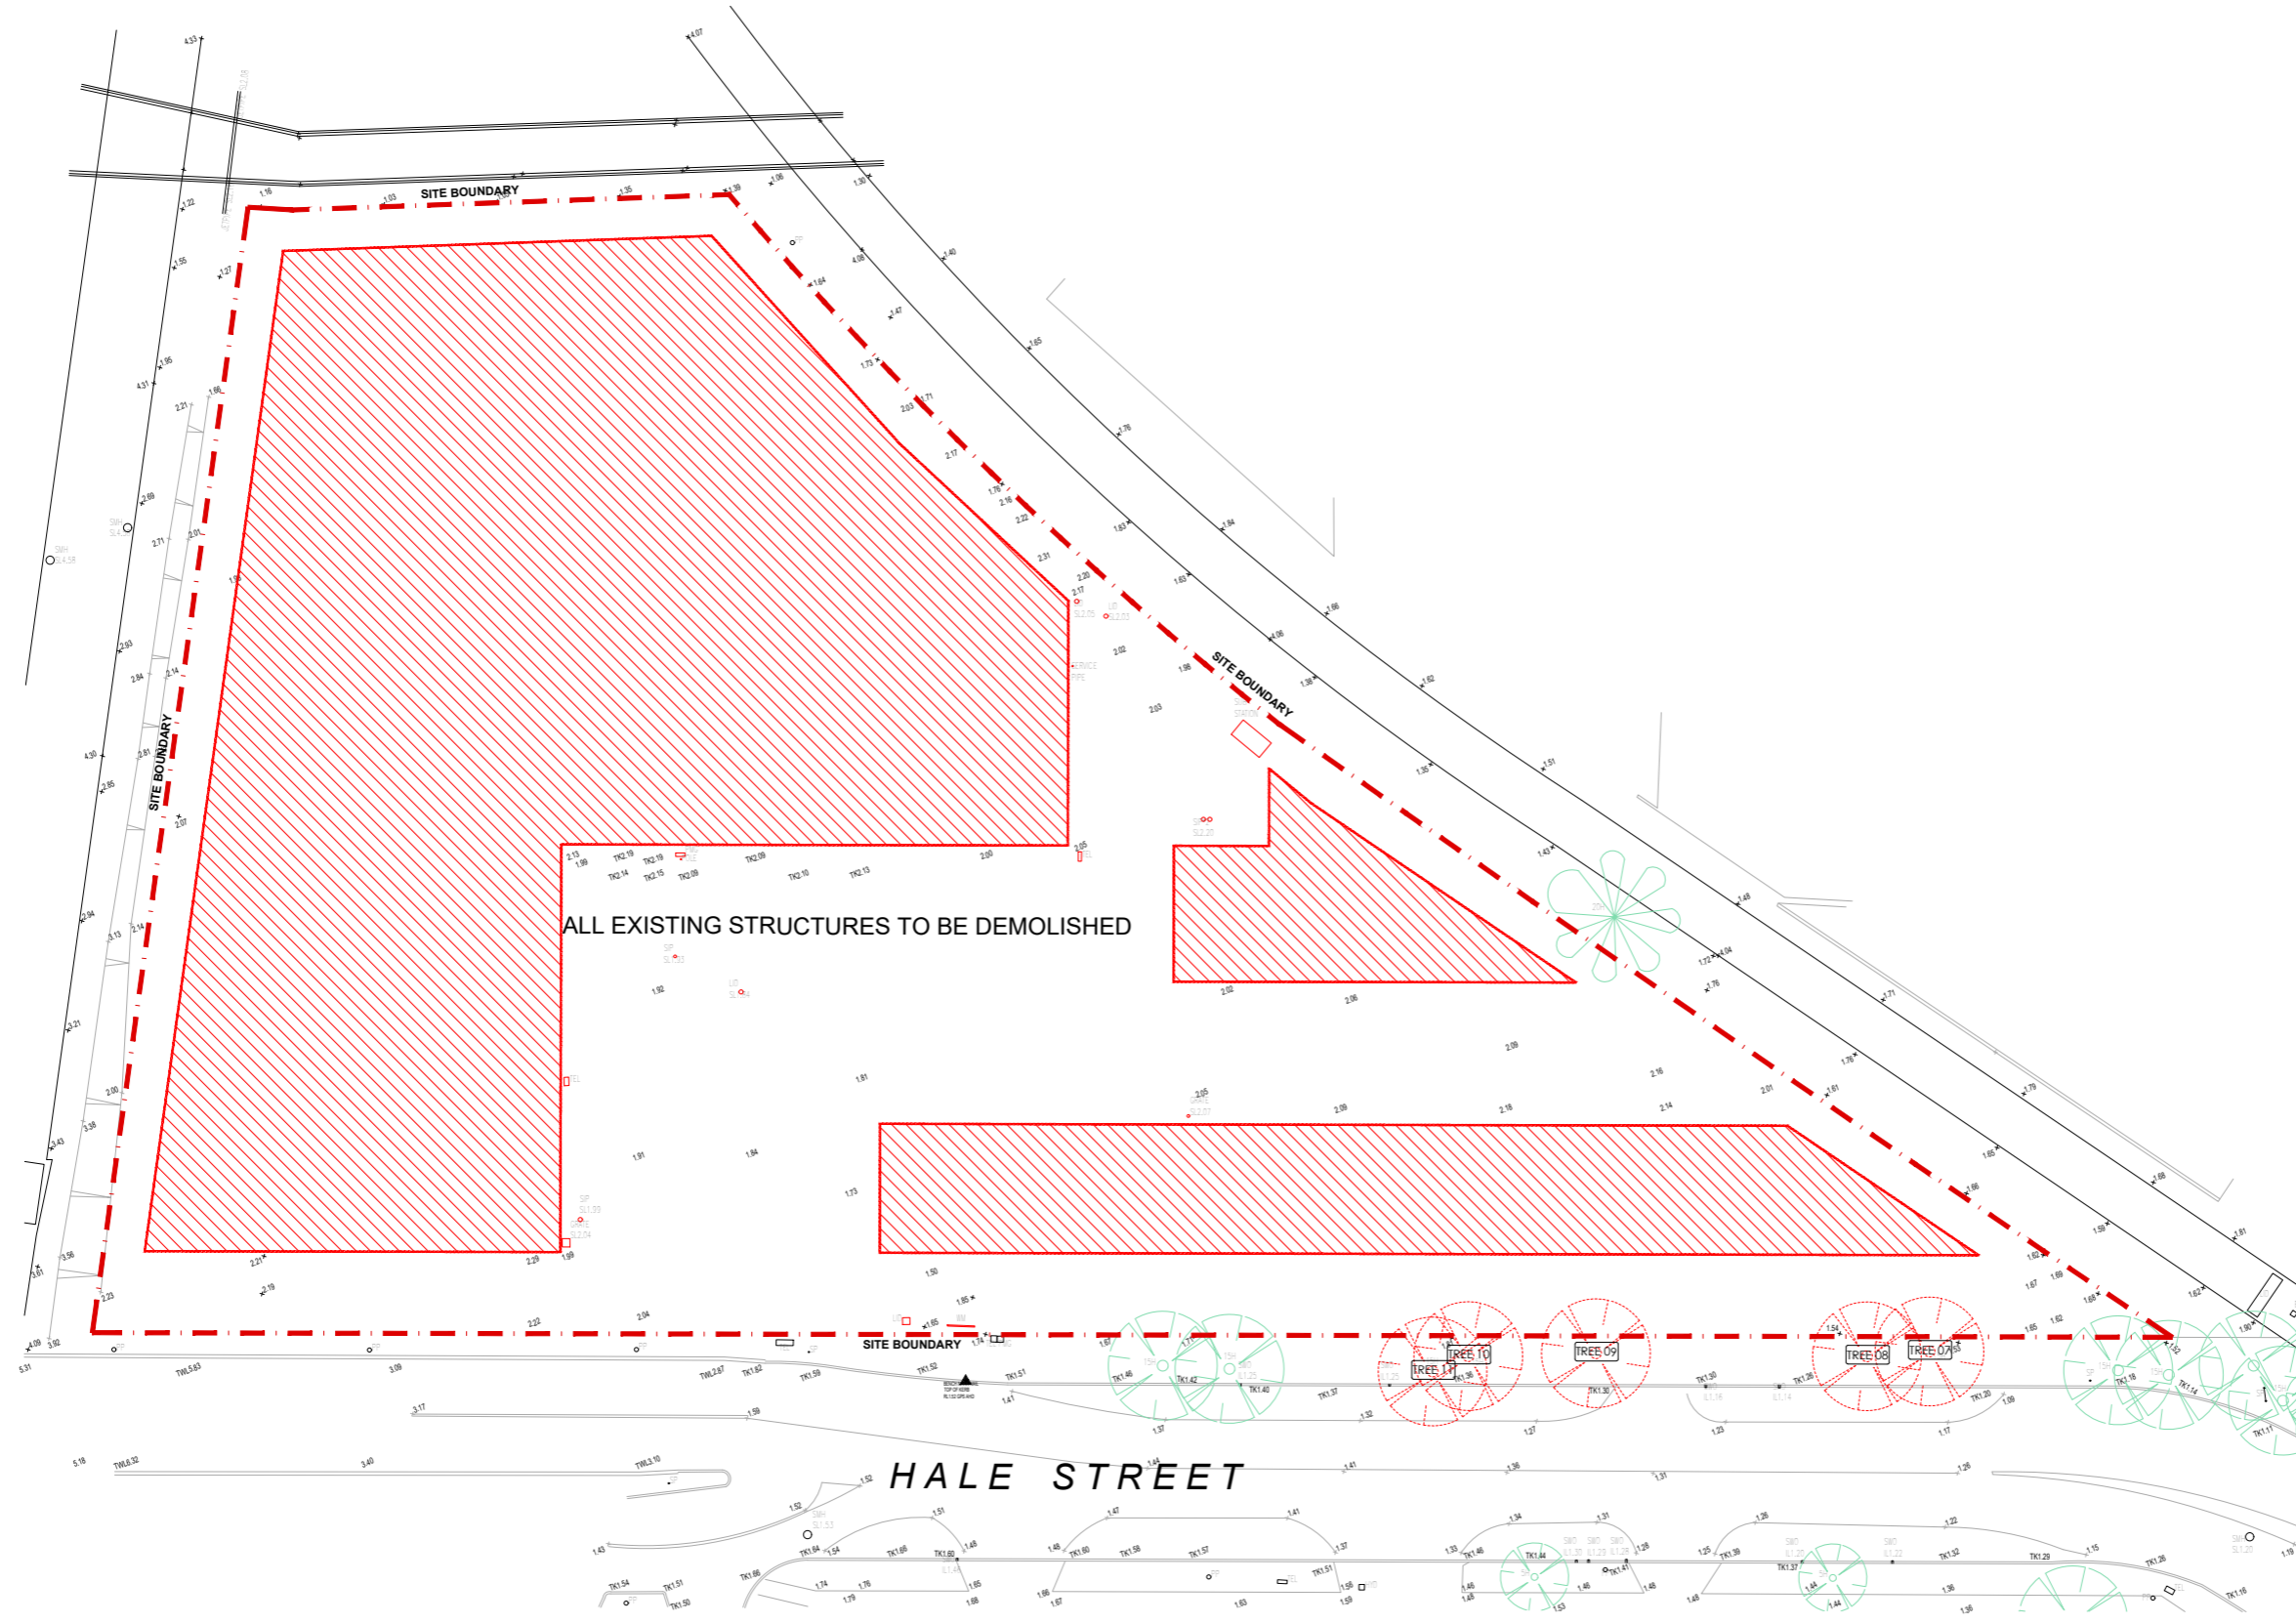
ALL EXISTING STRUCTURES TO BE DEMOLISHED

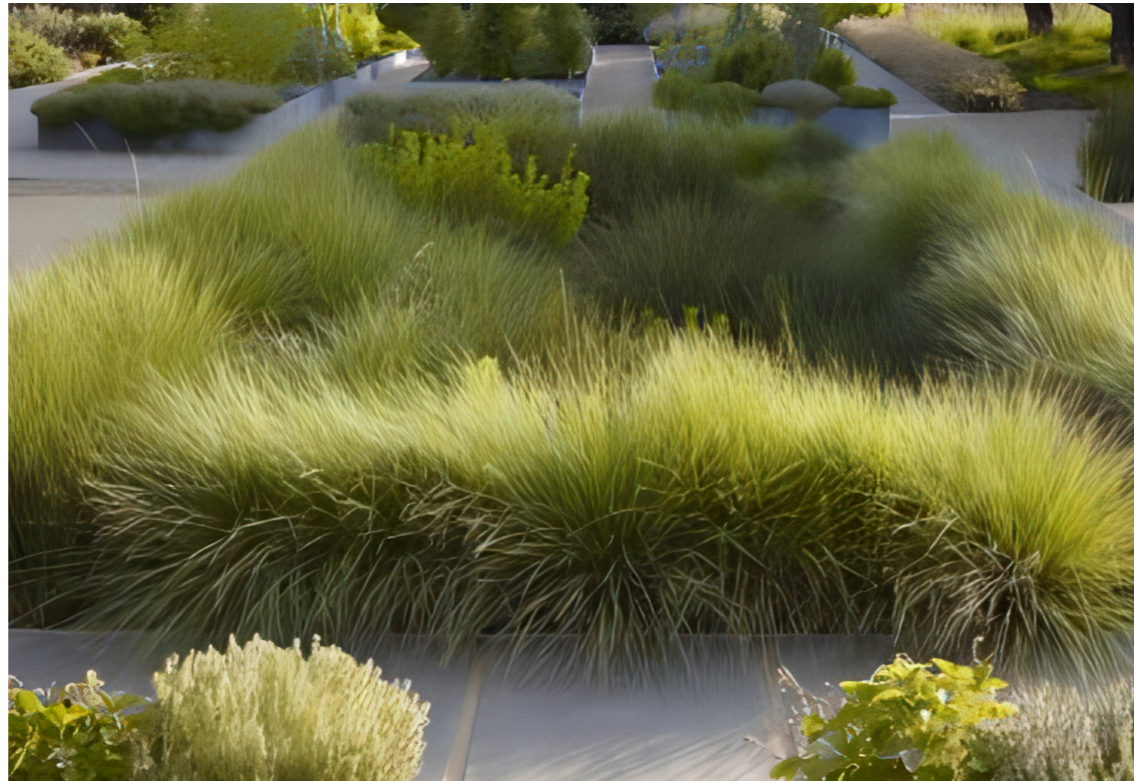
Reference image showing modest scale raingarden of hardy Indigenous plants to filter silt, nutrient & particulates before entering the storm water systems.

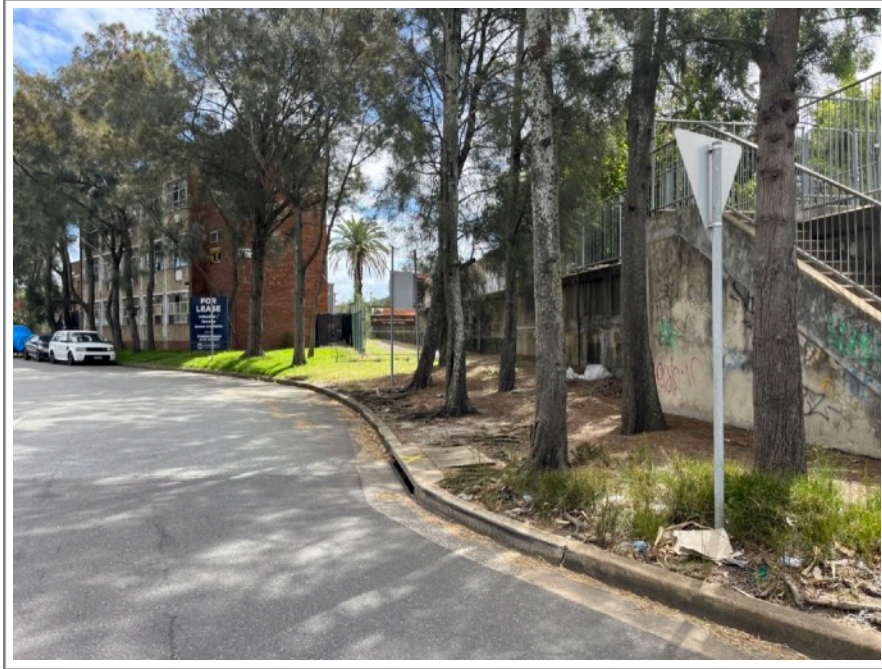
Figure 2 Shows the extent of the stand of She Oaks documented.

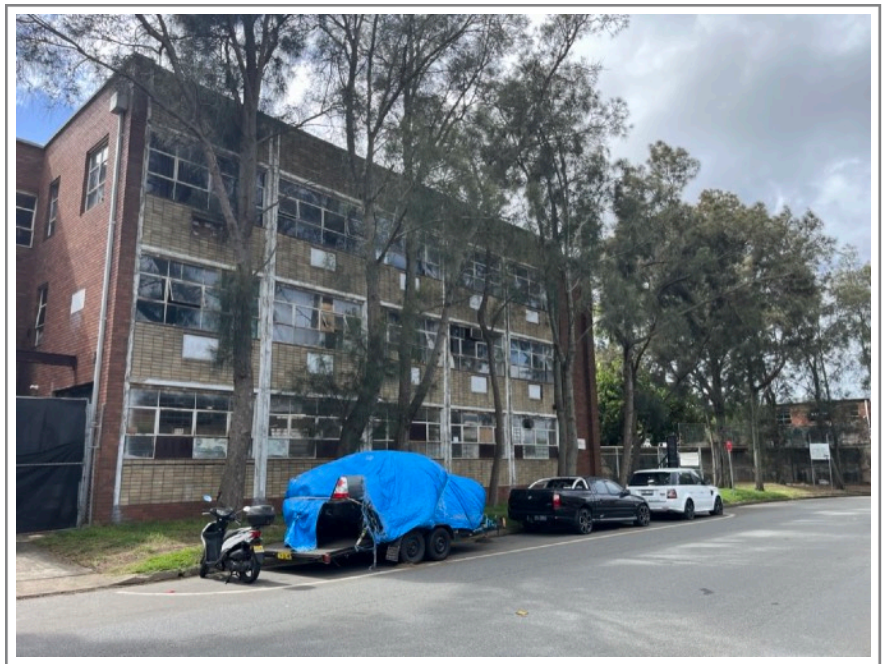
Figure 3 Shows part of the stand required for removal to allow vehicular access.

5.1 The reconfiguration of the proposed vehicular entrance is required to improve both pedestrian and vehicular access to the site. The affected trees are part of a stand of She oaks that appear to have been planted too close to each other. This has resulted in compromised growth and undermined the arboricultural contribution of the stand as a whole. The proposed removals will improve both growing conditions and the visual amenity of the broader stand.

6.1 It will be recommended that Trees 3, 4 and 5 be removed due to poor structure irrespective of the impacts of the proposed. Trees 7, 8, 9, 10 and 11 are recommended for removal to allow for the proposed driveway reconfiguration.

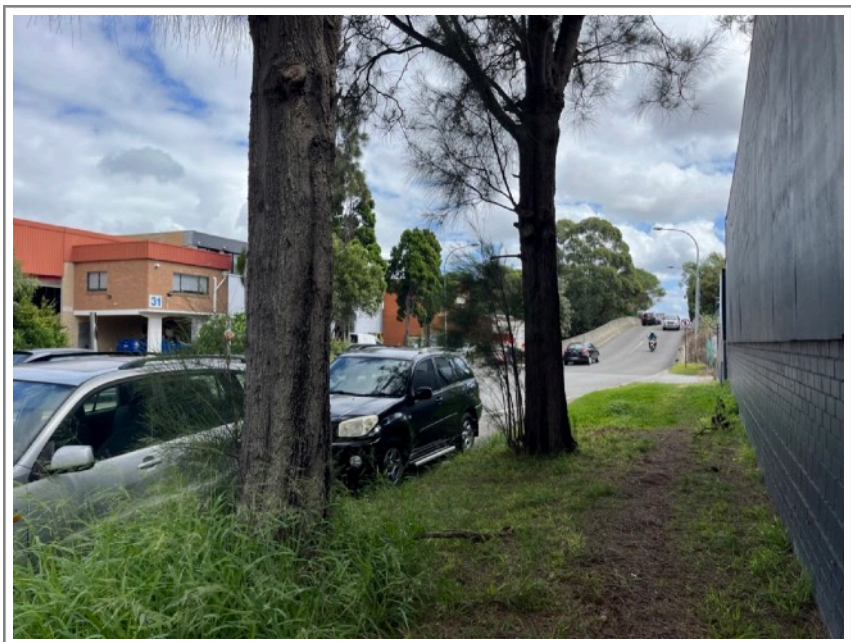
Figure 4 Shows the locations of Trees 12 and 13. Both documented for retention.
