## **Groundwater Inflow Assessment**

### **Sports and Aquatic Centre**

**84, 86 and 90-98 The Bouldevarde,  
Strathfield NSW**

**Project 224188.09**

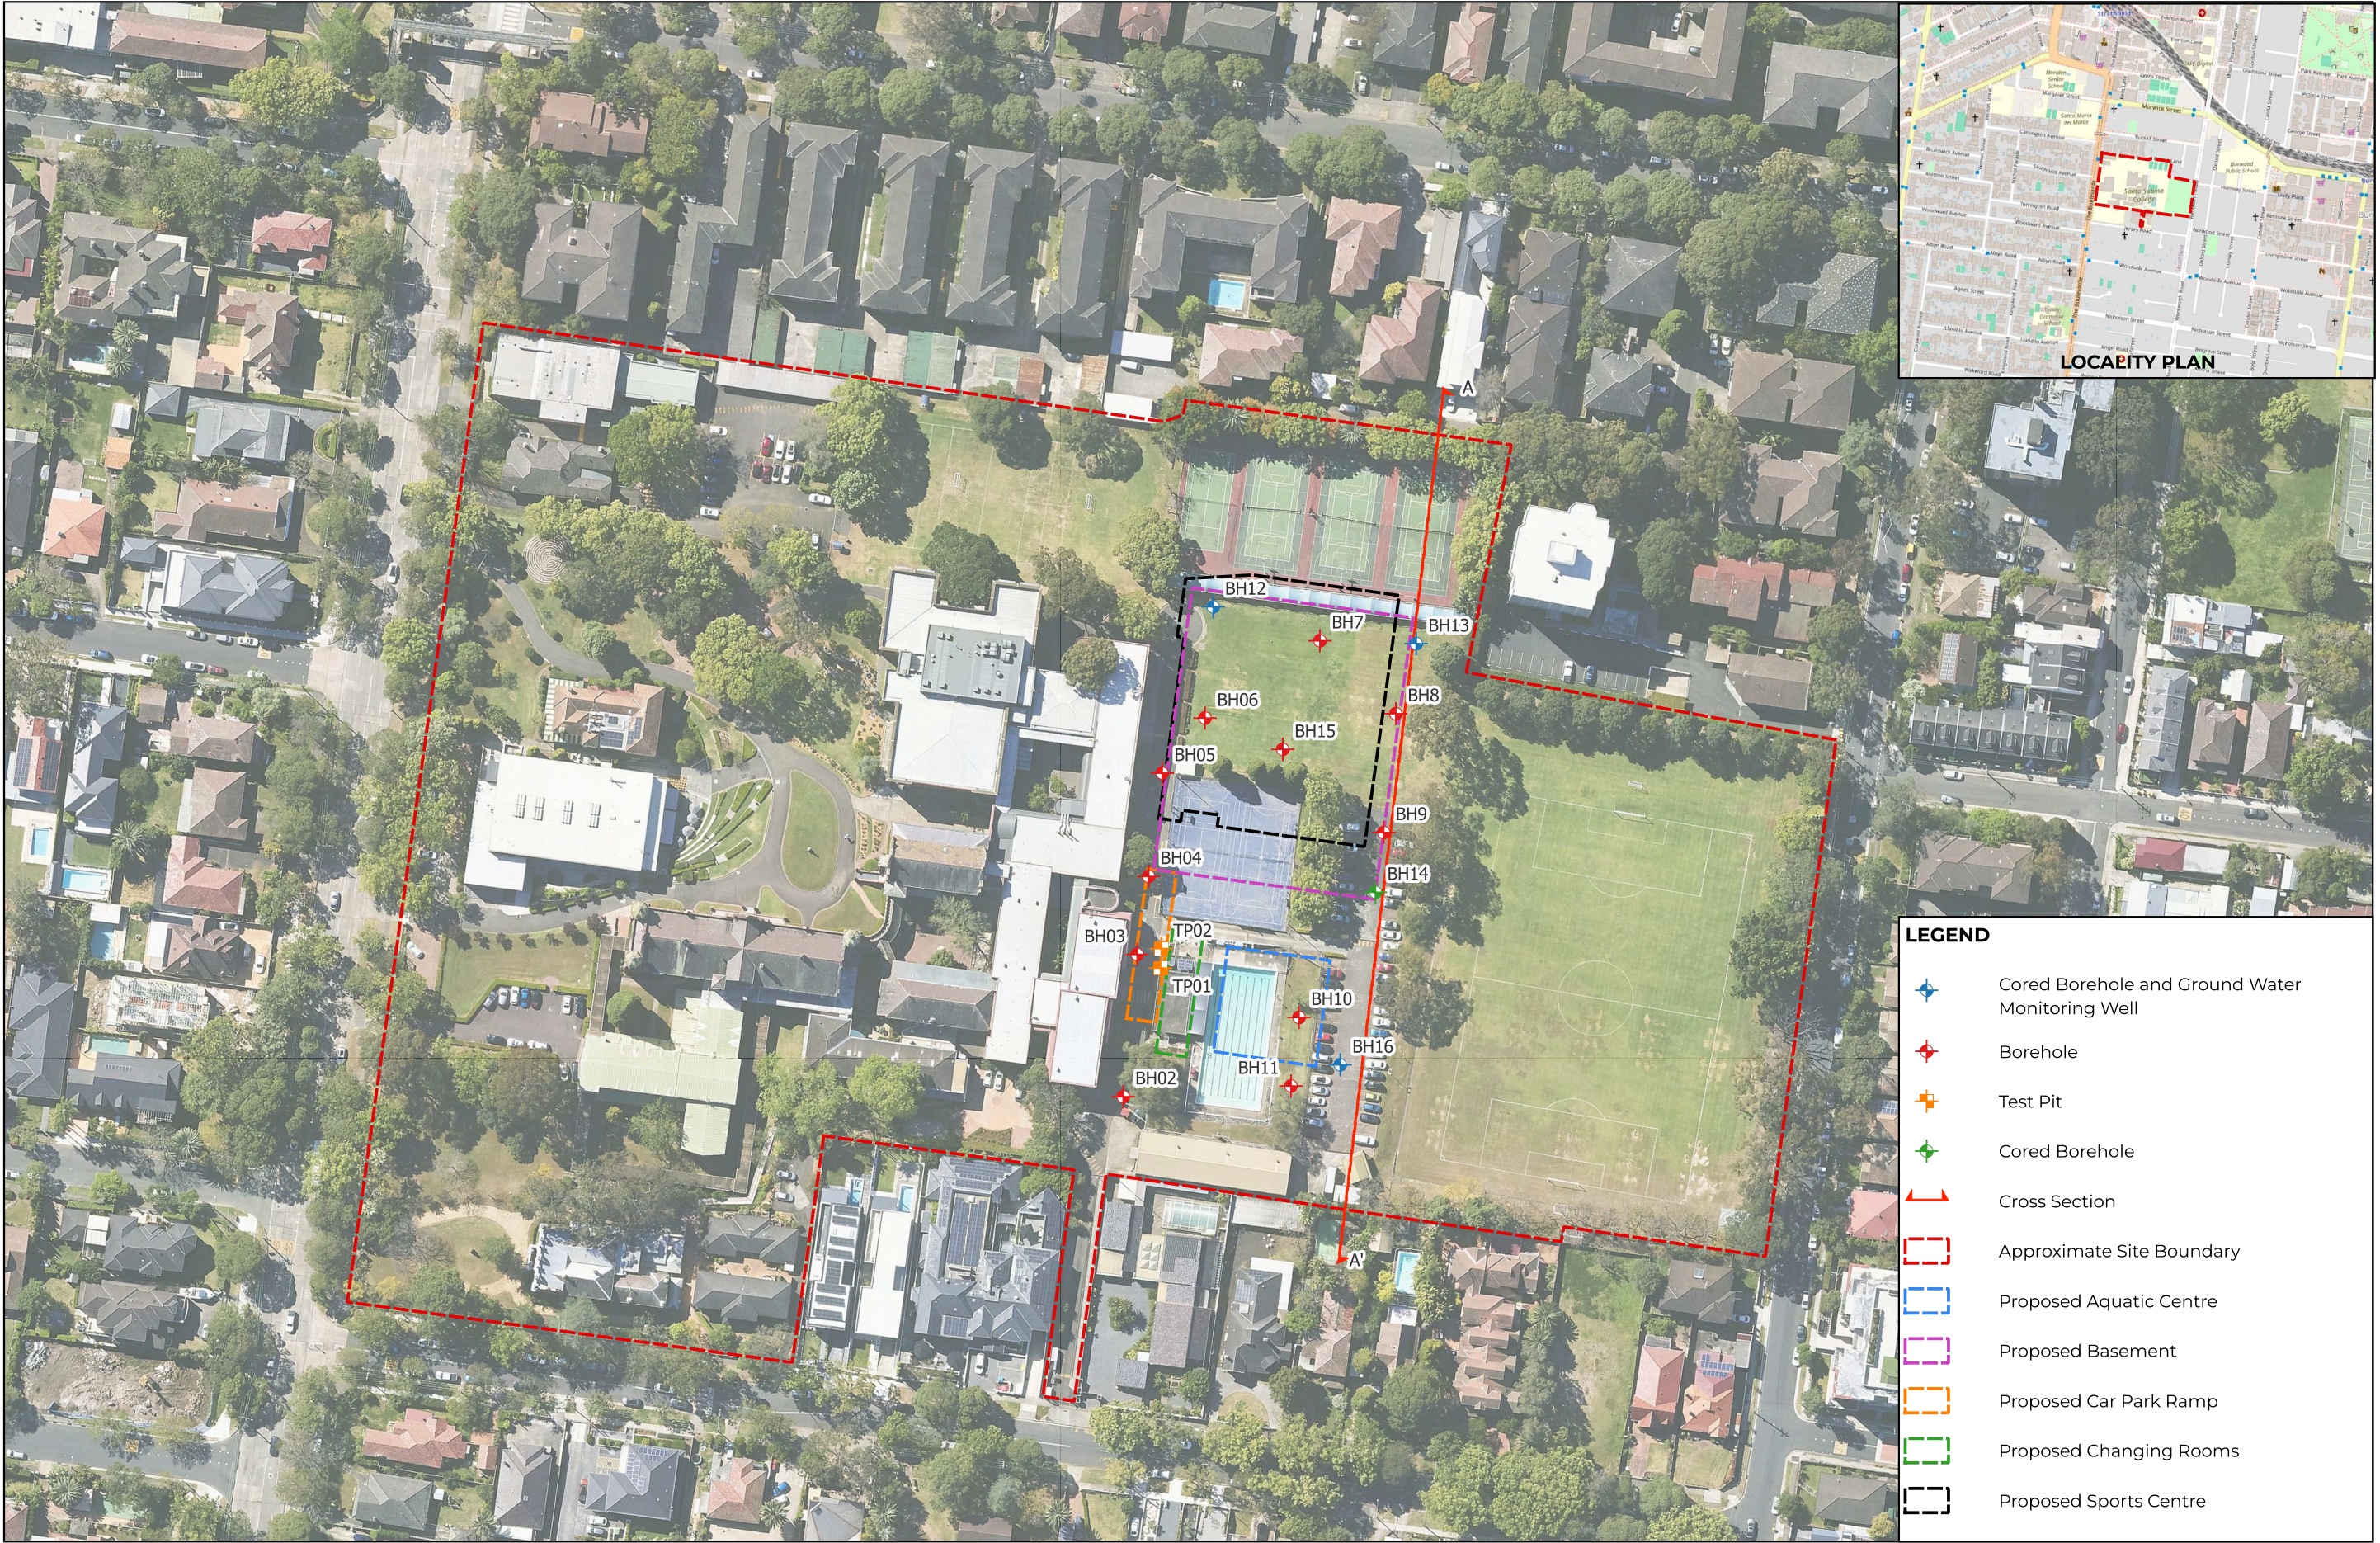
Details of the subsurface conditions encountered are given in the borehole logs within the above-mentioned geotechnical report. The test locations are shown in Drawing 1 (Appendix B).
