105 Miller St

Heritage Presentation

Investa

May 2025

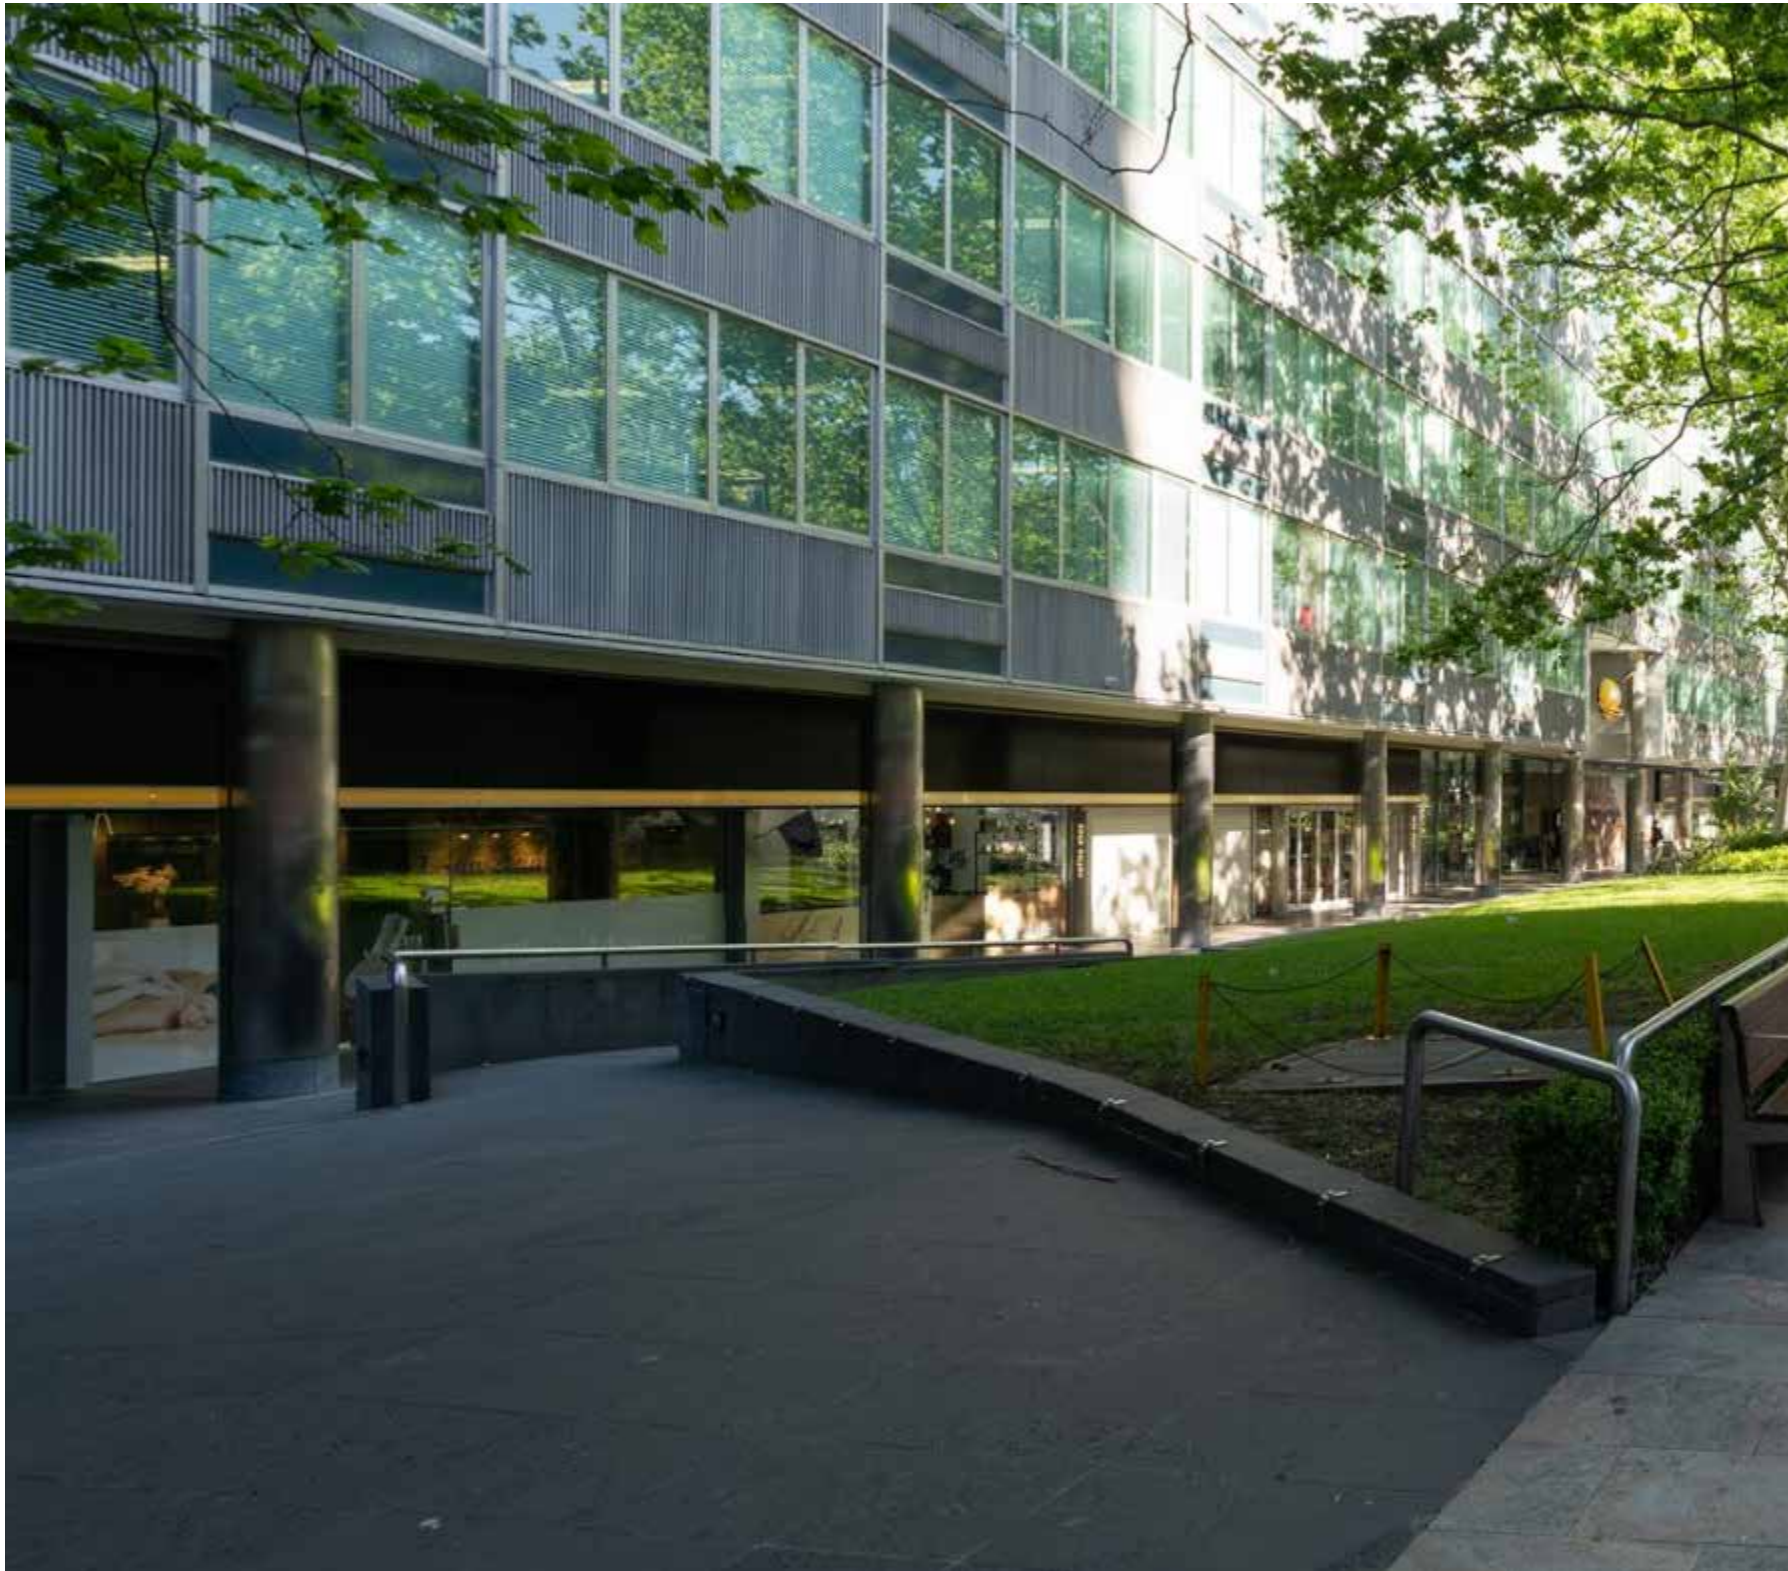
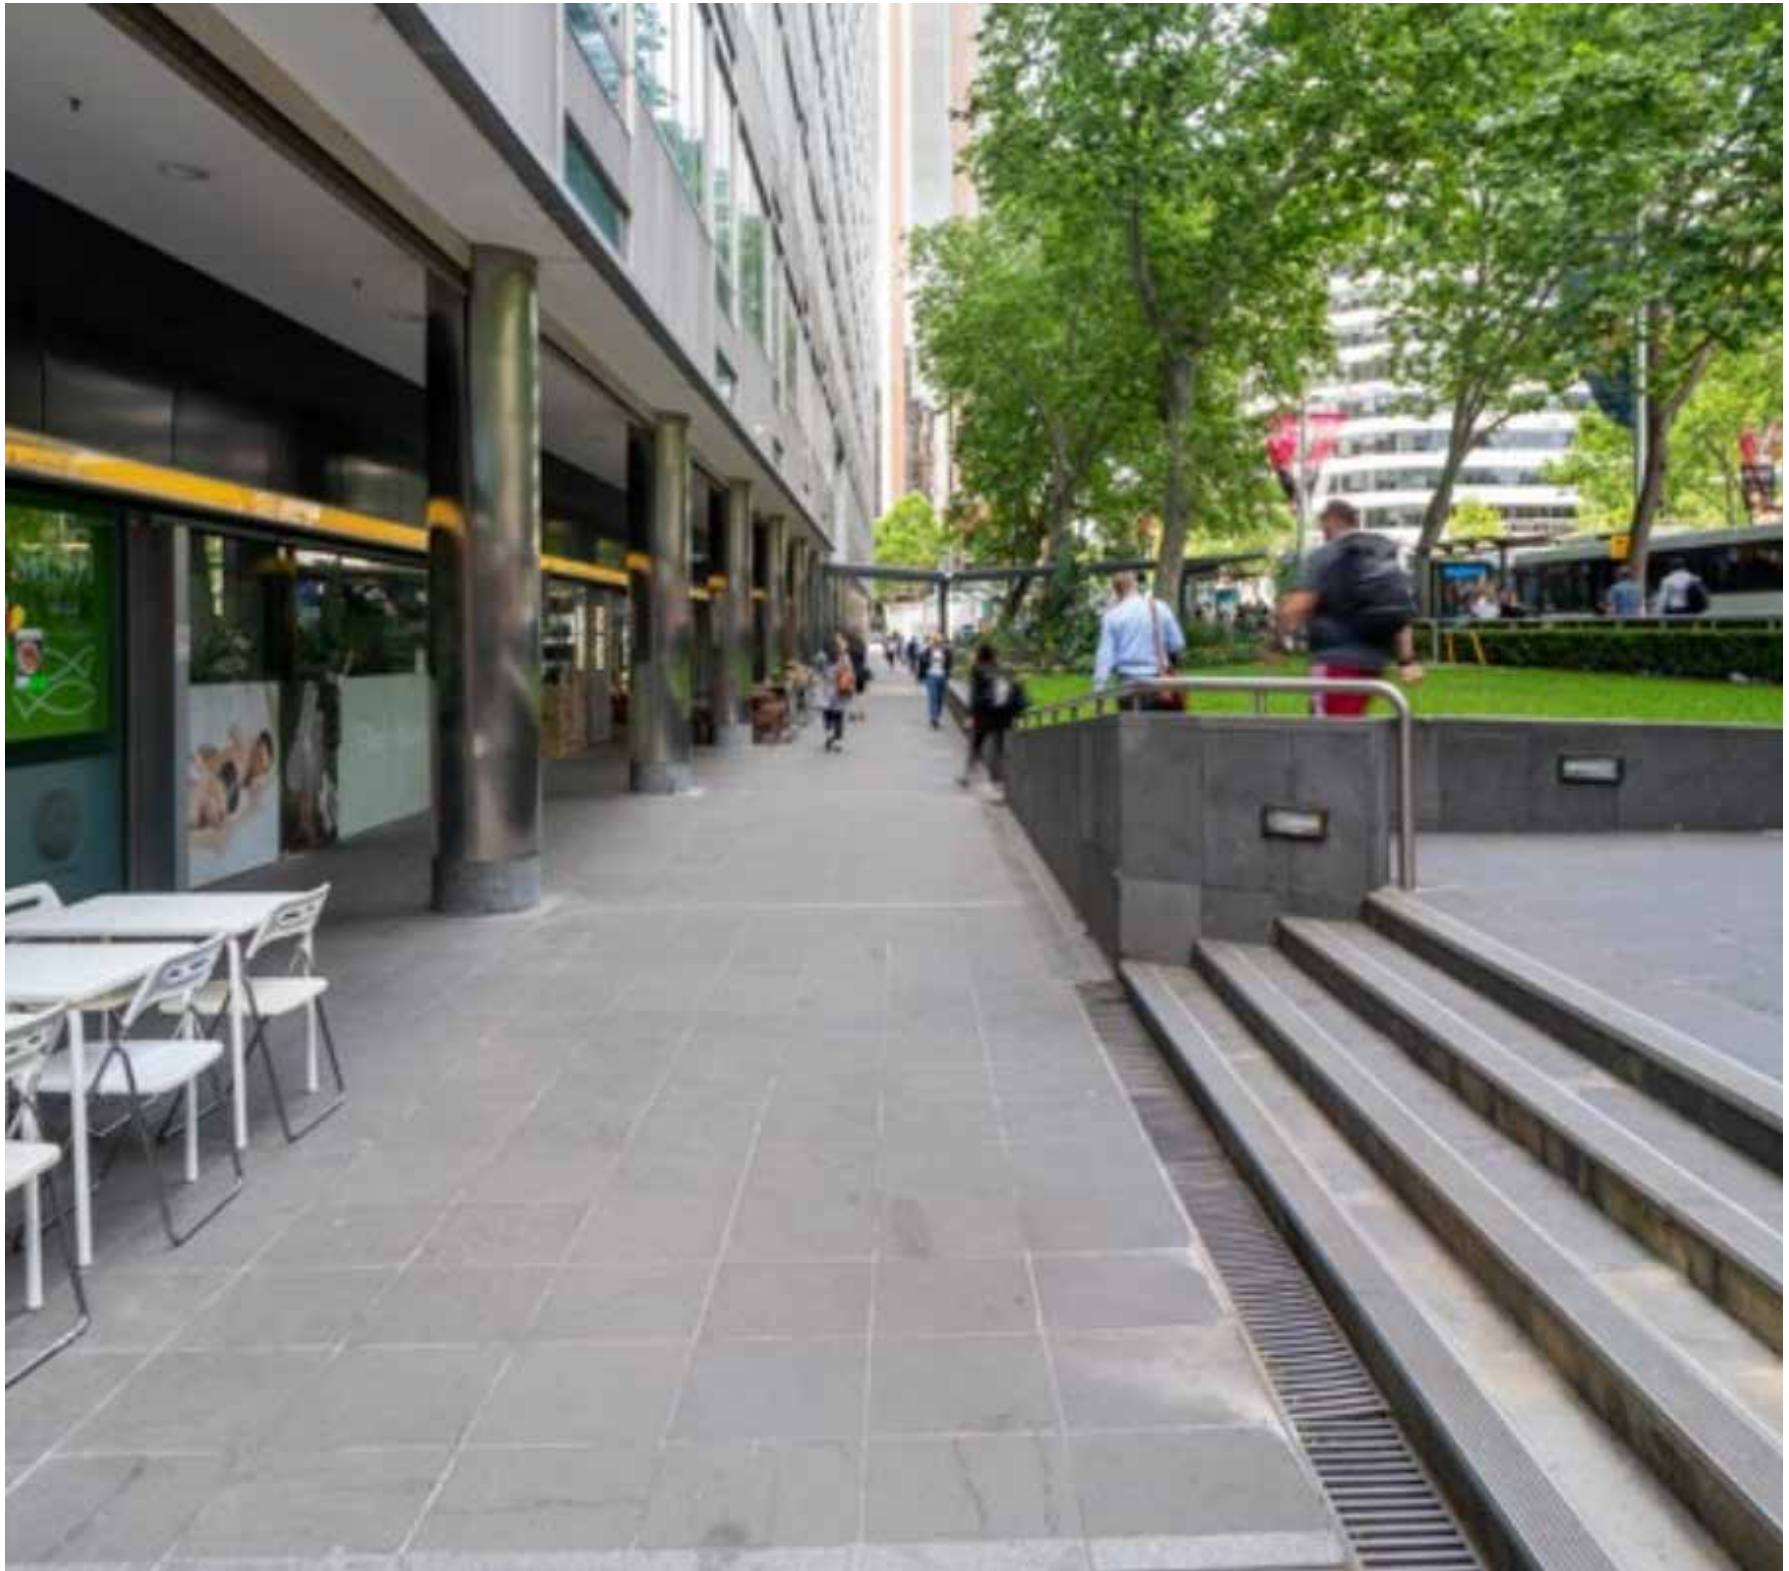
Miller Street Challenges

- Currently the Miller Street Special Area falls towards the building creating a sunken retail colonnade
- There are issues with accessibility, street activation and overland flow

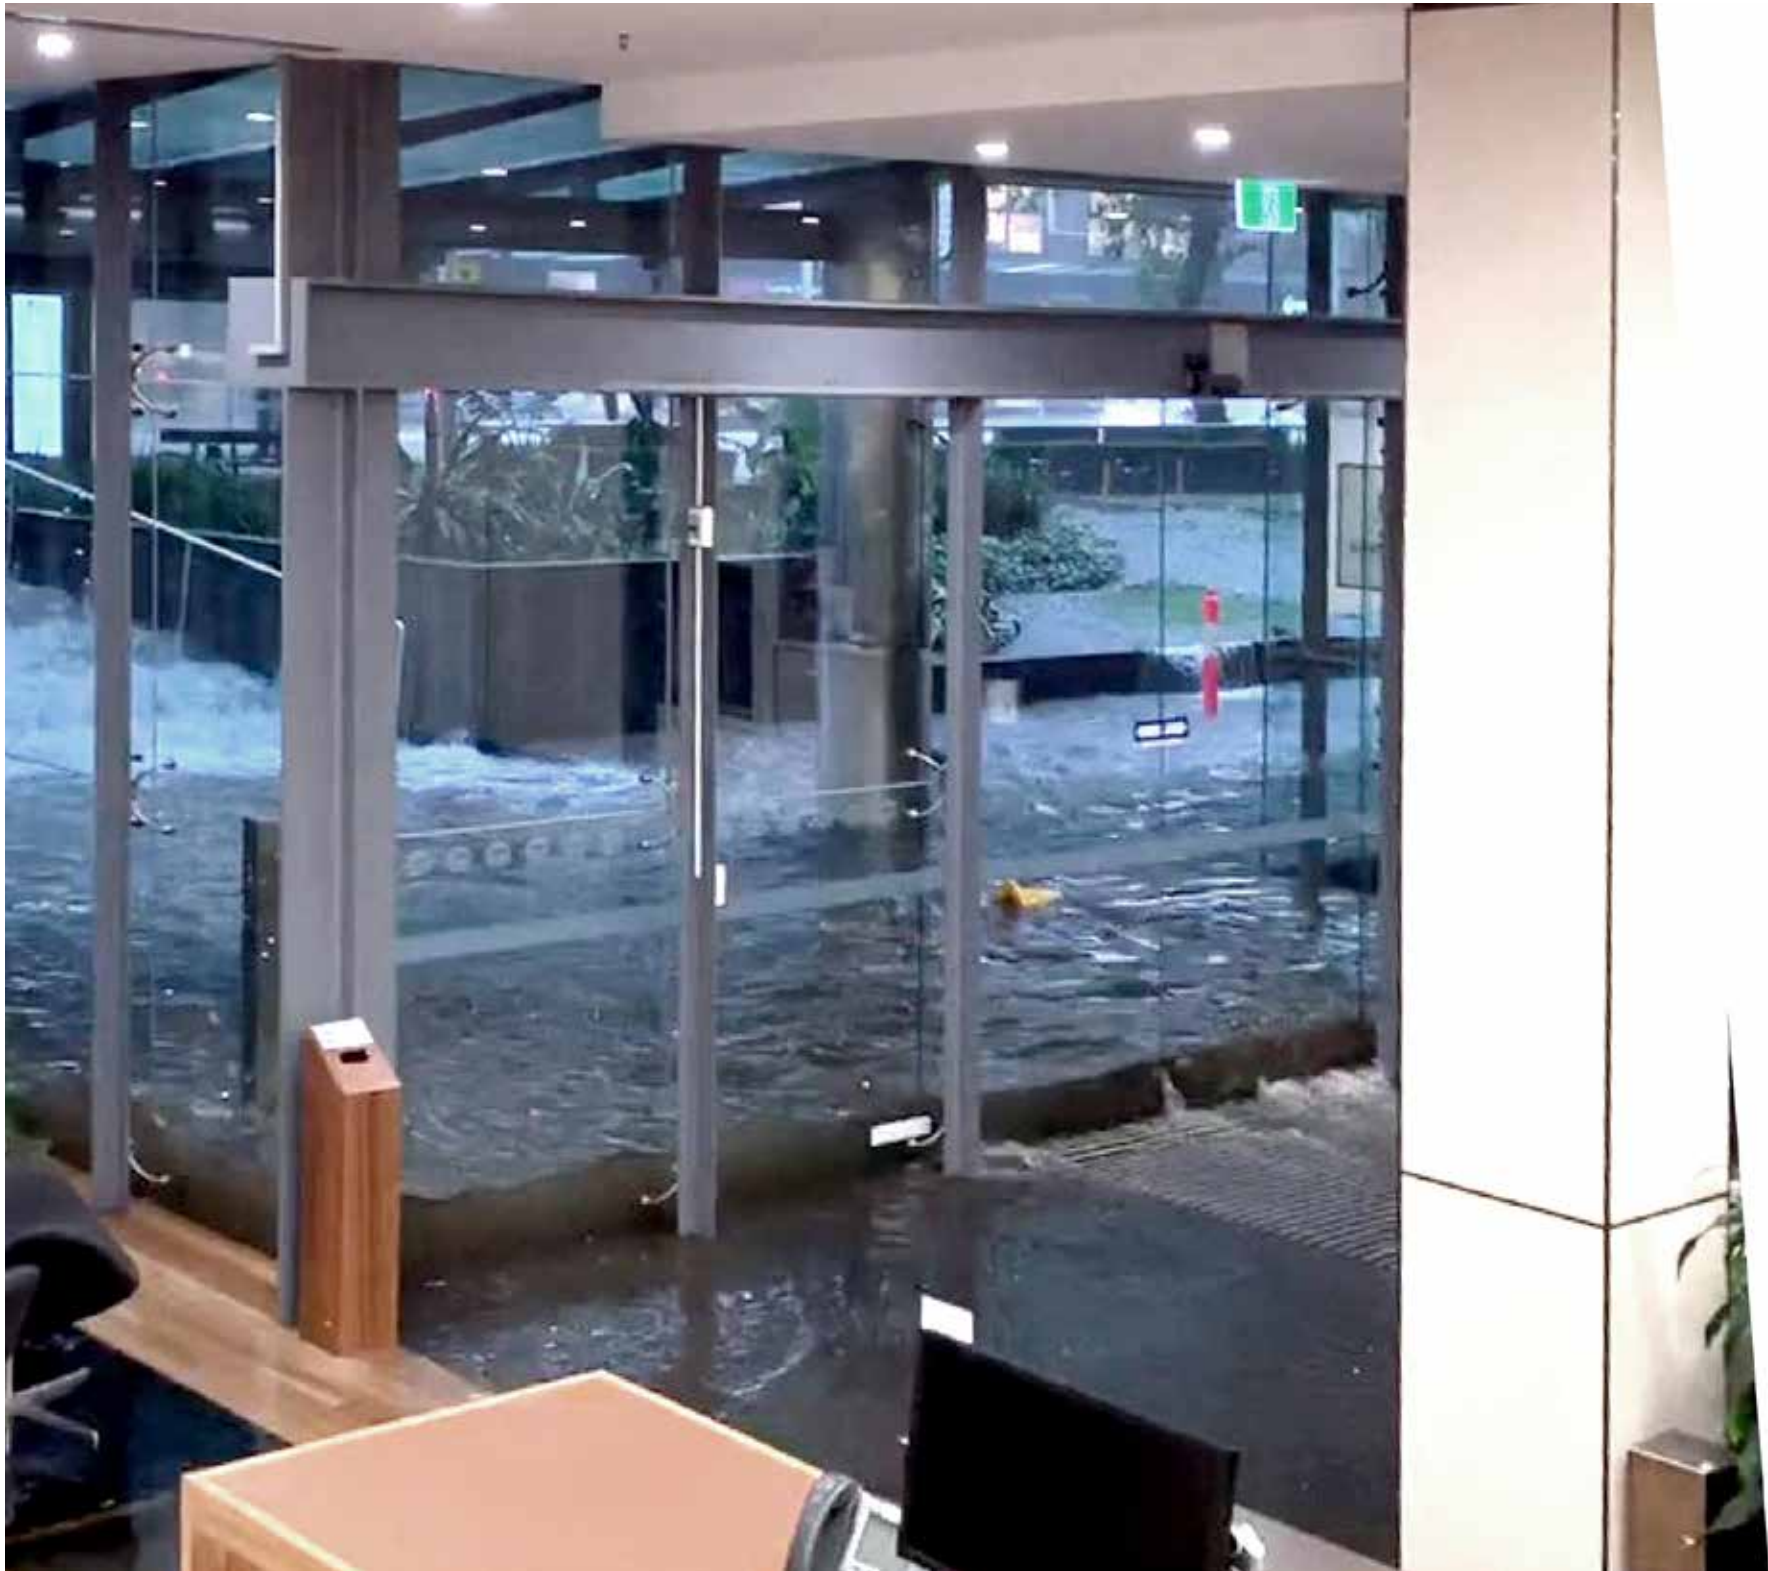
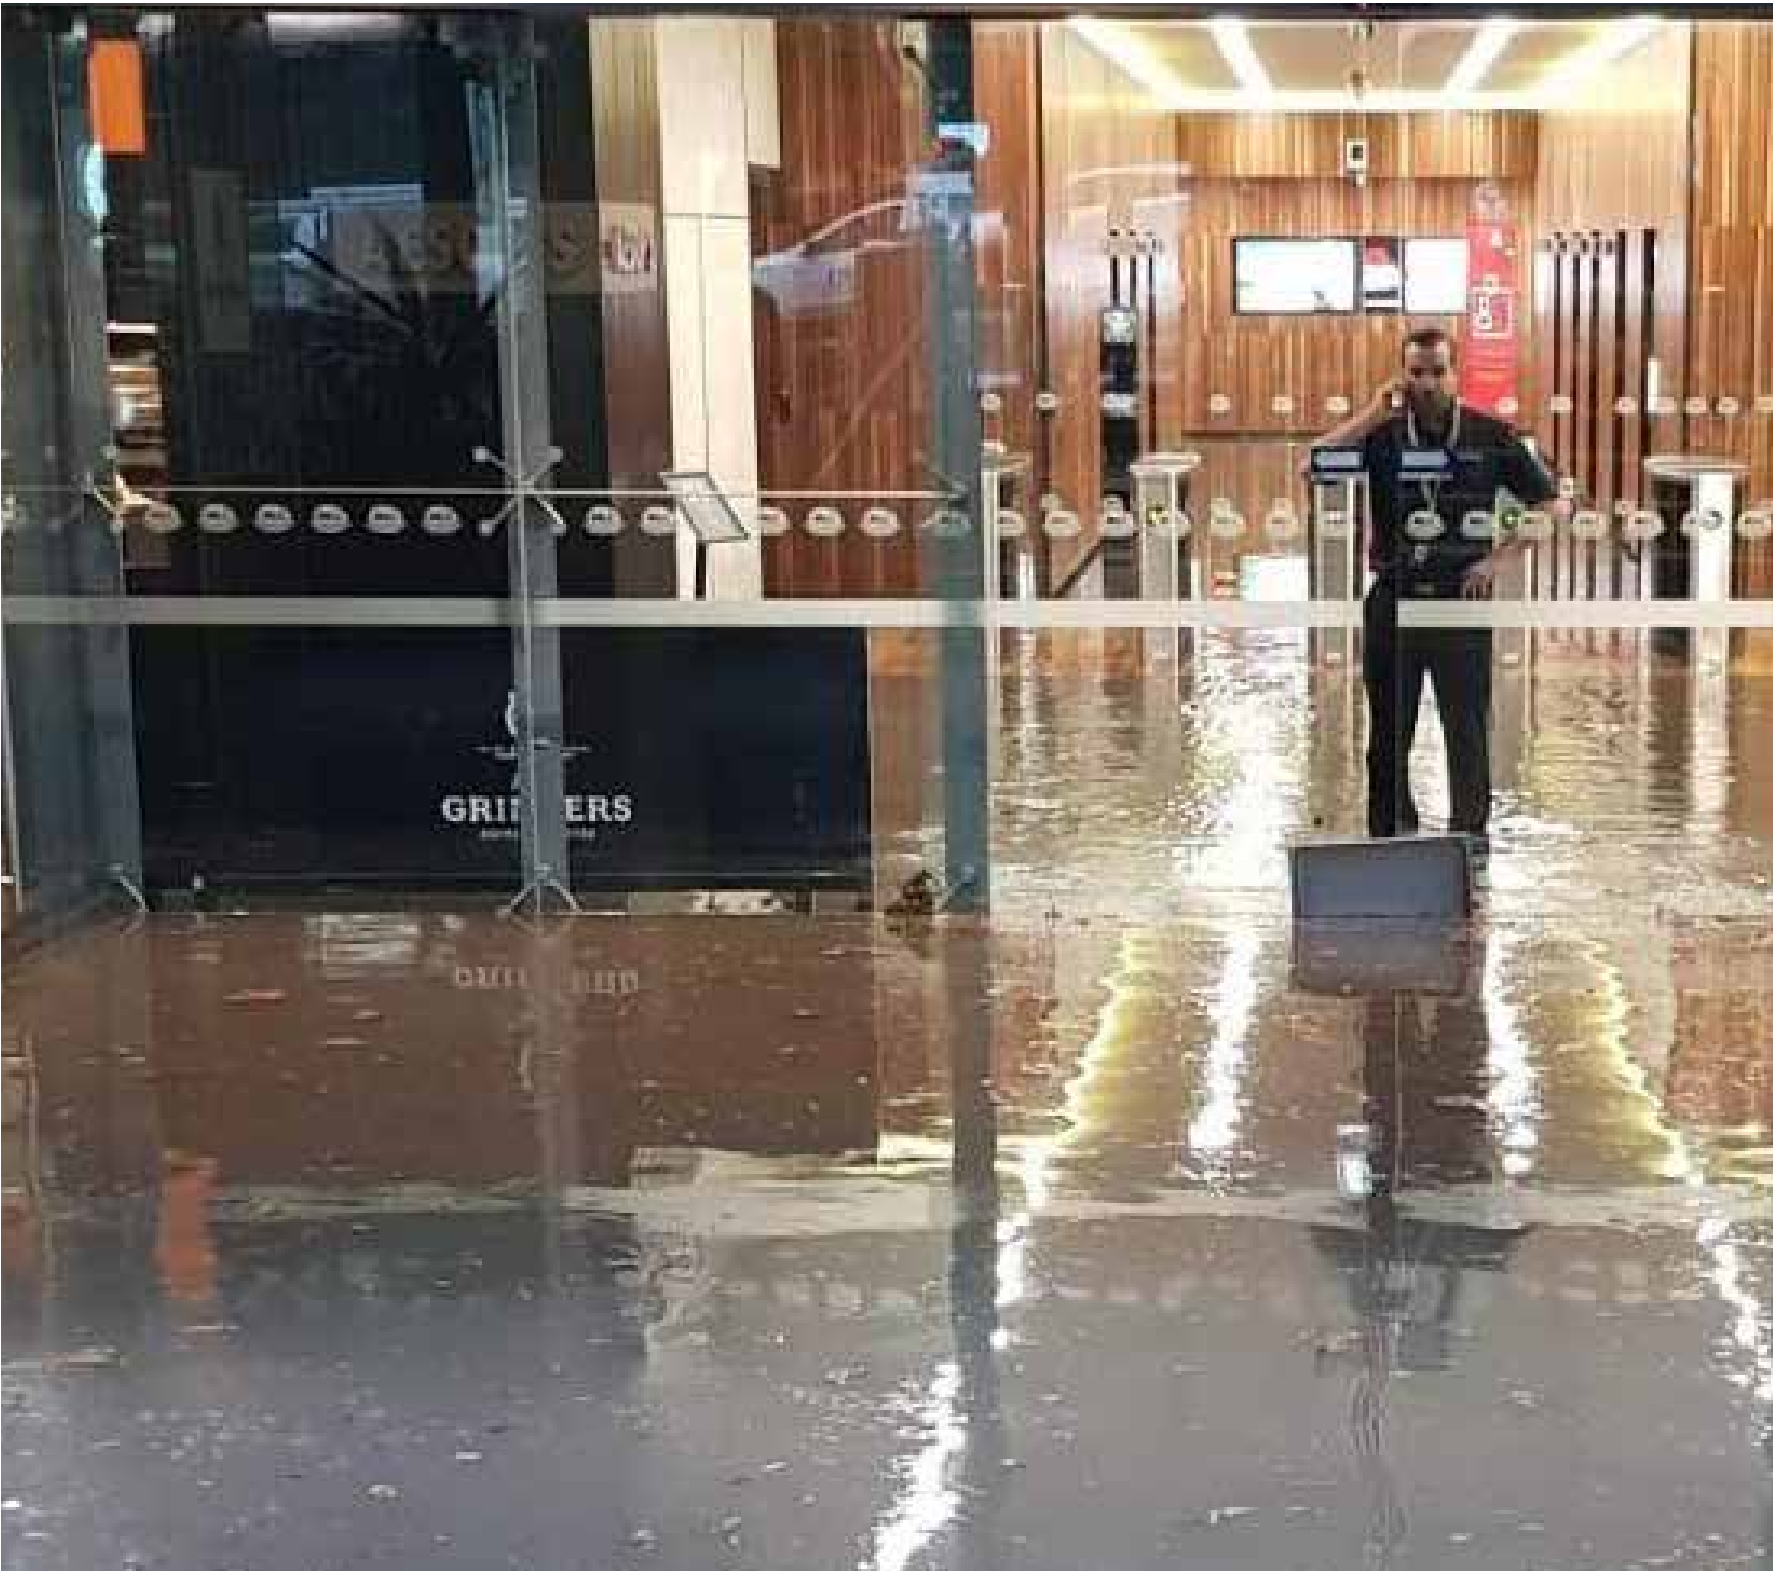
Miller Street Challenges

- The ground floor floods when there is a 100 year rain event which is approximately every two years
- This results in flood water entering the basement via lift shafts which presents a risk to life safety, damage to critical infrastructure and insurance risk

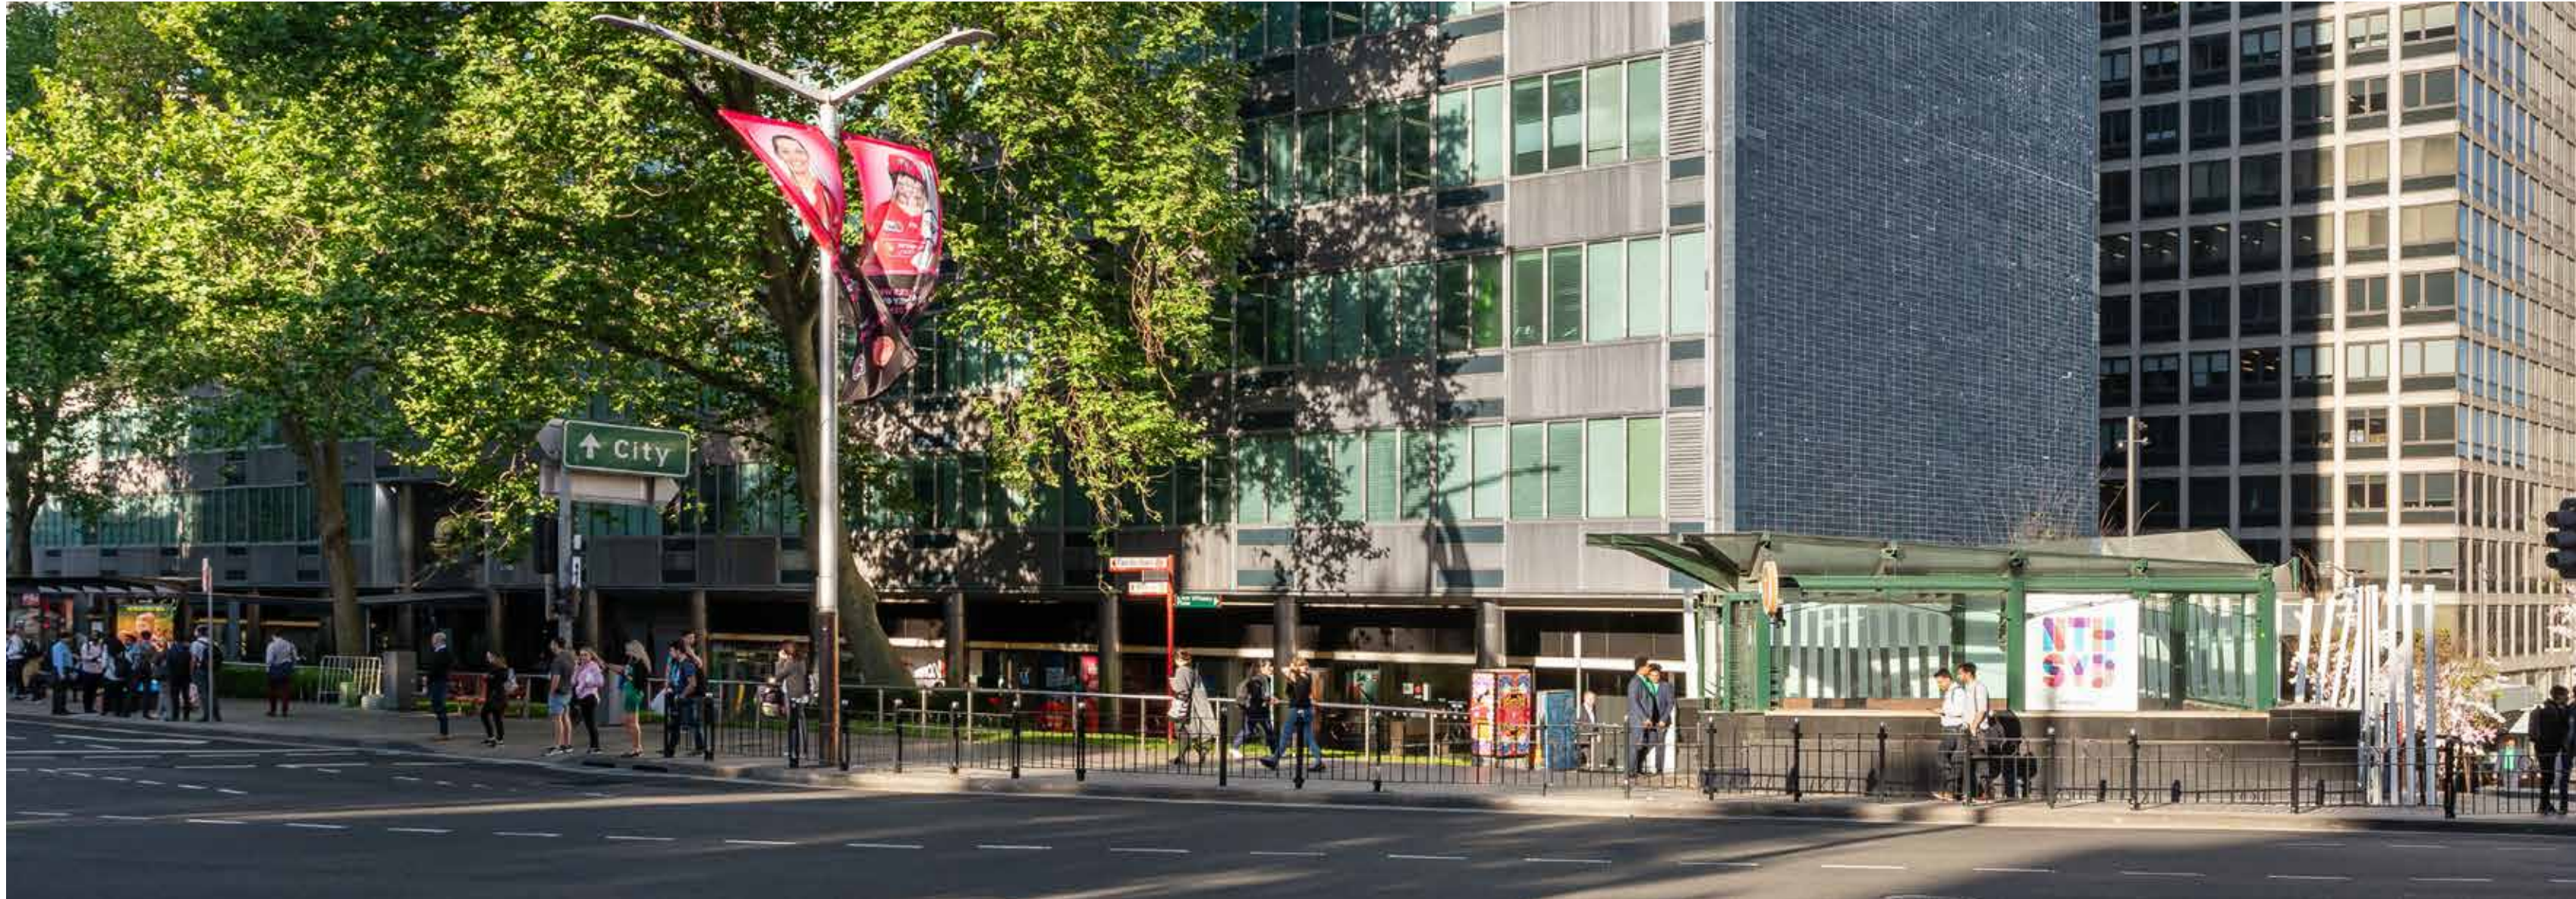
Existing Condition

Existing / Proposed
Comparison

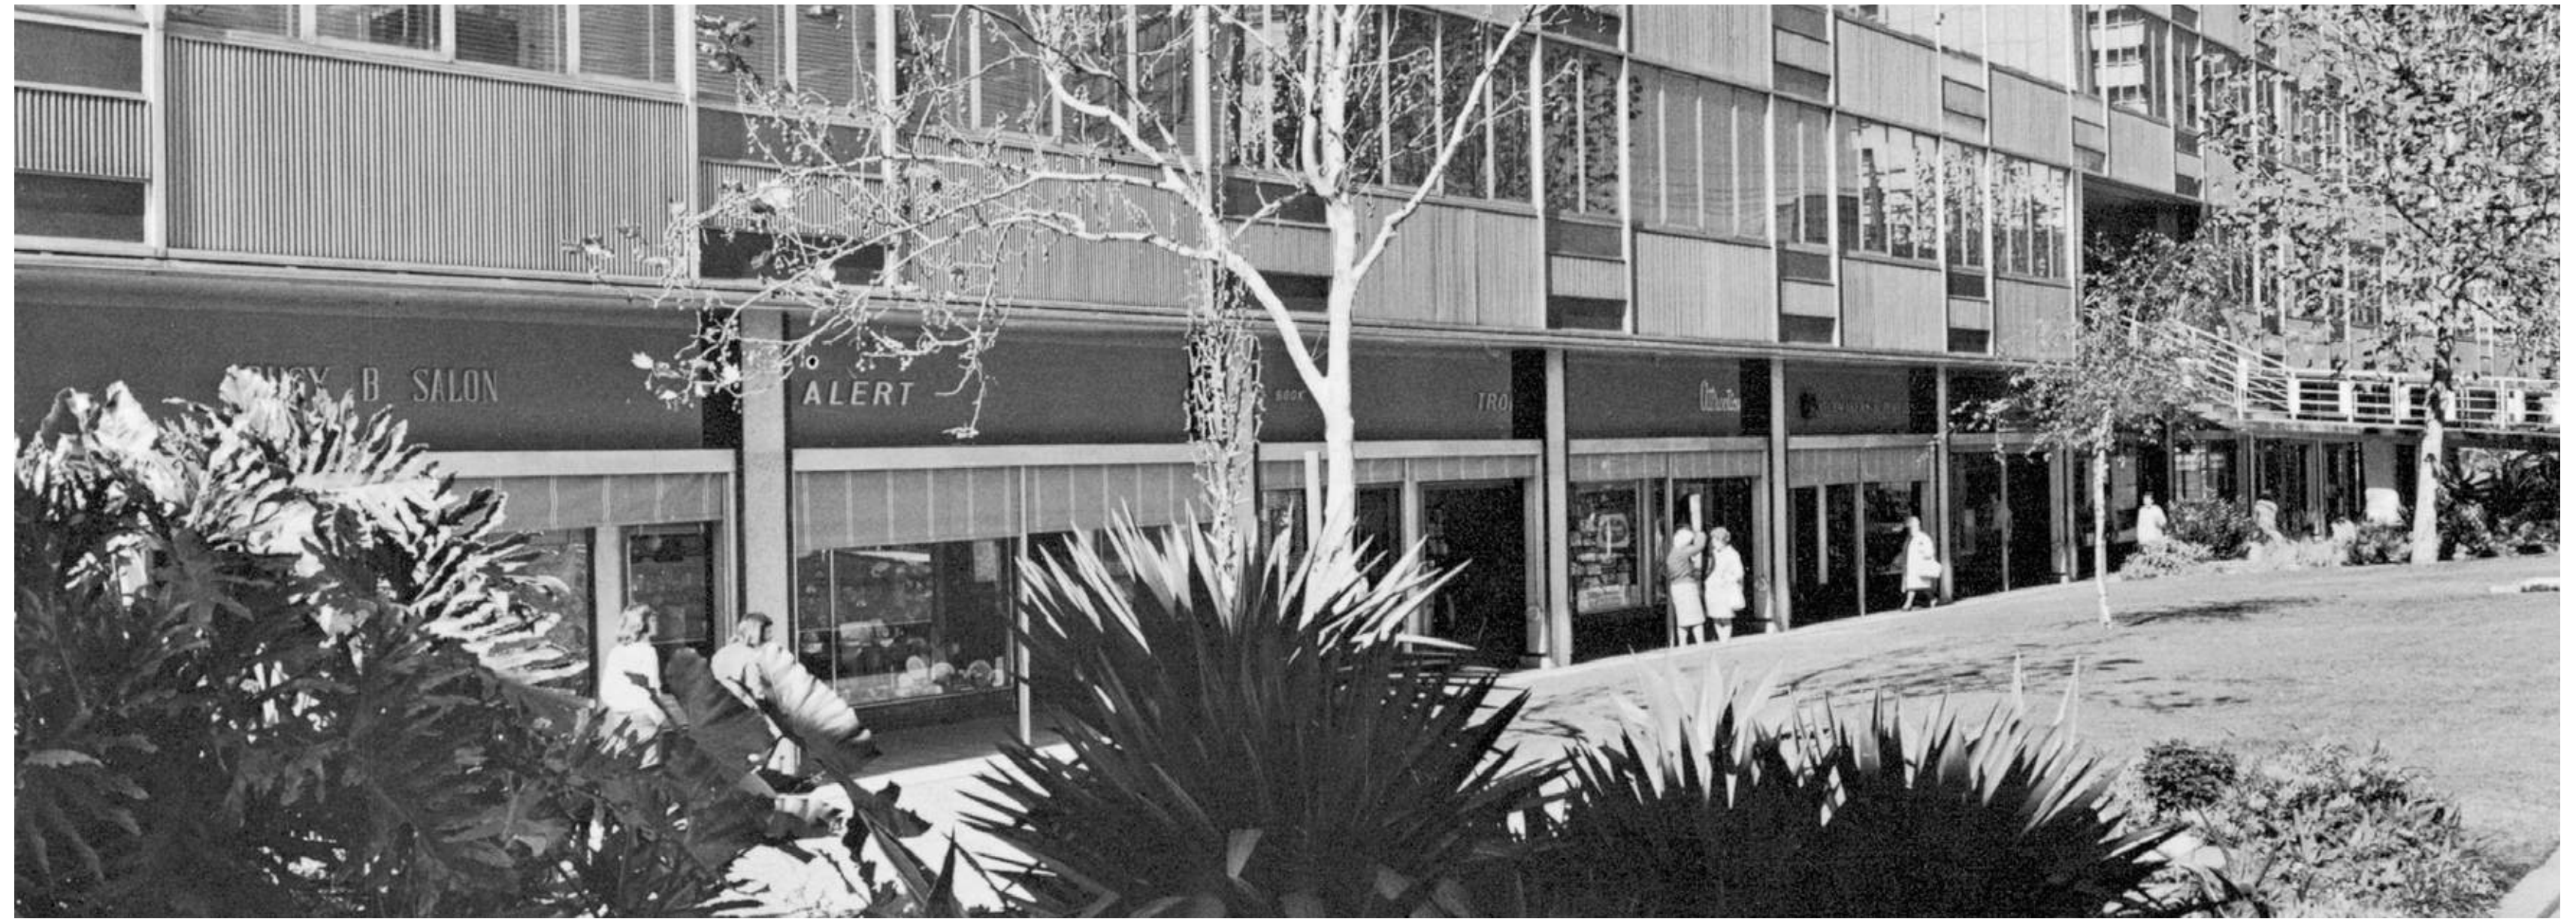
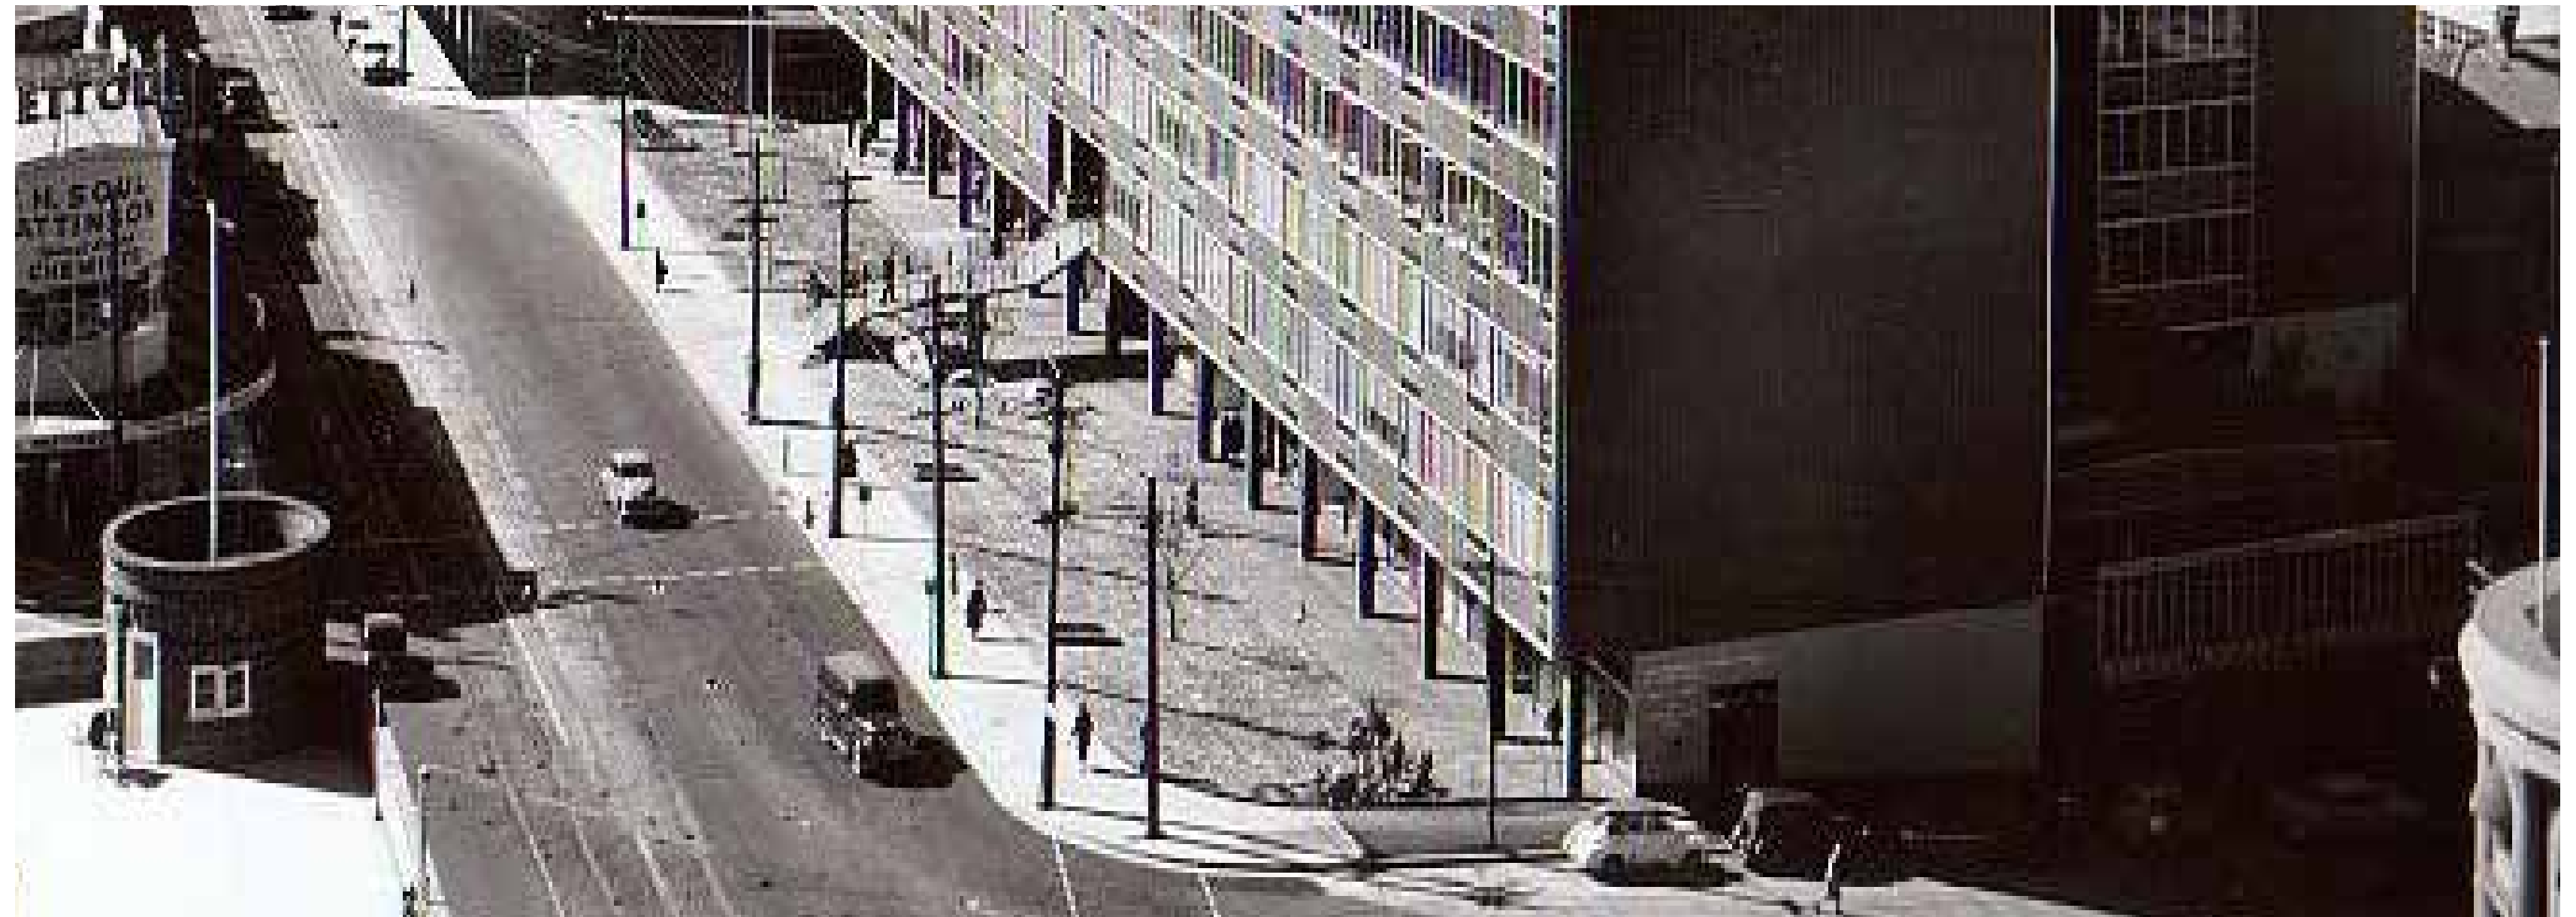
Original Design

- Original drawings have been used to design the colonnade. Each shopfront has been designed with an aluminium clad portal that recalls the original portal to the MLC entry
- The existing circular metal-clad colonnade columns, which are not original and lack heritage value, will be replaced as part of the redevelopment. In their place original square-format columns will be reinstated
- This approach ensures a respectful and accurate restoration, enhancing the architectural integrity of the colonnade while contributing to the overall heritage aesthetic of the building

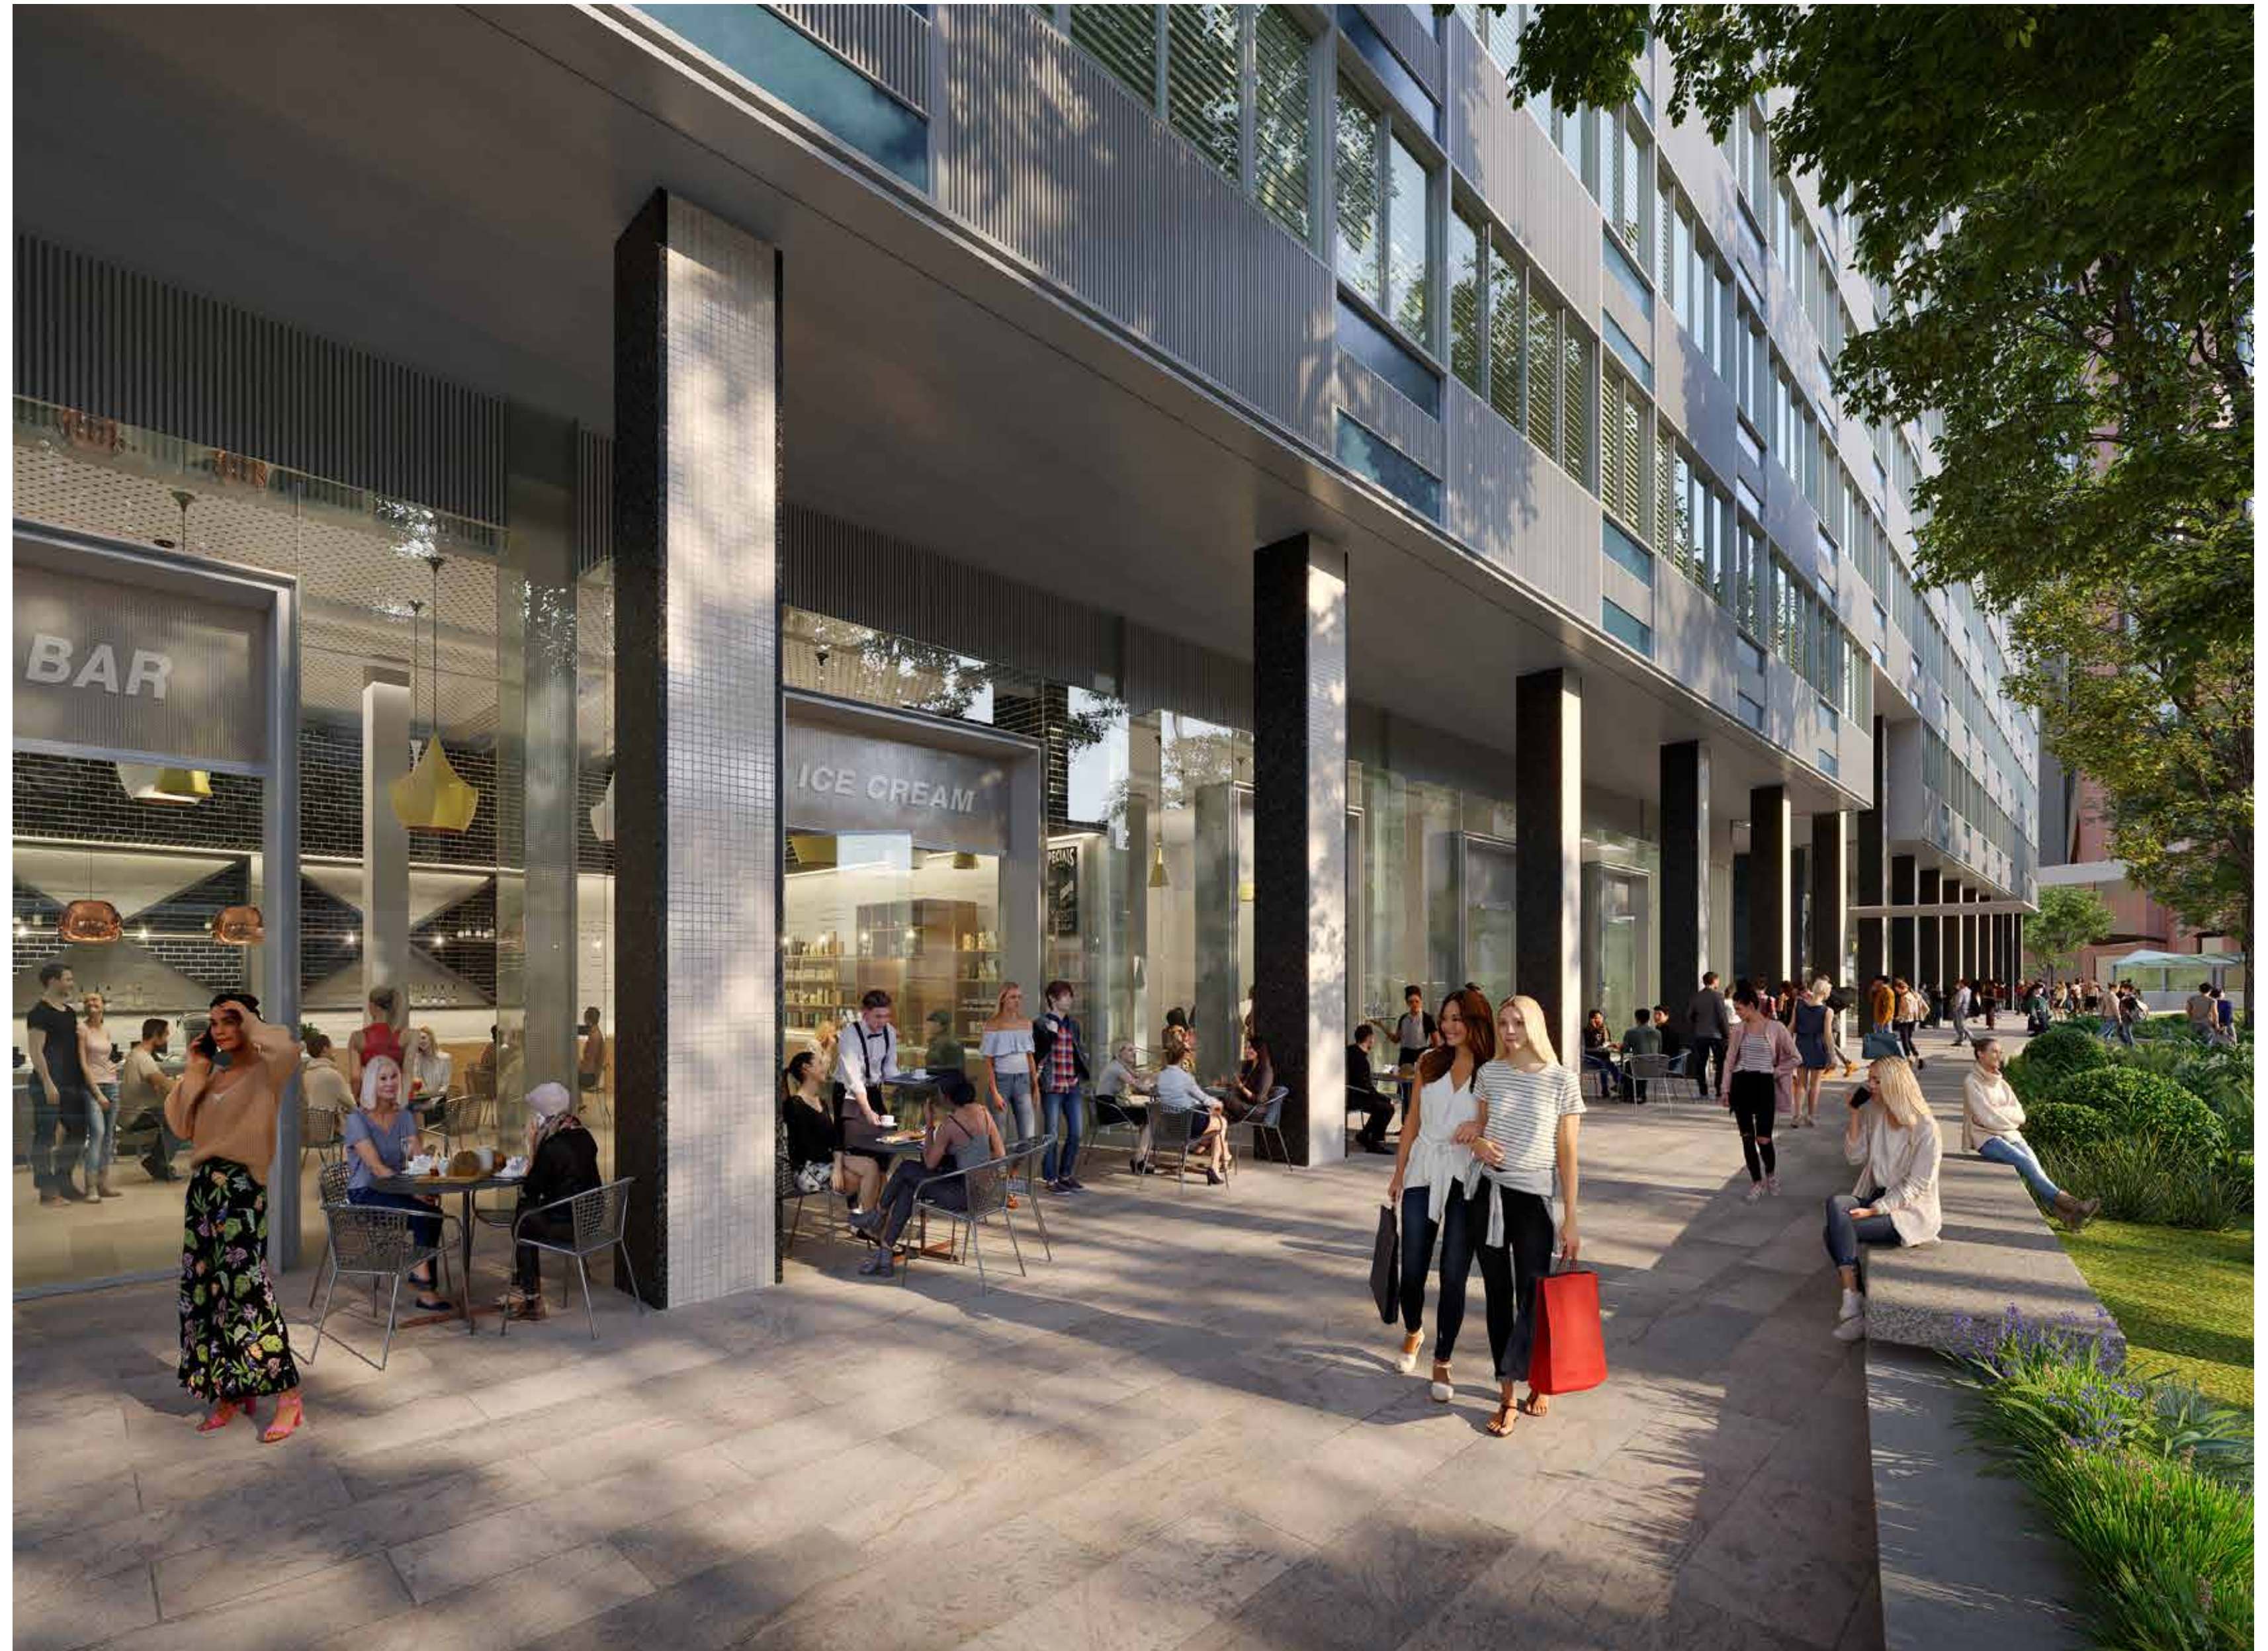
Proposed Design

- Mitigates against flooding by raising ground floor to PMF flood level
- Improves urban design by creating a greater street presence
- Meets contemporary standards in terms of retail heights and shopfront quality
- Meets current DDA requirements
- Enhances heritage significance by reinstating original shape and material to columns
