105 Miller St

Heritage Presentation

Investa

May 2025

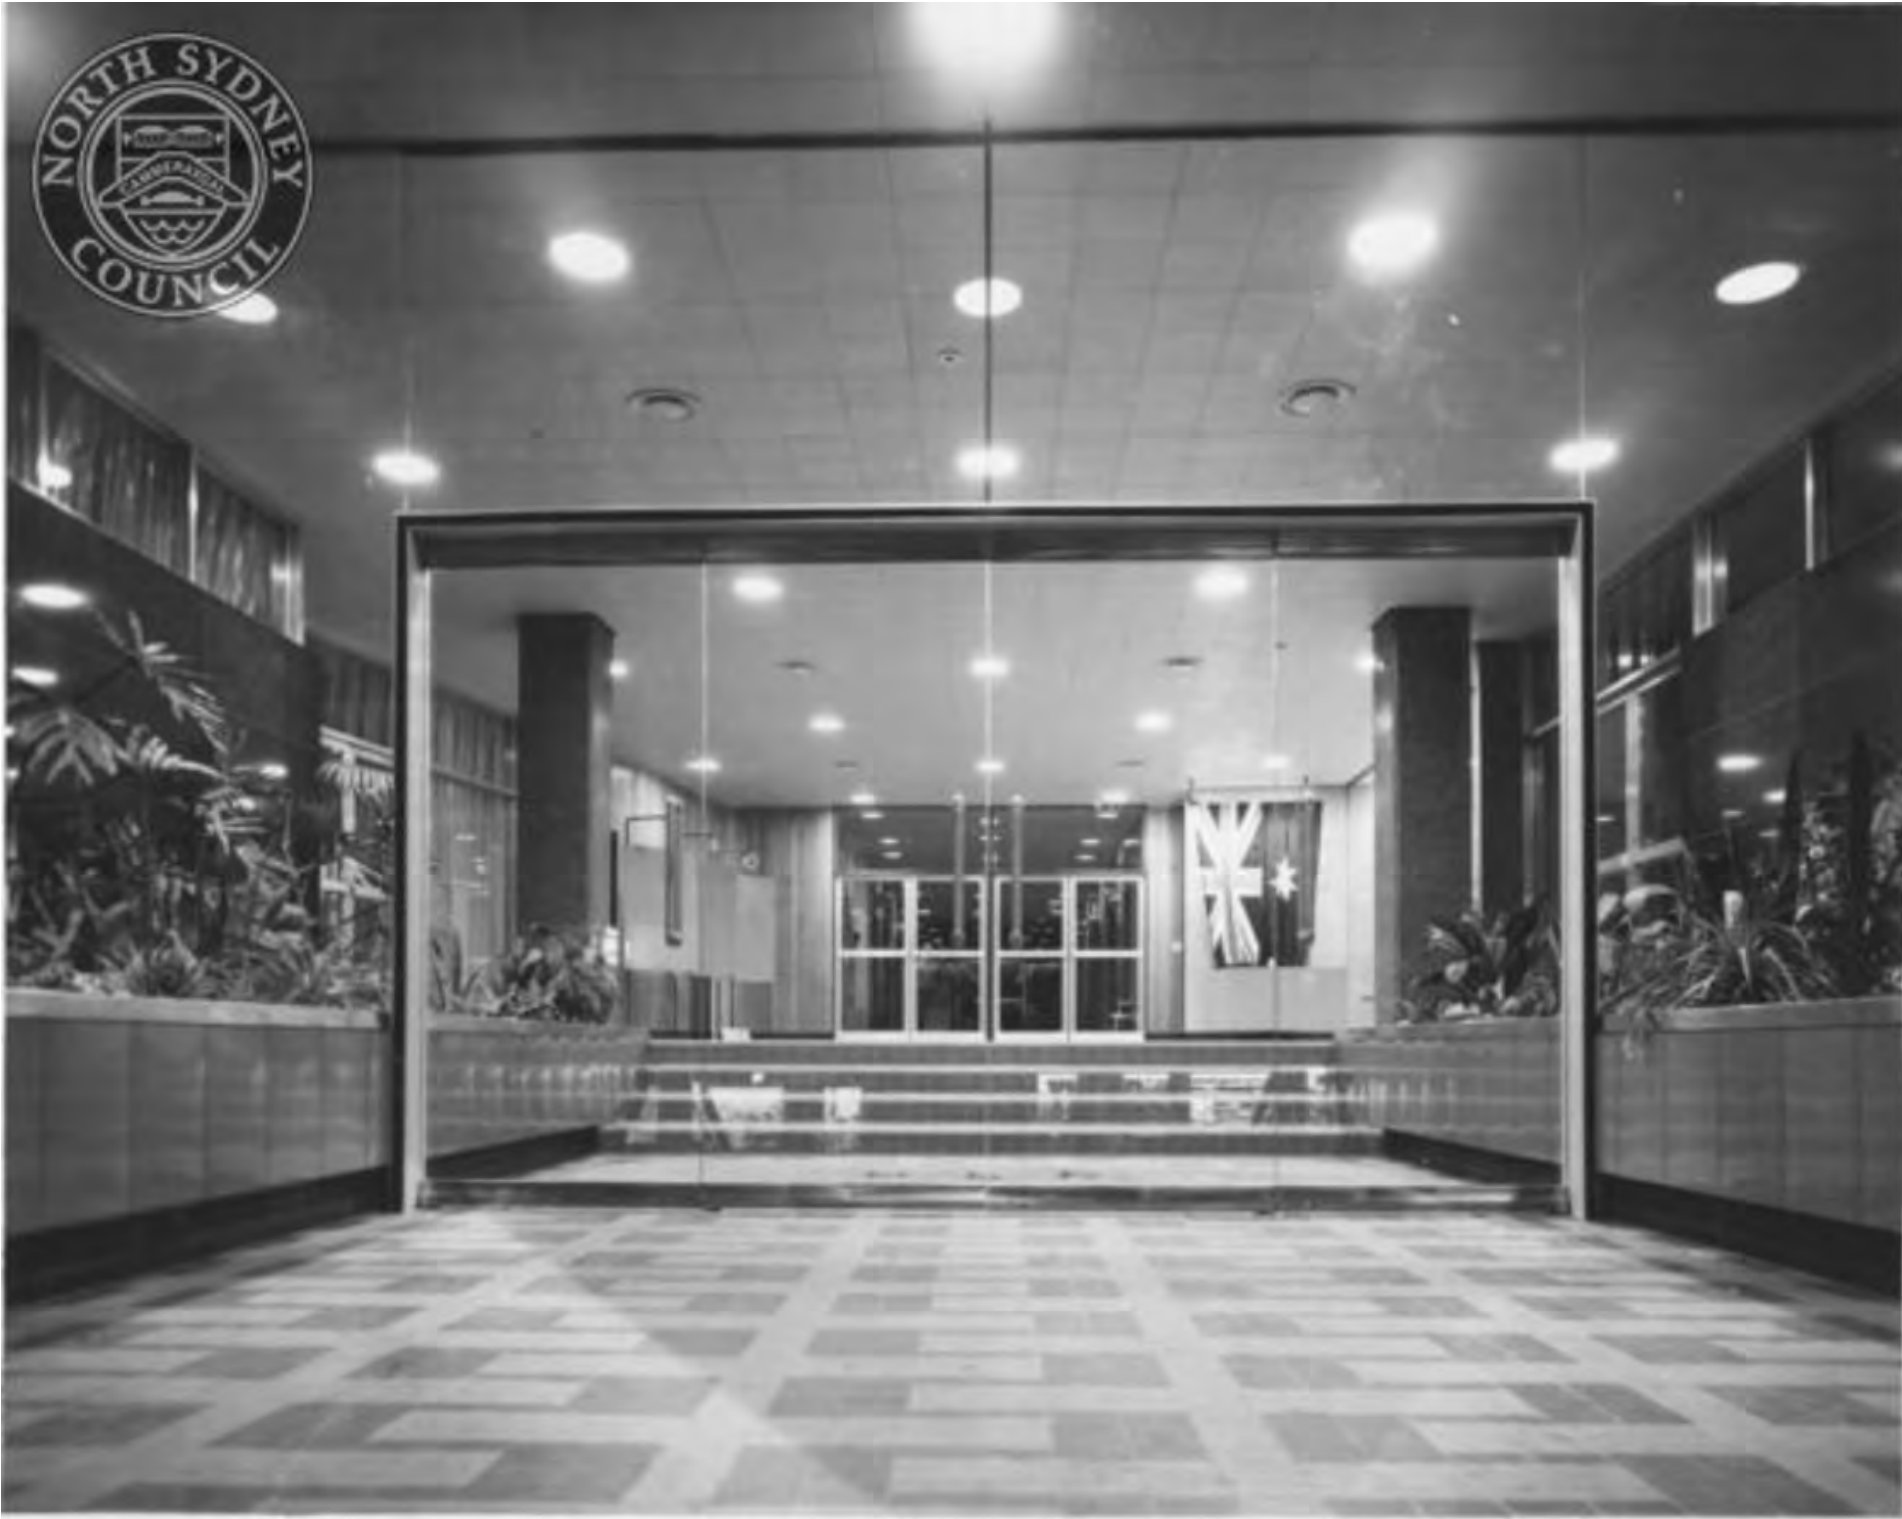
Main Entry

- The proposed entry and retail facades make reference to the original portal-framed entry doors and frameless glazing

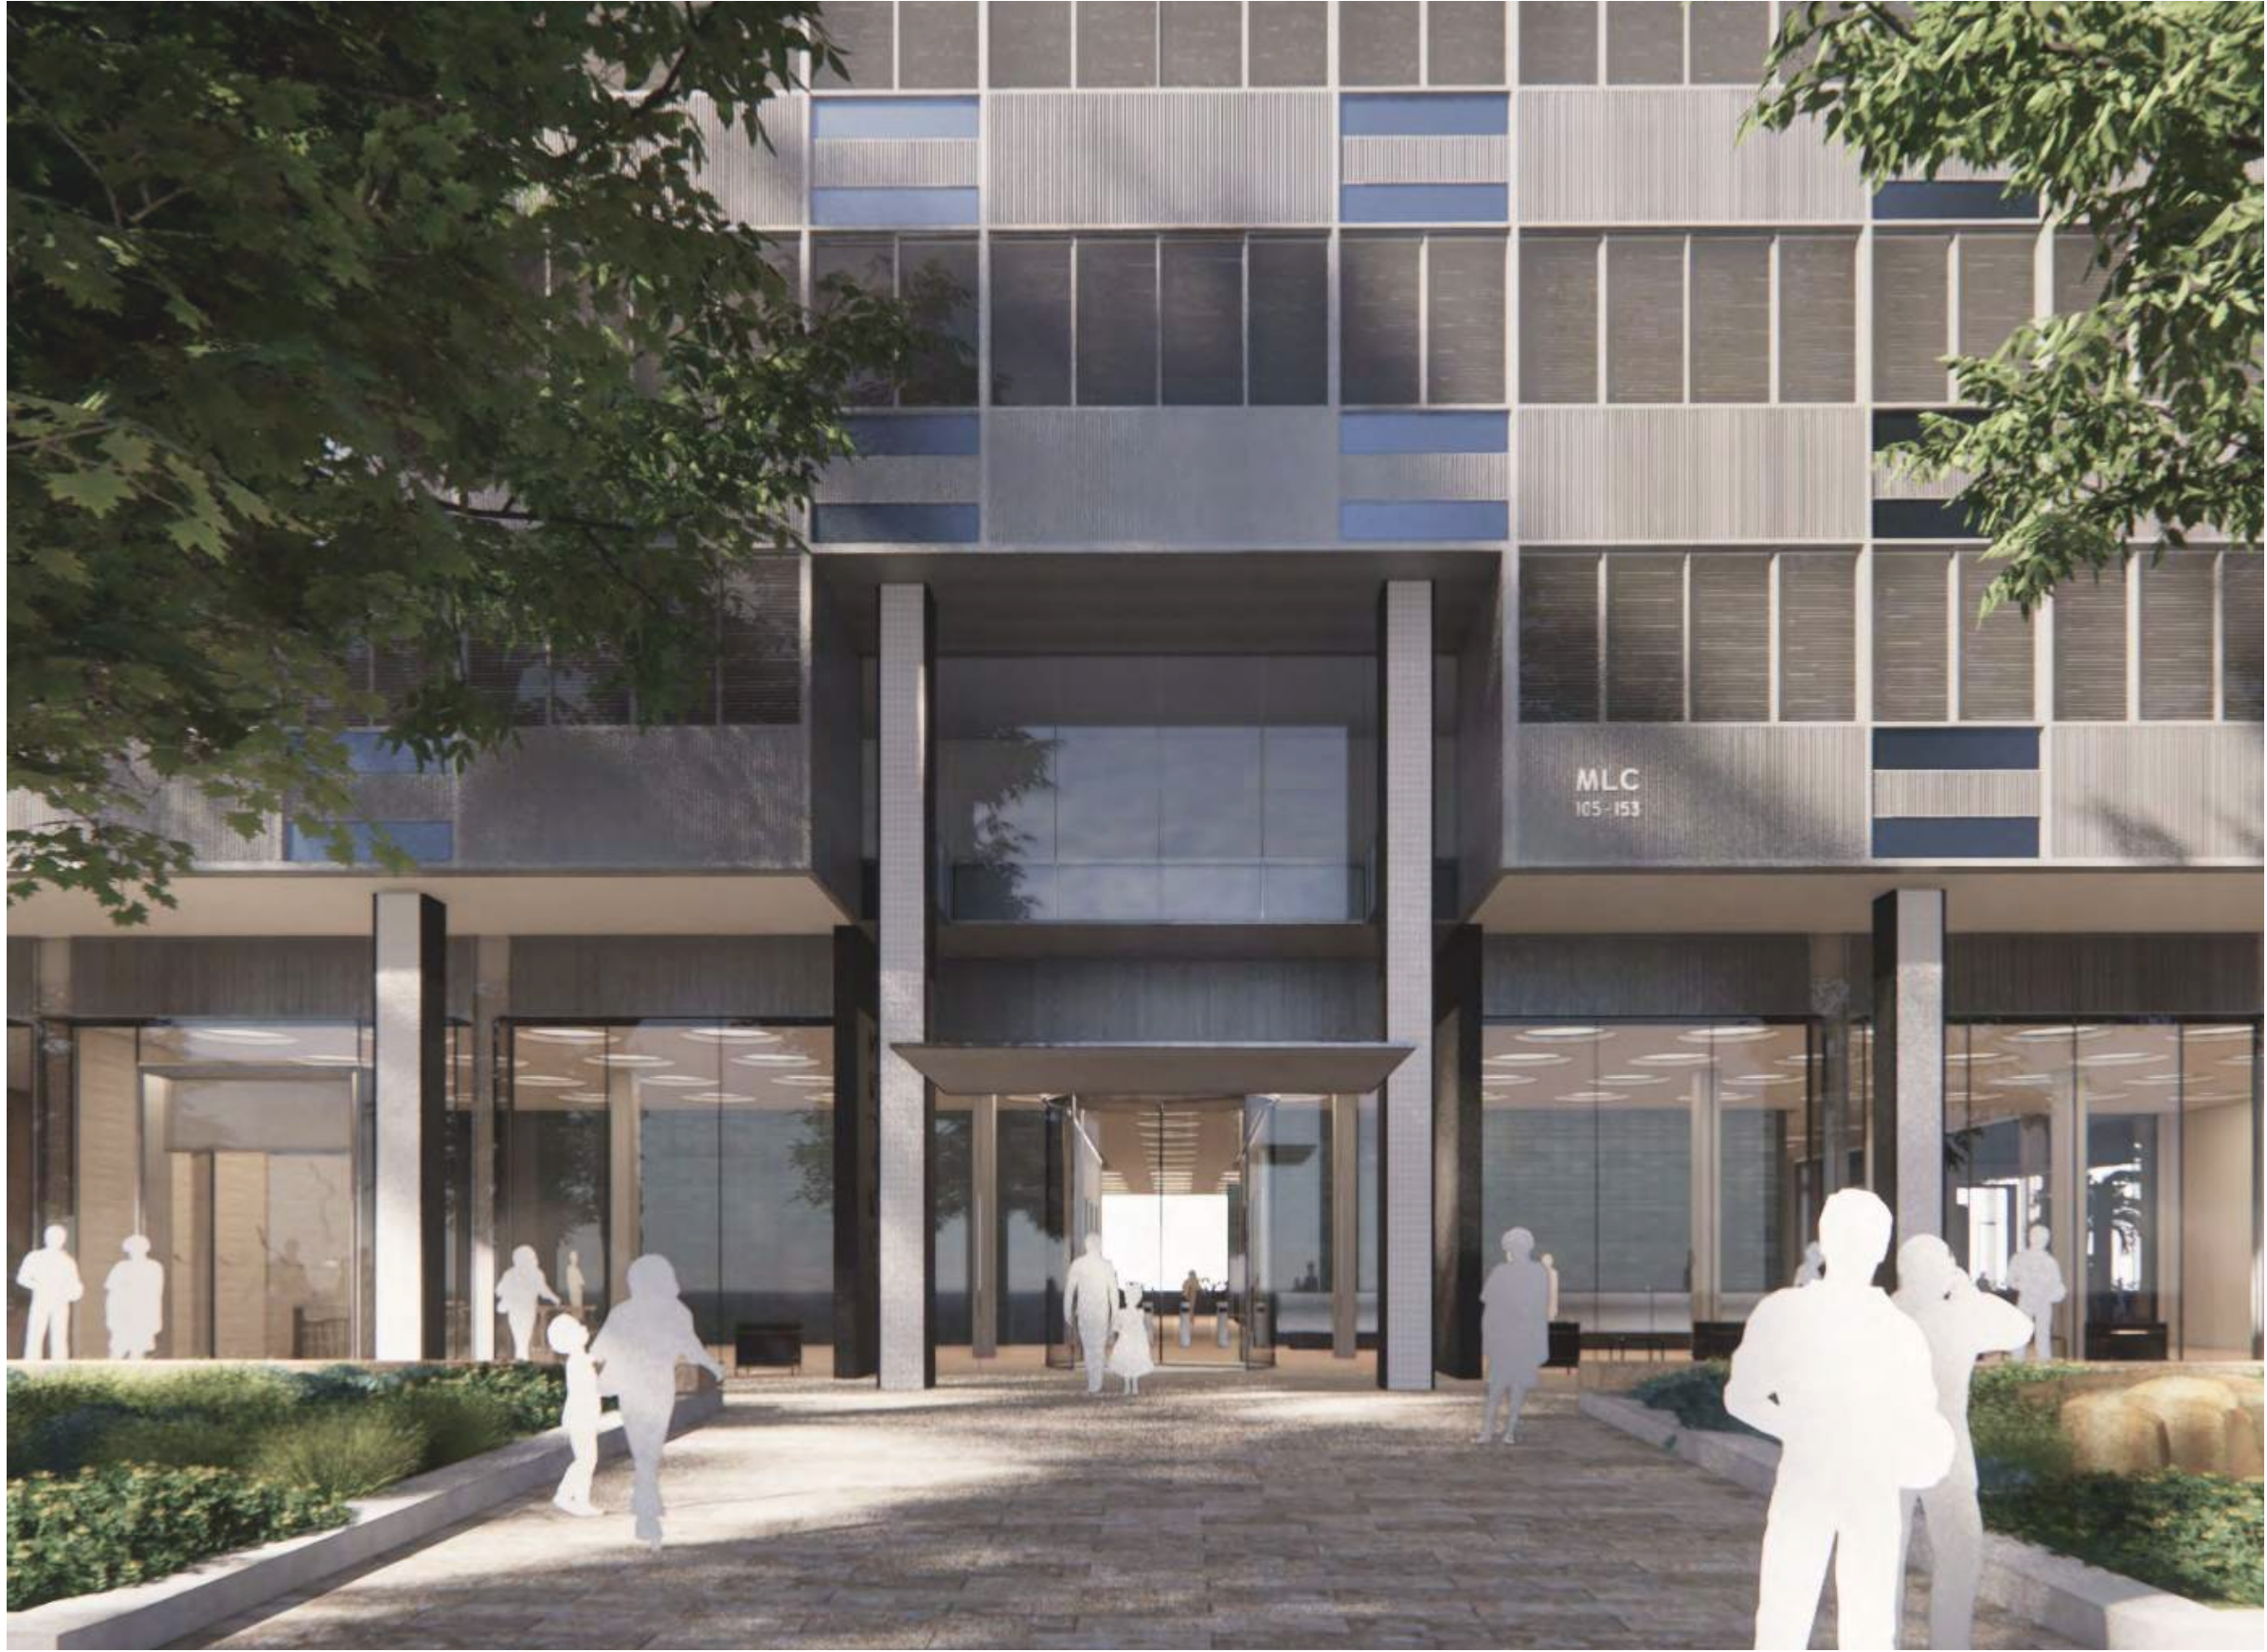
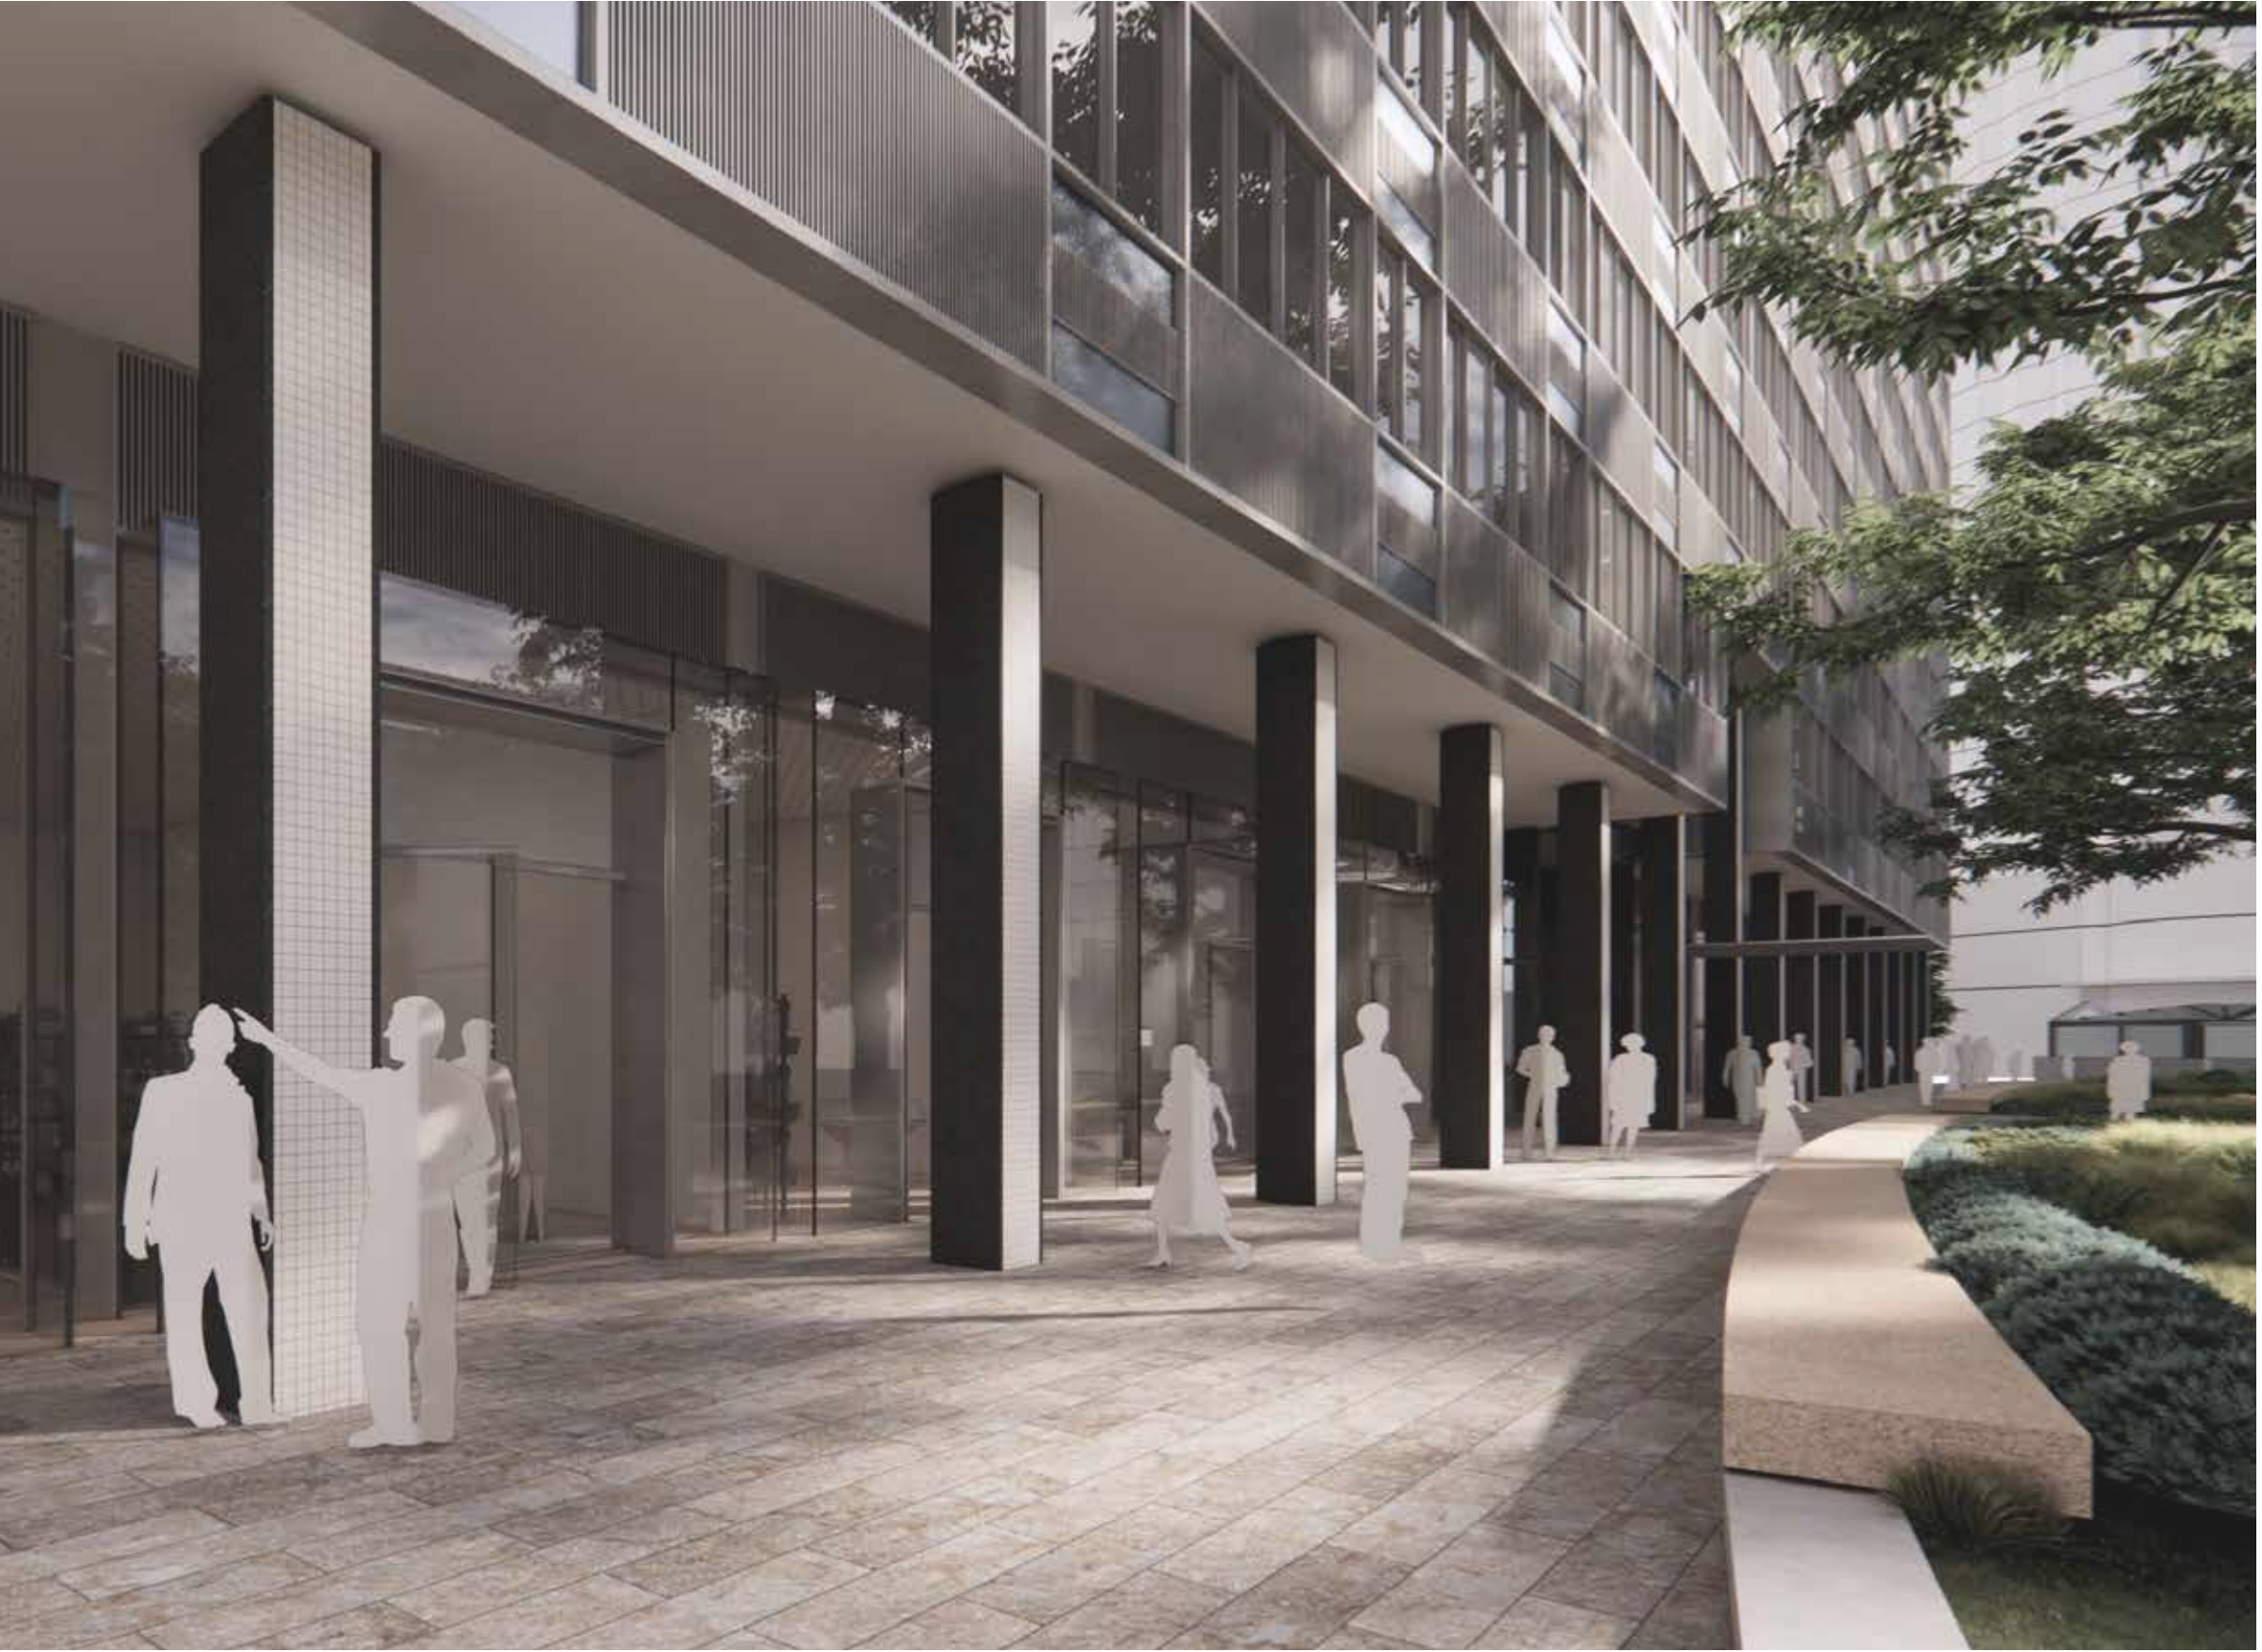
As Lodged

RECOMMENDED

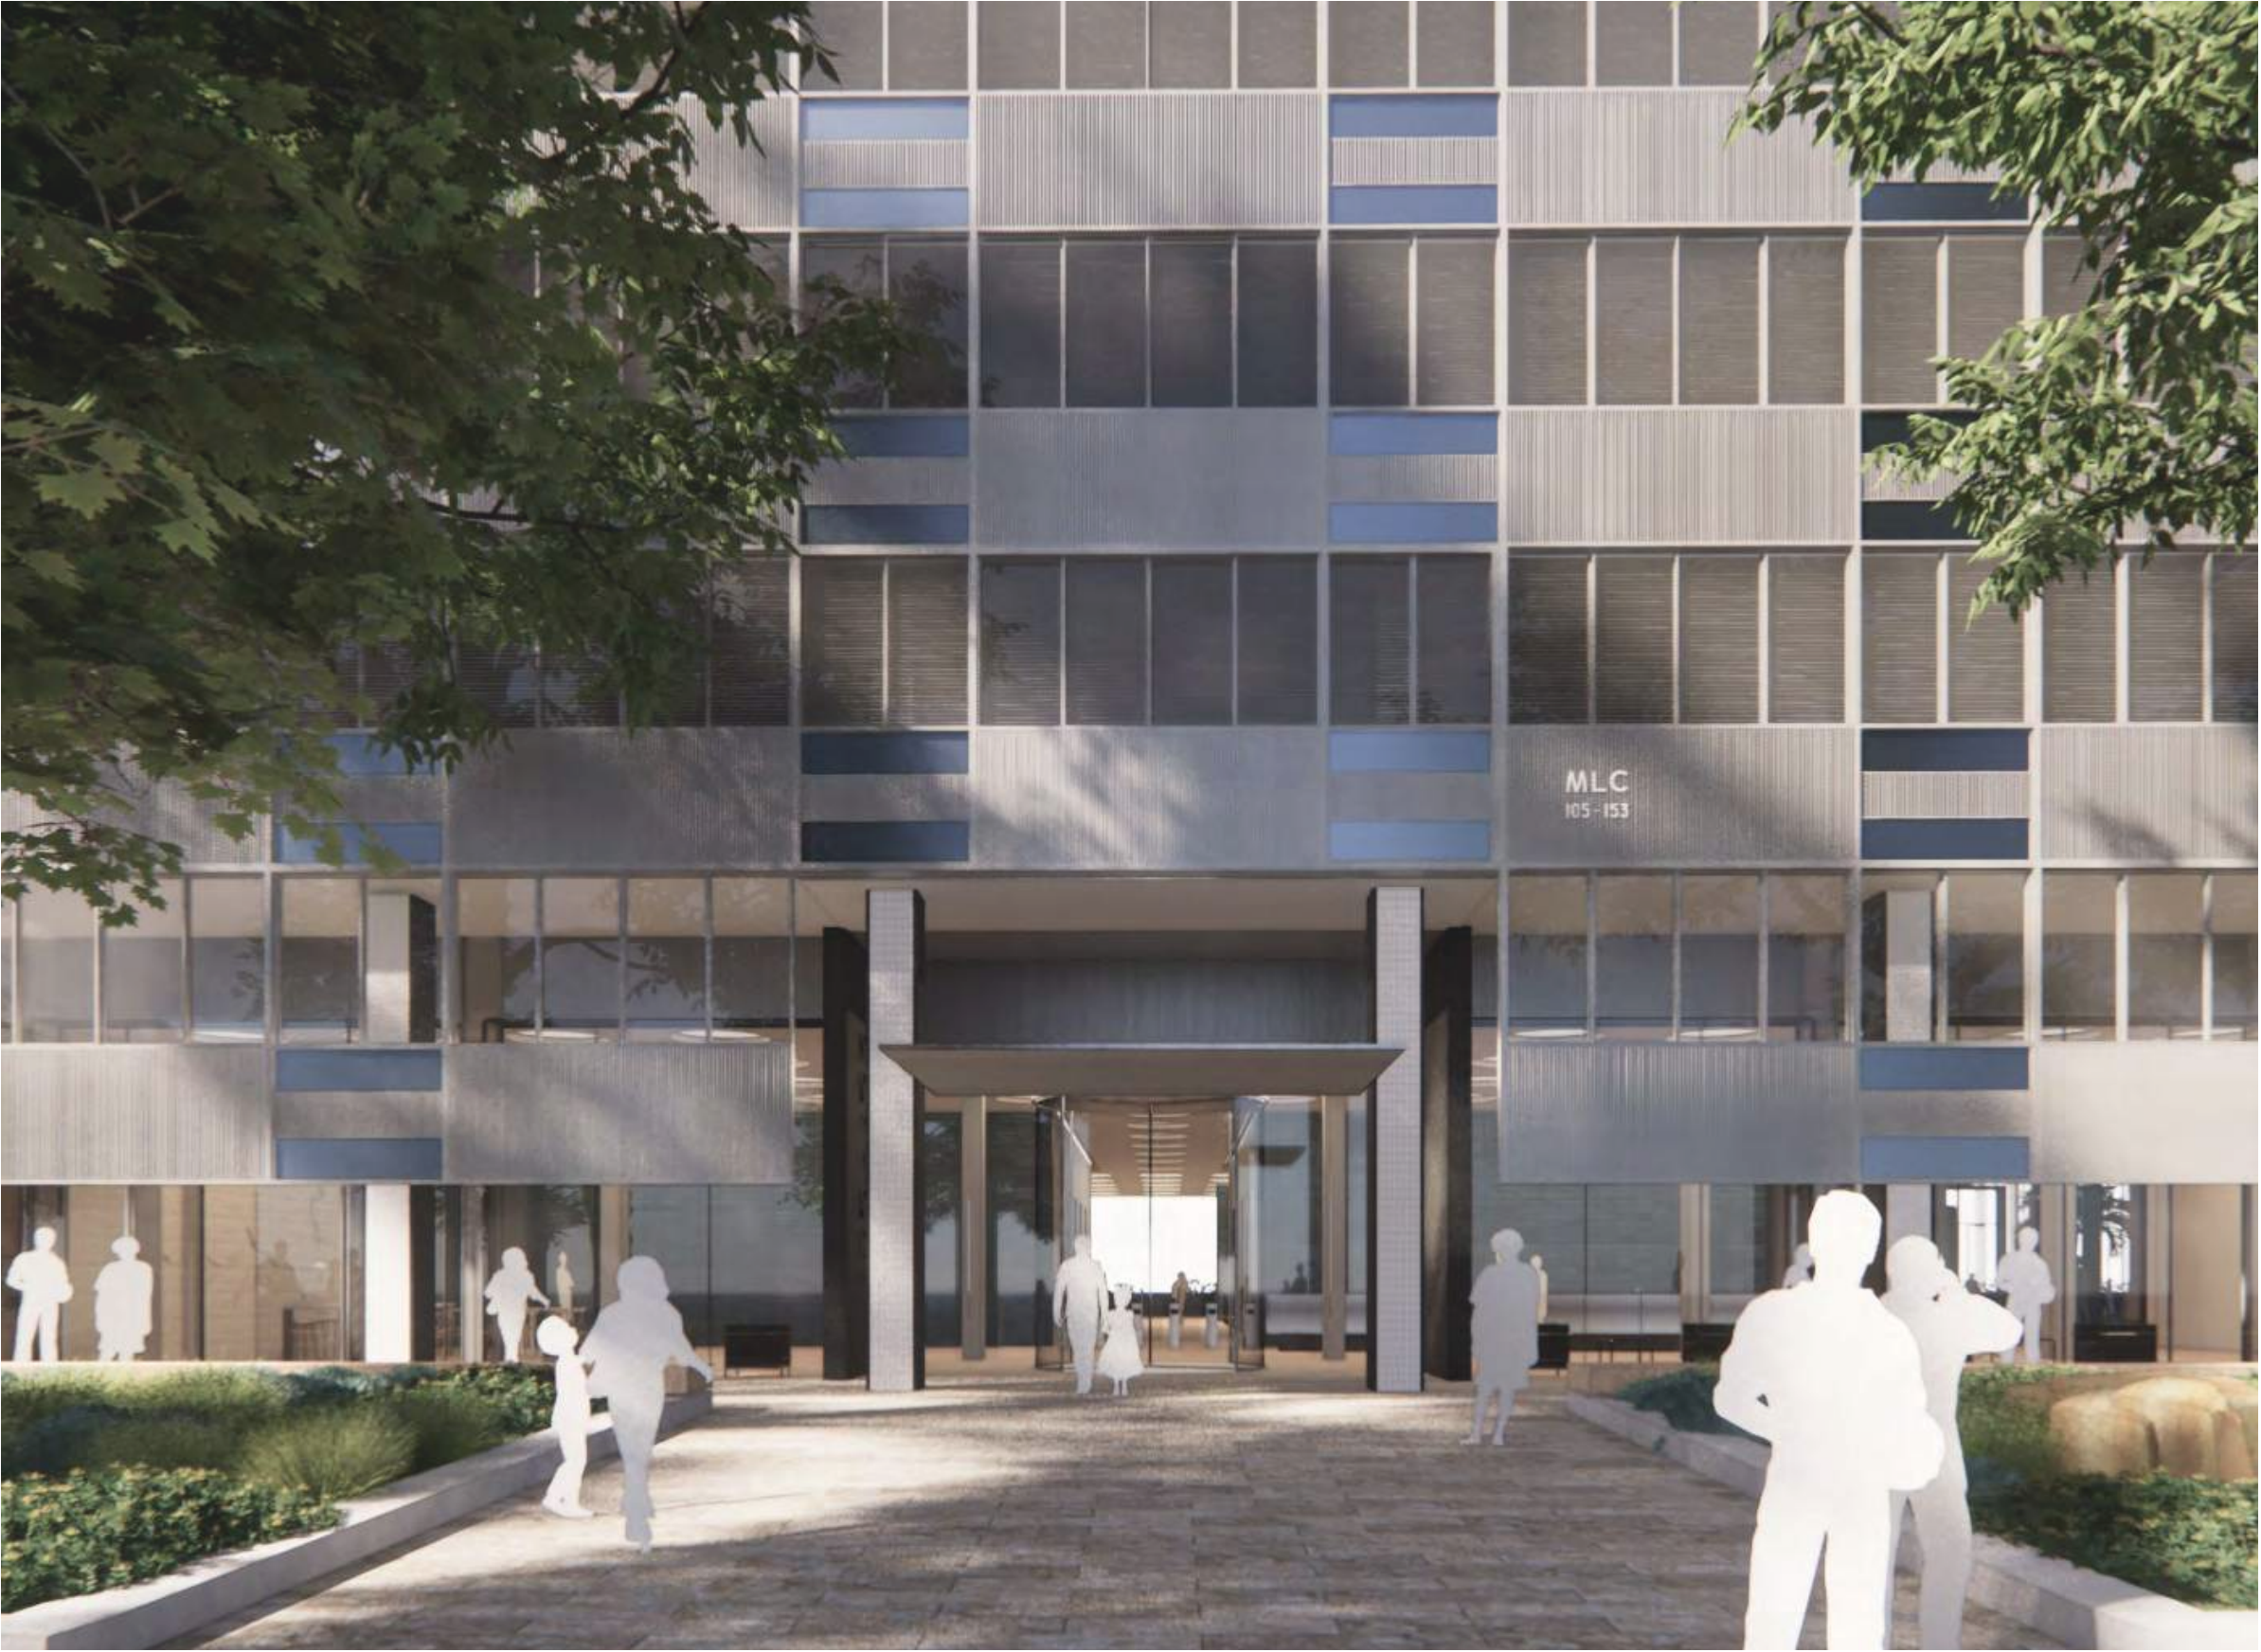
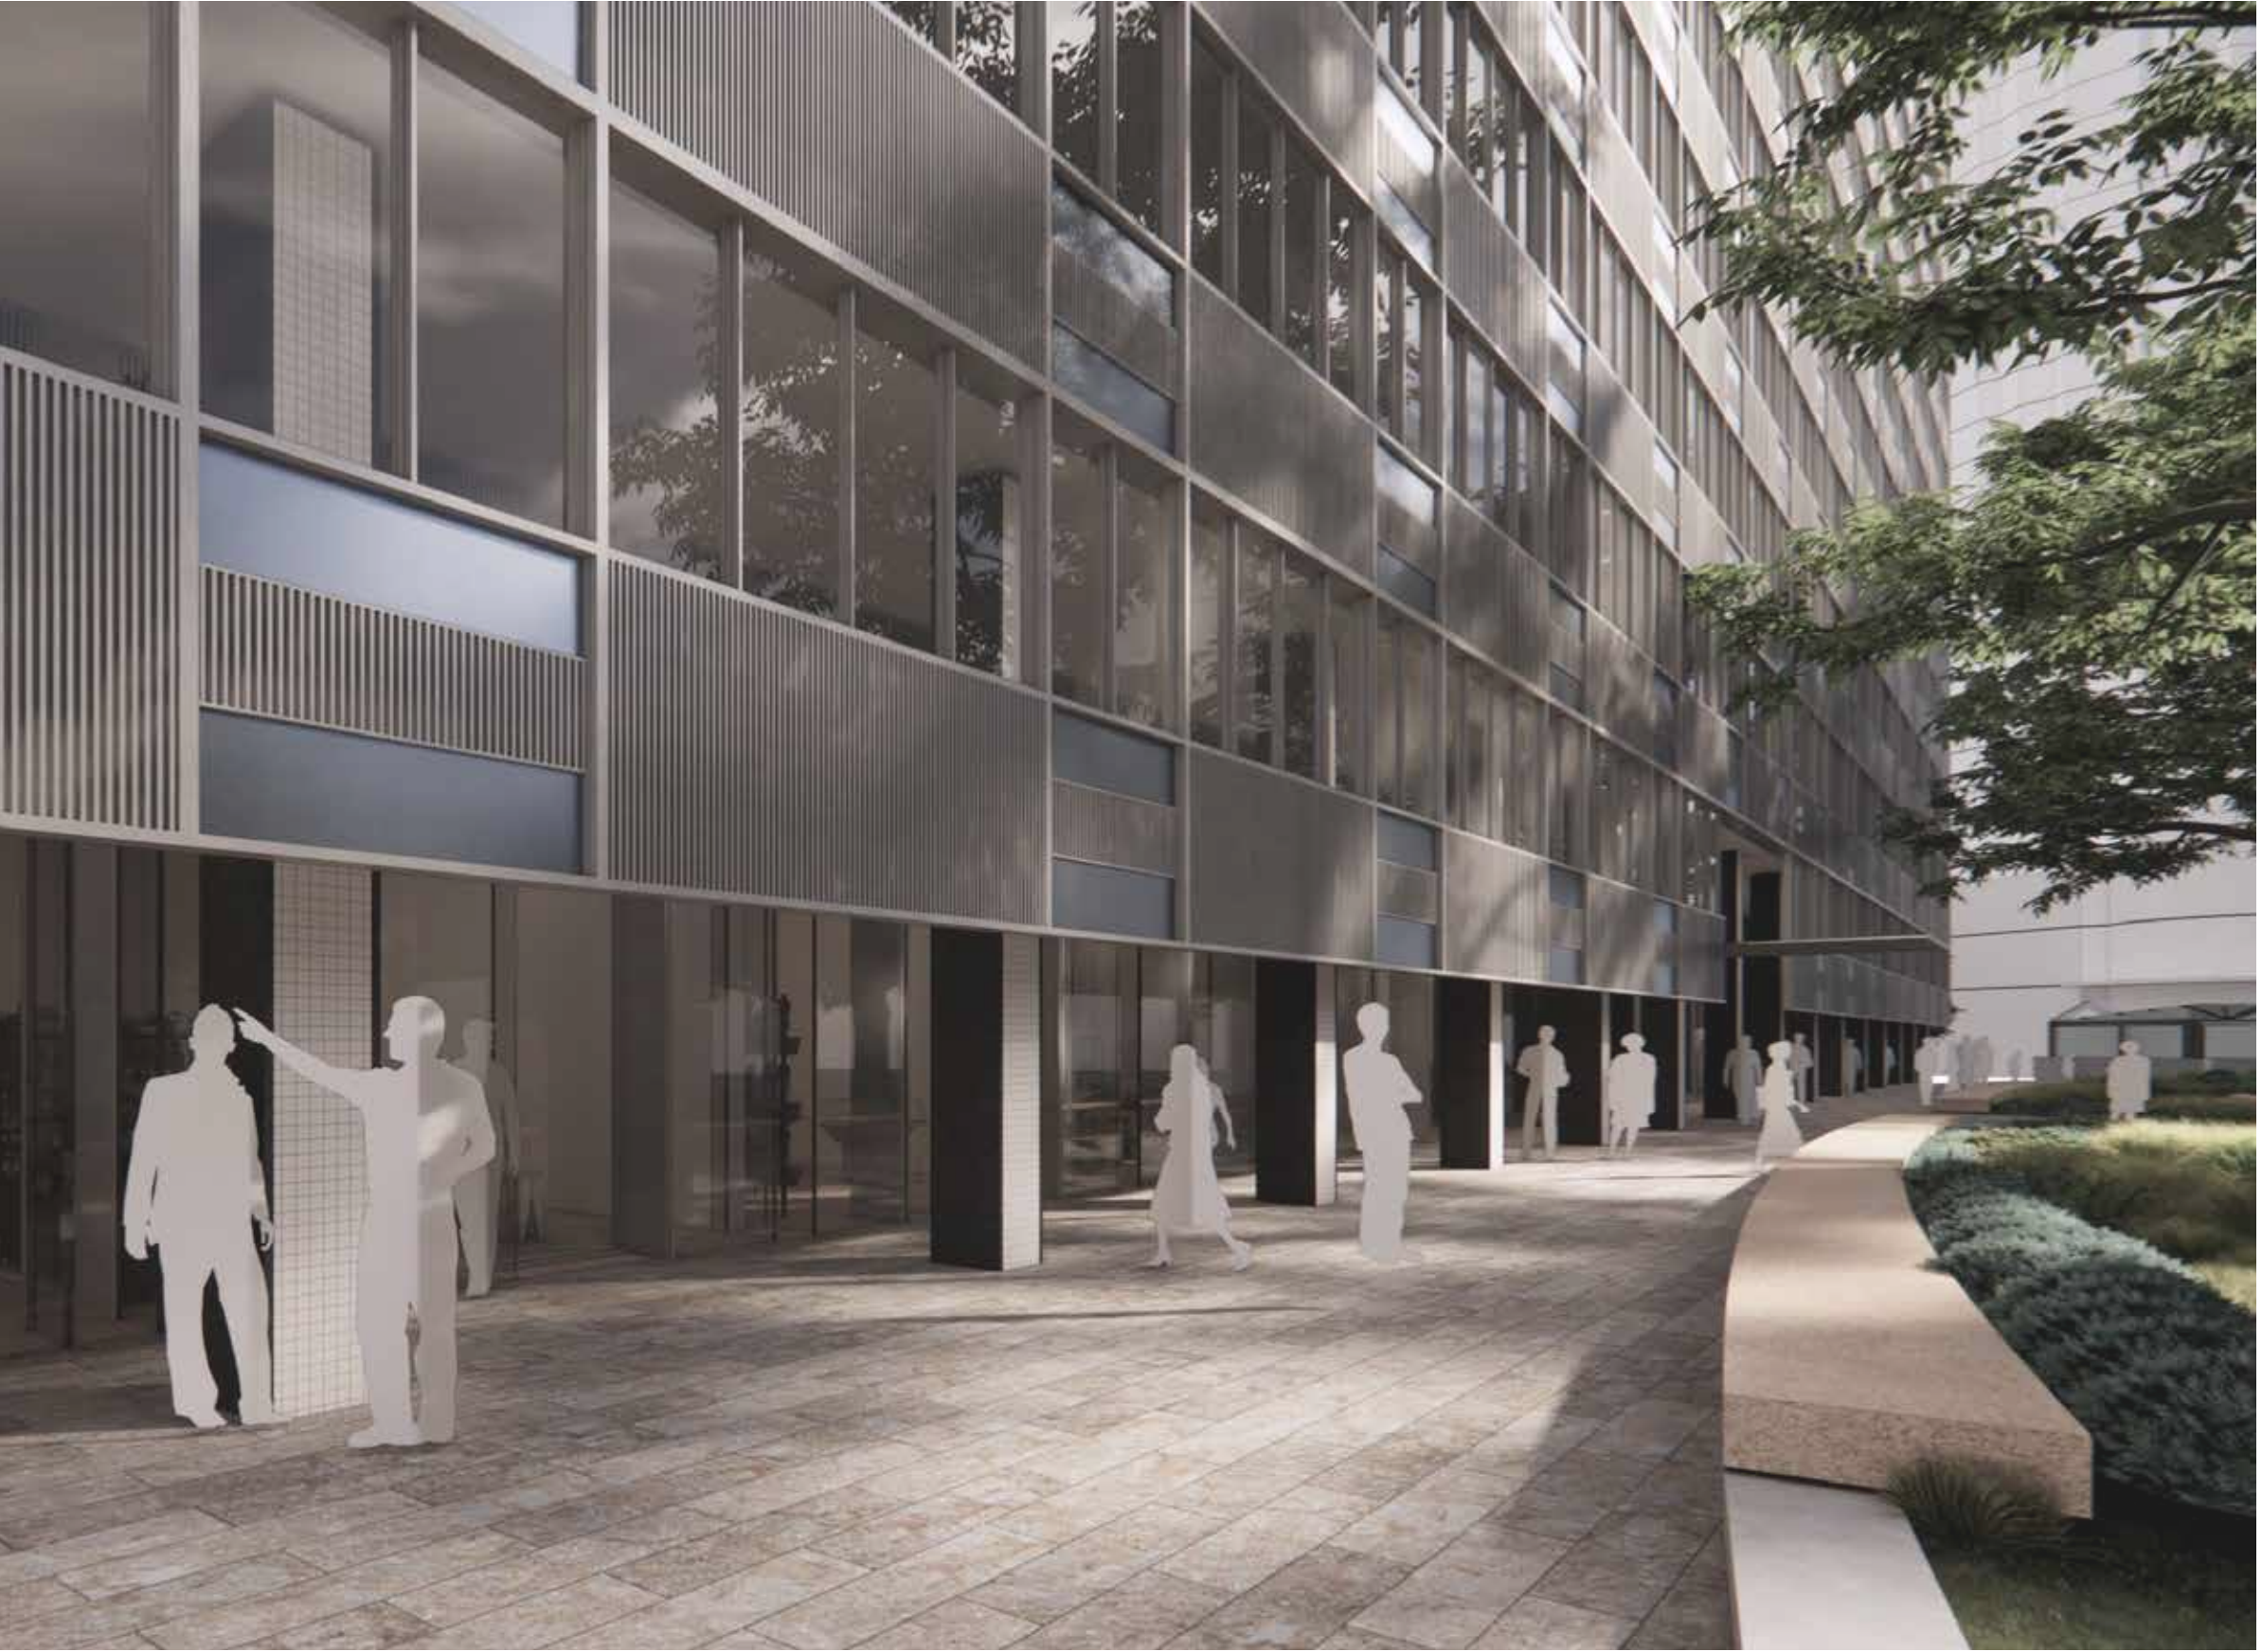
Retain L01 as Hanging Screen

NOT RECOMMENDED
