105 Miller St

Heritage Presentation

Investa

May 2025

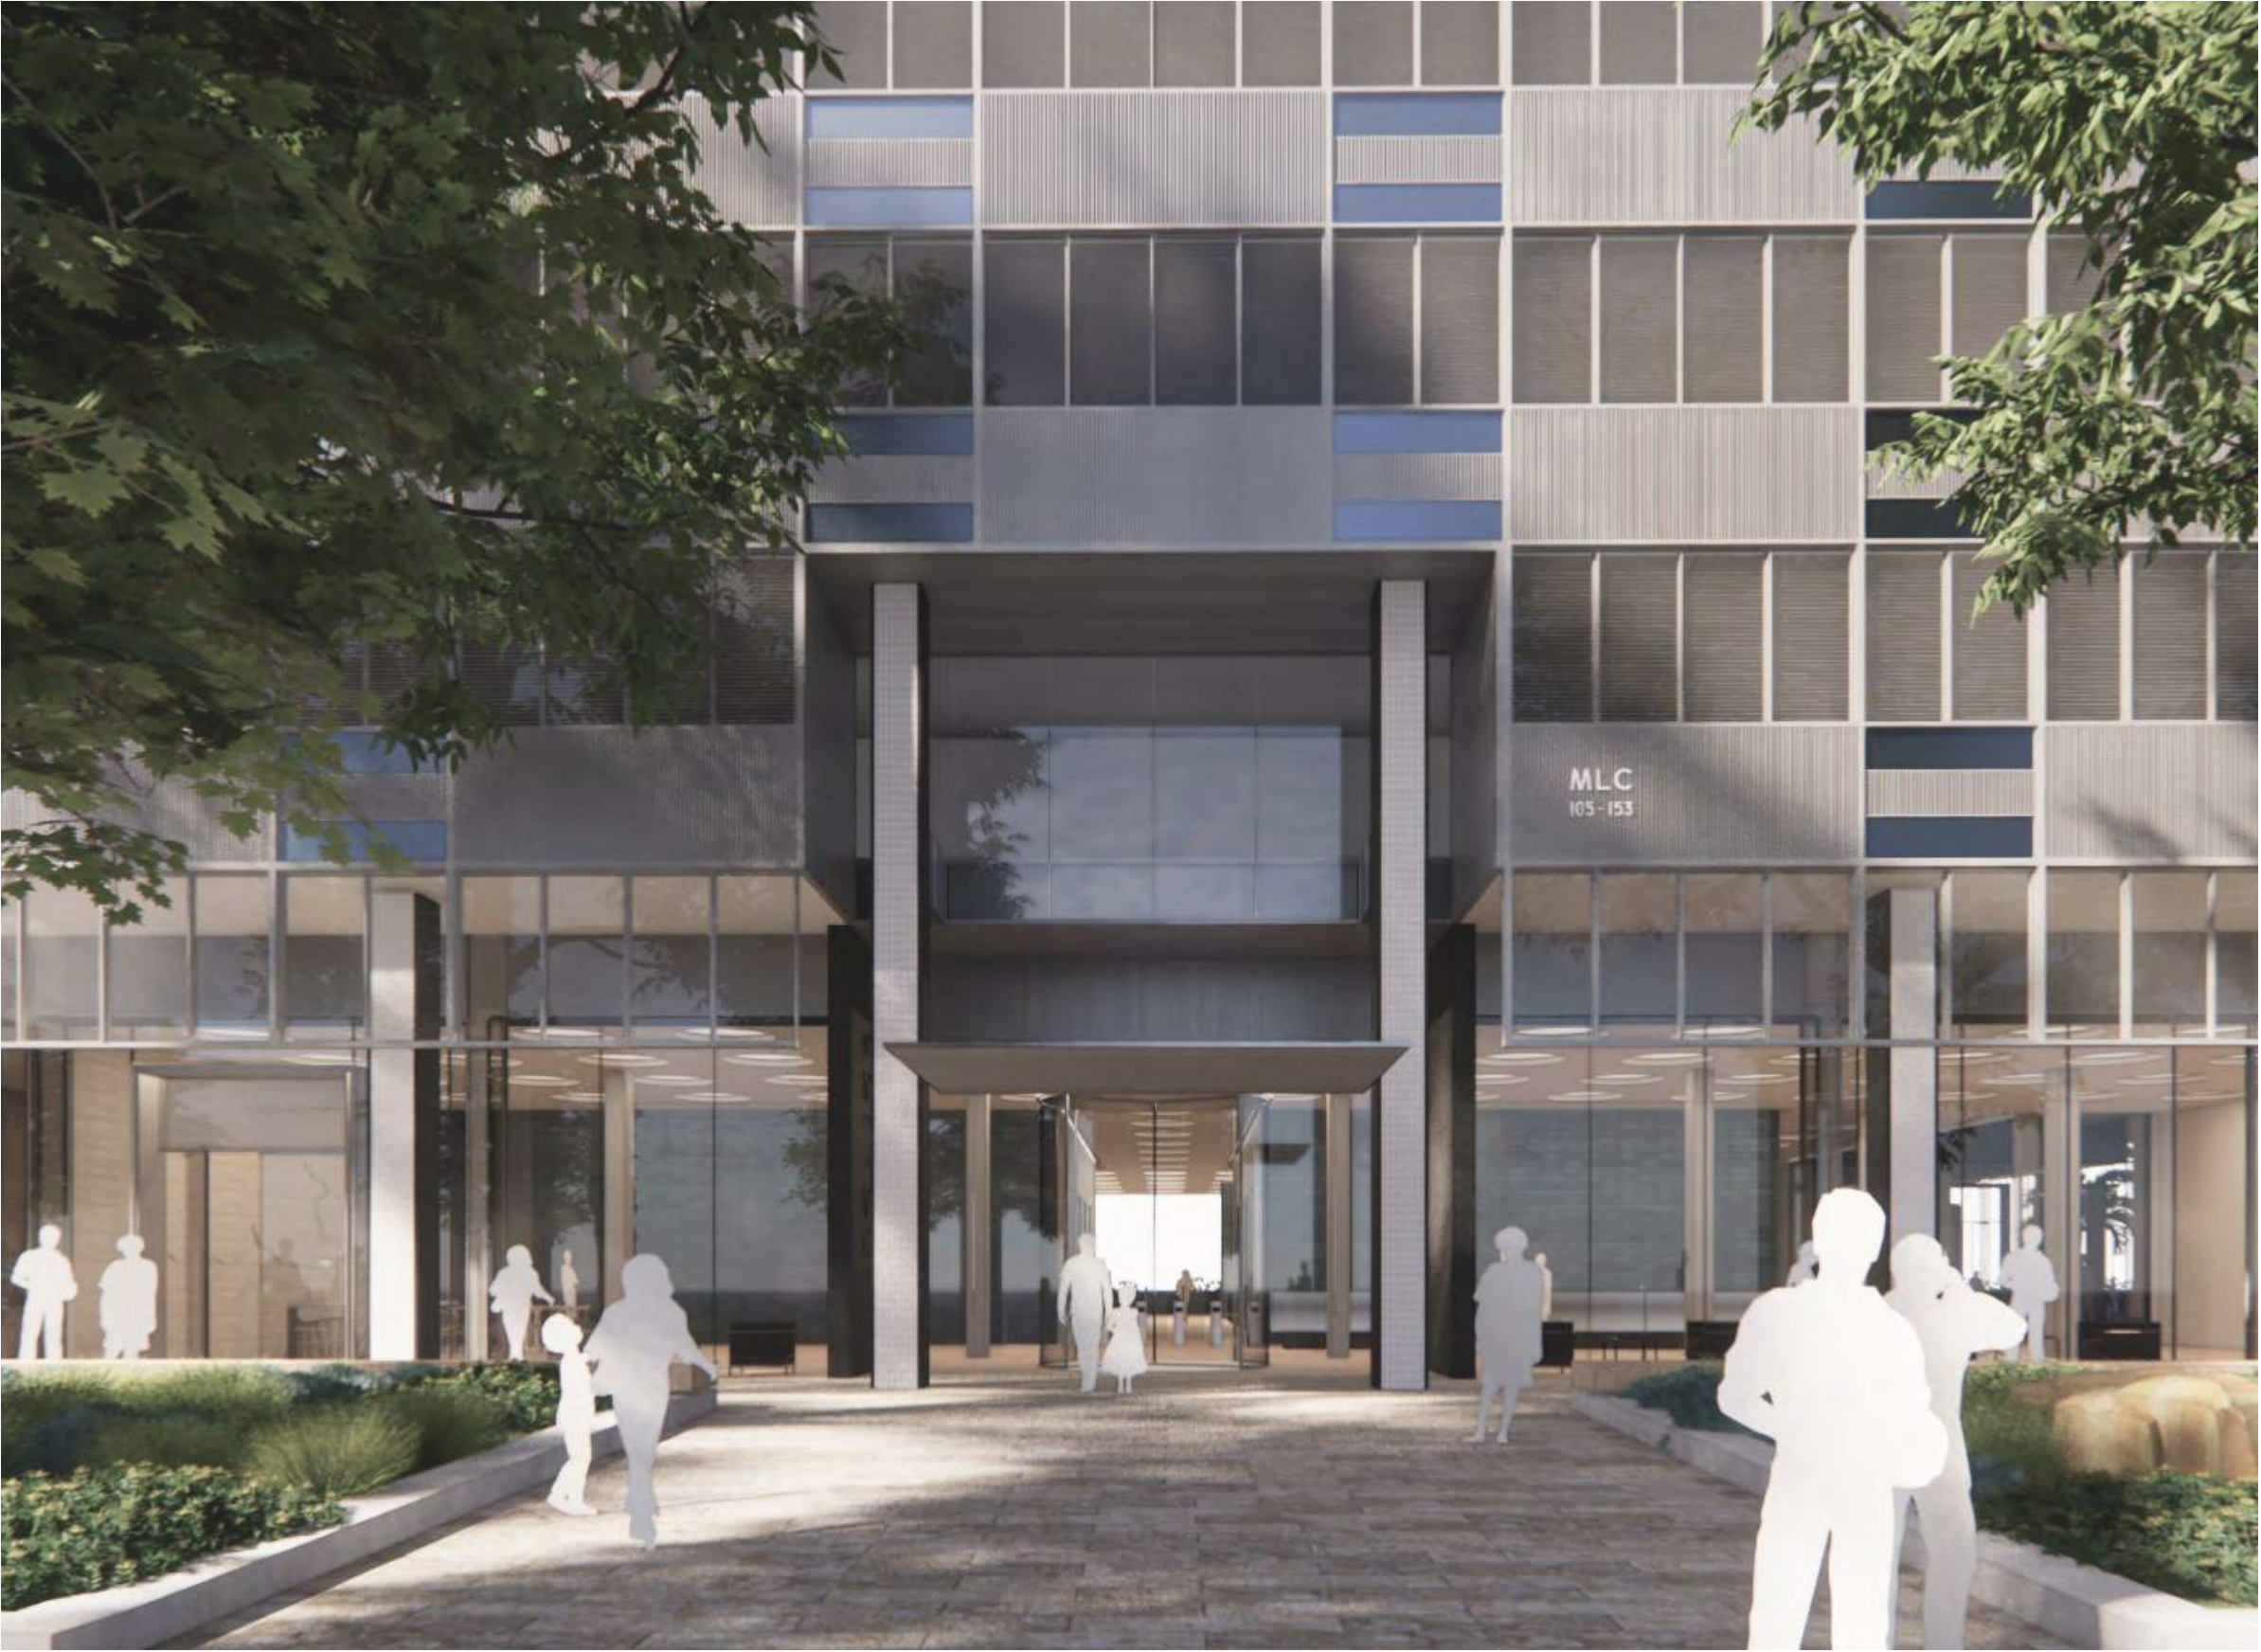
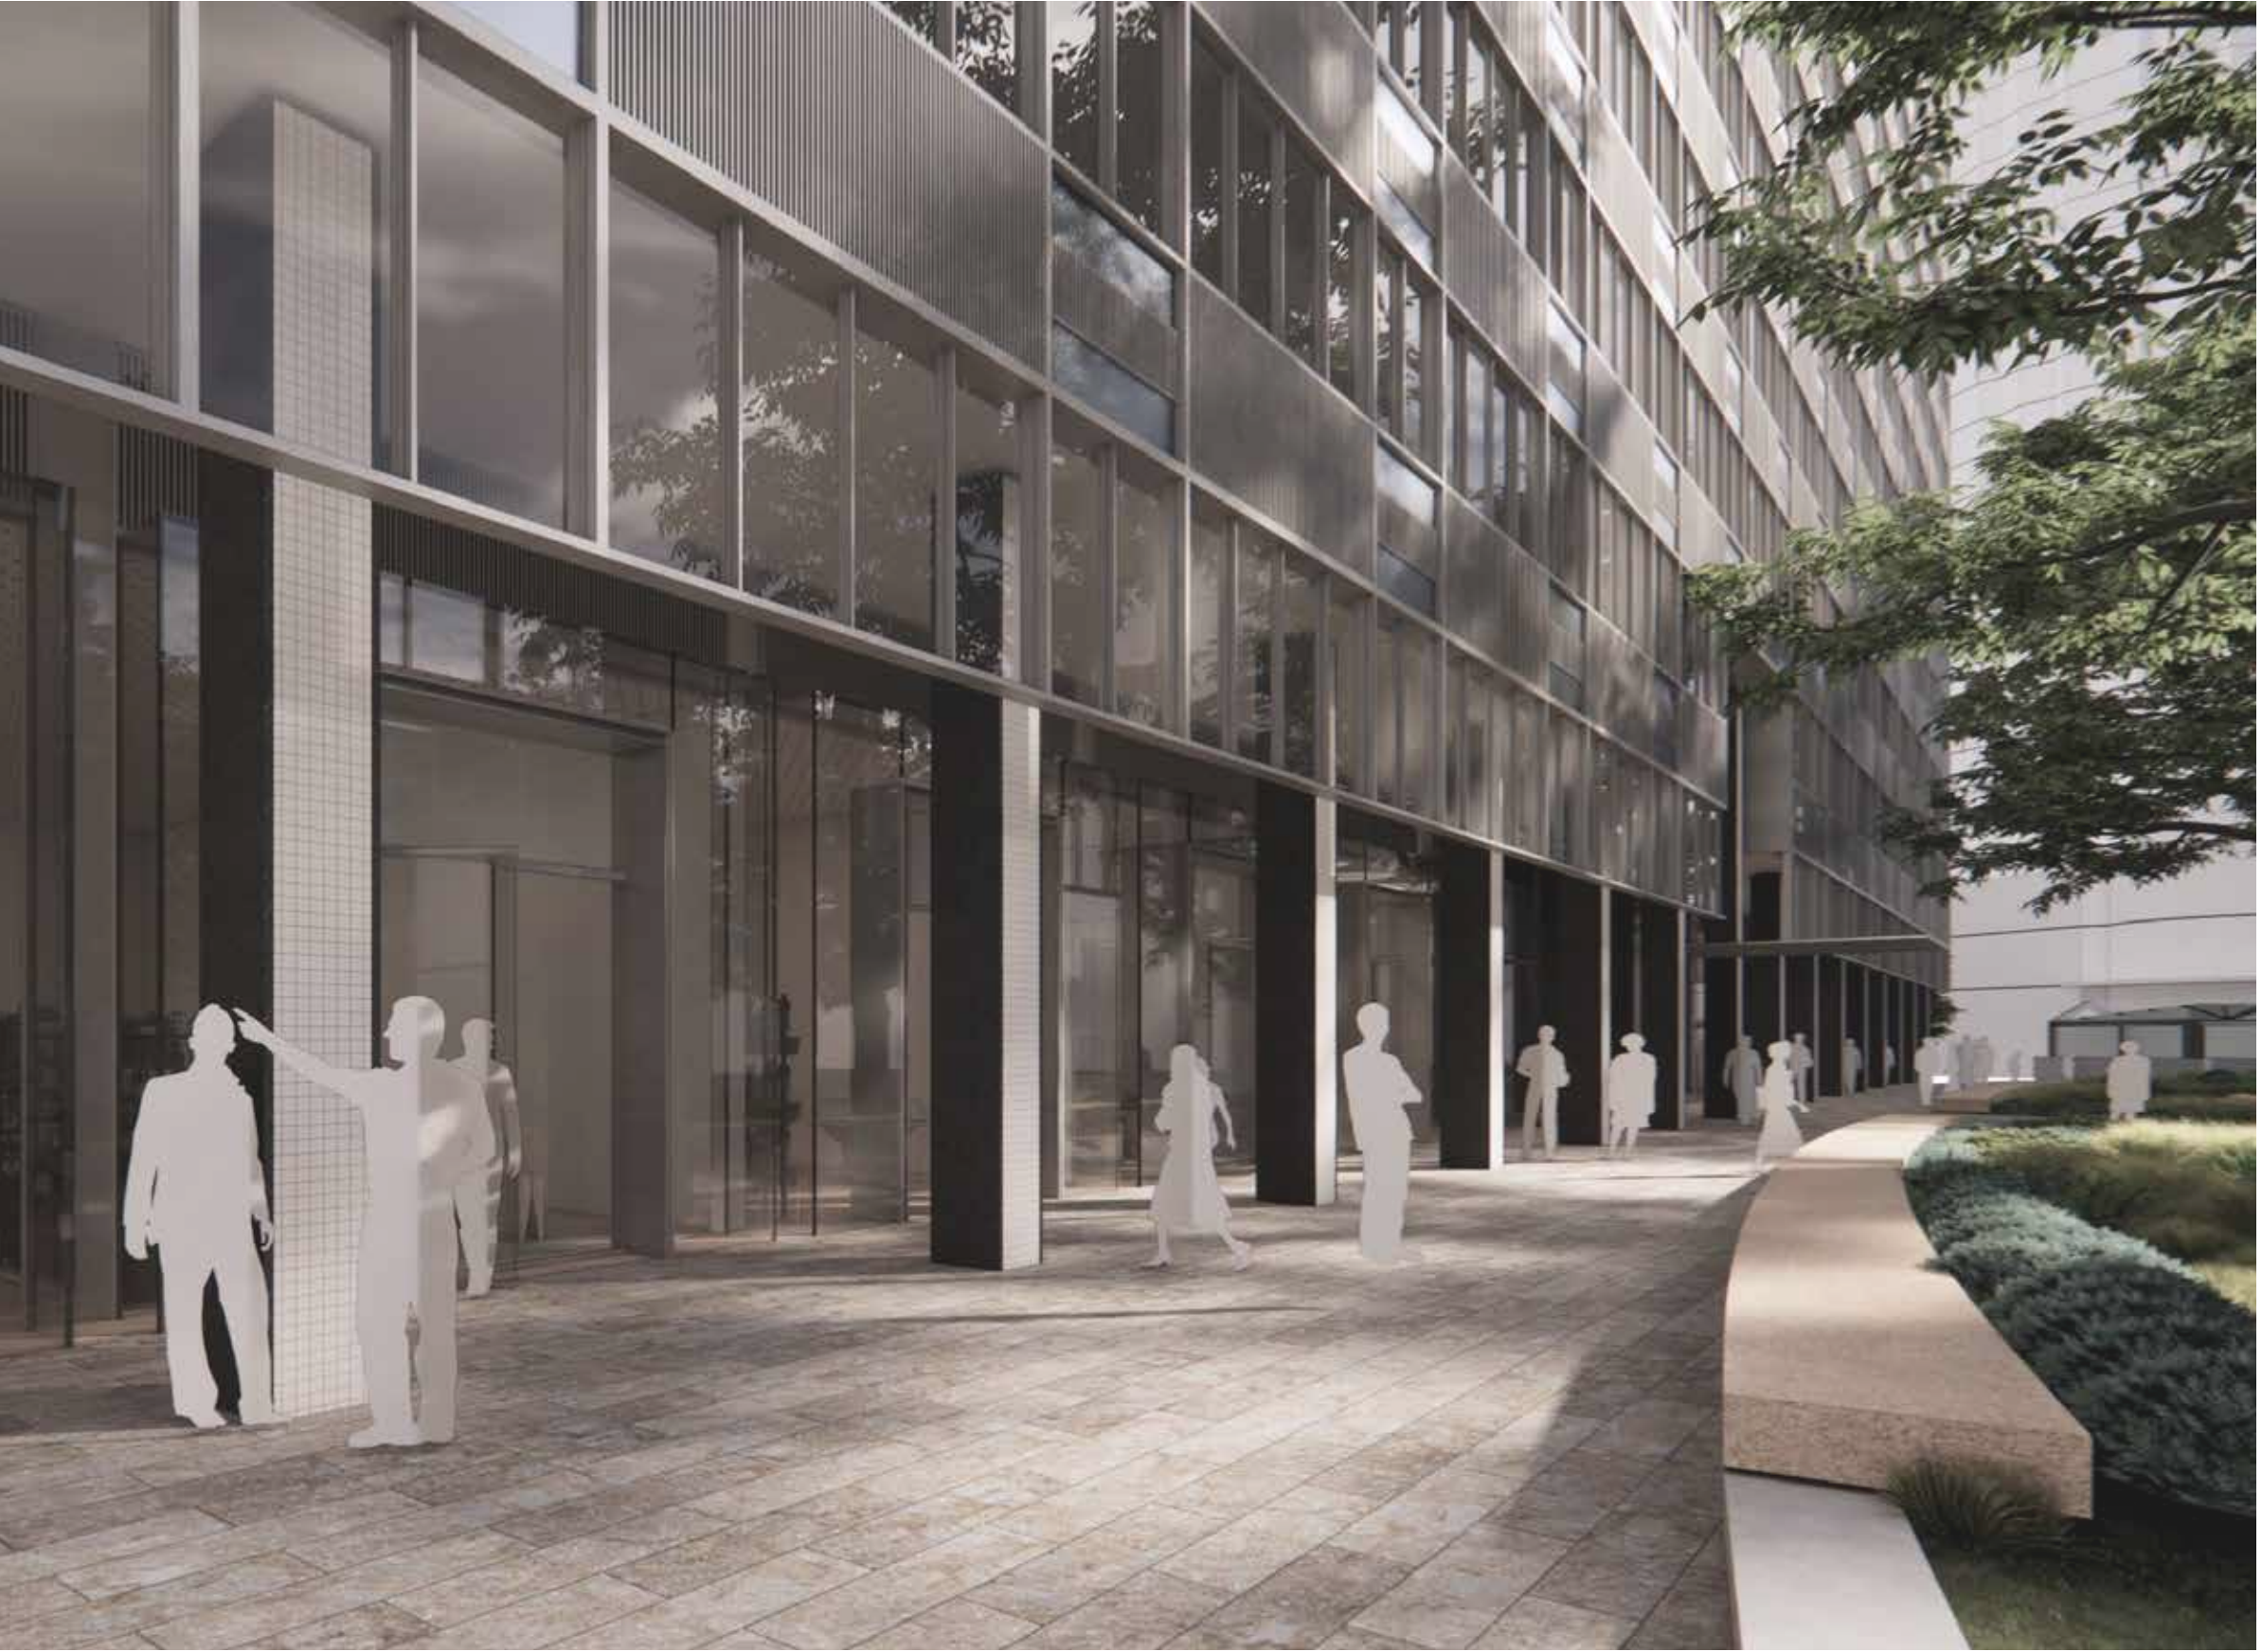
Retain L01 Glazing Only

NOT RECOMMENDED

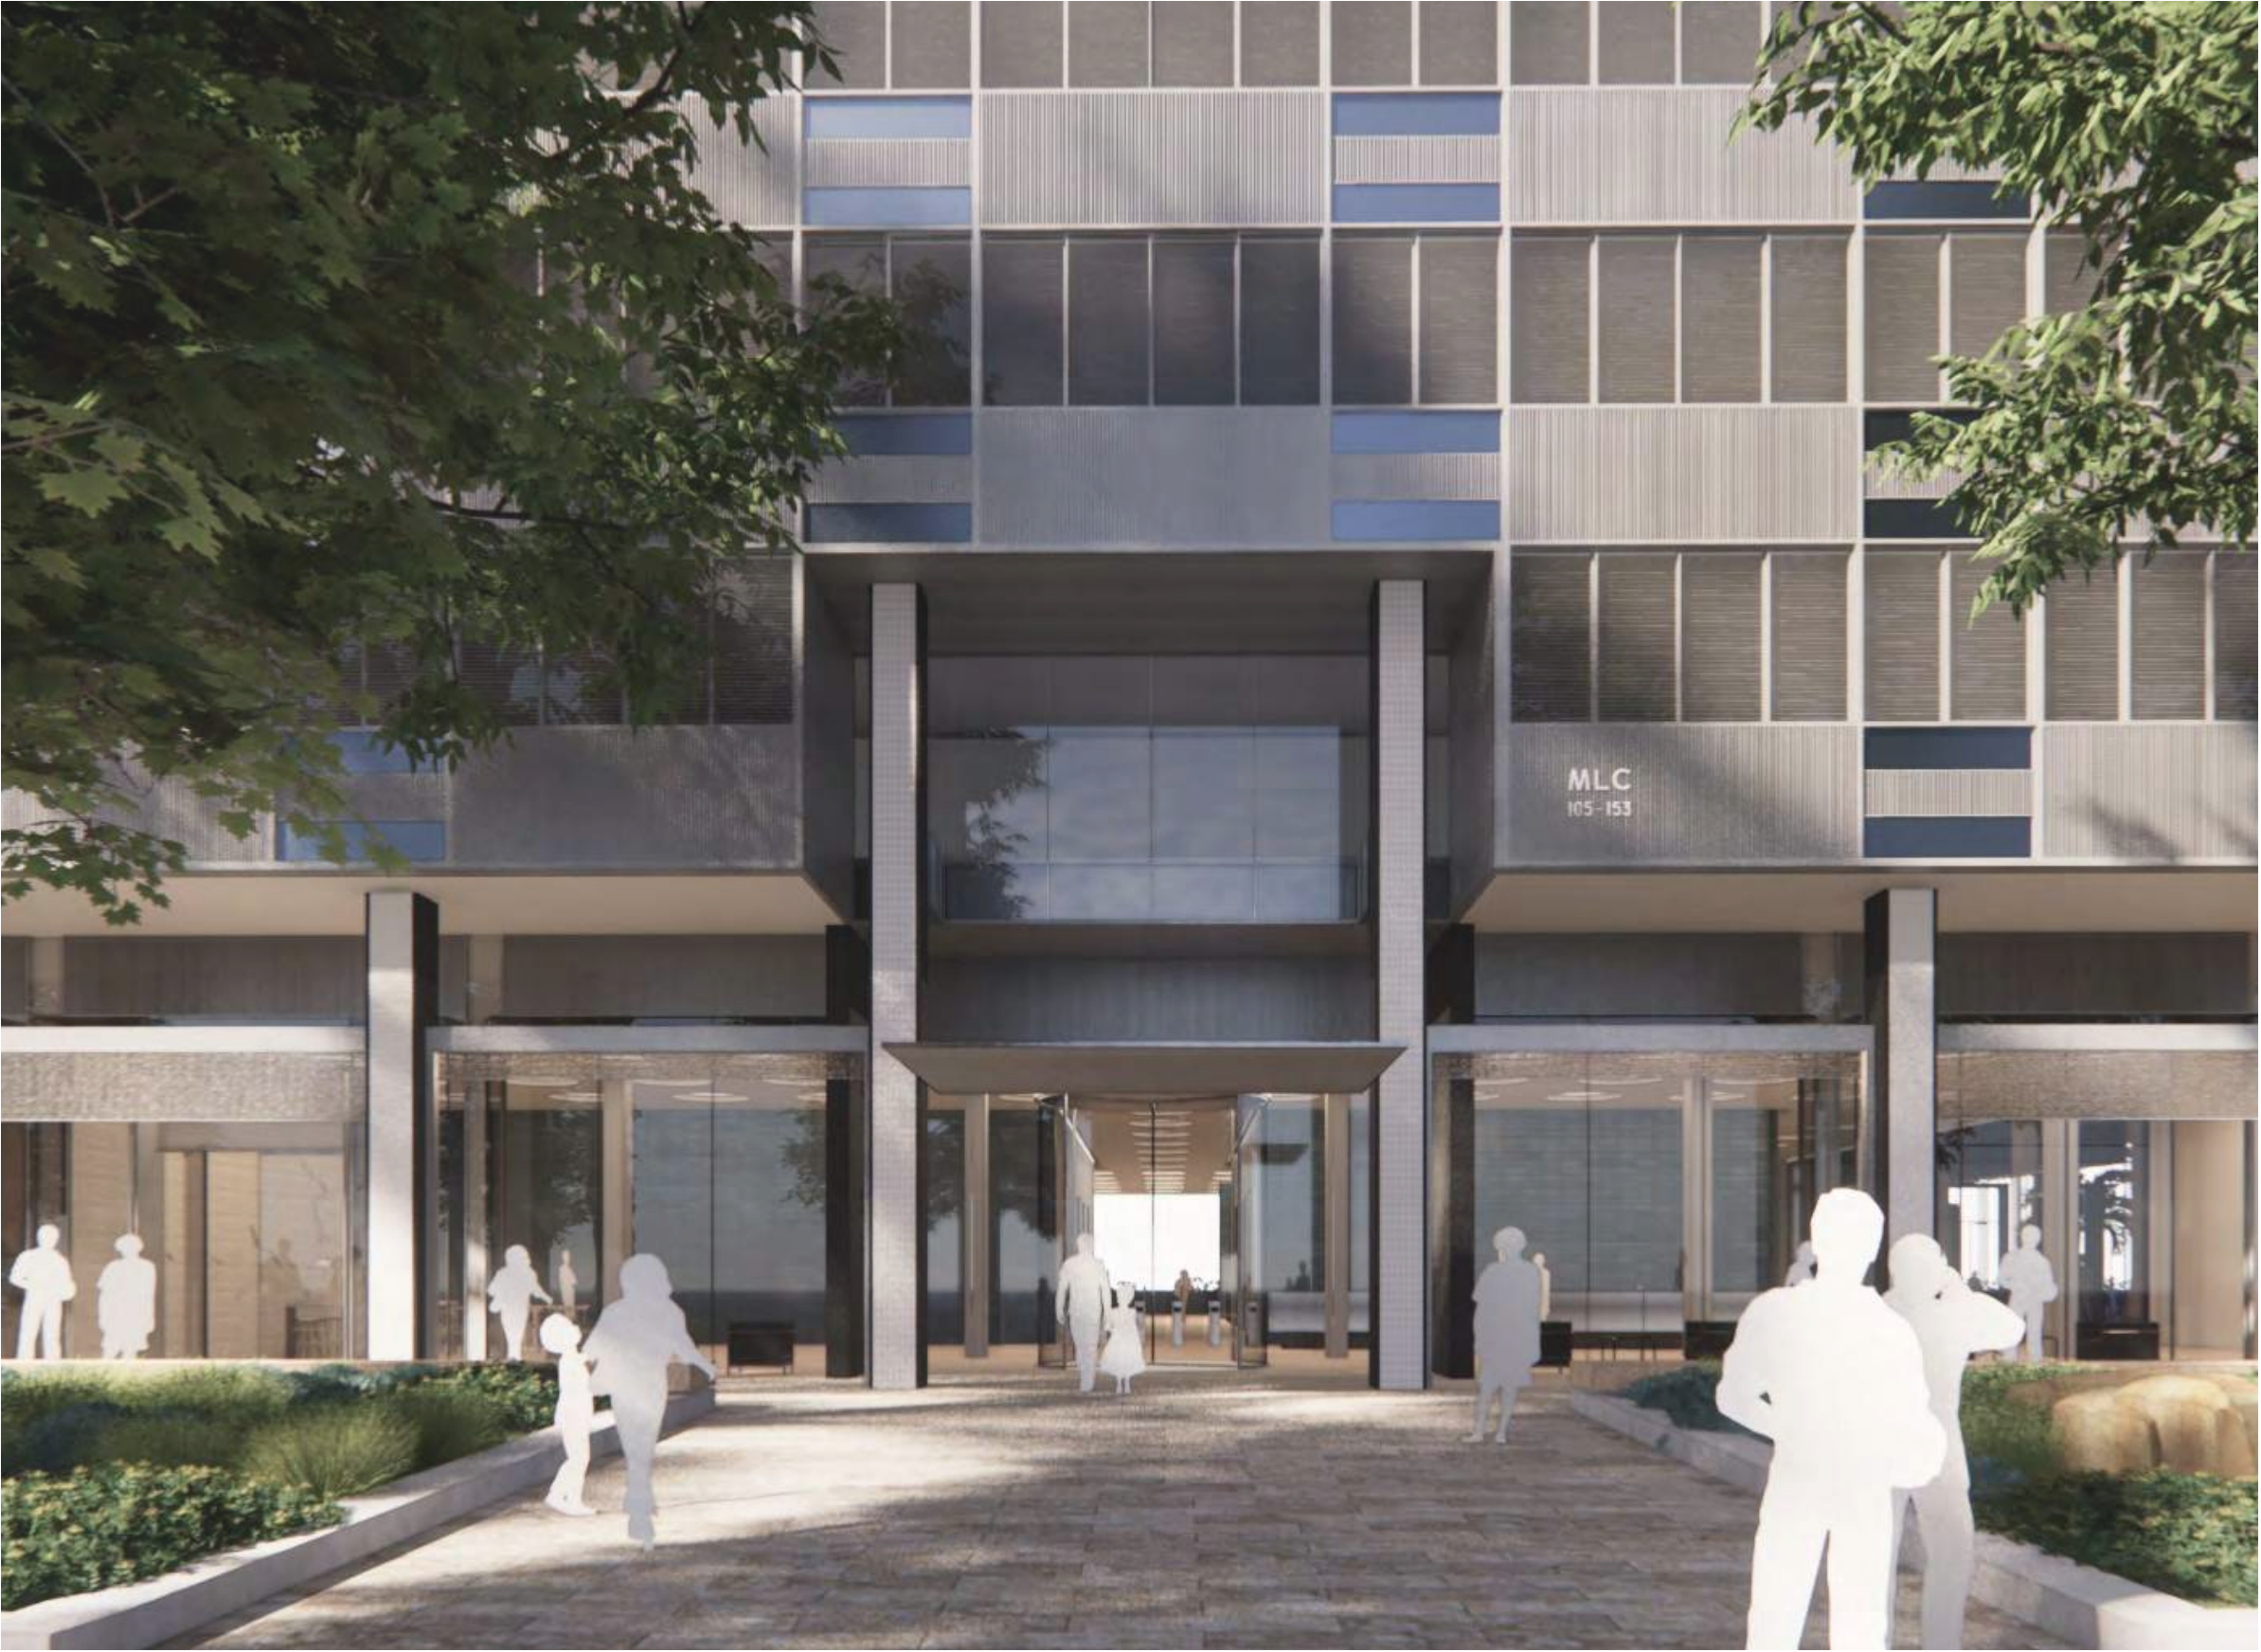
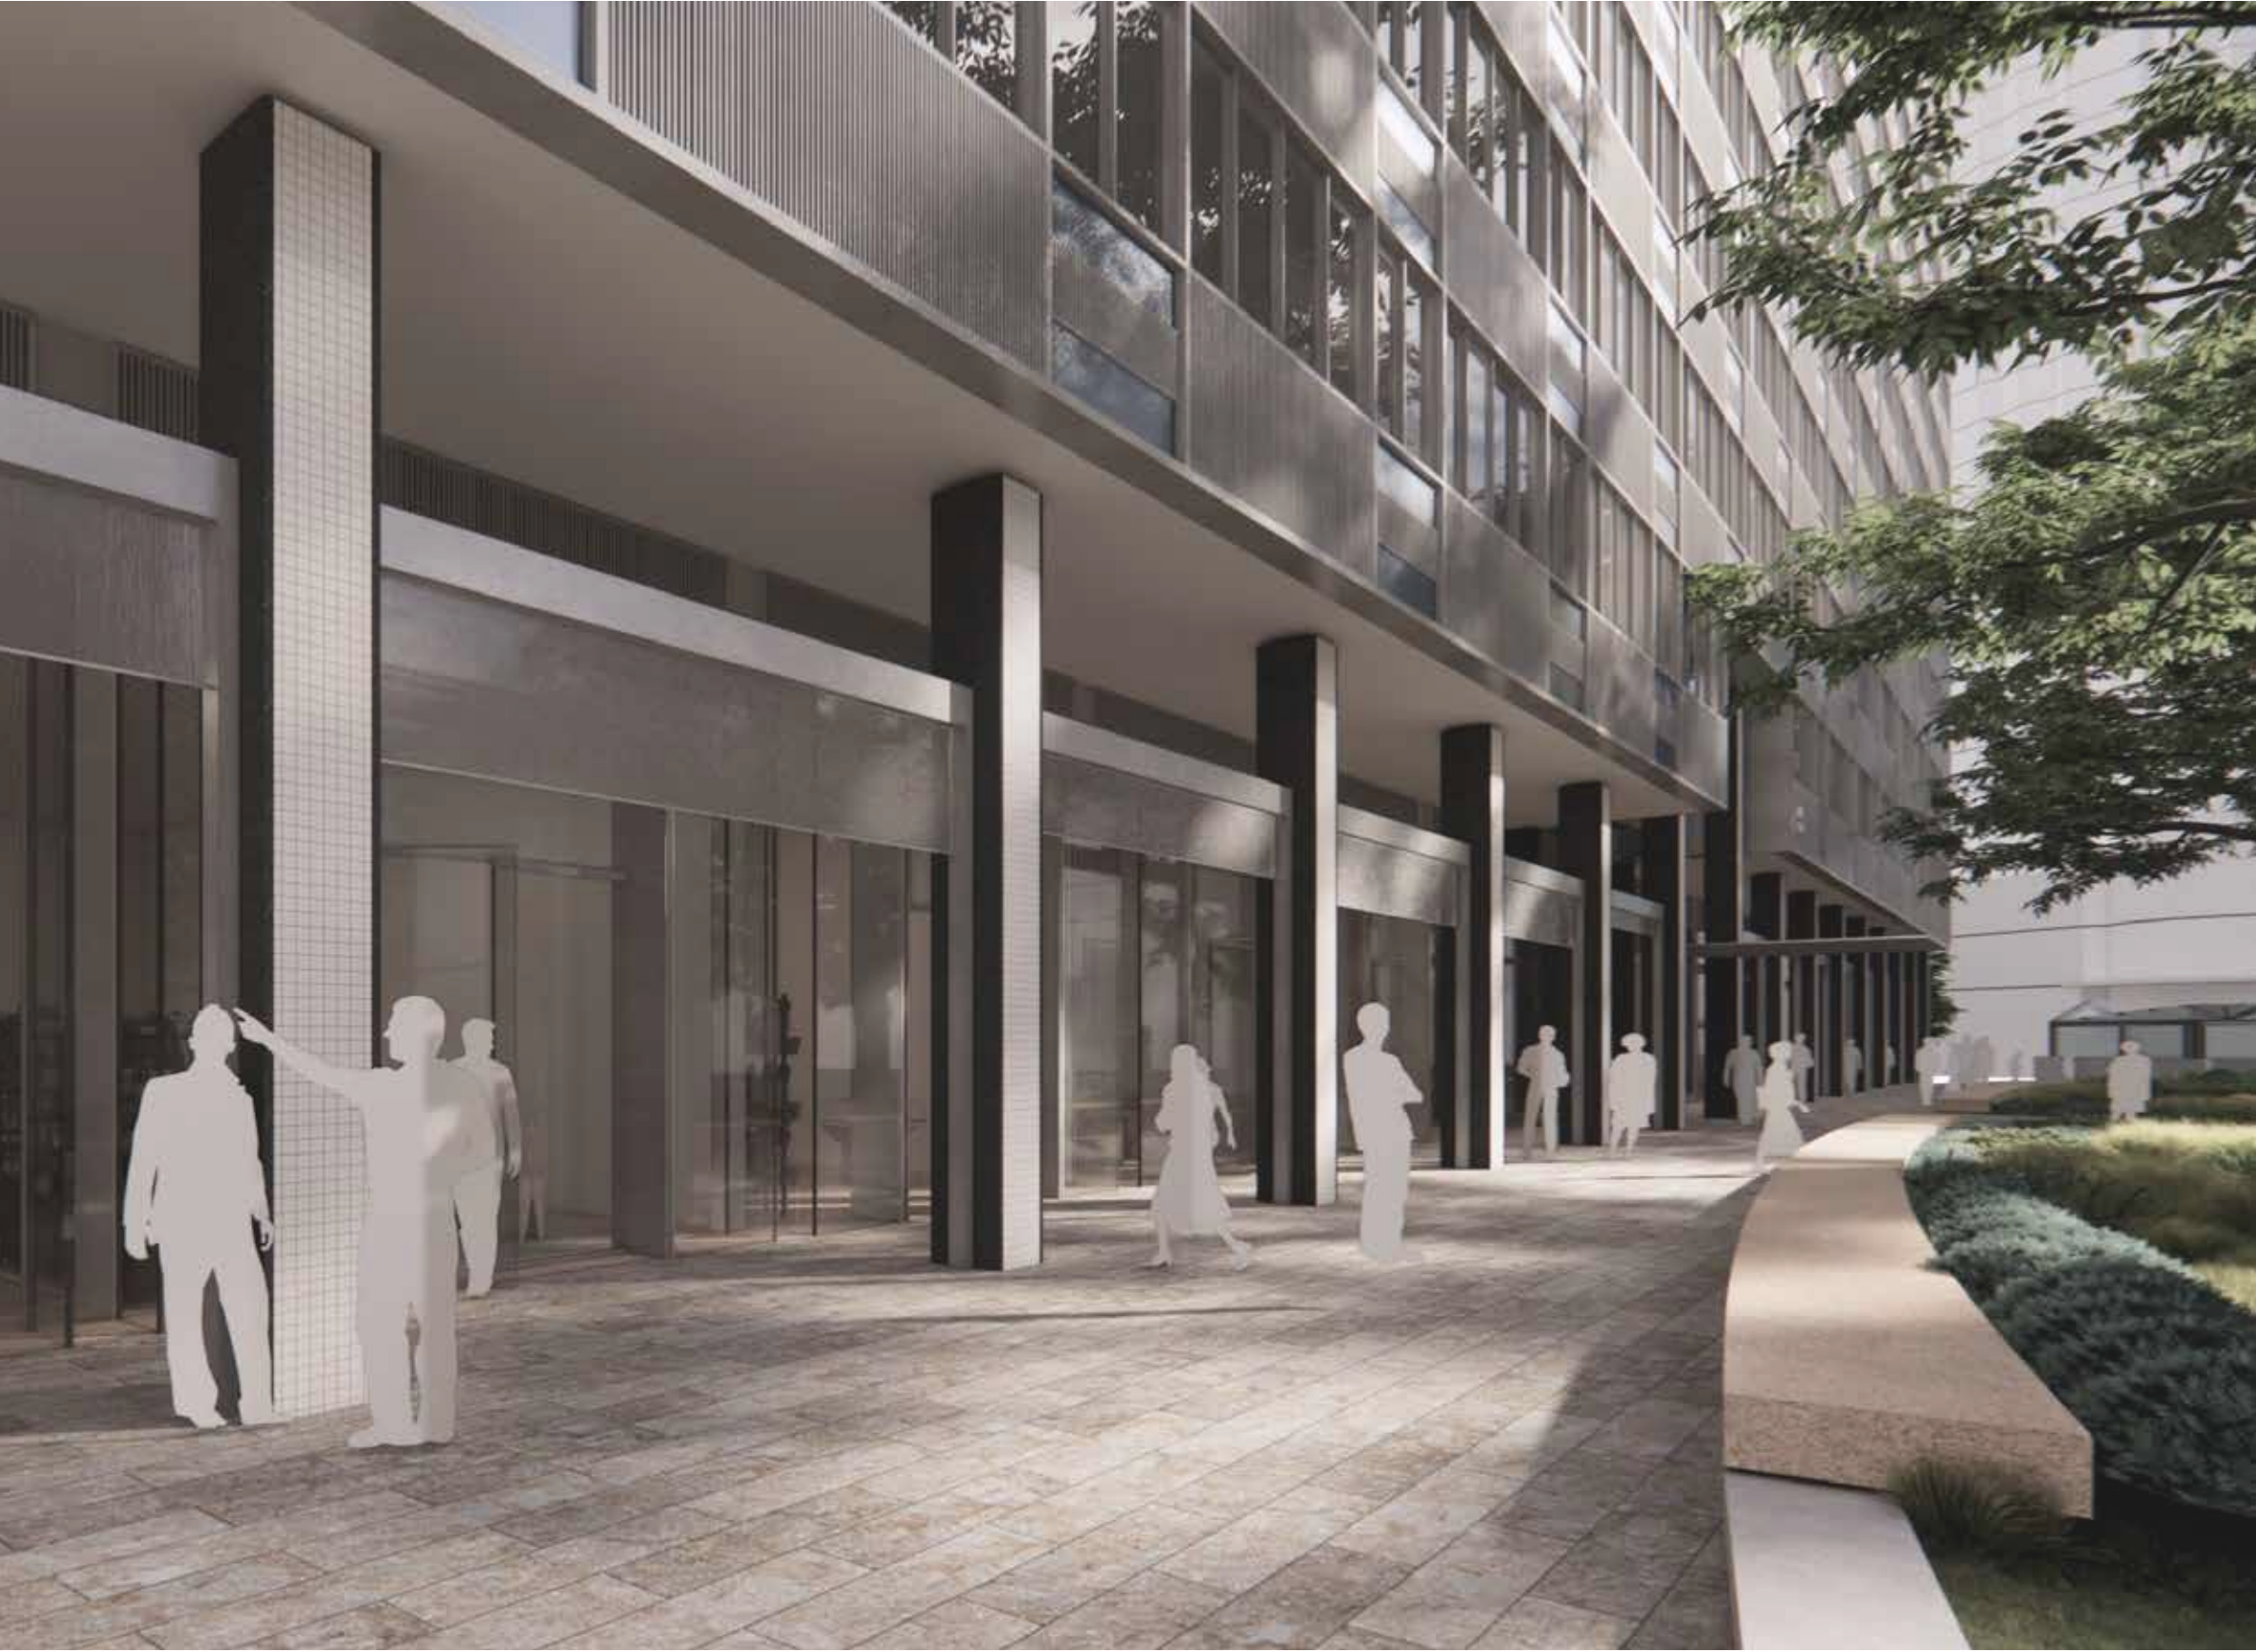
Reinstate Original Blinds

NOT RECOMMENDED

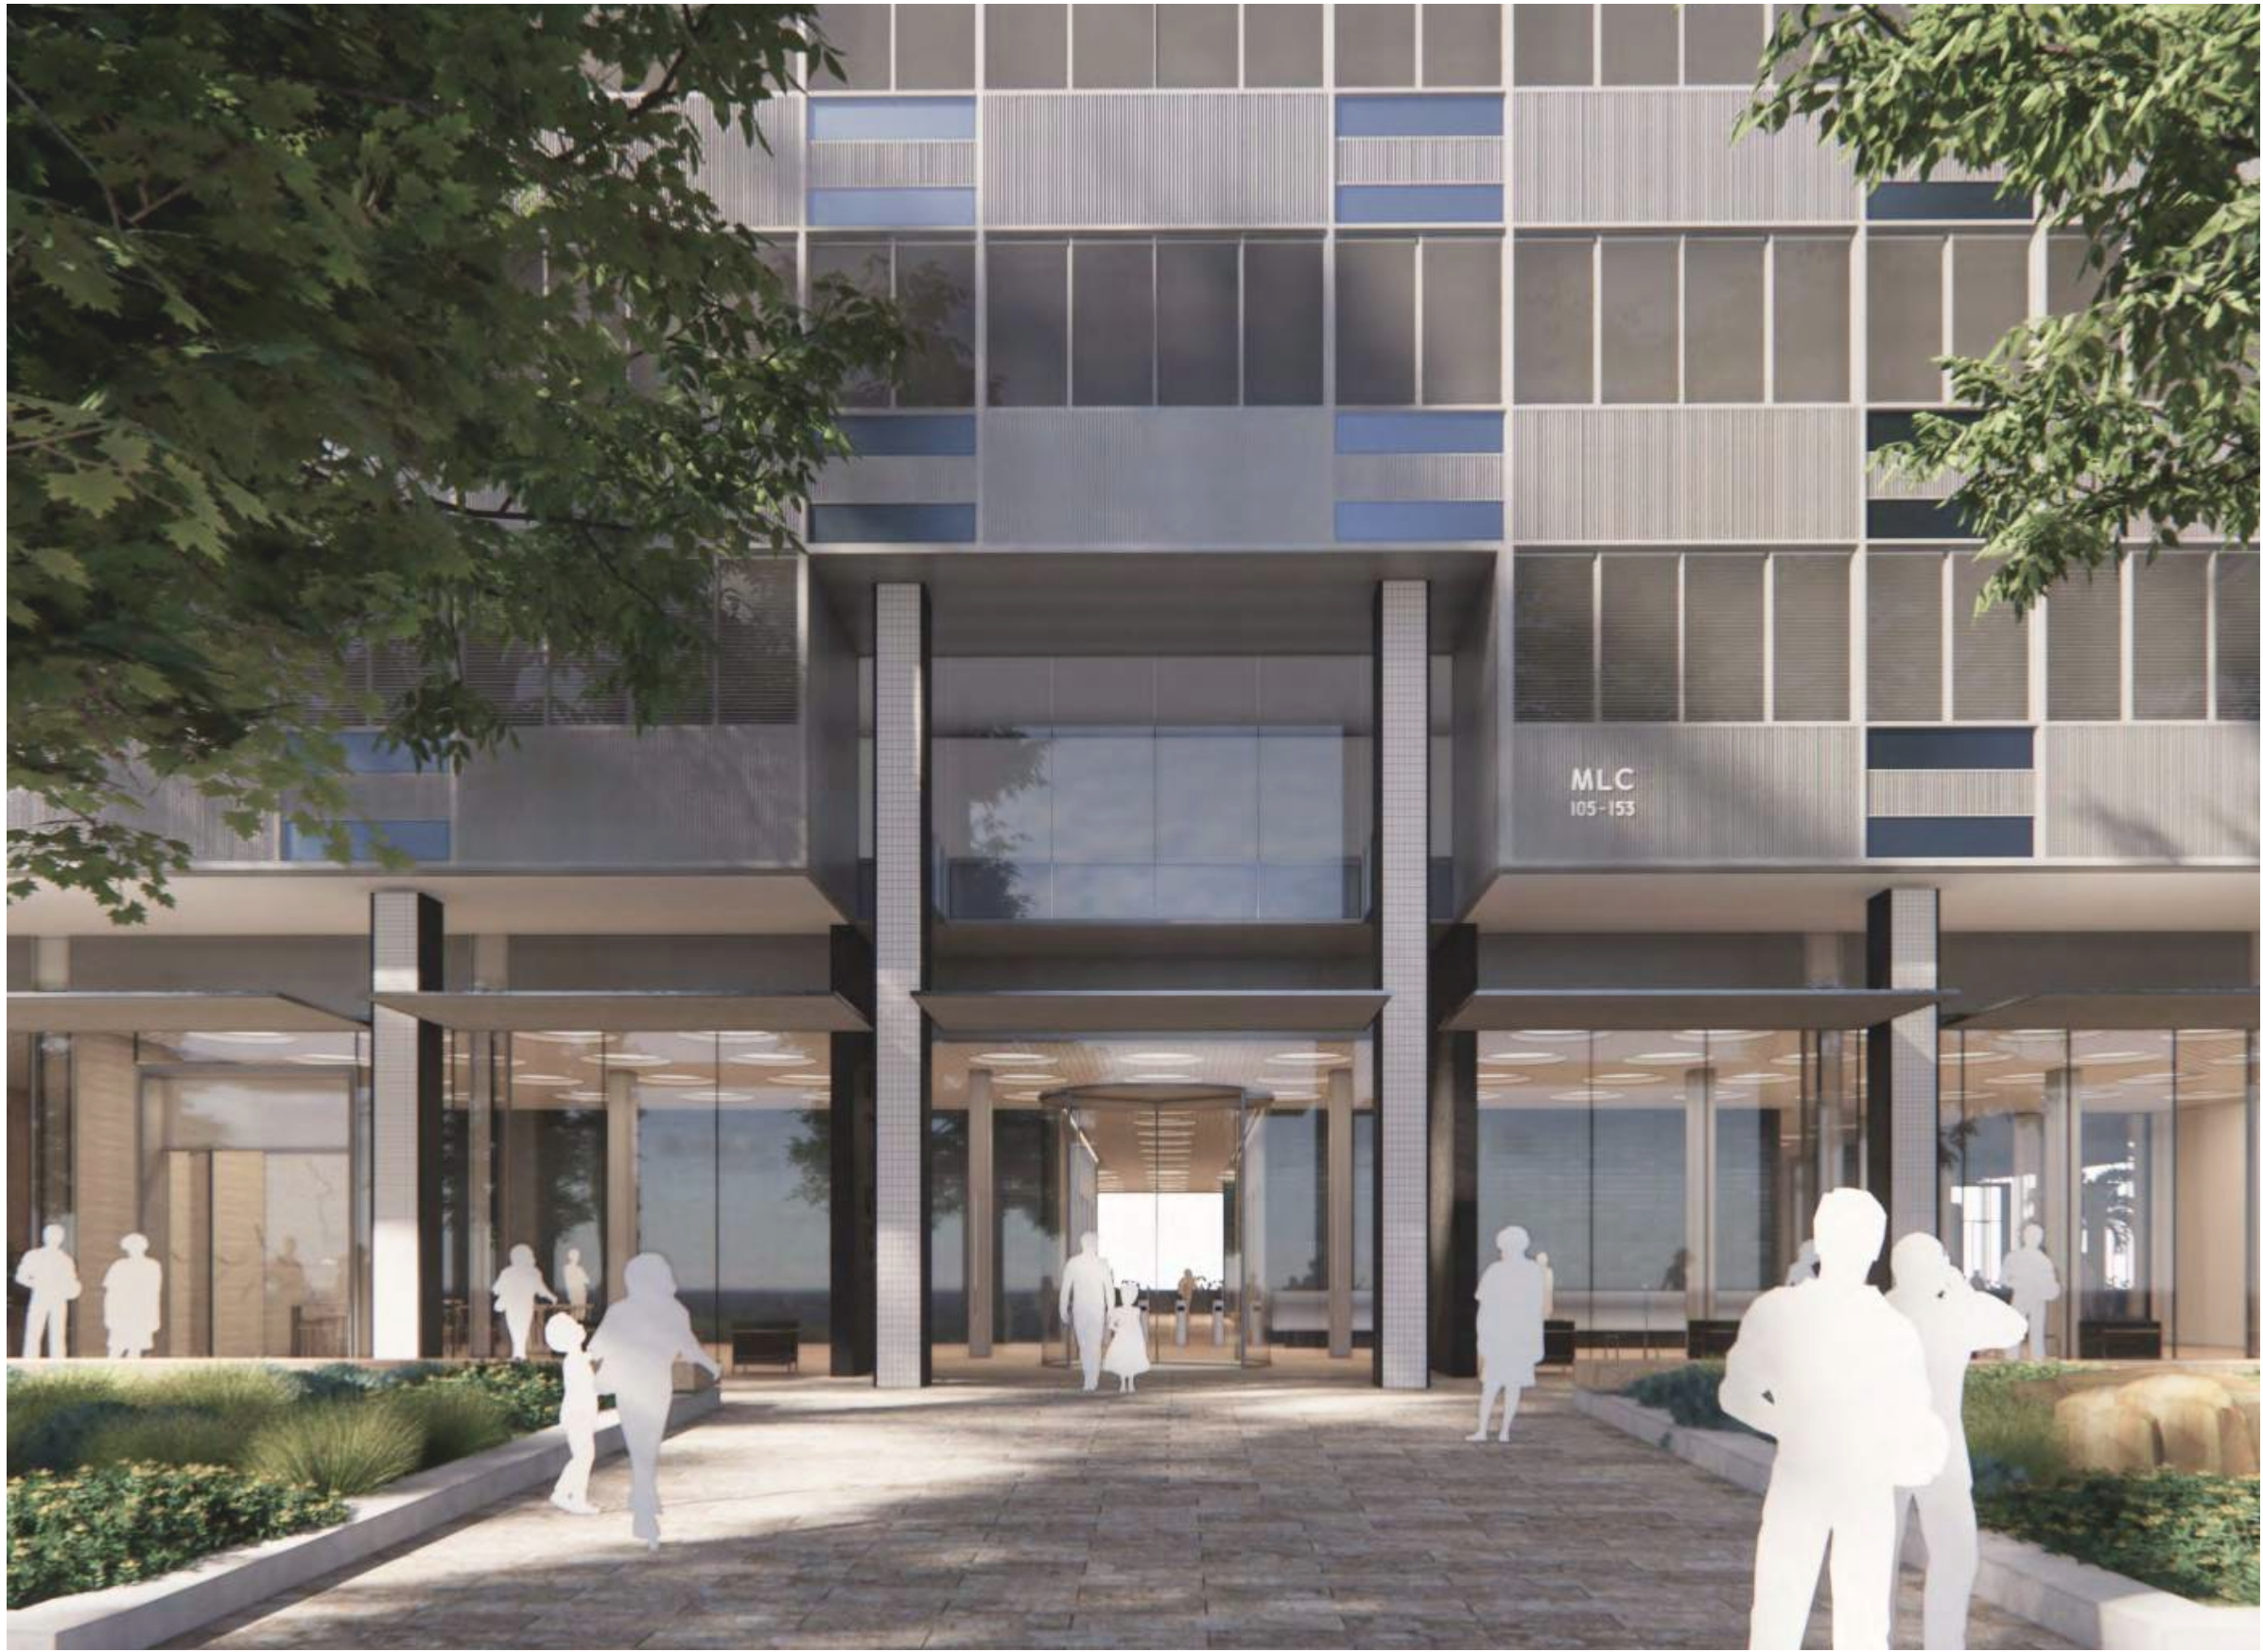
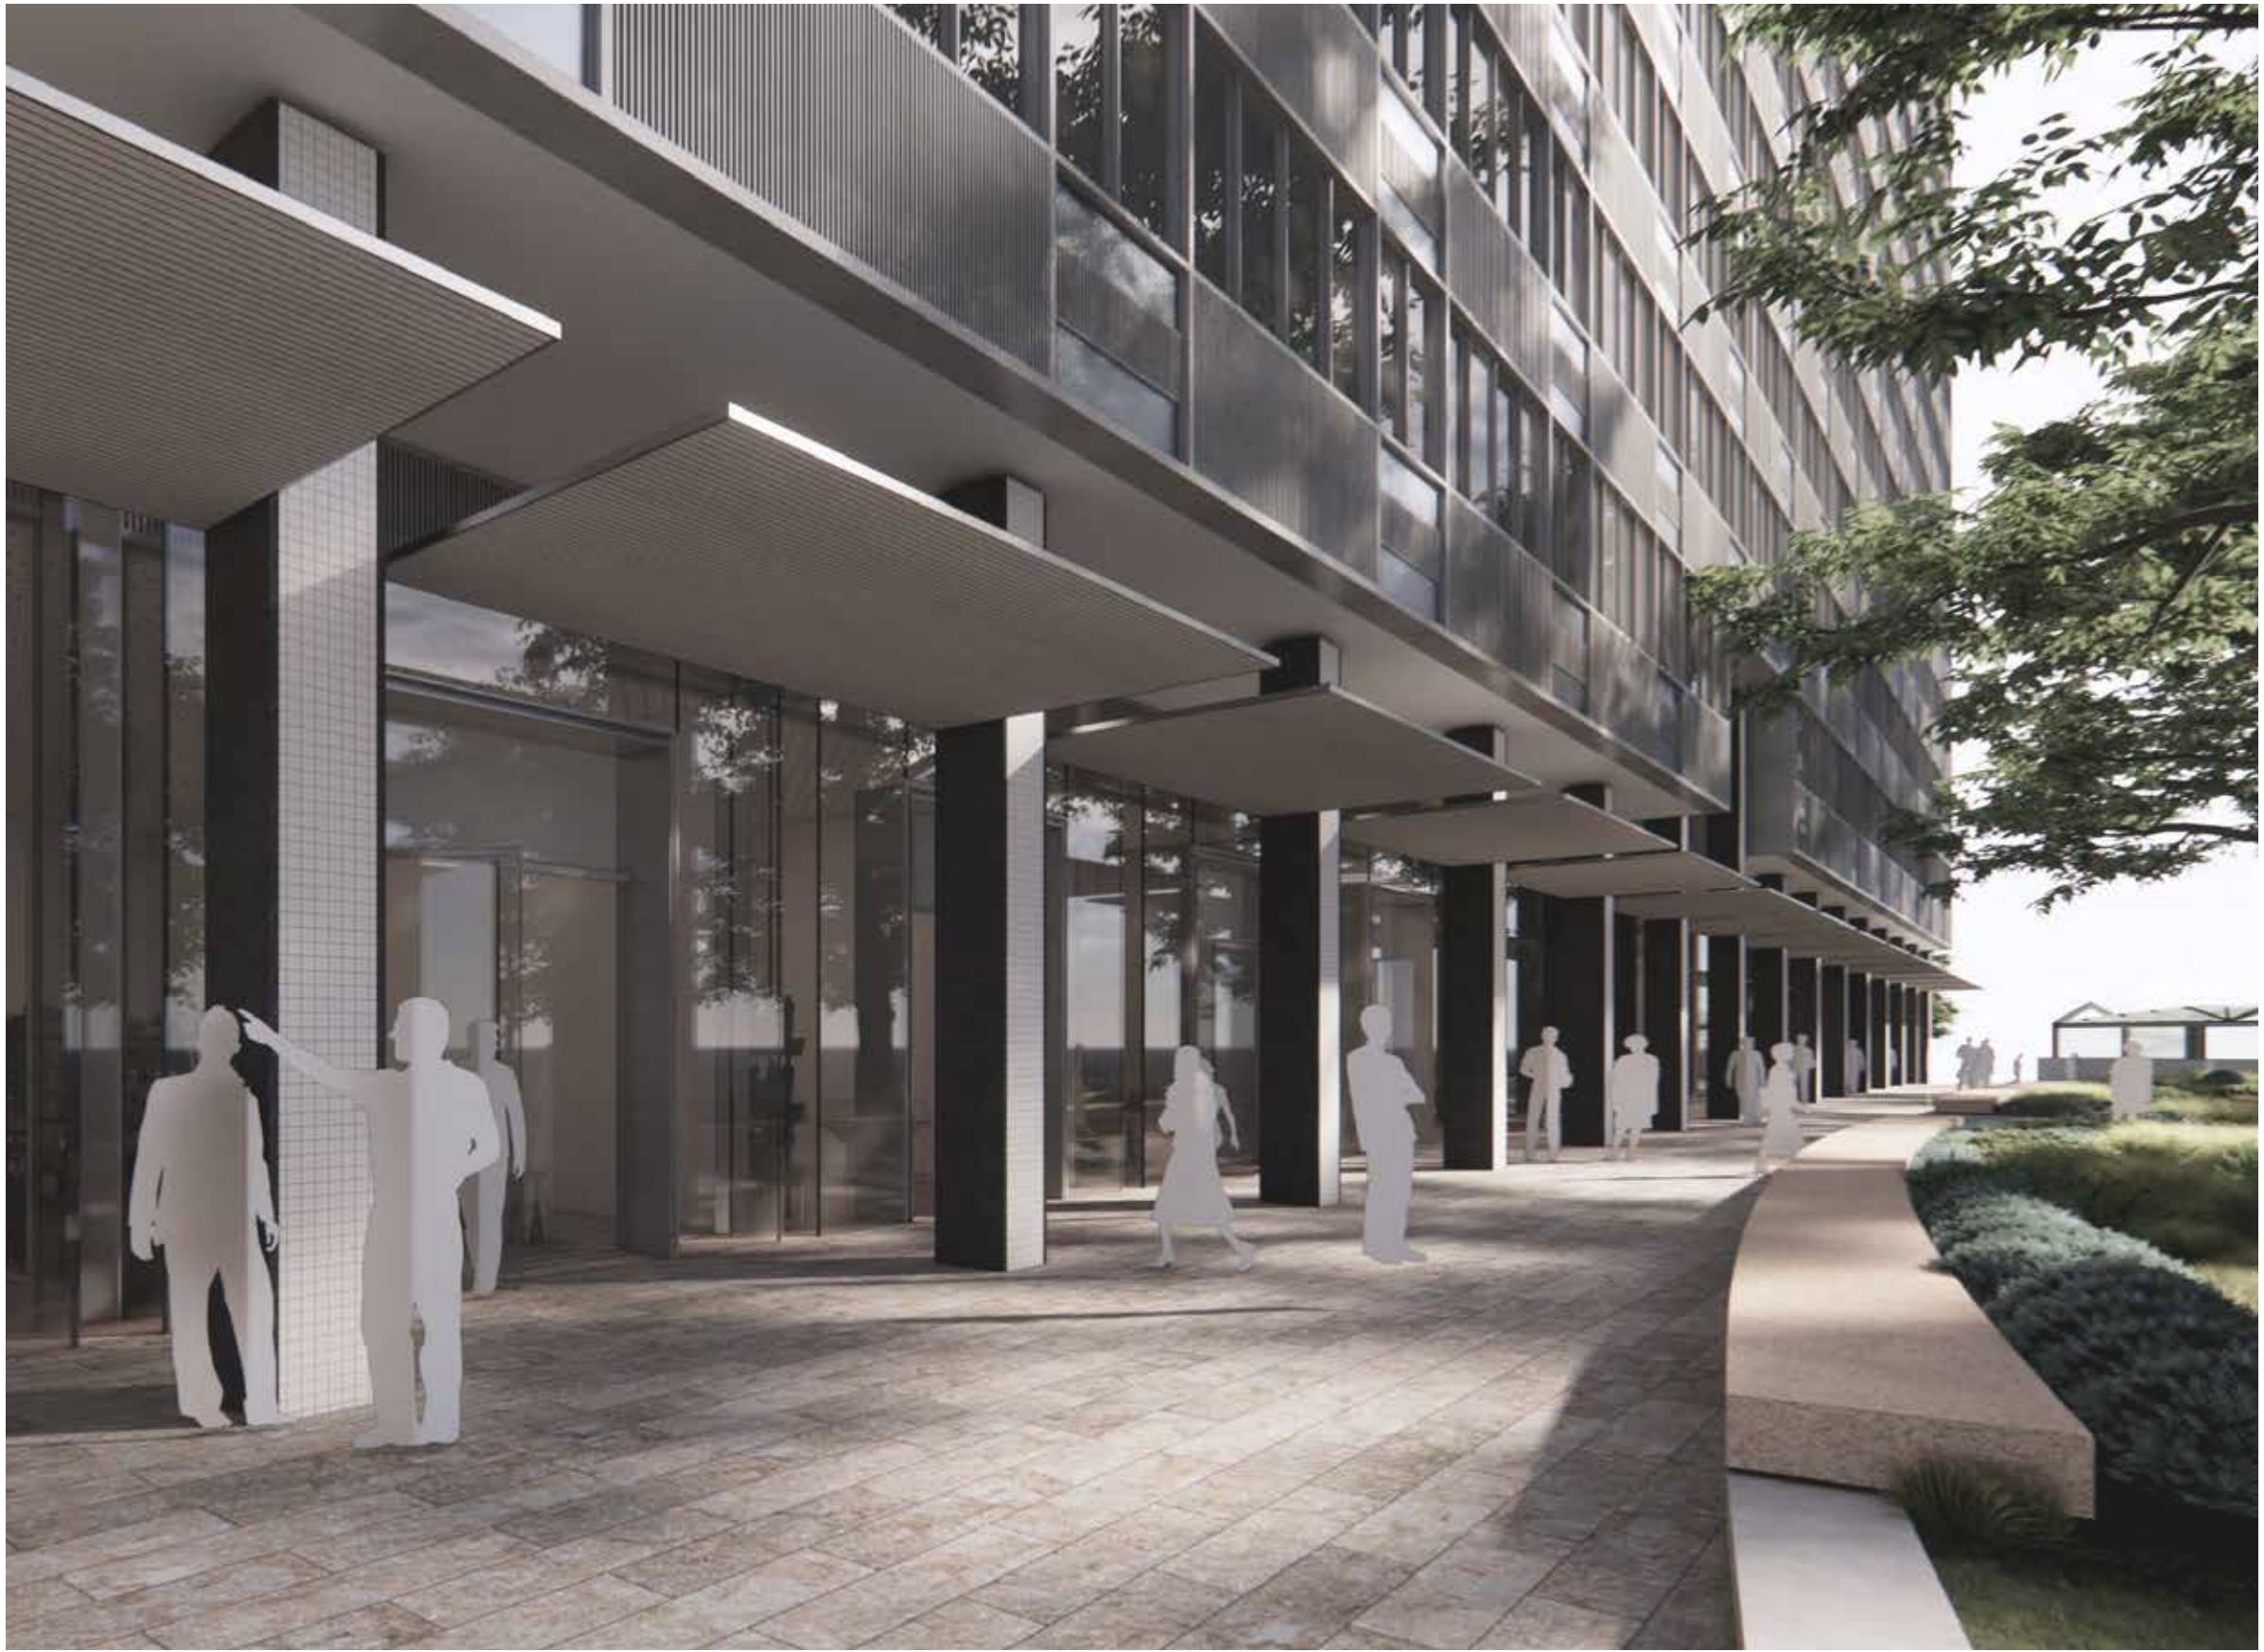
Introduce Awning

NOT RECOMMENDED
