105 Miller St

Heritage Presentation

Investa

May 2025

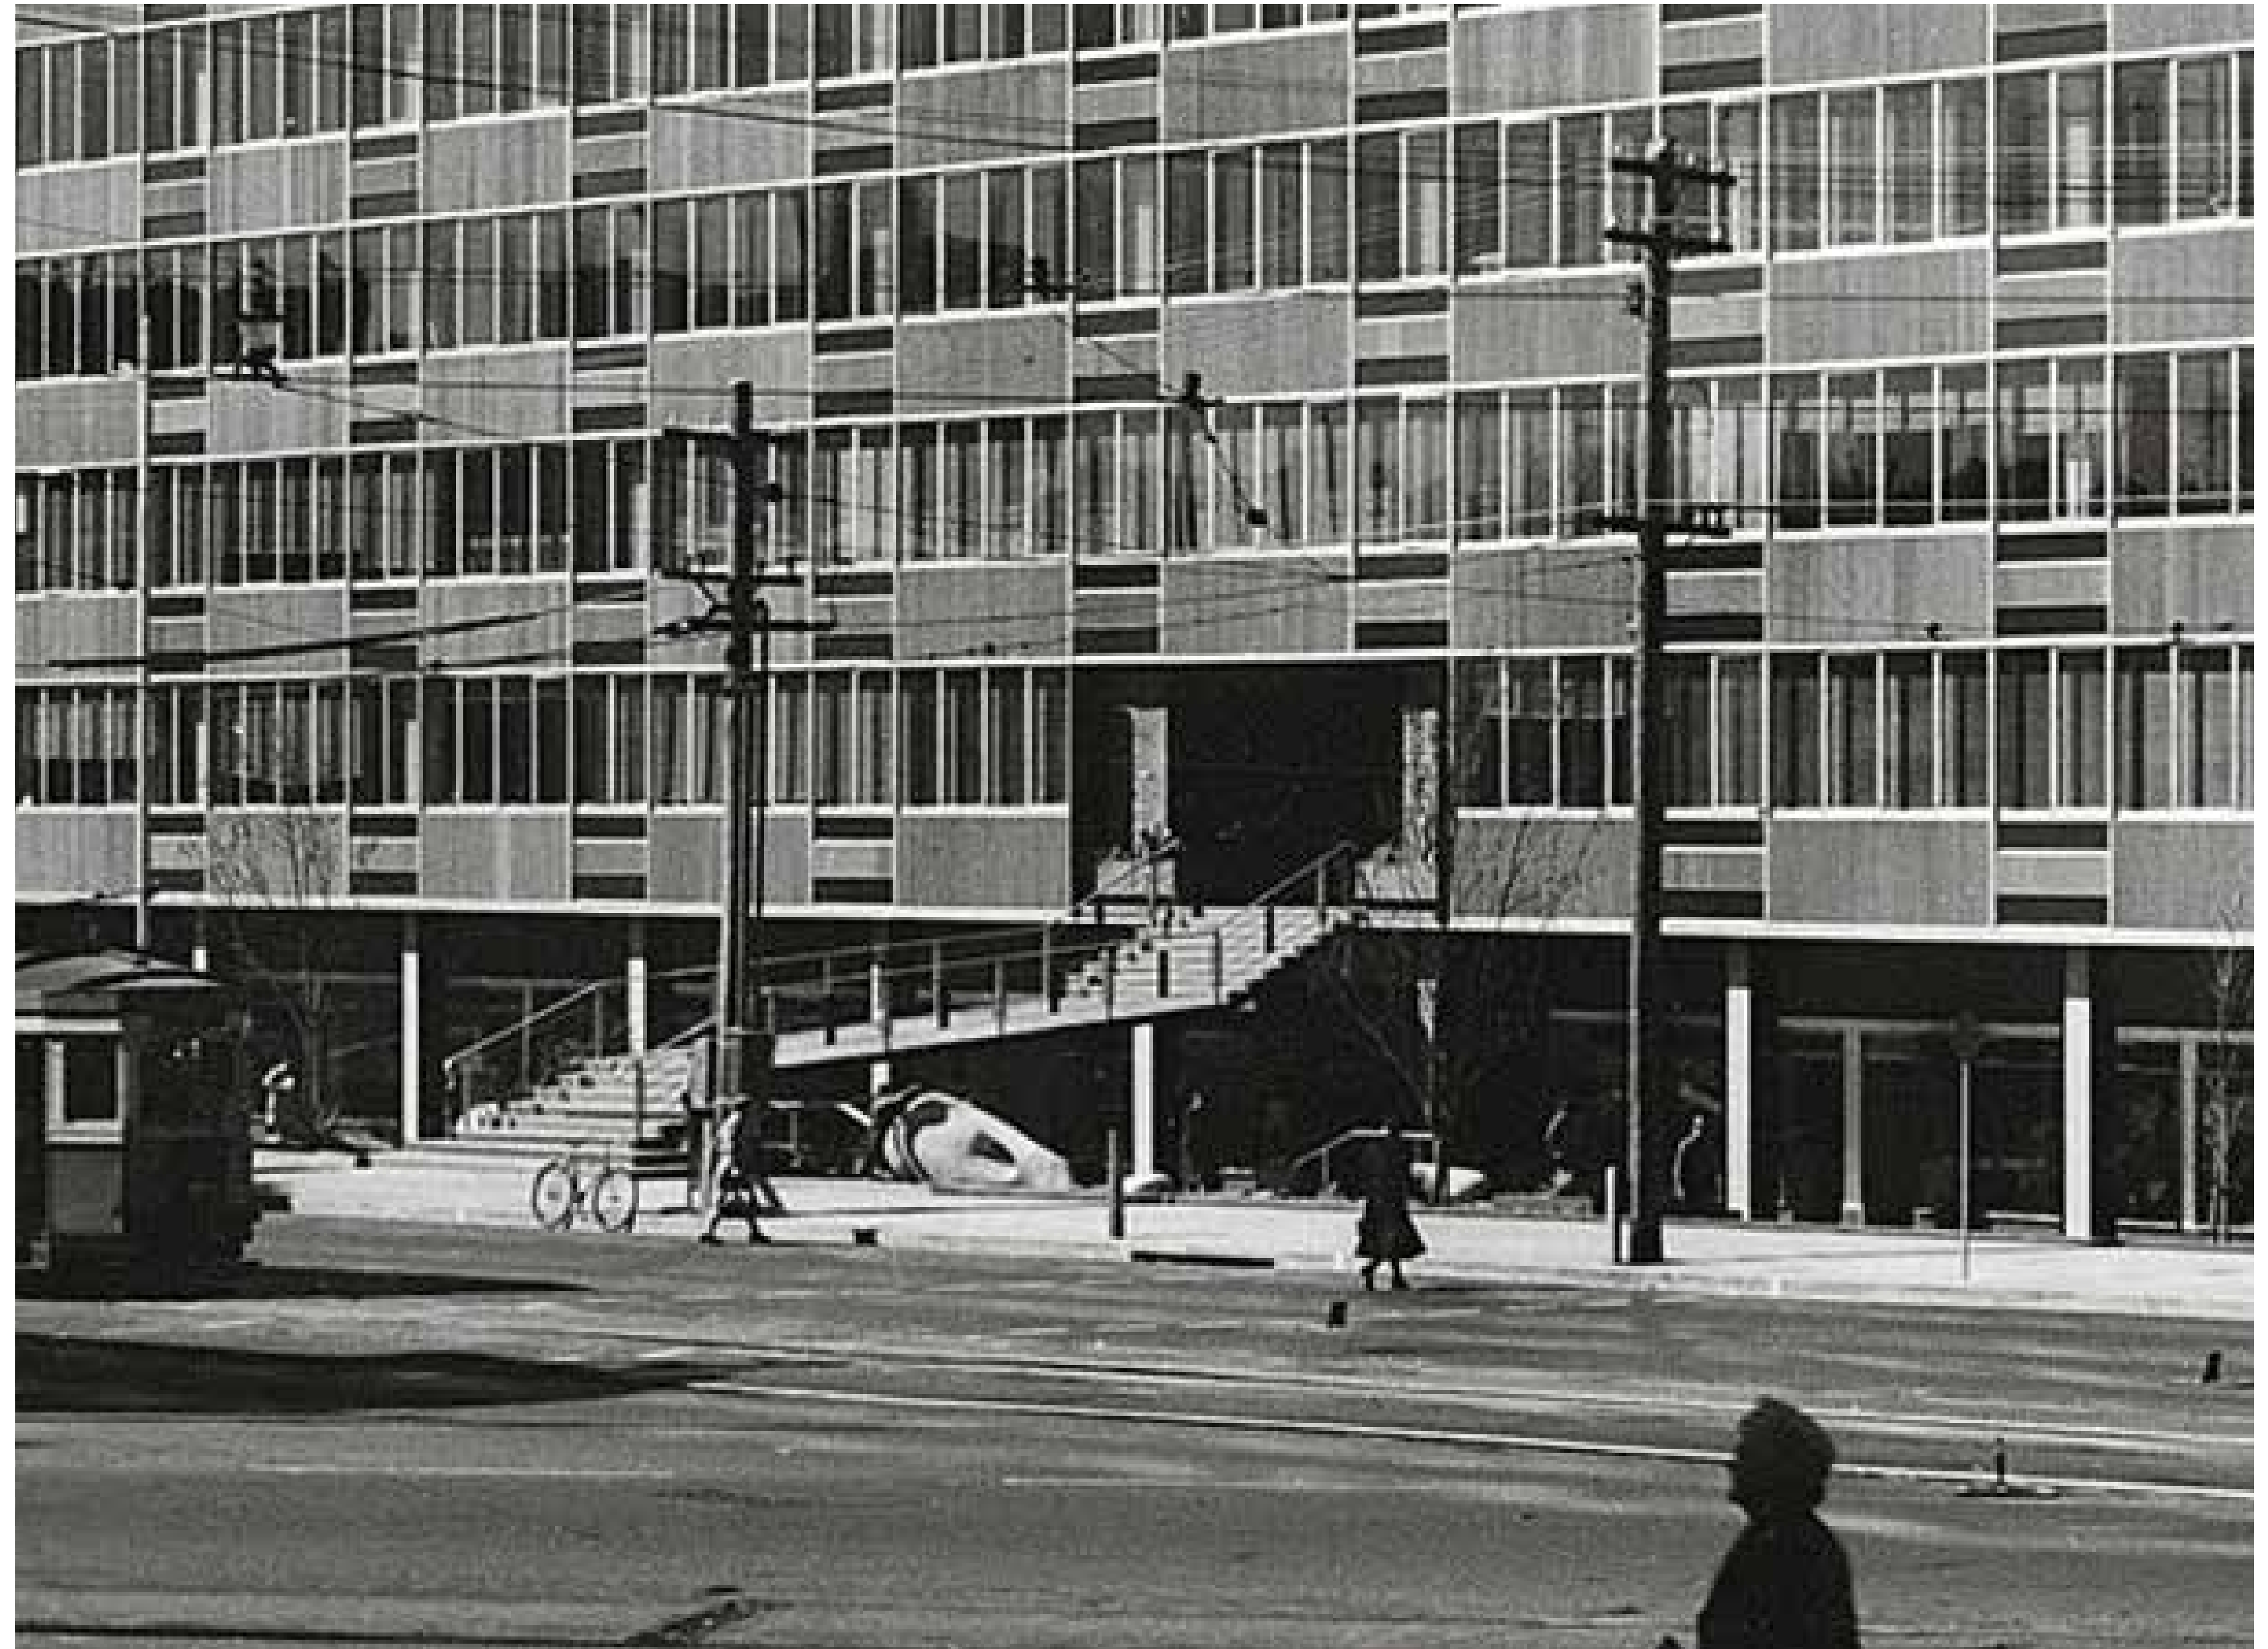
Miller St Stair

- Main entry was originally at Level 1 accessed via external stair and ramp
- Stair would not meet current accessibility code in terms of providing equitable access to the building
- Reinstatement of the stair would force the entry lobby to be located at Level 1 detached from the public realm
- A lift would be required adjacent to the stair to ensure equitable access and the stair features would need to be amended to meet AS1428.1 requirements
- The stair would dominate and overshadow the forecourt and discourage pedestrian flow through the site

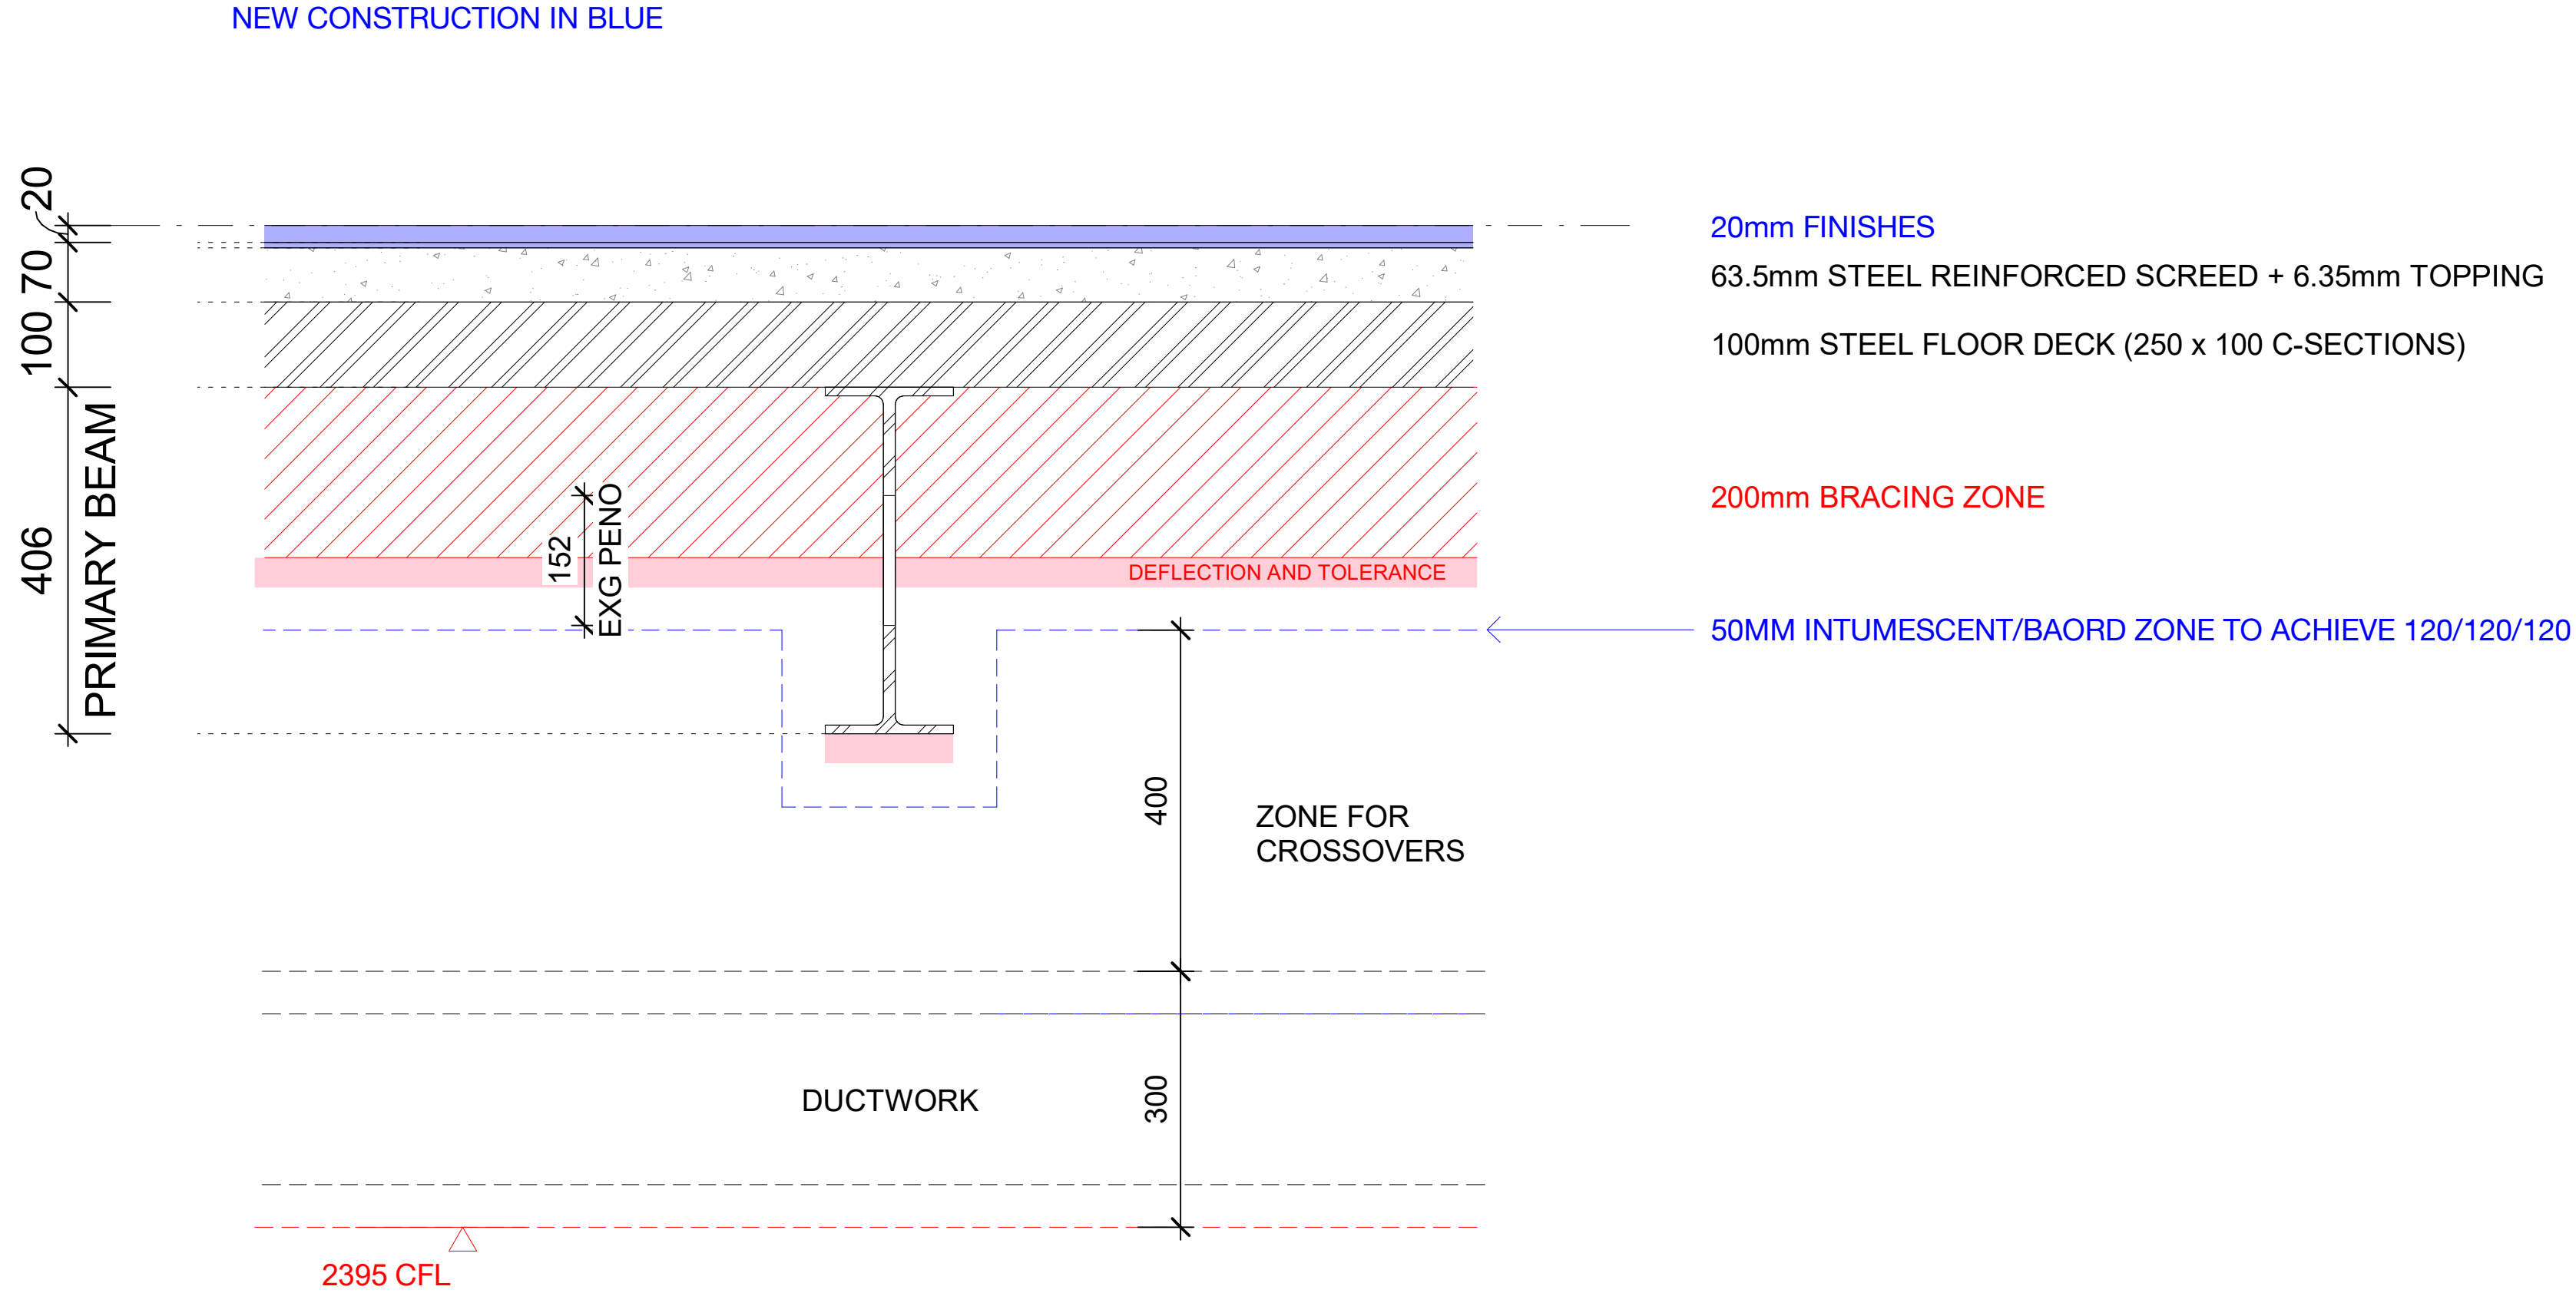
Miller St Wing Floor Slabs

Replace Slab

- Retain existing steel beams and replace steel deck and screed with new 120mm concrete slab to achieve 2hr fire rating in two directions
- Concrete slab is able to meet current code requirements for floor diaphragm and resist seismic loading
- Positioning of slab within depth of beam optimises available height and makes the target 2.7m ceiling height feasible

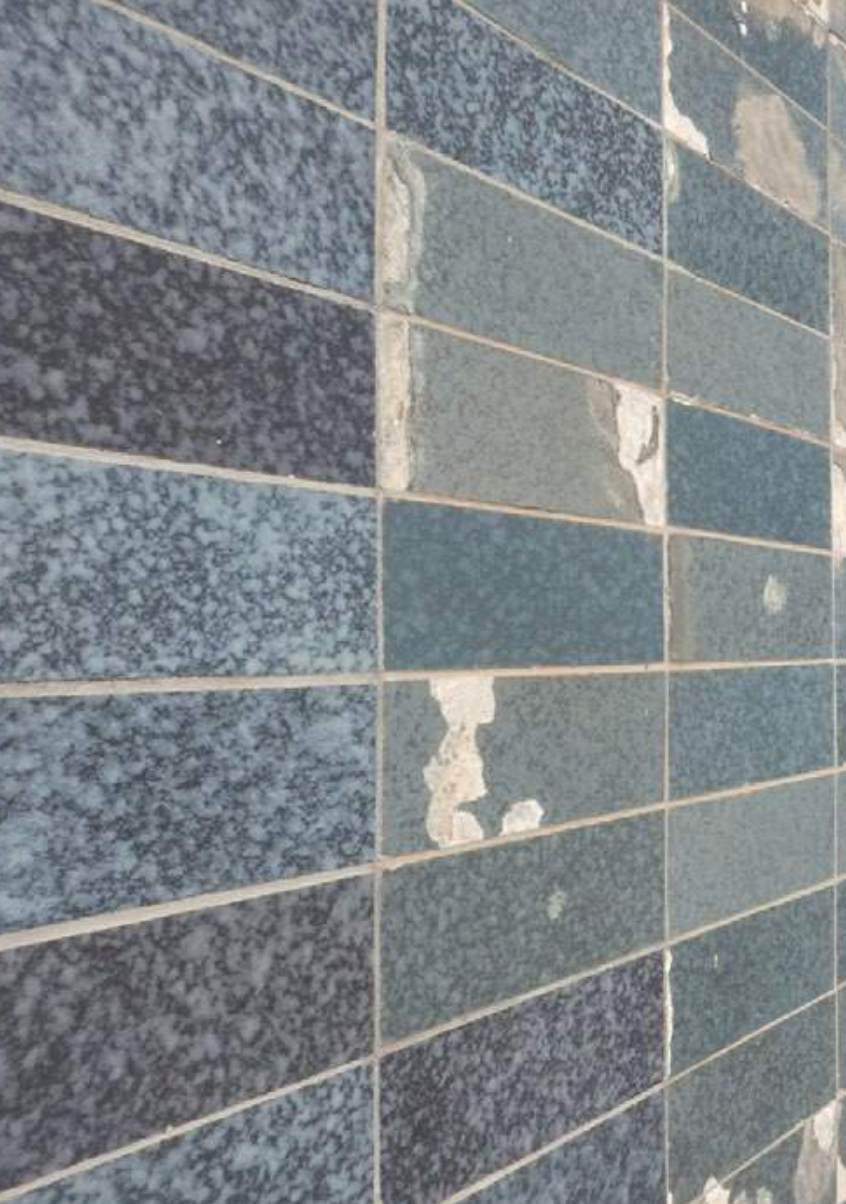
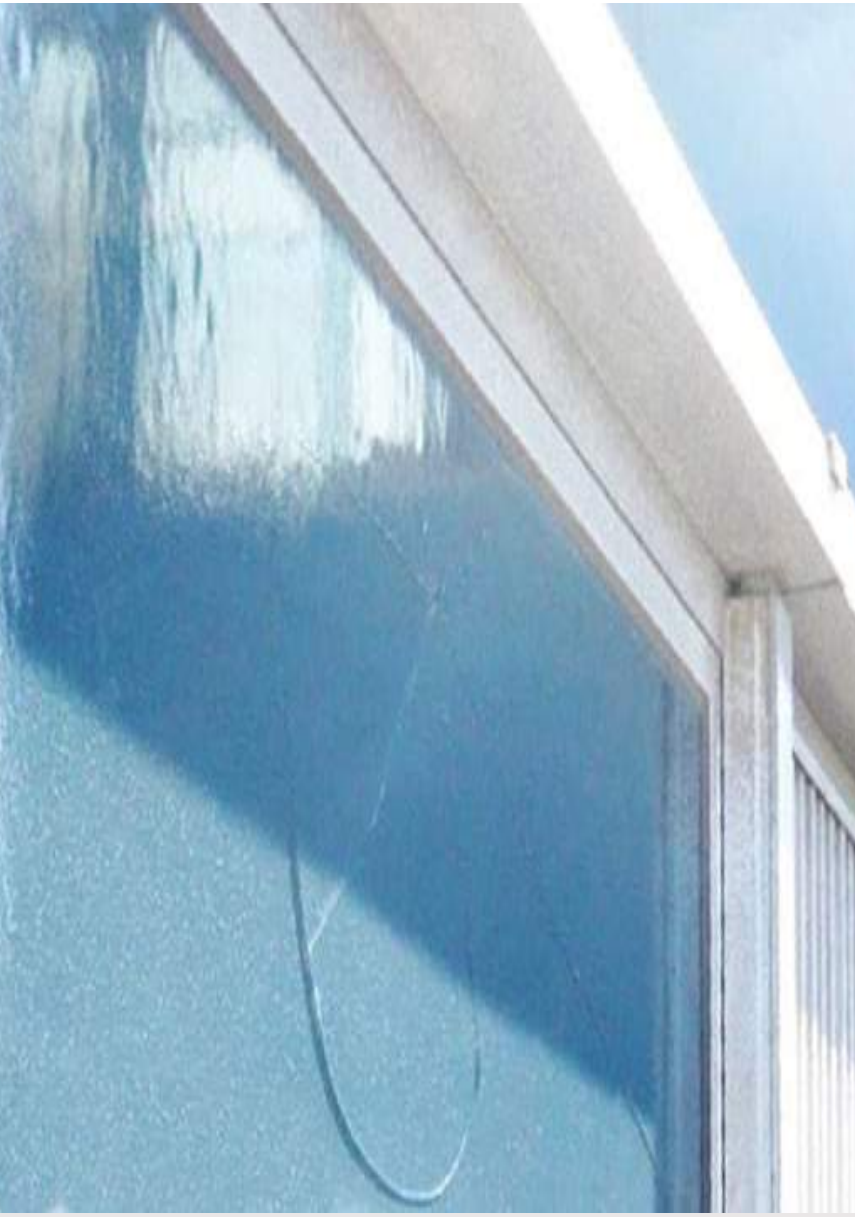
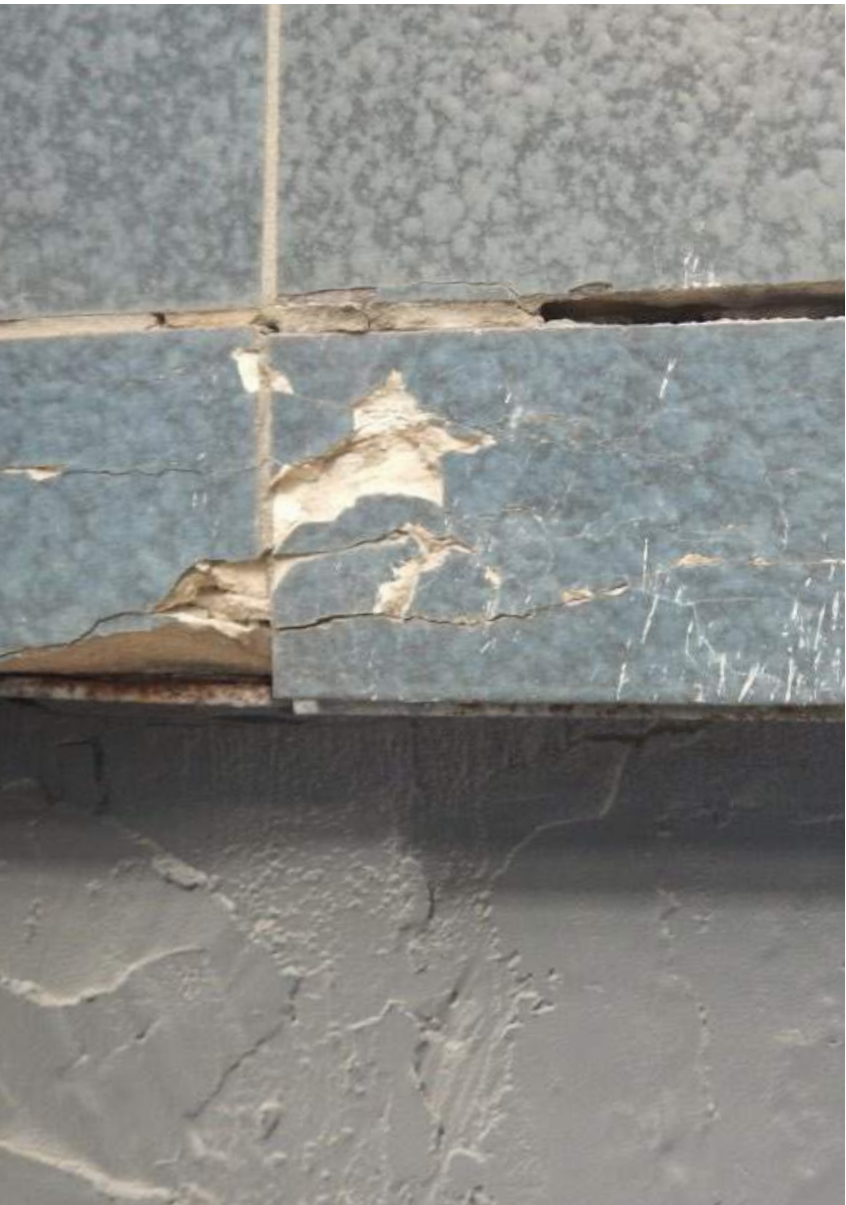
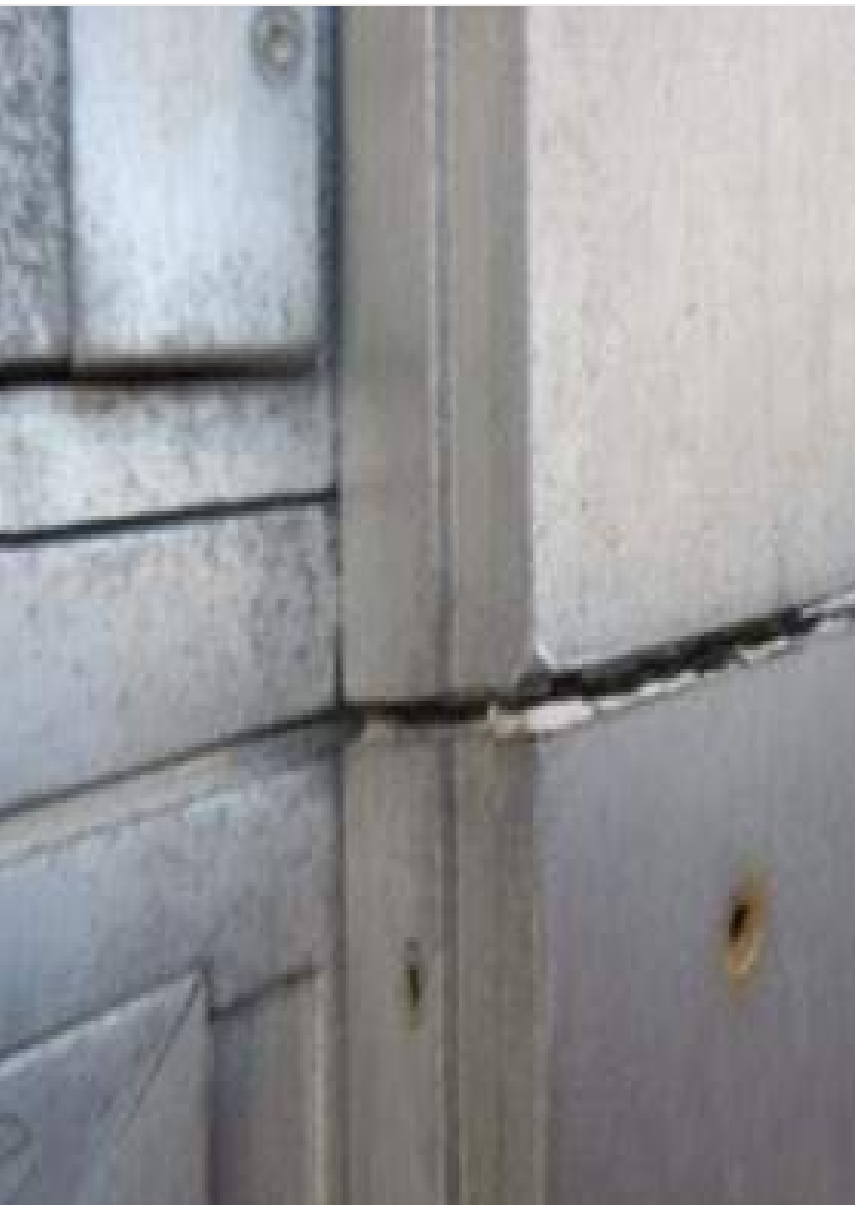
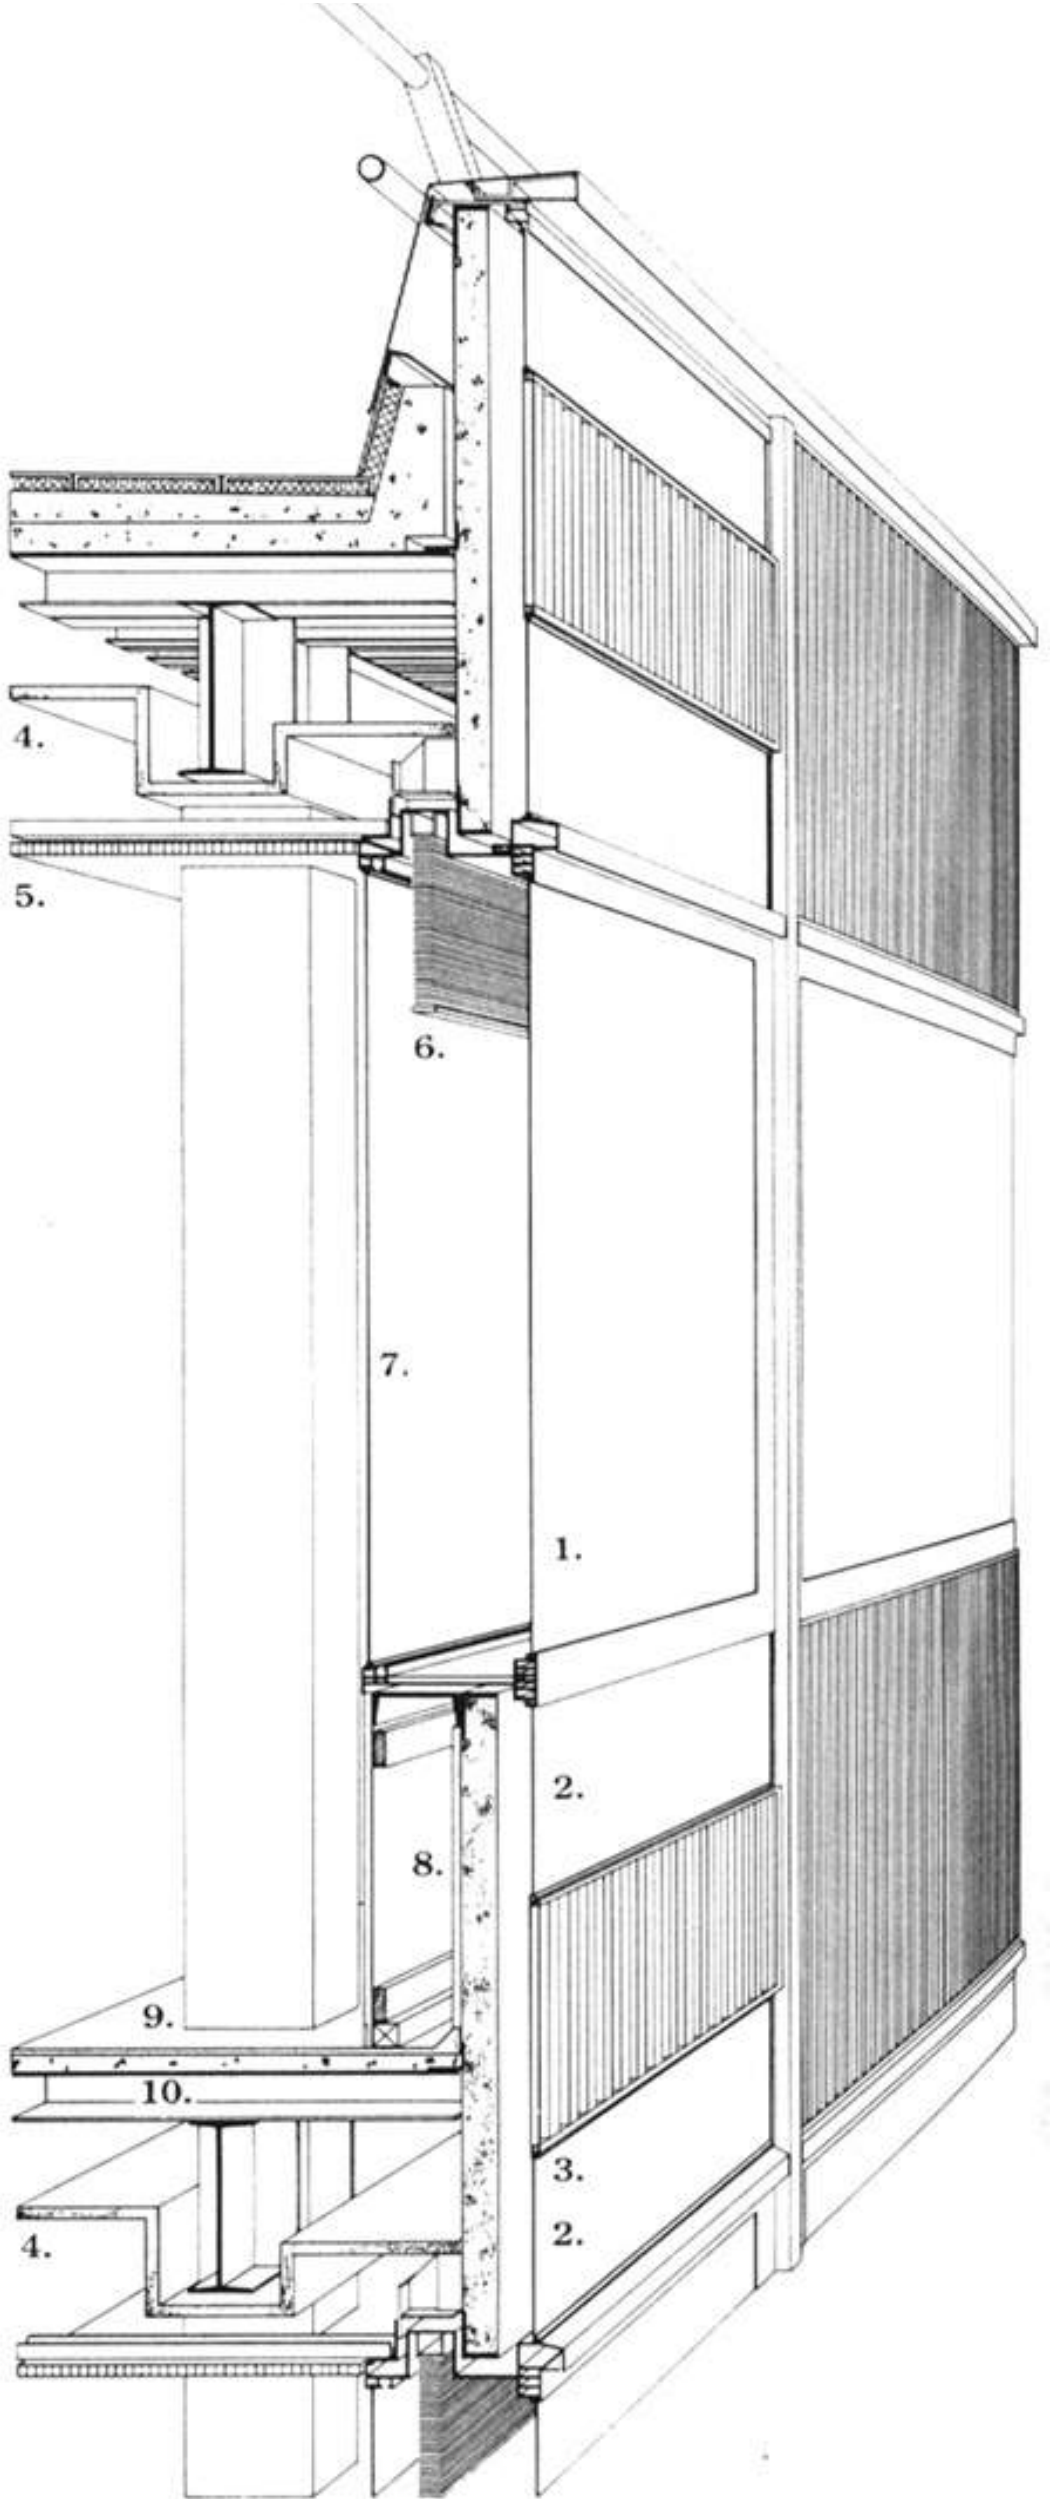
Existing Facades

Challenges and Proposals

- Challenges:
- Asbestos has been detected in seals across the curtain wall facades
 - The aluminium has corroded requiring treatment or replacement
 - The terracotta tiling to the north and south facades and core are delaminating from their substrate
 - Loose tiles have been mechanically fixed to prevent from falling which is unsightly
 - Does not meet wind load requirements
 - Does not meet BCA Section J or NABERS 5.5 energy rating which is a requirement

- Proposals:
- Full replacement of tiles and substrate with a new rainscreen system to be visually consistent with the original design intent
 - Opportunity to retain and refurbish the curtain wall facades requires further investigation

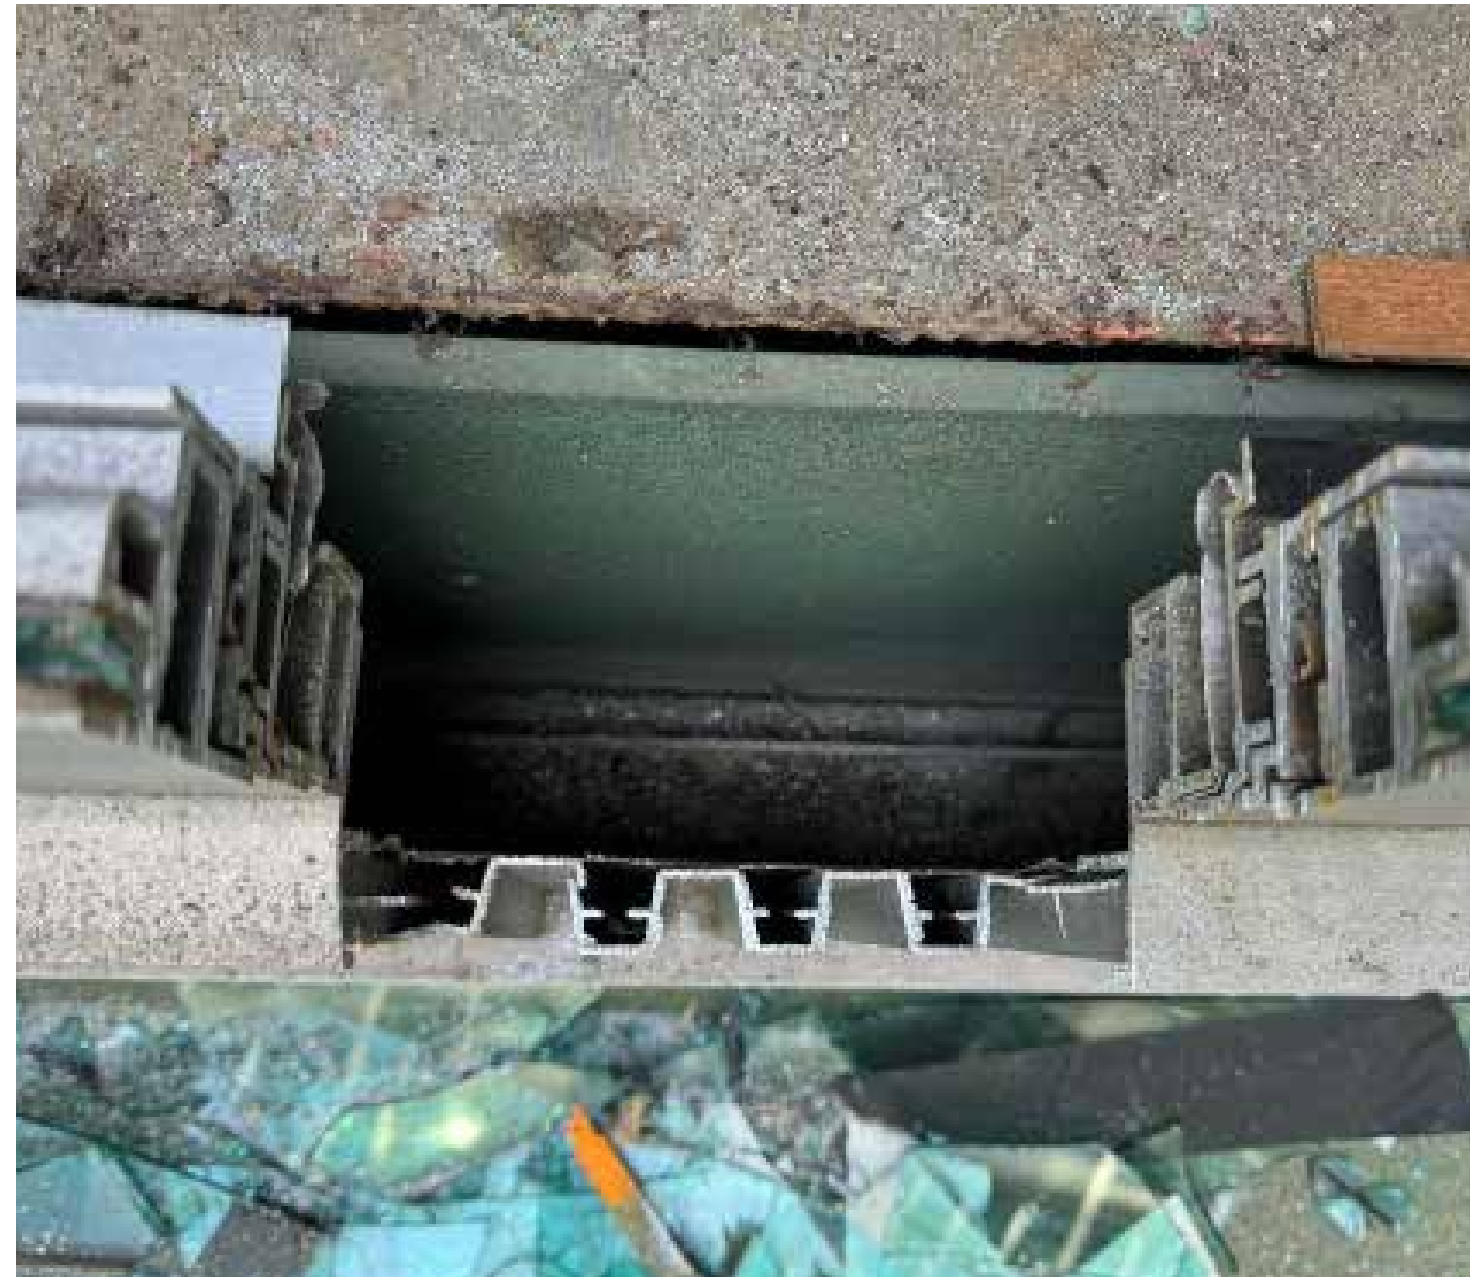
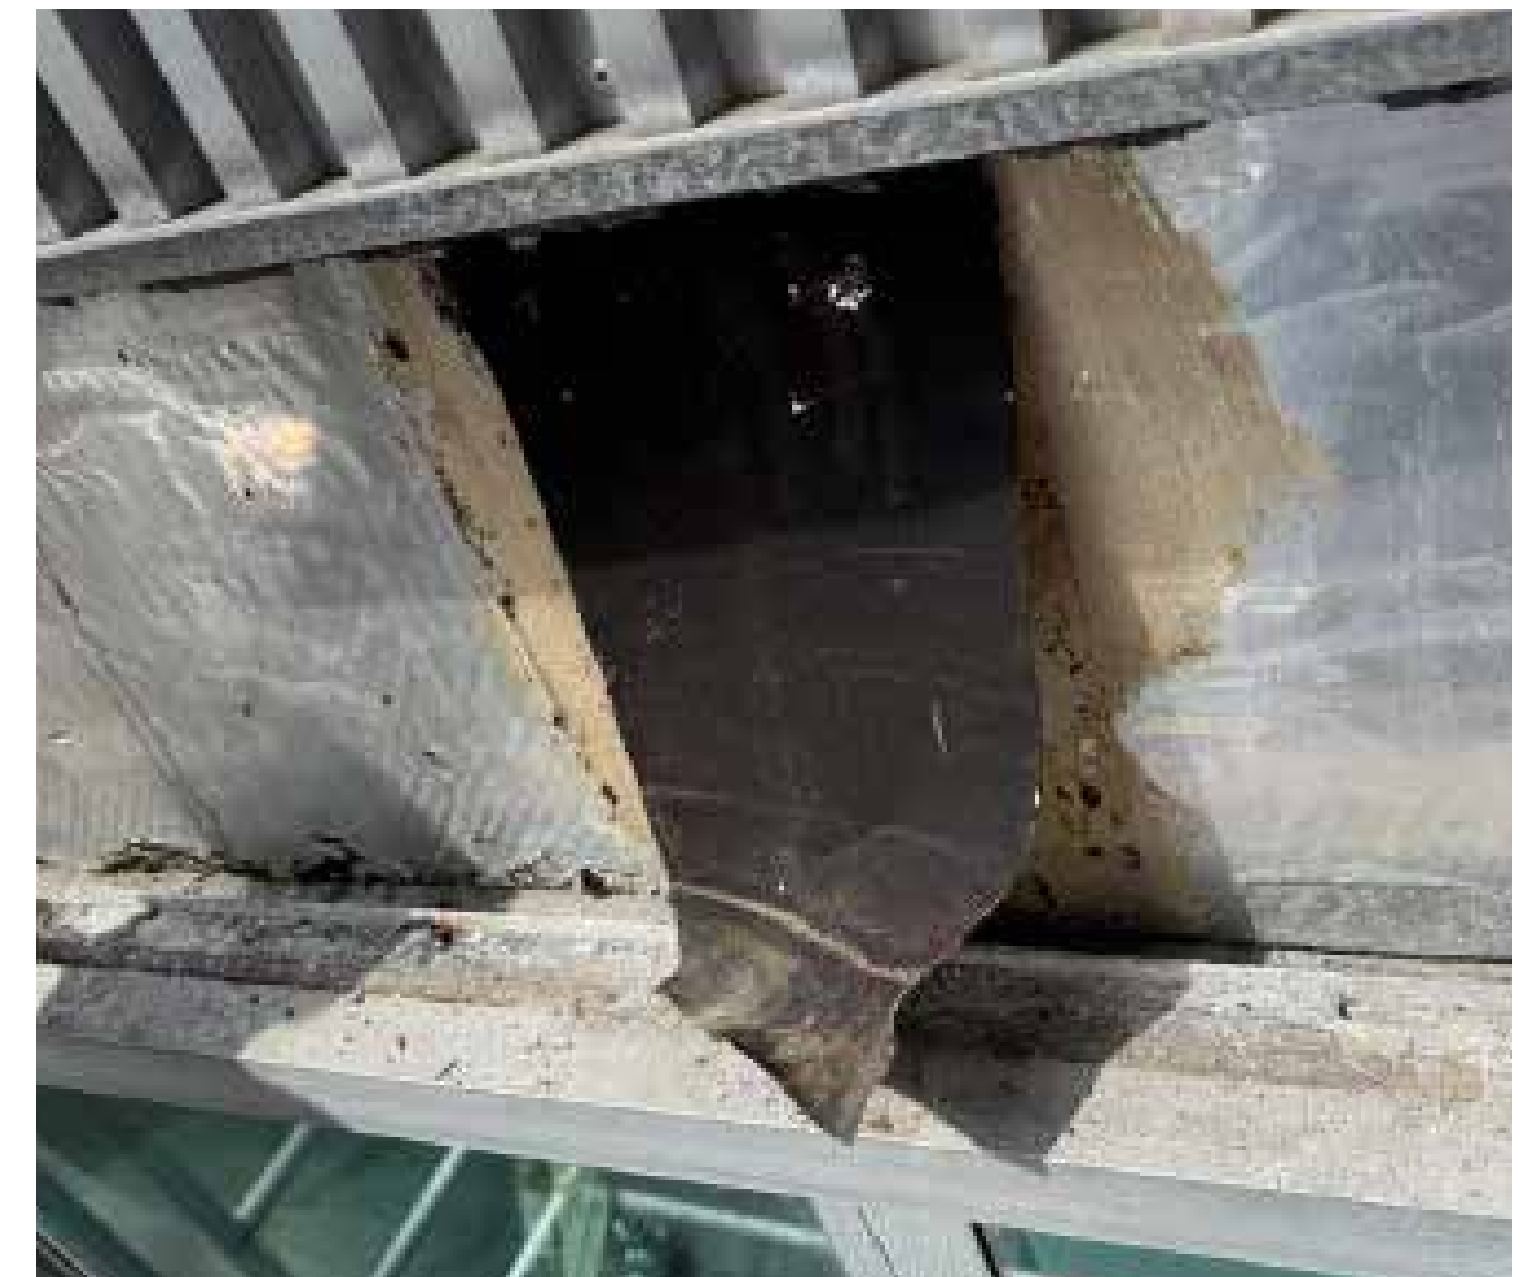
Miller St Wing Curtain Wall

Site Investigations

- Window frames are made of **unsealed interlocking extrusions** that don't provide fully weathertight joints. The system **will not comply with the BCA or AS/NZ 4284** for weatherproofing and without a weather tight façade, the development **will not be able to achieve the statutory sustainability targets**, specifically a GBCA 5 Star rating and 5.5 NABERS Energy Rating

- Existing spandrel panels have **damaged foil, dislodged junction flashing and unsealed flashing** in some locations which is **leading to water ingress and corrosion**. If the façade is not weathertight the project will be unable to achieve the statutory sustainability targets

- **Metal back pans** have been installed in some locations and **plastic sheets** have also been installed behind corrugated metal cladding, **none are in a good state of repair** or are suitable to satisfy weather tightness

- Risk of water ingress presents an **insurance risk** and will reduce lifespan of long-term maintenance works

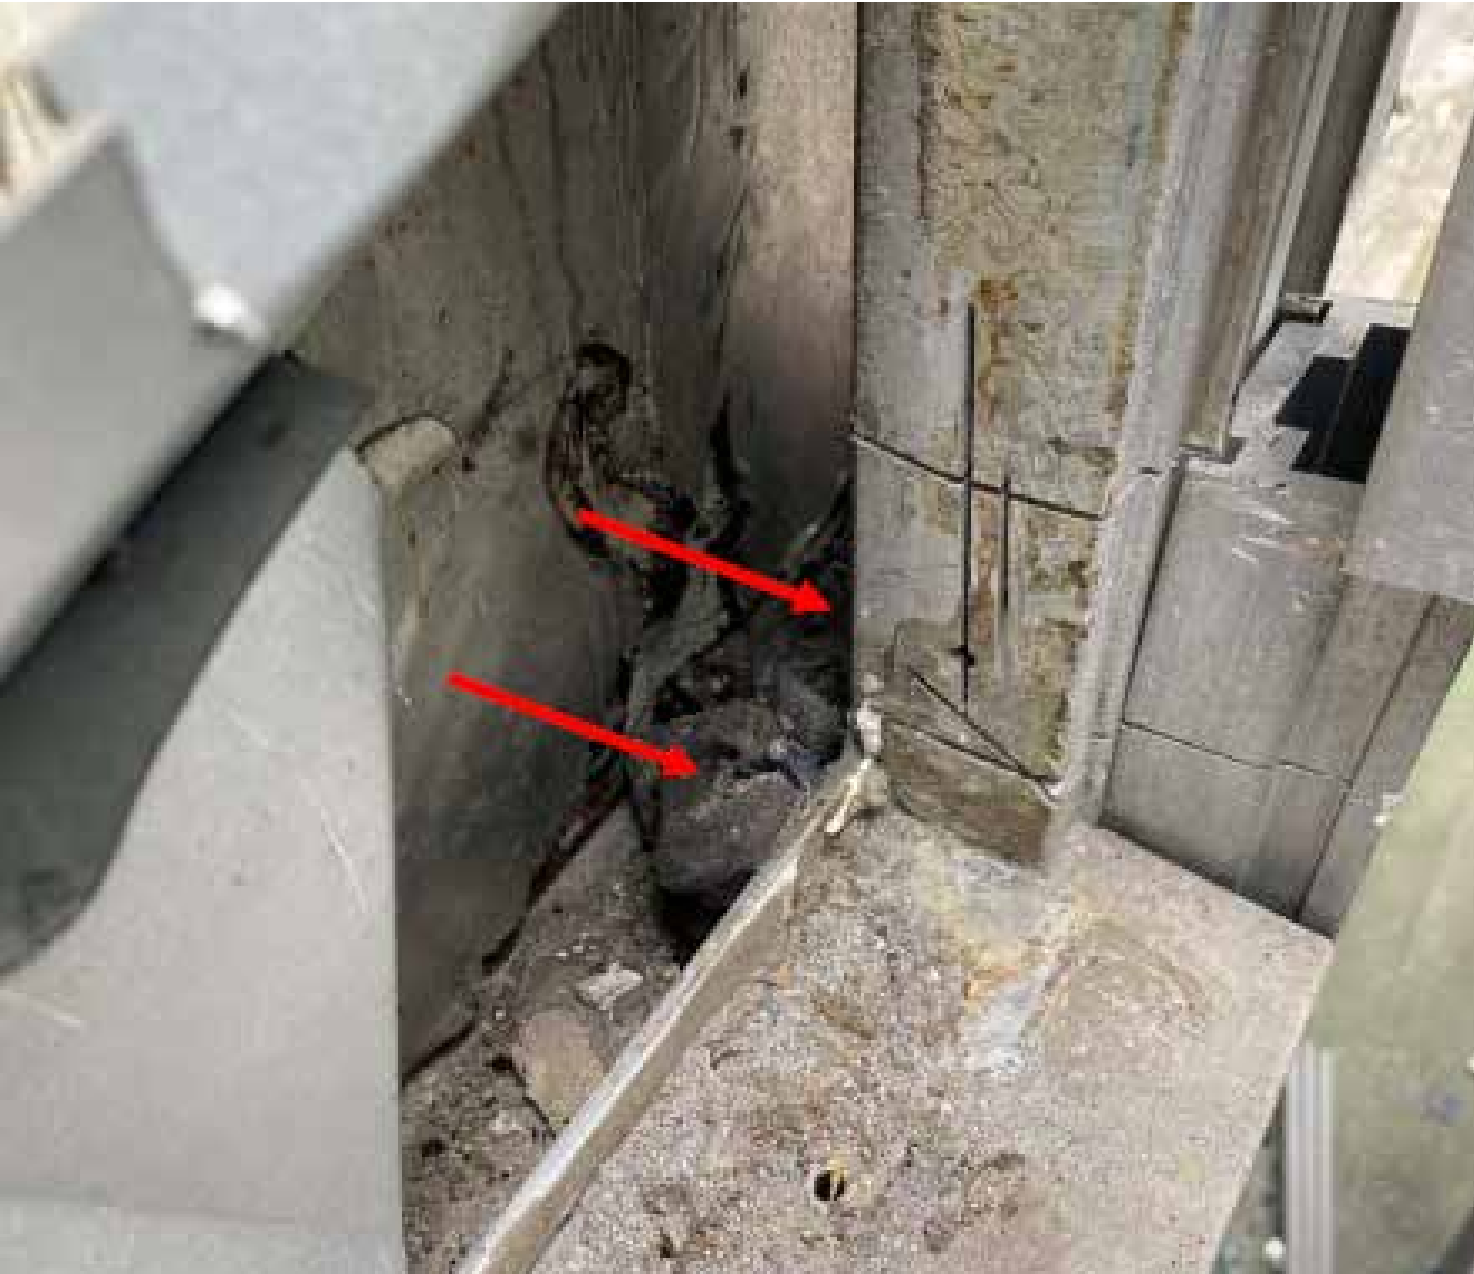
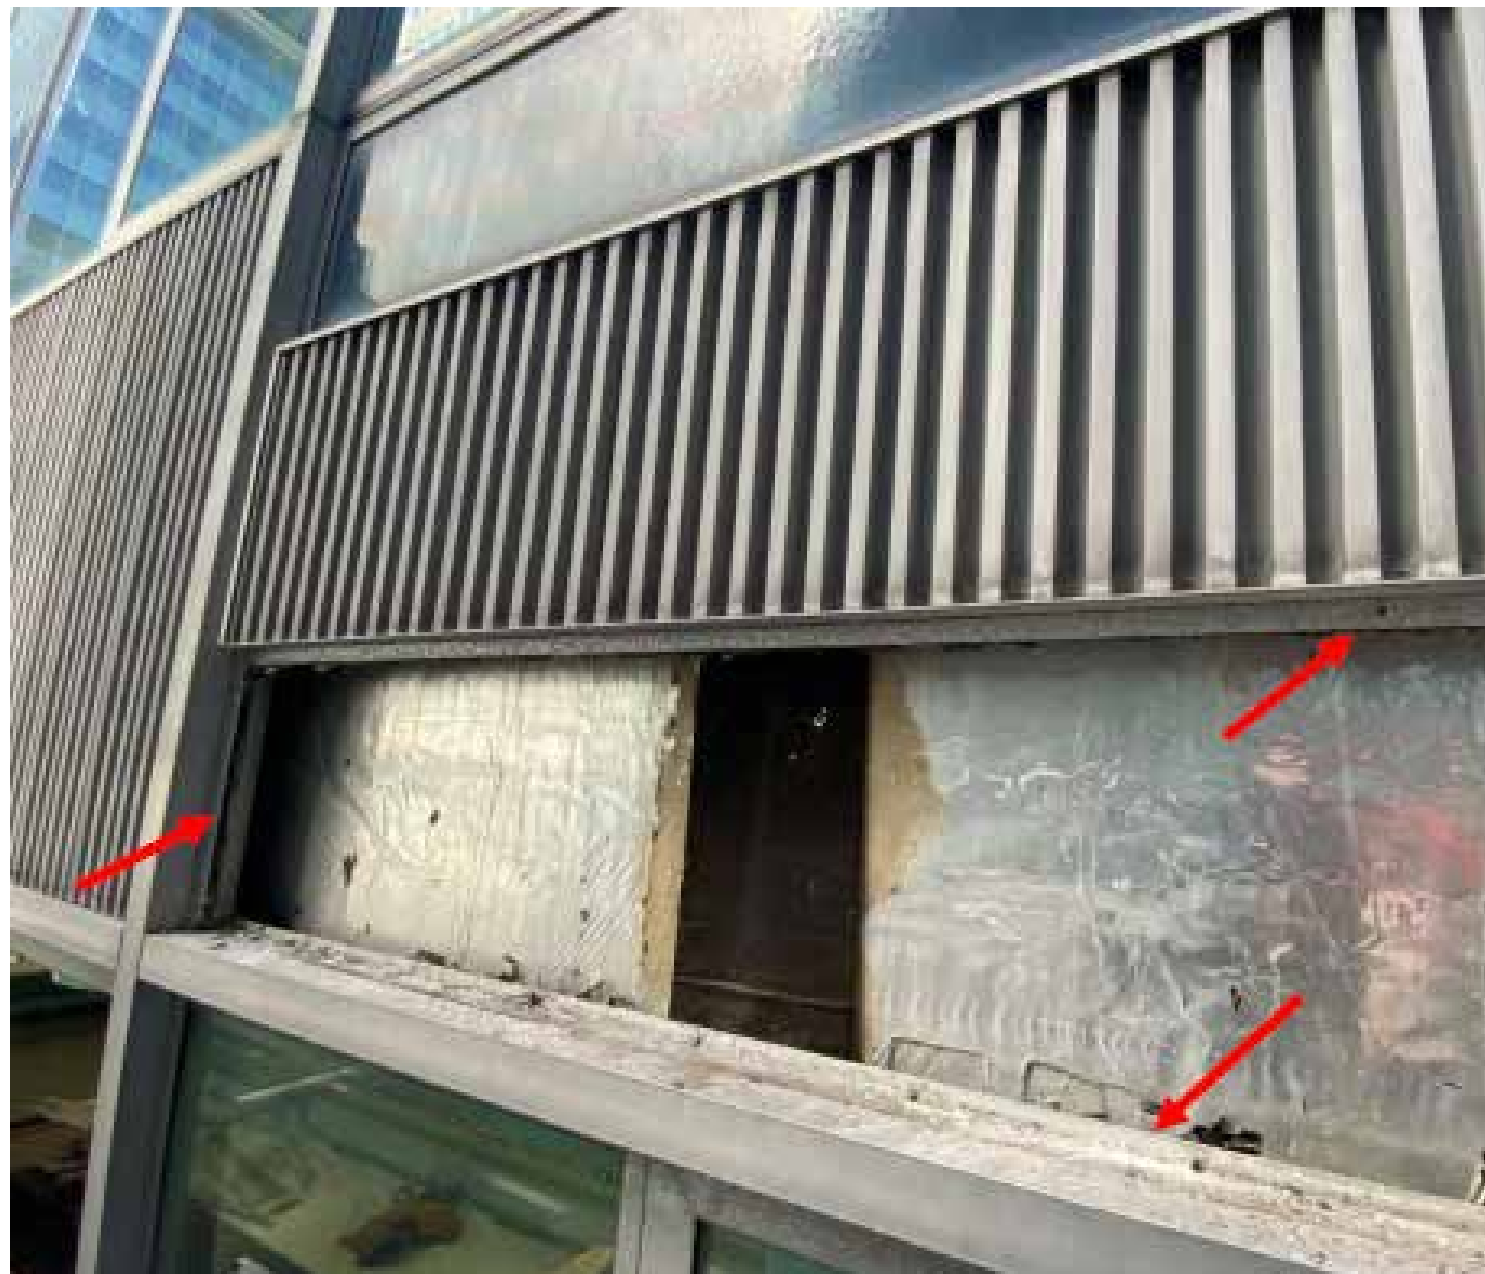
Site Investigations

Contamination and Corrosion

- Testing has verified the **widespread presence of asbestos**-containing material in the mastic sealant requiring a licenced asbestos removal specialist to undertake any repair works, including glass replacement

- The external glass has been glazed into the window frames on all sides, testing of the sealant has confirmed that it contains asbestos, as a result any glass replacement would require a licenced asbestos removal specialist to undertake the work

- Aluminium surfaces have deteriorated with pitting corrosion evident throughout. The surface pitting is not reparable, it can be managed, but further deterioration in the surface finish would be expected in the medium to long term
